**REPORT NUMBER: NCAP-MGA-2006-005**

**NEW CAR ASSESSMENT PROGRAM  
FRONTAL BARRIER IMPACT TEST**

**FORD MOTOR COMPANY  
2006 FORD FUSION  
NHTSA NUMBER: M60203**

**PREPARED BY:  
MGA RESEARCH CORPORATION  
5000 WARREN ROAD  
BURLINGTON, WI 53105**

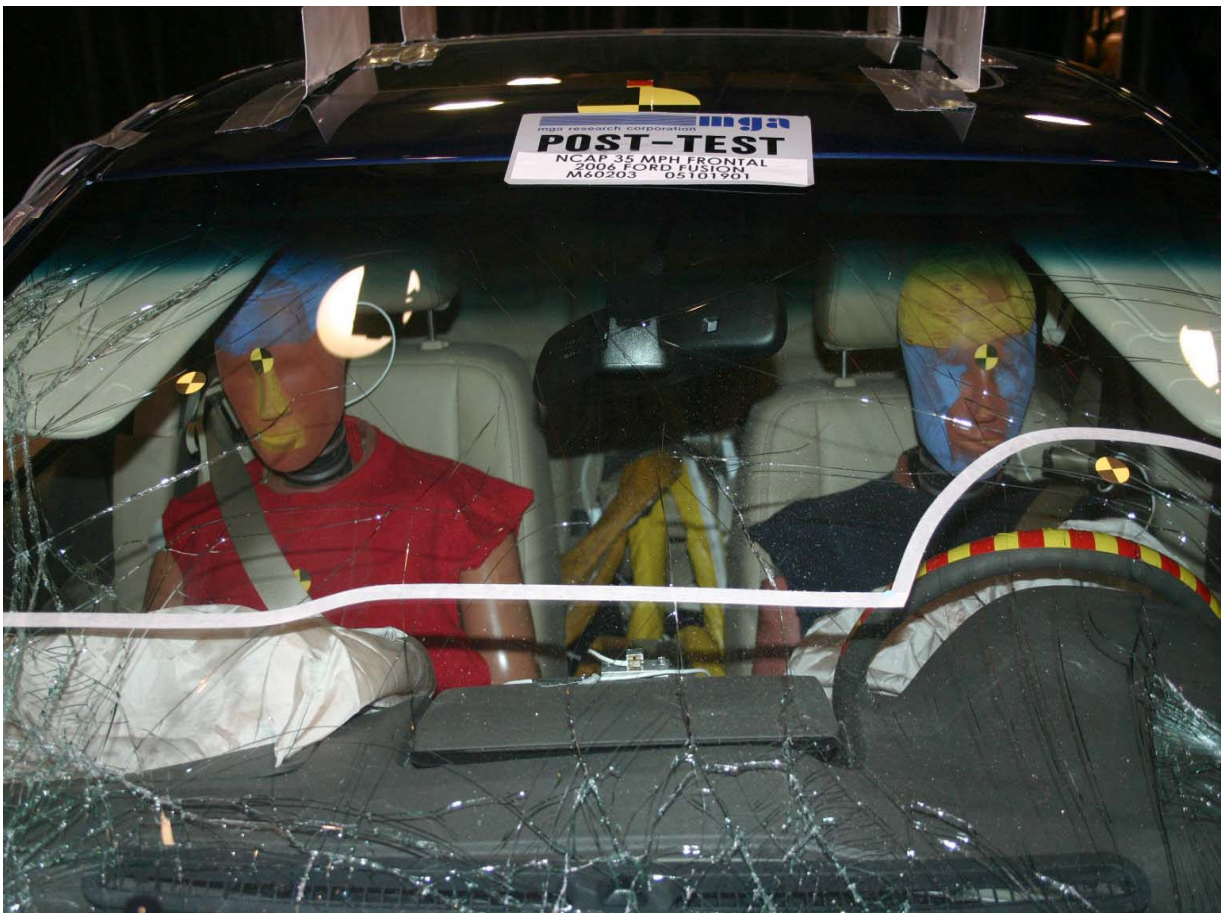
There was 100 percent windshield retention and no intrusion into the protected zone of the windshield during the event. There was no Stoddard Solvent leakage after the event or during any phase of the static rollover.

Post-Test Windshield View

| Description | Driver | Passenger |
|---|---|---|
| Glazing Damage | The windshield cracked | |

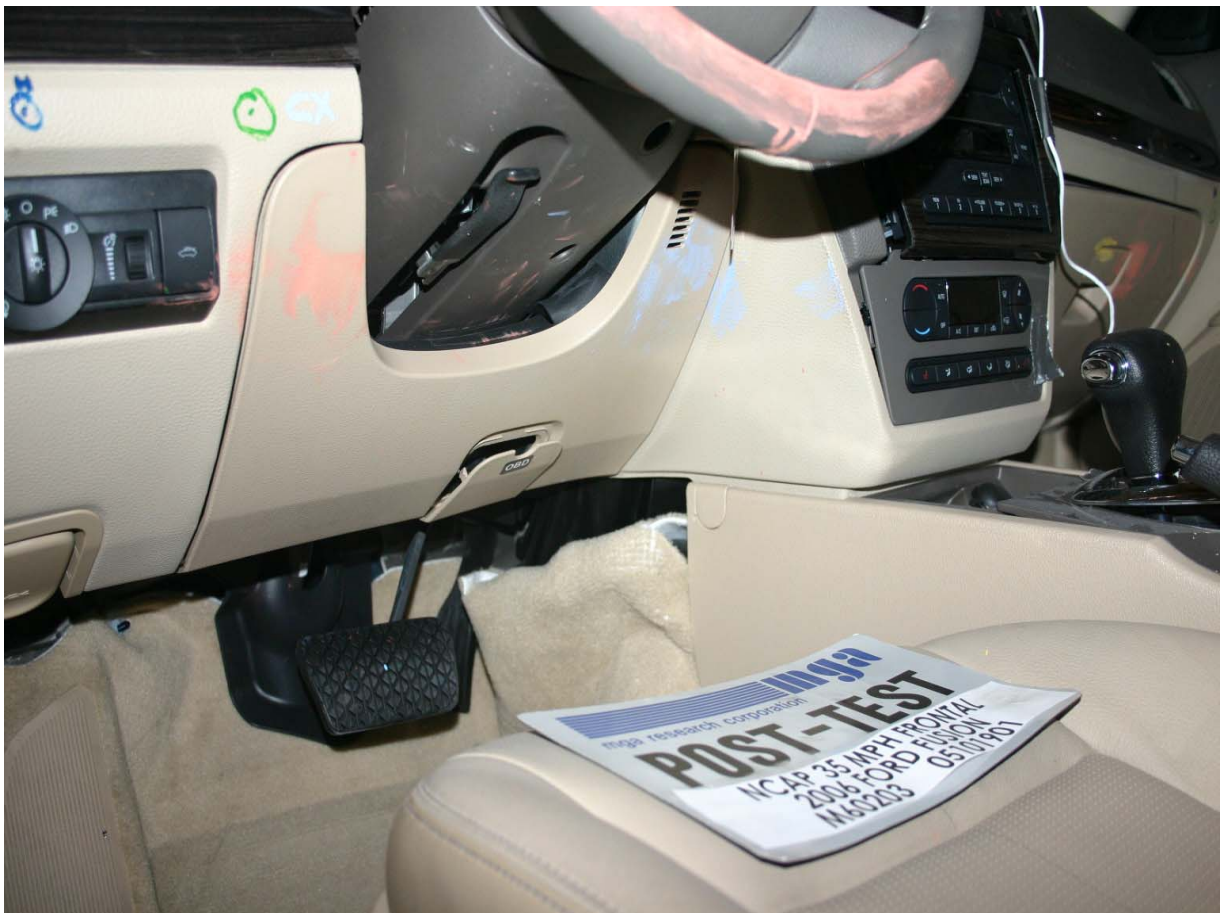
The driver's head, chest, and abdomen contacted the airbag. The driver's head also contacted the headrest. The driver's knees contacted the bolster. The passenger's head and chest contacted the airbag. The passenger's head also contacted side header. The passenger's knees contacted the glove box.

Post-Test Driver Dummy Knee Contact

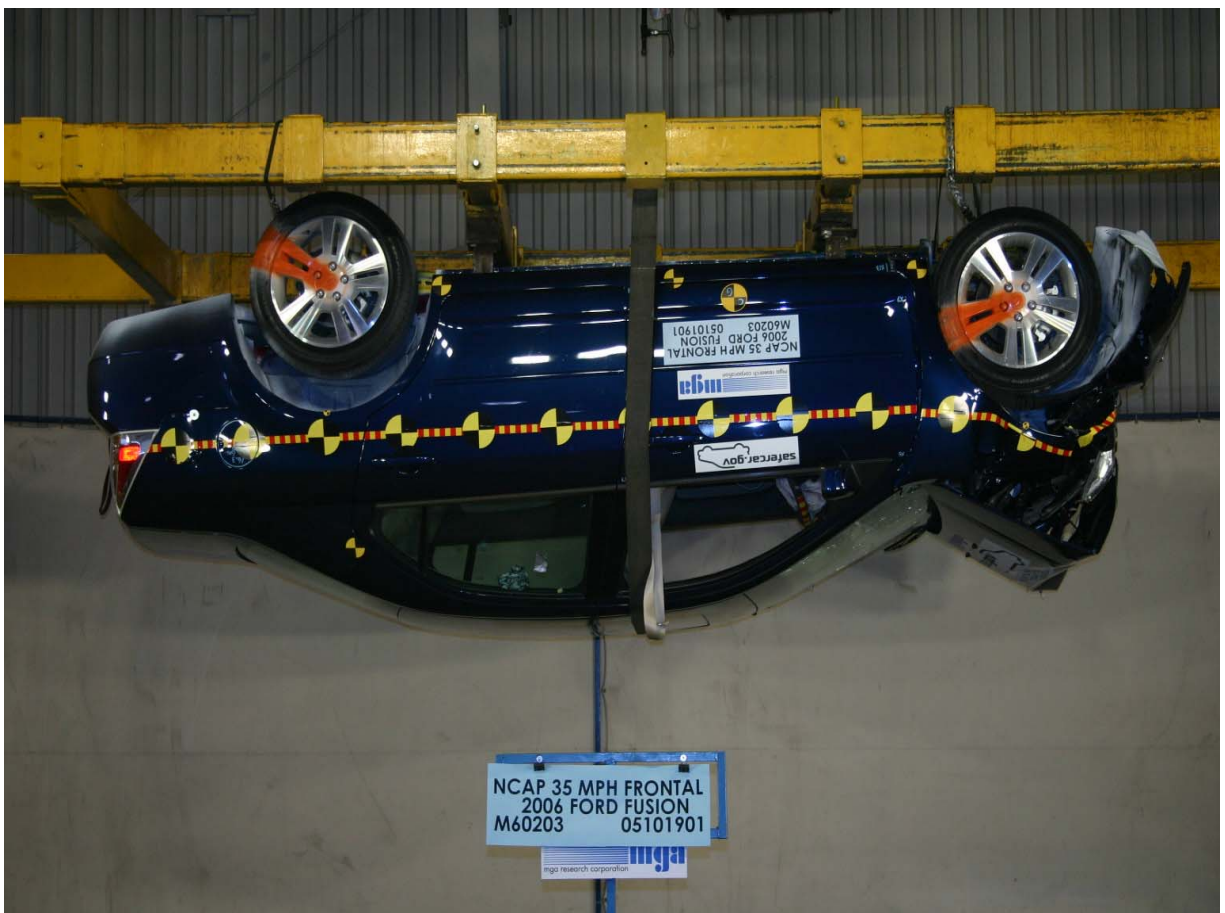
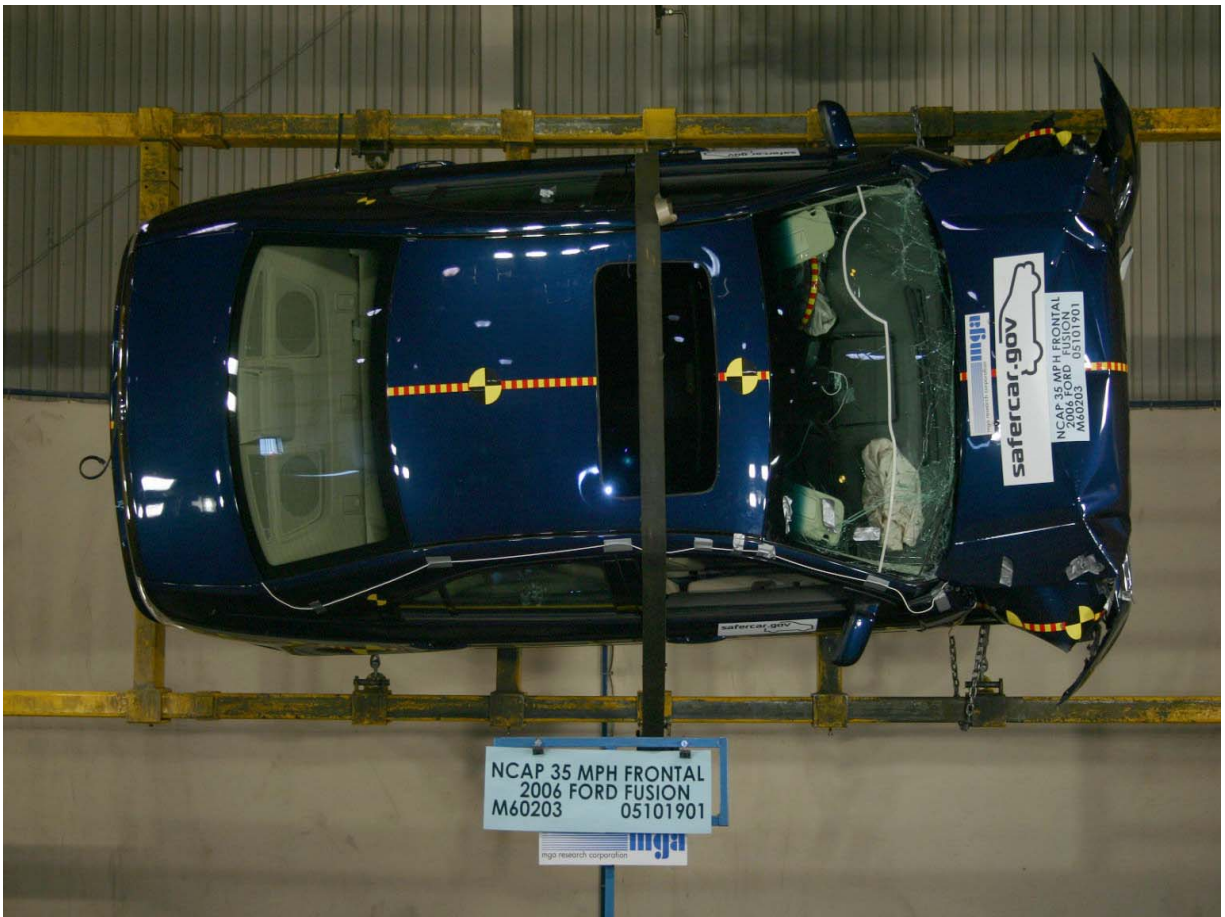
Vehicle on Rollover Device at 90 Degrees

Vehicle on Rollover Device at 180 Degrees

Vehicle on Rollover Device at 270 Degrees

Vehicle on Rollover Device at 360 Degrees

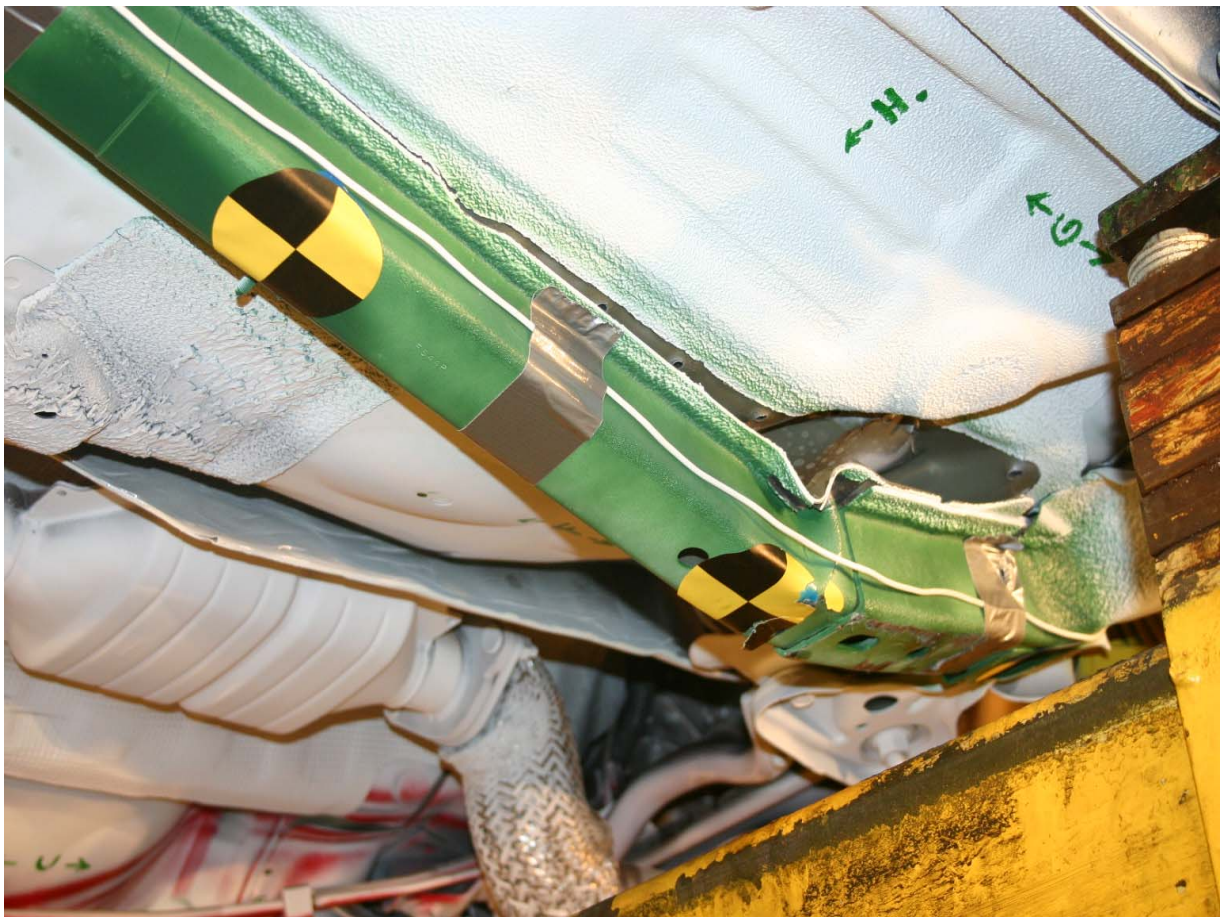
There was separation of the unibody on the right side of the vehicle located about 140mm behind the right side of the engine crossmember. The length of separation was approximately 465mm and was 60mm at the widest point.

Unibody Separation
