**REPORT NUMBER TR-P26001-02-NC**

**NEW CAR ASSESSMENT PROGRAM  
FRONTAL BARRIER IMPACT TEST**

**GENERAL MOTORS OF CANADA LTD.  
2006 CHEVROLET IMPALA SEDAN  
4-DOOR SEDAN**

**NHTSA NUMBER: M60110**

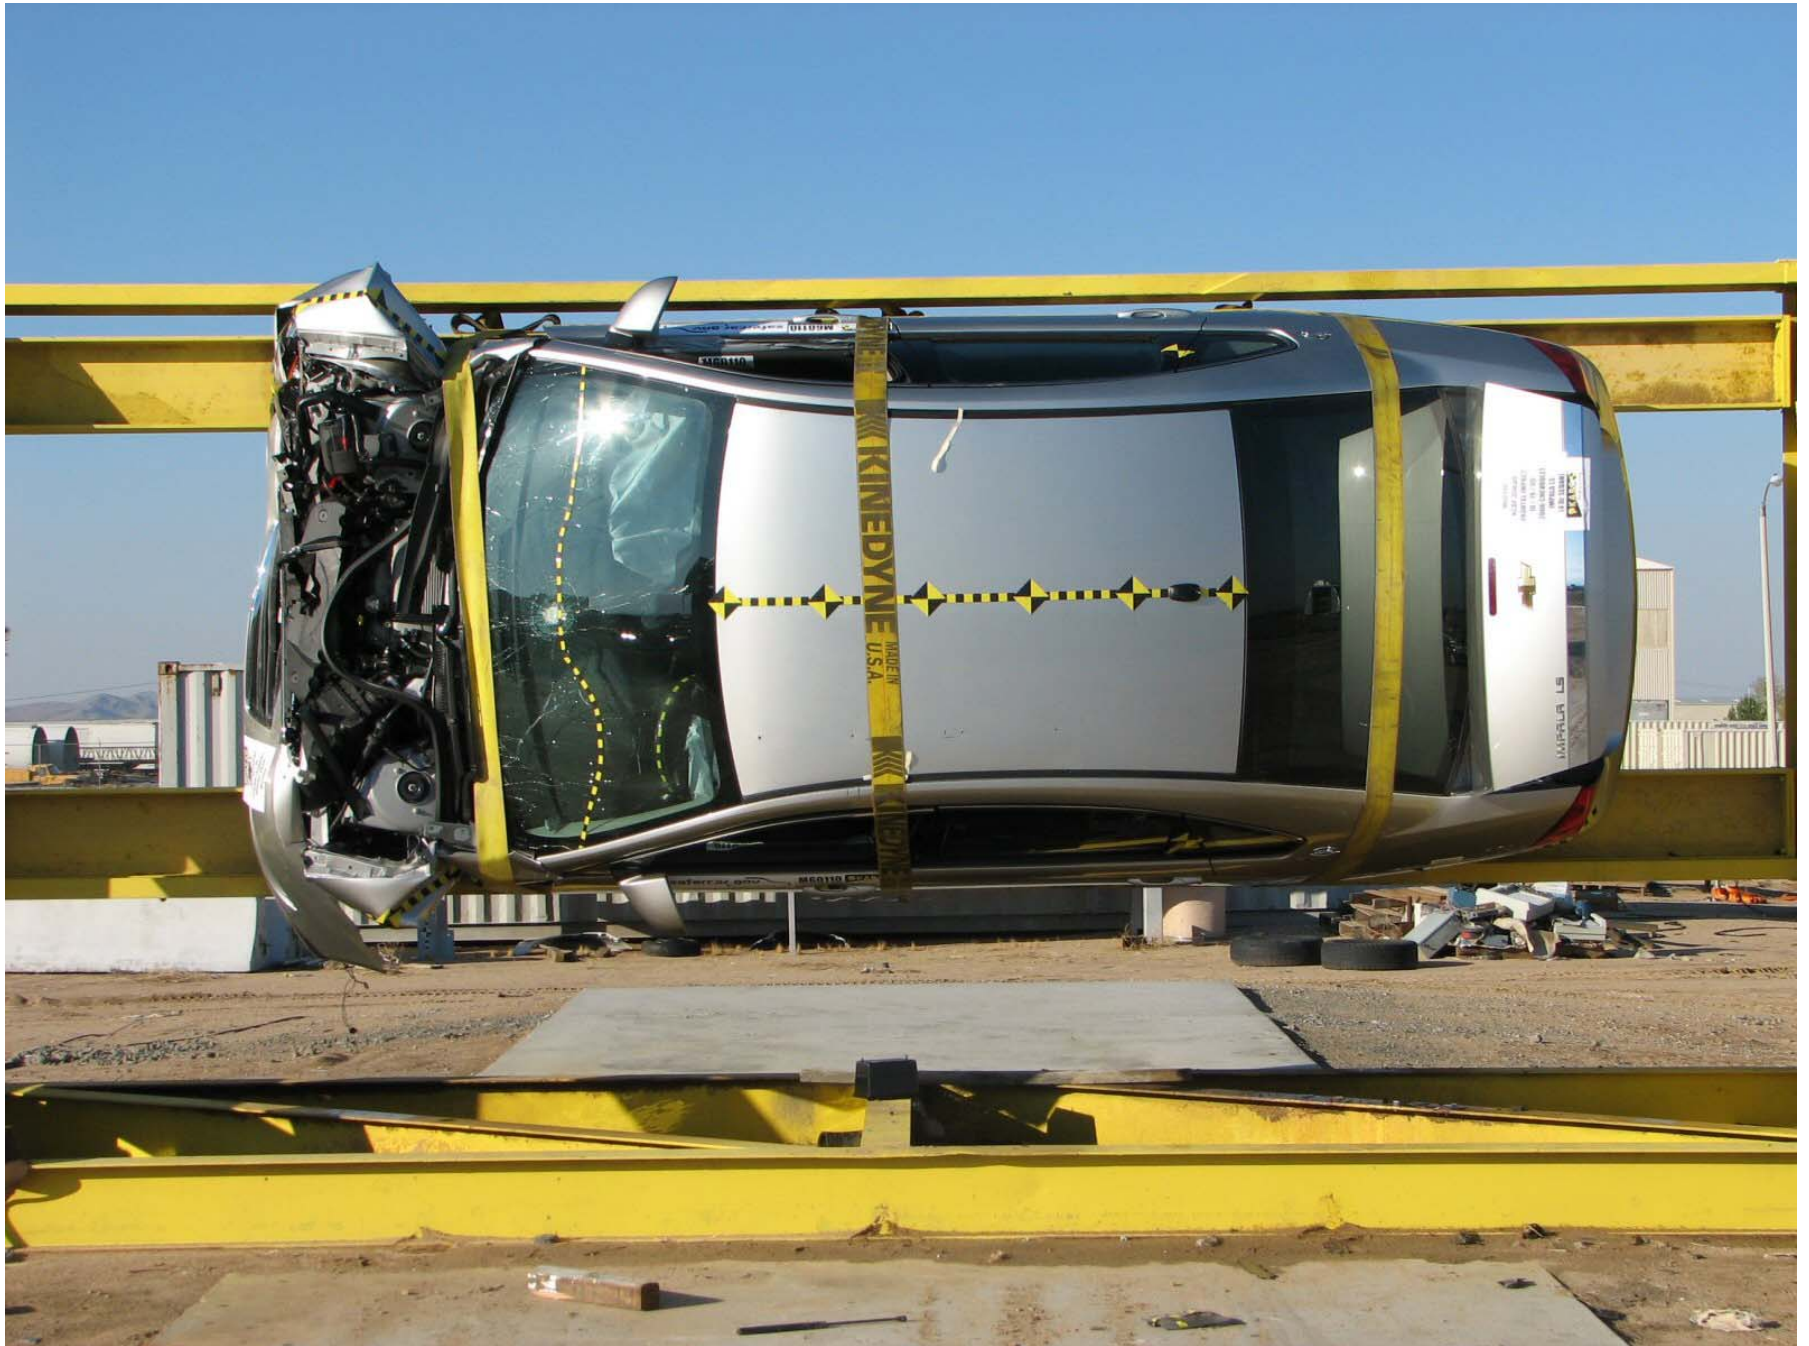
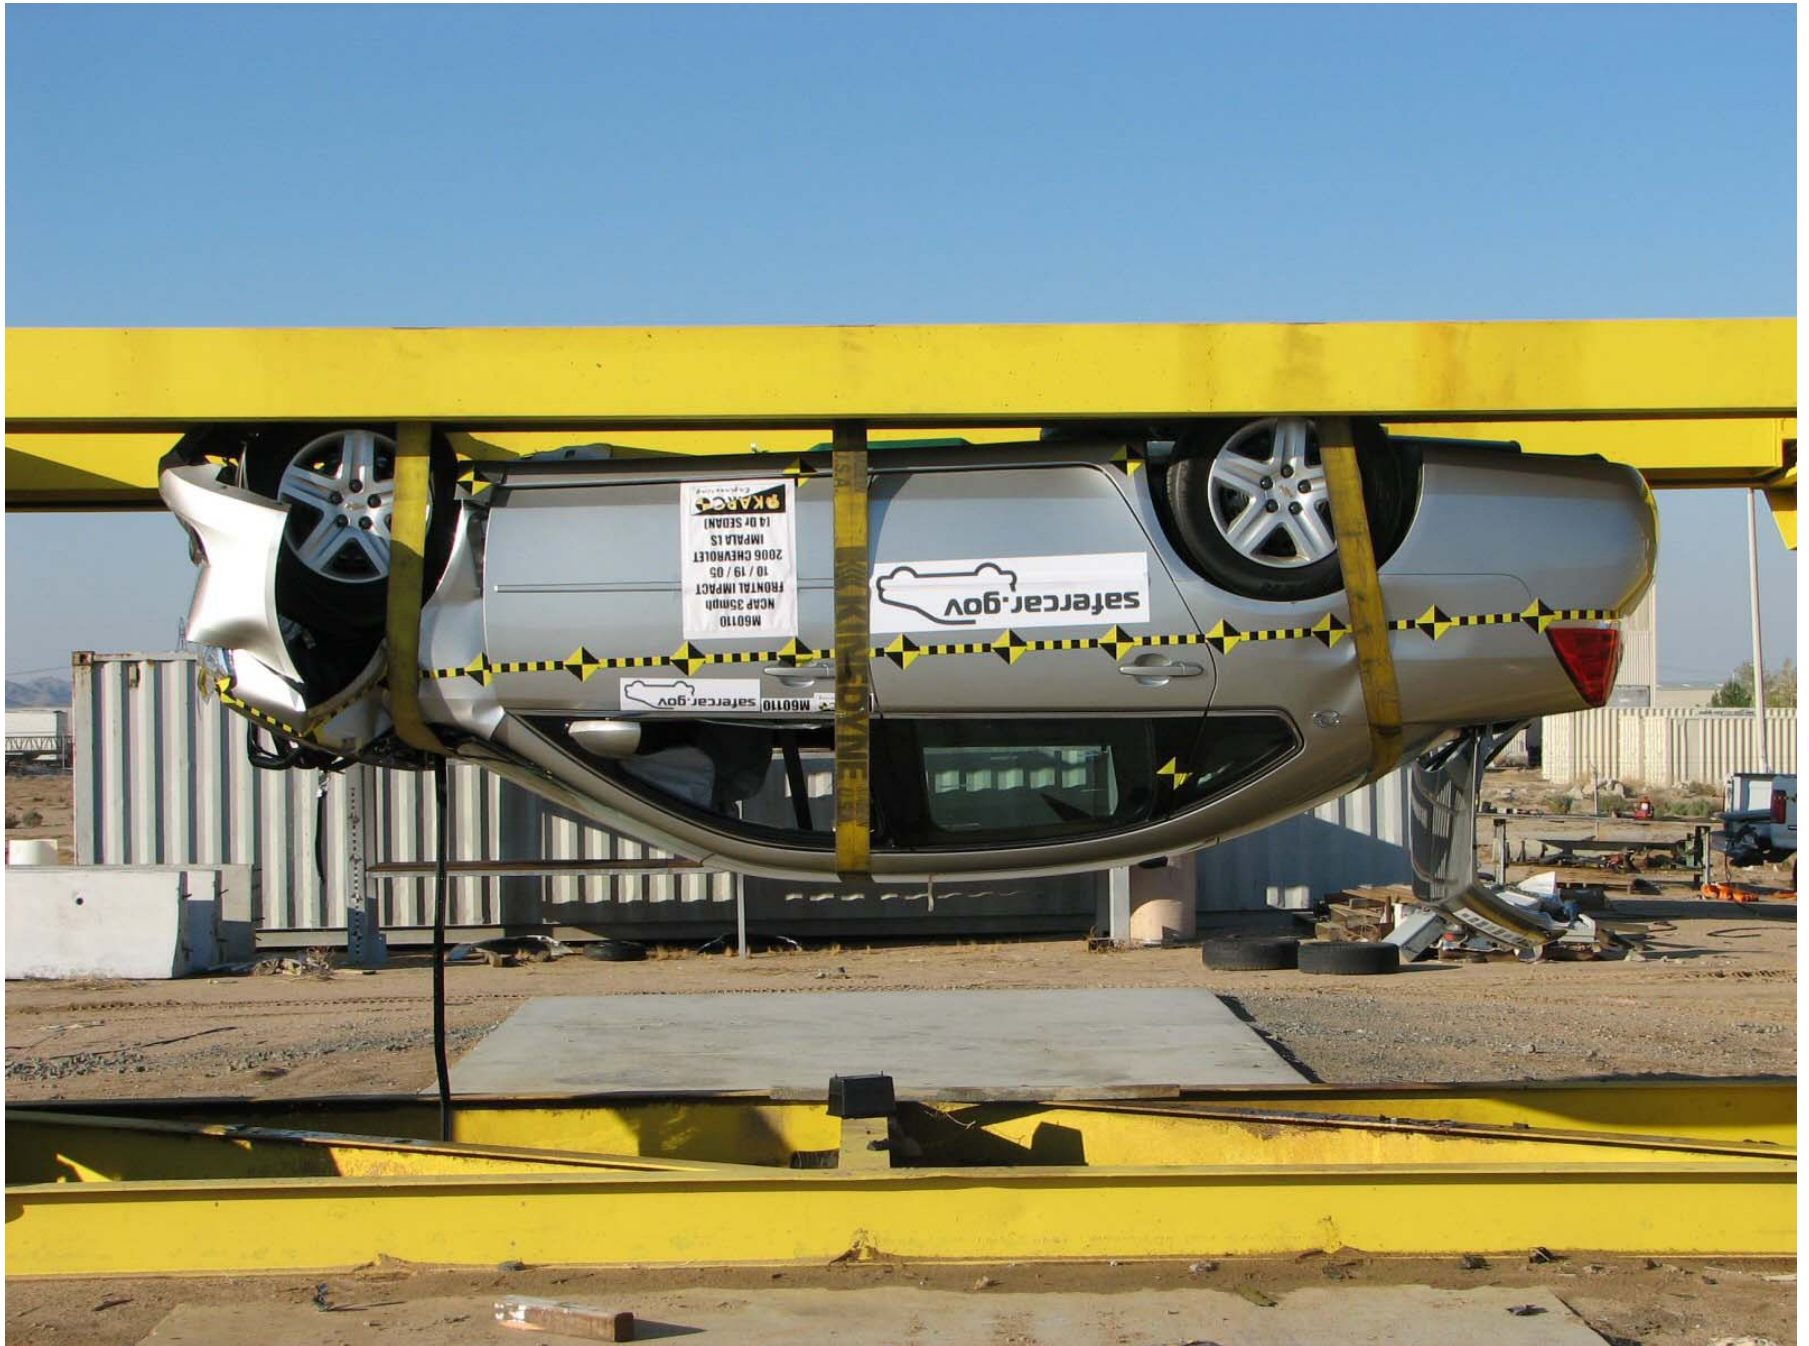
Figure A-58: Vehicle on Rollover Device (0°)

Figure A-59: Vehicle on Rollover Device (90°)

Figure A-60: Vehicle on Rollover Device (180°)

Figure A-61: Vehicle on Rollover Device (270°)

1. The specified fixture rollover rate for each 90° of rotation is 60 to 120 seconds.
2. The position hold time at each position is 300 seconds (minimum).
3. No solvent leakage occurred during rollover.
