**REPORT NUMBER TR-P26003-01-NC**

**NEW CAR ASSESSMENT PROGRAM  
SIDE IMPACT TEST**

**GENERAL MOTORS CORPORATION  
2006 CHEVROLET IMPALA  
4-DOOR SEDAN**

**FINAL REPORT**

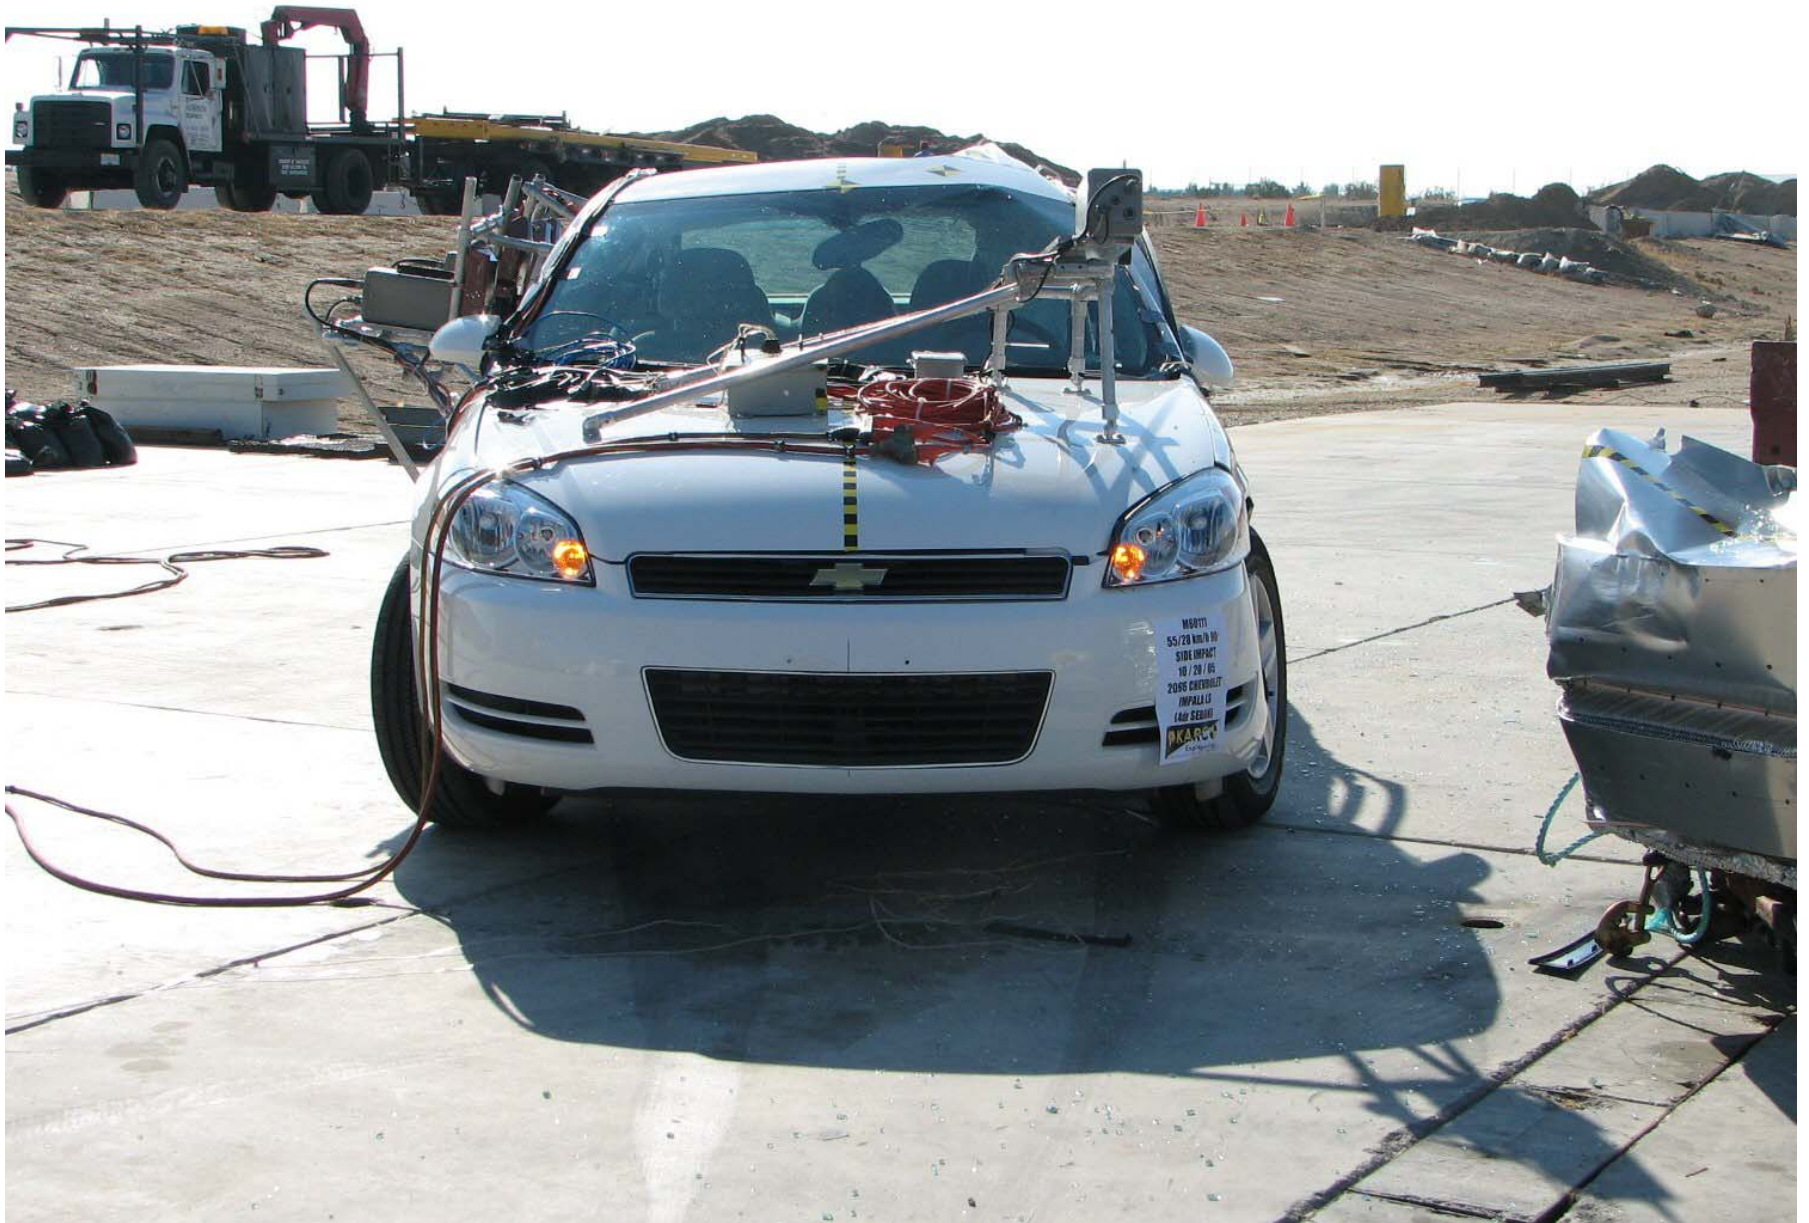
Figure A-6: Post-Test Front View

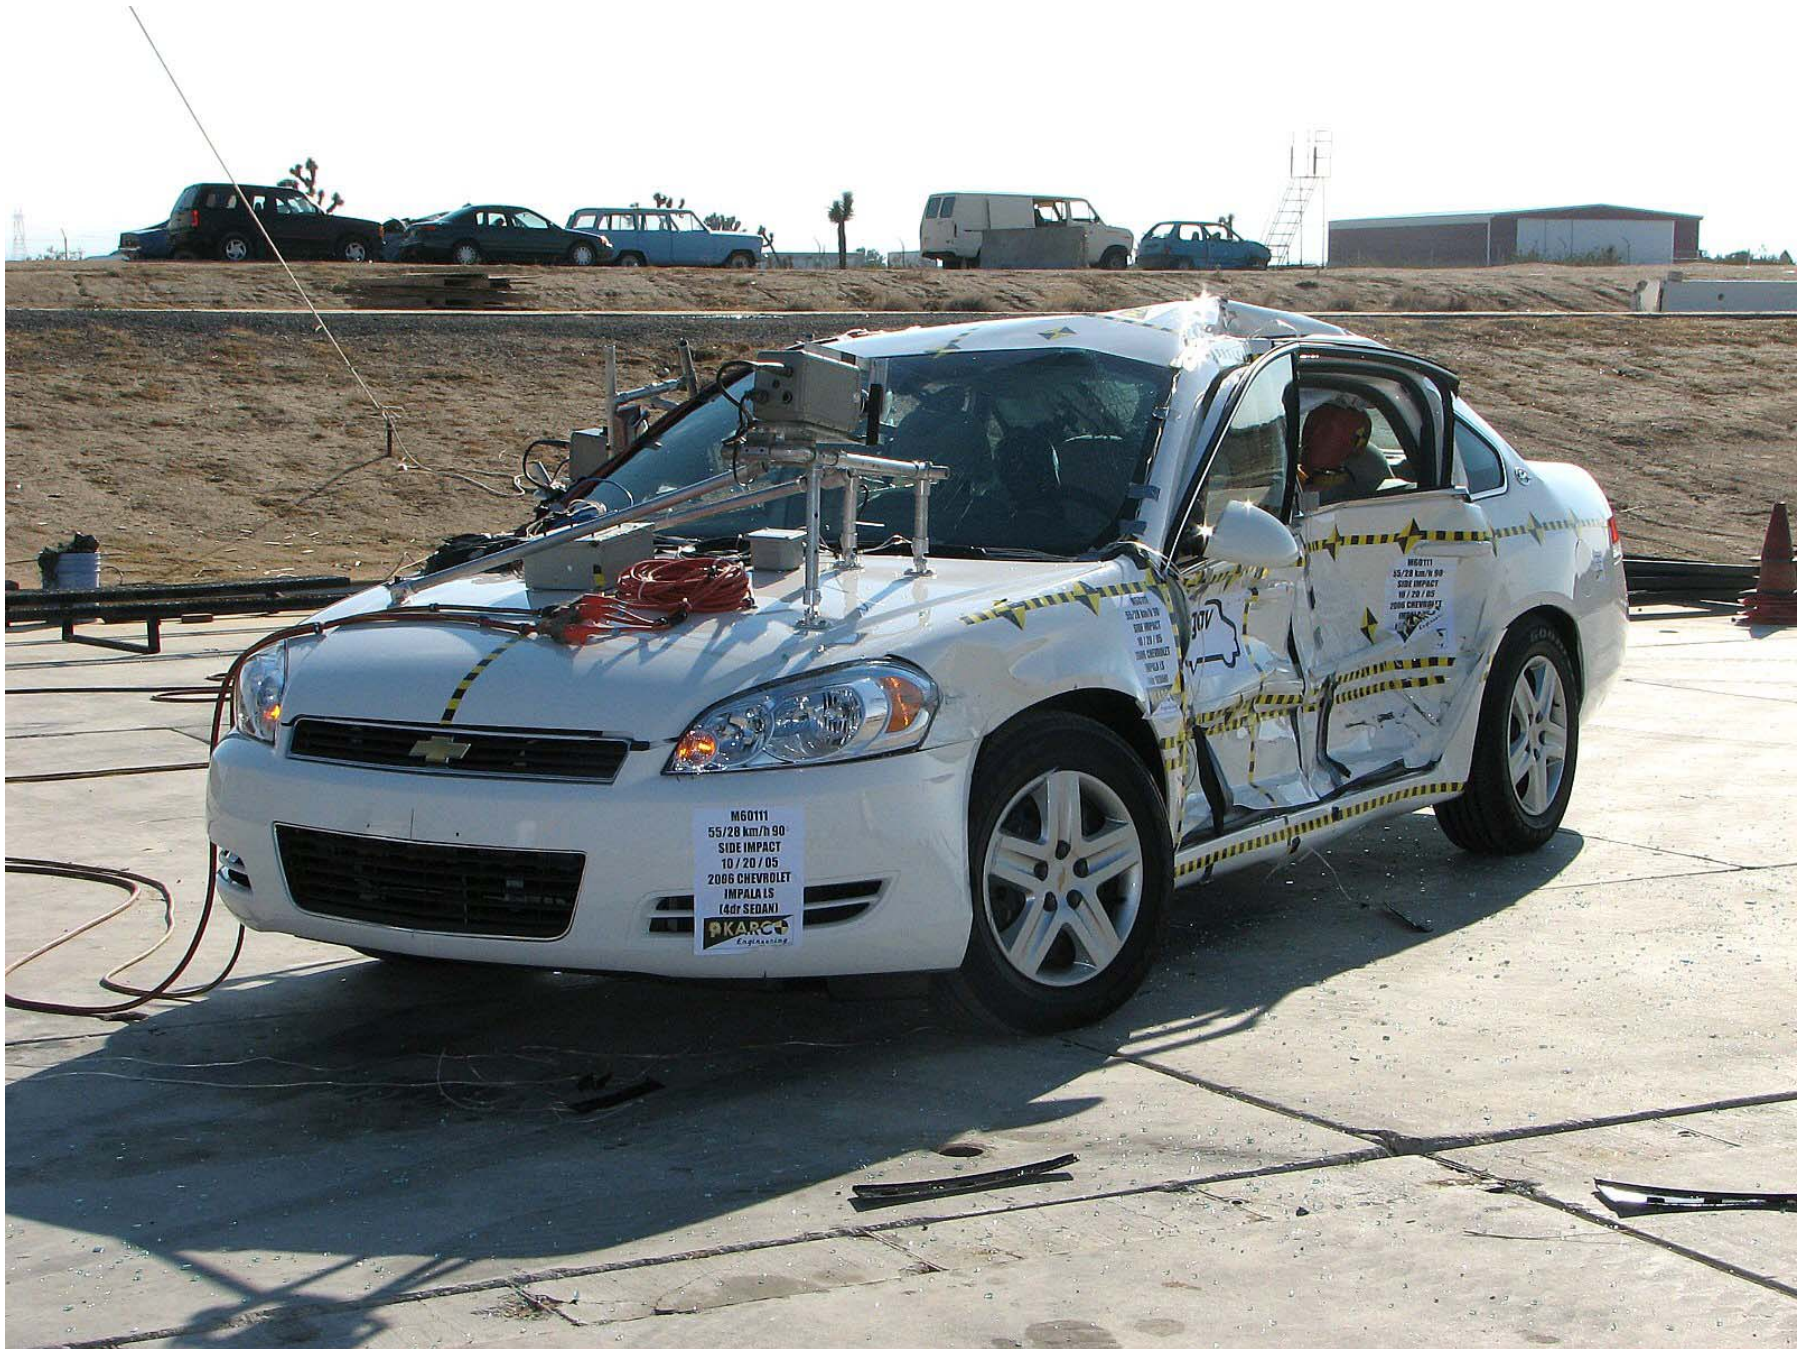
Figure A-8: Post-Test Left Front  $\frac{3}{4}$  View

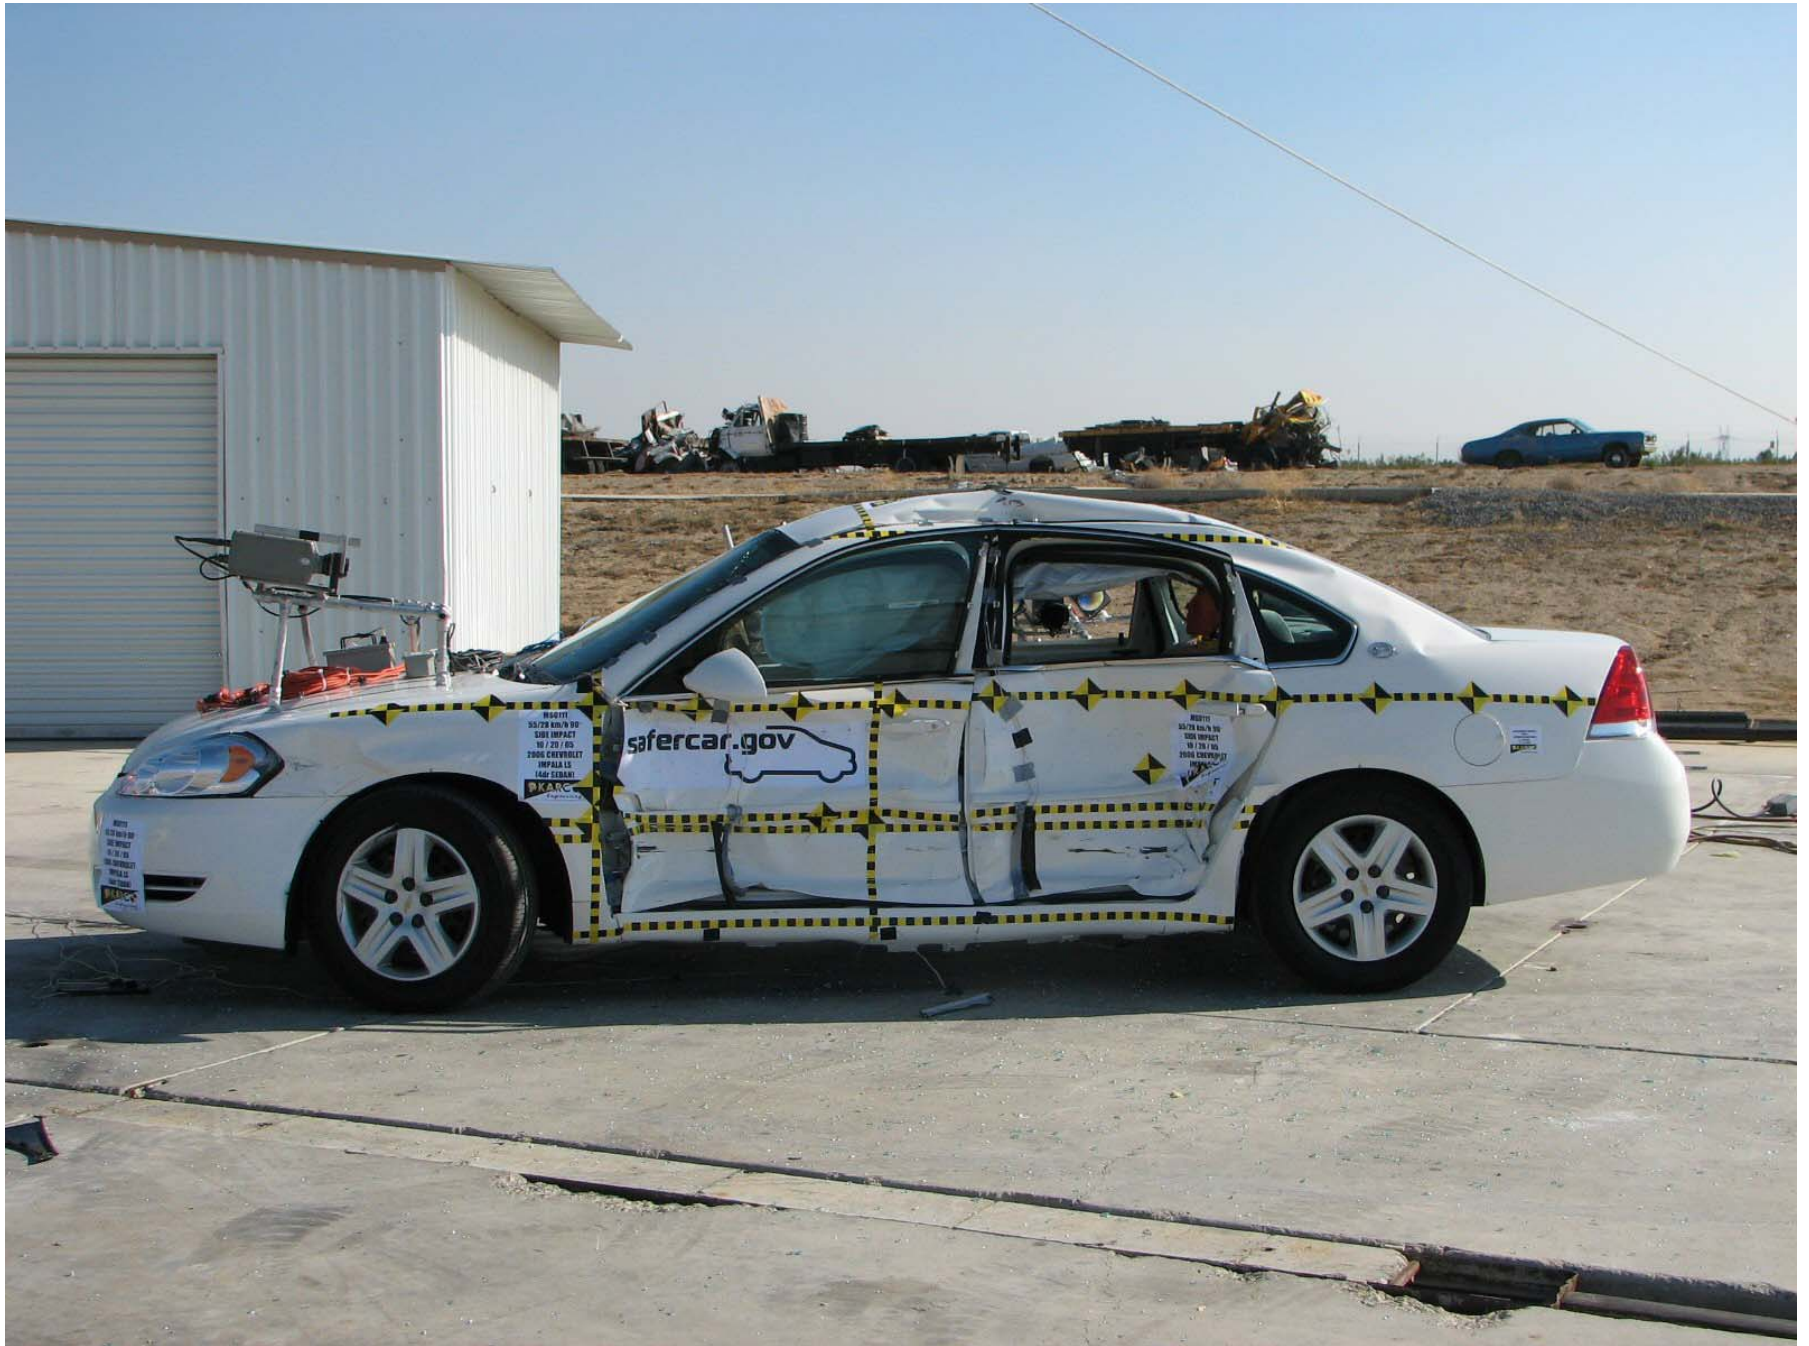
Figure A-10: Post-Test Left Side View

The driver and passenger doors remained closed during impact. The test vehicle sustained a maximum static crush of 223 mm at level 4, 1500 mm at the impact point. The driver SID/Hybrid III, Serial No. 275 and the passenger SID/Hybrid III, Serial No. 274 were calibrated prior to this test. The SID/Hybrid III injury criteria is summarized as follows:

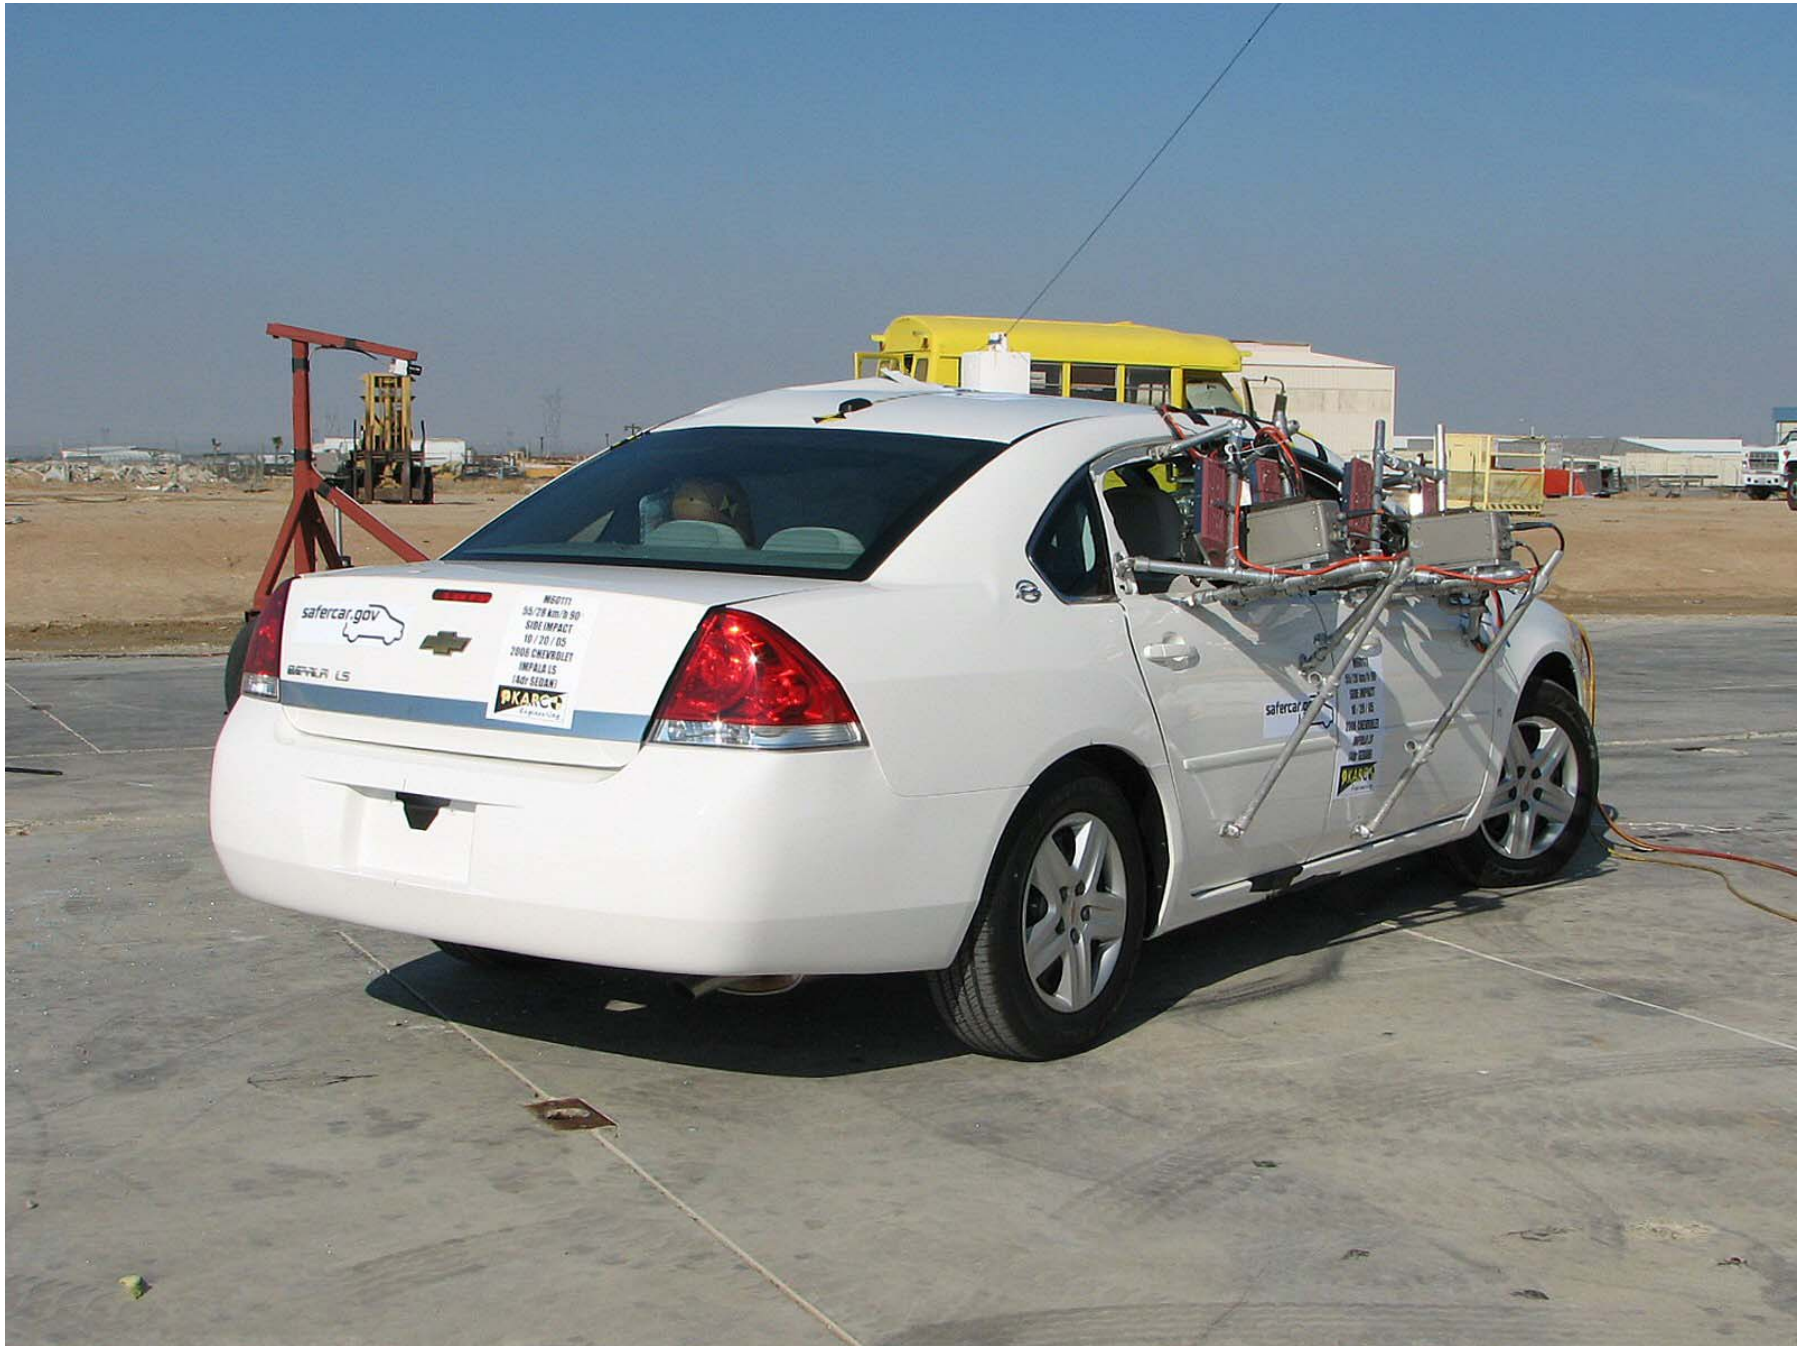
Figure A-16: Post-Test Right Rear  $\frac{3}{4}$  View

| Critical Areas of Performance | Observations and Conclusions |
|---|---|
| Window Damage | Rear passenger side window broke |

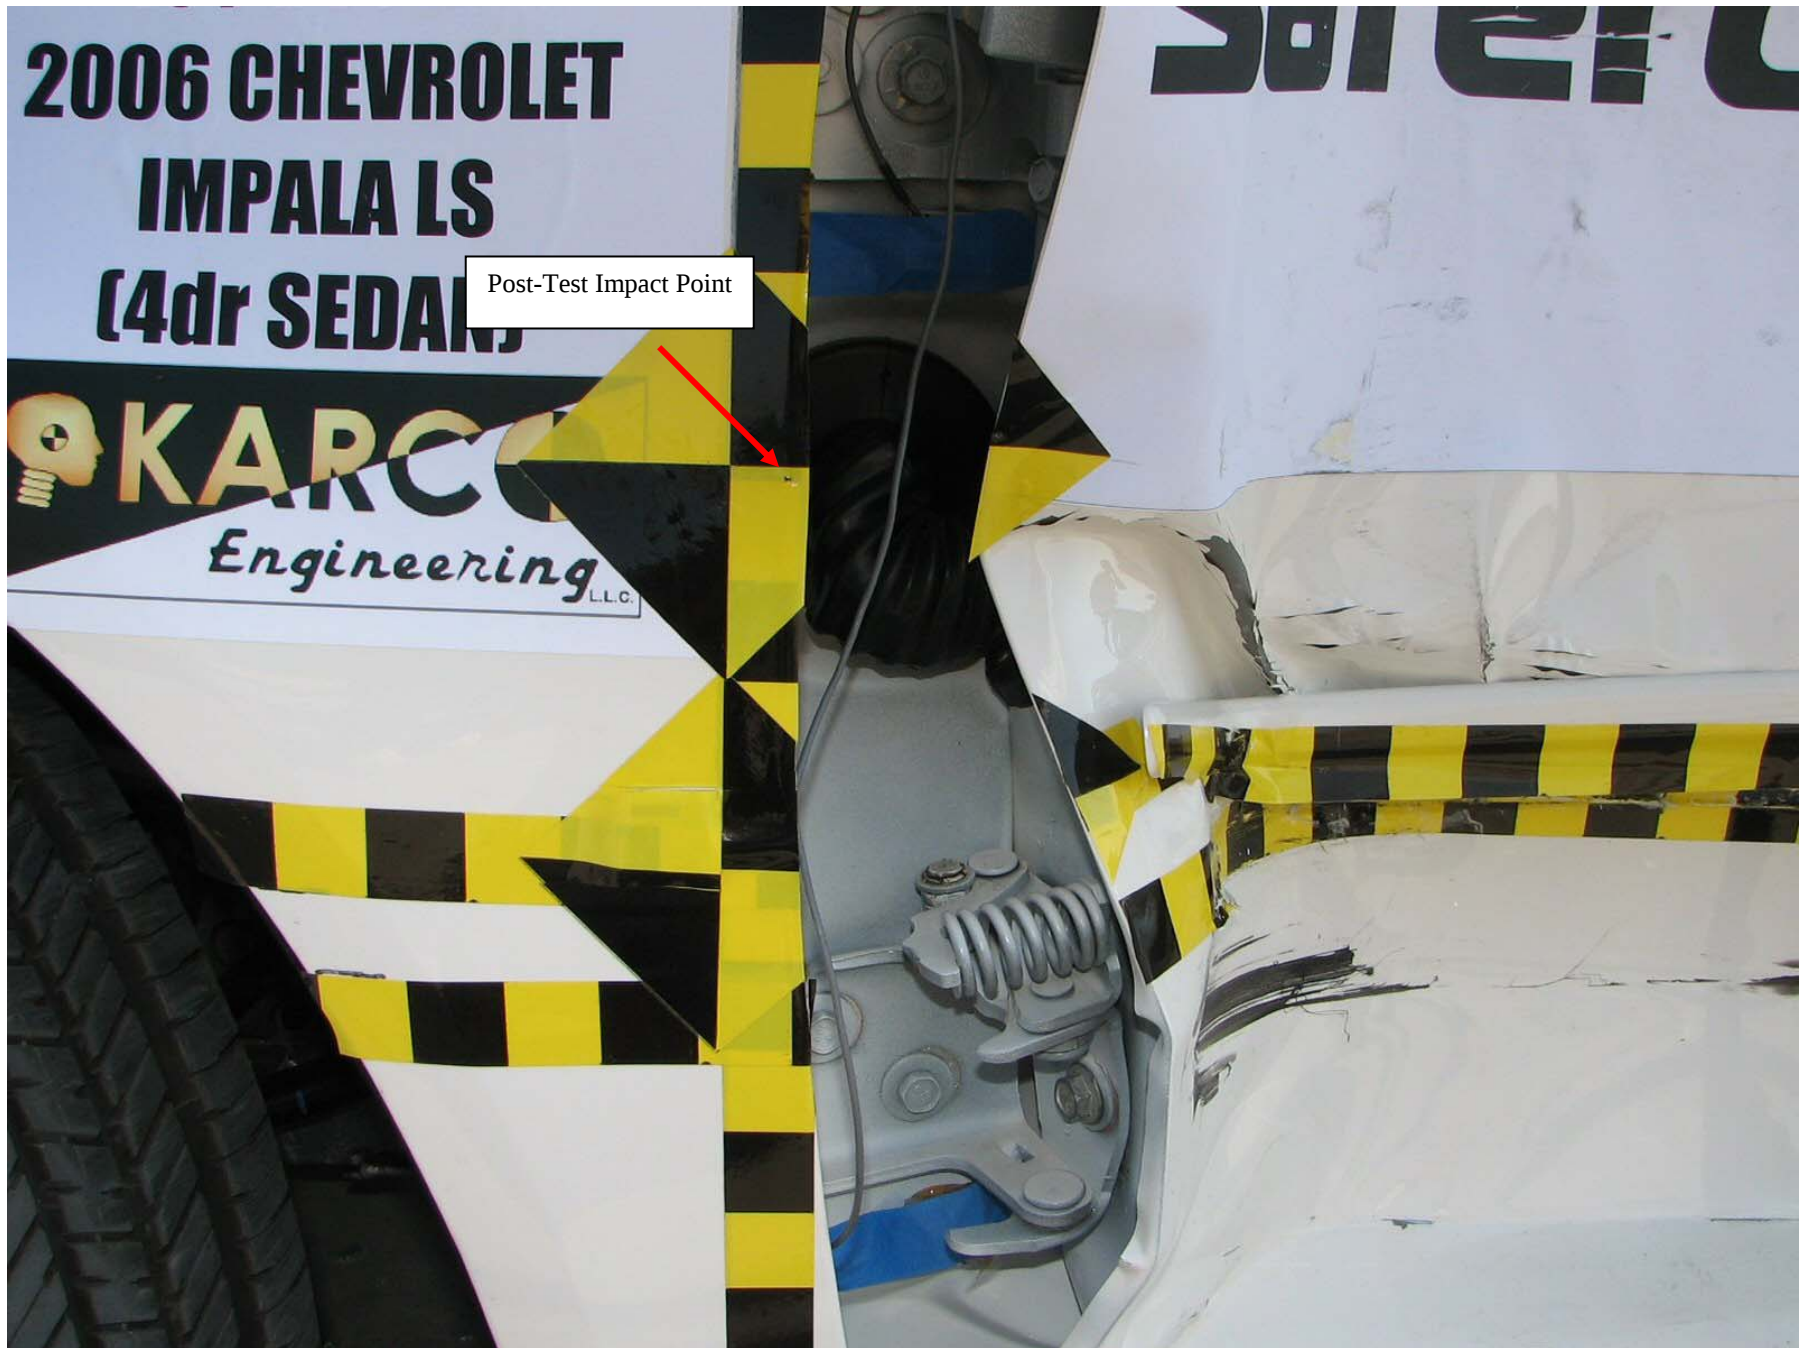
Figure A-26: Post-Test Left Impact Point

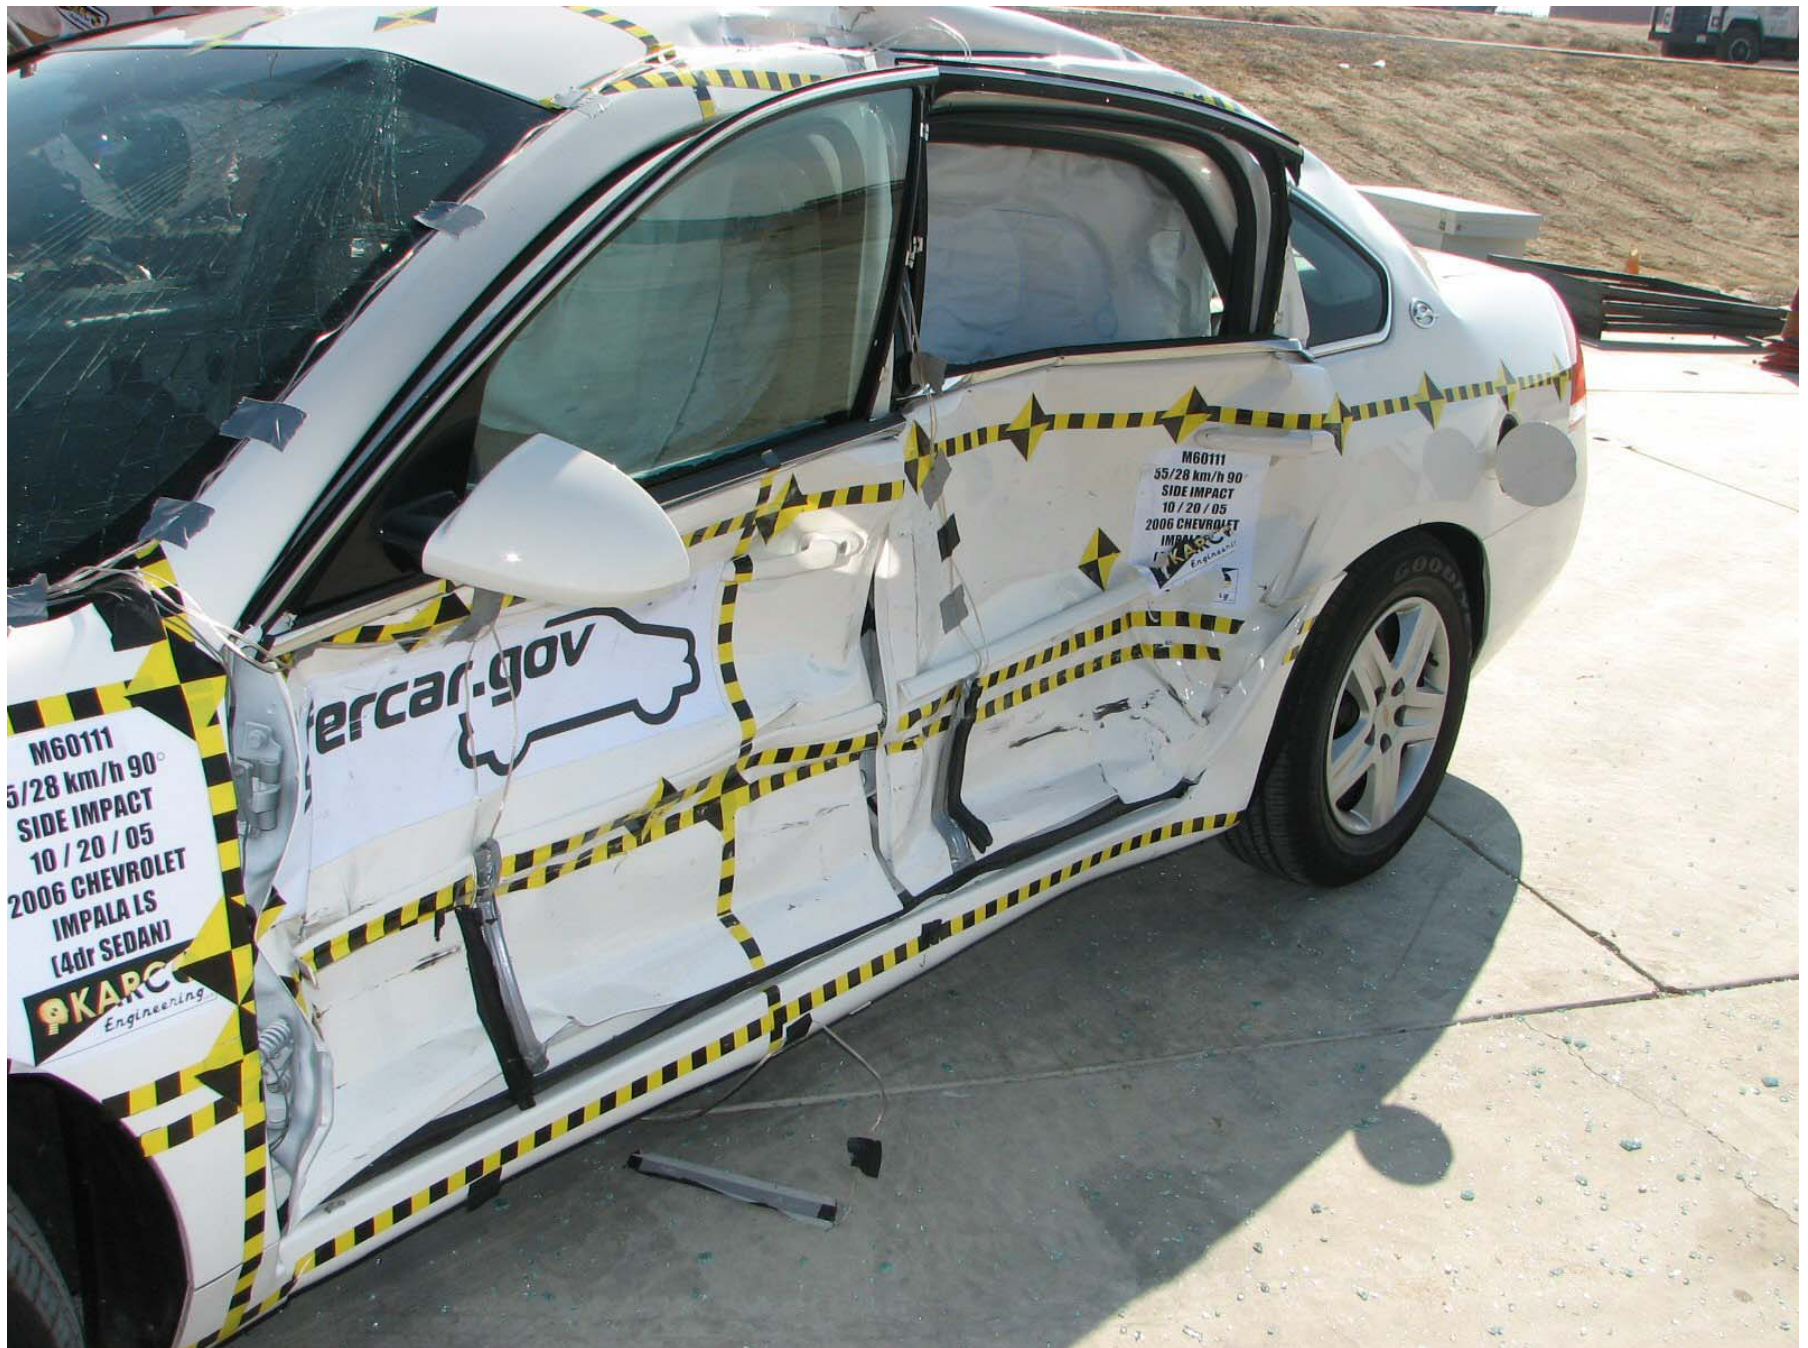
Figure A-28: Post-Test Front  $\frac{3}{4}$  View of Left Side Doors

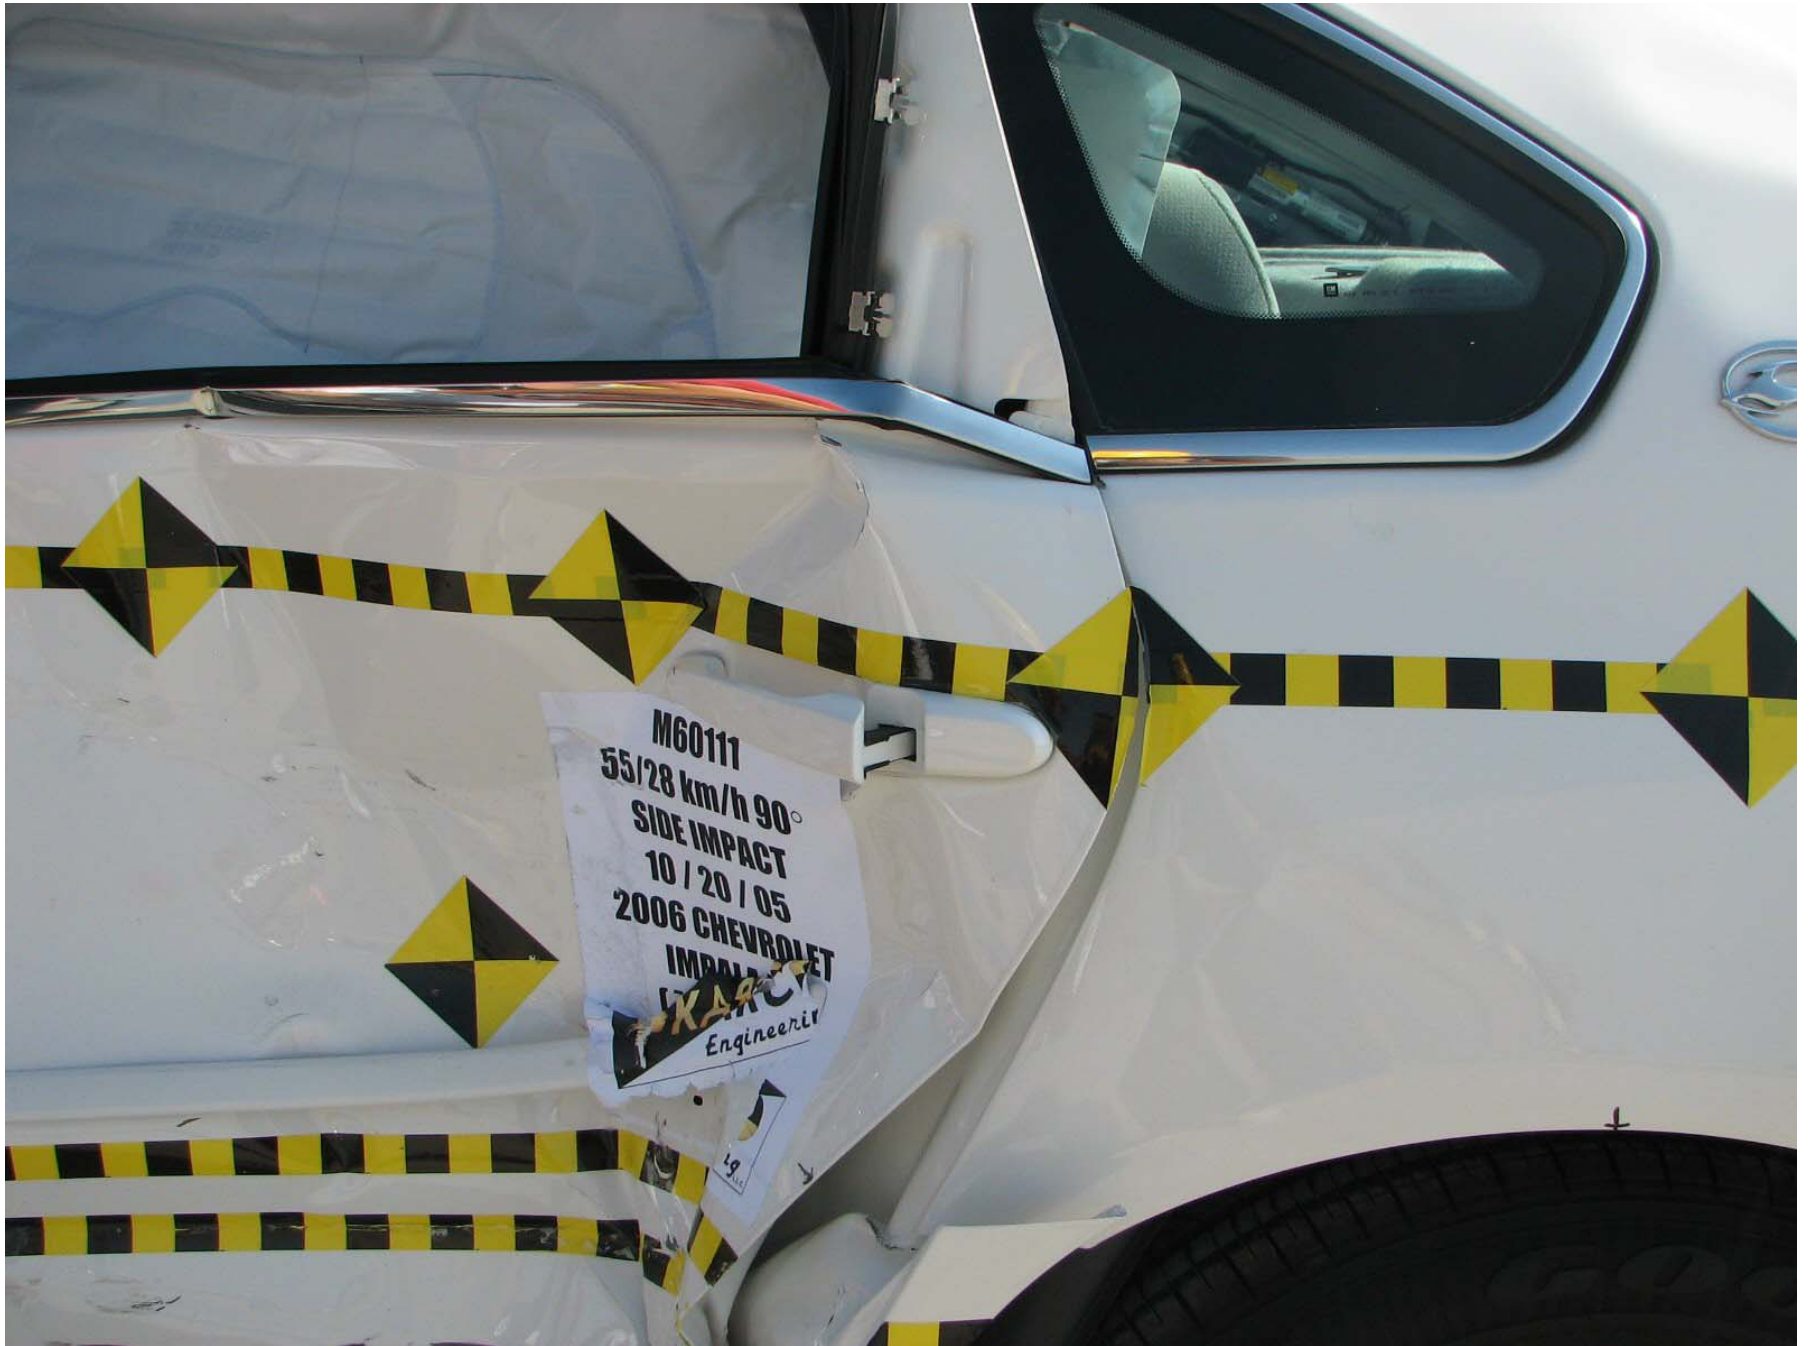
Figure A-34: Post-Test Left Rear Door

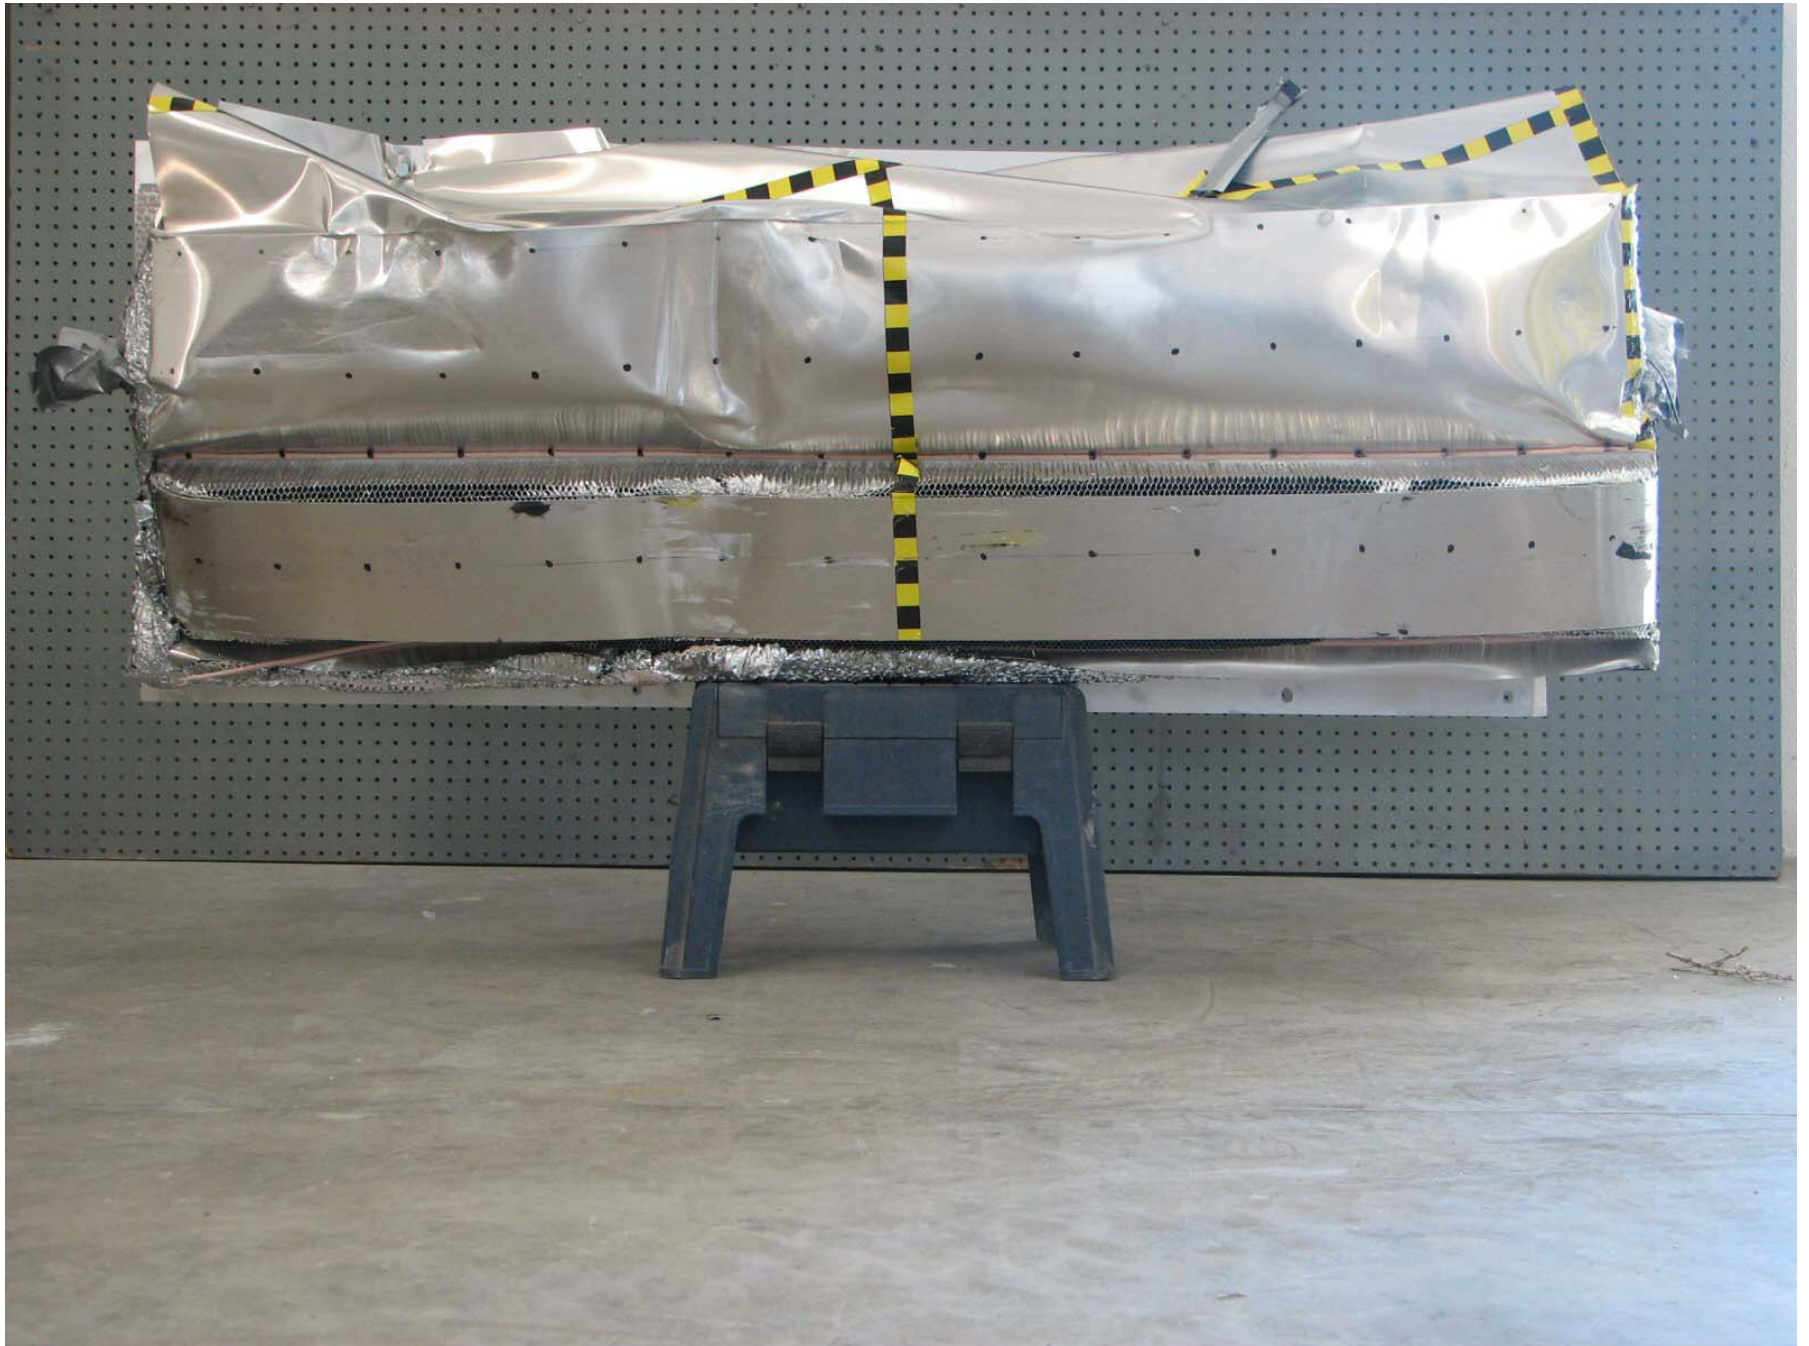
Figure A-54: Post-Test Front View of Deformable Barrier

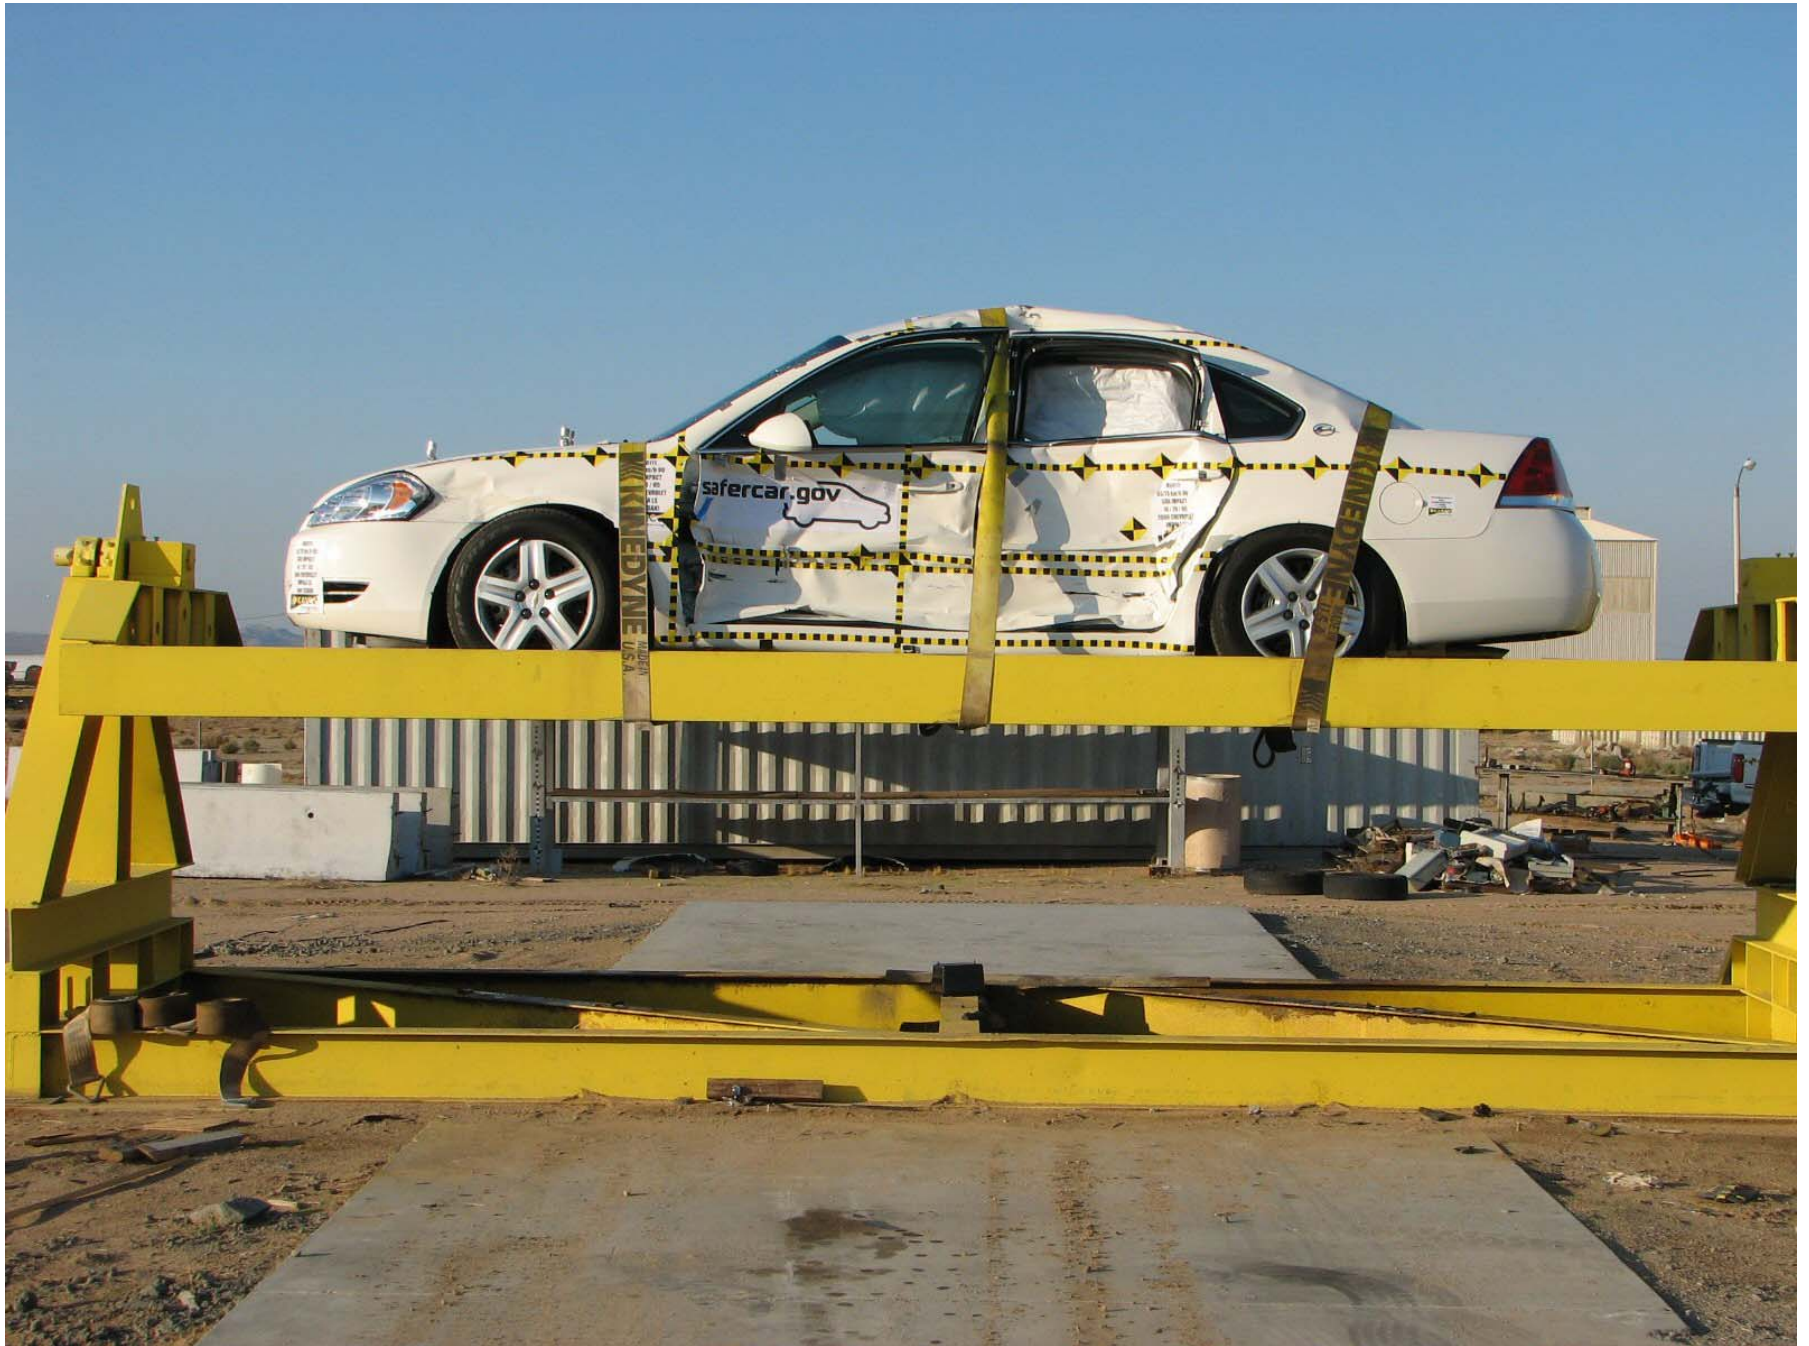
Figure A-61: Vehicle on Rollover Device (0°)

1. The specified fixture rollover rate for each 90° of rotation is 60 to 120 seconds.
2. The position hold time at each position is 300 seconds (minimum).
3. Details of Stoddard Solvent spillage locations.  
No solvent leakage occurred during static rollover testing.
