**REPORT NUMBER TR-P26003-01-NC**

**NEW CAR ASSESSMENT PROGRAM  
SIDE IMPACT TEST**

**GENERAL MOTORS CORPORATION  
2006 CHEVROLET IMPALA  
4-DOOR SEDAN**

**FINAL REPORT**

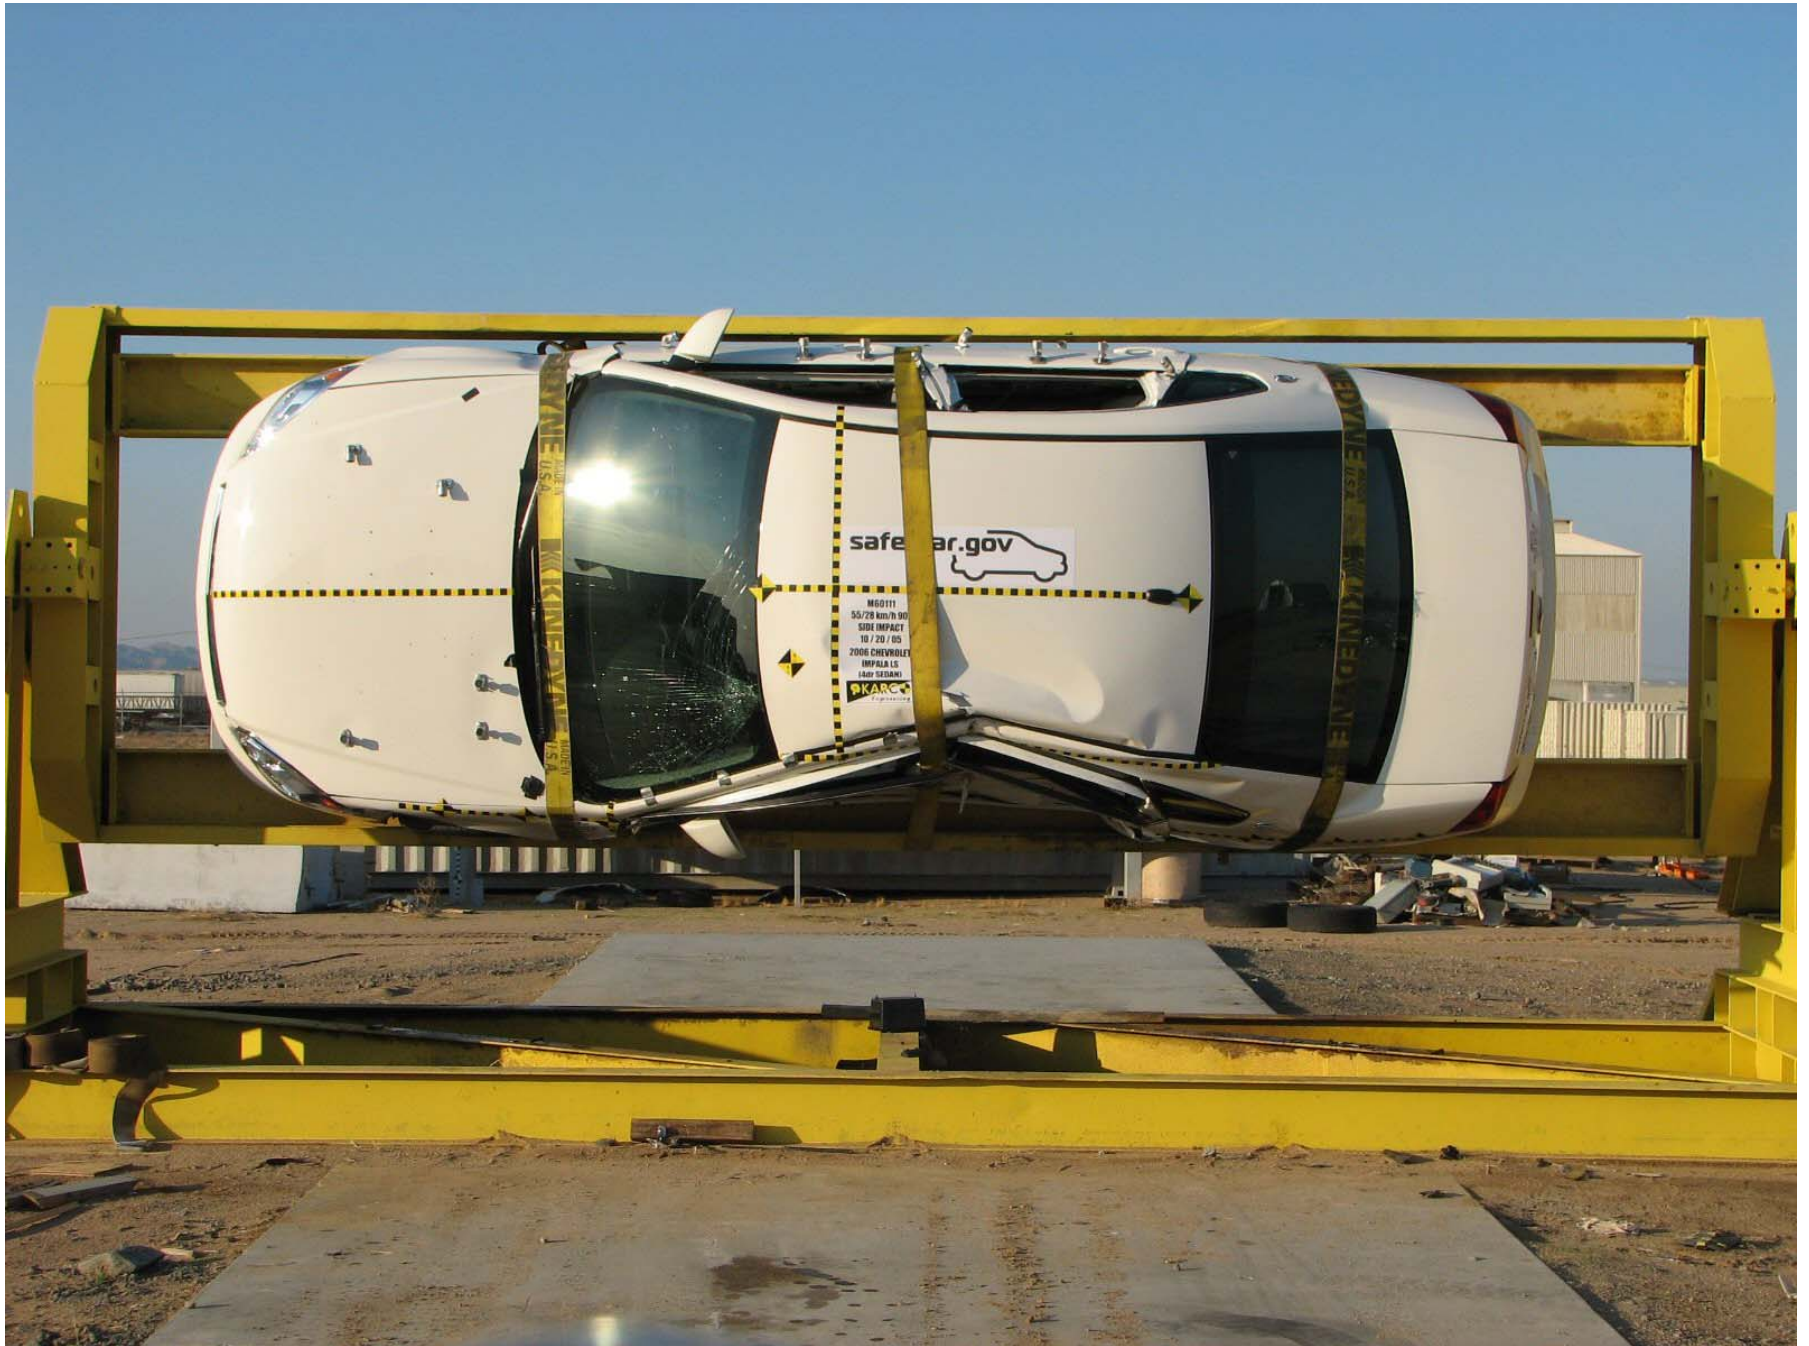
Figure A-62: Vehicle on Rollover Device (90°)

1. The specified fixture rollover rate for each 90° of rotation is 60 to 120 seconds.
2. The position hold time at each position is 300 seconds (minimum).
3. Details of Stoddard Solvent spillage locations.  
No solvent leakage occurred during static rollover testing.

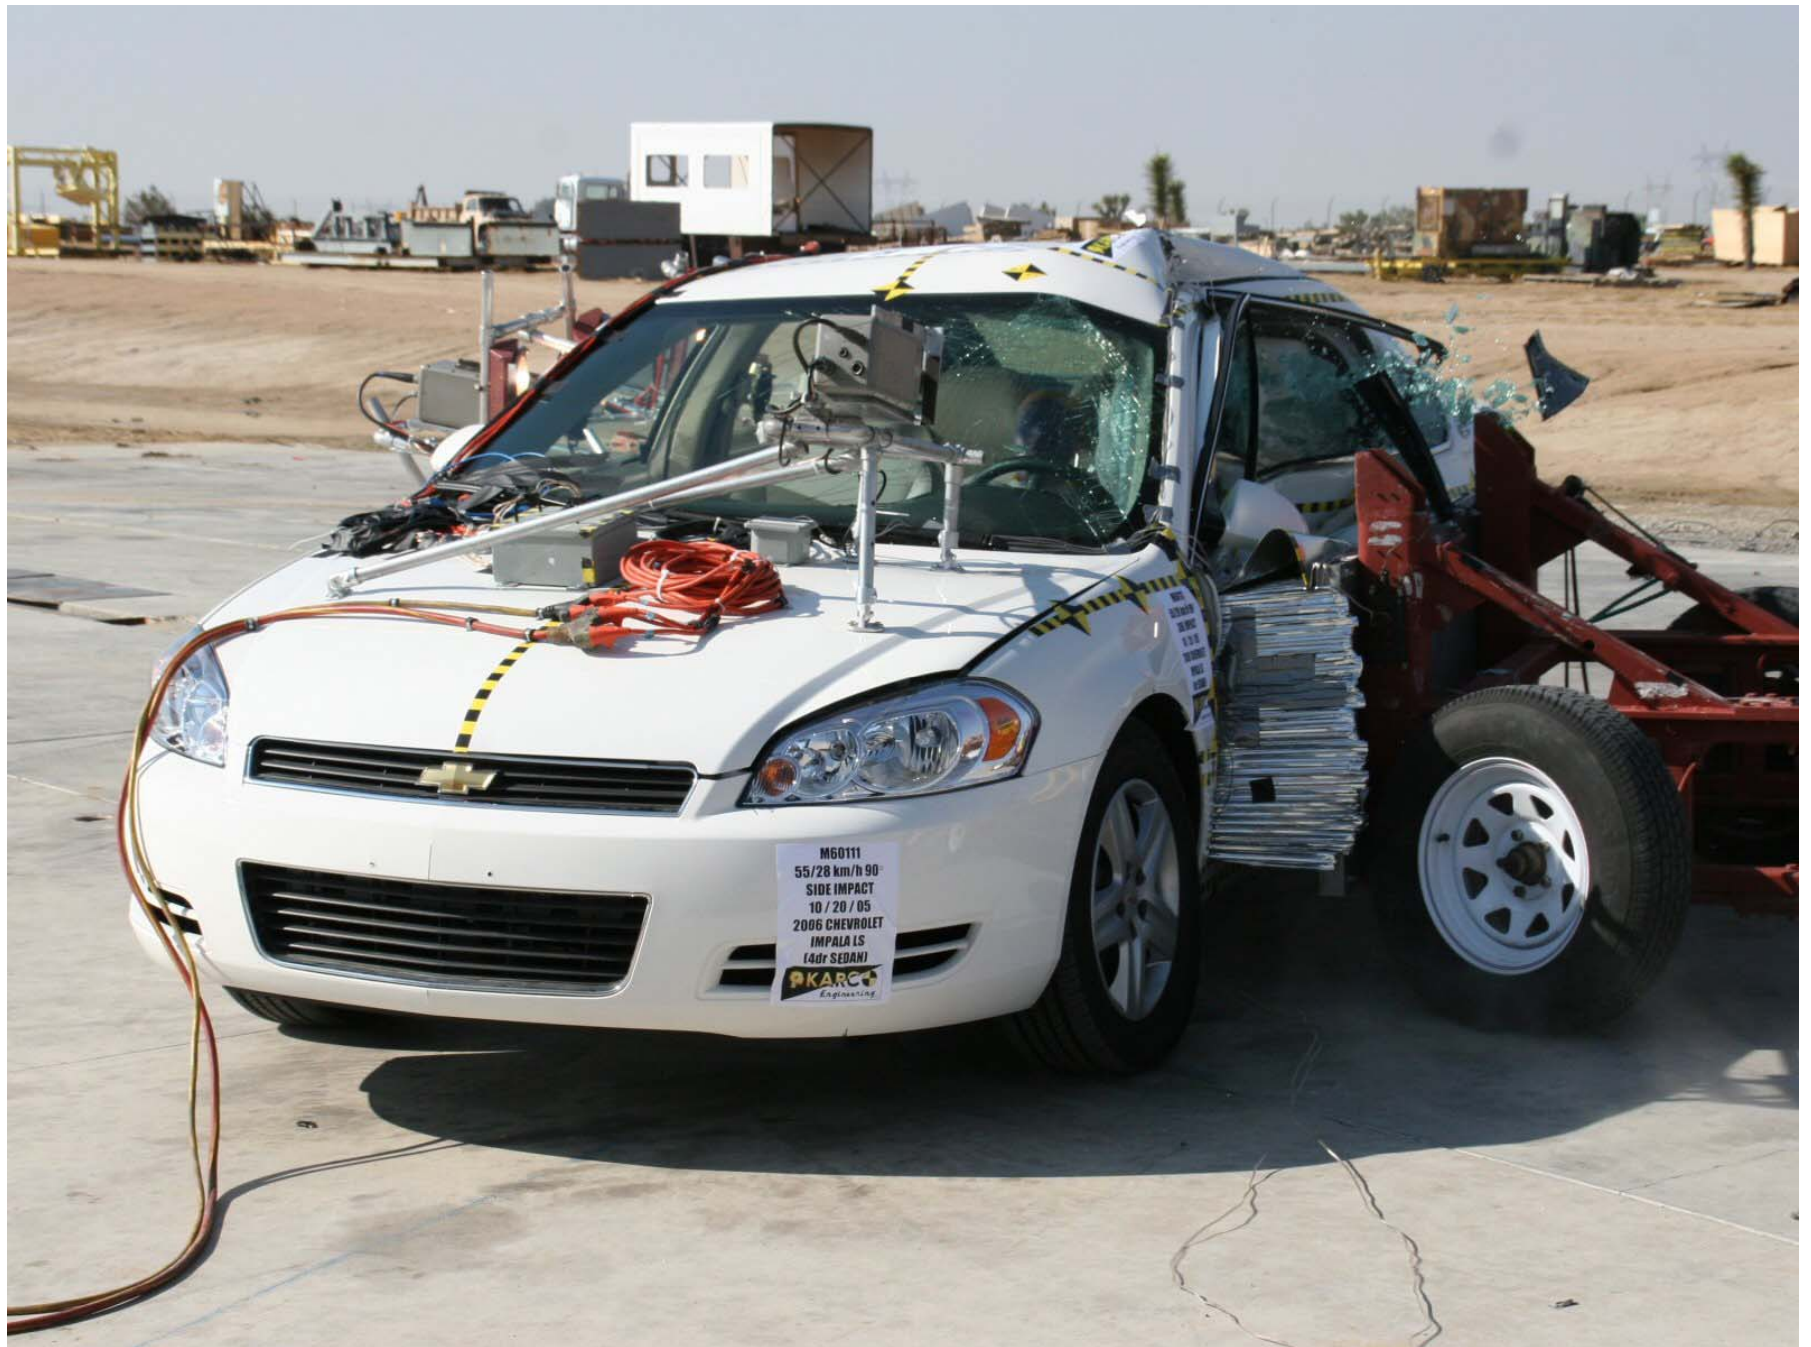
Figure A-65: Vehicle Impact

A model year 2006 Chevrolet Impala 4-Door Sedan was impacted on the left (driver's) side by a Moving Deformable Barrier (MDB) which was moving forward in a 27° crabbed position to the tow road guidance system at a velocity of 61.67 km/h. The specified impact velocity range is from 61.14 to 62.75 km/h. The test (target) vehicle was stationary and positioned 63° to the line of forward motion. The weight of the vehicle as tested was 1843 kg and the test weight of the MDB was 1361 kg. The test was conducted at KARCO Engineering, LLC in Adelanto, California, on October 20, 2005.
