FMVSS 301-FUEL SYSTEM INTEGRITY

GM DAEWOO AUTO & TECHNOLOGY COMPANY  
2005 CHEVROLET AVEO  
4-DOOR SEDAN

NHTSA NUMBER: C50105

FINAL REPORT

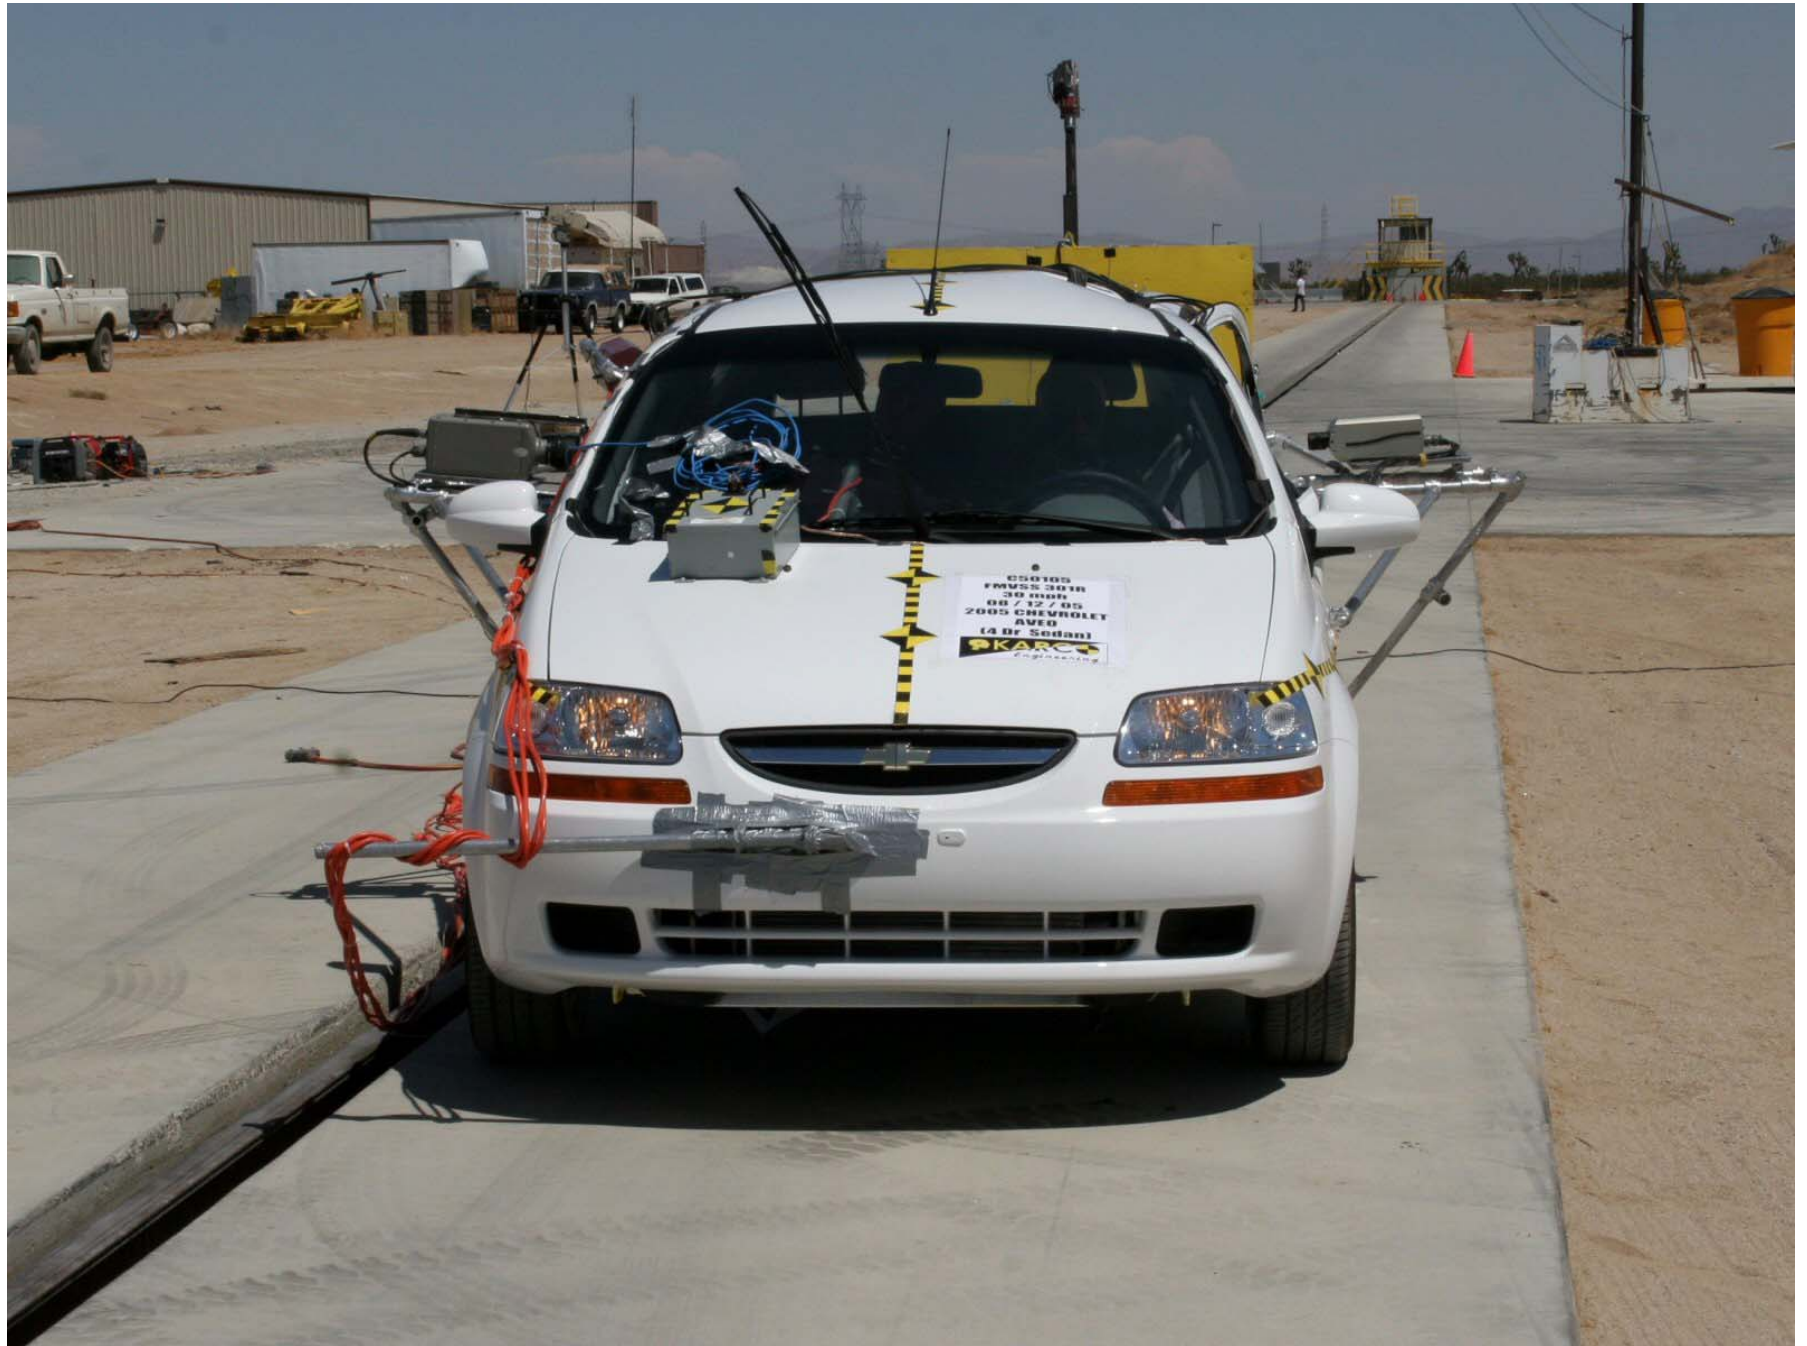
Figure A-6: Post-Test Front View

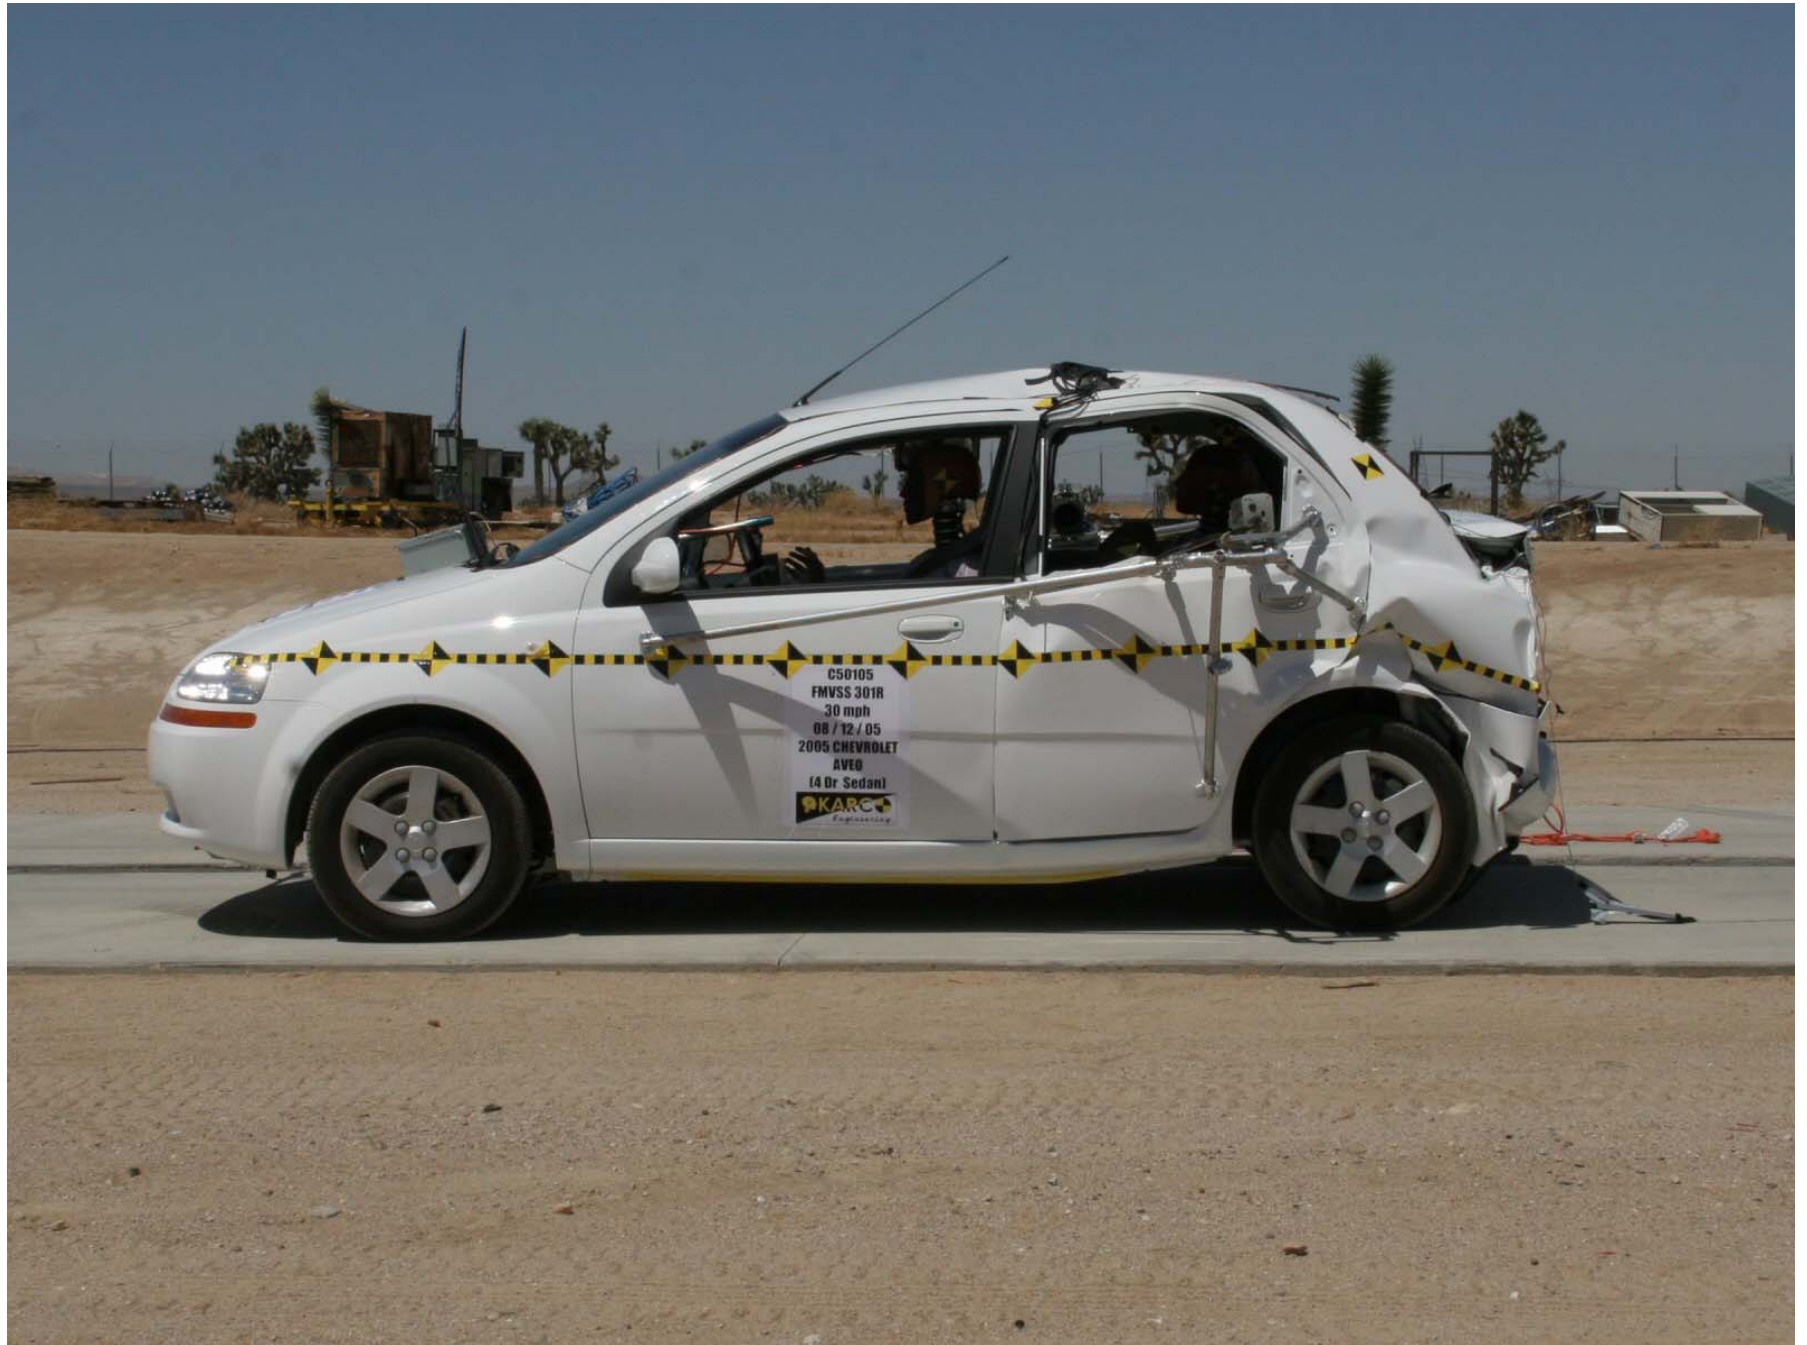
Figure A-8: Post-Test Left Side View

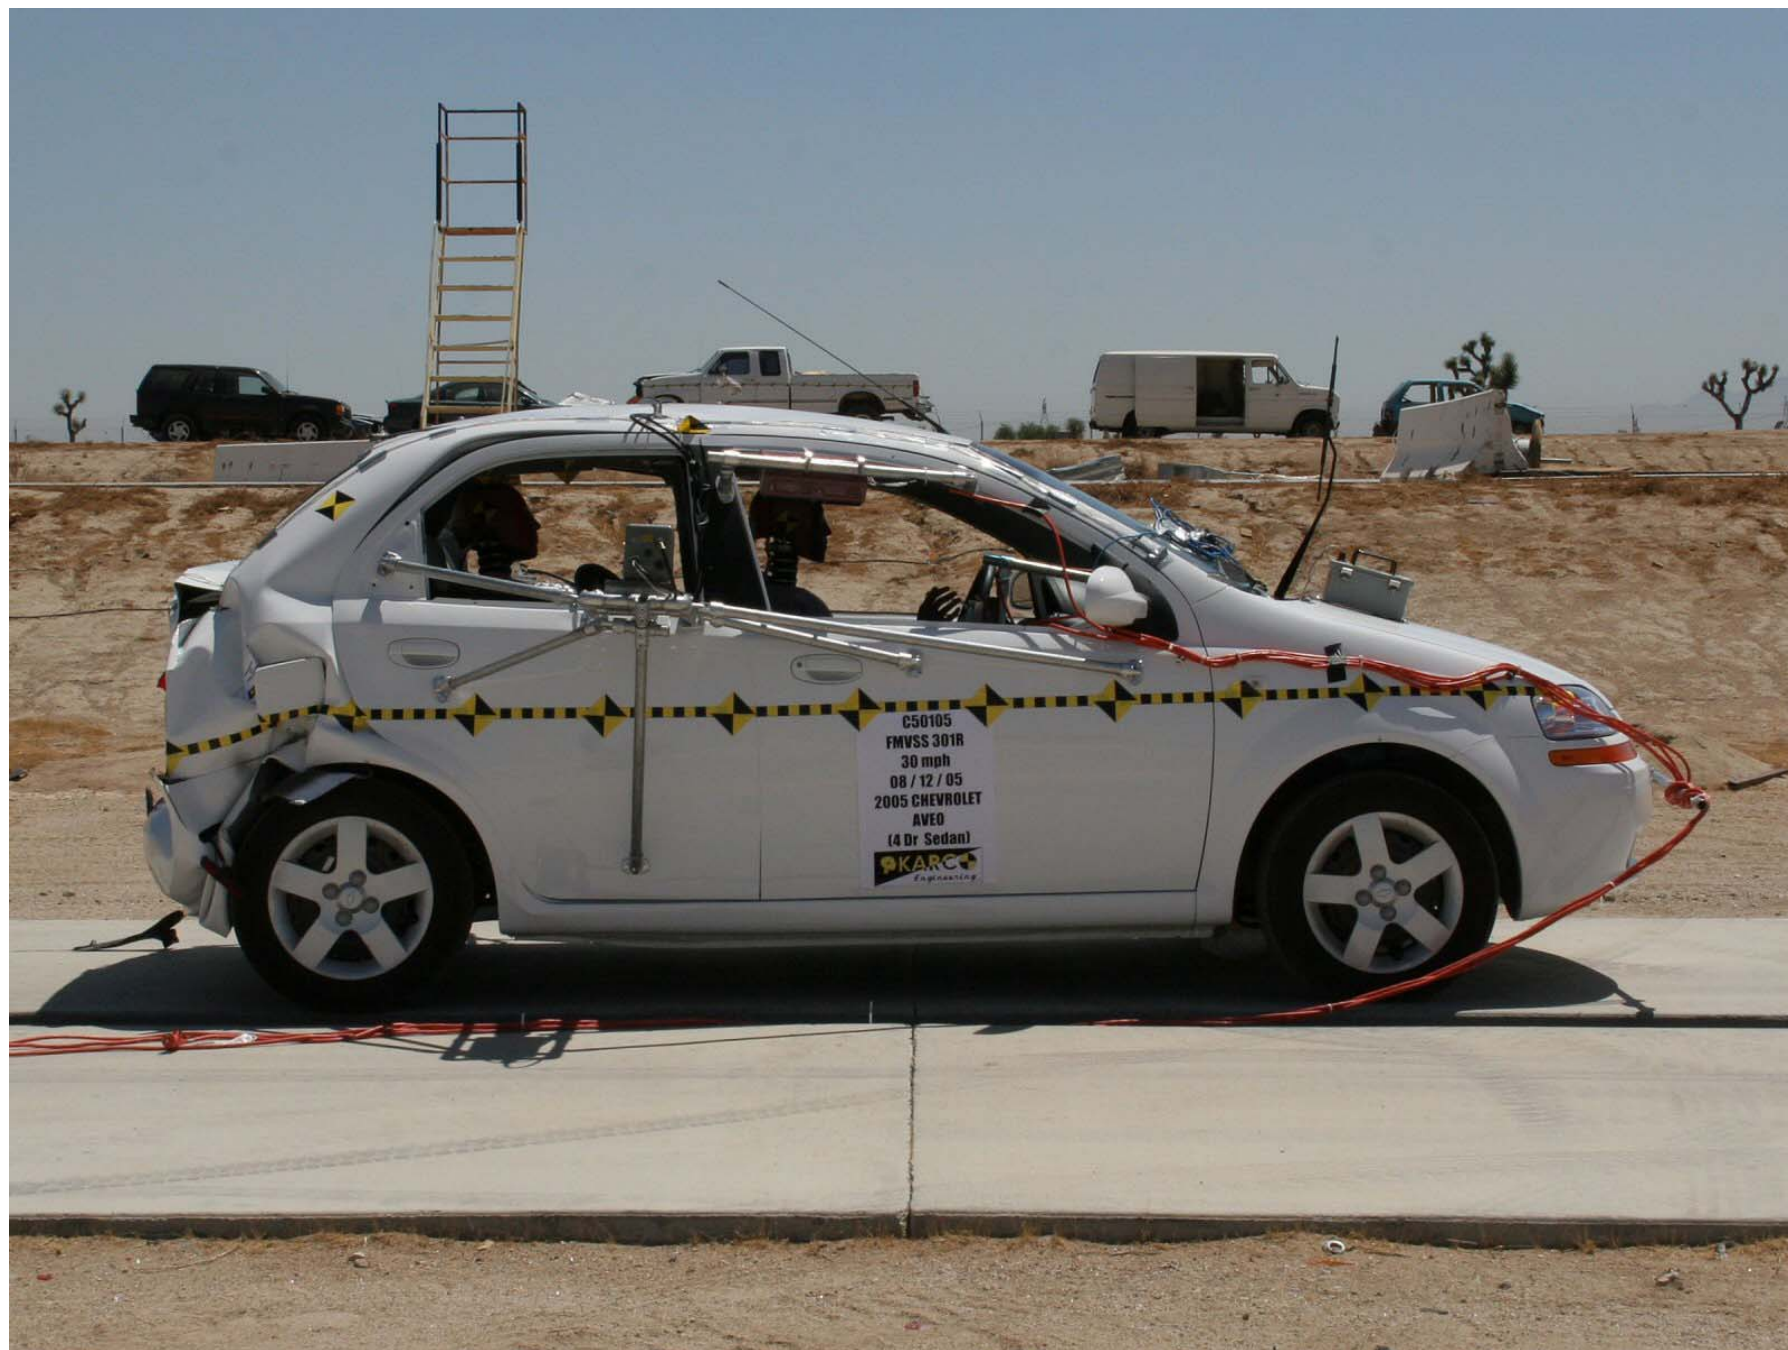
Figure A-10: Post-Test Right Side View

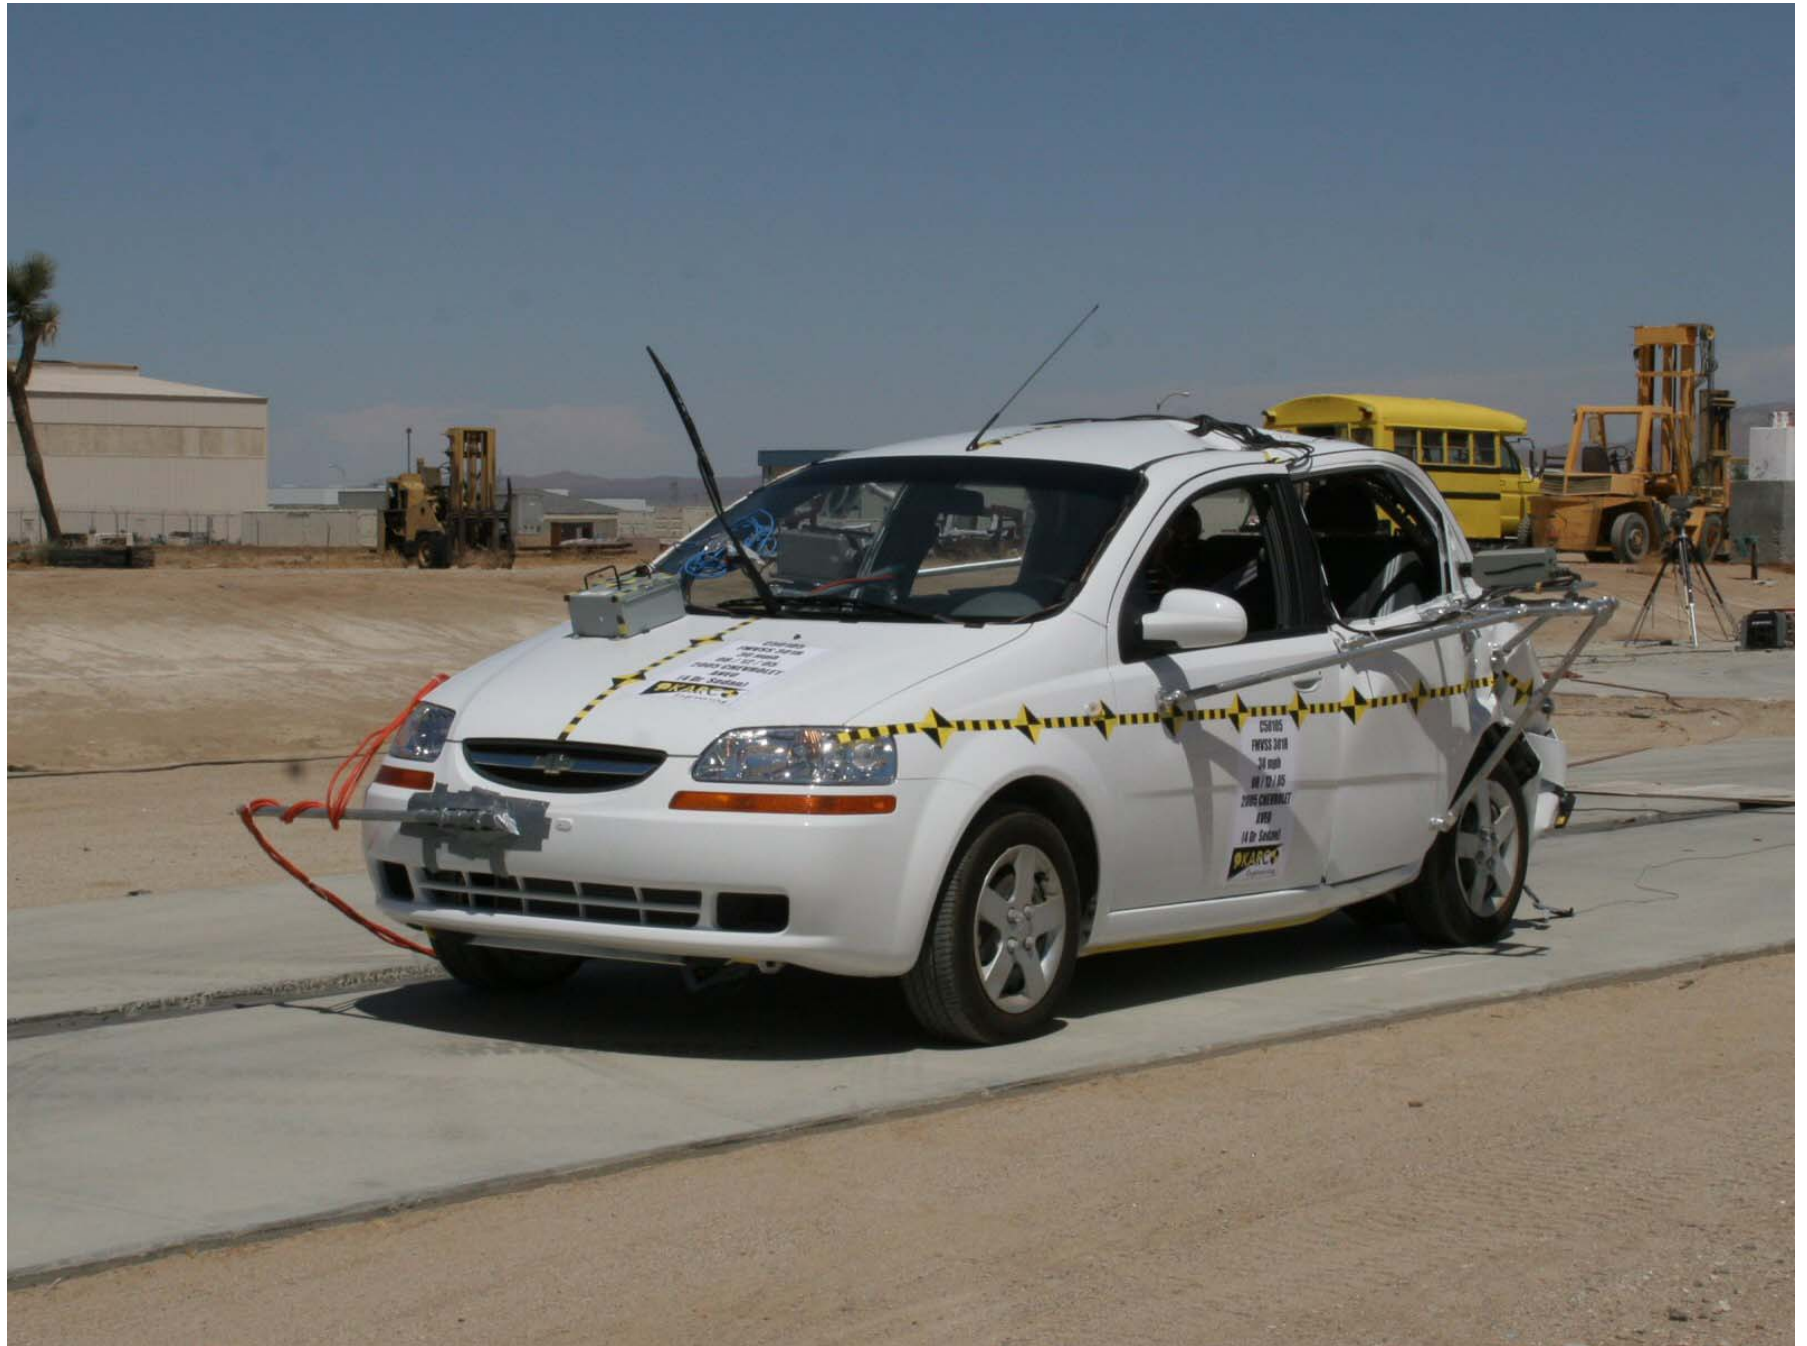
Figure A-12: Post-Test Left Front  $\frac{3}{4}$  View (Vehicle Moved)

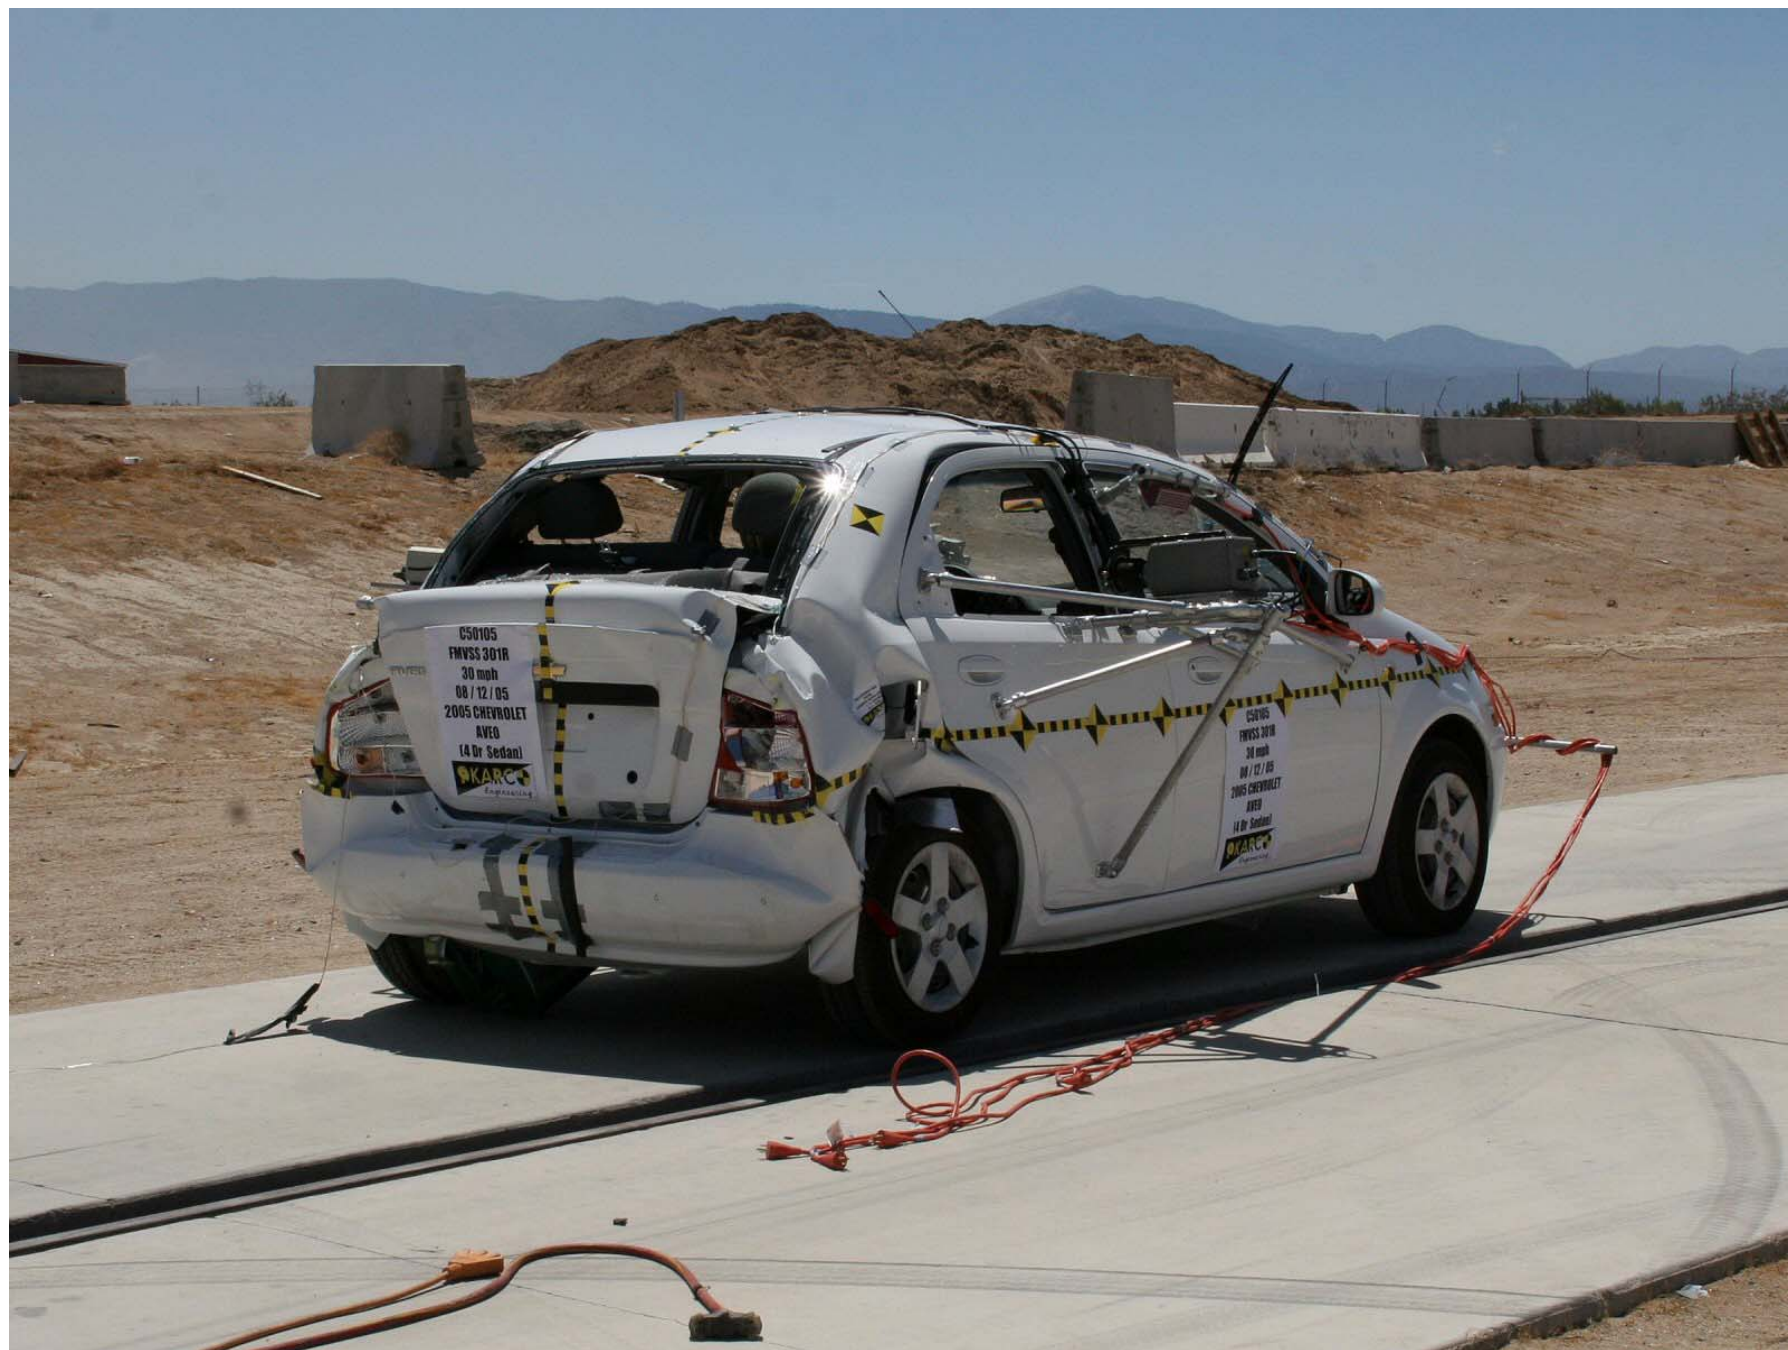
Figure A-14: Post-Test Right Rear  $\frac{3}{4}$  View

There was no fuel system fluid spillage following the impact event or during any portion of the static rollover test. The maximum longitudinal crush was 410 millimeters. The vehicle appeared to comply with all the requirements of FMVSS No. 301 "Fuel System Integrity."

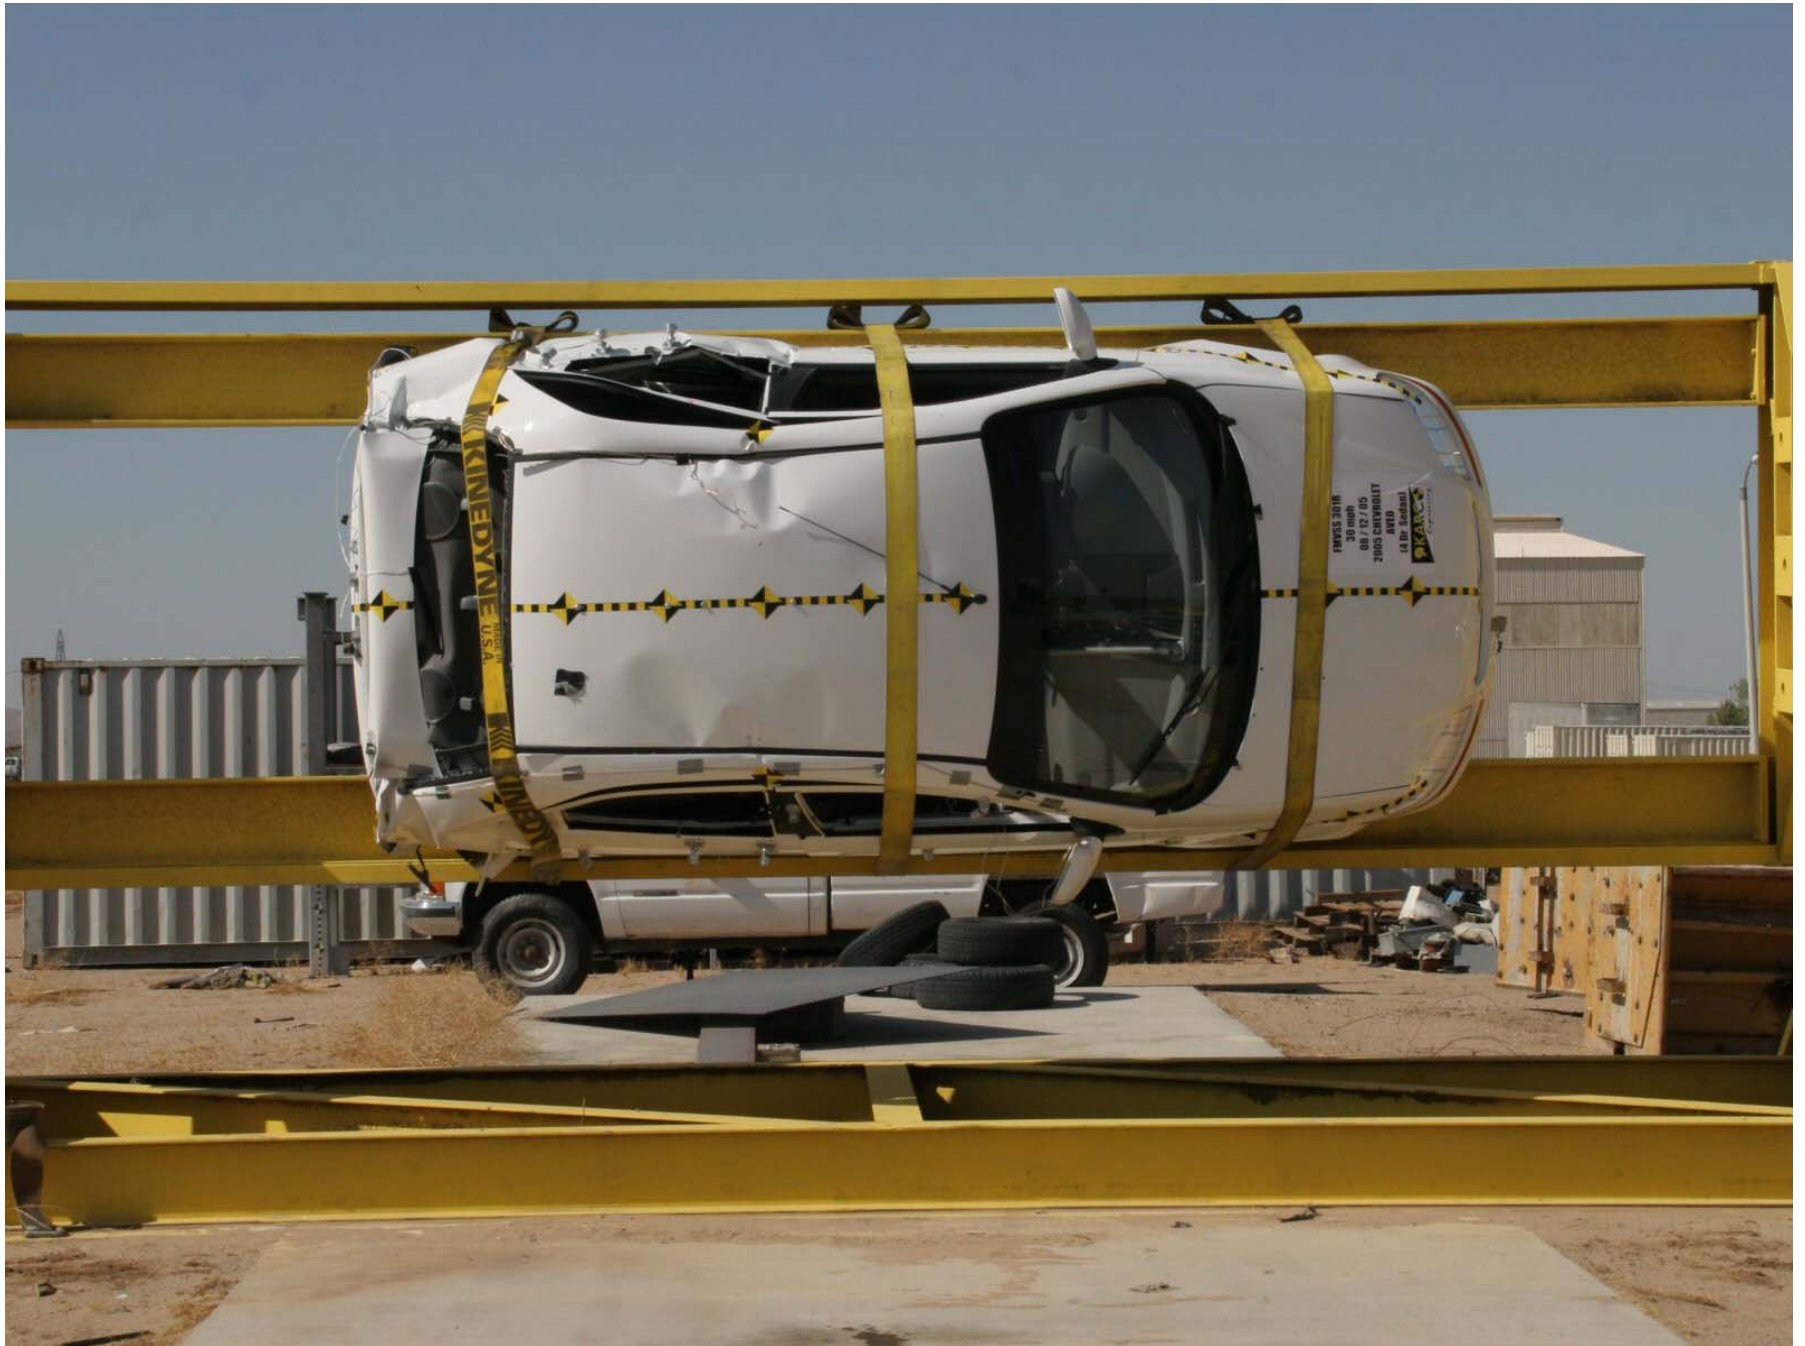
Figure A-22: Vehicle on Rollover Device at 90°

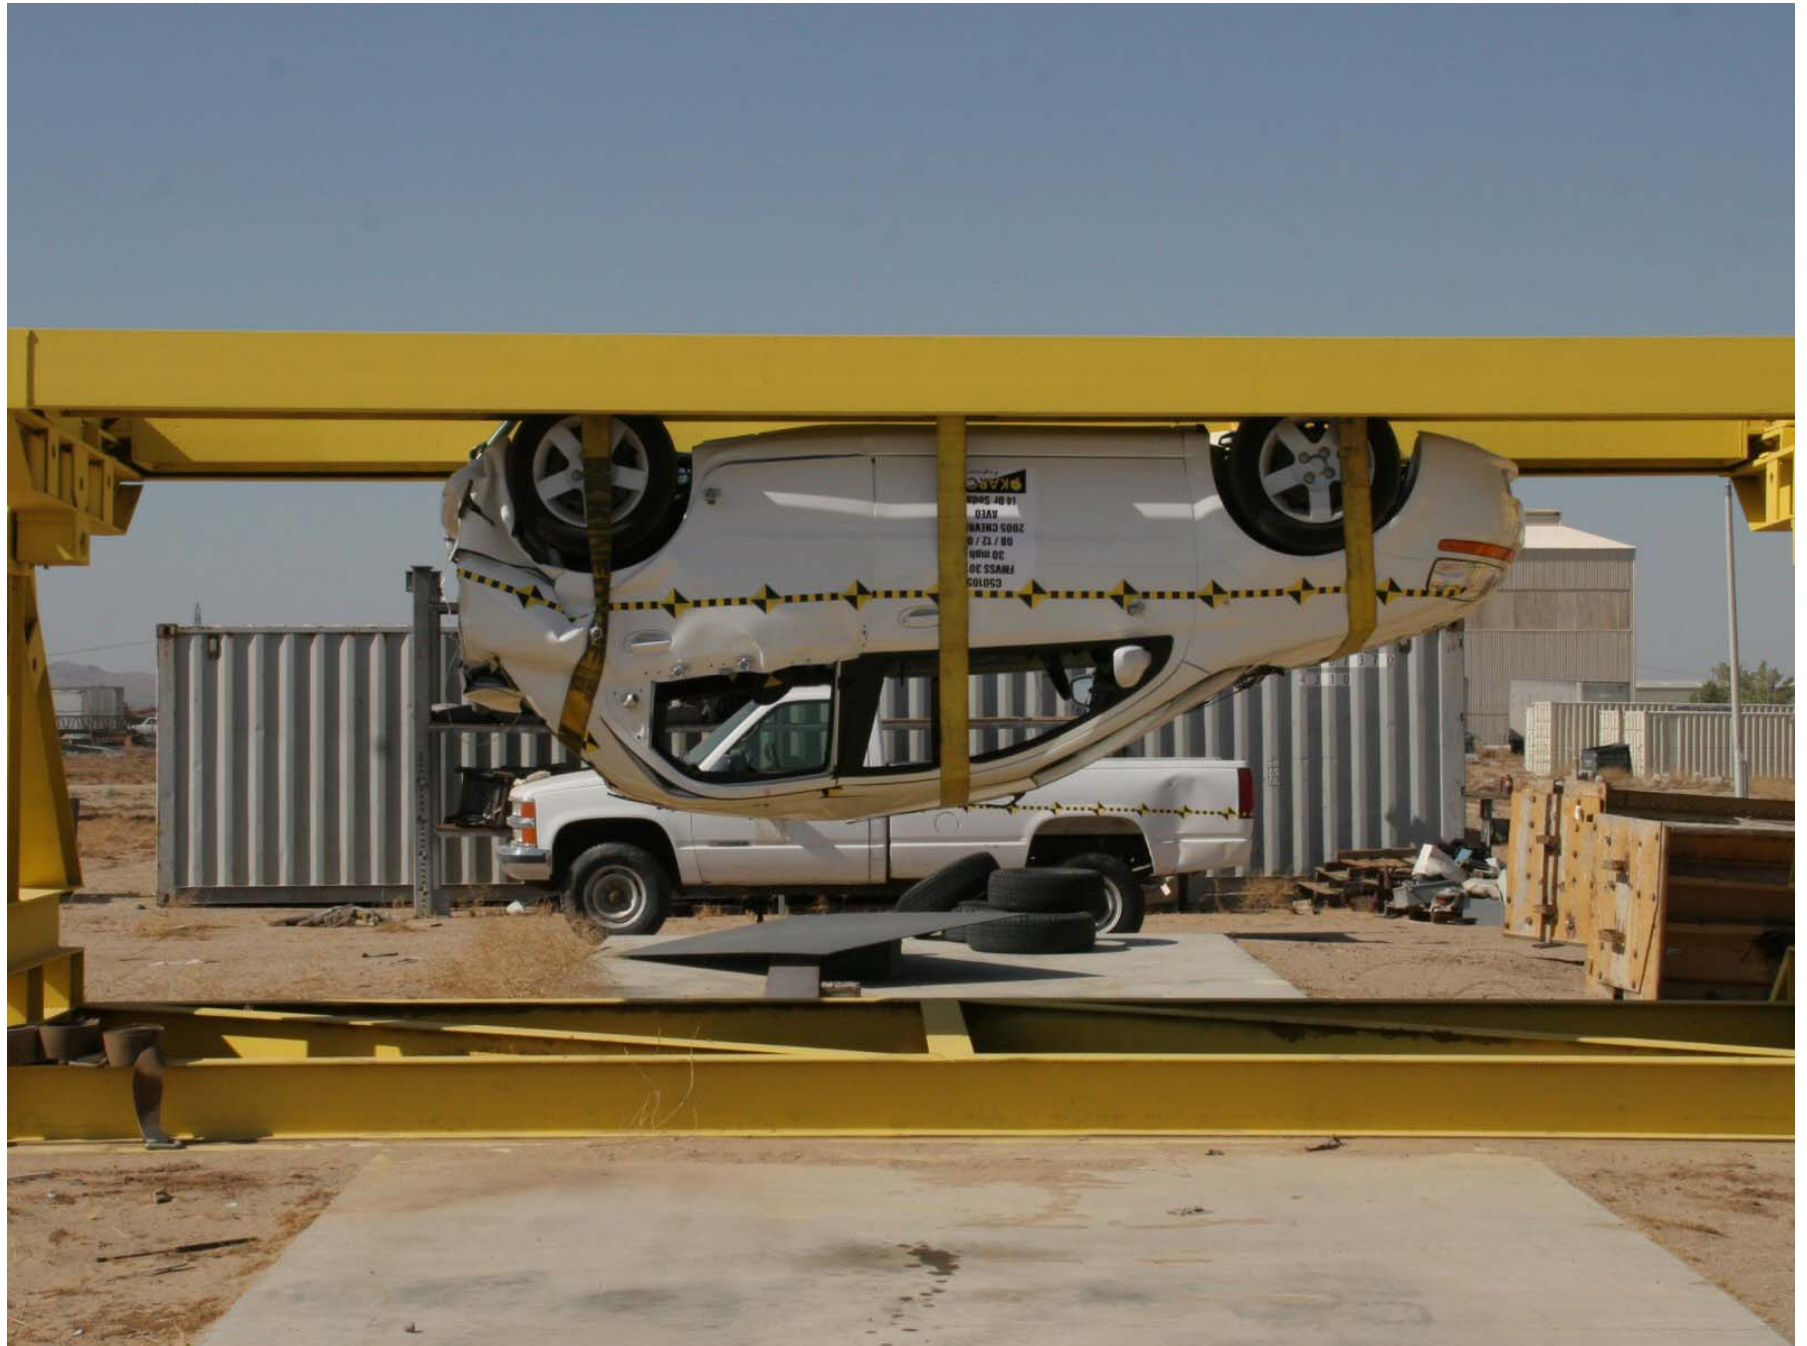
Figure A-23: Vehicle on Rollover Device at 180°

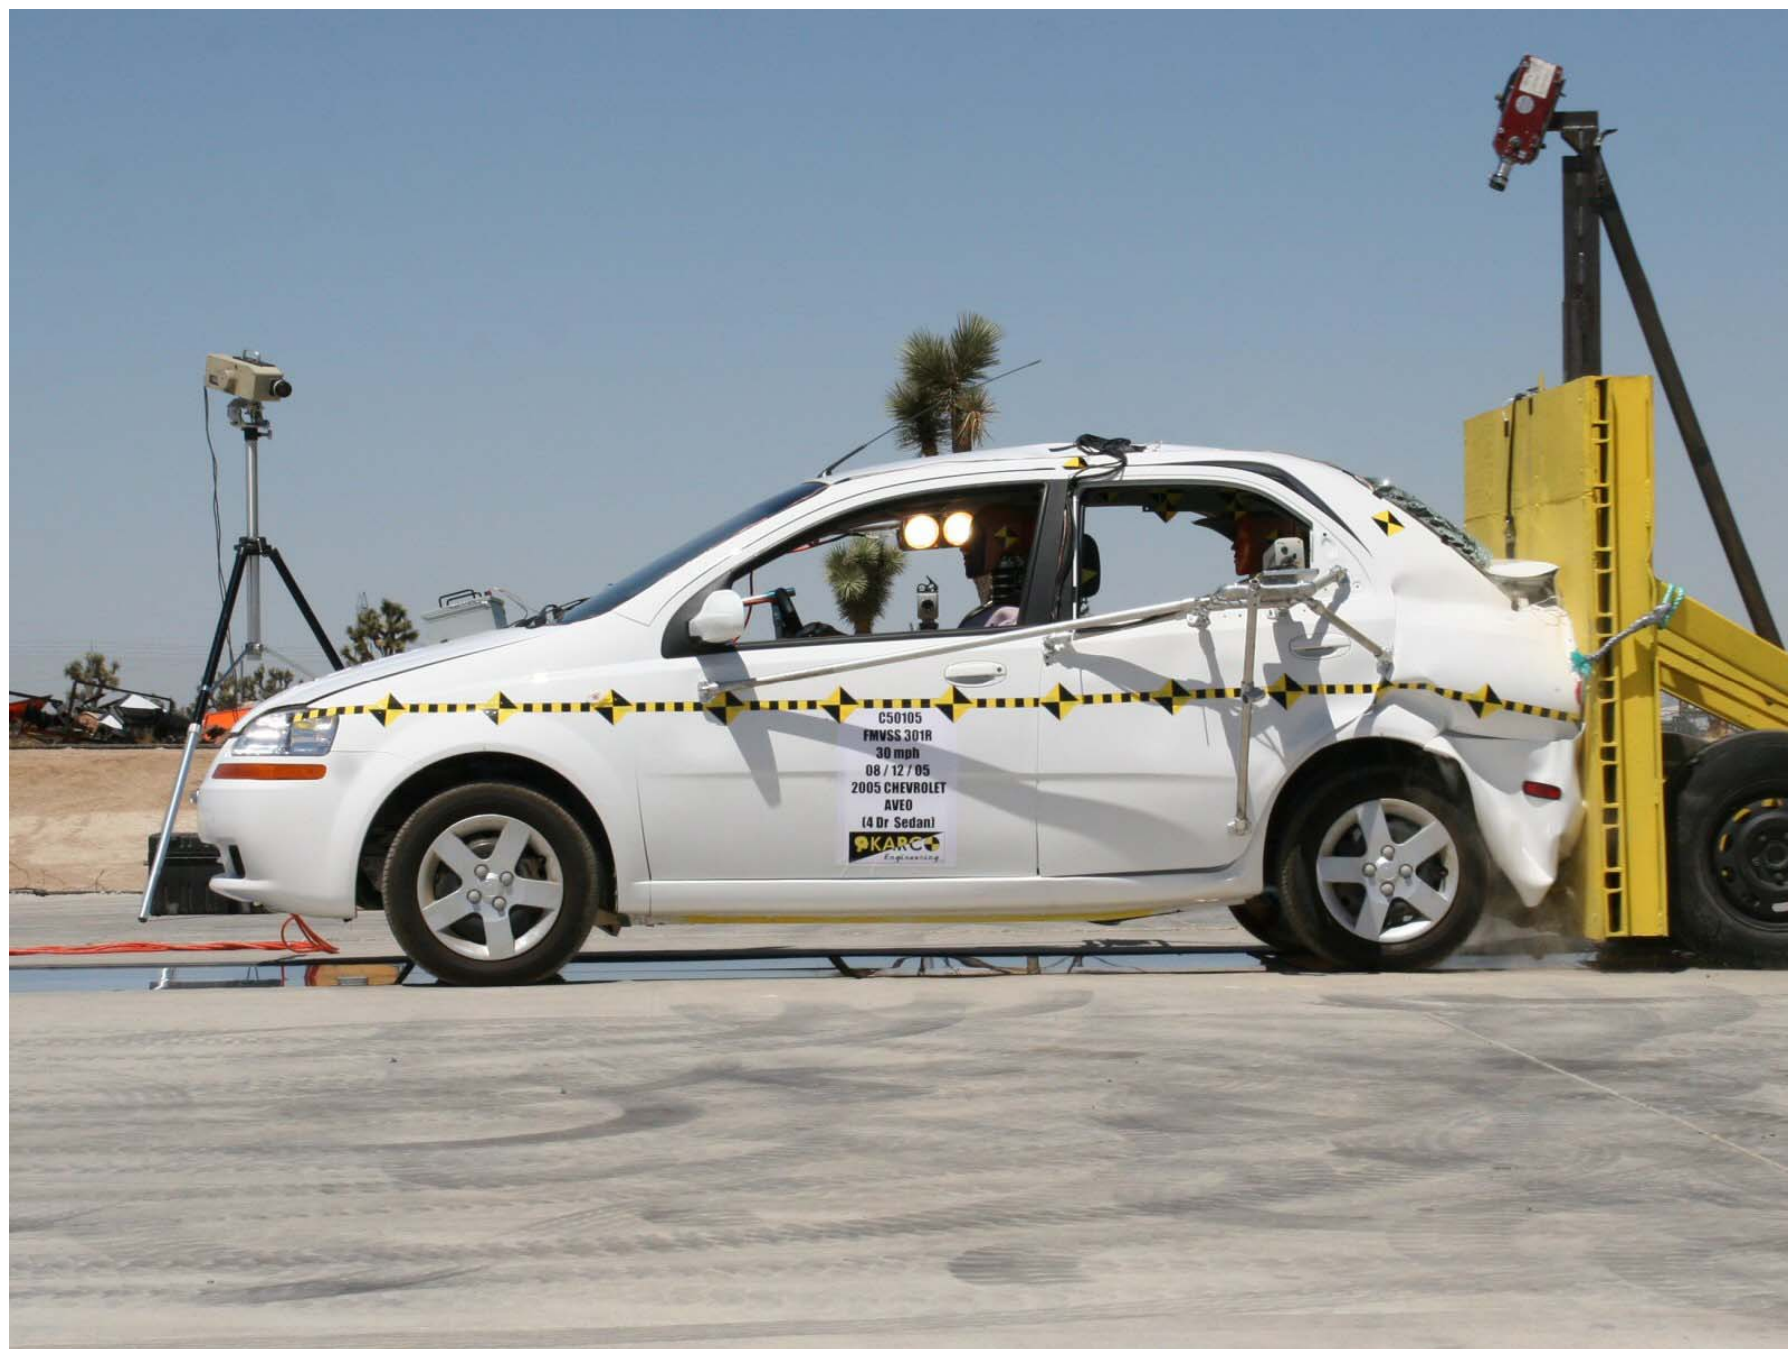
Figure A-25: Vehicle During Impact

A 1313 kg 2005 Chevrolet Aveo 4-Door Sedan was impacted from the rear by a 1799 kg moving barrier at a velocity of 47.80 Km/h (29.71 mph). The test was performed by KARCO Engineering, LLC on August 12, 2005.

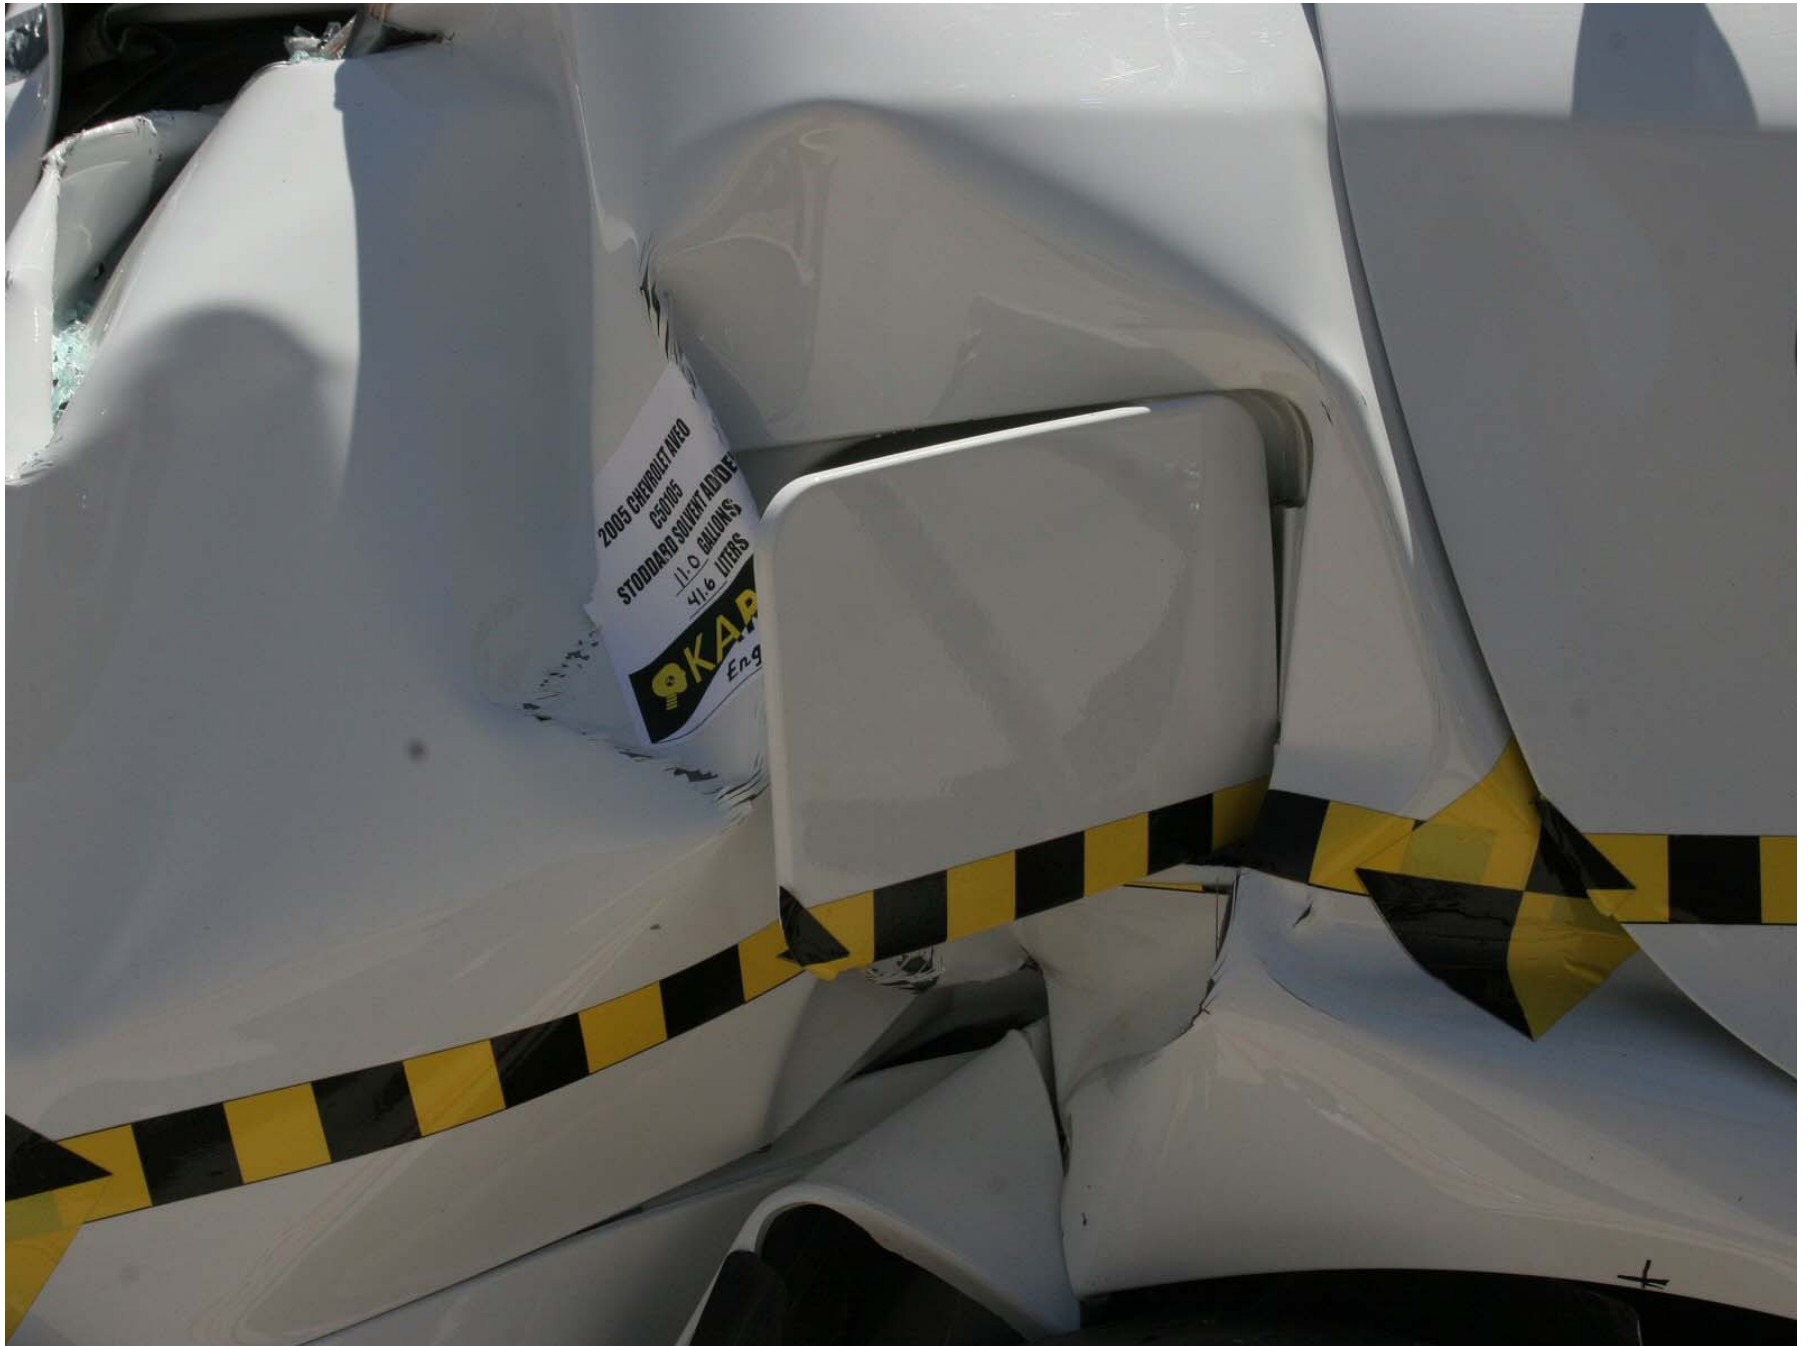
Figure A-26: Post-Test Fuel Door
