**REPORT NUMBER TR-P26003-02-NC**

**NEW CAR ASSESSMENT PROGRAM  
SIDE IMPACT TEST**

**FORD MOTOR COMPANY  
2006 FORD EXPLORER  
4-DOOR MPV**

**FINAL REPORT**

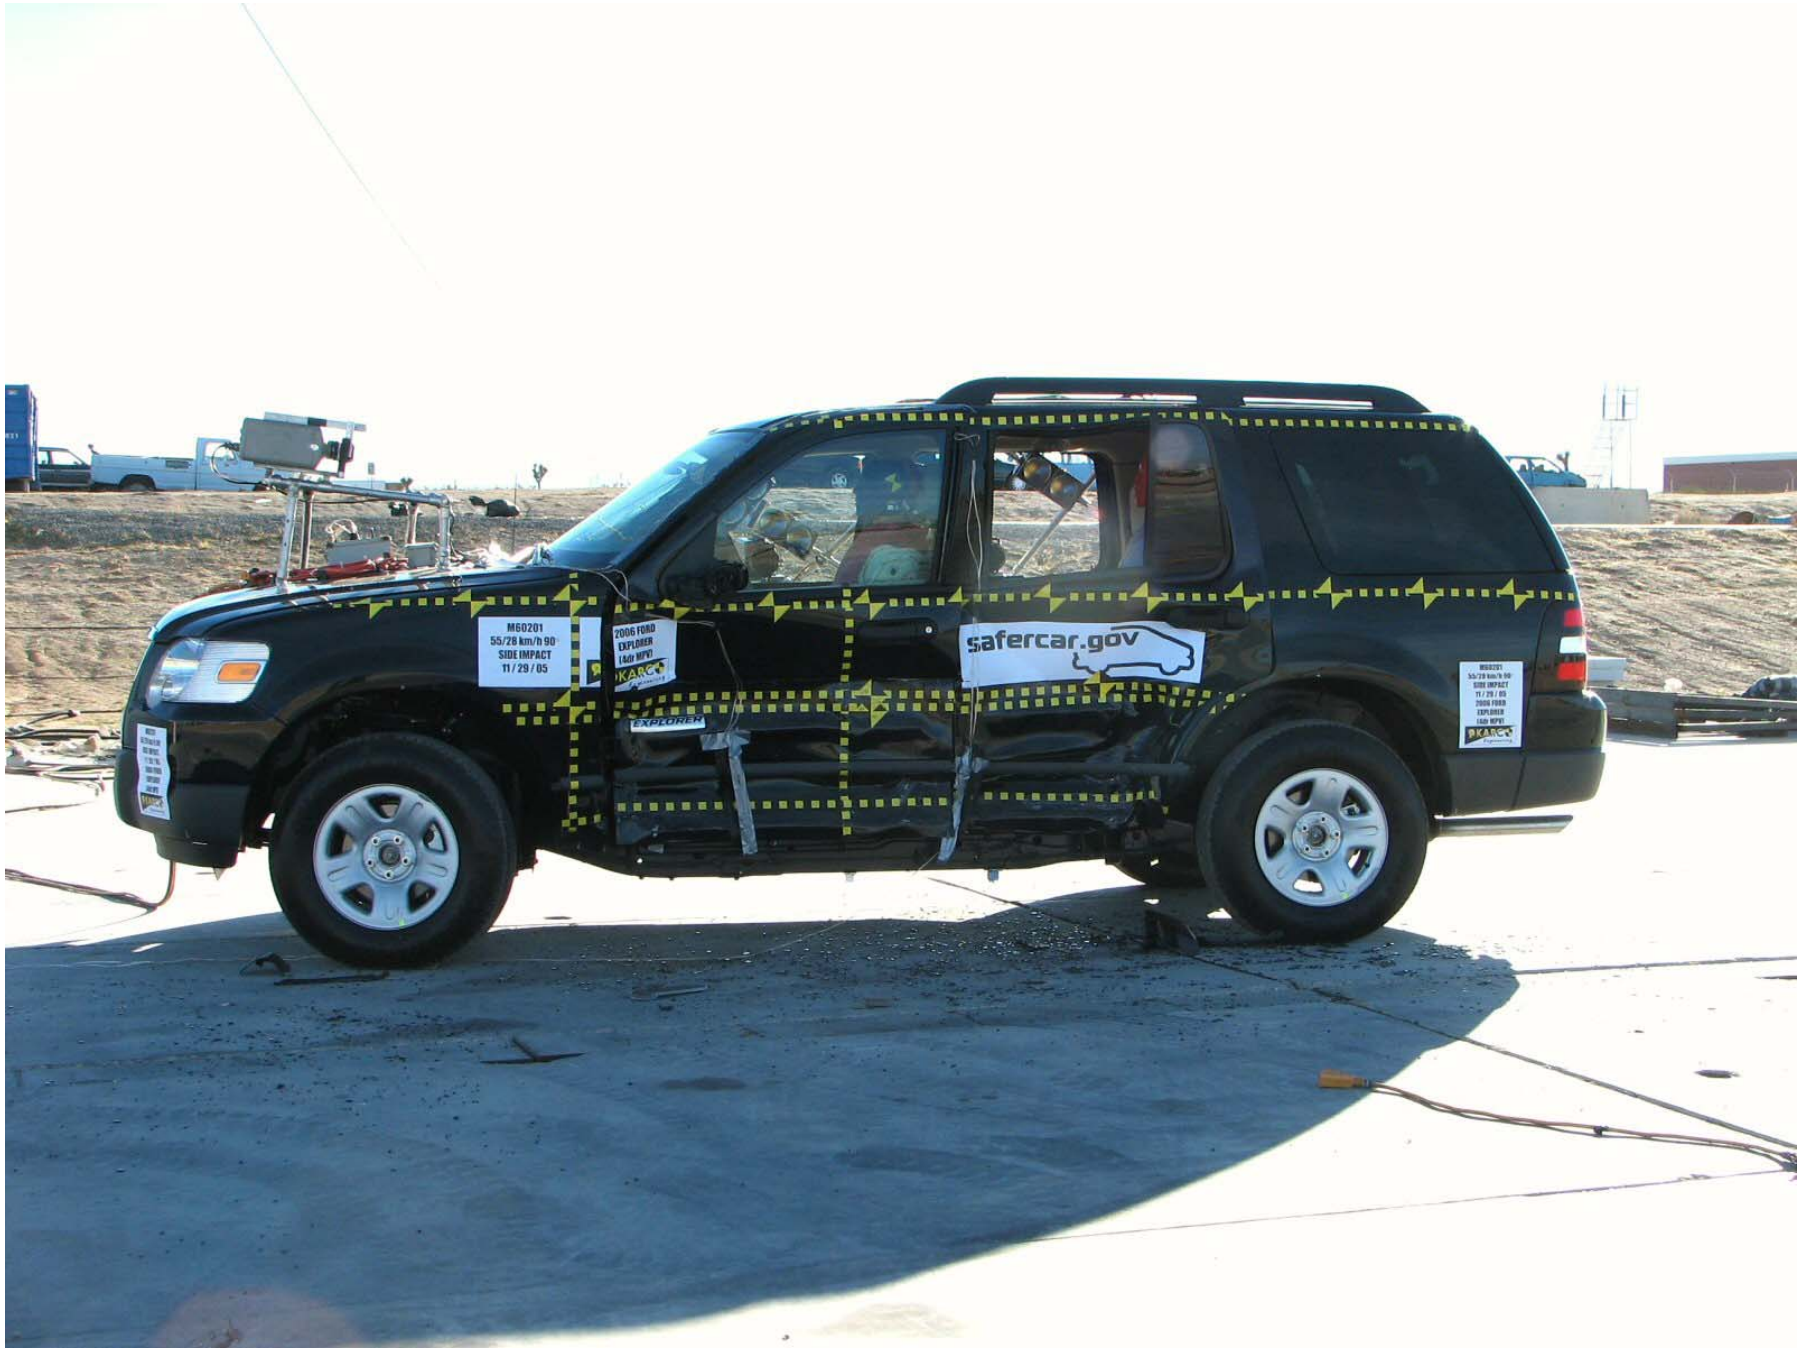
Figure A-10: Post-Test Left Side View

The driver and passenger doors remained closed during impact. The test vehicle sustained a maximum static crush of 245 mm at level 3, 1650 mm rearward of the left vertical impact point. The driver SID/Hybrid III, Serial No. 274 and the passenger SID/Hybrid III, Serial No. 275 were calibrated prior to this test. The SID/Hybrid III injury criteria is summarized as follows:

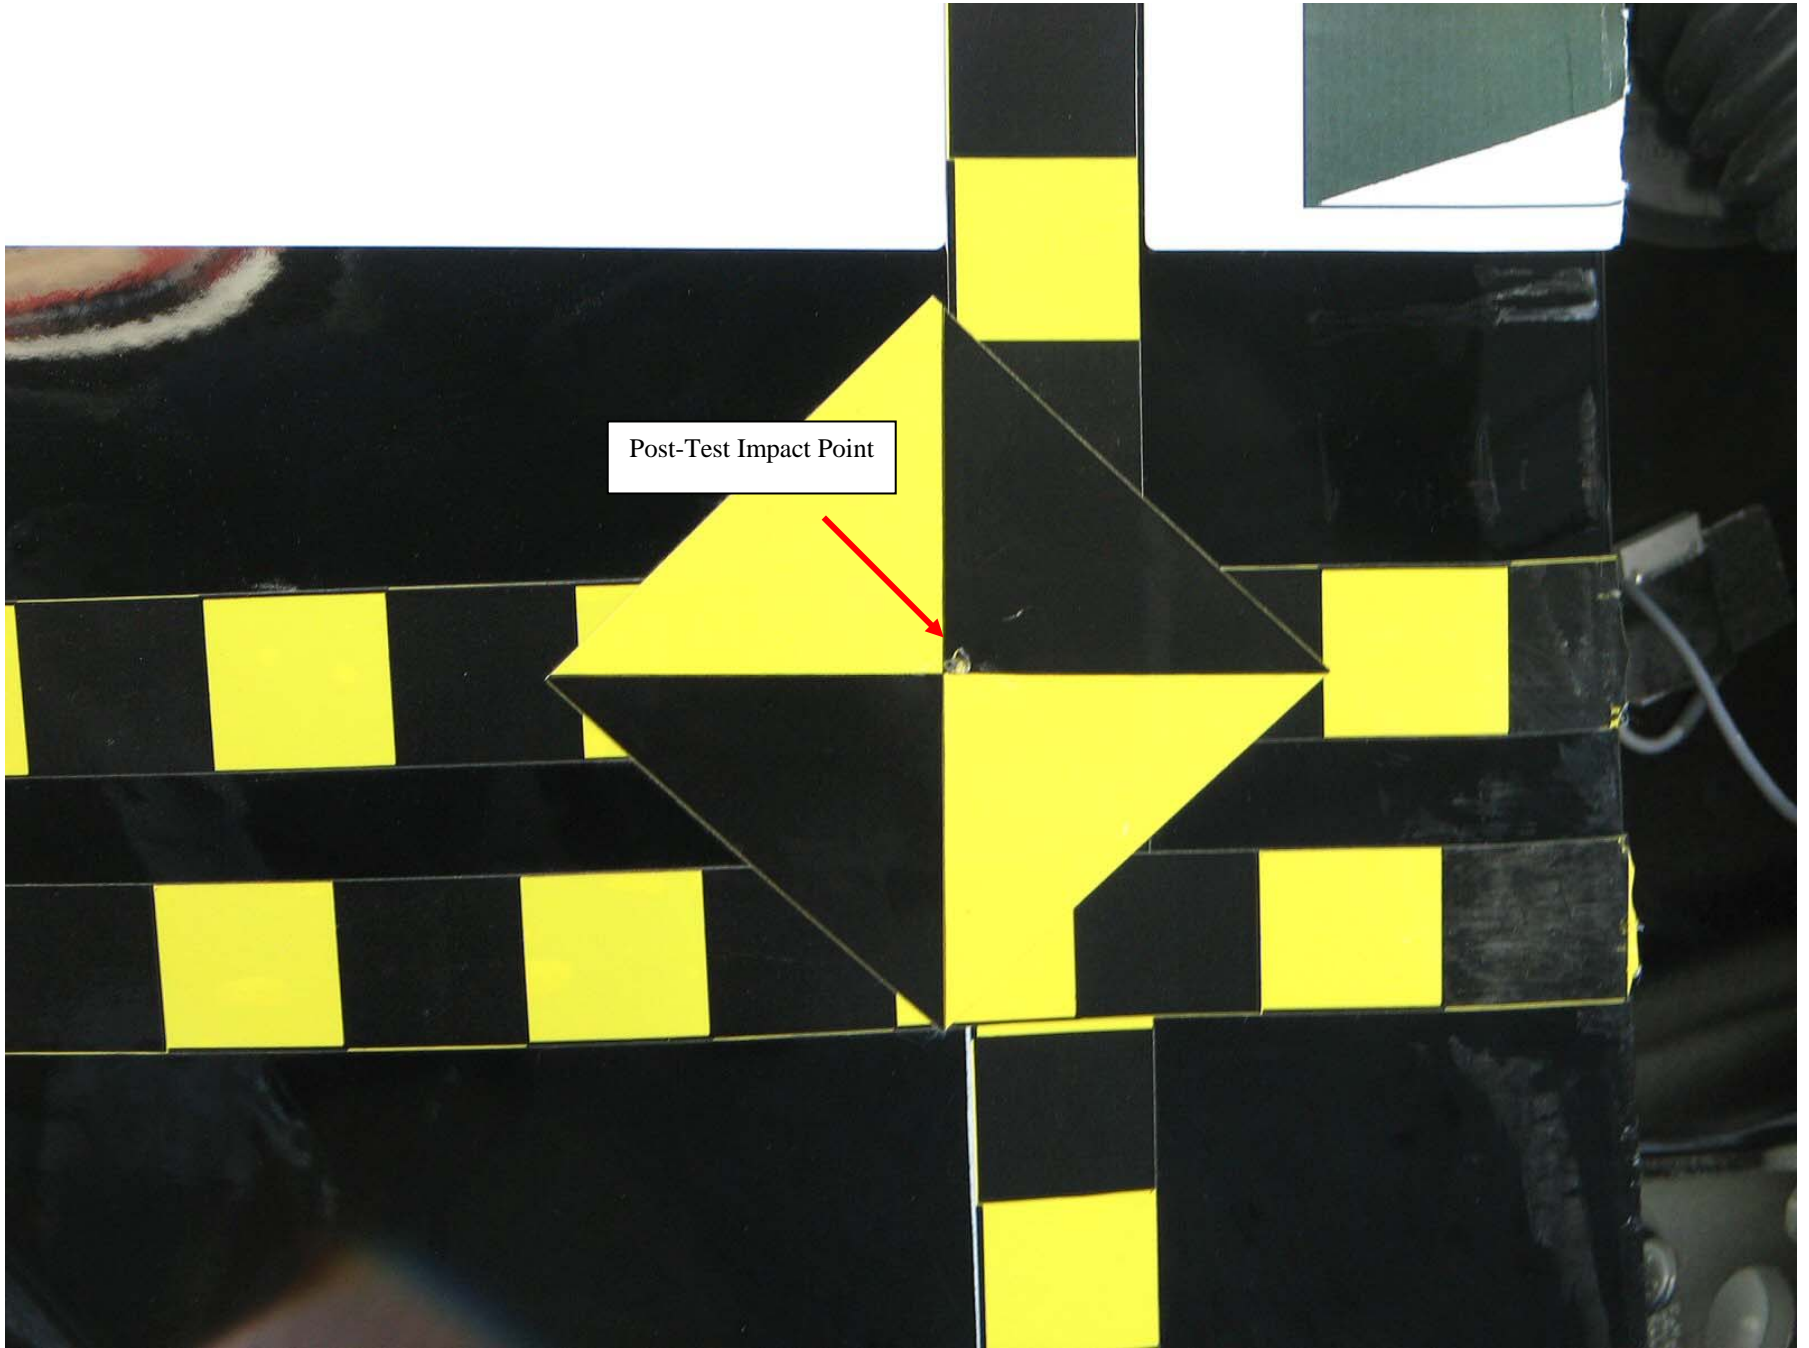
Figure A-26: Post-Test Left Impact Point

Post-Test Impact Point

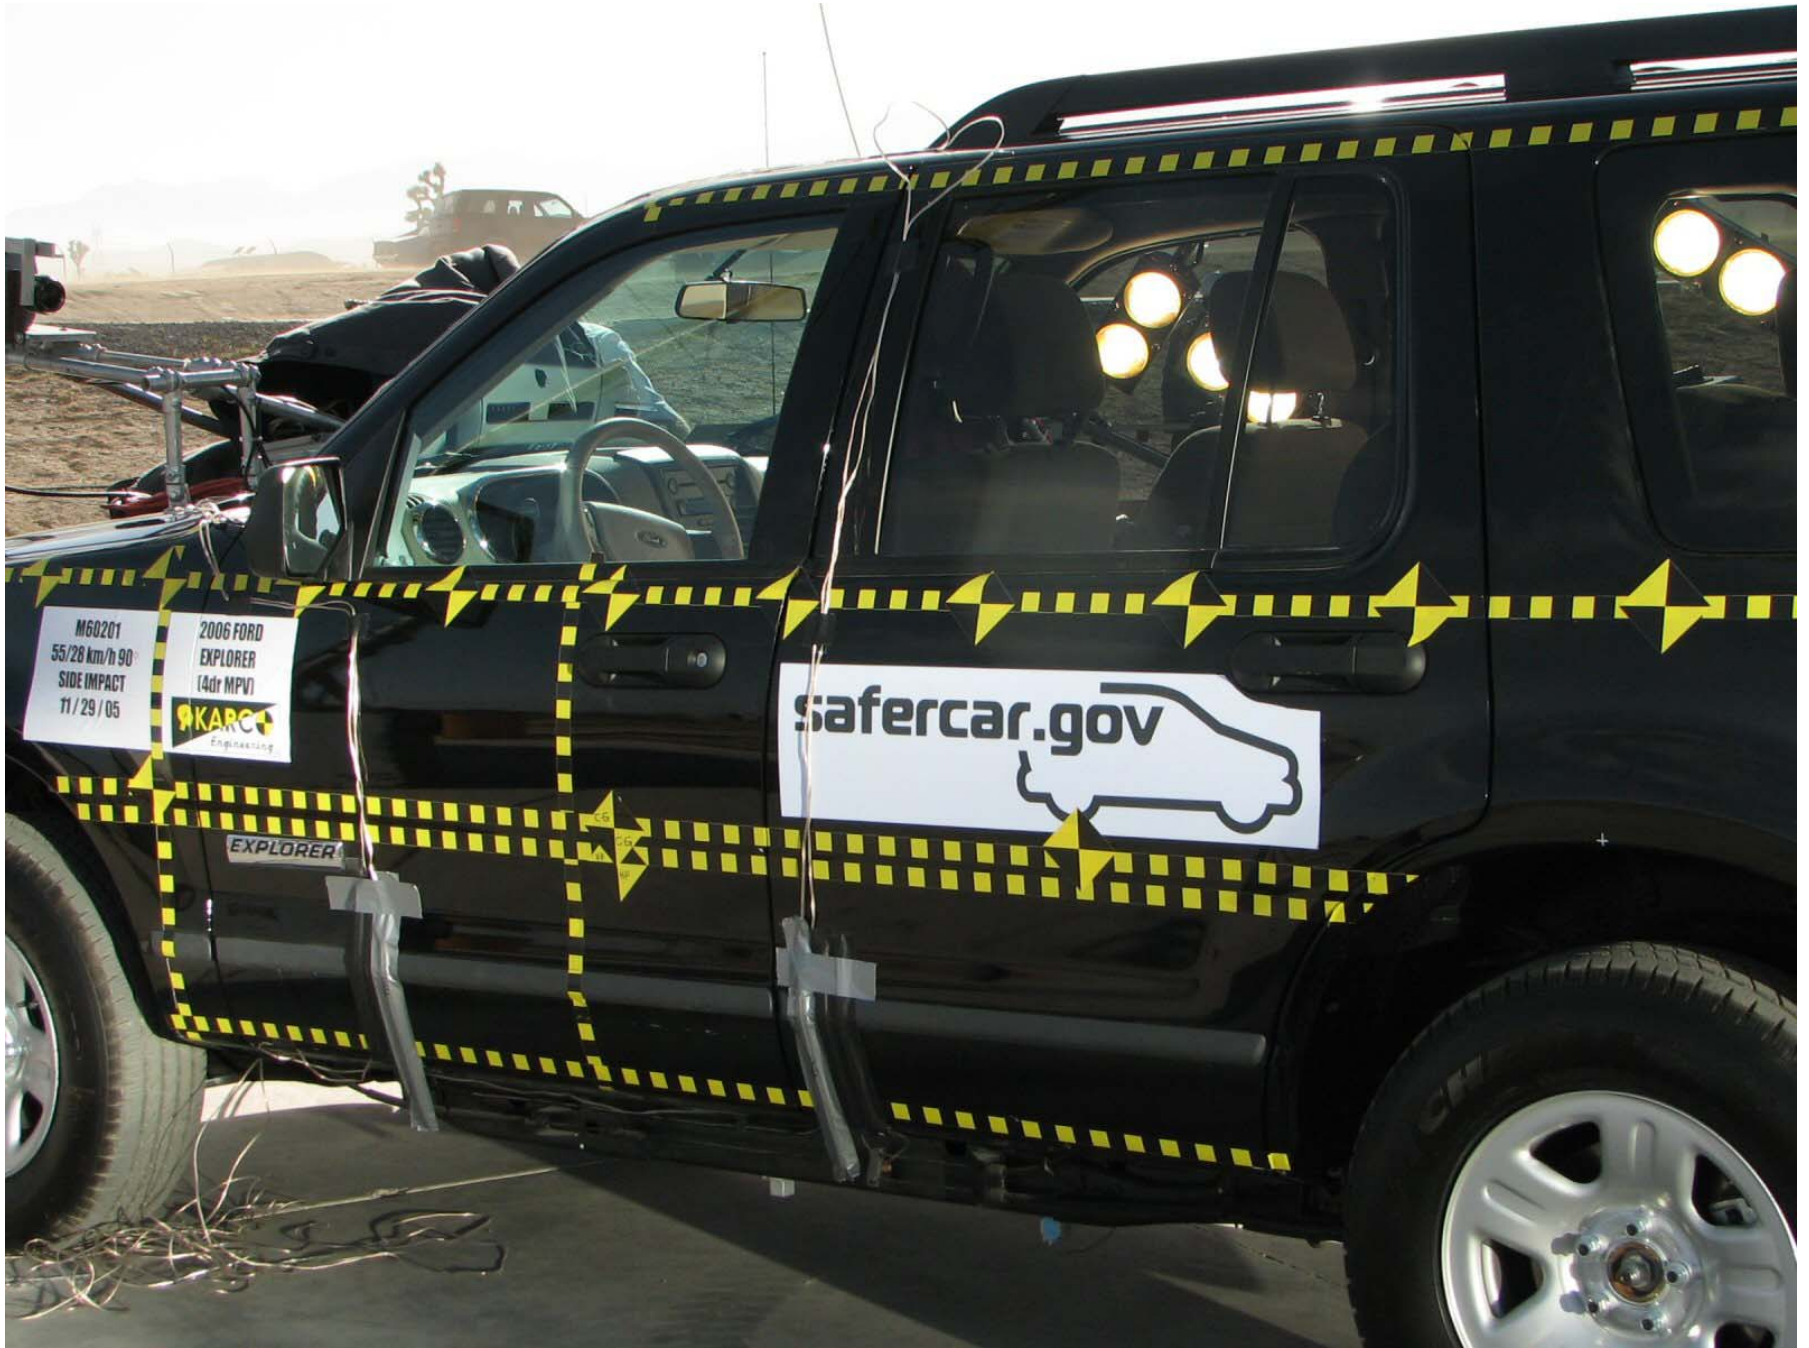
Figure A-28: Post-Test Front ¾ View of Left Side Doors

Description	Front	Rear
Left Side Door Opening	Door remained closed and latched, jammed	Door remained closed and latched, jammed
Right Side Door Opening	Remained closed and latched, operational	Remained closed and latched, operational
Seat Movement	None	None
Seat Back Failure	None	None

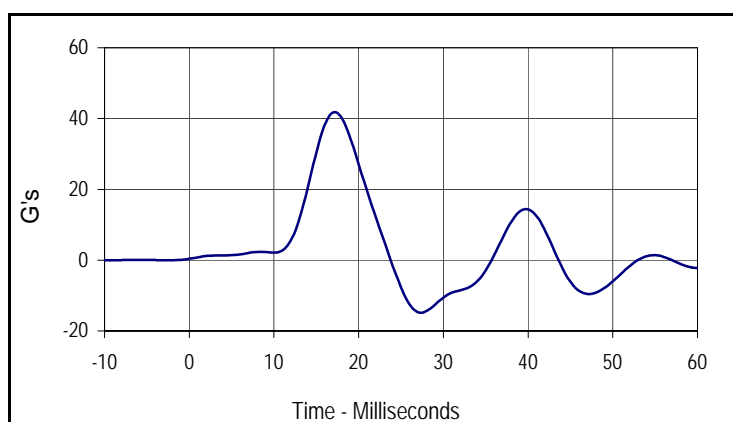
Curve Description			
Upper Rib Primary			
CURNO	Type	SAE Class	Units
001	FIL	FIR100	G's
Max	Time	Min	Time
41.6	16.9	-14.8	27.5

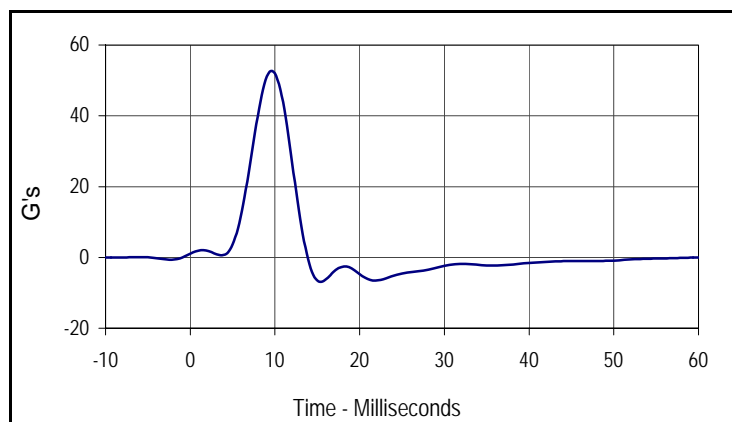
Curve Description			
Pelvis Primary Y			
CURNO	Type	SAE Class	Units
001	FIL	FIR100	G's
Max	Time	Min	Time
52.5	9.4	-6.8	15.6

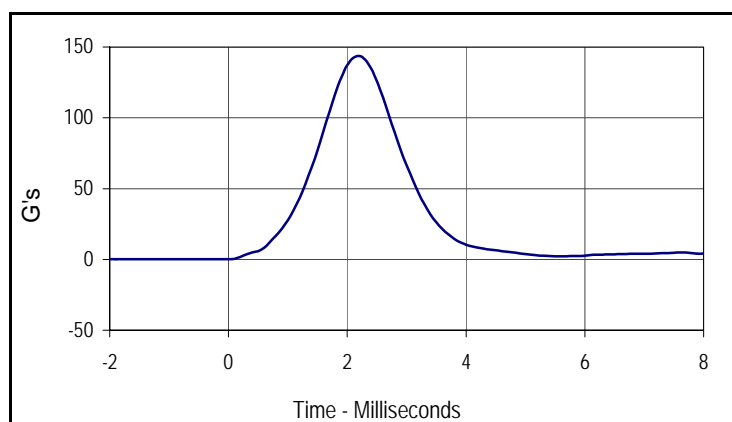
Curve Description			
Head Resultant			
CURNO	Type	SAE Class	Units
001	RES	1000	G's
Max	Time	Min	Time
143.7	2.2	0.1	-0.9

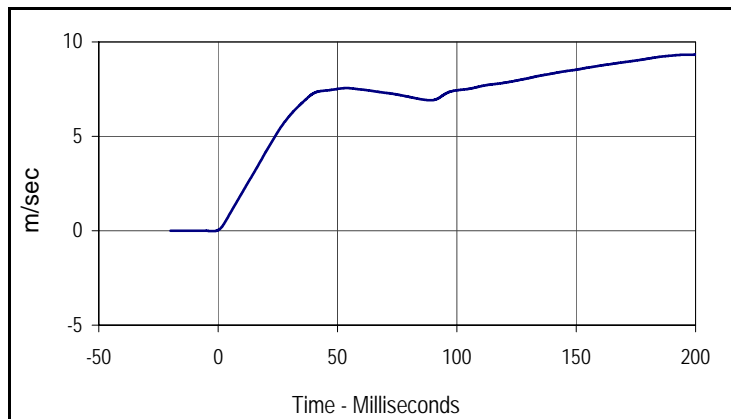
Curve Description			
Pendulum Velocity			
CURNO	Type	SAE Class	Units
001	FIL	180	m/sec
Max	Time	Min	Time
9.3	200.0	0.0	-2.0

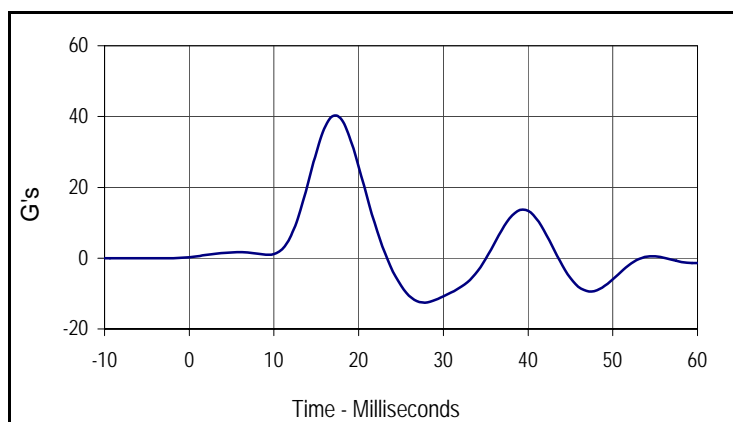
Curve Description			
Upper Rib Primary			
CURNO	Type	SAE Class	Units
001	FIL	FIR100	G's
Max	Time	Min	Time
40.2	17.5	-12.5	27.5

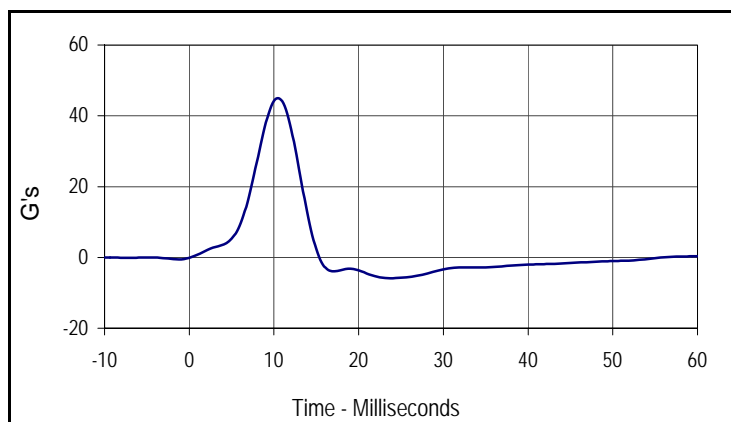
Curve Description			
Pelvis Primary Y			
CURNO	Type	SAE Class	Units
001	FIL	FIR100	G's
Max	Time	Min	Time
44.9	10.6	-5.9	23.8

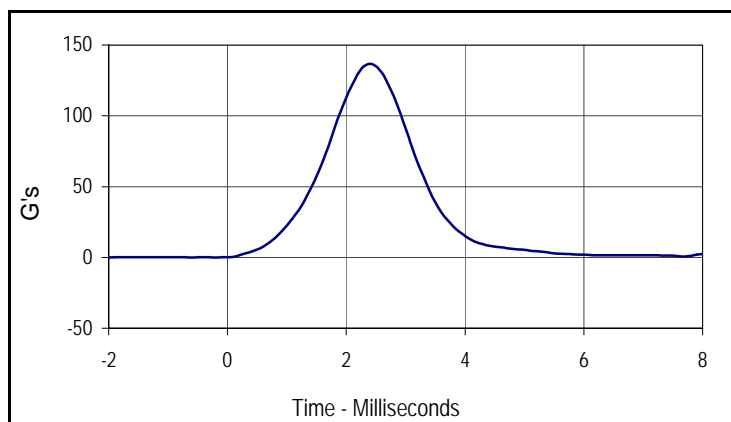
Curve Description			
Head Resultant			
CURNO	Type	SAE Class	Units
001	RES	1000	G's
Max	Time	Min	Time
136.6	2.4	0.0	-0.2

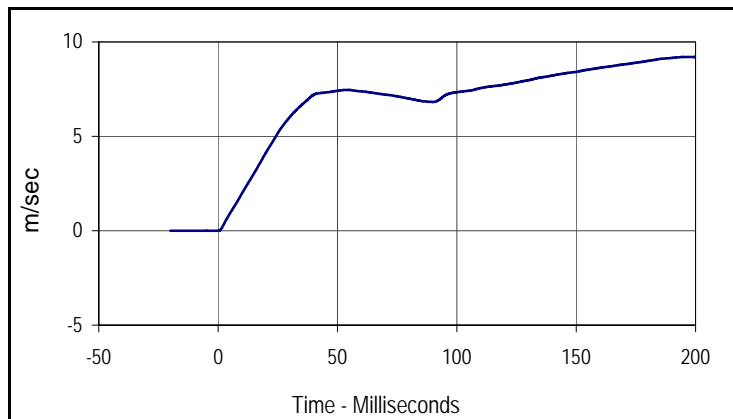
Curve Description			
Pendulum Velocity			
CURNO	Type	SAE Class	Units
001	FIL	180	m/sec
Max	Time	Min	Time
9.2	200.0	0.0	-0.1

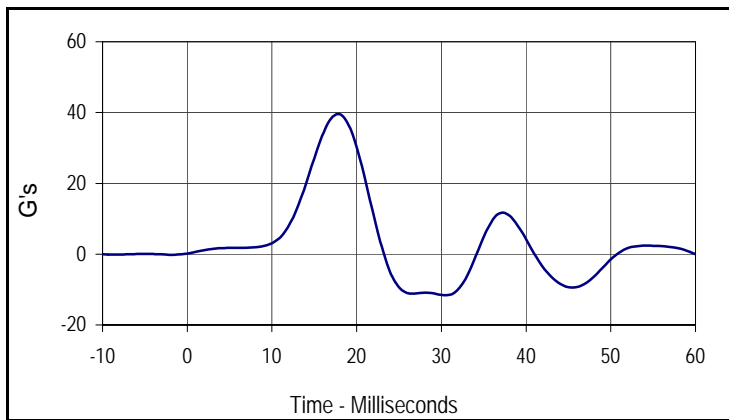
Curve Description			
Upper Rib Primary			
CURNO	Type	SAE Class	Units
001	FIL	FIR100	G's
Max	Time	Min	Time
39.4	17.5	-11.6	30.6

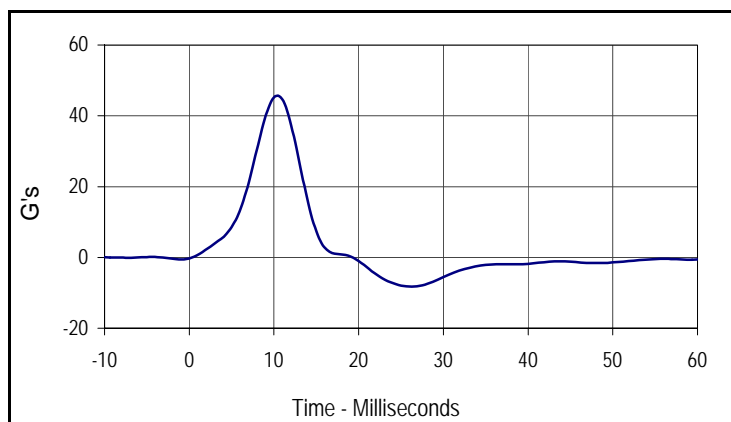
Curve Description			
Pelvis Primary Y			
CURNO	Type	SAE Class	Units
001	FIL	FIR100	G's
Max	Time	Min	Time
45.6	10.6	-8.3	26.3

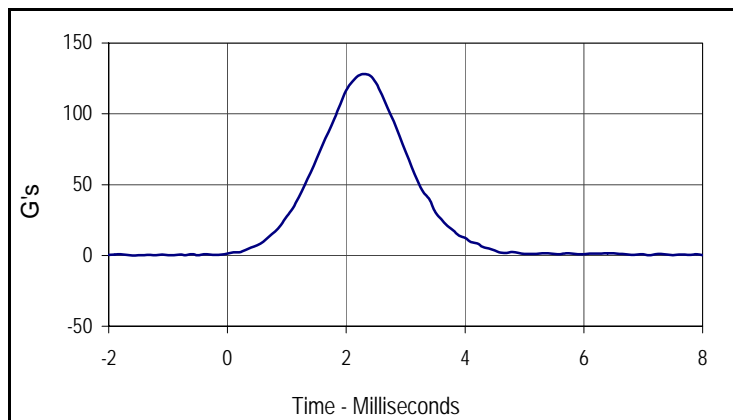
Curve Description			
Head Resultant			
CURNO	Type	SAE Class	Units
001	RES	1000	G's
Max	Time	Min	Time
128.0	2.3	0.0	-1.6

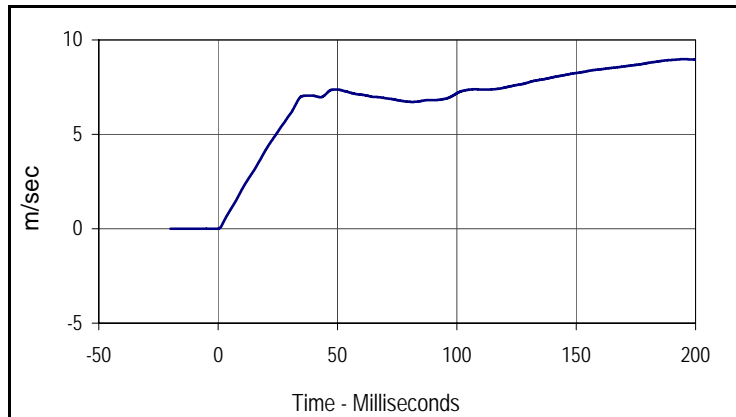
Curve Description			
Pendulum Velocity			
CURNO	Type	SAE Class	Units
001	FIL	180	m/sec
Max	Time	Min	Time
9.0	194.7	0.0	-0.3

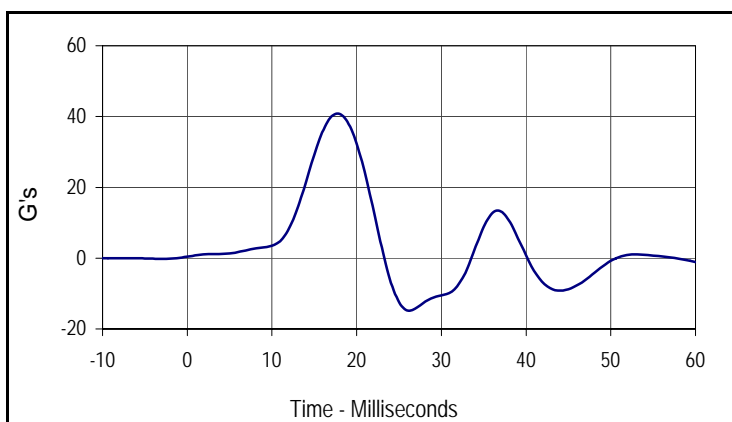
Curve Description			
Upper Rib Primary			
CURNO	Type	SAE Class	Units
001	FIL	FIR100	G's
Max	Time	Min	Time
40.7	17.5	-14.8	26.3

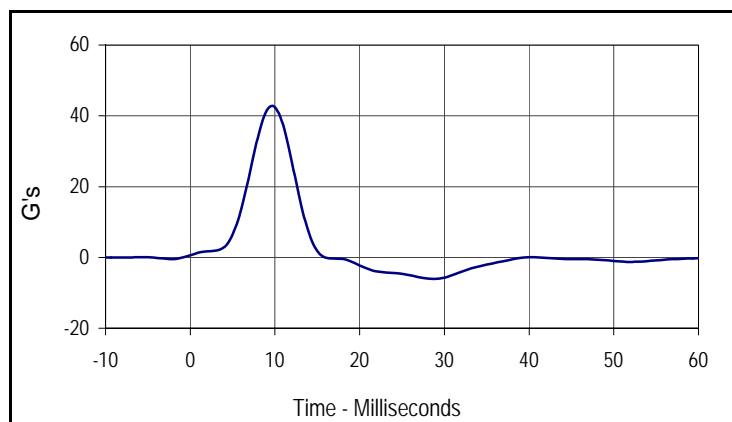
Curve Description			
Pelvis Primary Y			
CURNO	Type	SAE Class	Units
001	FIL	FIR100	G's
Max	Time	Min	Time
42.6	9.4	-6.1	28.8

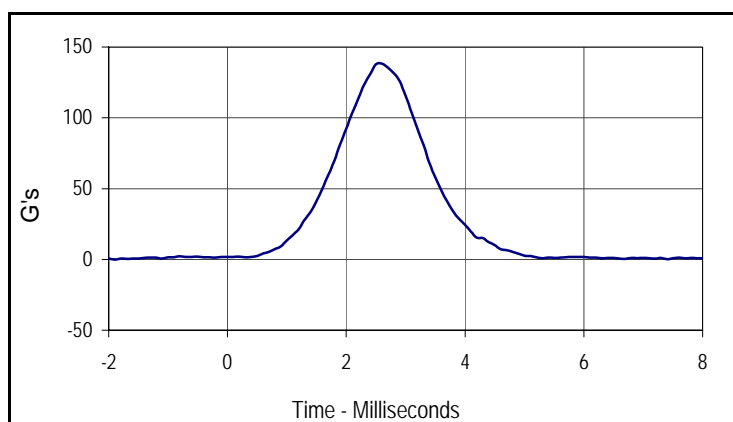
Curve Description			
Head Resultant			
CURNO	Type	SAE Class	Units
001	RES	1000	G's
Max	Time	Min	Time
138.3	2.6	0.0	-1.9

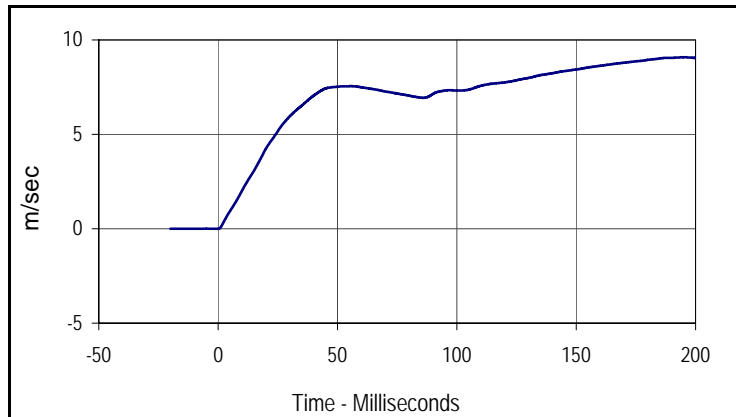
Curve Description			
Pendulum Velocity			
CURNO	Type	SAE Class	Units
001	FIL	180	m/sec
Max	Time	Min	Time
9.1	195.0	0.0	-0.2
