**REPORT NUMBER: NCAP-MGA-2006-007**

**NEW CAR ASSESSMENT PROGRAM  
FRONTAL BARRIER IMPACT TEST**

**HONDA OF CANADA MANUFACTURING  
2006 HONDA CIVIC LX 2-Door  
NHTSA NUMBER: M65300**

**PREPARED BY:  
MGA RESEARCH CORPORATION  
5000 WARREN ROAD  
BURLINGTON, WI 53105**

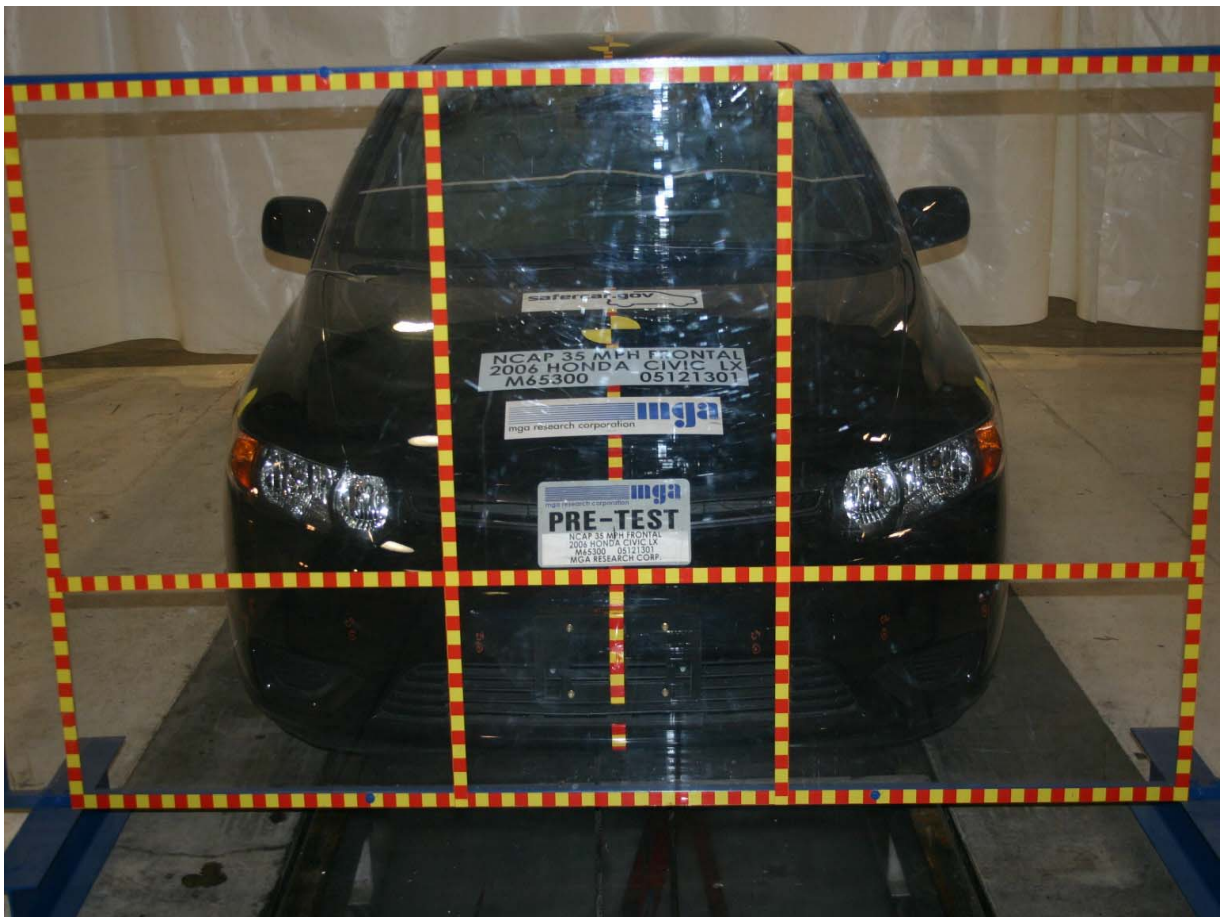
Load Cell Location

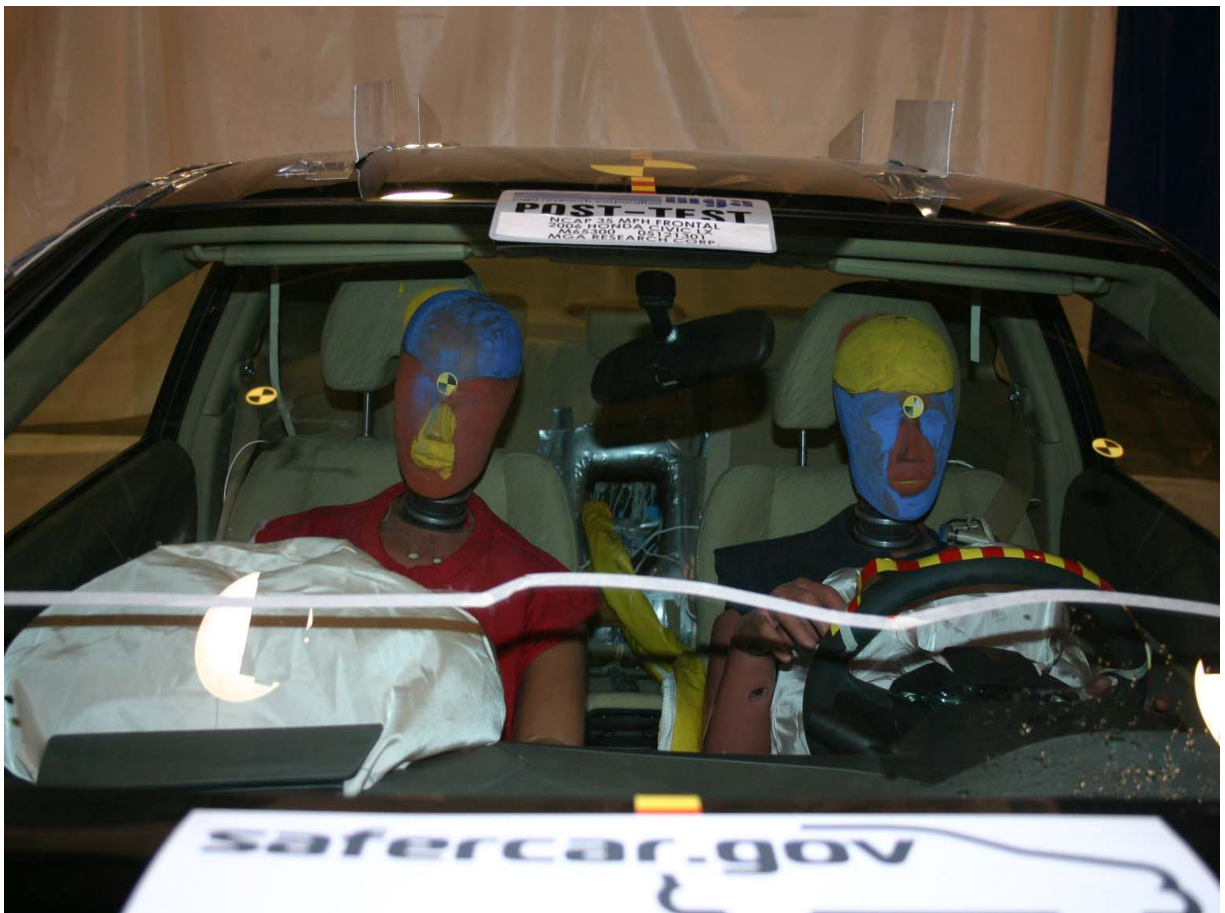
Post-Test Windshield View

There was 100 percent windshield retention and no intrusion into the protected zone of the windshield during the event. There was no Stoddard Solvent leakage after the event or during any phase of the static rollover.

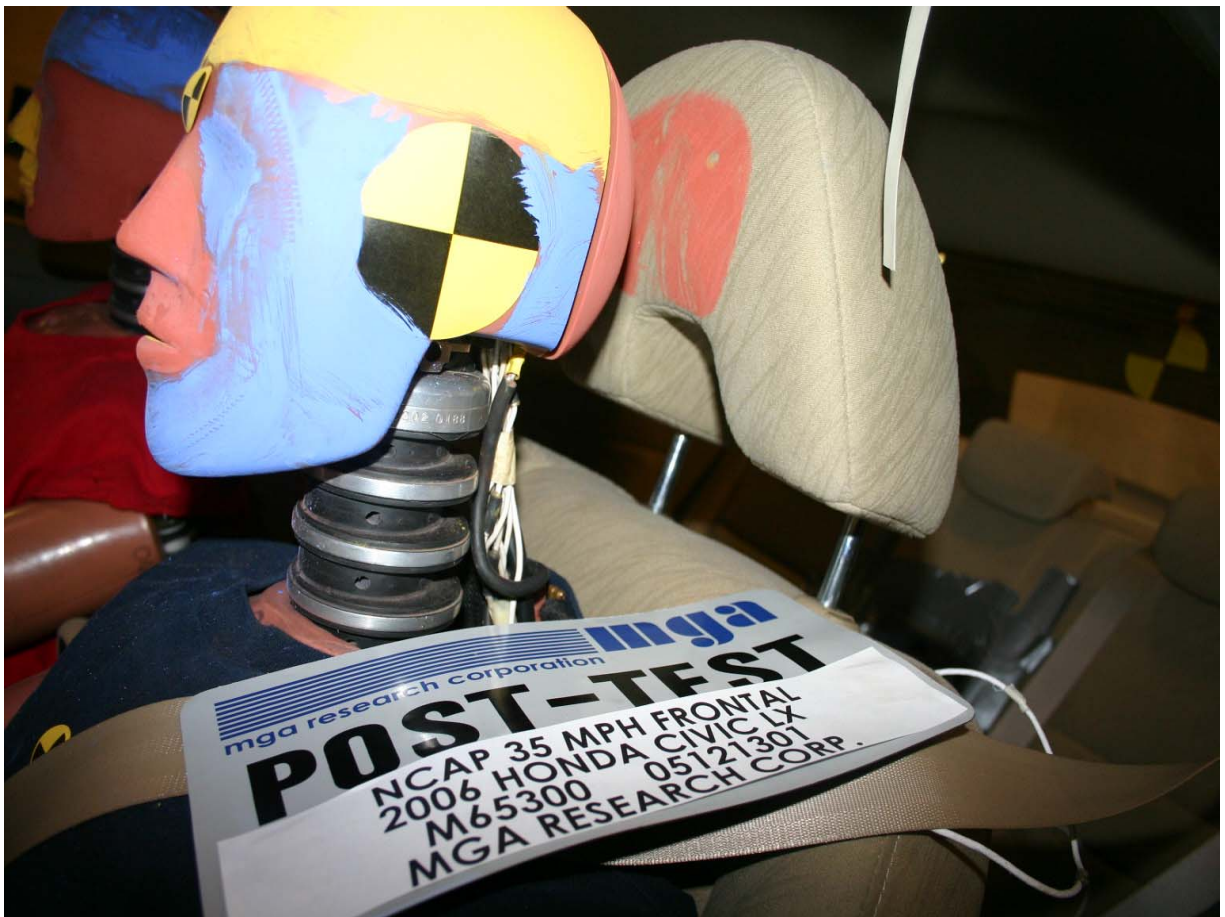
Post-Test Driver Dummy Head Contact

The driver's head, chest, and abdomen contacted the airbag. The driver's head also contacted the headrest. The driver's knees contacted the bolster and steering column. The passenger's head and chest contacted the airbag. The passenger's head also contacted the headrest. The passenger's knees contacted the glove box.

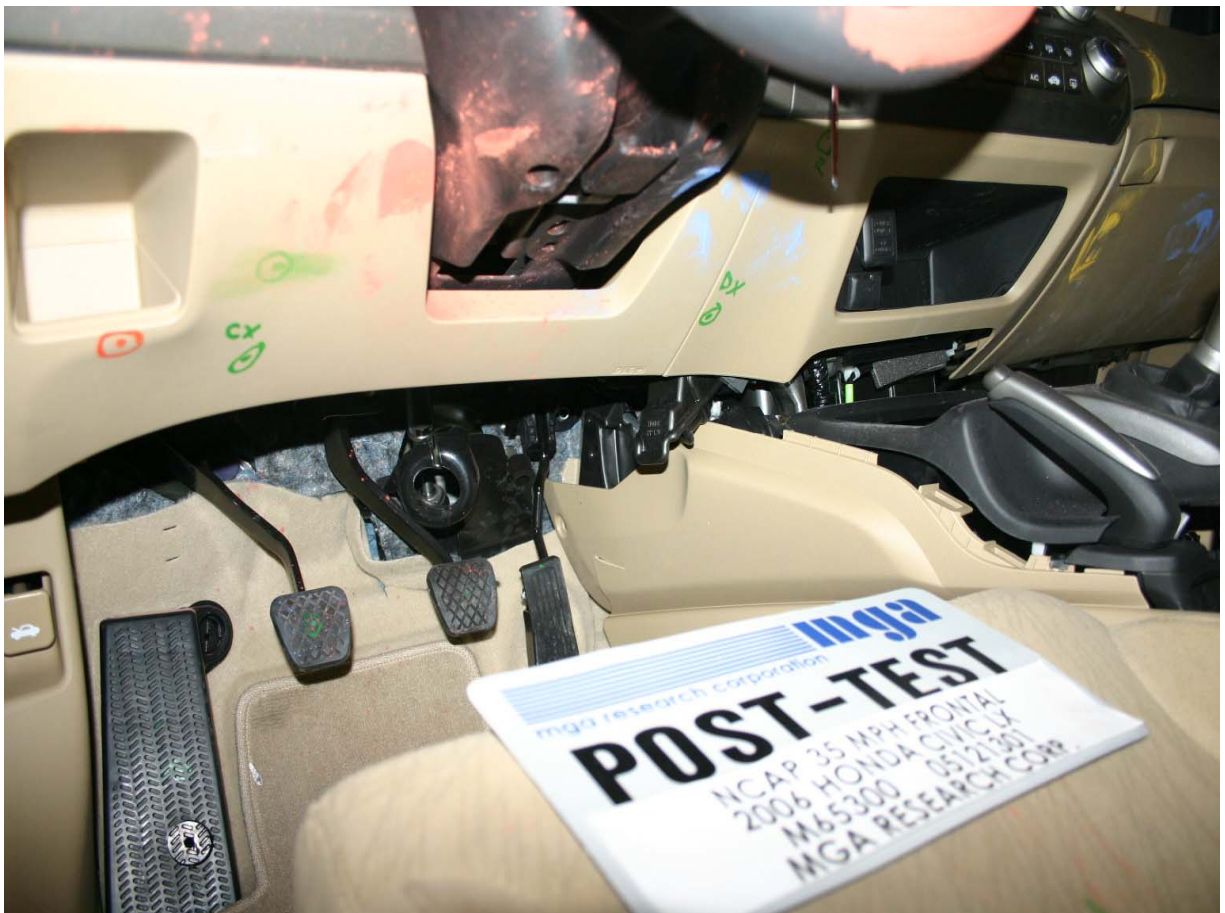
Post-Test Driver Dummy Left Knee Contact

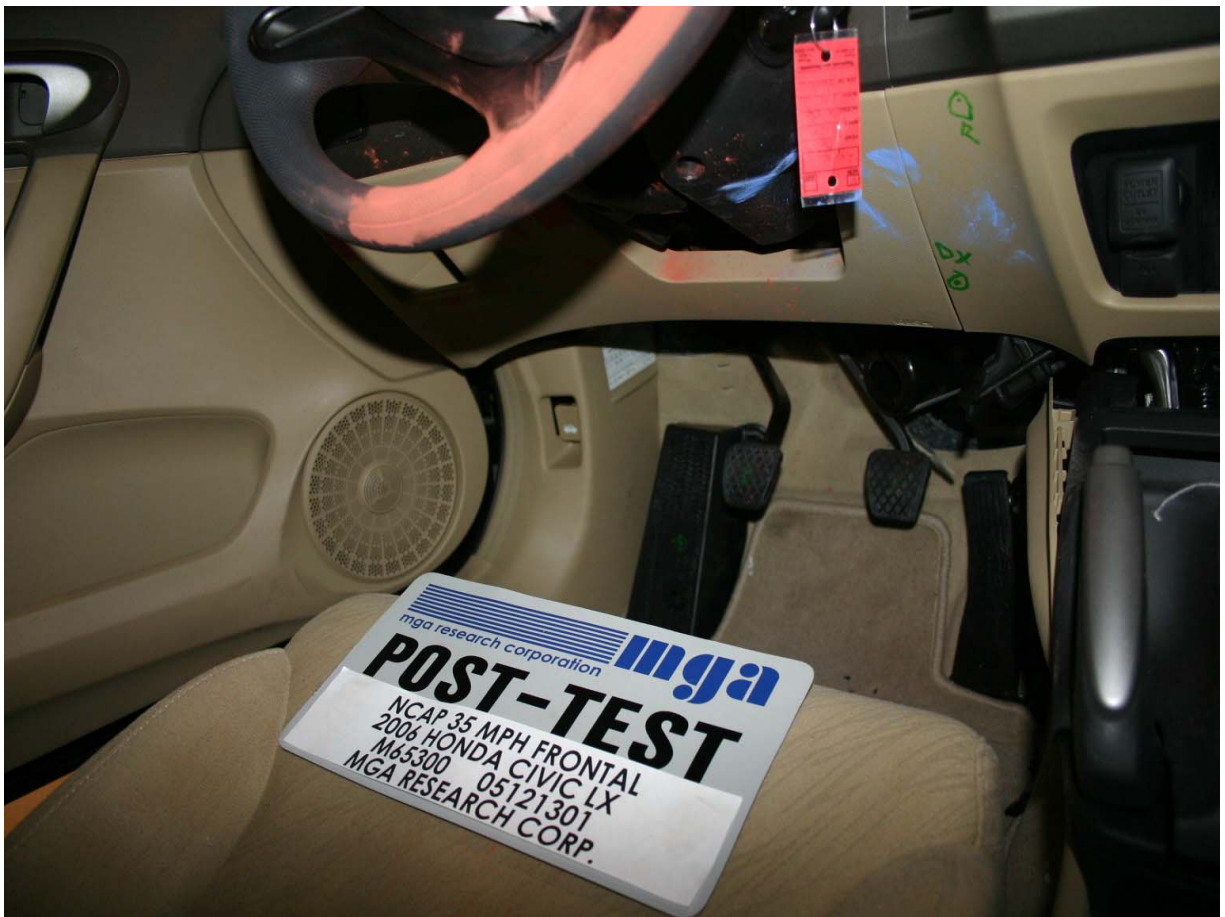
Post-Test Driver Dummy Right Knee Contact

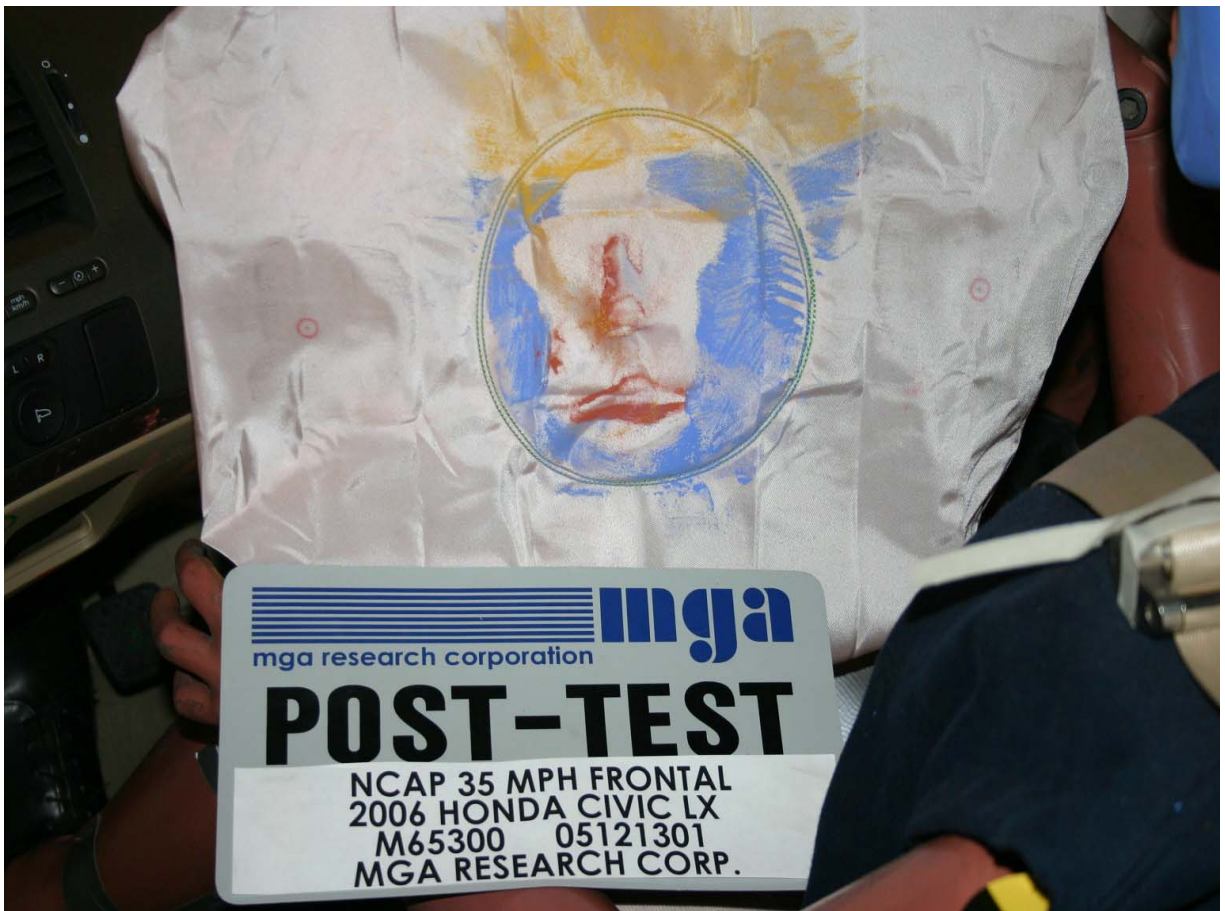
Post-Test Driver Dummy Airbag Contact

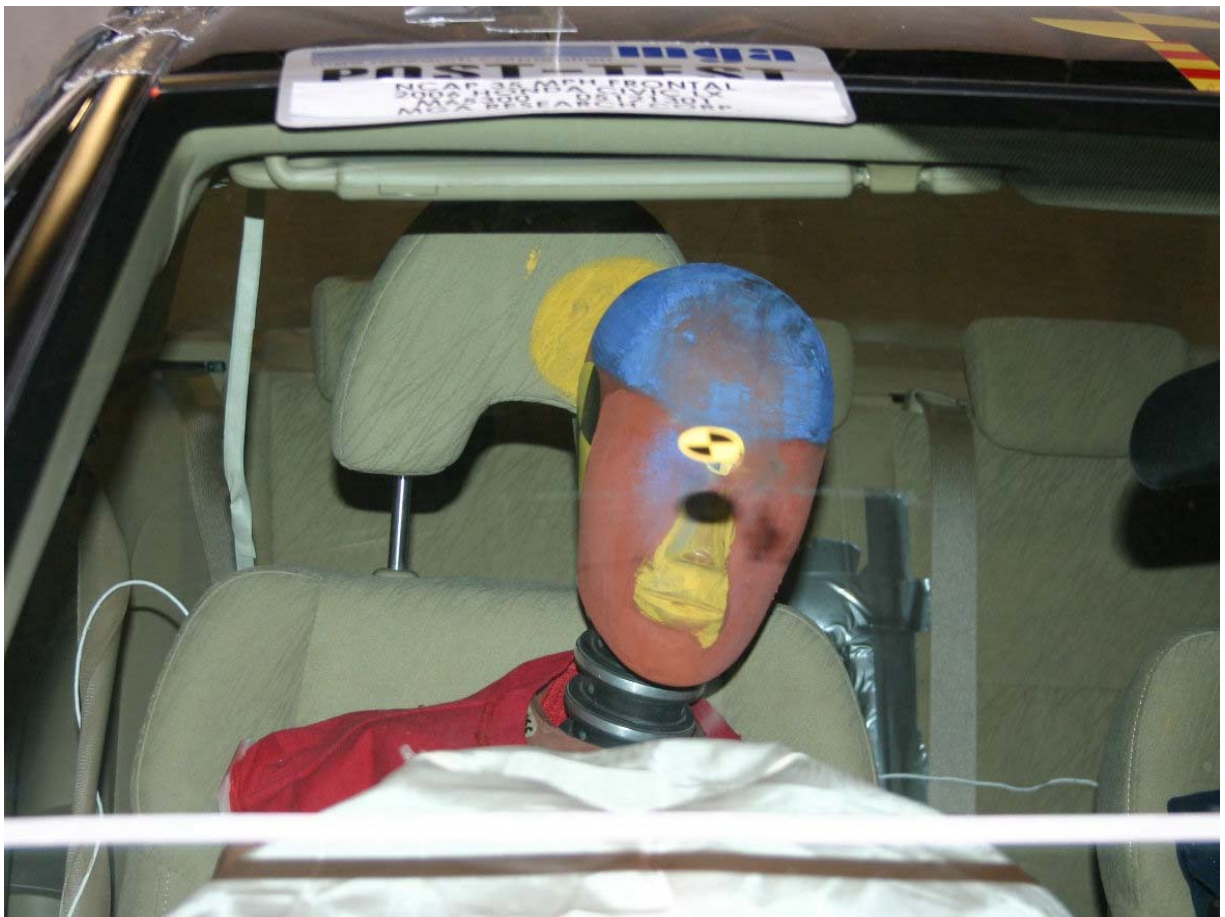
Post-Test Passenger Dummy Head Contact

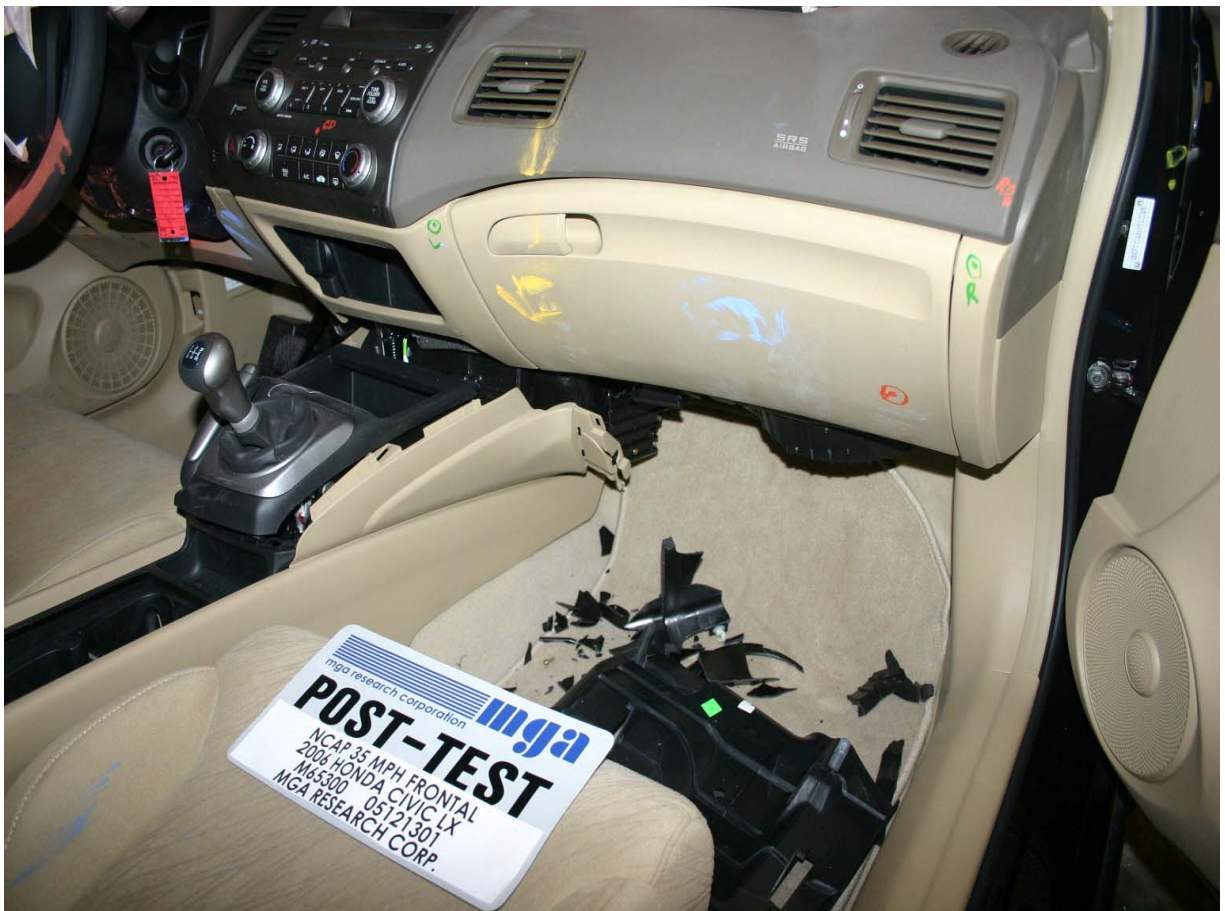
Post-Test Passenger Dummy Knee Contact

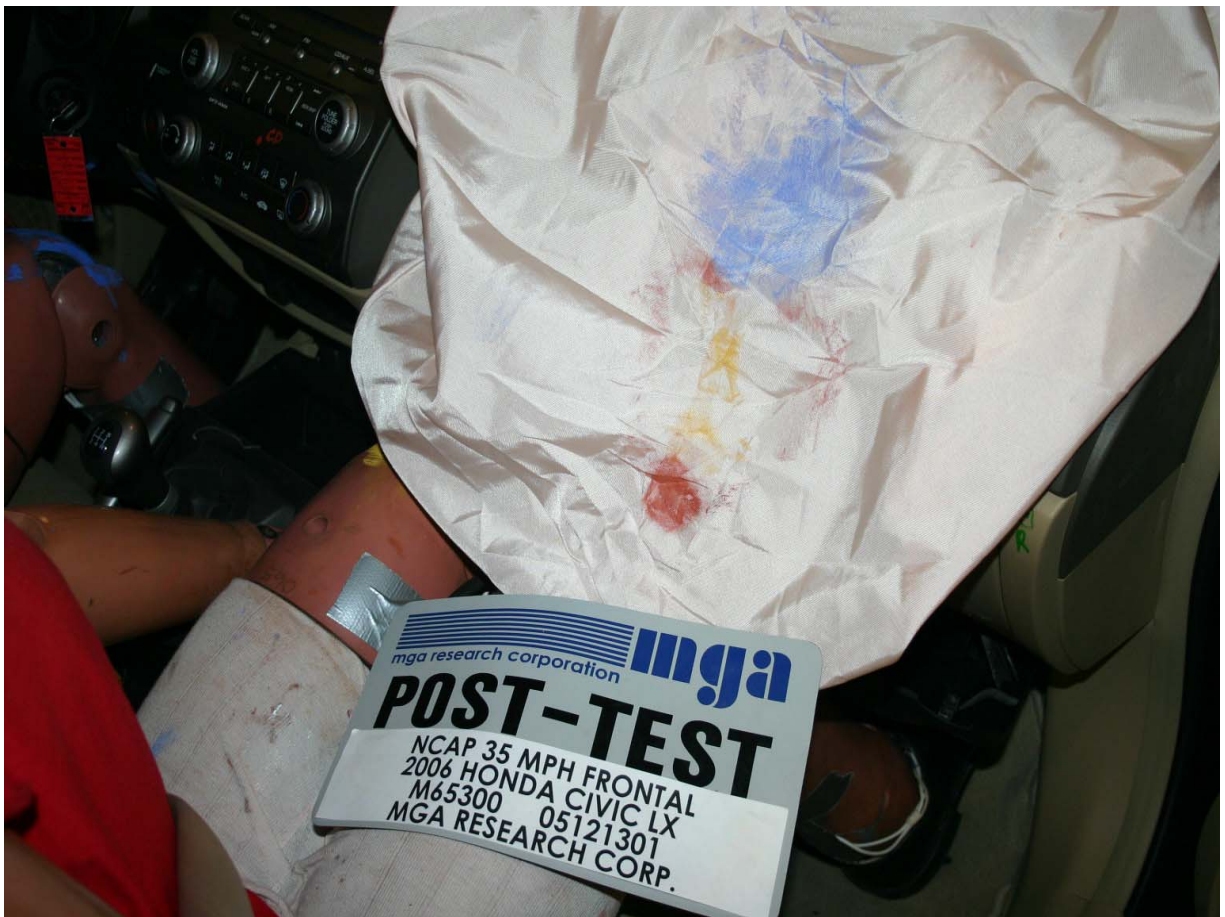
Post-Test Passenger Dummy Airbag Contact

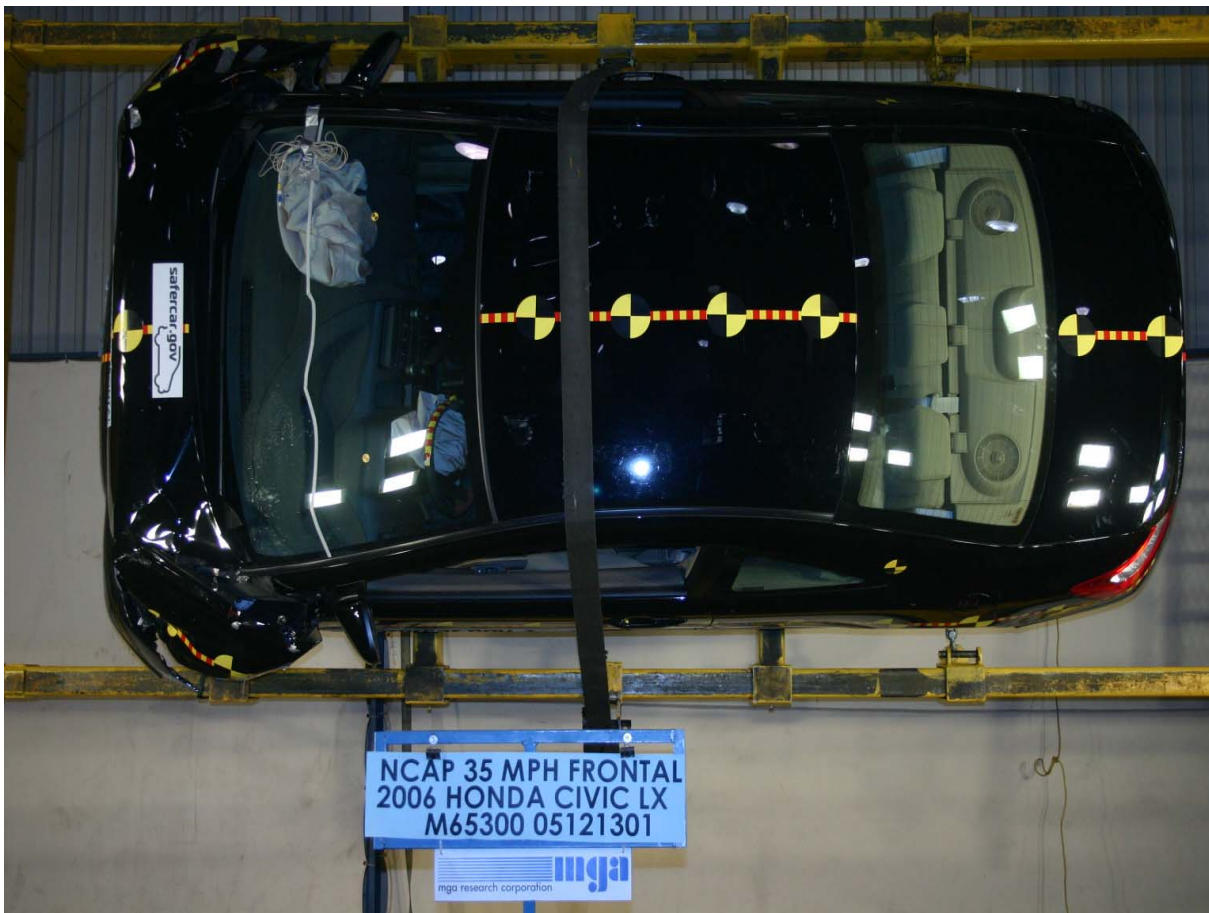
Vehicle on Rollover Device at 90 Degrees

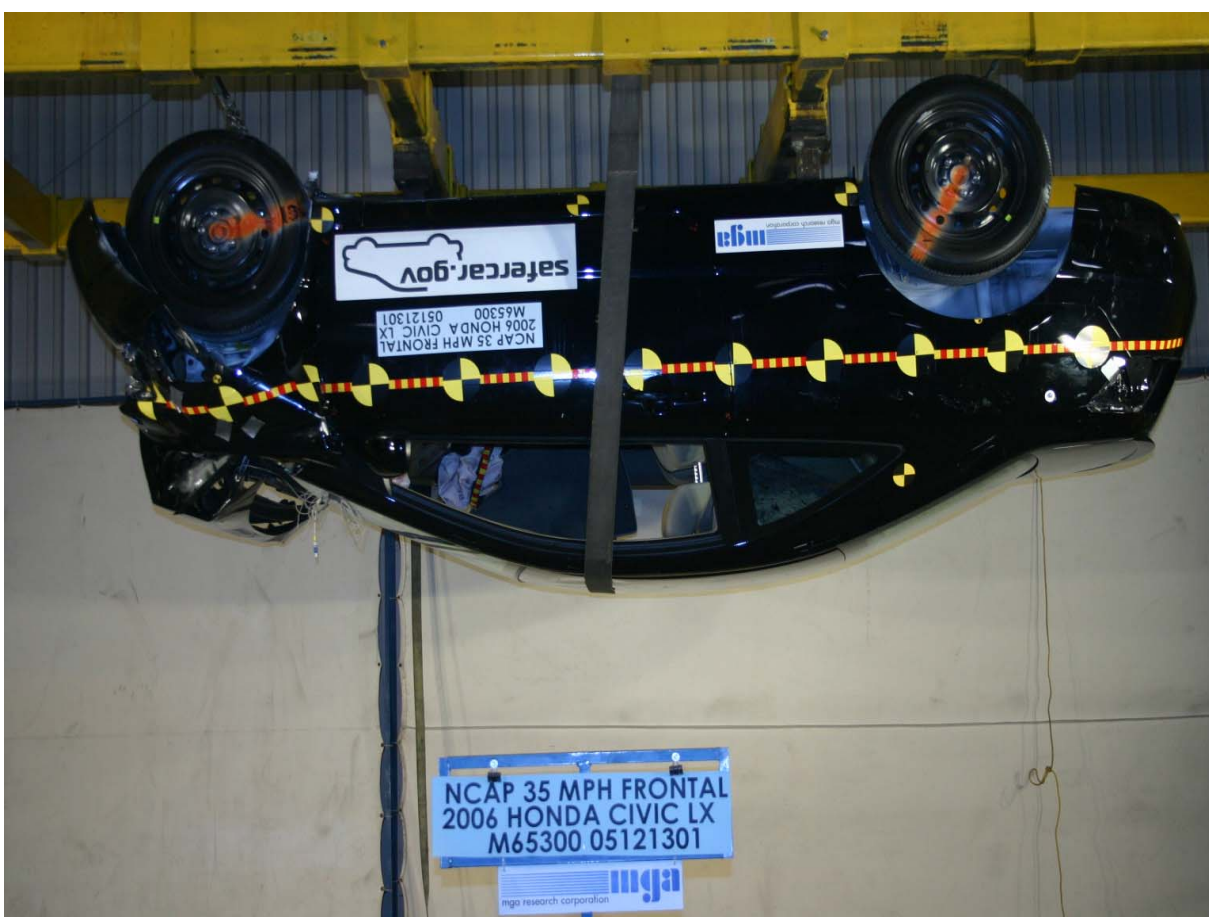
Vehicle on Rollover Device at 180 Degrees

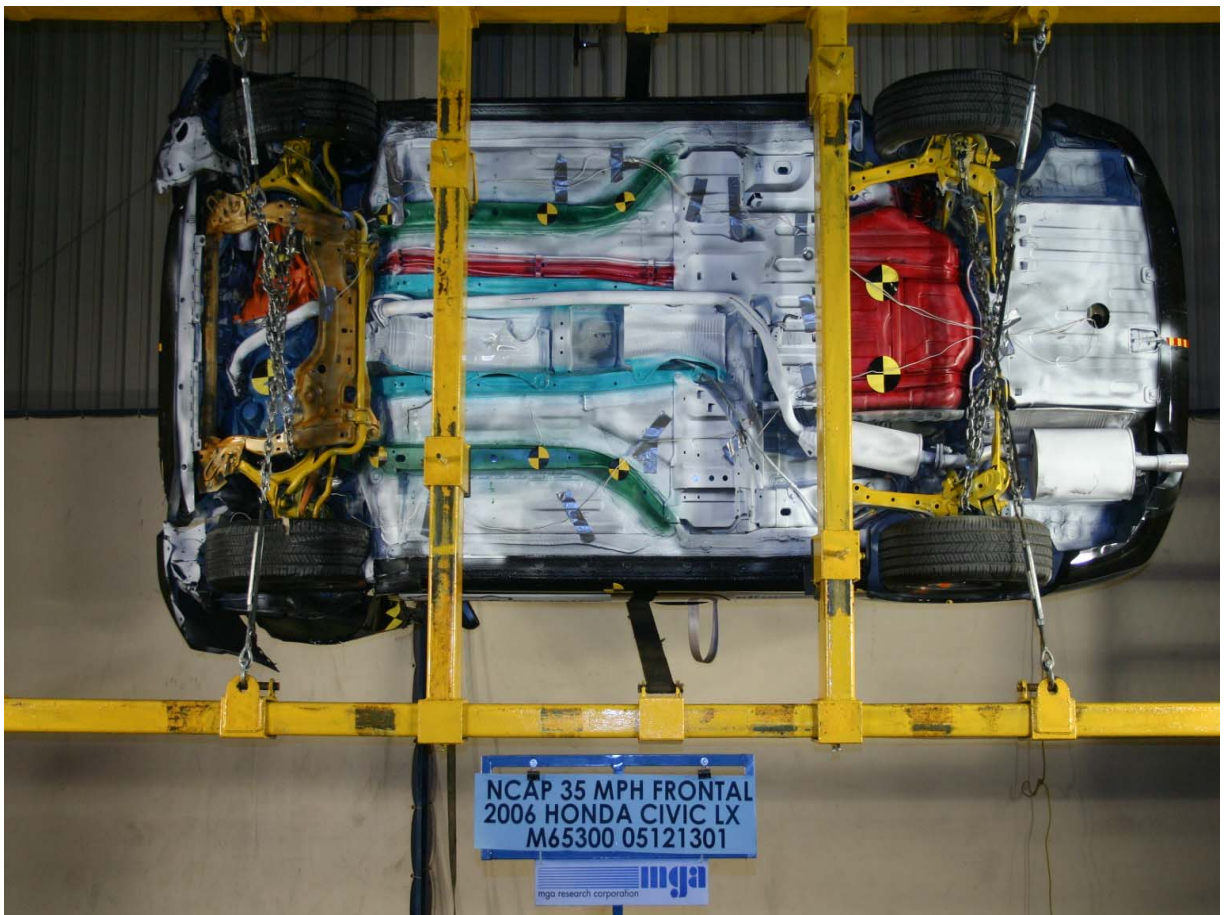
Vehicle on Rollover Device at 270 Degrees

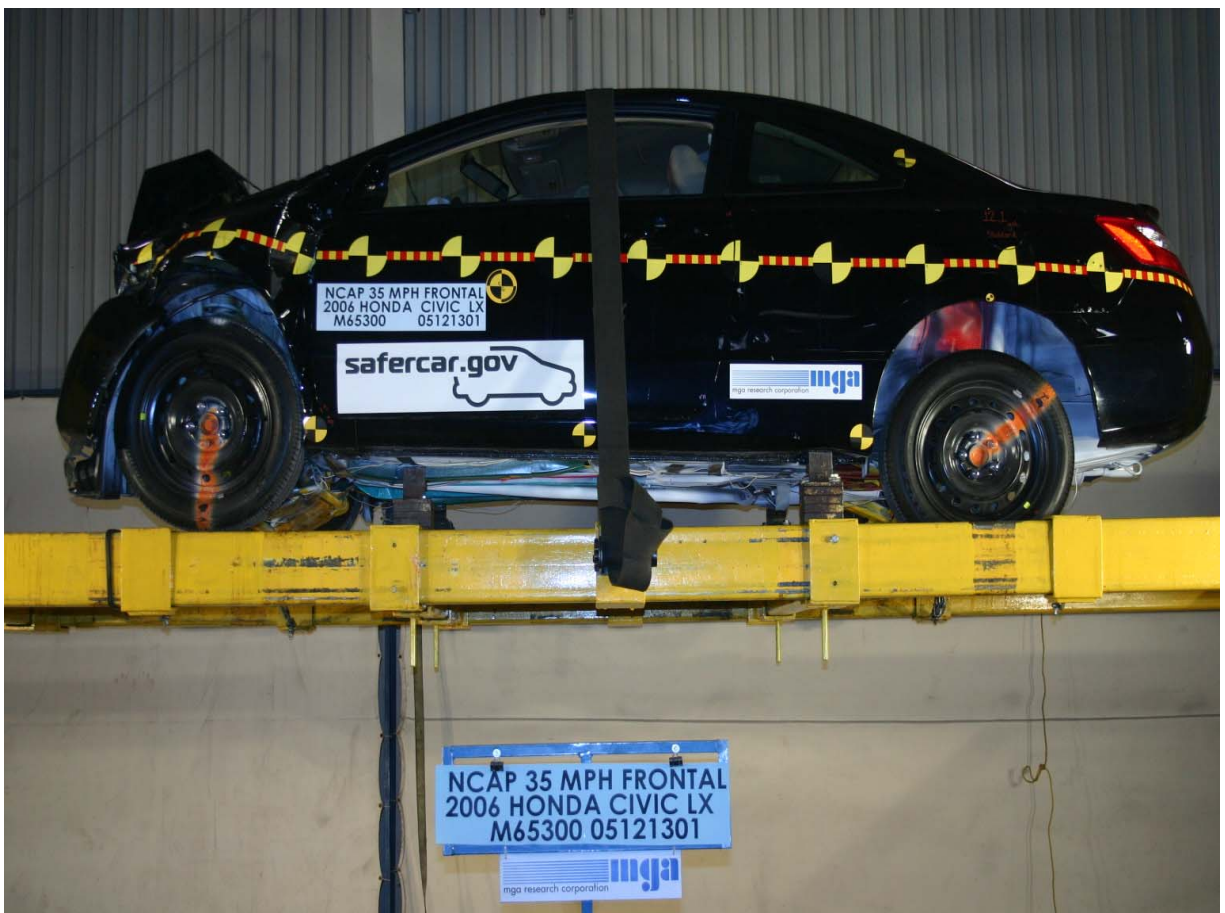
Vehicle on Rollover Device at 360 Degrees

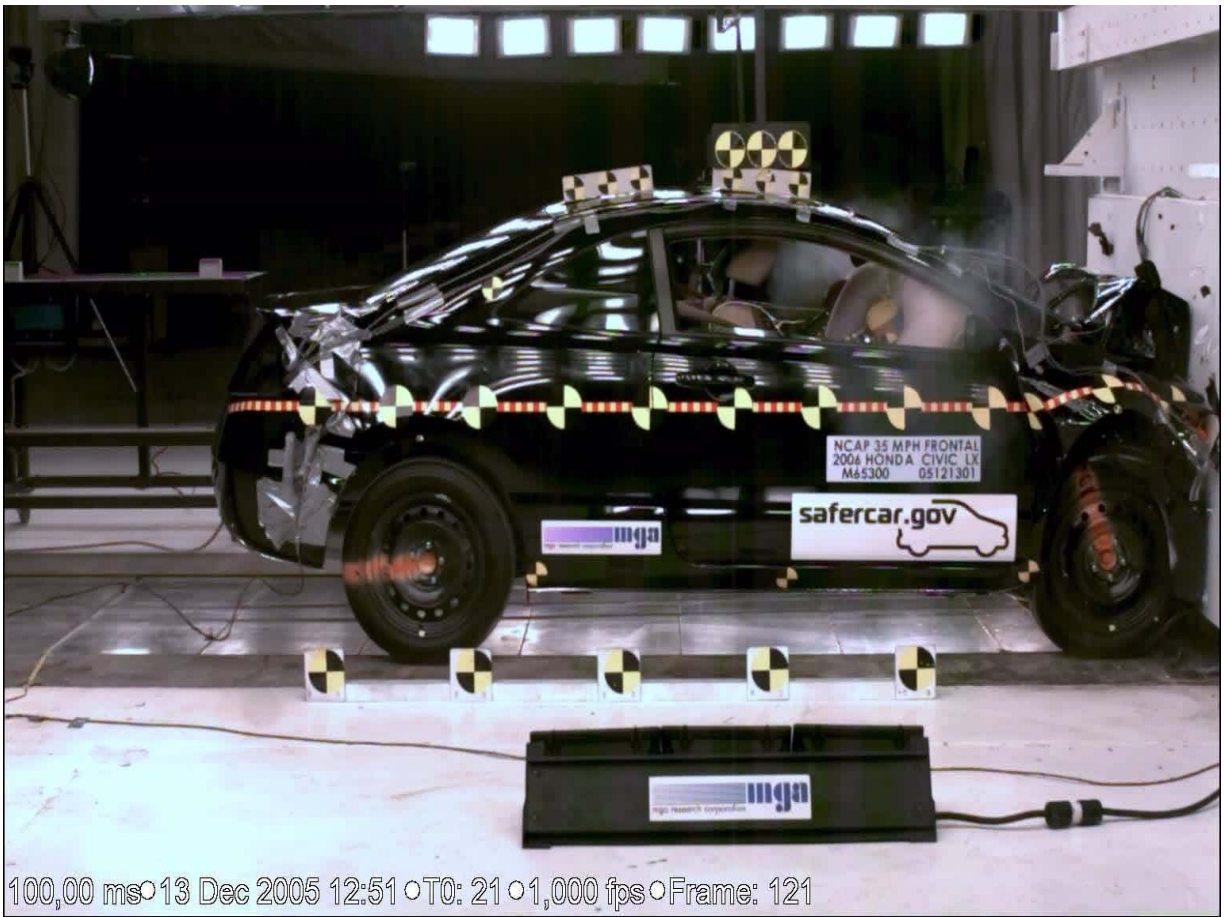
Vehicle Impact

A load cell barrier was impacted by a 2006 Honda Civic LX 2-Door at a velocity of 56.3 kph. The test was performed at MGA Research Corporation on December 13, 2005. Pre-and post-test photographs of the vehicle and dummies can be found in Appendix A.
