**REPORT NUMBER: NCAP-MGA-2006-006**

**NEW CAR ASSESSMENT PROGRAM  
FRONTAL BARRIER IMPACT TEST**

**GENERAL MOTORS CORPORATION  
2006 CHEVROLET TRAILBLAZER EXT  
NHTSA NUMBER: M60121**

**PREPARED BY:  
MGA RESEARCH CORPORATION  
5000 WARREN ROAD  
BURLINGTON, WI 53105**

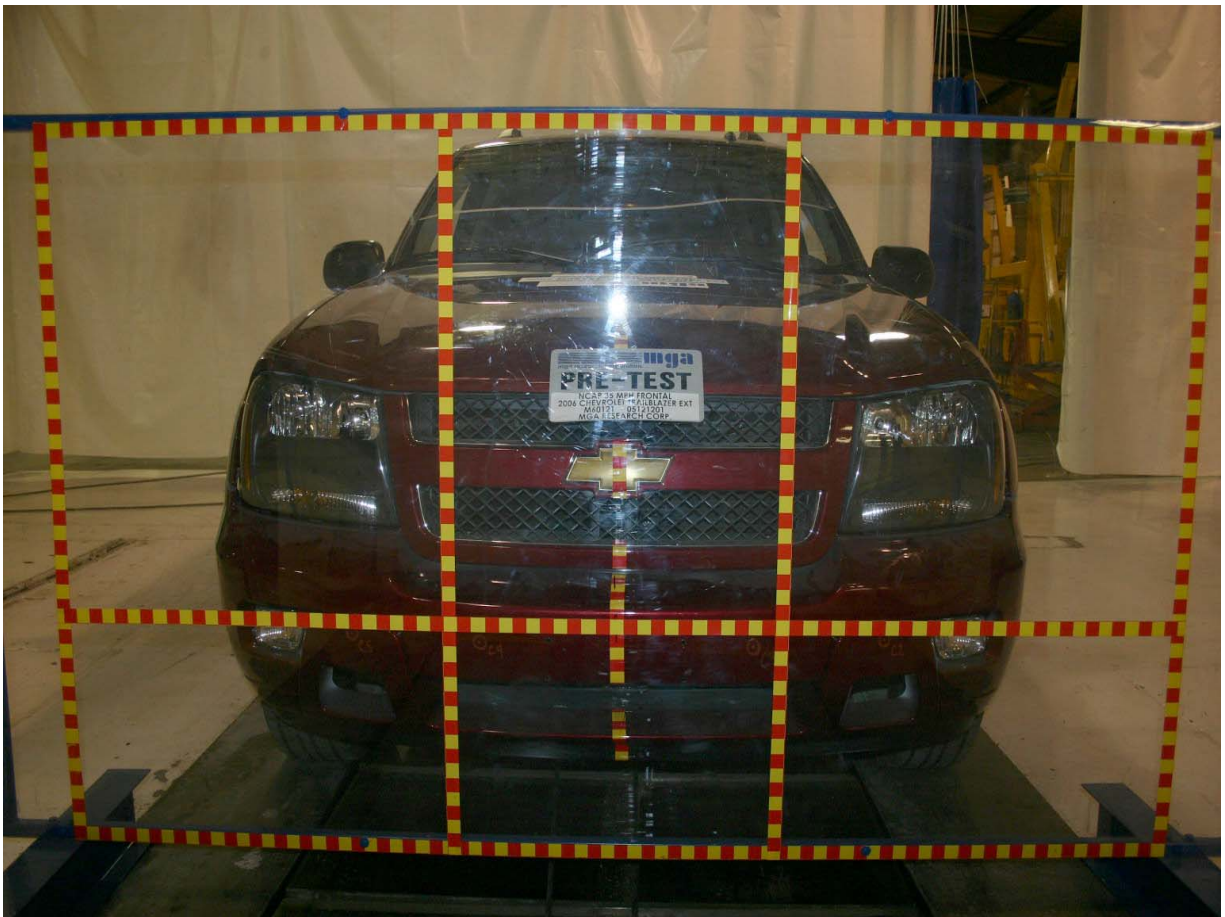
Load Cell Location

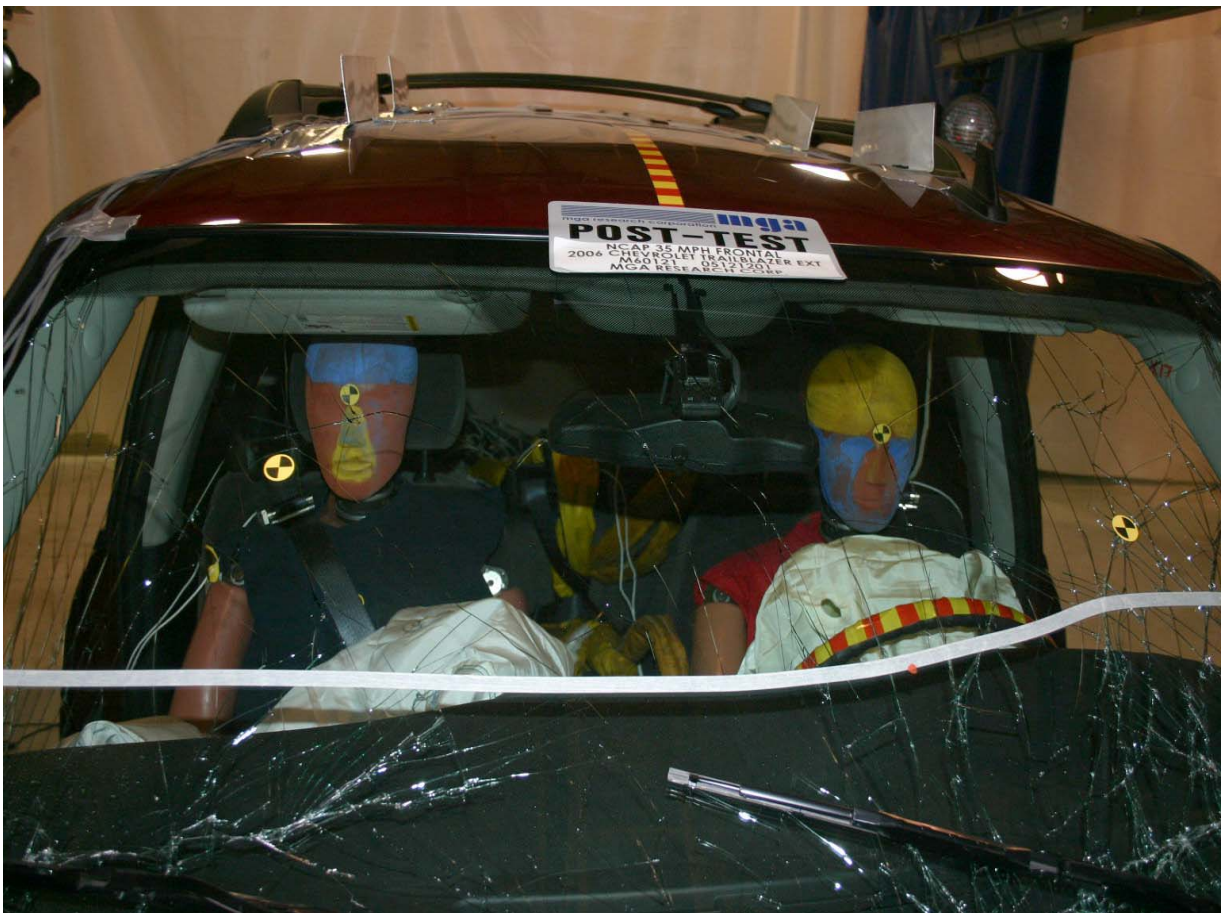
Post-Test Windshield View

There was 100 percent windshield retention and no intrusion into the protected zone of the windshield during the event. There was no Stoddard Solvent leakage after the event or during any phase of the static rollover.

| Description | Driver | Passenger |
|---|---|---|
| Glazing Damage | The windshield cracked | |

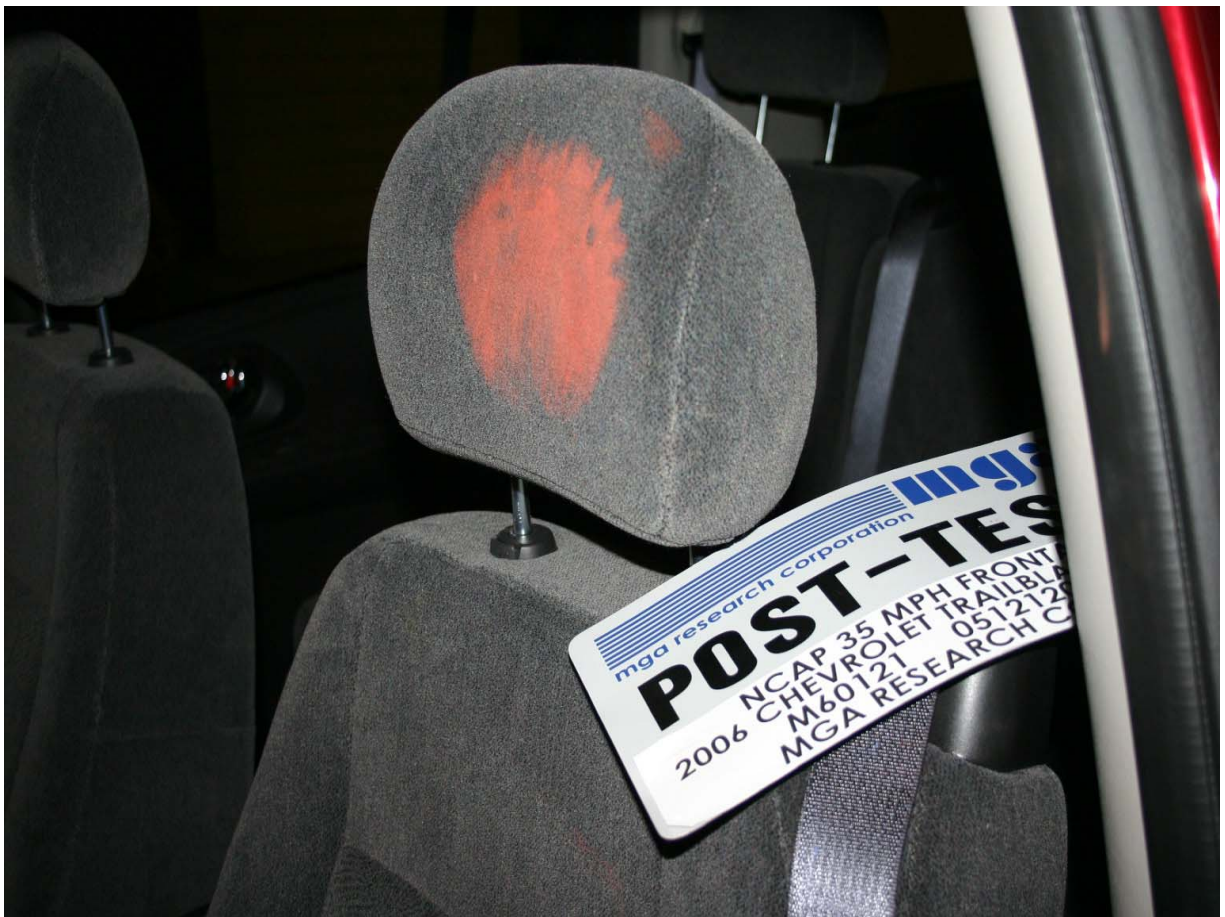
Post-Test Driver Dummy Head Contact

The driver's head, chest, and abdomen contacted the airbag. The driver's head also contacted the headrest. The driver's left knee contacted the steering column and both knees contacted the bolster. The passenger's head and chest contacted the airbag. The passenger's head also contacted the headrest. The passenger's knees contacted the glove box.

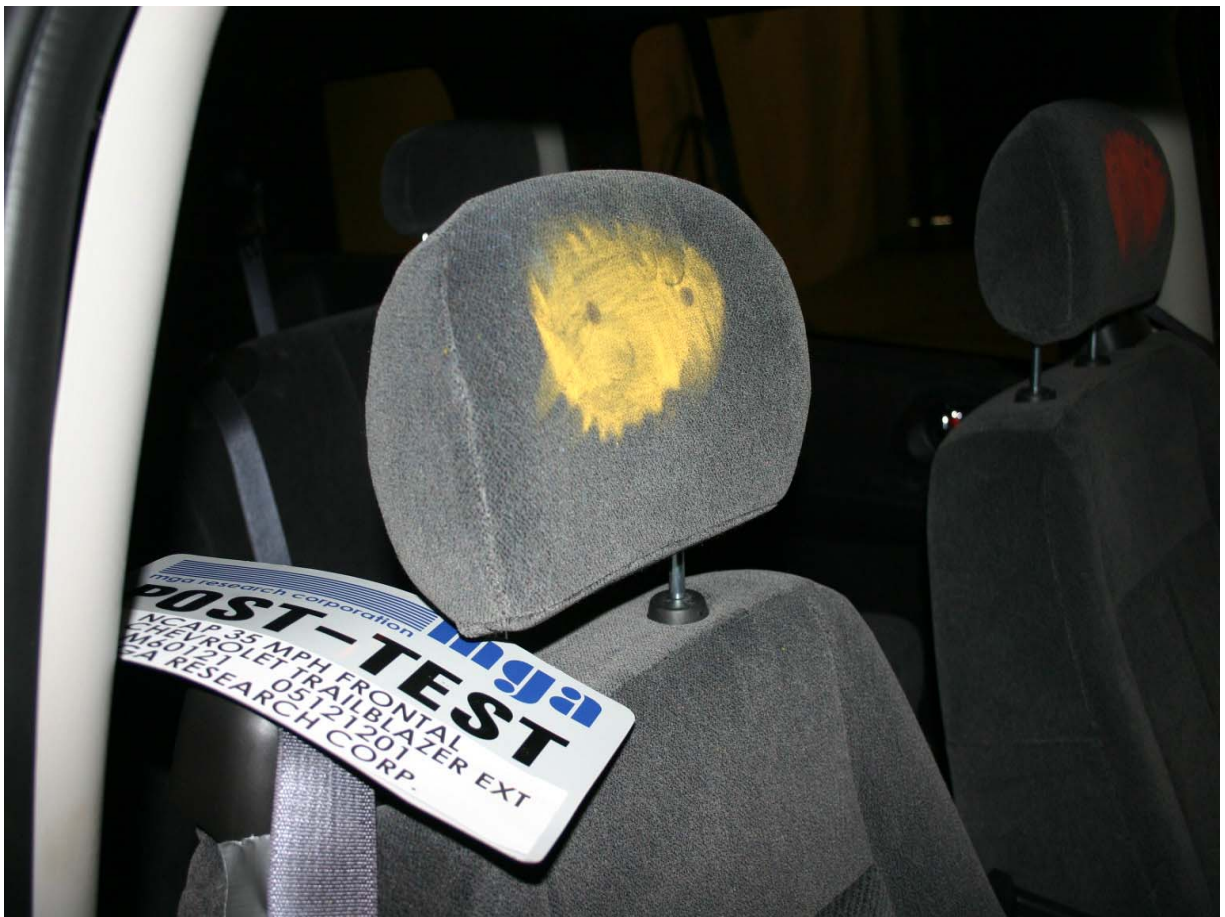
Post-Test Passenger Dummy Head Contact

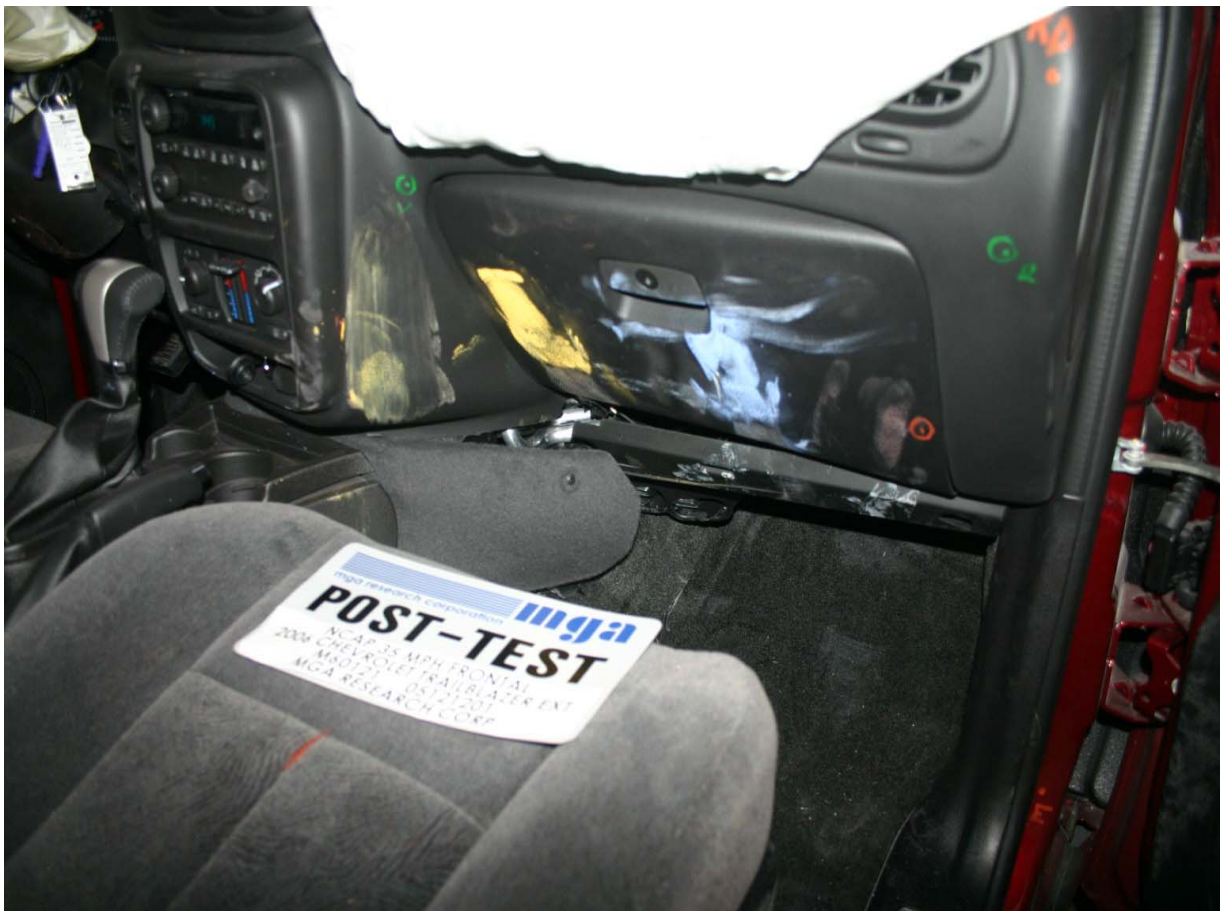
Post-Test Passenger Dummy Knee Contact

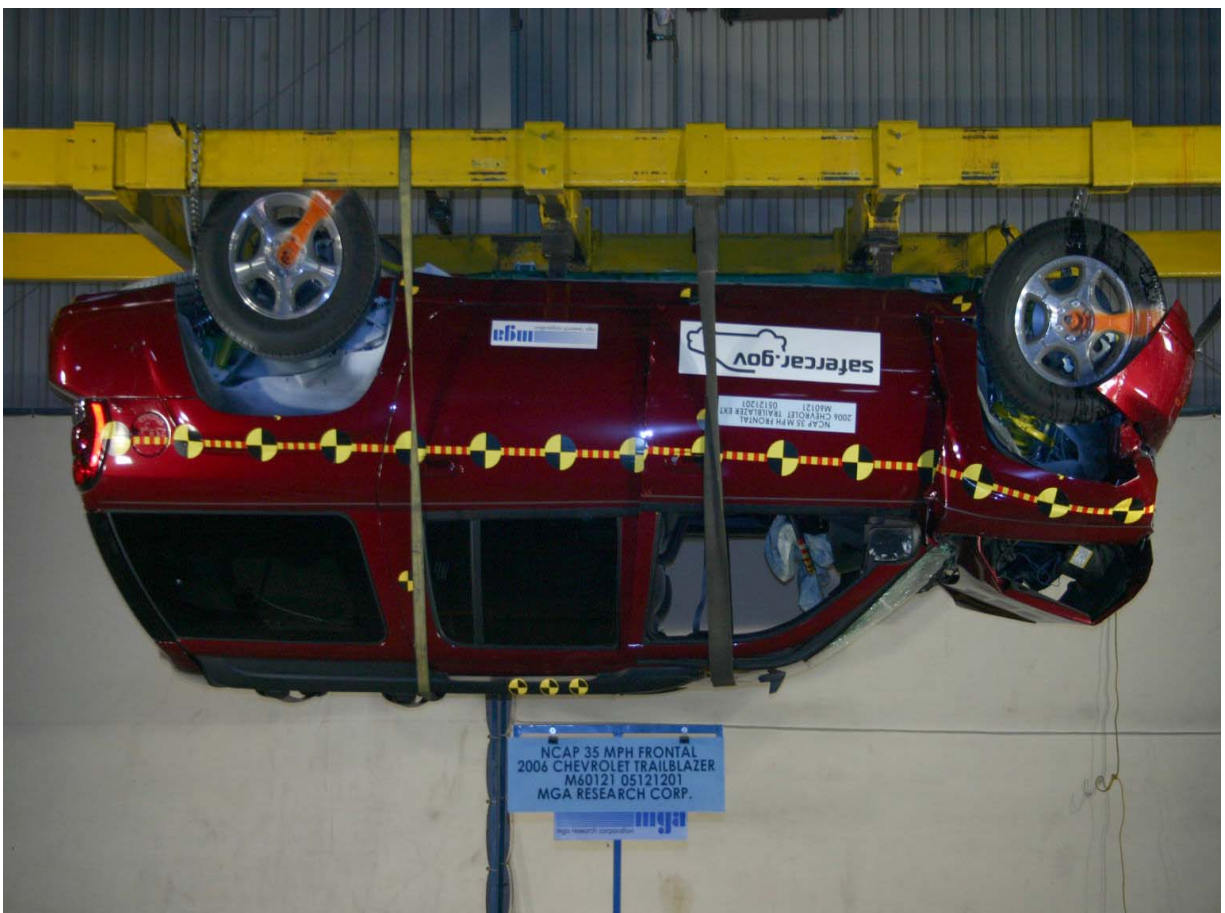
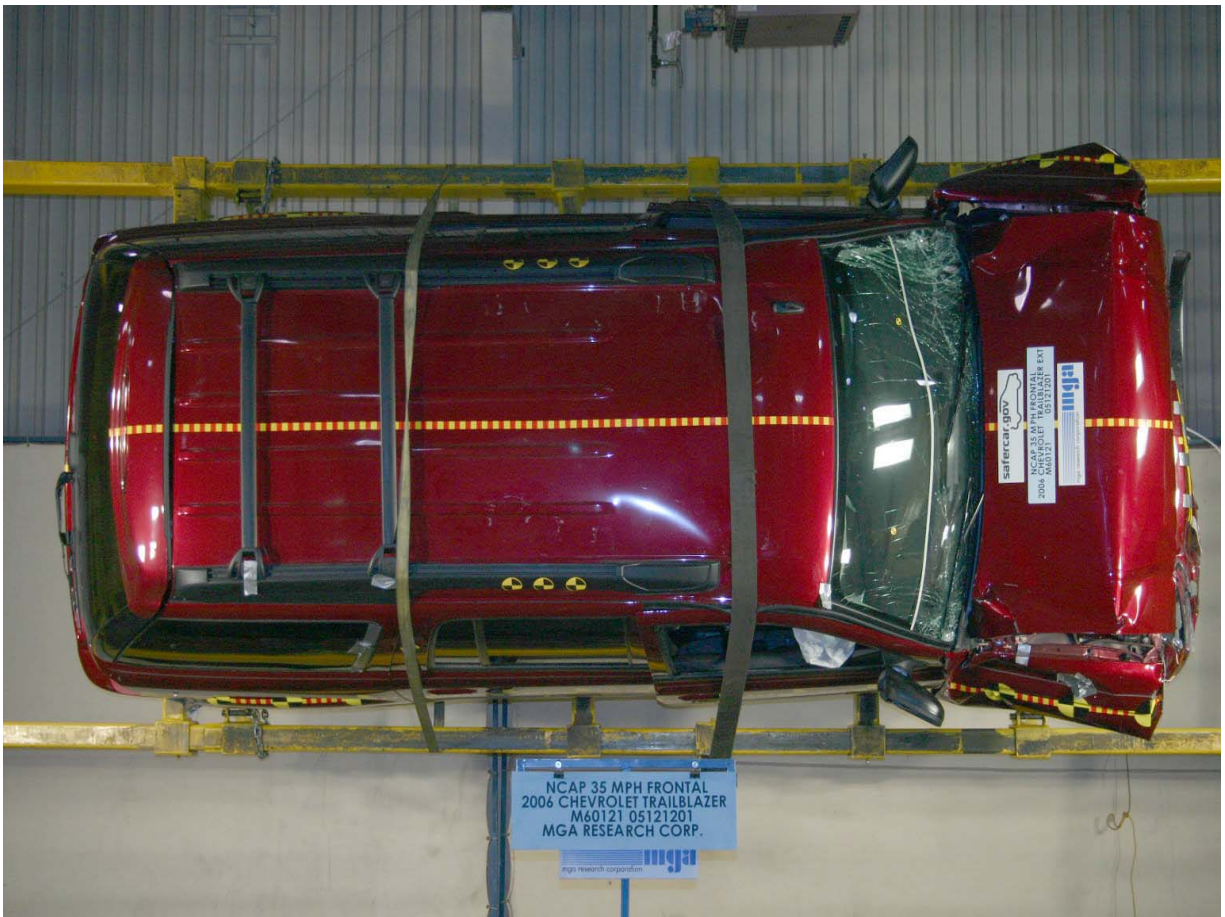
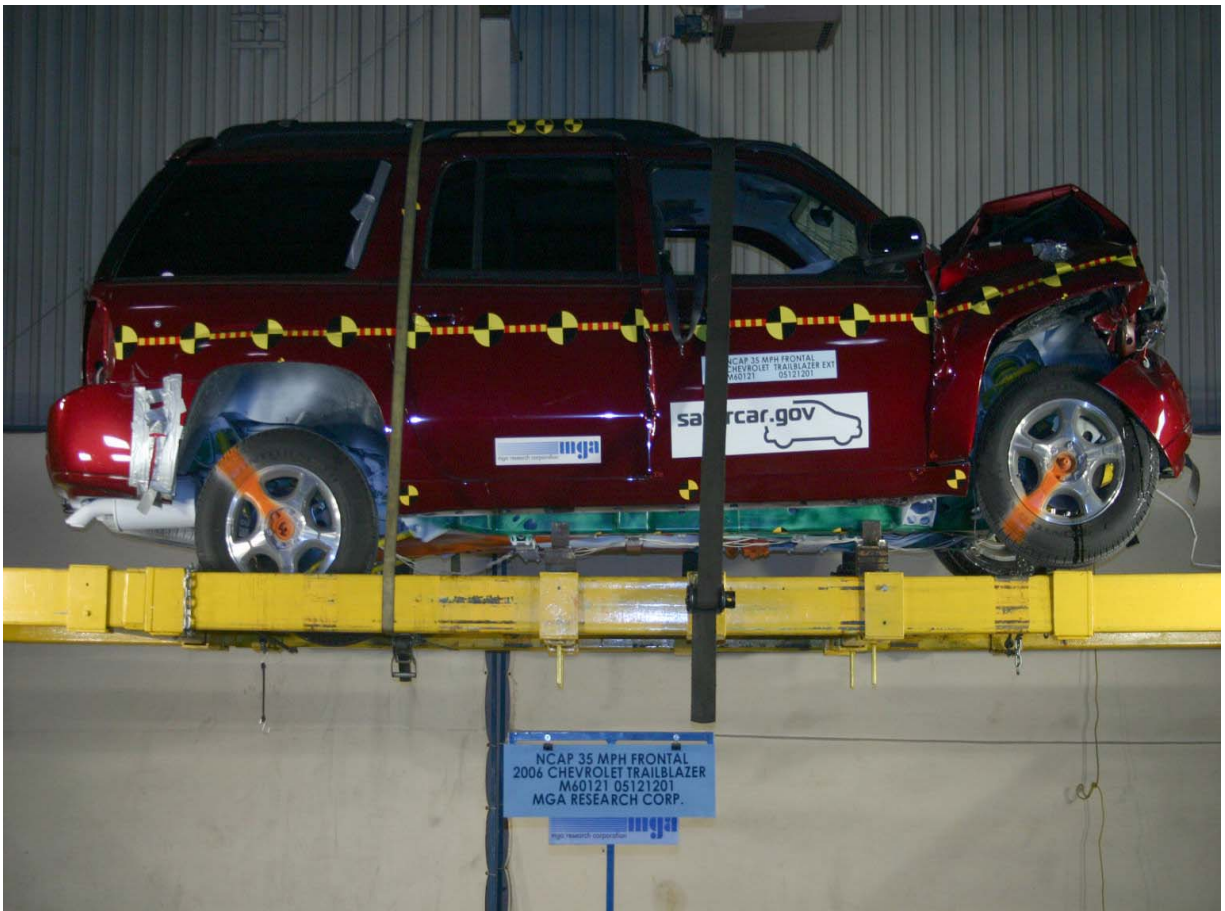
Vehicle on Rollover Device at 90 Degrees

Vehicle on Rollover Device at 180 Degrees

Vehicle on Rollover Device at 270 Degrees

Vehicle on Rollover Device at 360 Degrees

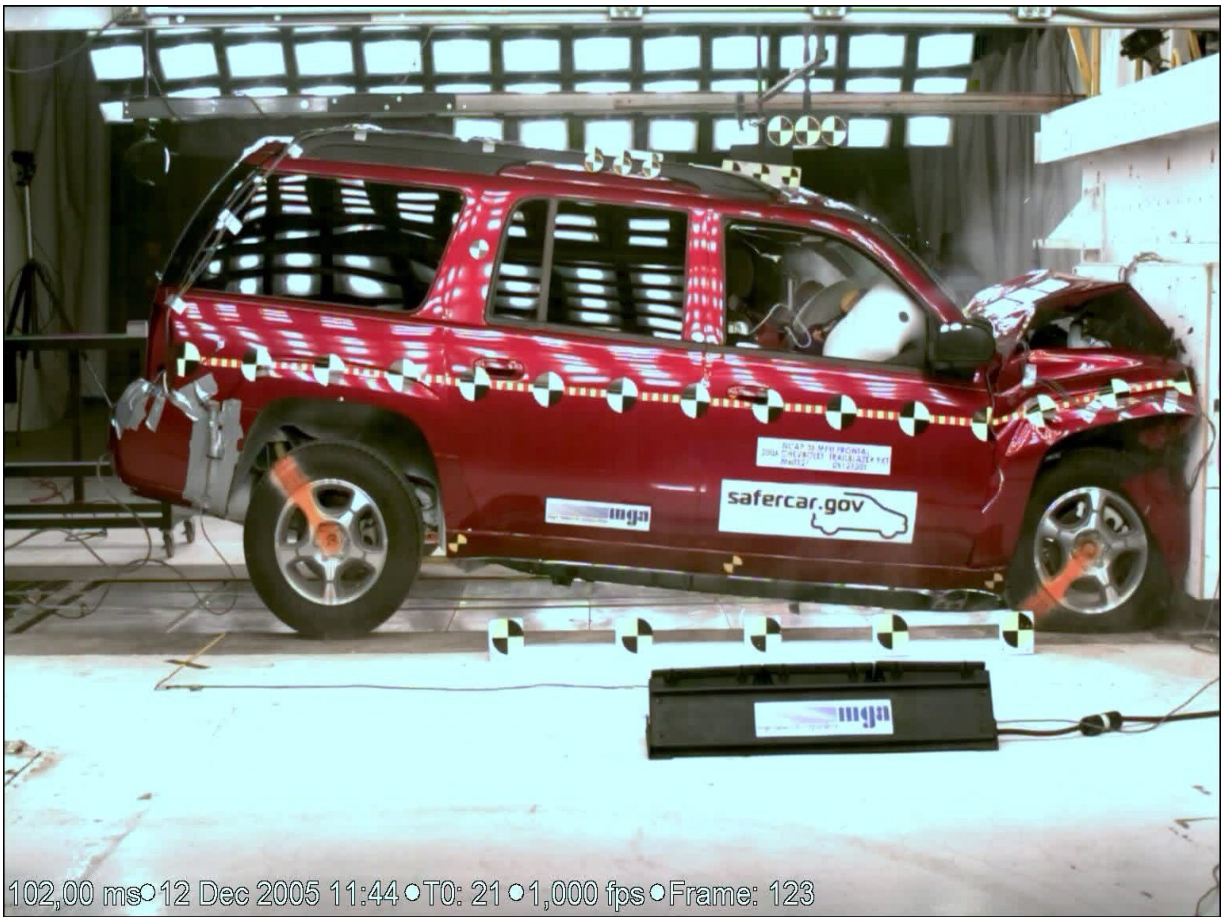
102,00 ms • 12 Dec 2005 11:44 • T0: 21 • 1,000 fps • Frame: 123

Vehicle Impact

A load cell barrier was impacted by a 2006 Chevrolet Trailblazer EXT at a velocity of 56.6 kph. The test was performed at MGA Research Corporation on December 12, 2005. Pre-and post-test photographs of the vehicle and dummies can be found in Appendix A.
