REPORT NUMBER TR-P26001-04-NC

**NEW CAR ASSESSMENT PROGRAM
FRONTAL BARRIER IMPACT TEST**

**HONDA OF CANADA MFG.
2006 HONDA CIVIC LX
4-DOOR SEDAN**

NHTSA NUMBER: M65302

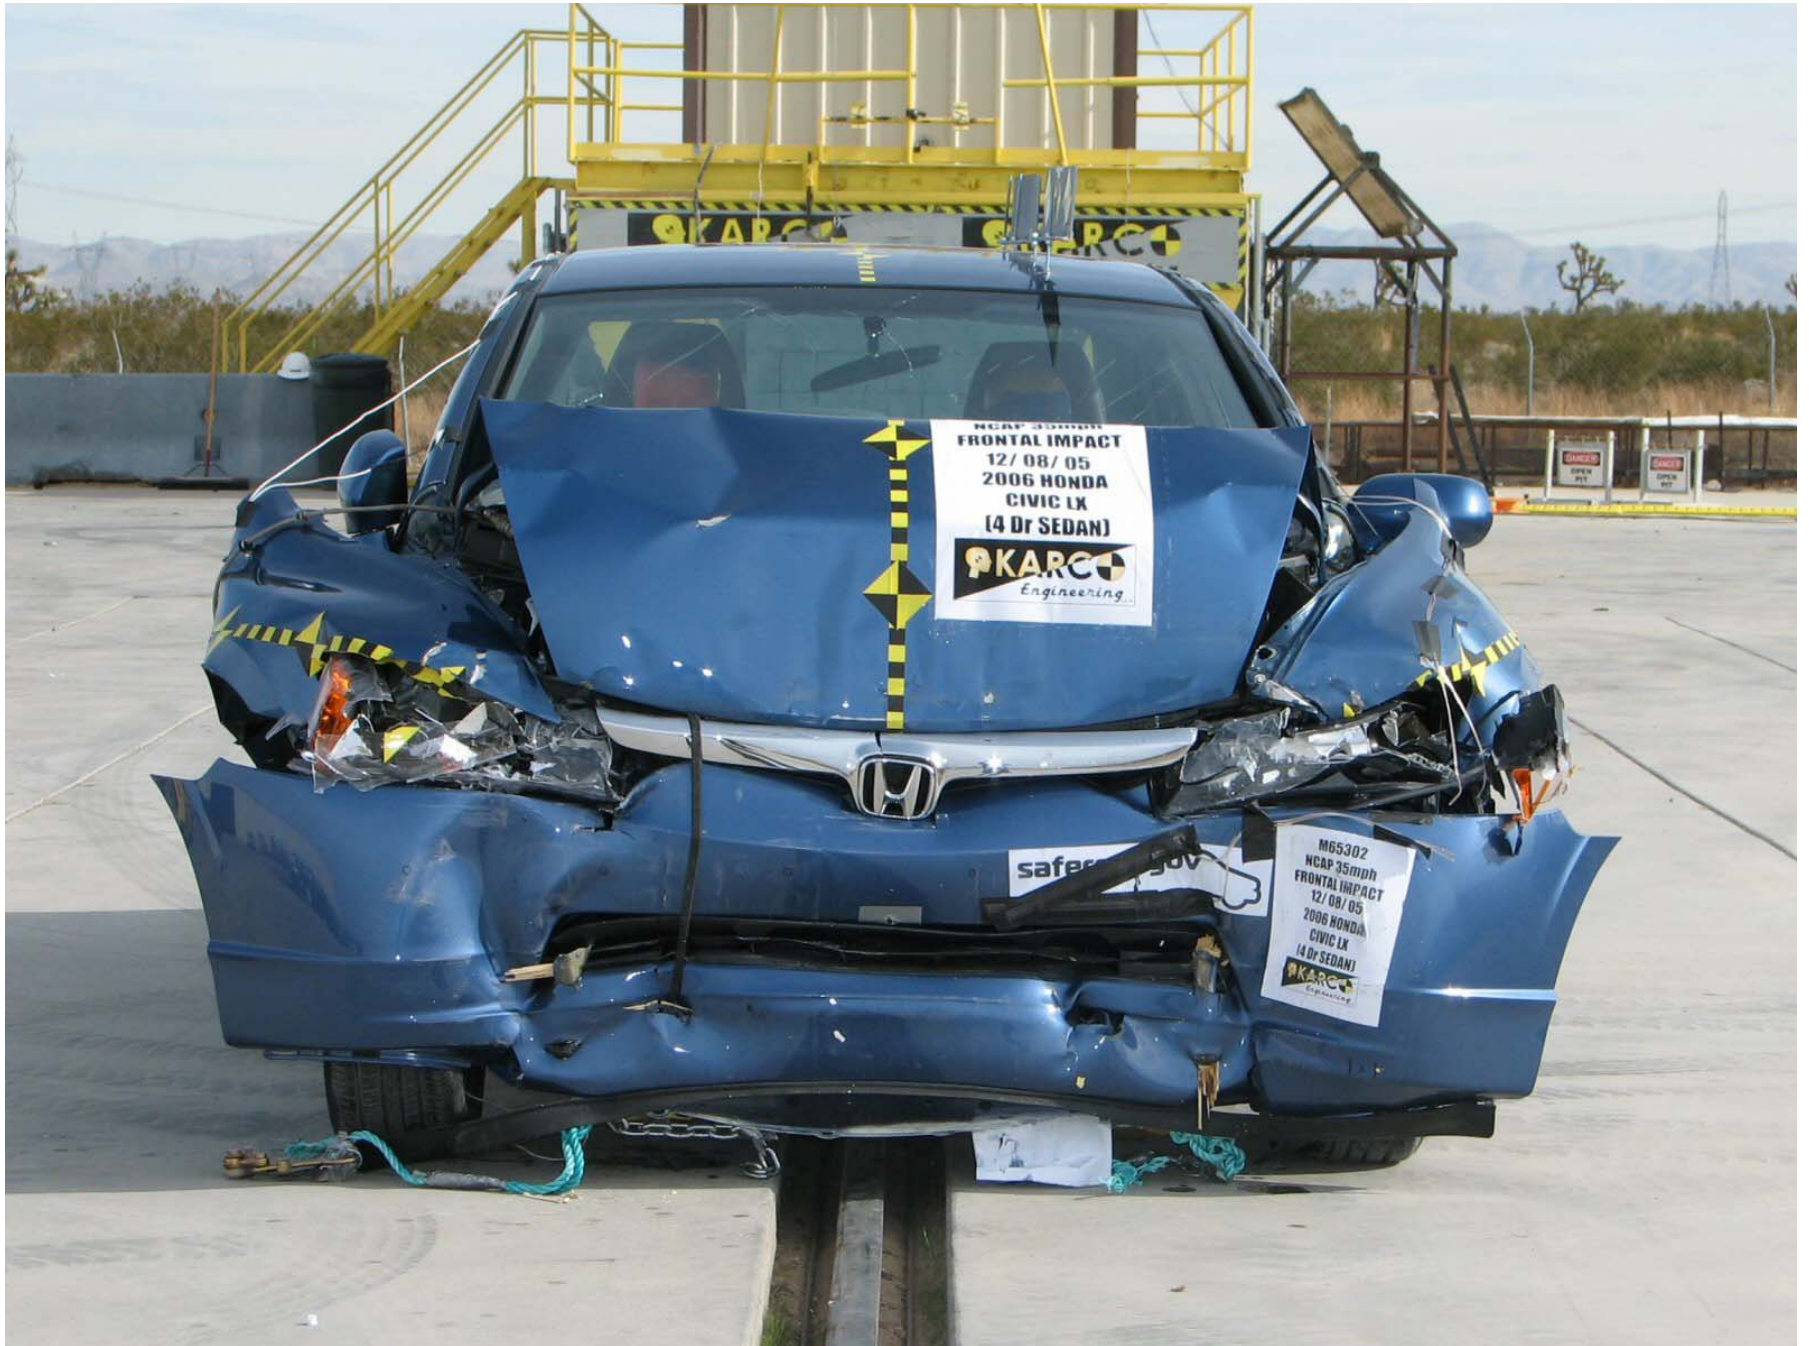
Figure A-7: Post-Test Front View (Vehicle Moved)

The maximum static crush of the vehicle was 530 mm at the vehicle's centerline and both the driver and the passenger side doors remained closed and latched during the impact event and were operable after the impact.

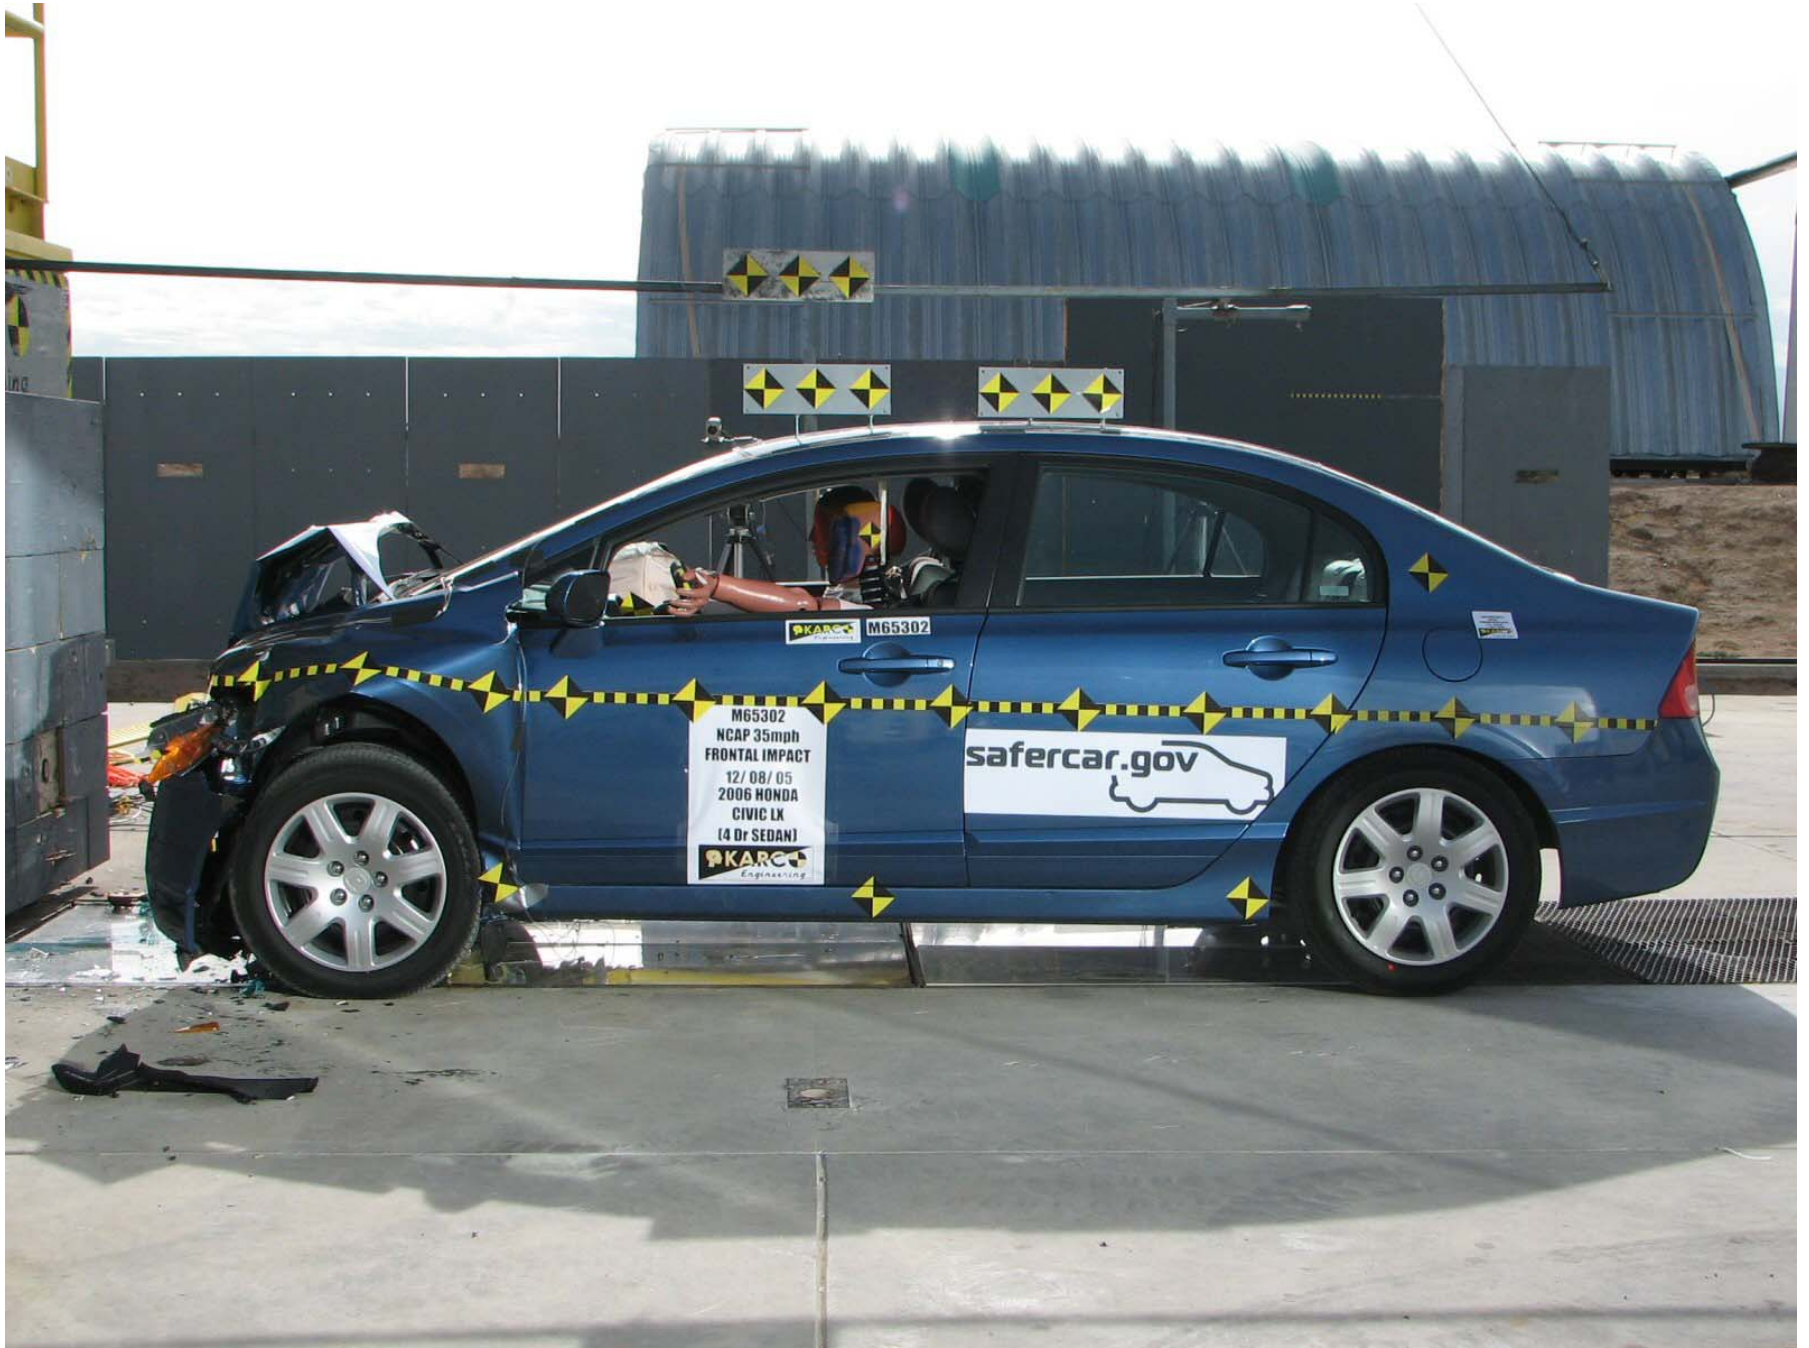
Figure A-9: Post-Test Left Side View

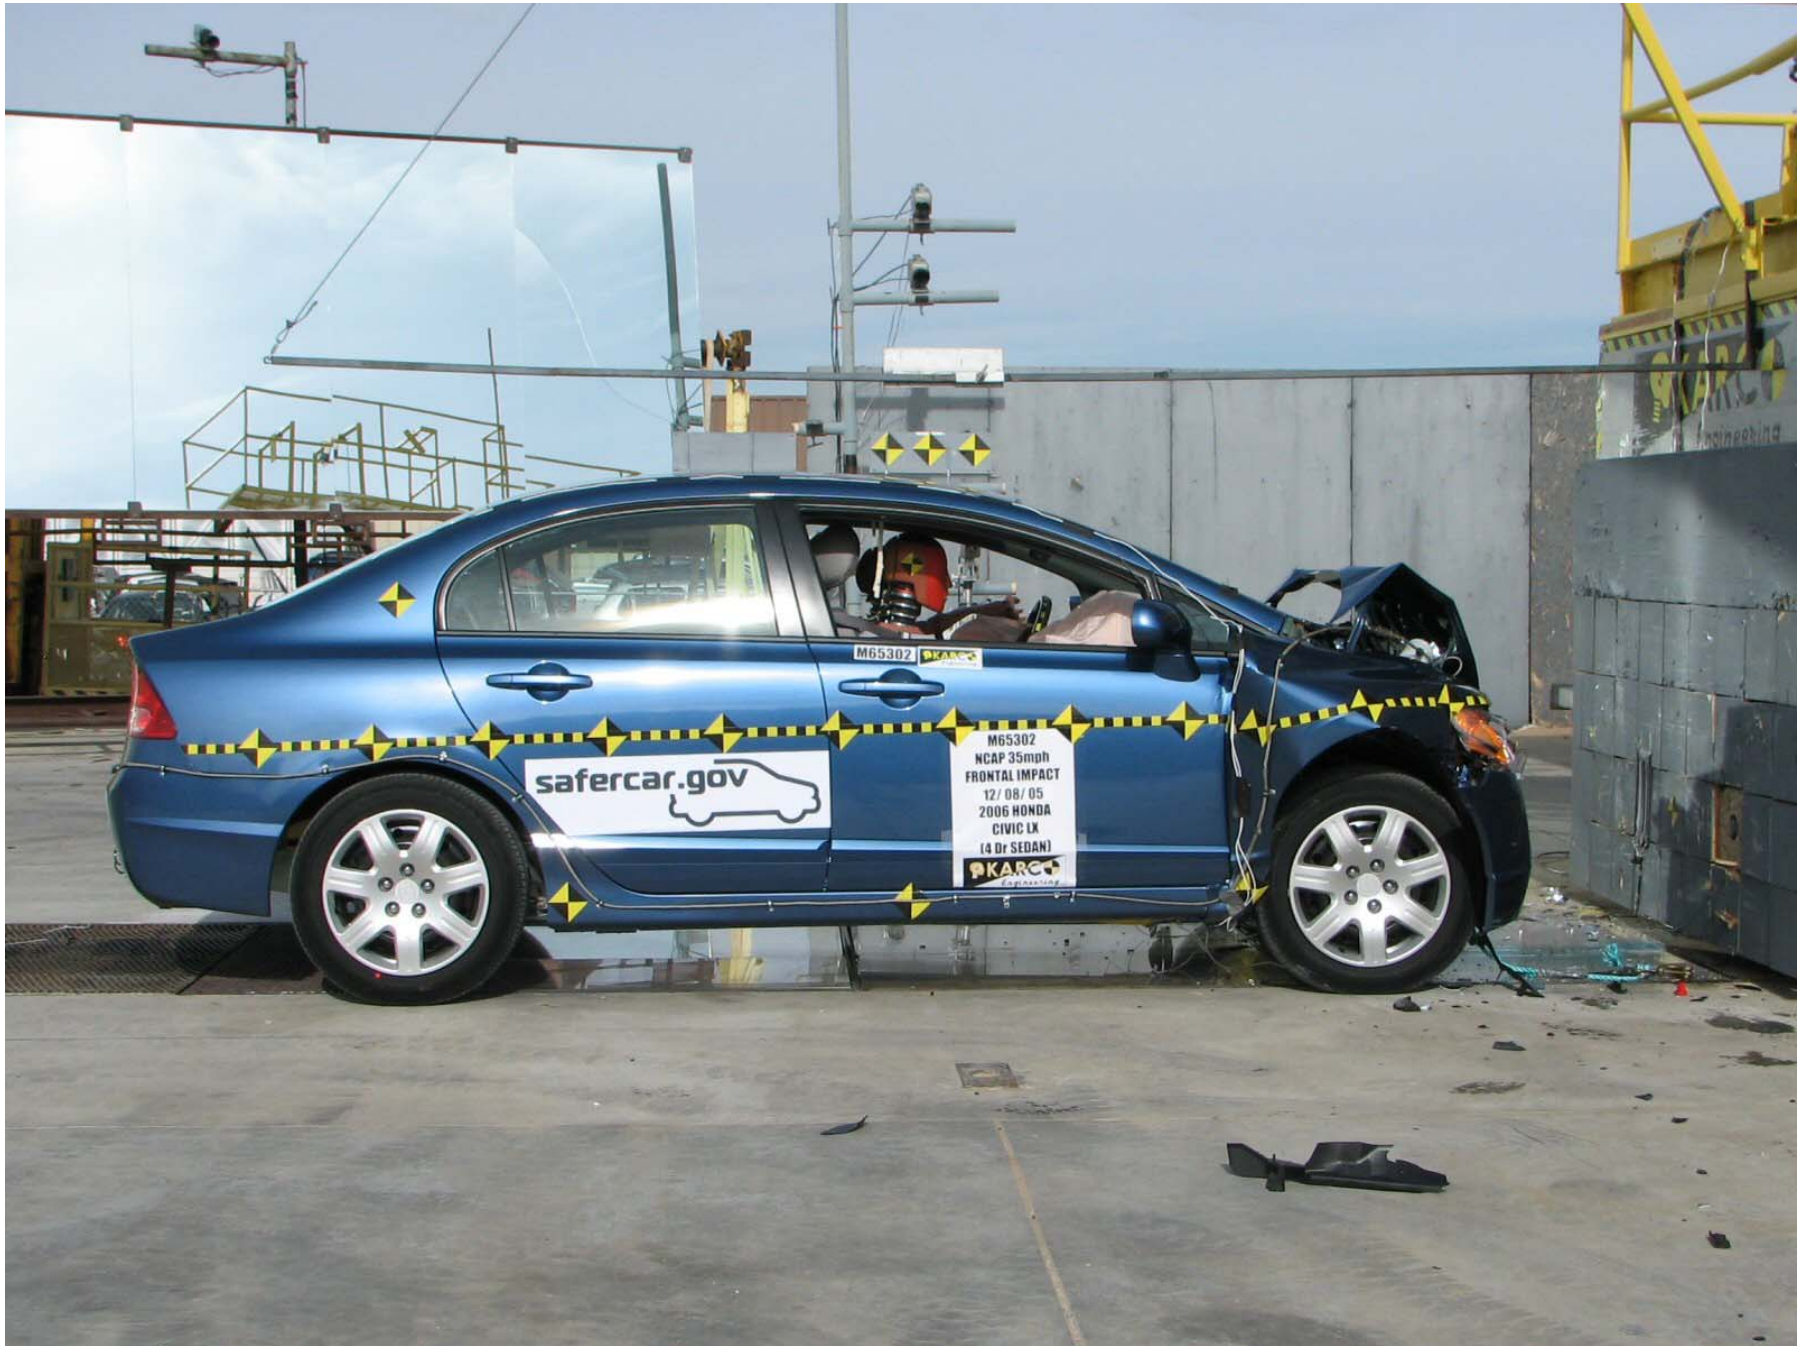
Figure A-11: Post-Test Right Side View

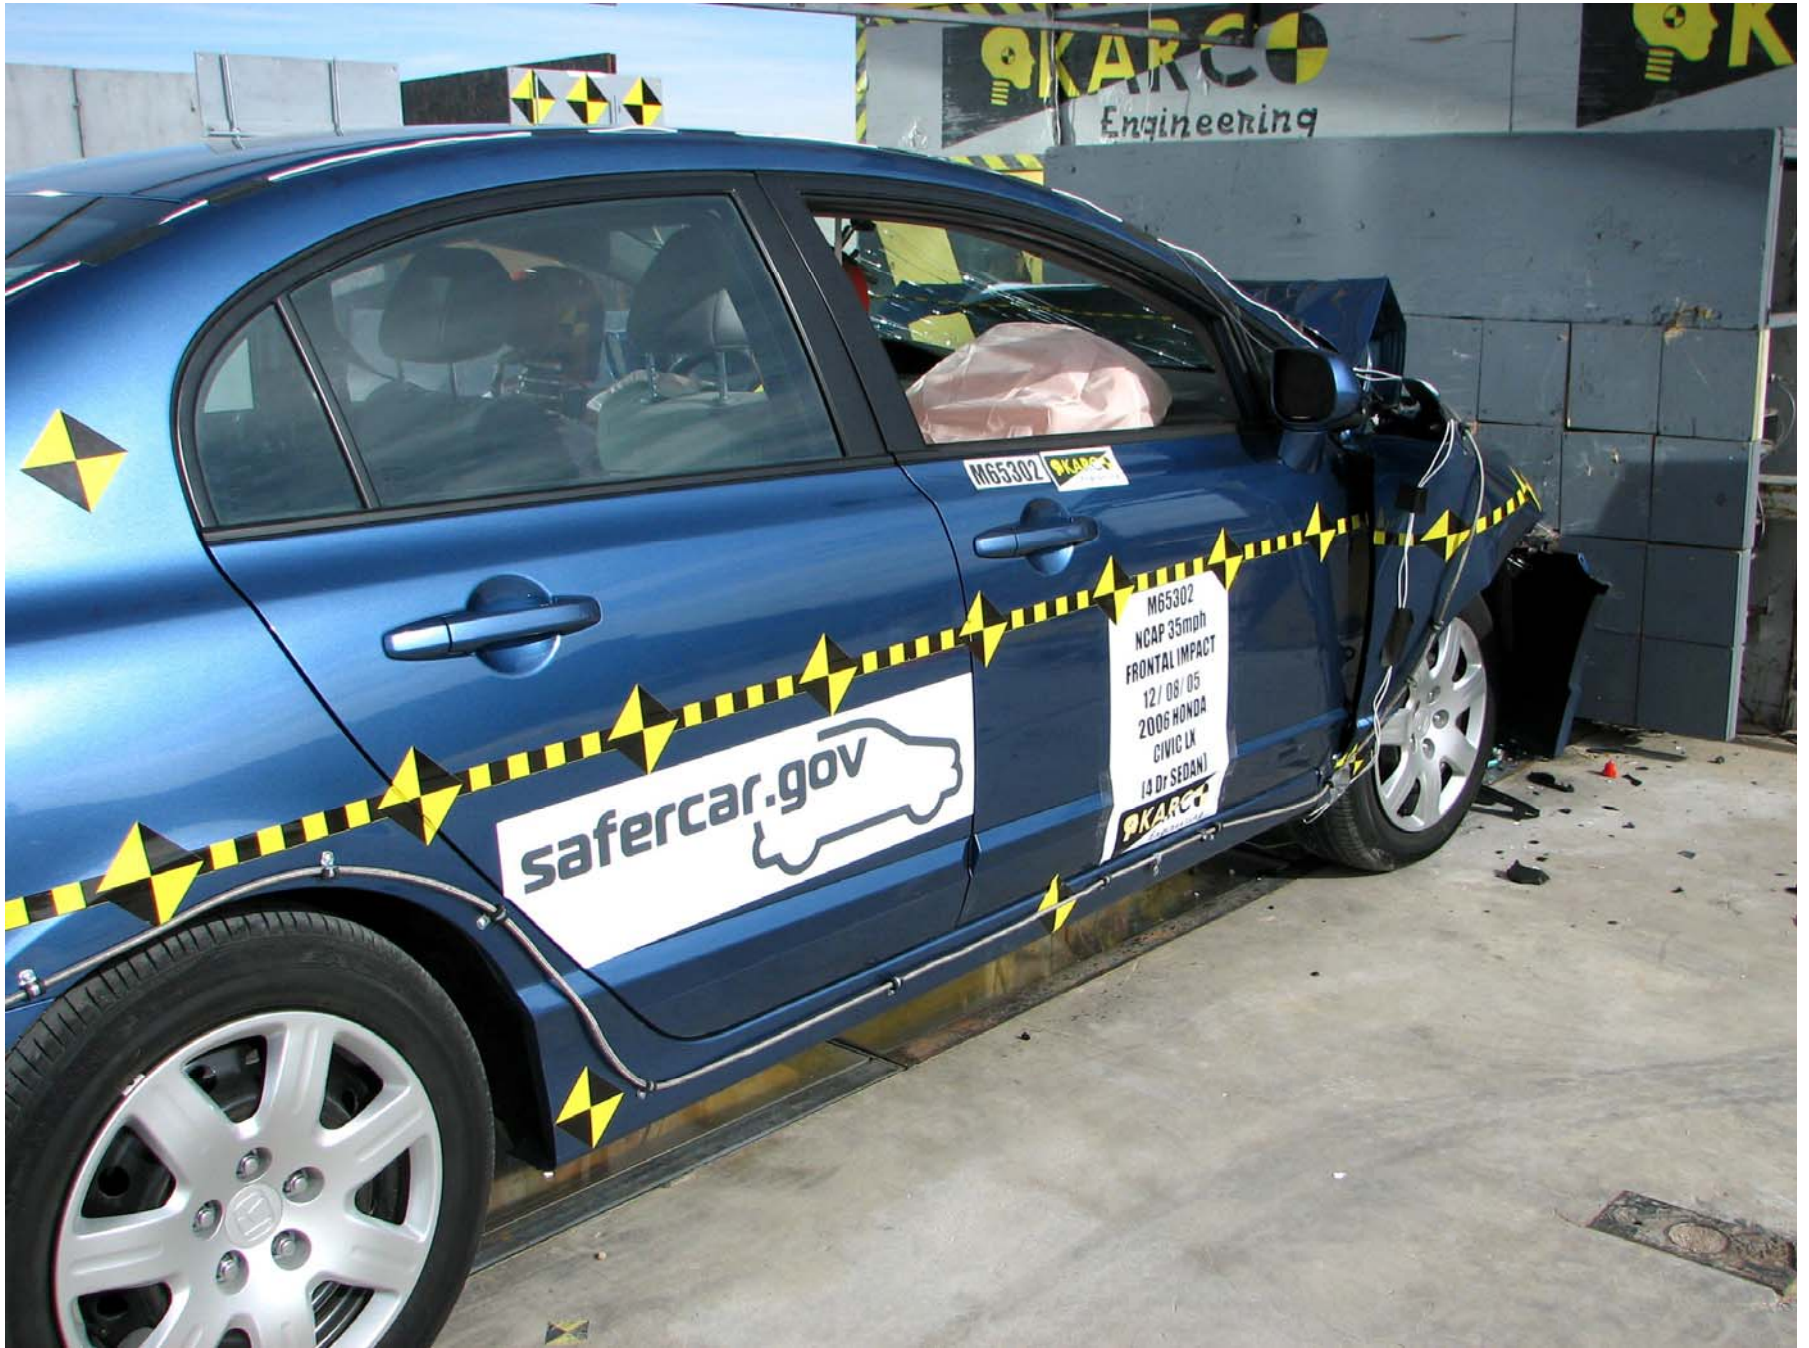
Figure A-17: Post-Test Right Side $\frac{3}{4}$ View of Doors After Impact

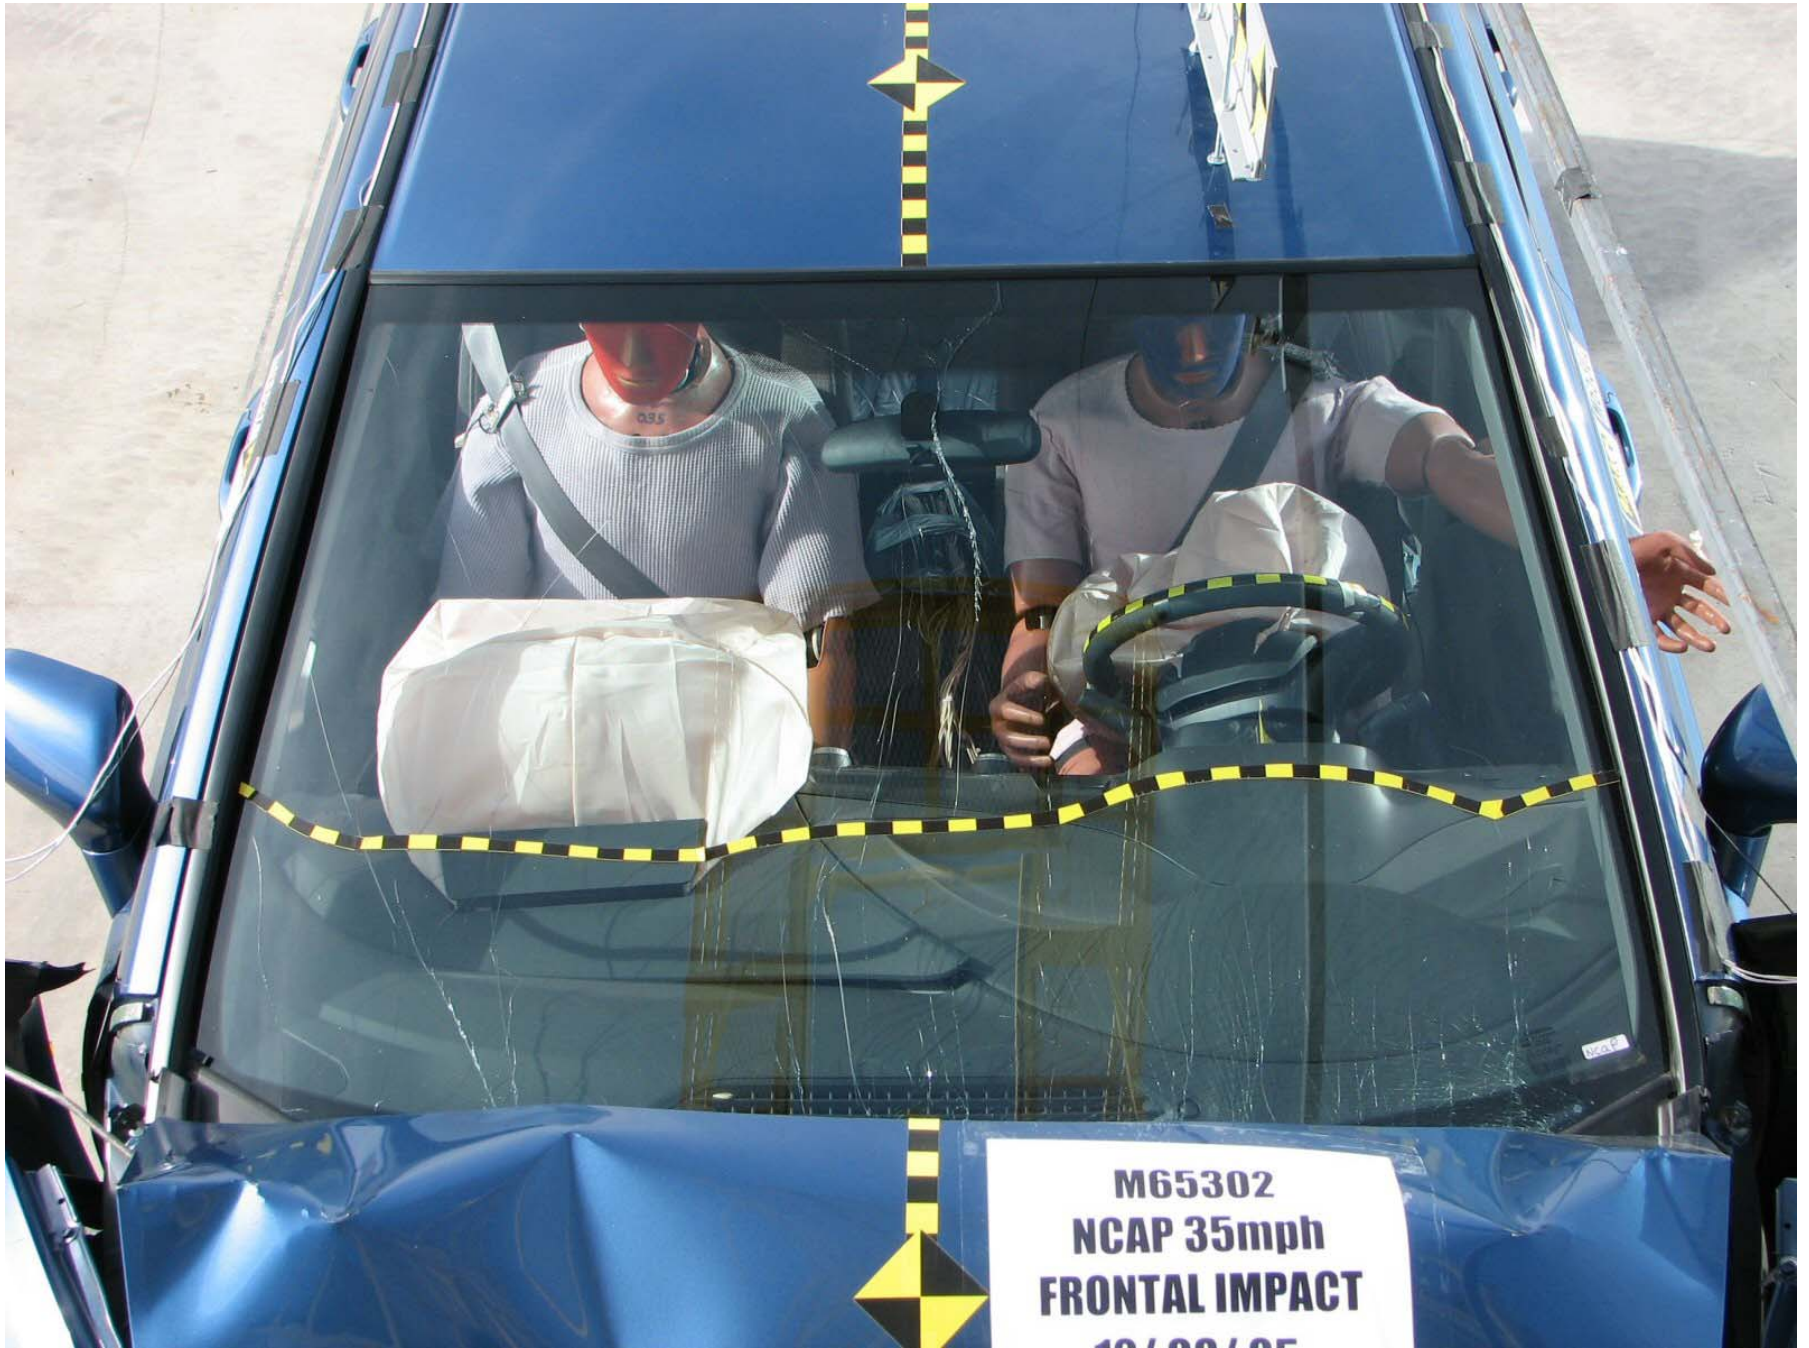
Figure A-19: Post-Test Windshield

There was 100 percent windshield retention and there was intrusion into the protected zone of the windshield during the impact event. There was no stoddard solvent leakage after the event or during any phase of the static rollover.

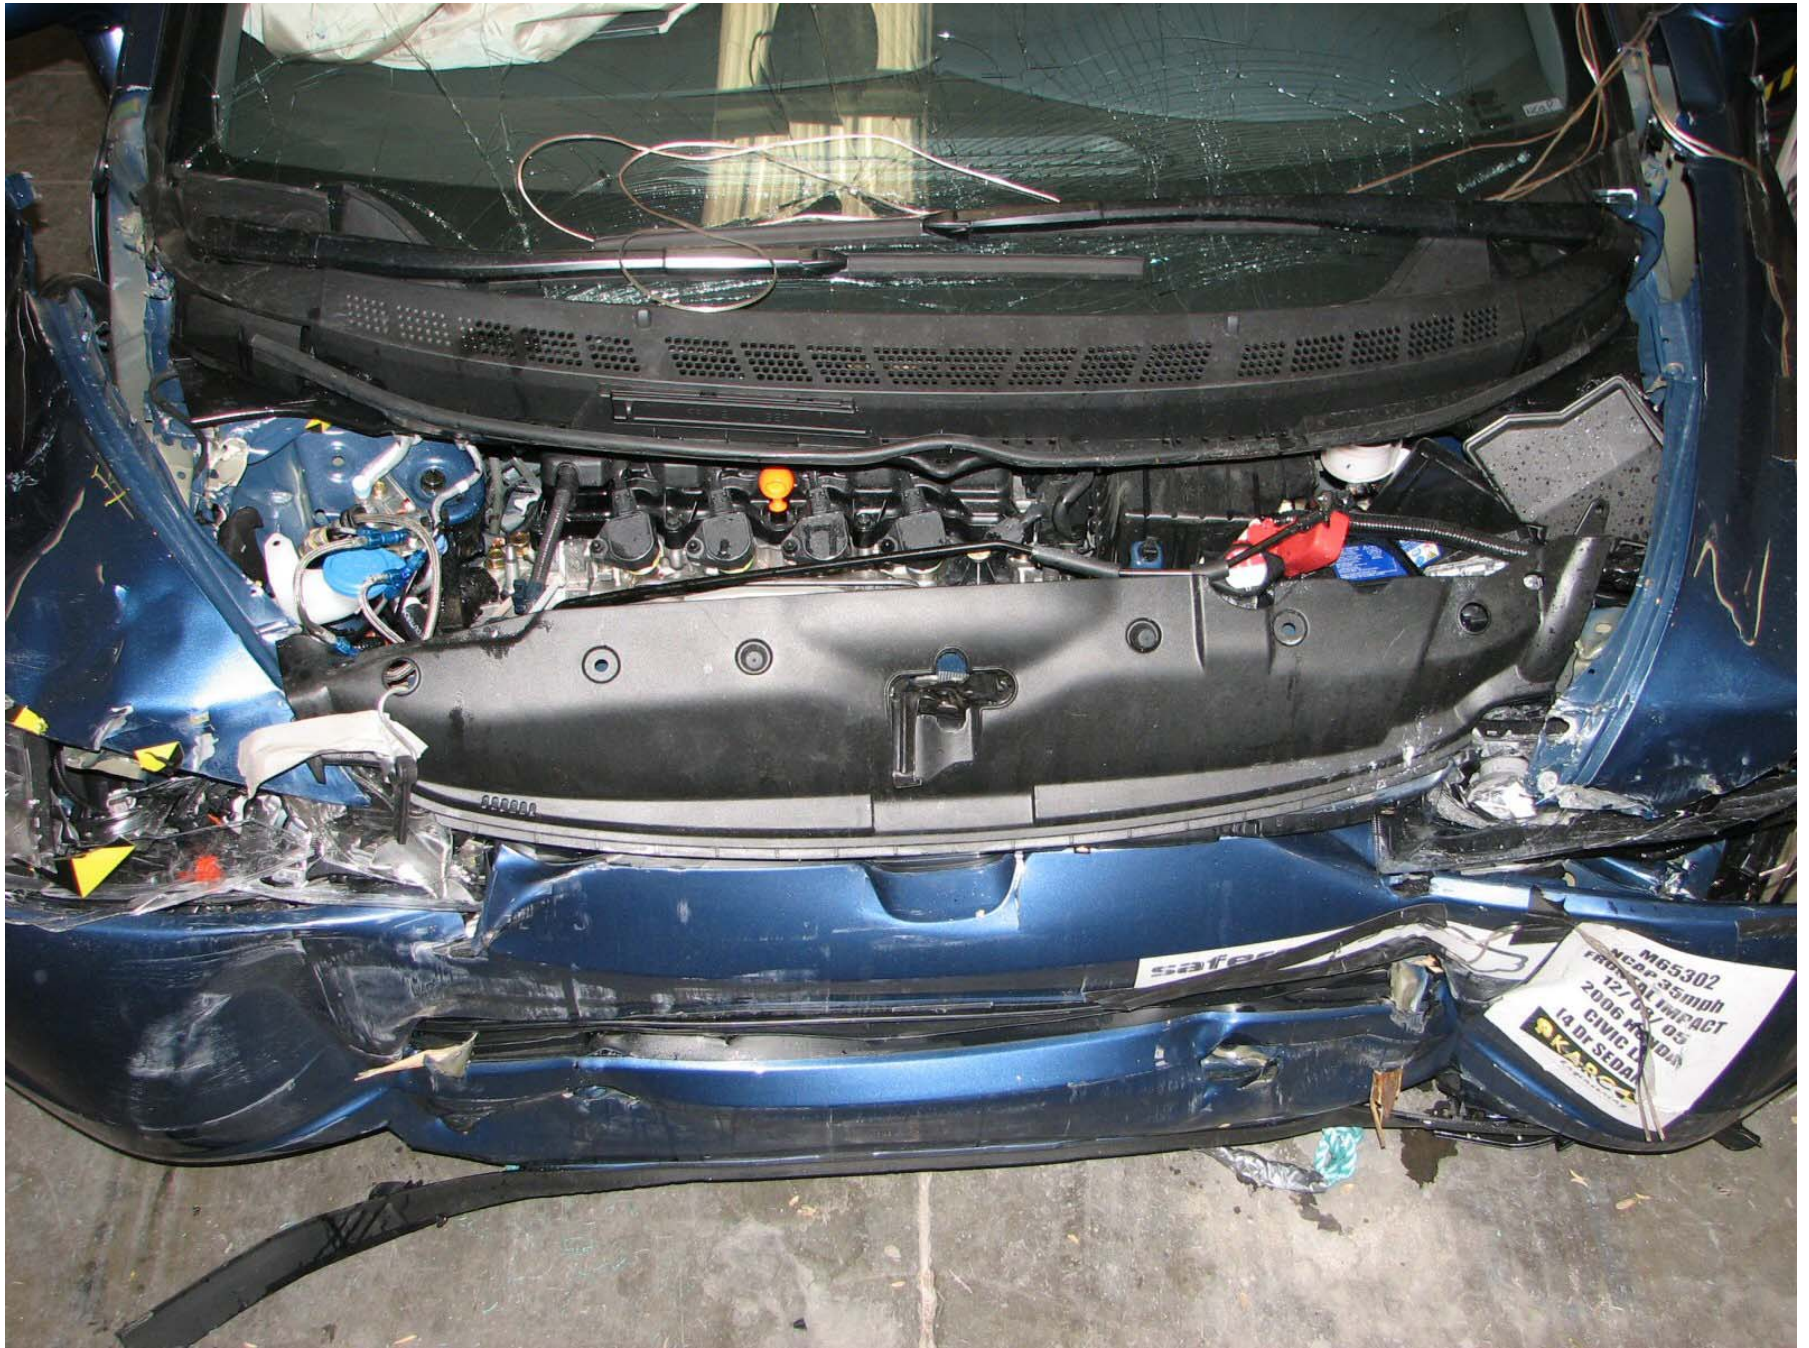
Figure A-21: Post-Test Engine Compartment (Vehicle Moved)

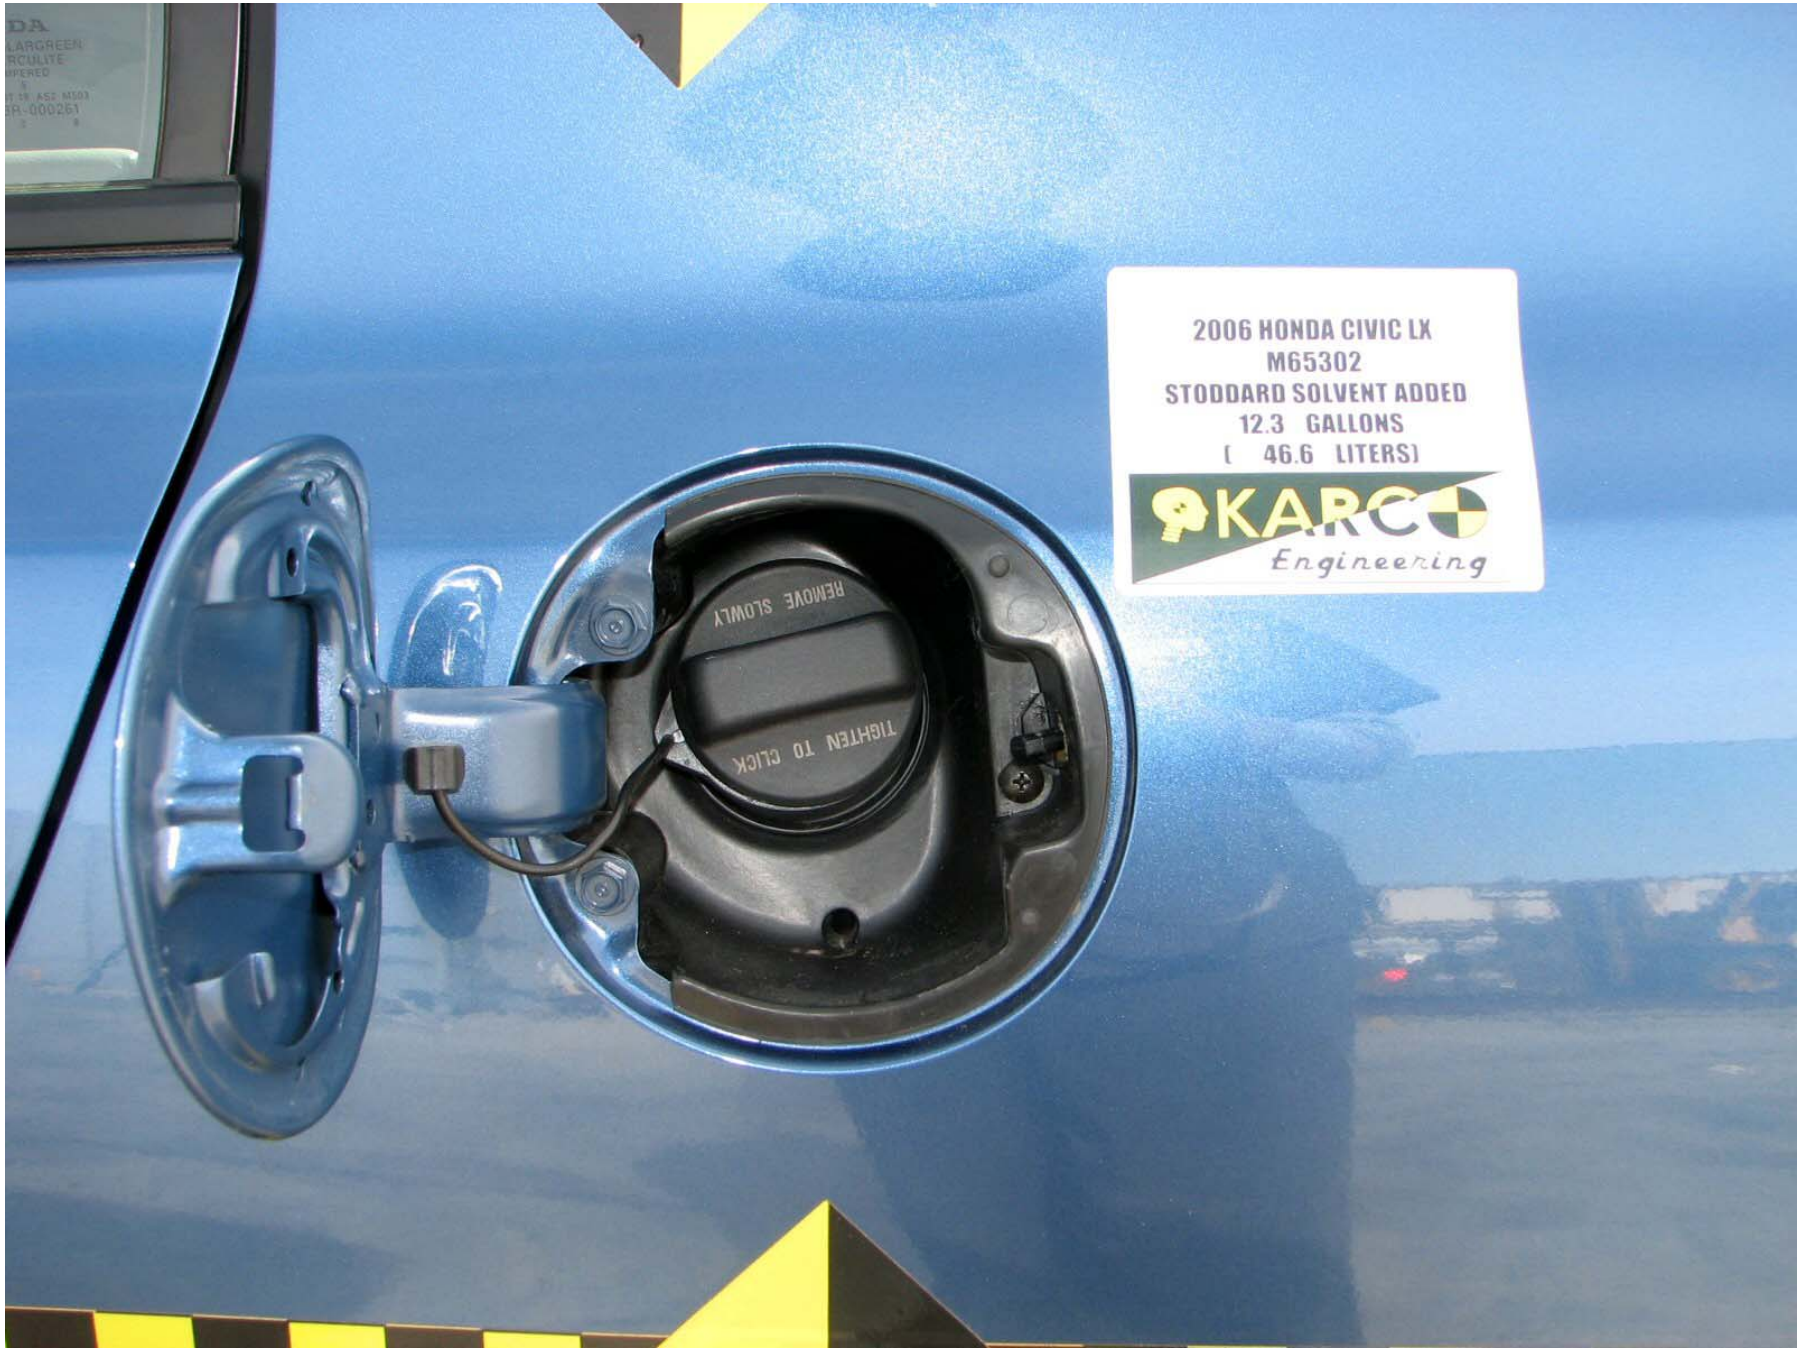
2006 HONDA CIVIC LX
M65302
STODDARD SOLVENT ADDED
12.3 GALLONS
(46.6 LITERS)
KARCO
Engineering

Figure A-23: Post-Test Fuel Cap

Actual Test Volume with entire fuel System Filled (L) 46.55

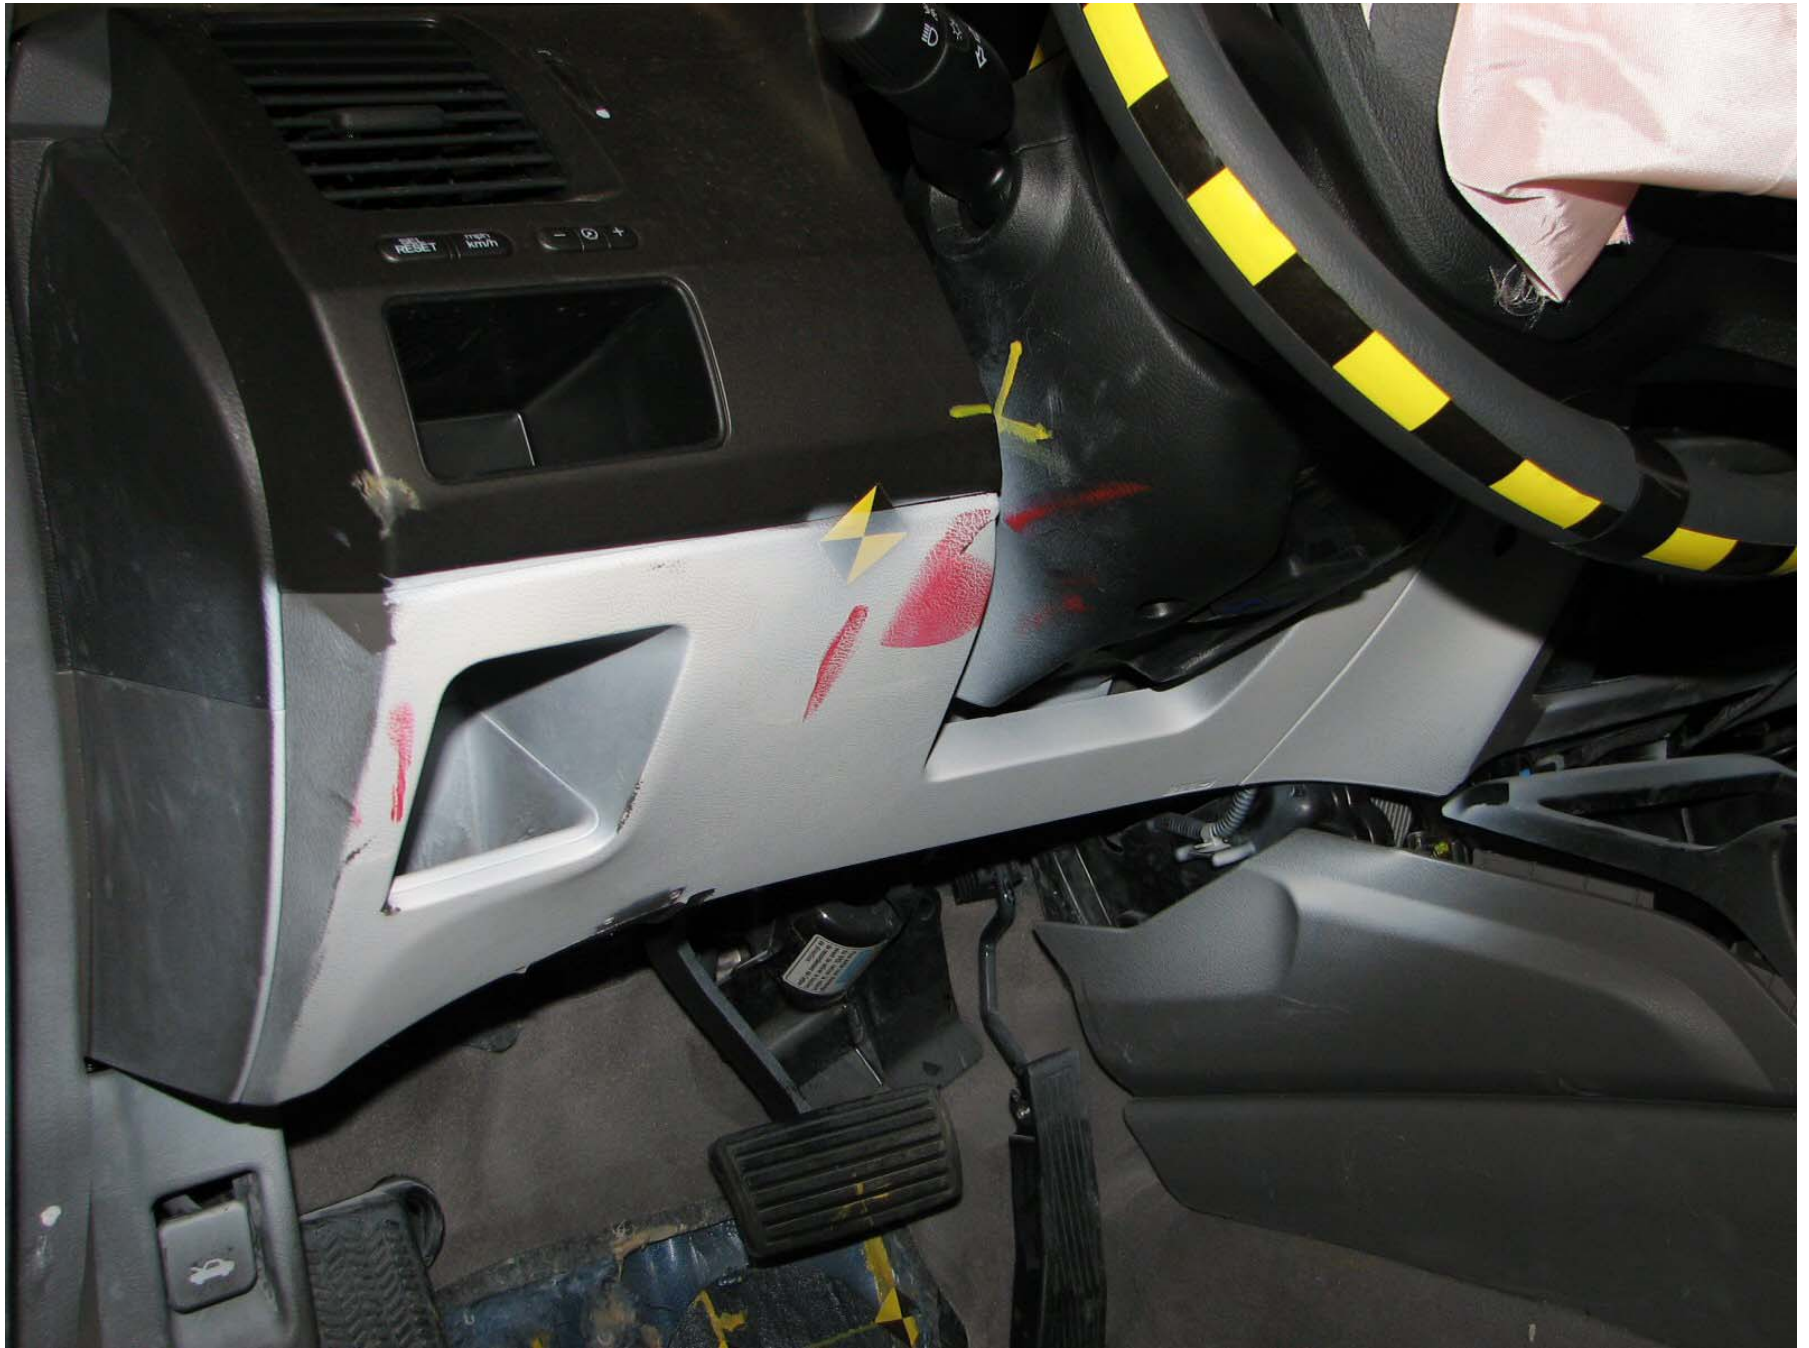
Figure A-39: Post-Test Driver Side Knee Bolster

The driver's visible contact points were as follows: The driver ATD's head and chest contacted the airbag, and the abdomen had no contact. Both knees contacted the knee bolster.

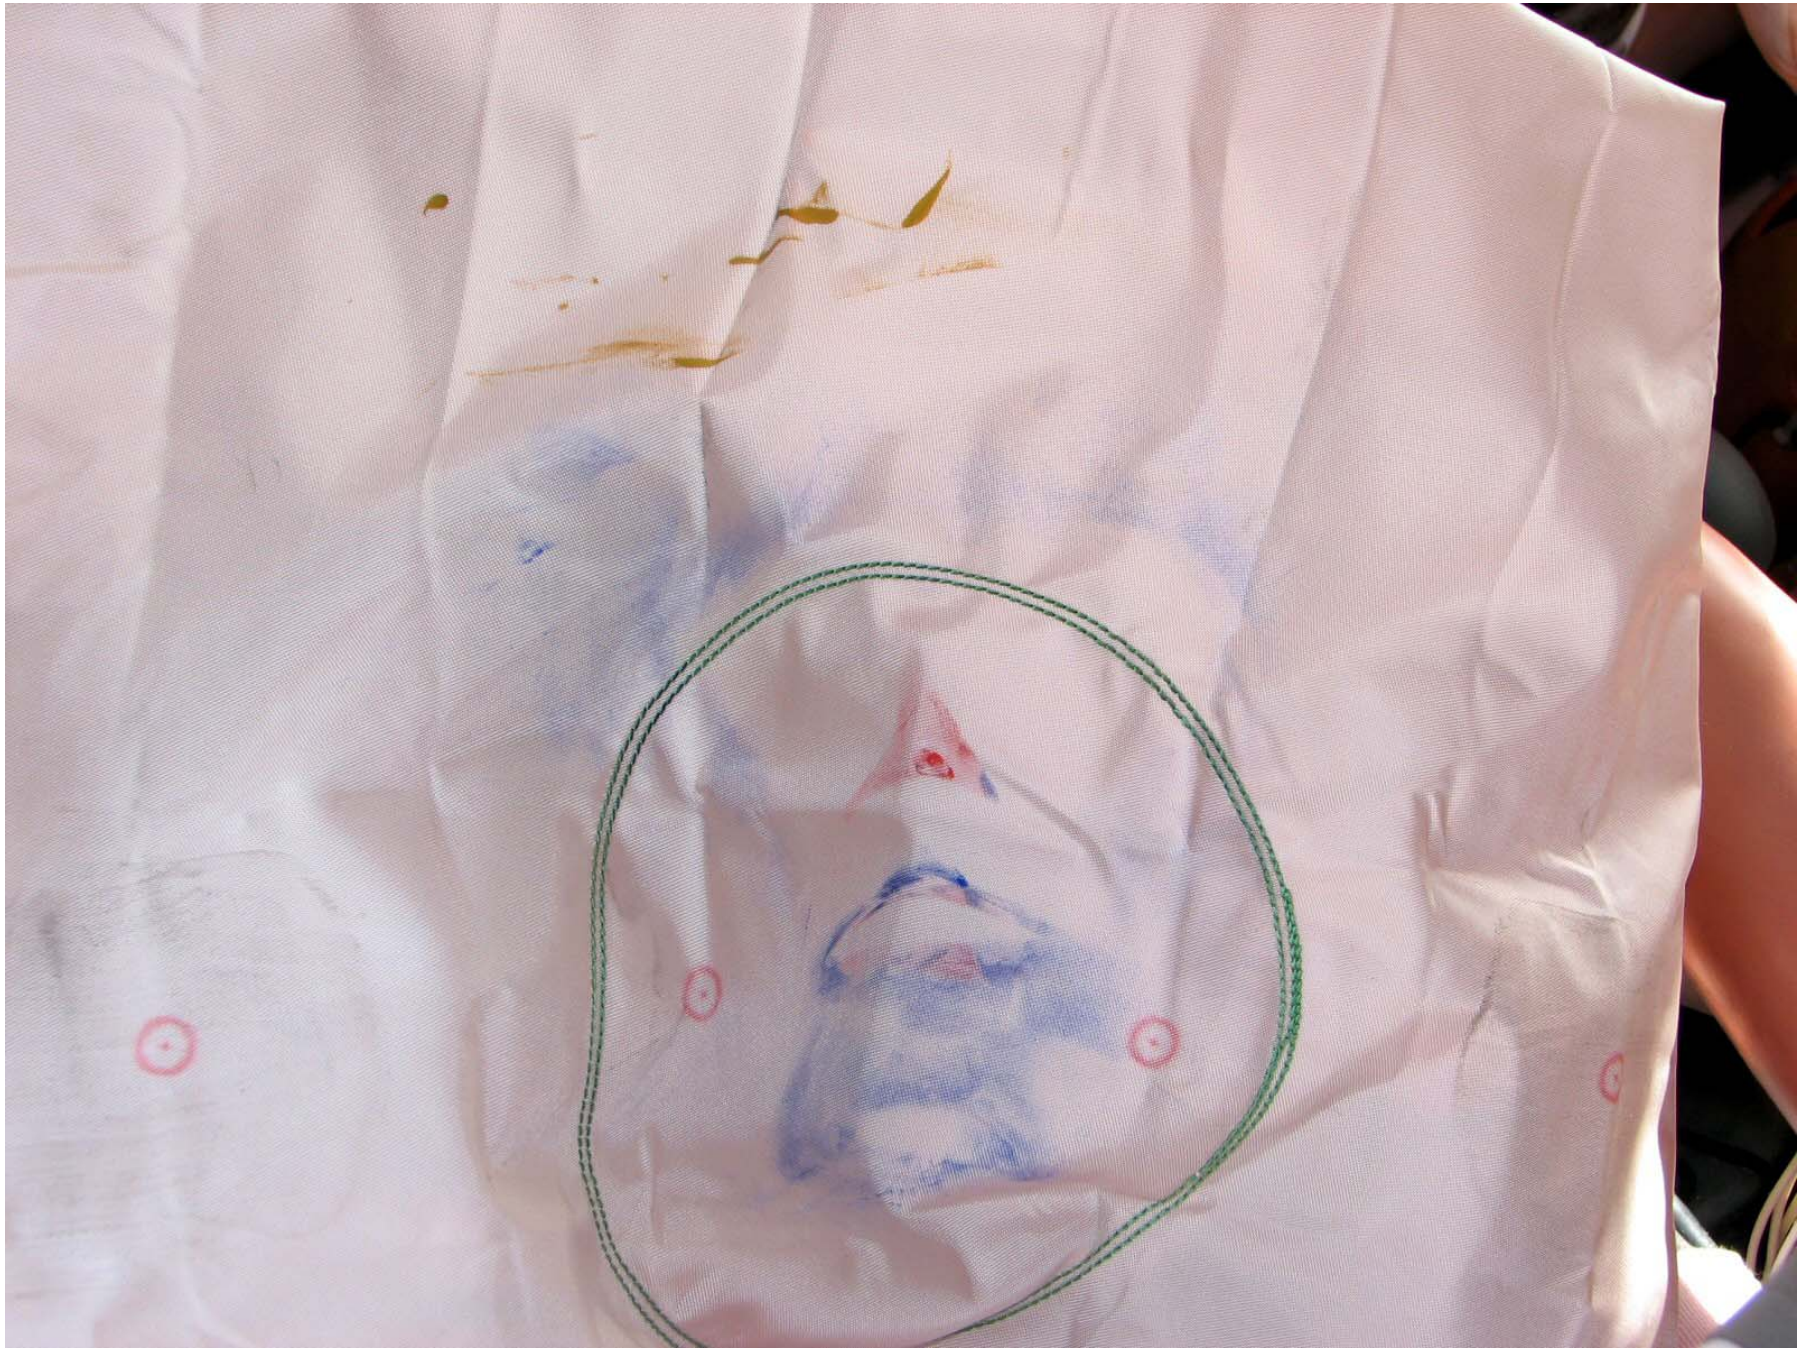
Figure A-43: Post-Test Driver Dummy Airbag Contact
