REPORT NUMBER TR-P26001-04-NC

**NEW CAR ASSESSMENT PROGRAM
FRONTAL BARRIER IMPACT TEST**

**HONDA OF CANADA MFG.
2006 HONDA CIVIC LX
4-DOOR SEDAN**

NHTSA NUMBER: M65302

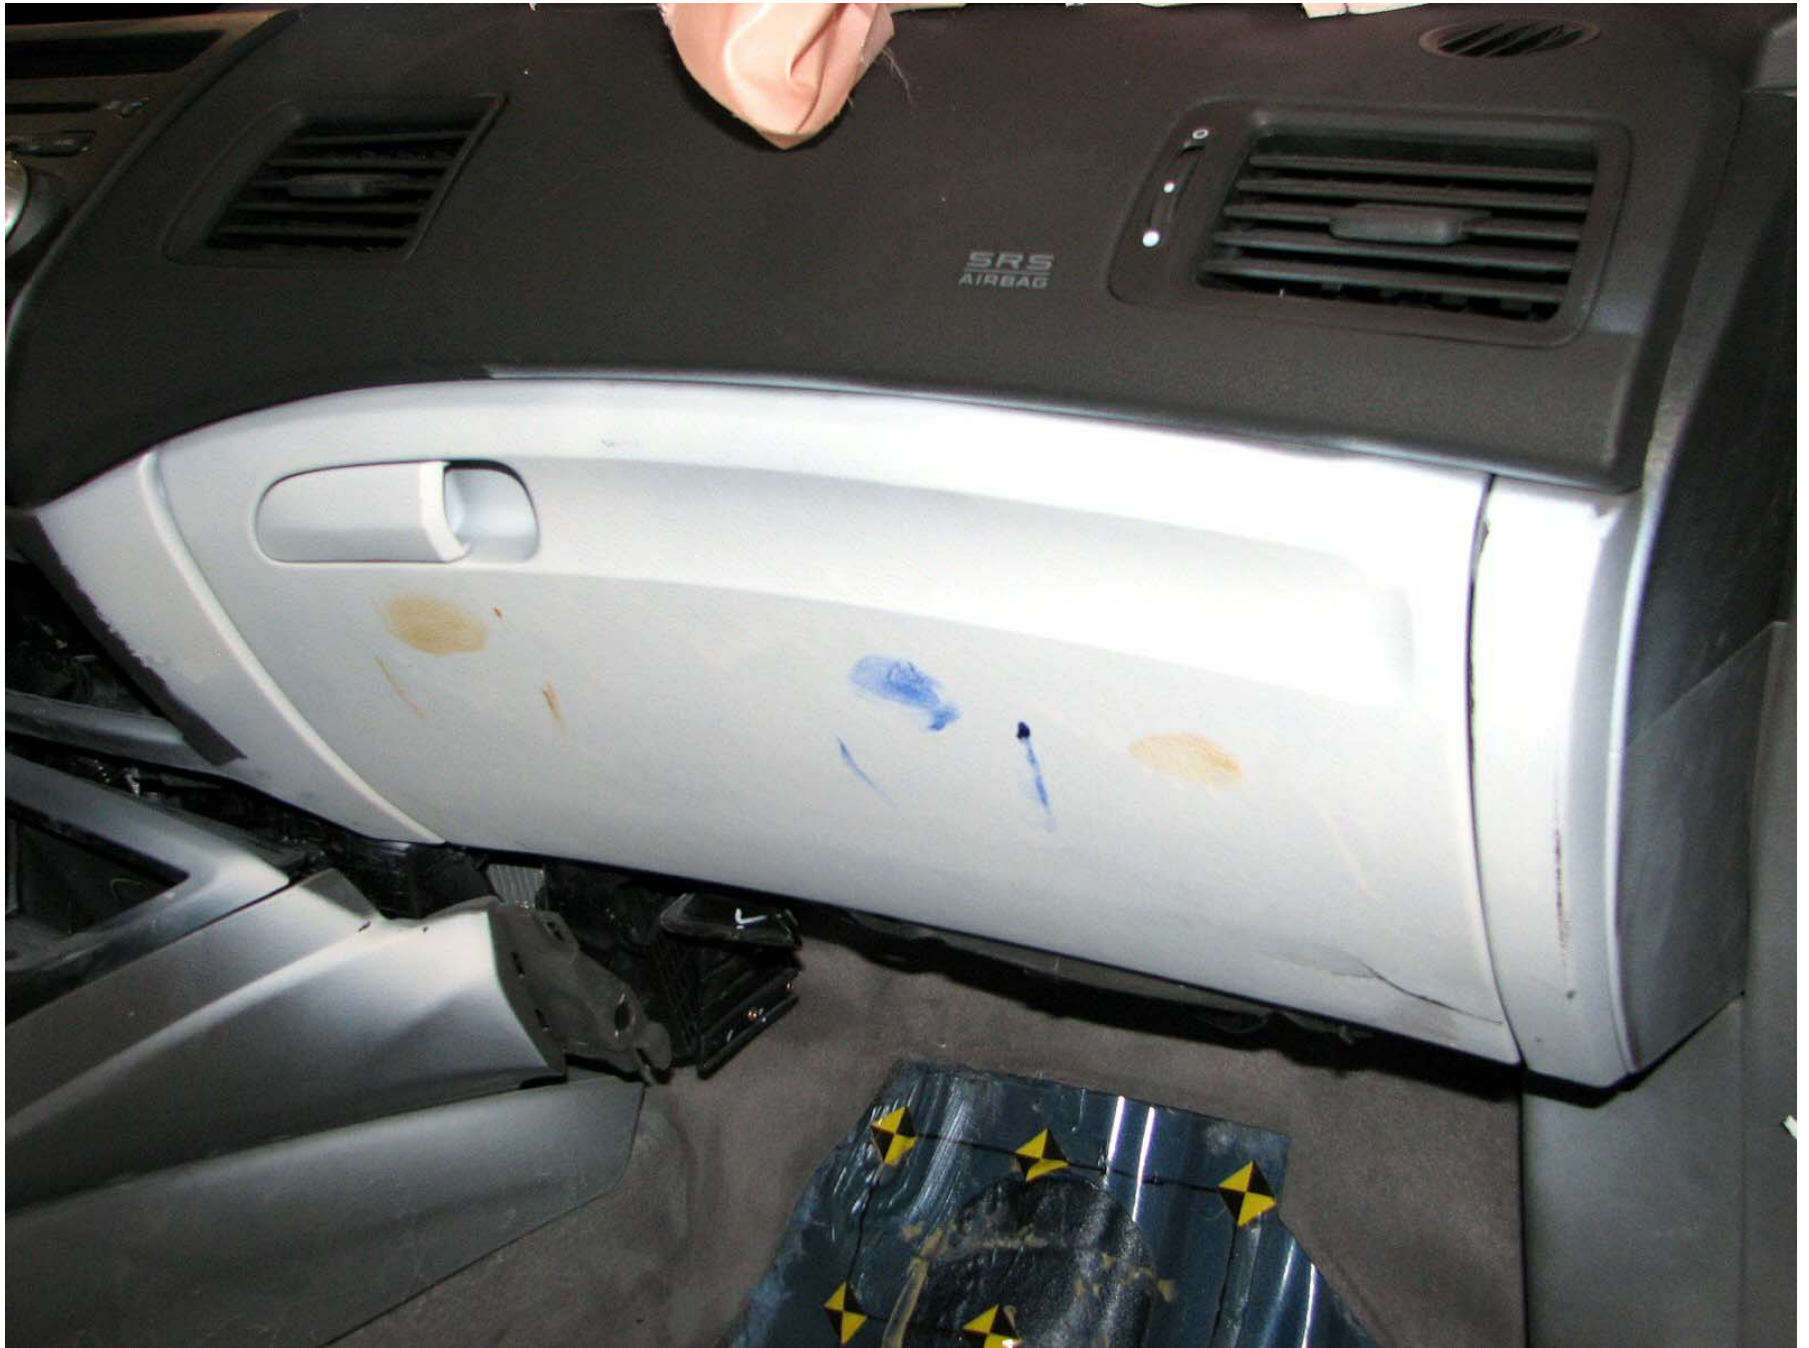
Figure A-53: Post-Test Passenger Side Glove Box

The passenger's visible contact points were as follows: The passenger ATD's head, chest and abdomen contacted the airbag. Both knees contacted the glove box.

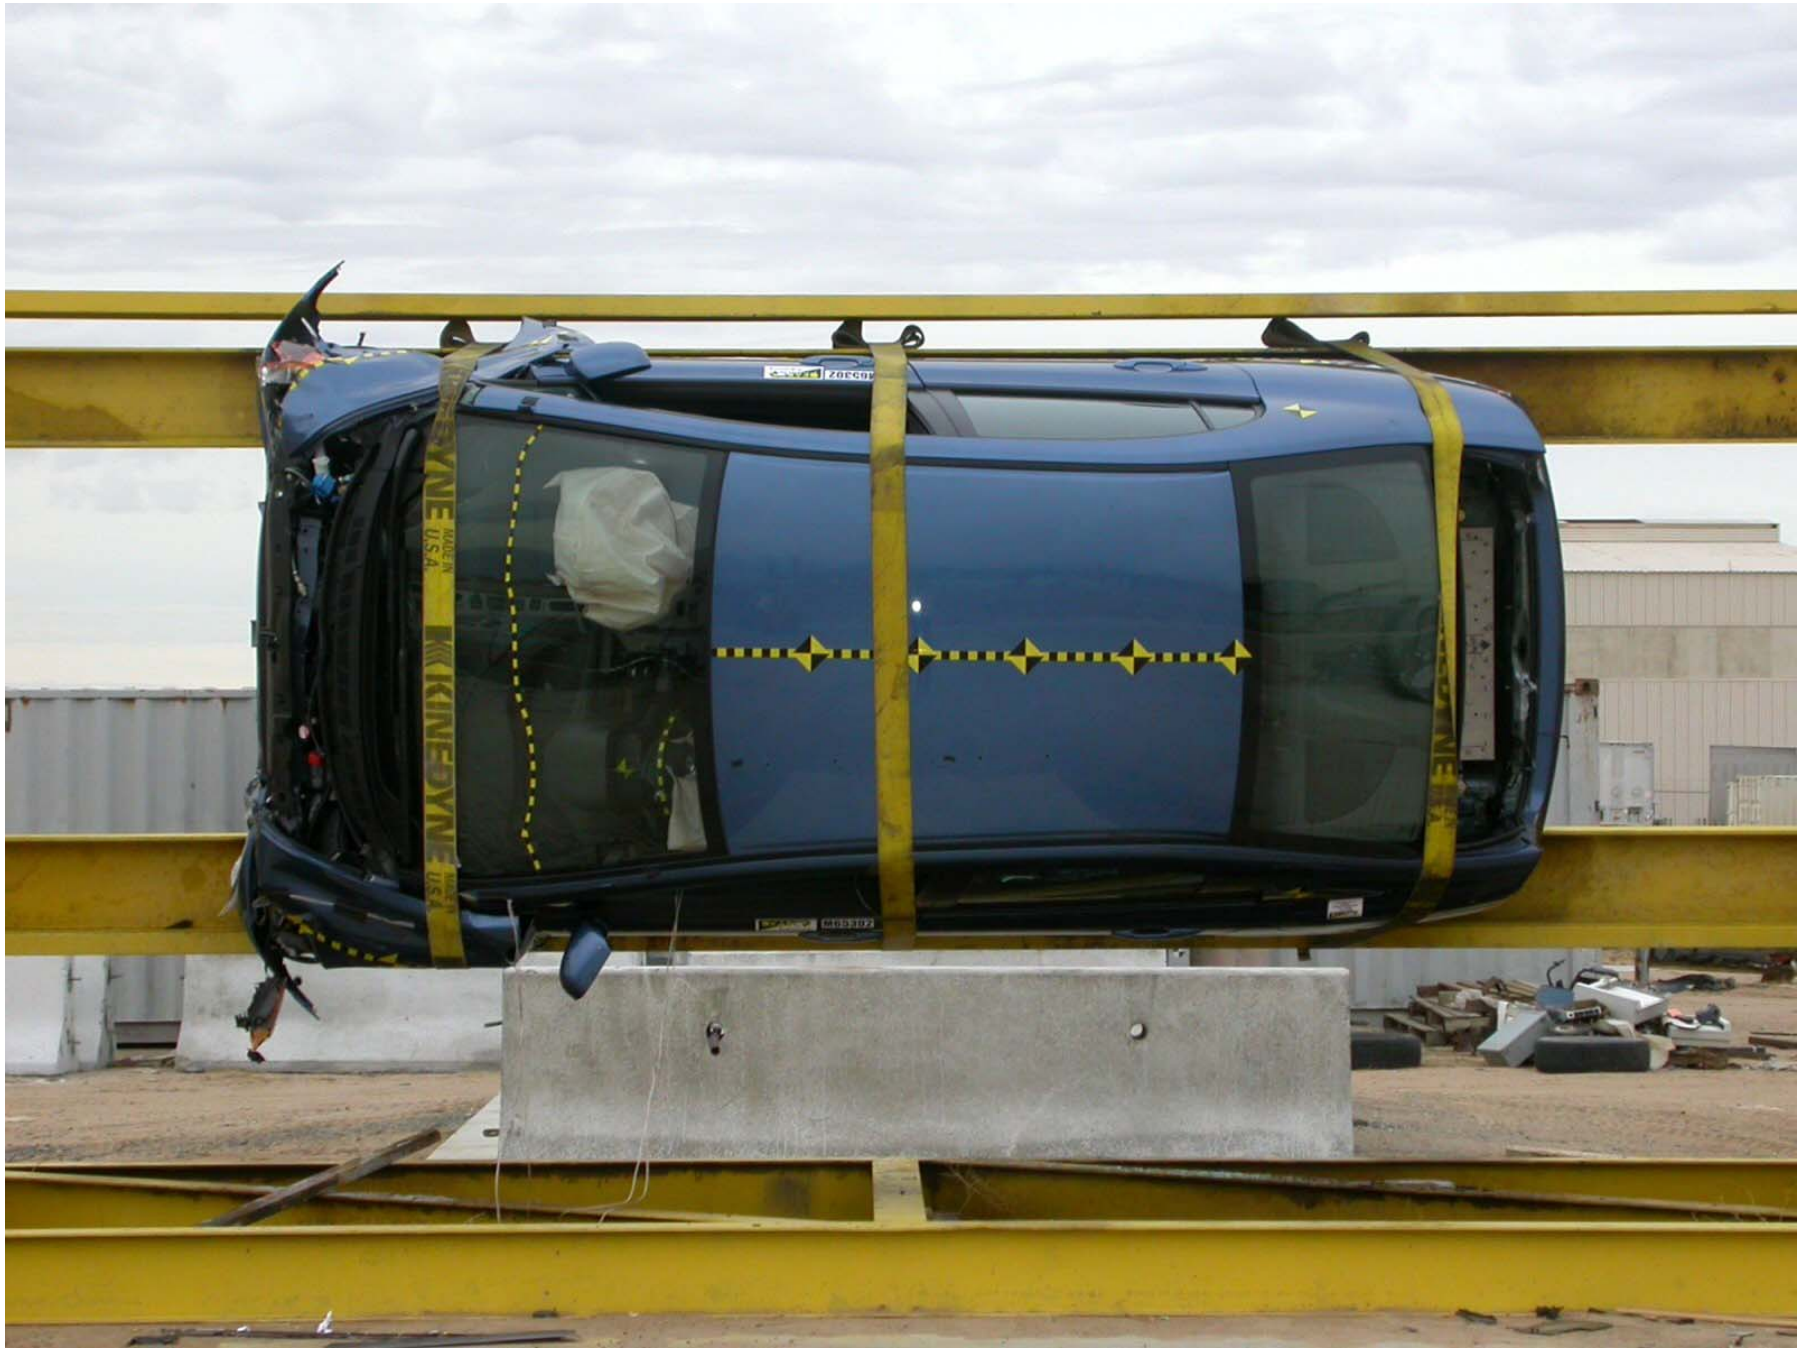
Figure A-59: Vehicle on Rollover Device (90°)

1. The specified fixture rollover rate for each 90° of rotation is 60 to 120 seconds.
2. The position hold time at each position is 300 seconds (minimum).
3. No solvent leakage occurred during rollover.

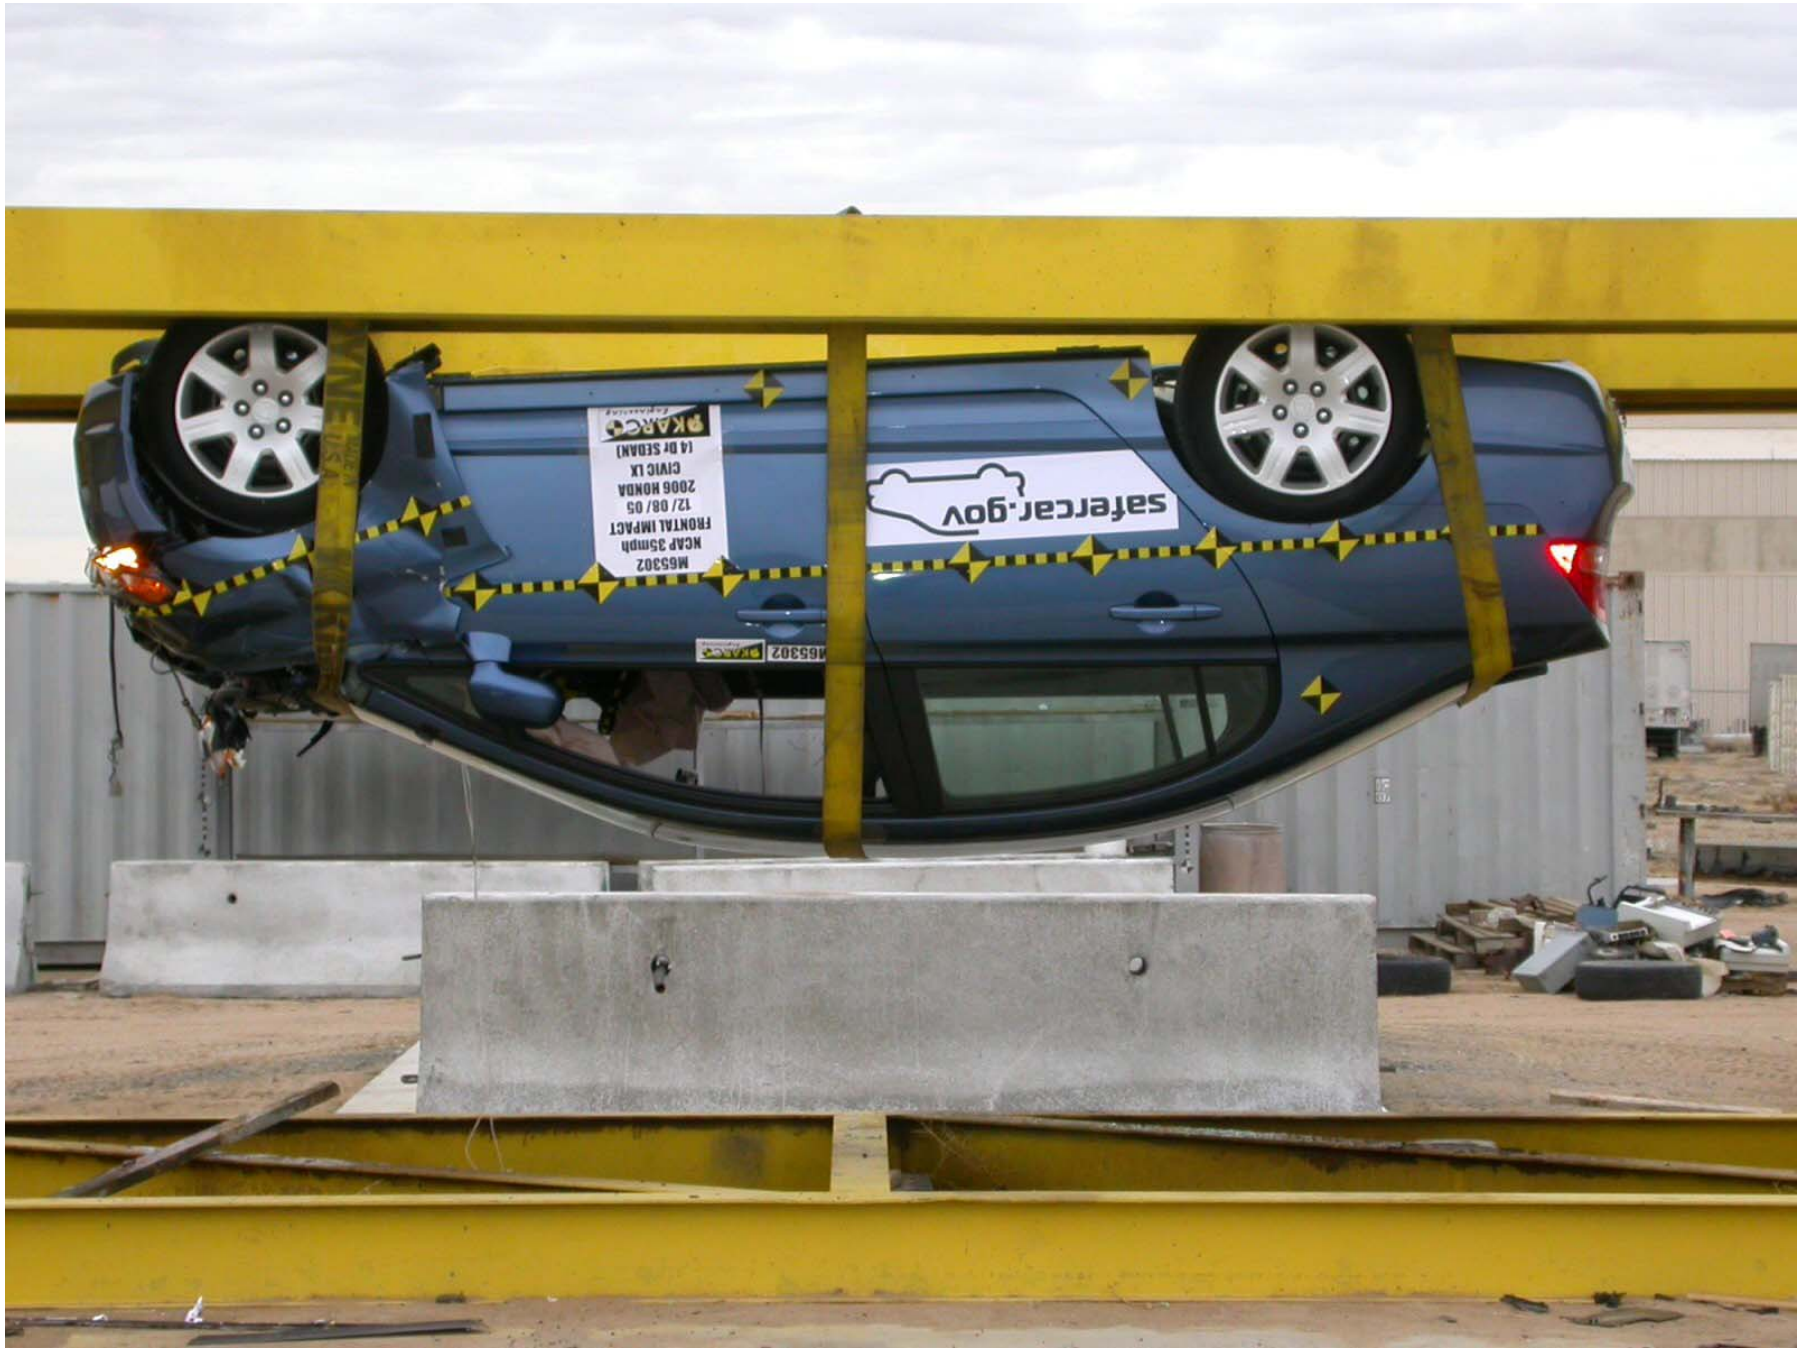
Figure A-60: Vehicle on Rollover Device (180°)
