REPORT NUMBER: CAL-06-06

**NEW CAR ASSESSMENT PROGRAM (NCAP)  
FRONTAL BARRIER IMPACT TEST**

GENERAL MOTORS OF CANADA, LTD.  
2006 CHEVROLET MONTE CARLO  
TWO-DOOR COUPE

NHTSA NUMBER: M60112

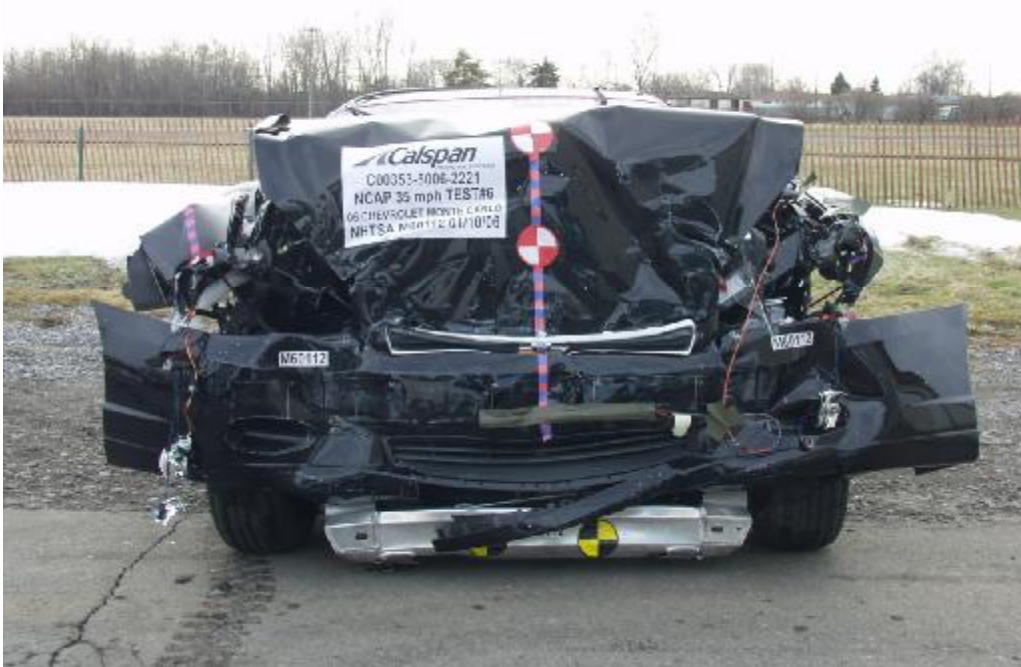
**Figure A-7: Post-Test Front View**

Vehicle NHTSA No.: M60112 Test Mode: 56.3 kph Frontal Barrier  
 Test Date: January 10, 2006 Time: 12:02 Temperature: 21 °C  
 Vehicle Make/Model/Body Style: 2006 Chevrolet Monte Carlo Two-Door Coupe  
 Vehicle Test Weight: 1779.0 kg Impact Velocity: 56.33 kph (55.5 – 57.1 kph)  
 Vehicle/Barrier Impact Angle: 0 ° Max Static Crush: 710 mm

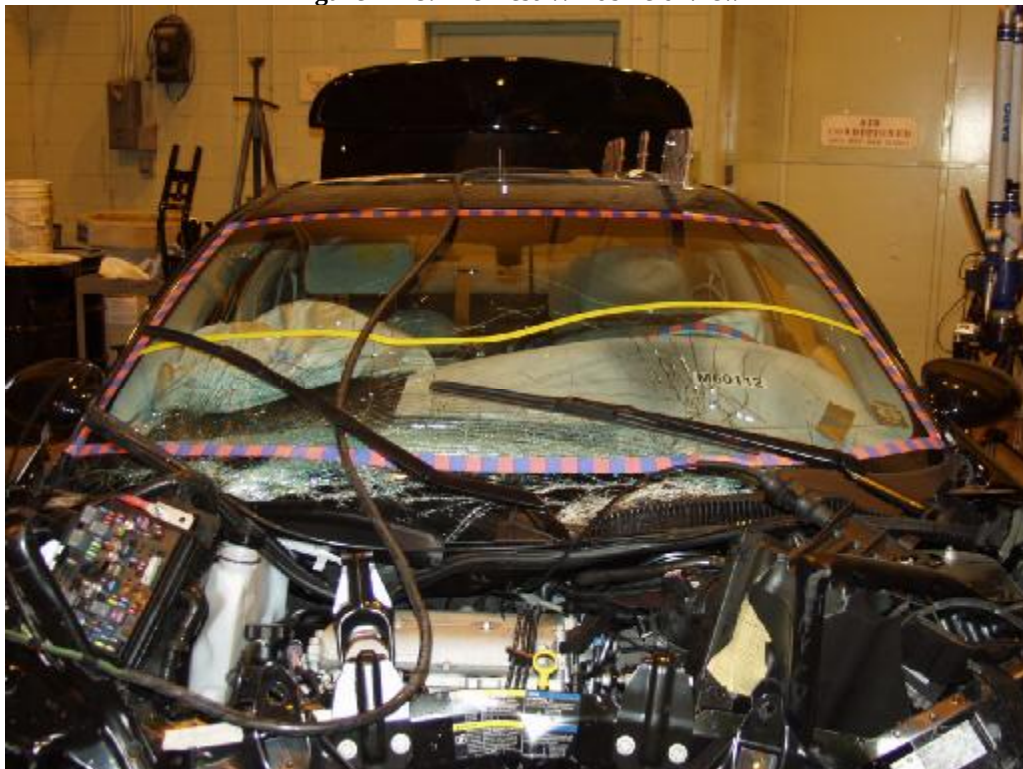
**Figure A-19: Post-Test Windshield View**

| Description | Driver Side | Passenger Side |
|---|---|---|
| Glazing Damage | The windshield cracked along the lower cowl due to deformation | |

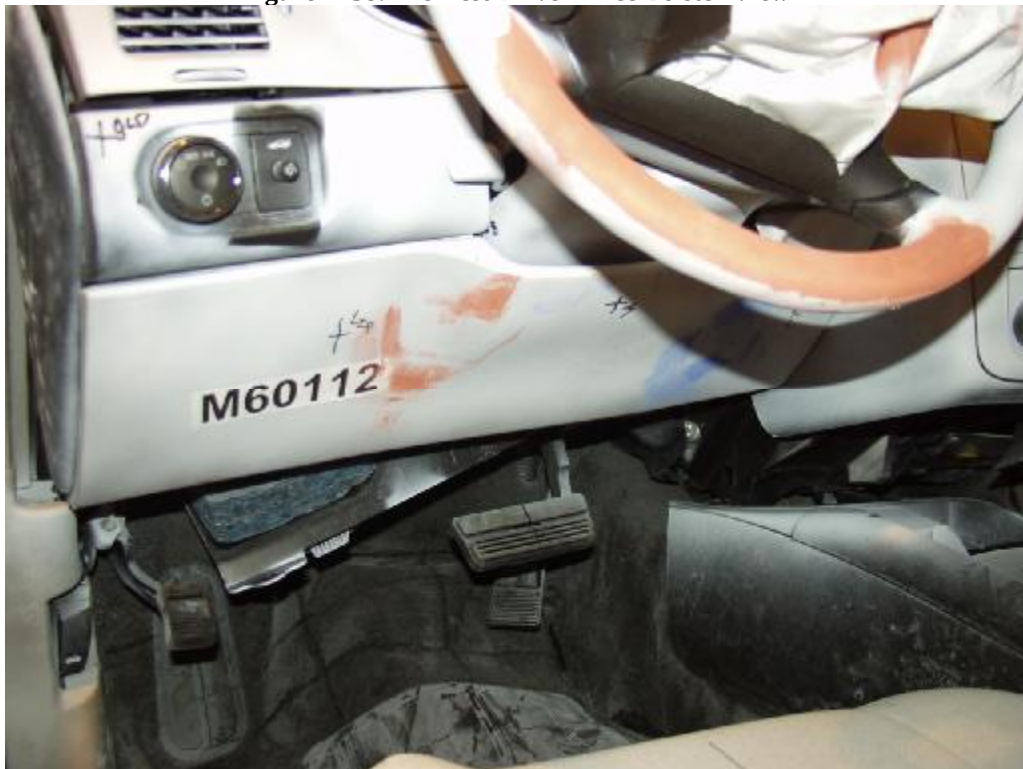
**Figure A-39: Post-Test Driver Knee Bolster View**

| | DRIVER | PASSENGER |
|---|---|---|
| Left Knee Contact: | Knee Bolster | Knee Bolster |
| Right Knee Contact: | Knee Bolster | Knee Bolster |

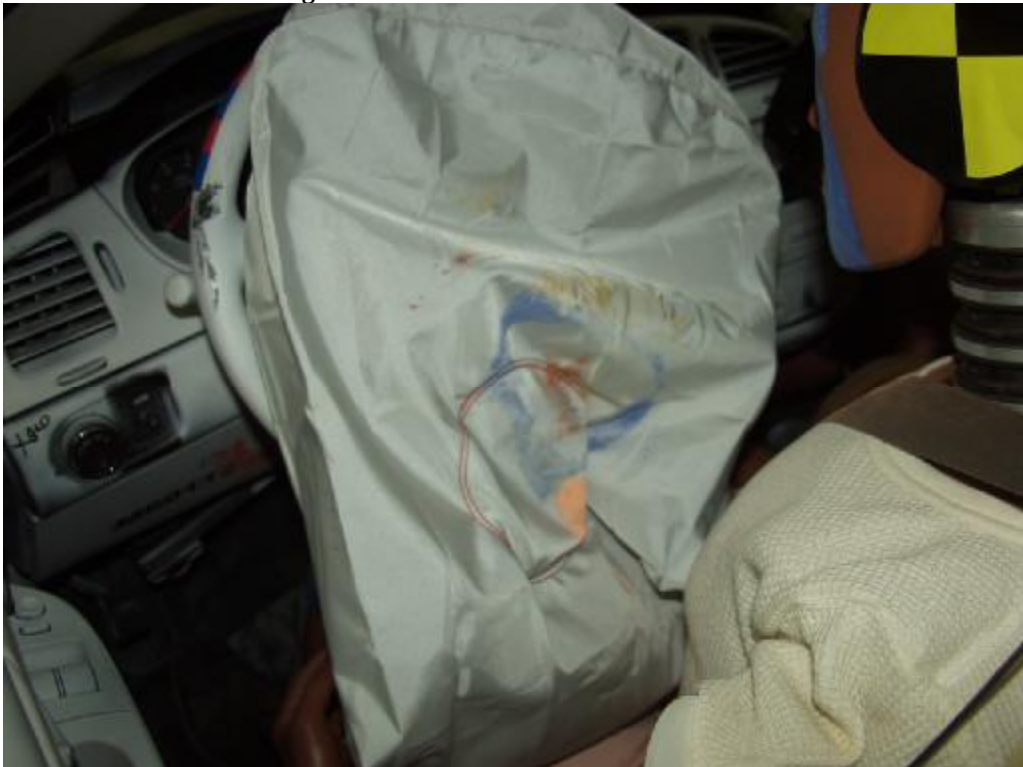
**Figure A-43: Post-Test Driver Contact to Airbag**

| | DRIVER | PASSENGER |
|---|---|---|
| Head Contact: | The face to the center of the airbag, the back of the head to the left center of the head restraint | The face to the center of the airbag, the back of the head to the left center of the head restraint |
| Chest Contact: | Airbag | Airbag |
