**REPORT NUMBER: NCAPSIDE-MGA-2006-006**

**NEW CAR ASSESSMENT PROGRAM  
SIDE IMPACT TEST**

**GM DAEWOO AUTO & TECHNOLOGY COMPANY  
2006 CHEVROLET AVEO SPECIAL VALUE MODEL 4-DR  
NHTSA NUMBER: M60109**

**PREPARED BY:  
MGA RESEARCH CORPORATION  
5000 WARREN ROAD  
BURLINGTON, WI 53105**

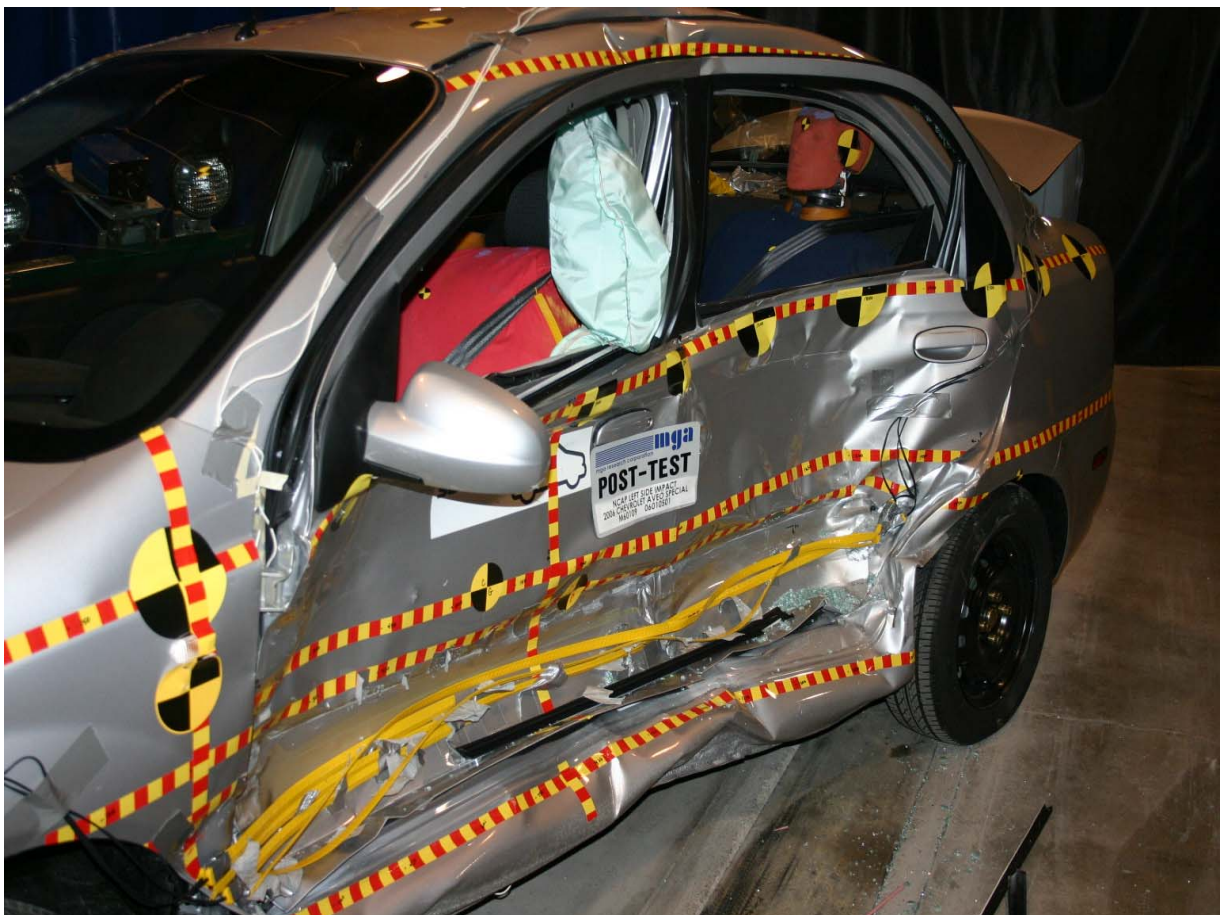
Post-Test Left Front  $\frac{3}{4}$  View

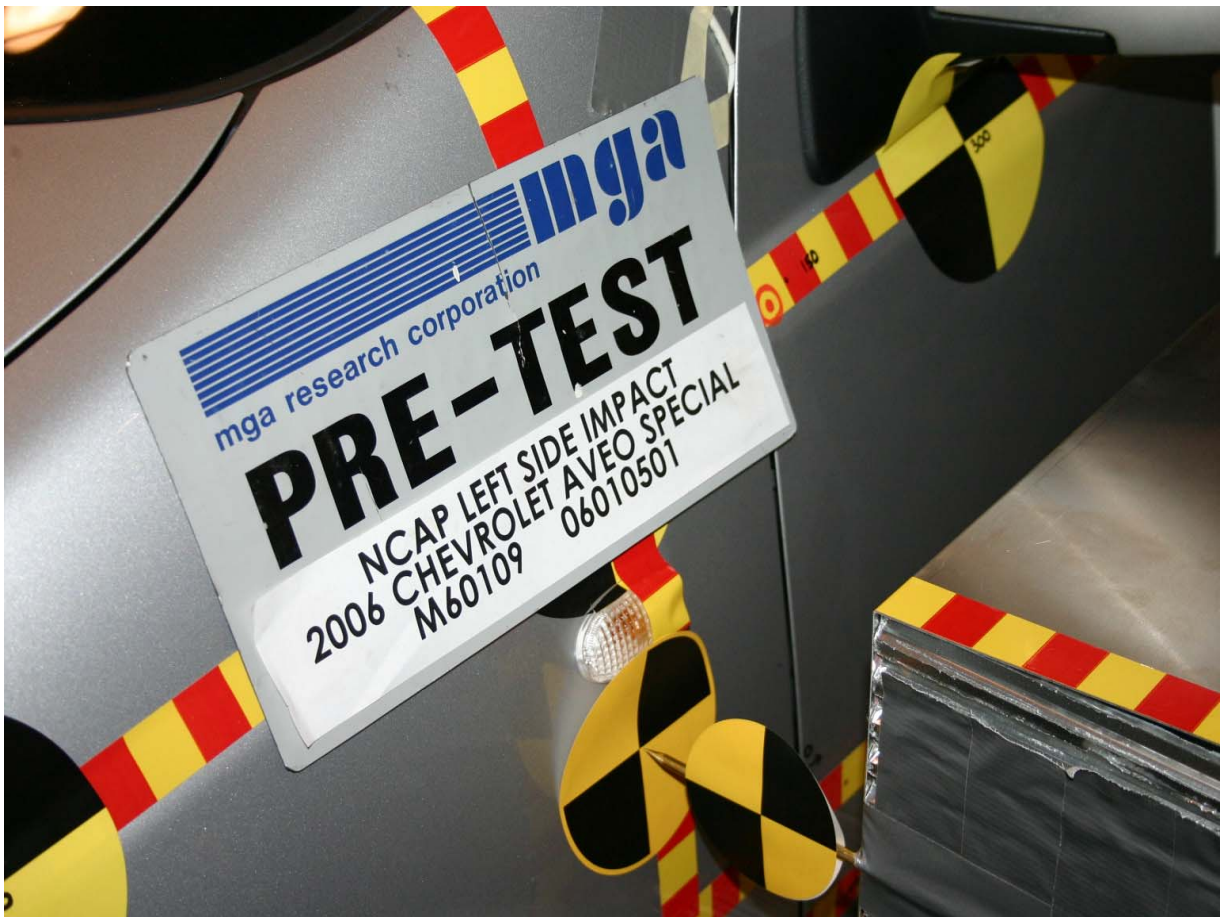
Pre-Test Left Impact Point

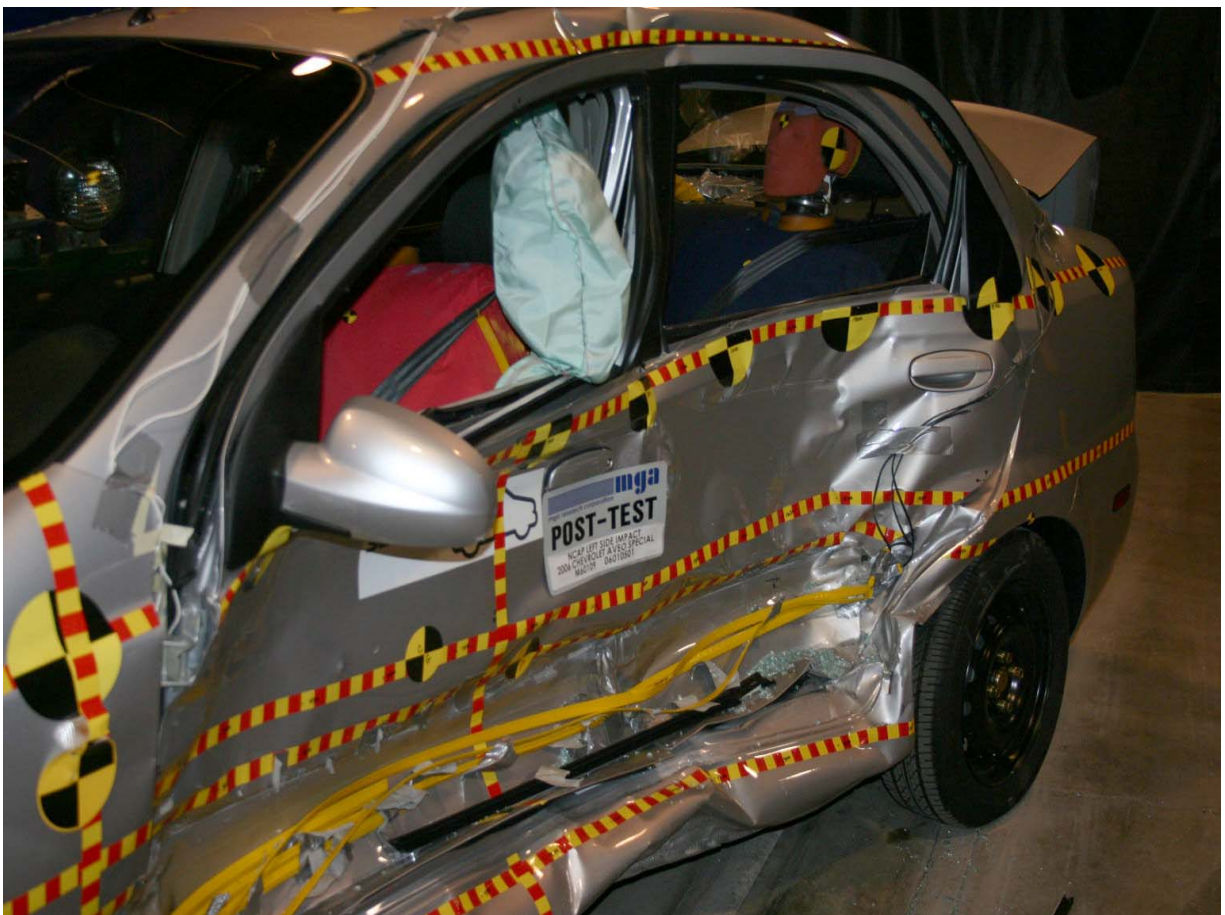
Post-Test Front  $\frac{3}{4}$  View of Left Side Doors

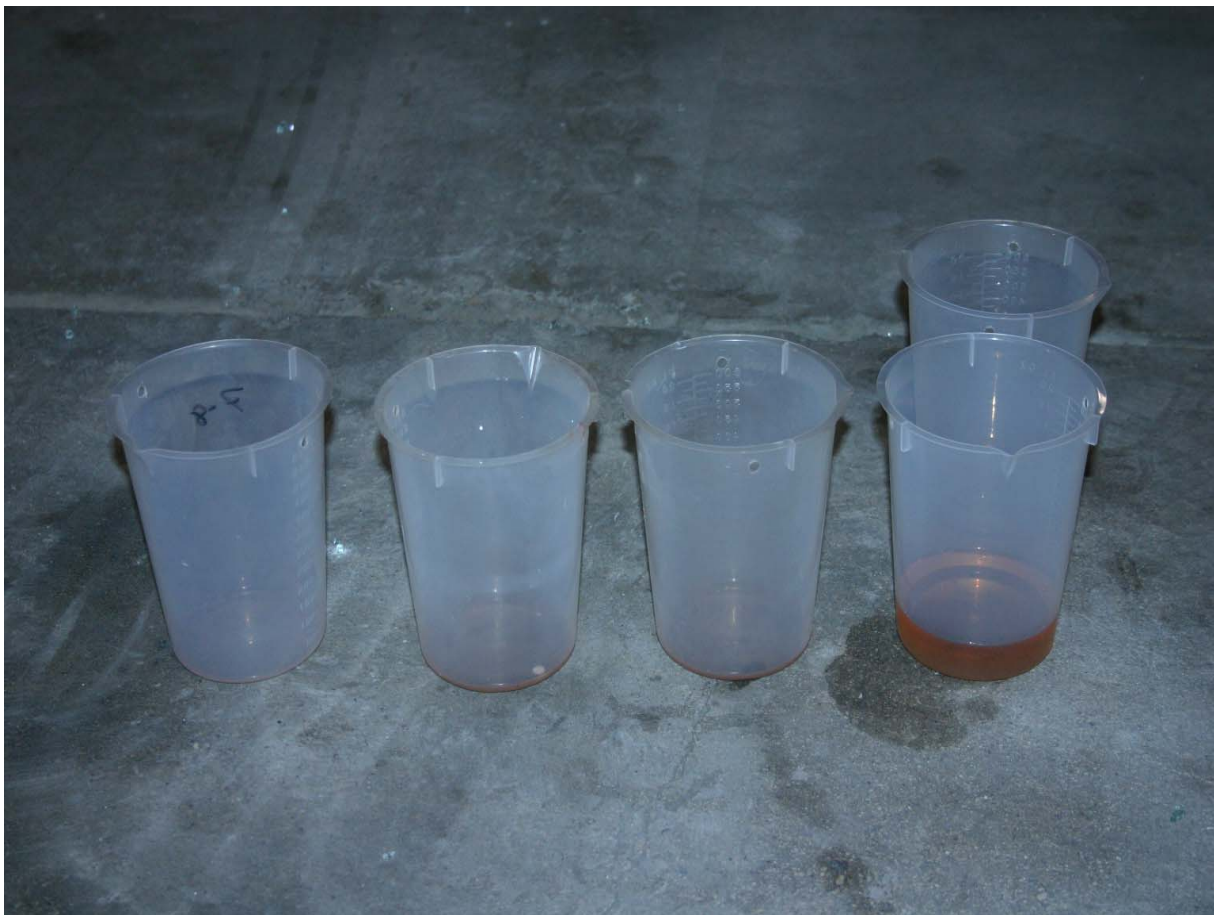
Fuel Leakage

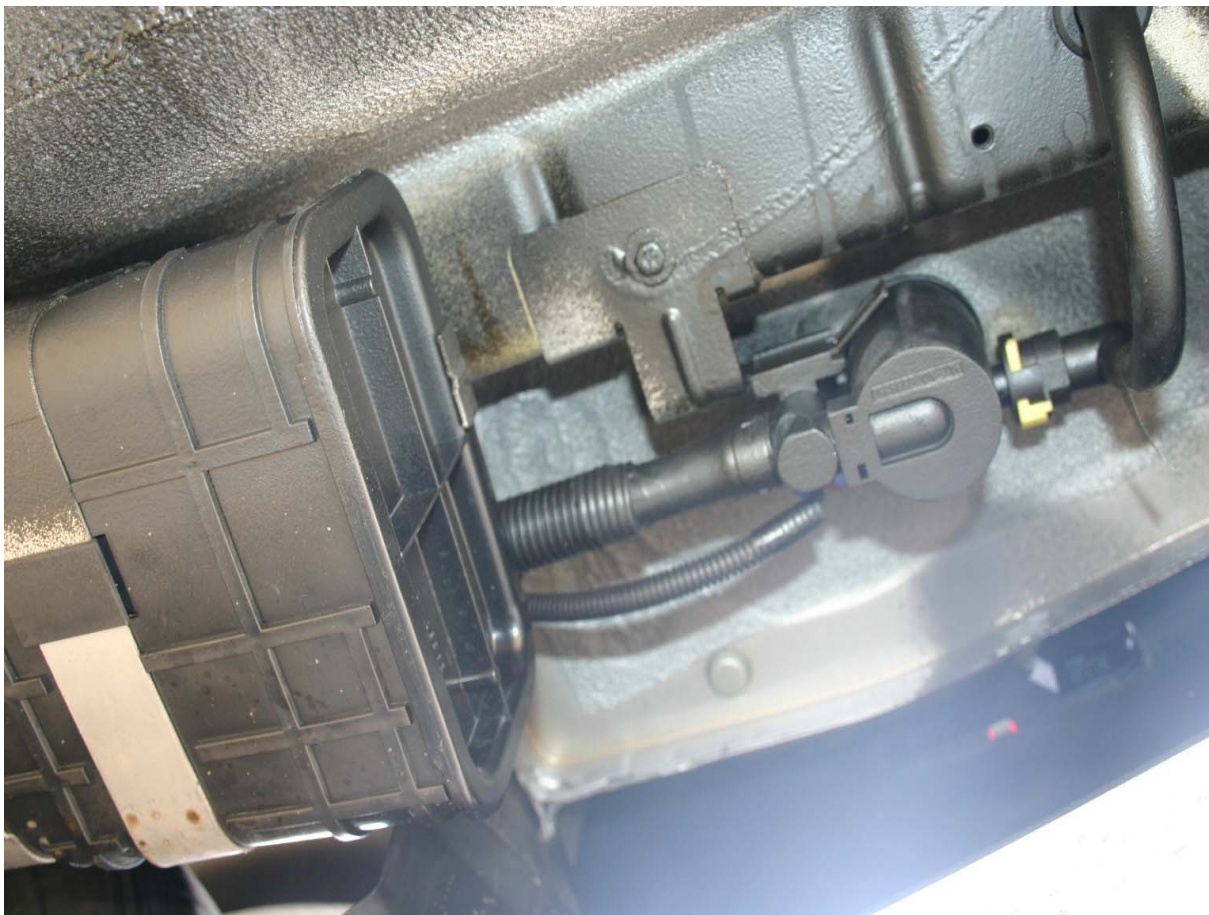
Fuel Leakage Location View #1
