**REPORT NUMBER TR-P26003-04-NC**

**NEW CAR ASSESSMENT PROGRAM  
SIDE IMPACT TEST**

**FORD MOTOR COMPANY  
2006 FORD FUSION  
4-DOOR SEDAN**

**NHTSA NUMBER: M60204**

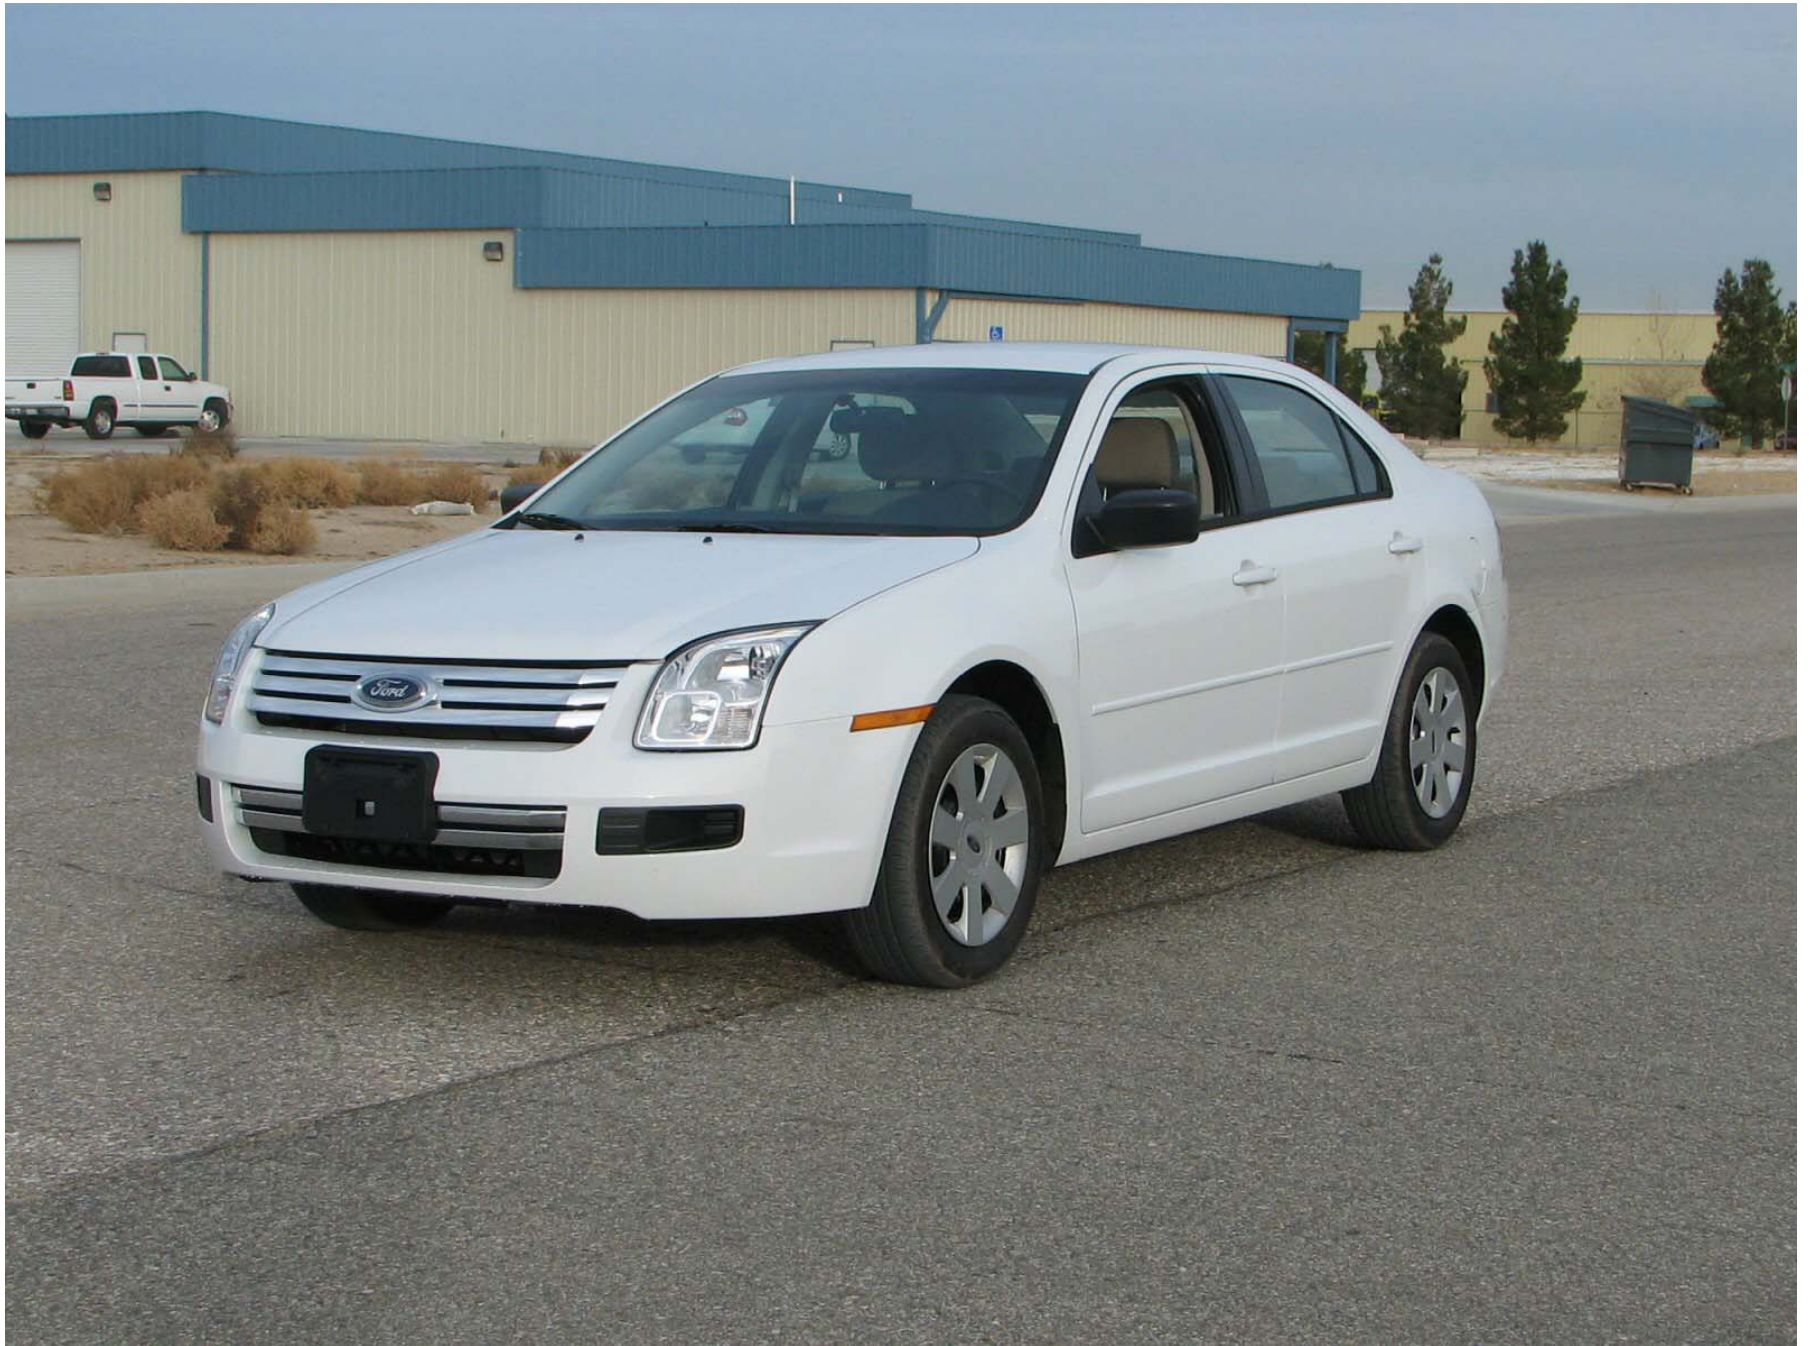
Figure A-1: Left Front  $\frac{3}{4}$  View, as Received

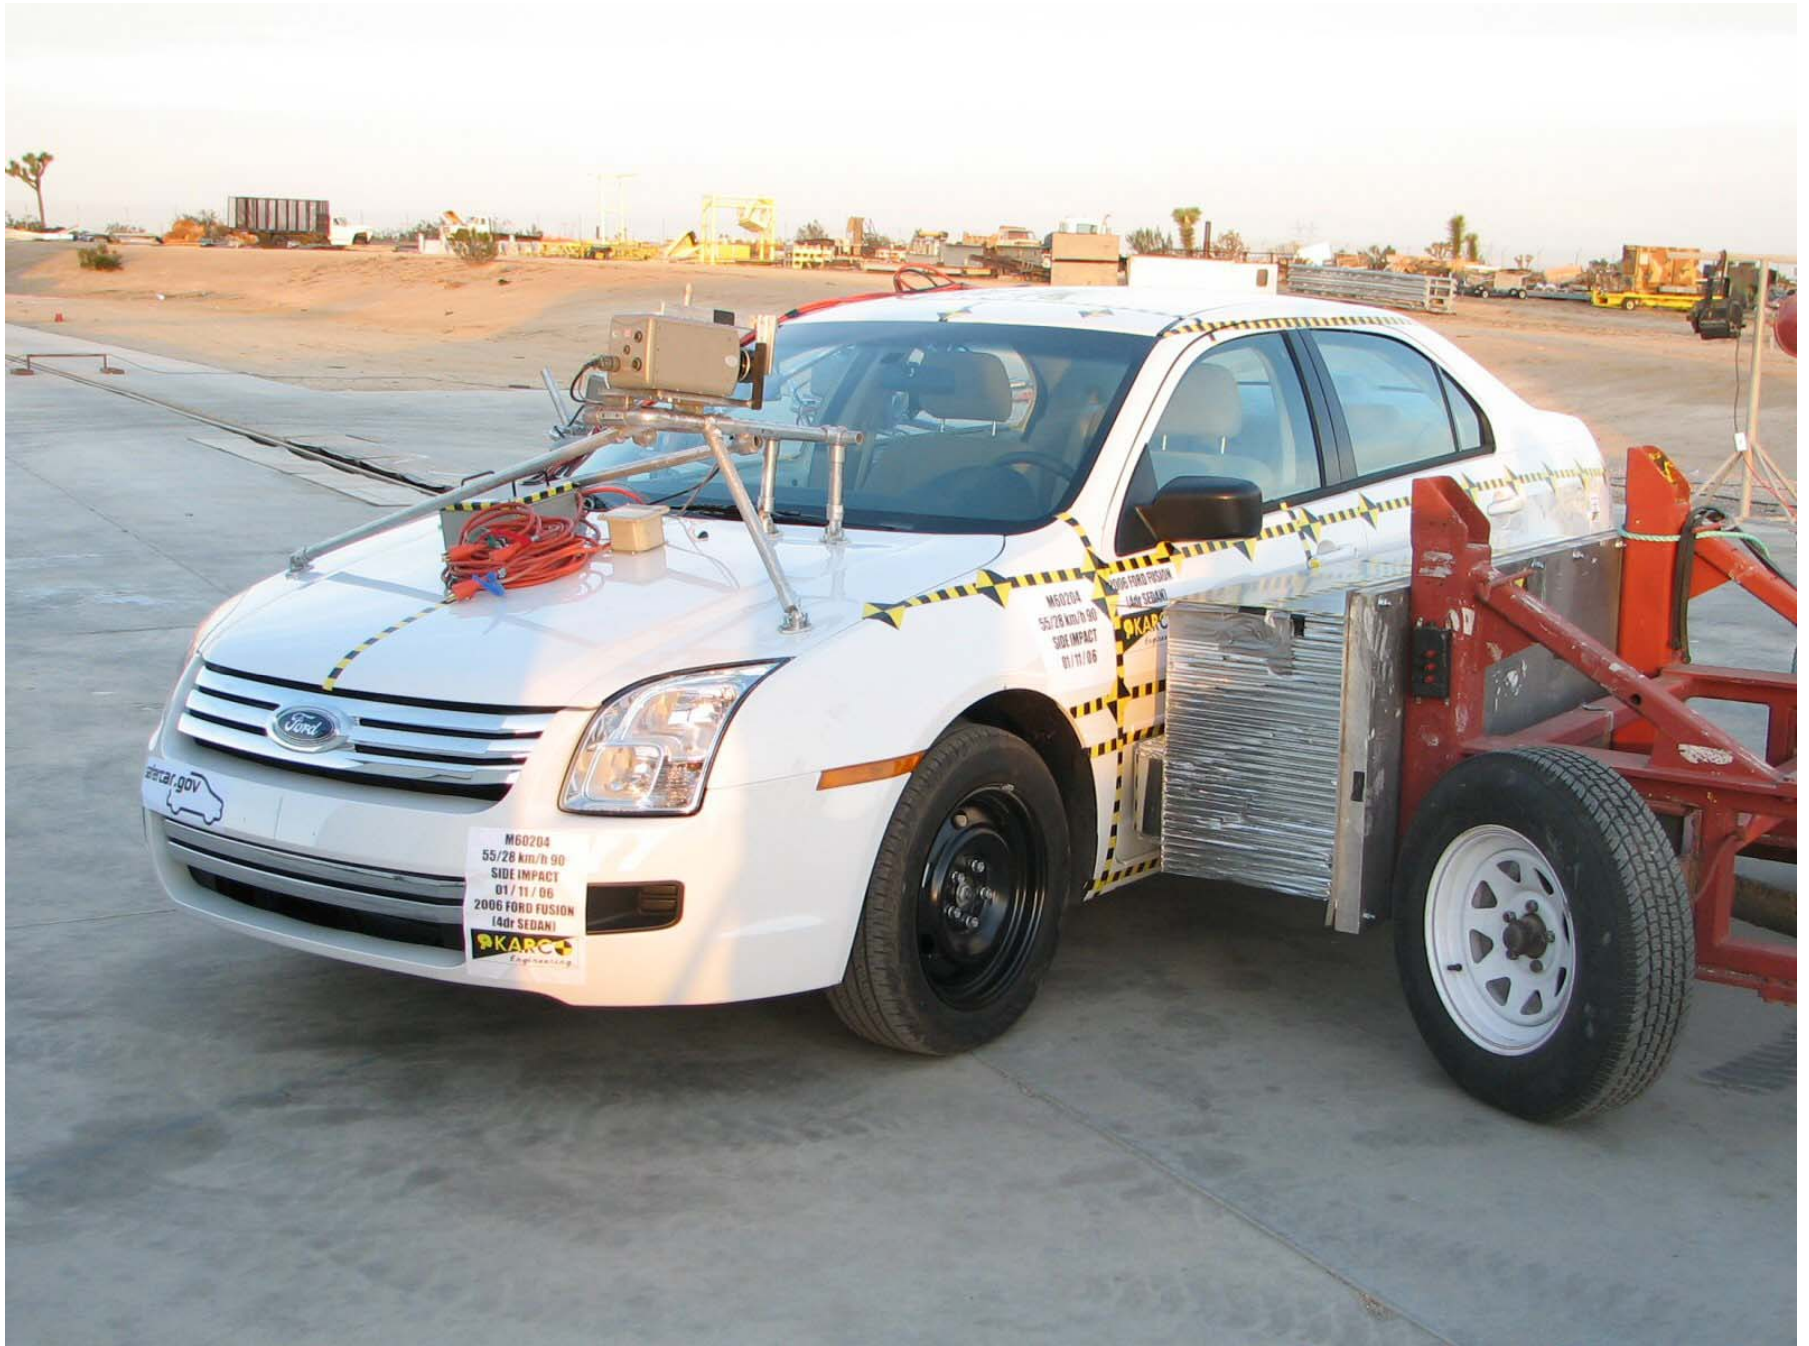
Figure A-7: Pre-Test Left Front ¾ View

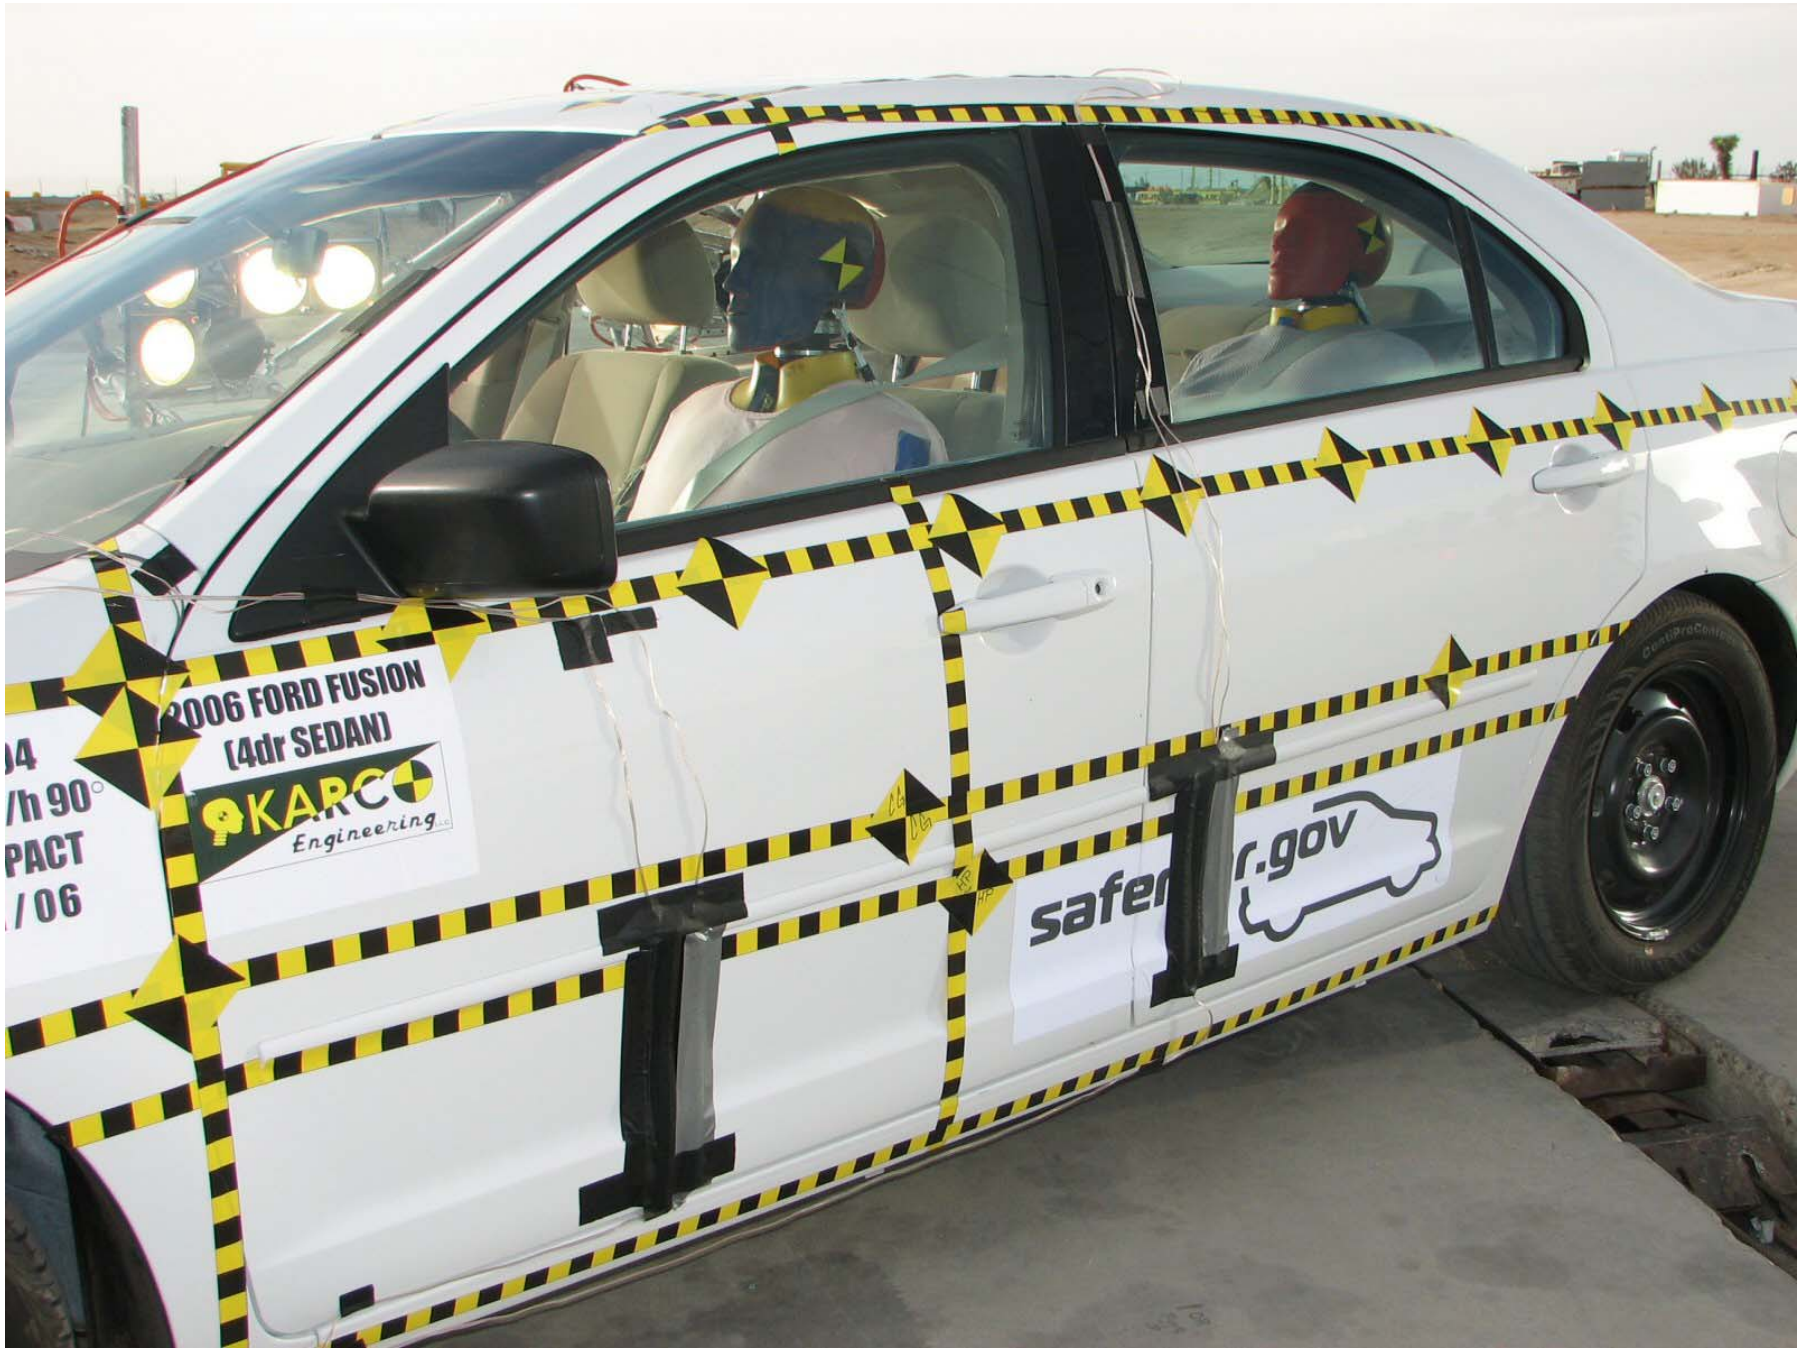
Figure A-26: Post-Test Left Impact Point

The driver and passenger doors remained closed during impact. The test vehicle sustained a maximum static crush of 307 mm at level 2, 1050 mm rearward of the left vertical impact point. The driver SID/Hybrid III, Serial No. 274 and the passenger SID/Hybrid III, Serial No. 275 were calibrated prior to this test. The SID/Hybrid III injury criteria is summarized as follows:

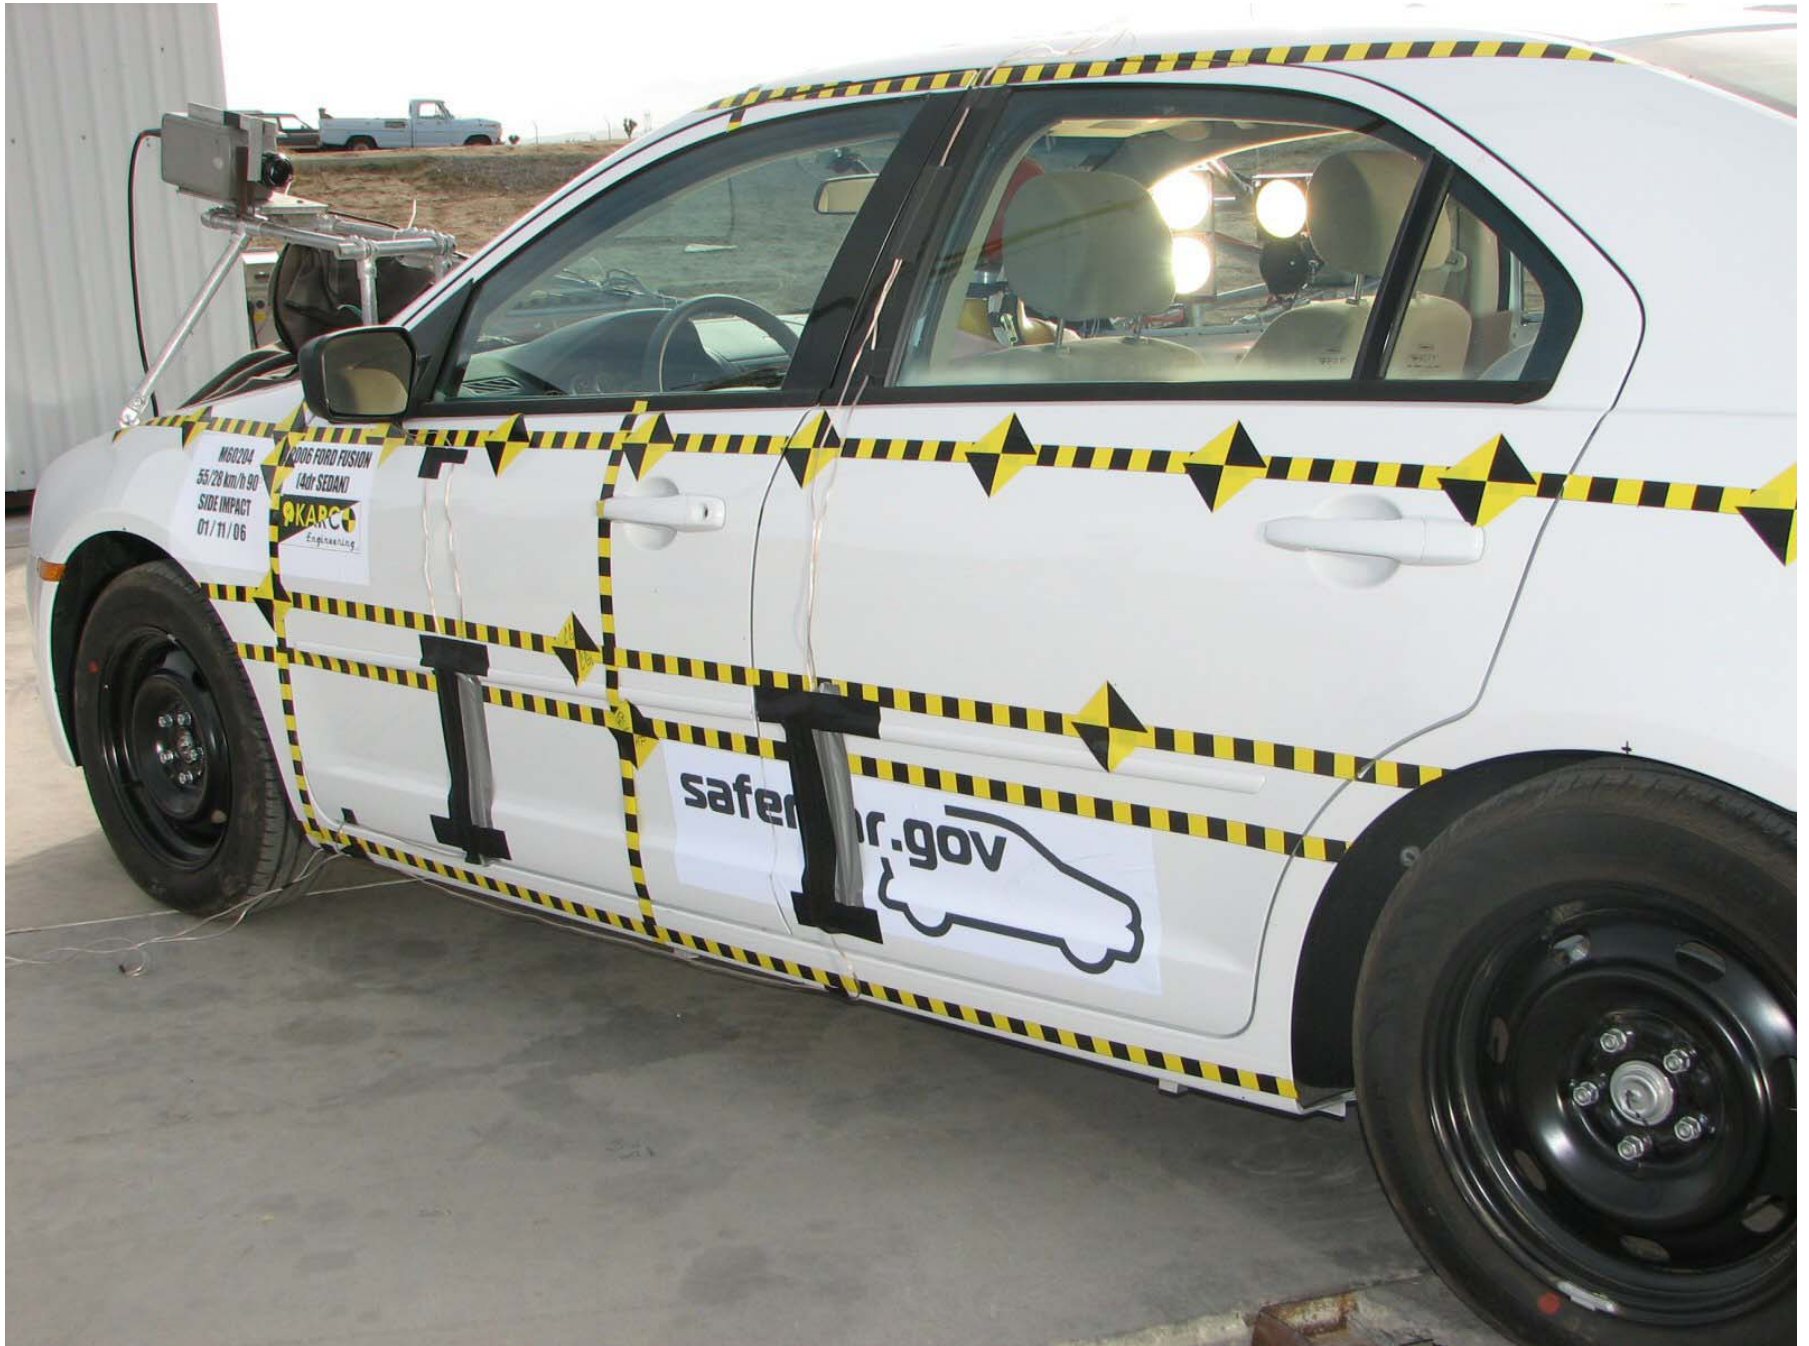
Figure A-28: Post-Test Front ¾ View of Left Side Doors

Description	Front	Rear
Left Side Door Opening	Door remained closed and latched, jammed	Door remained closed and latched, jammed
Right Side Door Opening	Remained closed and latched, operational	Remained closed and latched, operational
Seat Movement	None	None
Seat Back Failure	None	None

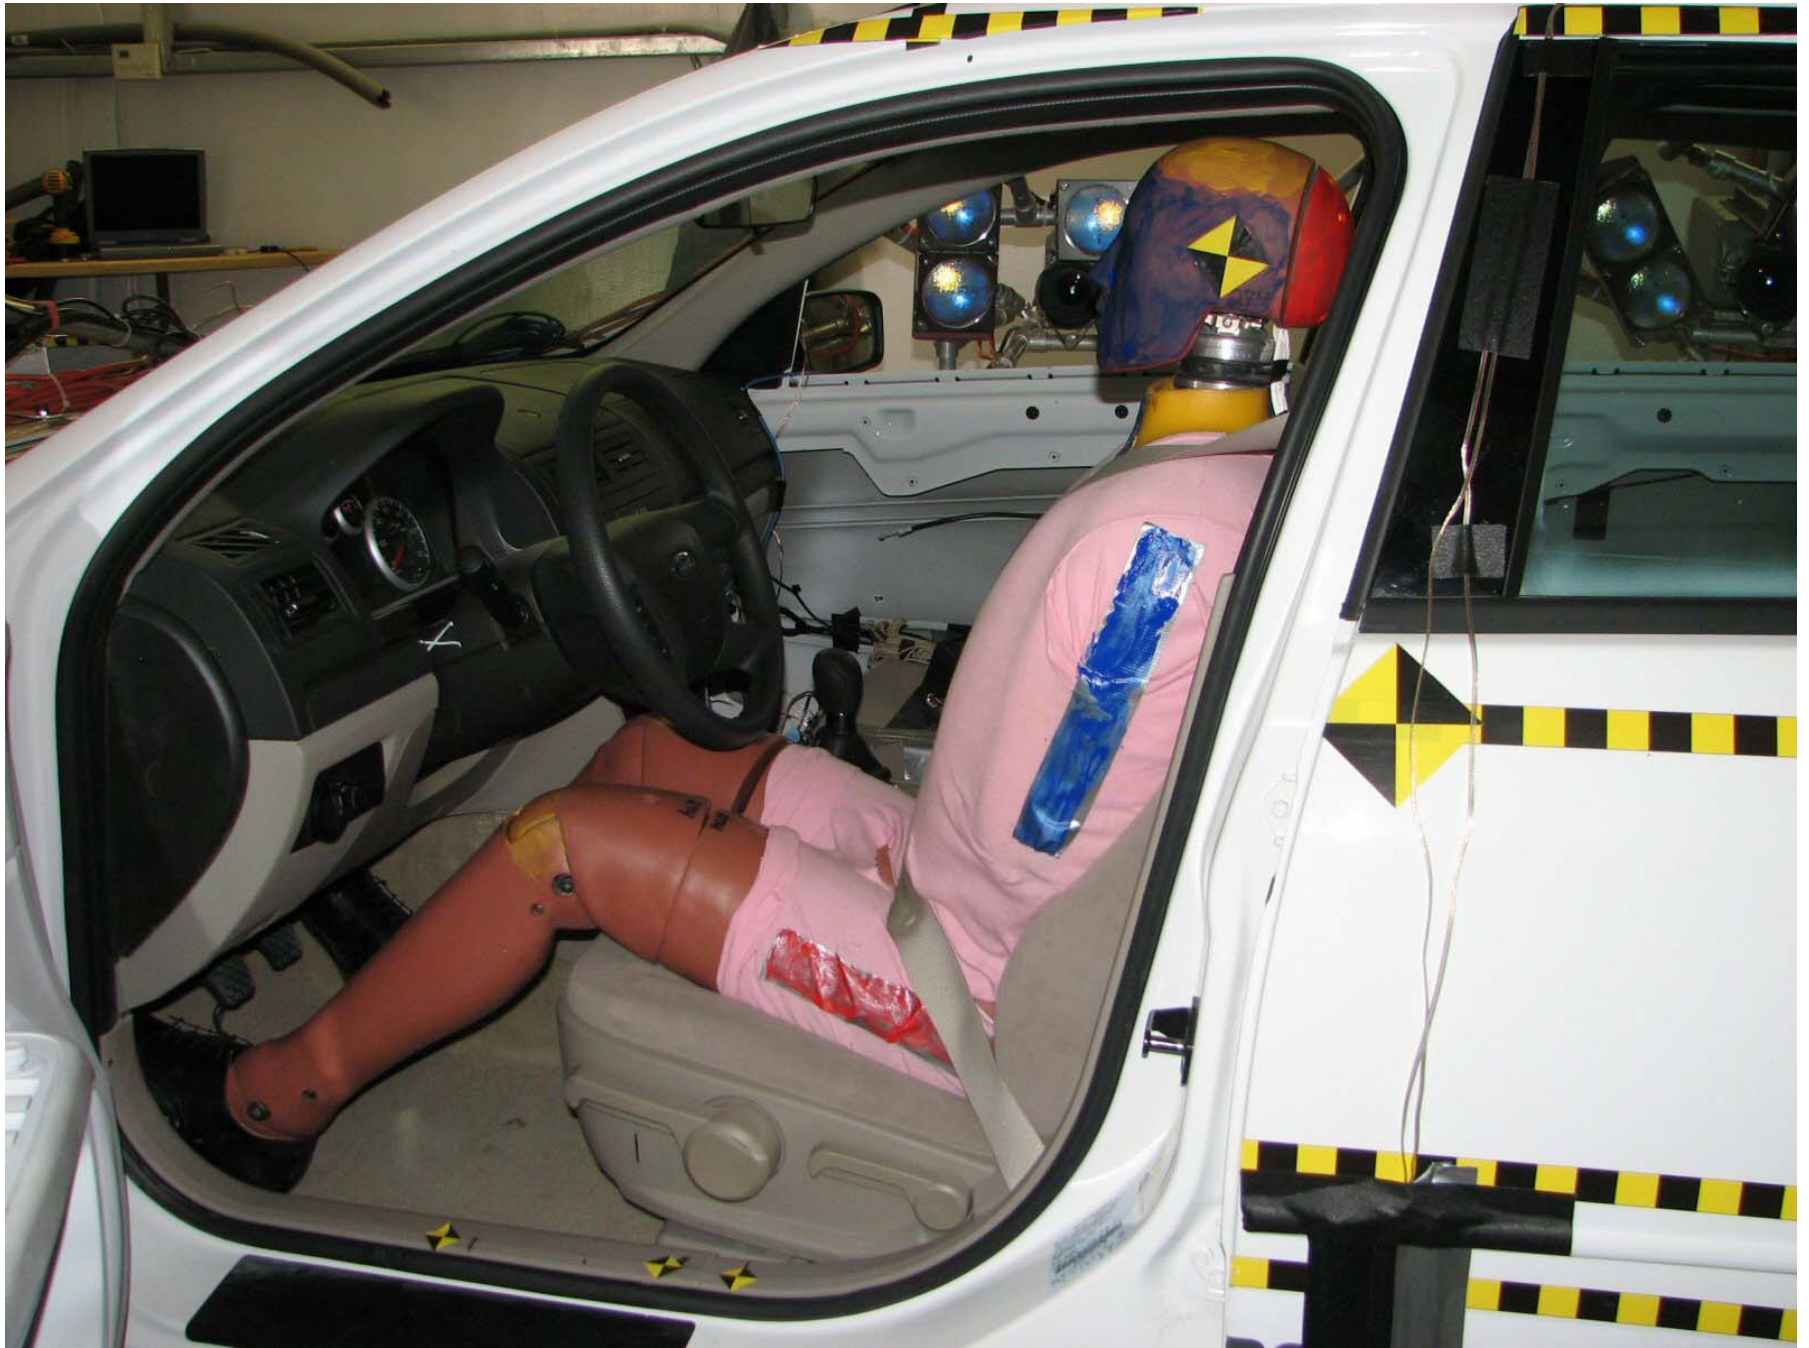
Figure A-34: Post-Test Left Rear Door

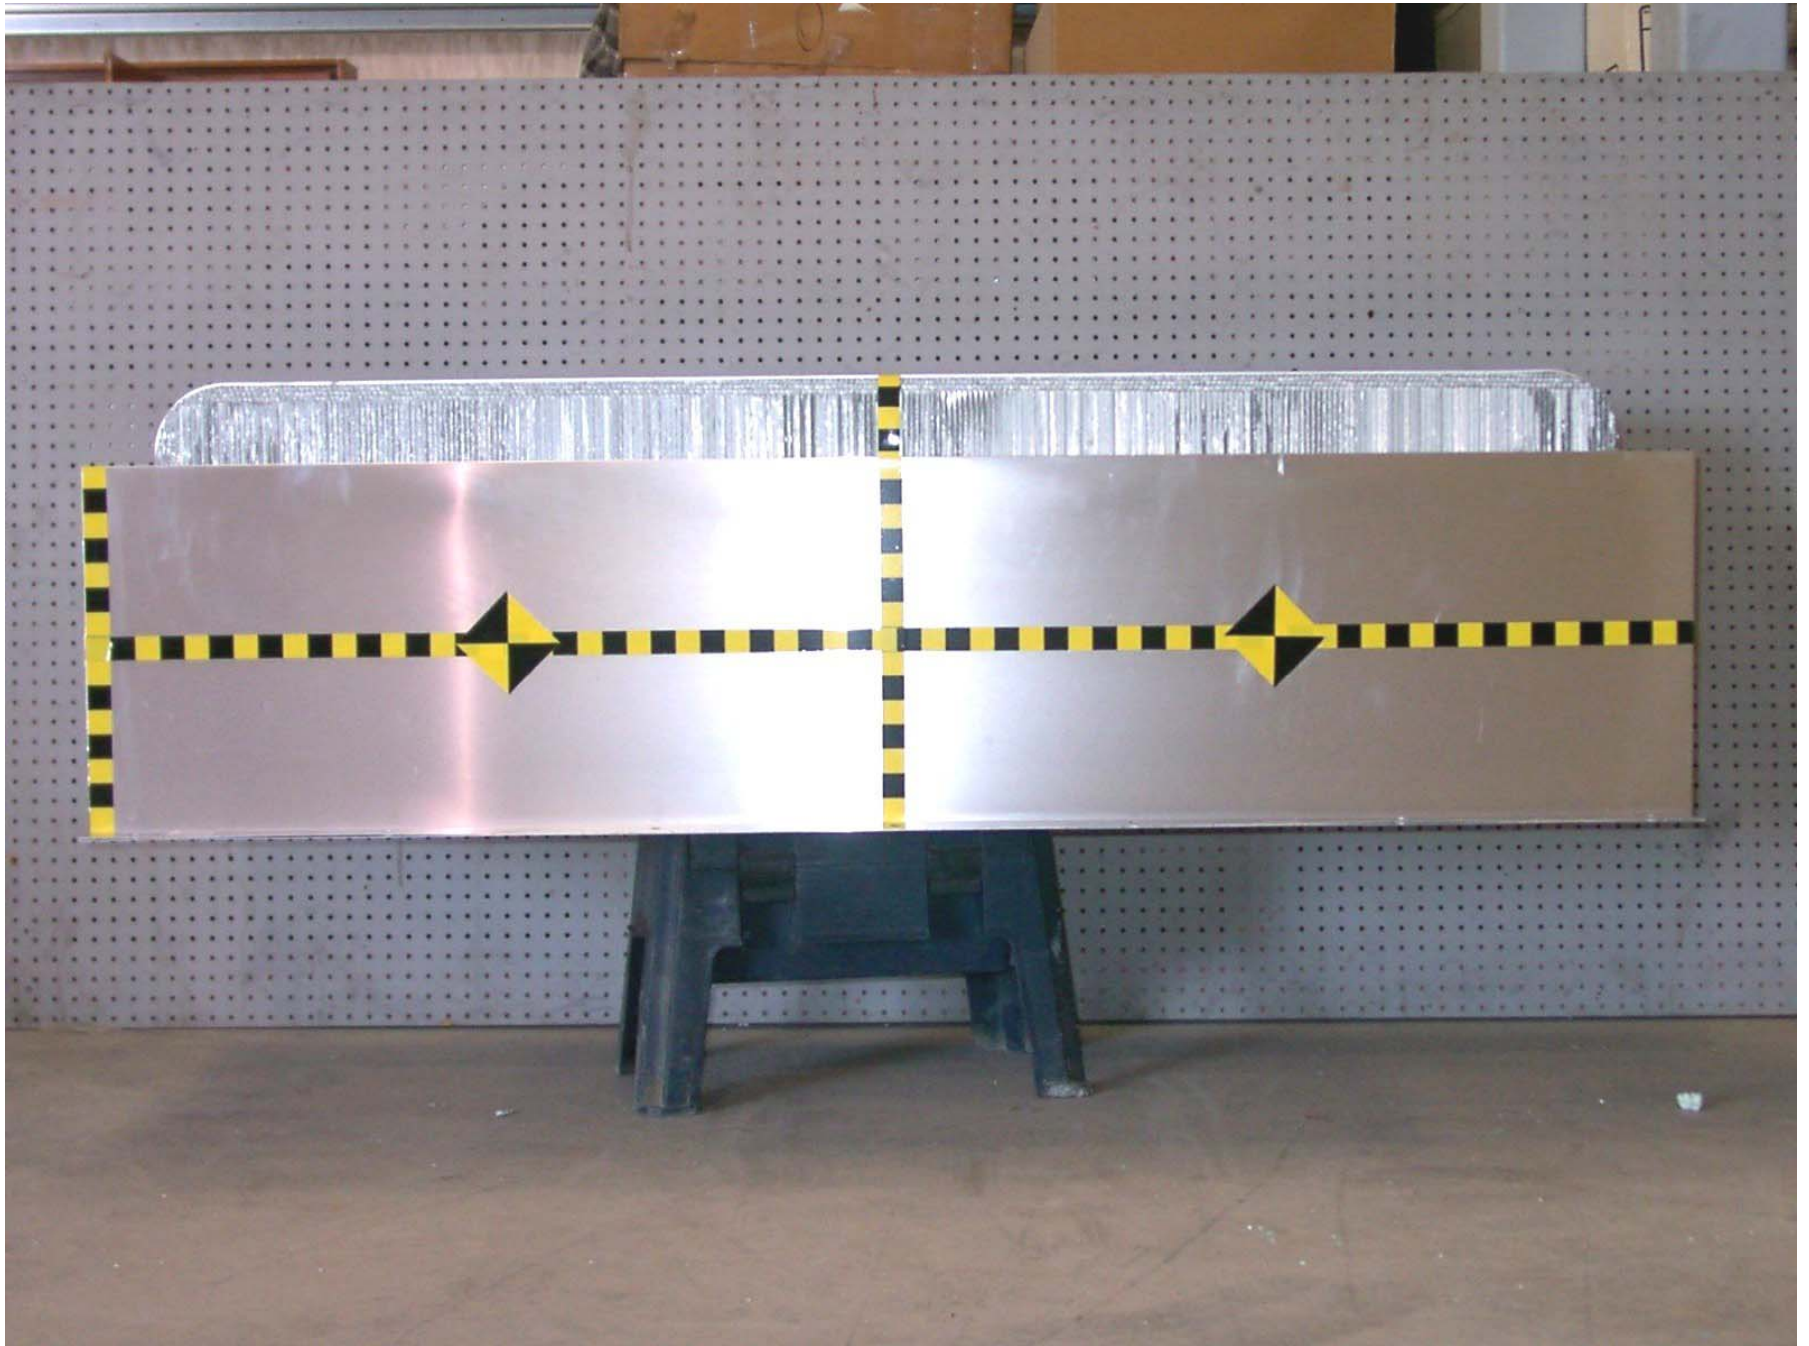
Figure A-54: Post-Test Front View of Deformable Barrier
