**REPORT NUMBER: NCAPSIDE-MGA-2006-007**

**NEW CAR ASSESSMENT PROGRAM  
SIDE IMPACT TEST**

**HYUNDAI MOTOR COMPANY  
2006 HYUNDAI ACCENT GLS  
NHTSA NUMBER: M60503**

**PREPARED BY:  
MGA RESEARCH CORPORATION  
5000 WARREN ROAD  
BURLINGTON, WI 53105**

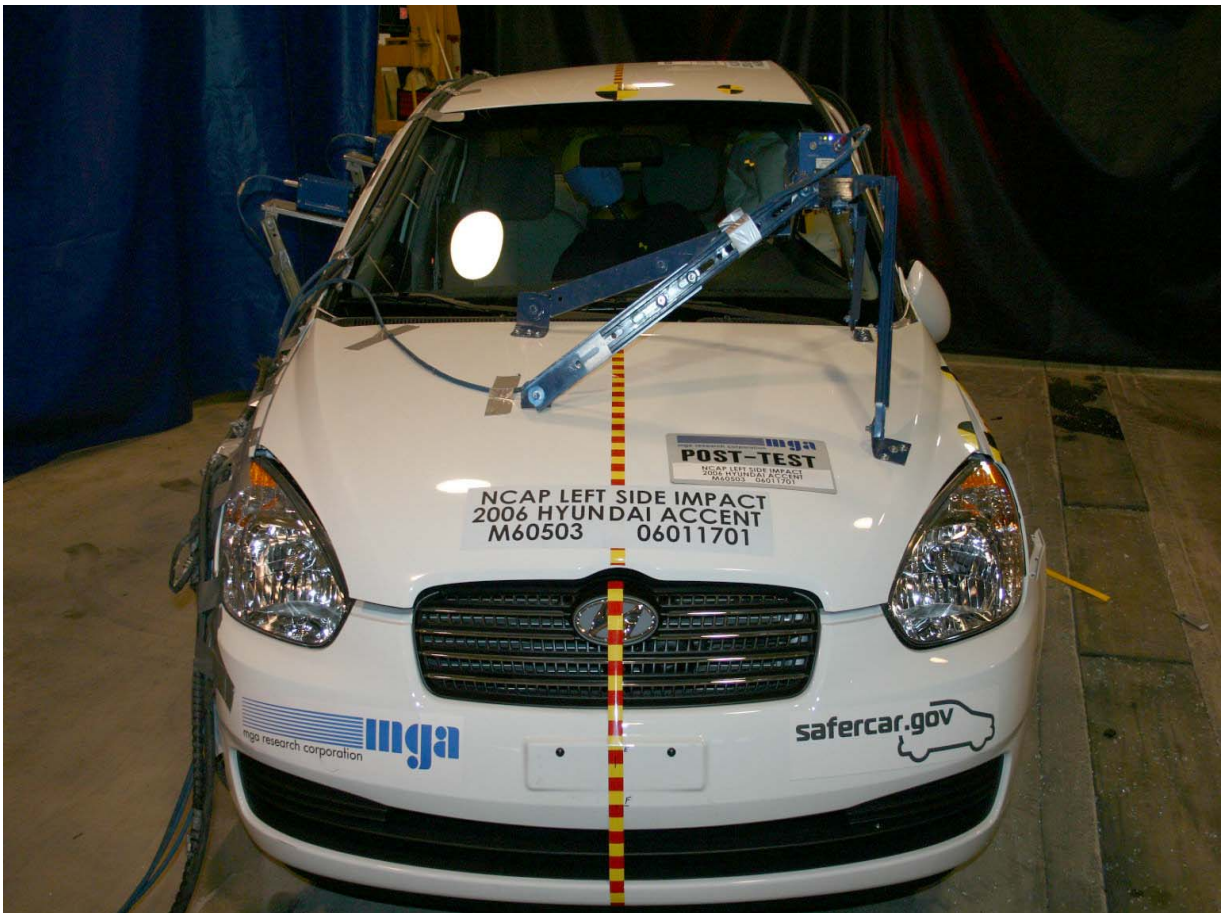
Post-Test Front View

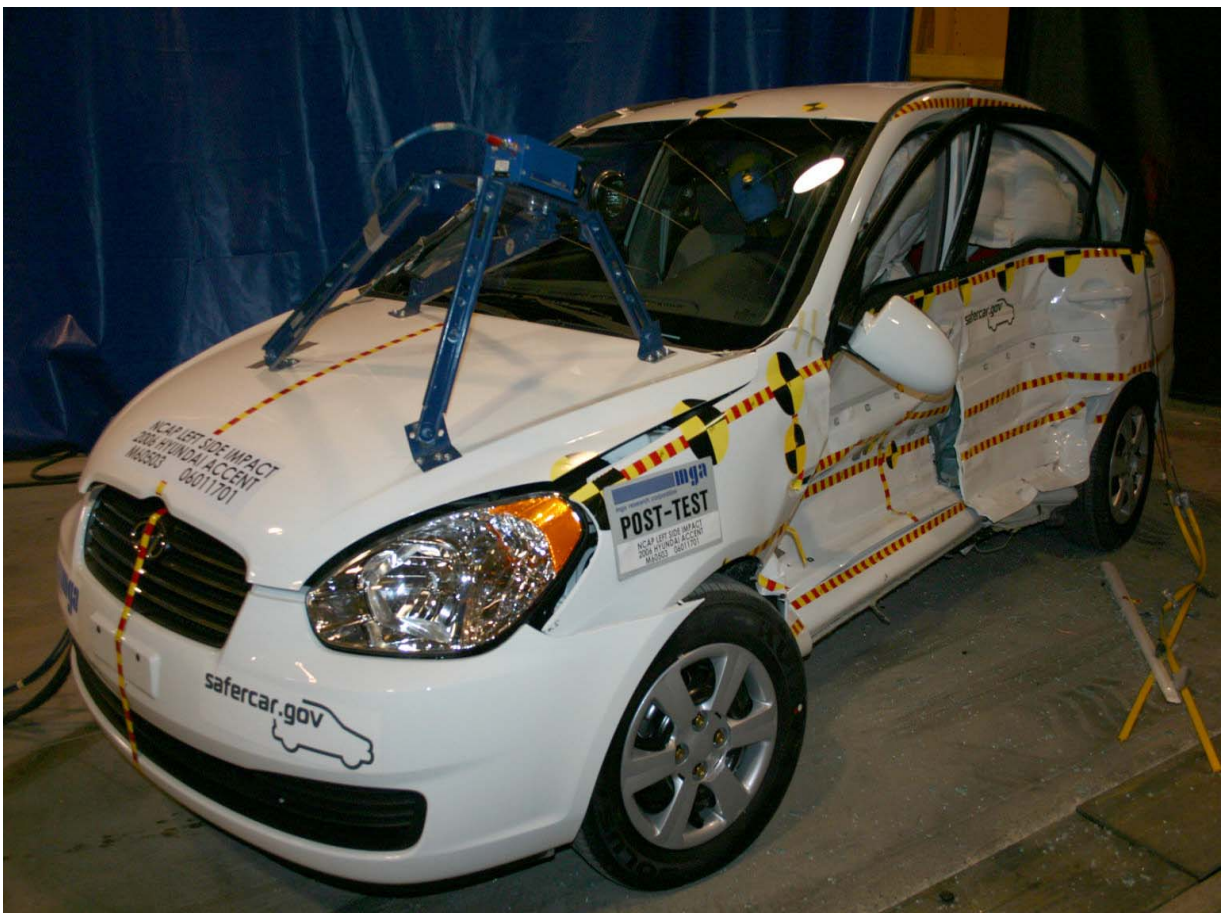
Post-Test Left Front  $\frac{3}{4}$  View

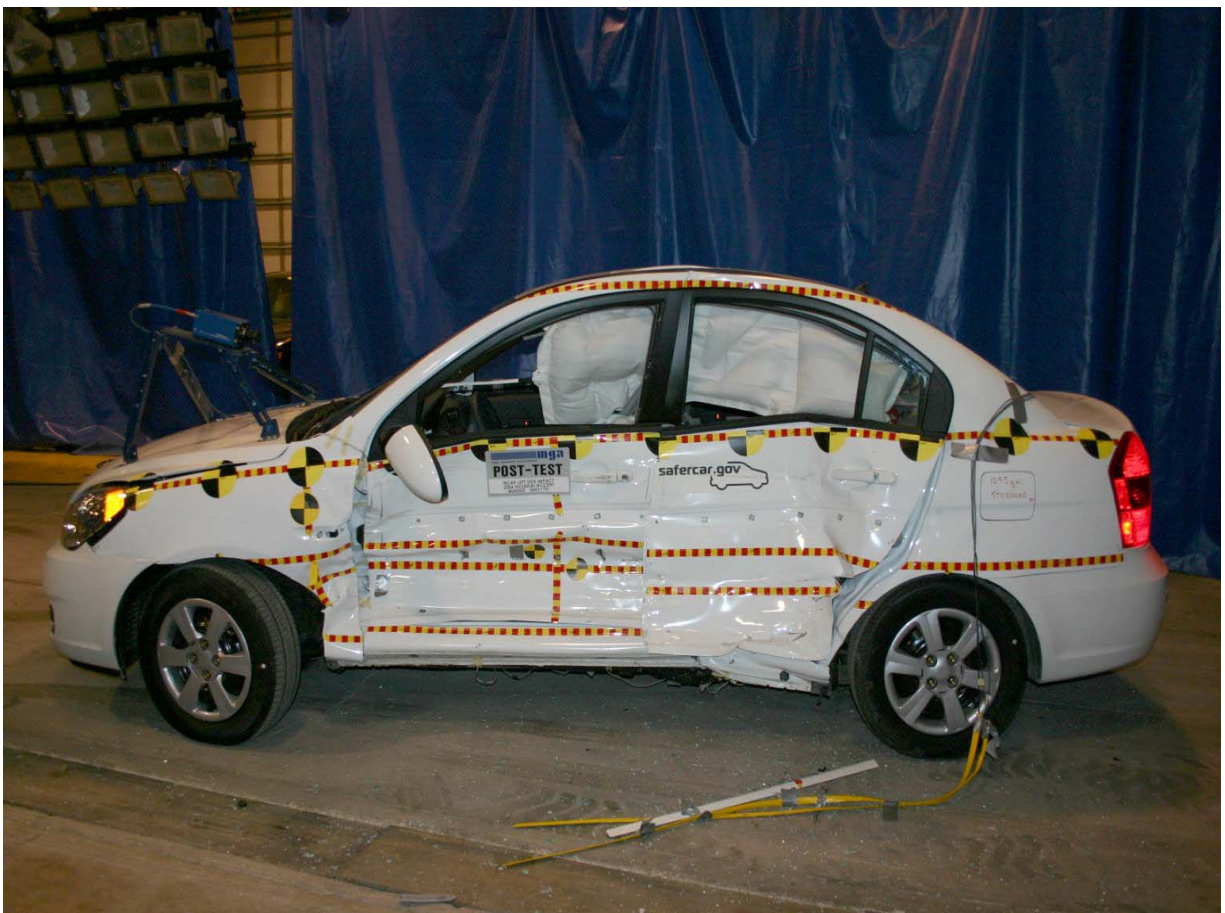
Post-Test Left Side View

| Critical Areas of Performance | Observations and Conclusions |
|---|---|
| Window Damage | Left Front Driver and Left Rear Passenger Window Broke |

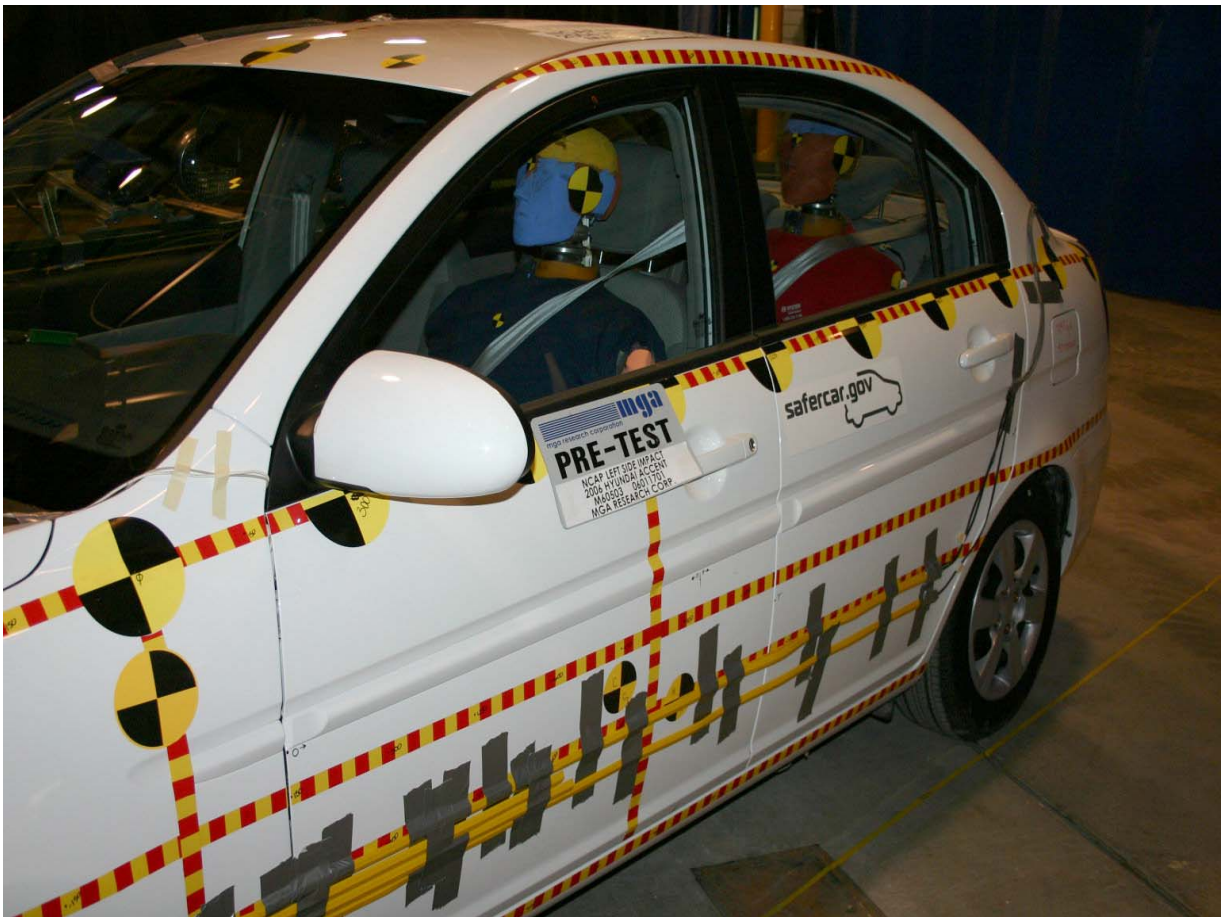
Pre-Test Front  $\frac{3}{4}$  View of Left Side Doors

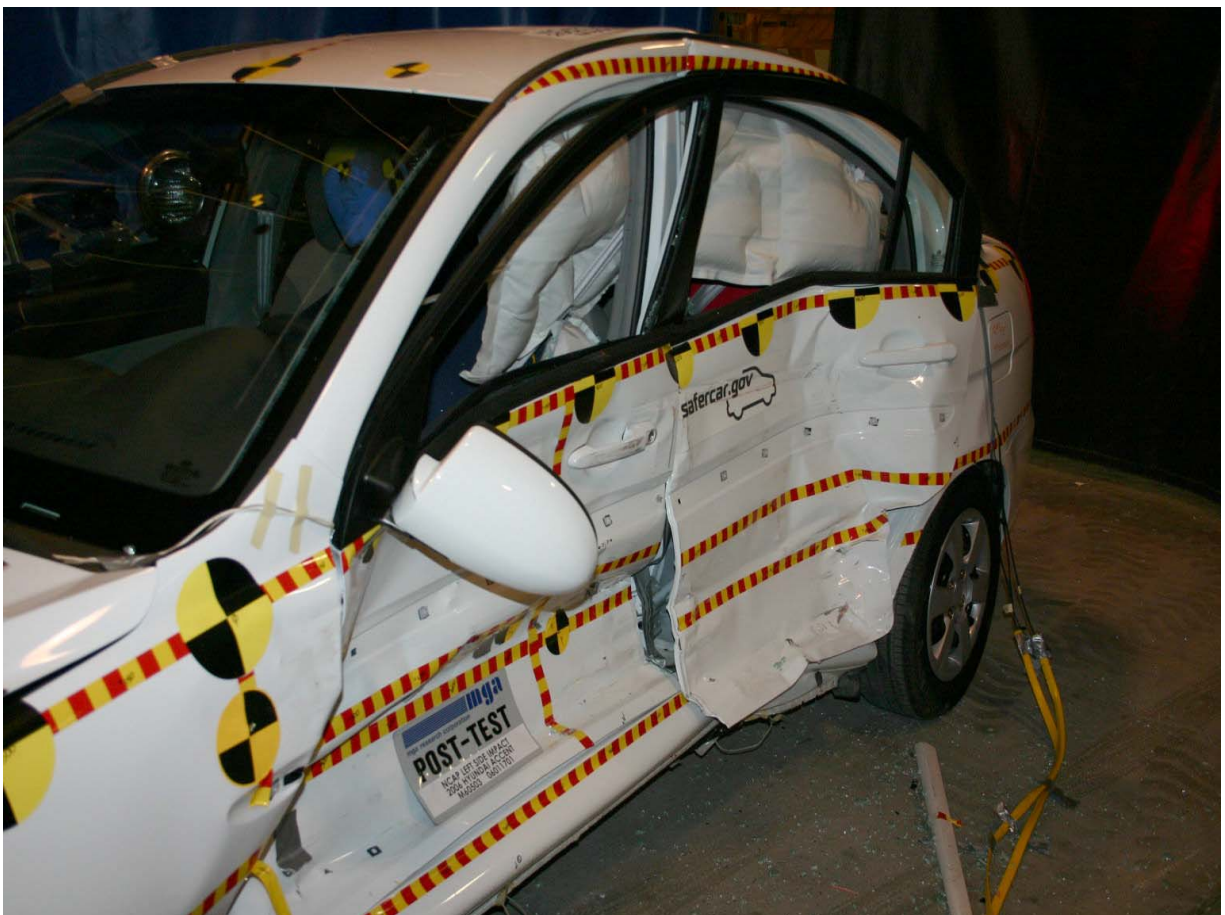
Post-Test Front  $\frac{3}{4}$  View of Left Side Doors

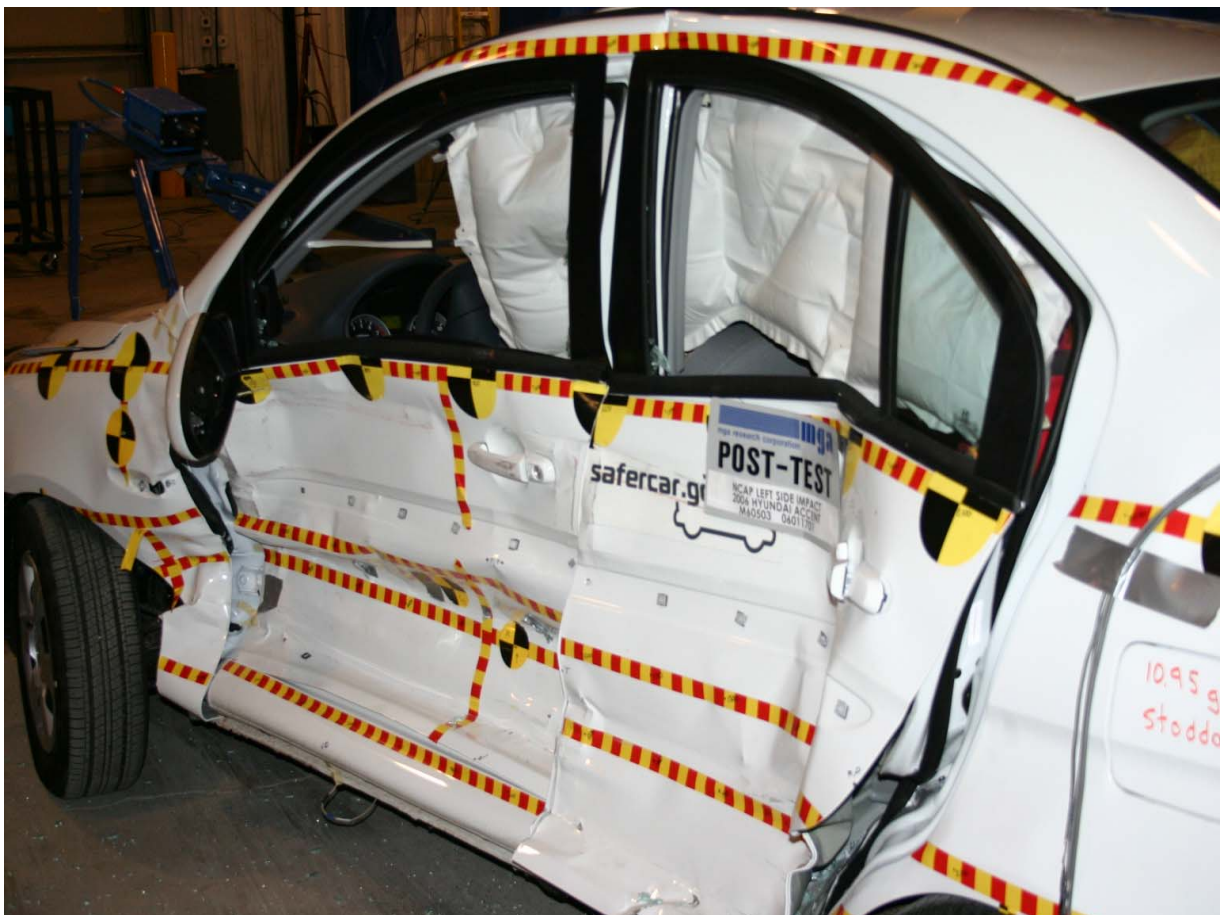
Post-Test Rear  $\frac{3}{4}$  View of Left Side Doors

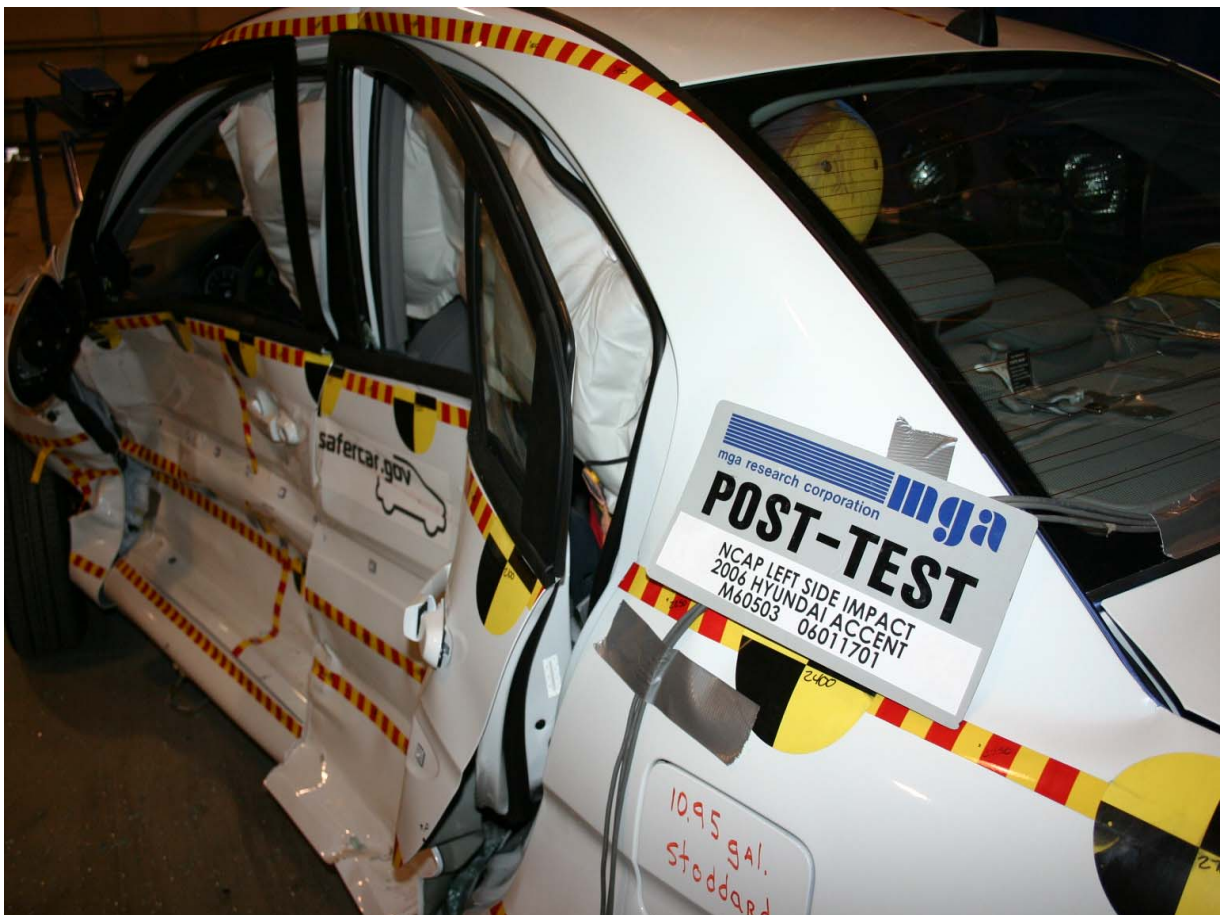
Post-Test Left Rear Door
