**NEW CAR ASSESSMENT PROGRAM  
FRONTAL BARRIER IMPACT TEST**

**TOYOTA MOTOR CORPORATION  
2006 LEXUS ES330  
4-DOOR SEDAN**

**NHTSA NUMBER: M65101**

**FINAL REPORT**

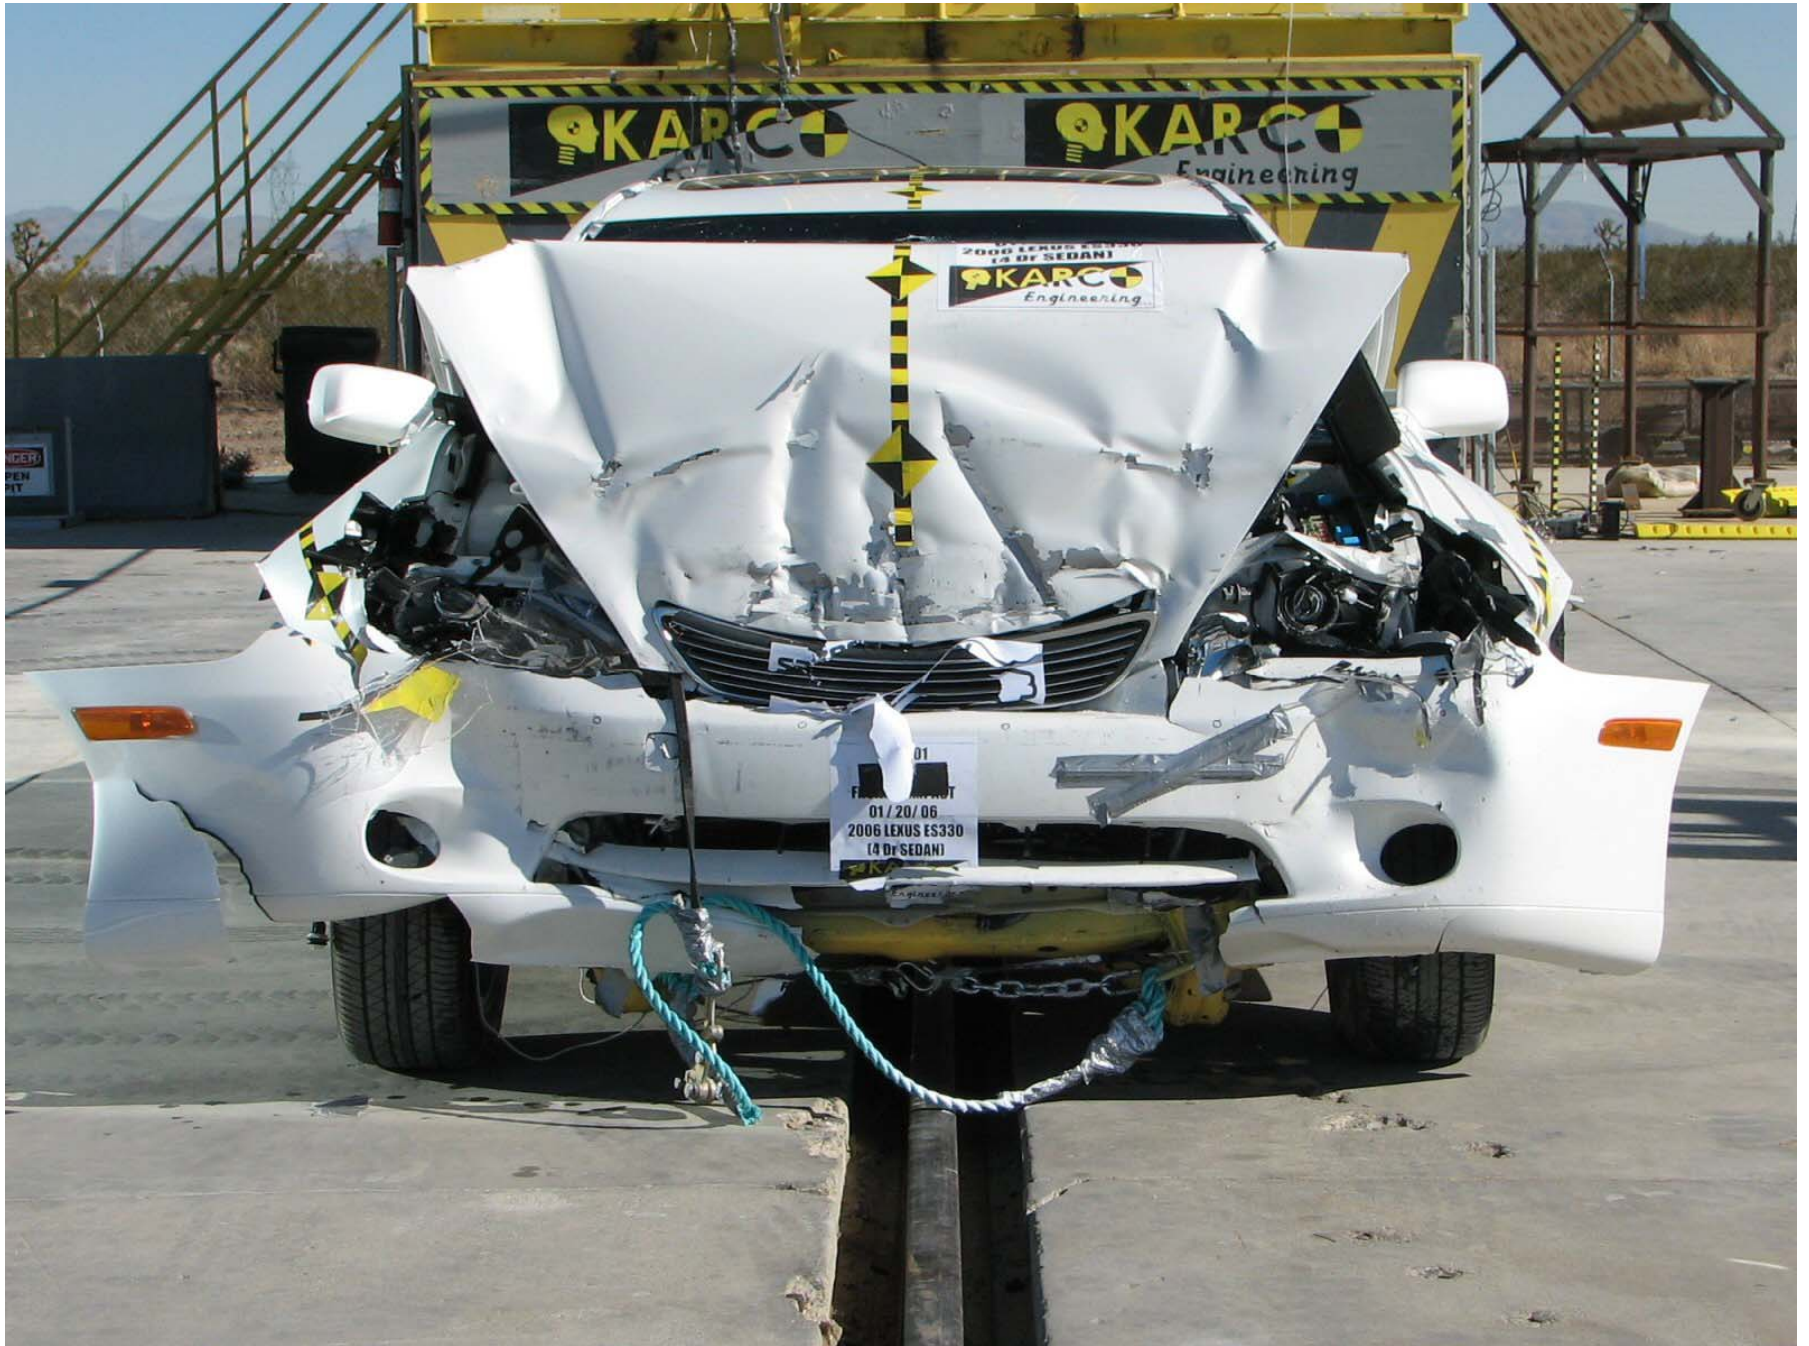
Figure A-7: Post-Test Front View (Vehicle Moved)

The maximum static crush of the vehicle was 525 mm at the vehicle's centerline and both the driver and the passenger side doors remained closed and latched during the impact event and were operable after the impact.

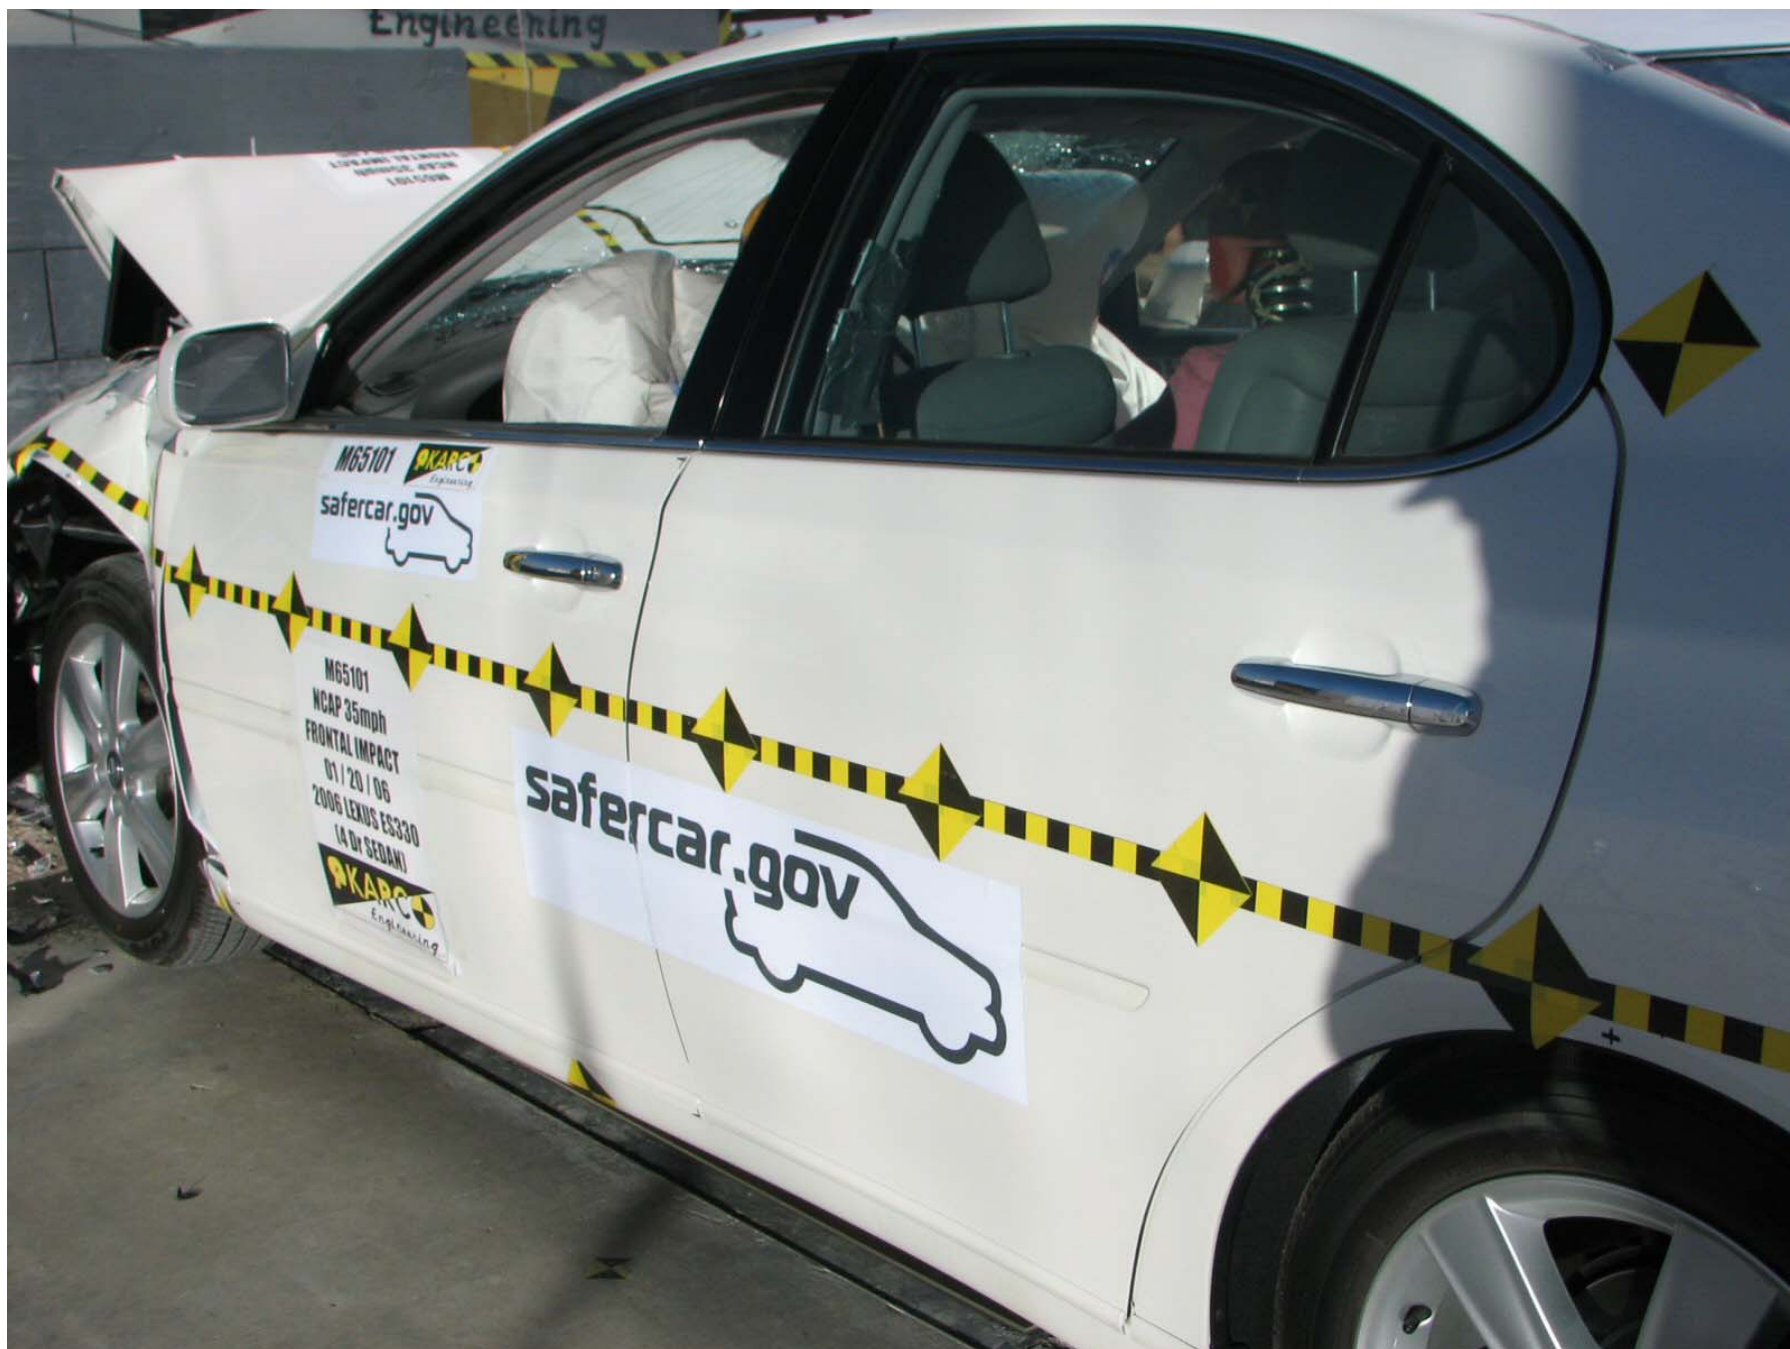
Figure A-16: Post-Test Left Side  $\frac{3}{4}$  View of Doors After Impact

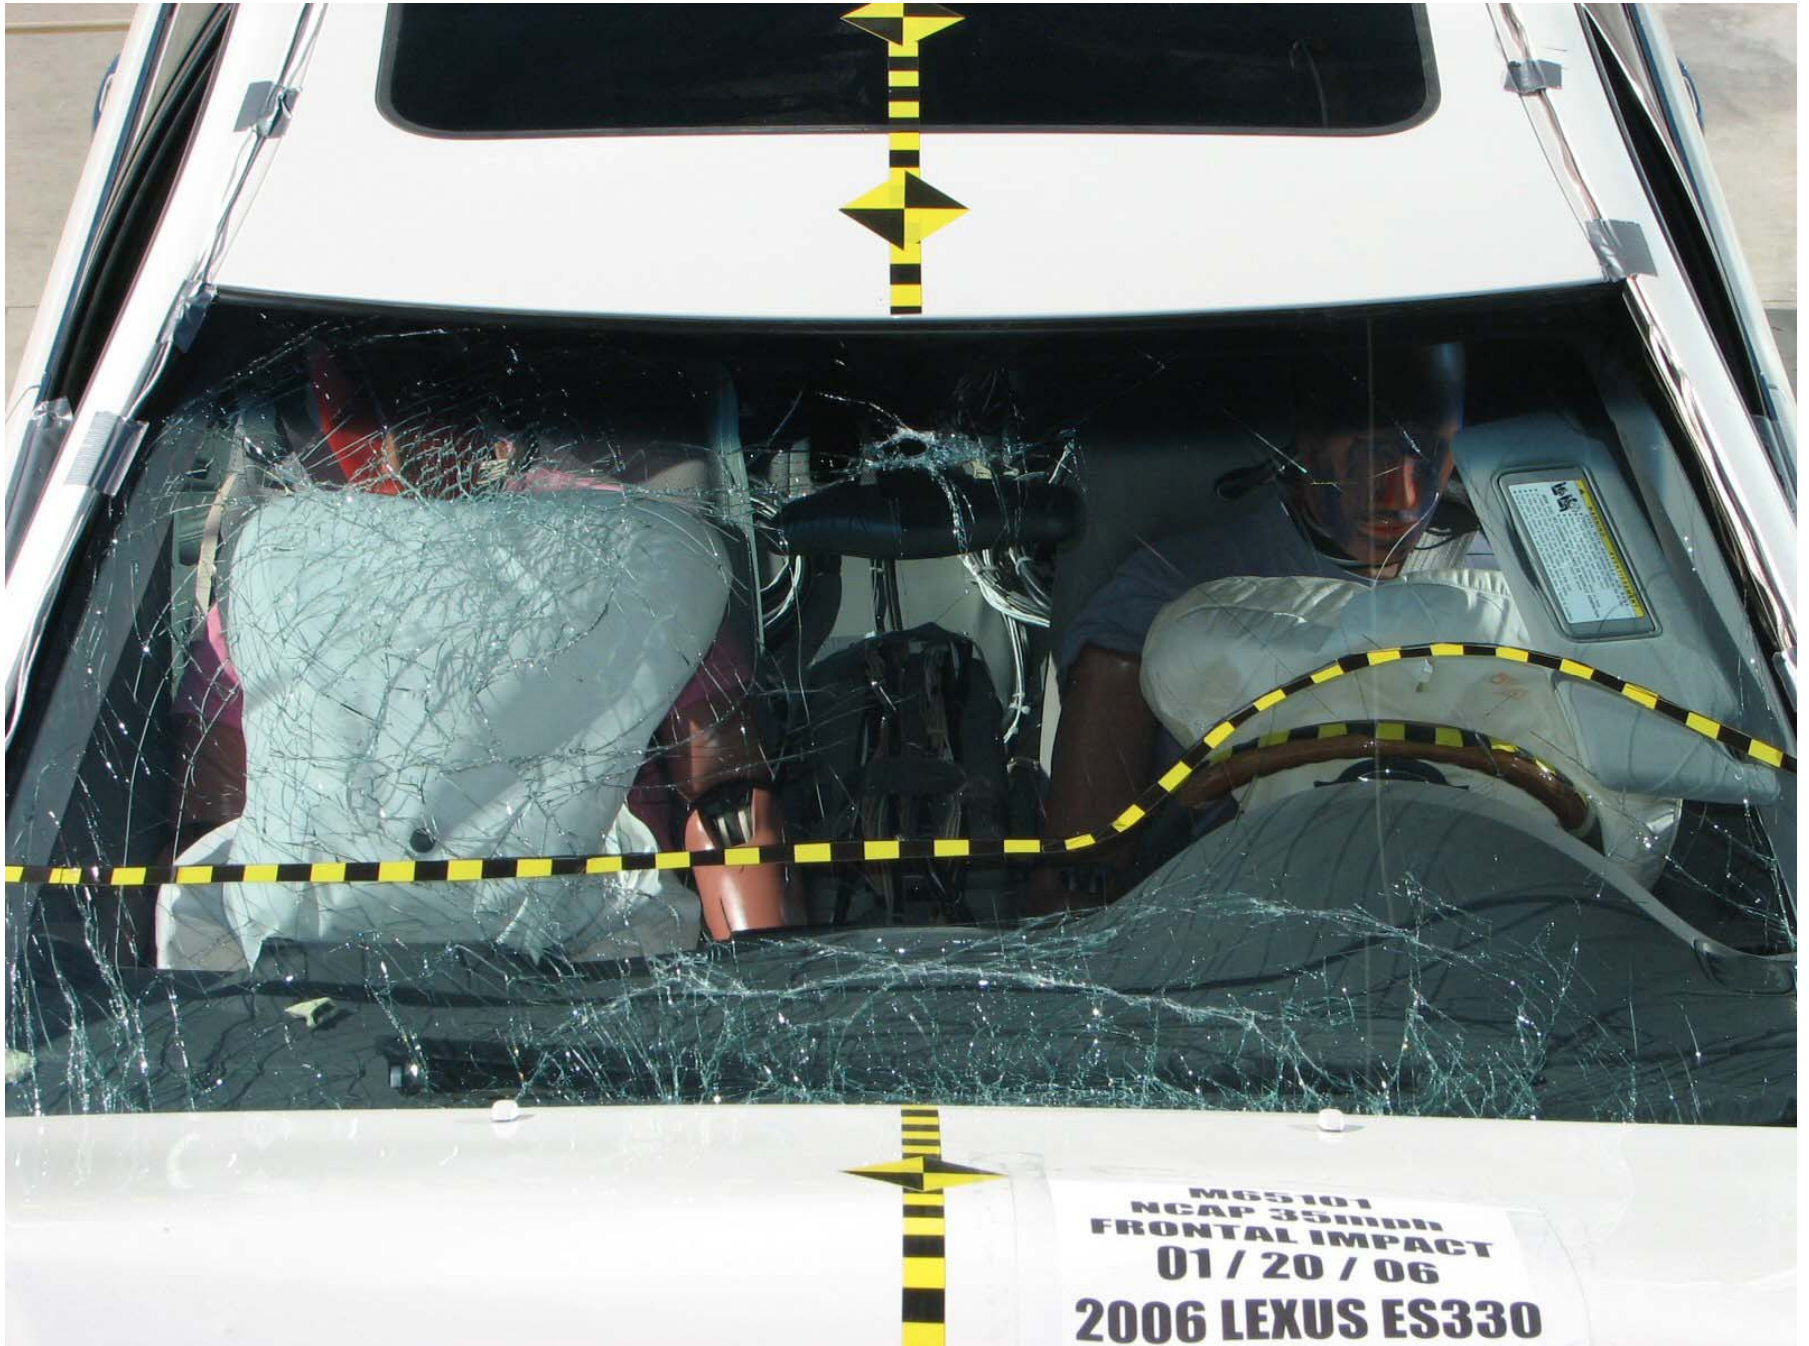
Figure A-19: Post-Test Windshield

There was 100 percent windshield retention and there was intrusion into the protected zone of the windshield during the impact event. There was no stoddard solvent leakage after the event or during any phase of the static rollover.

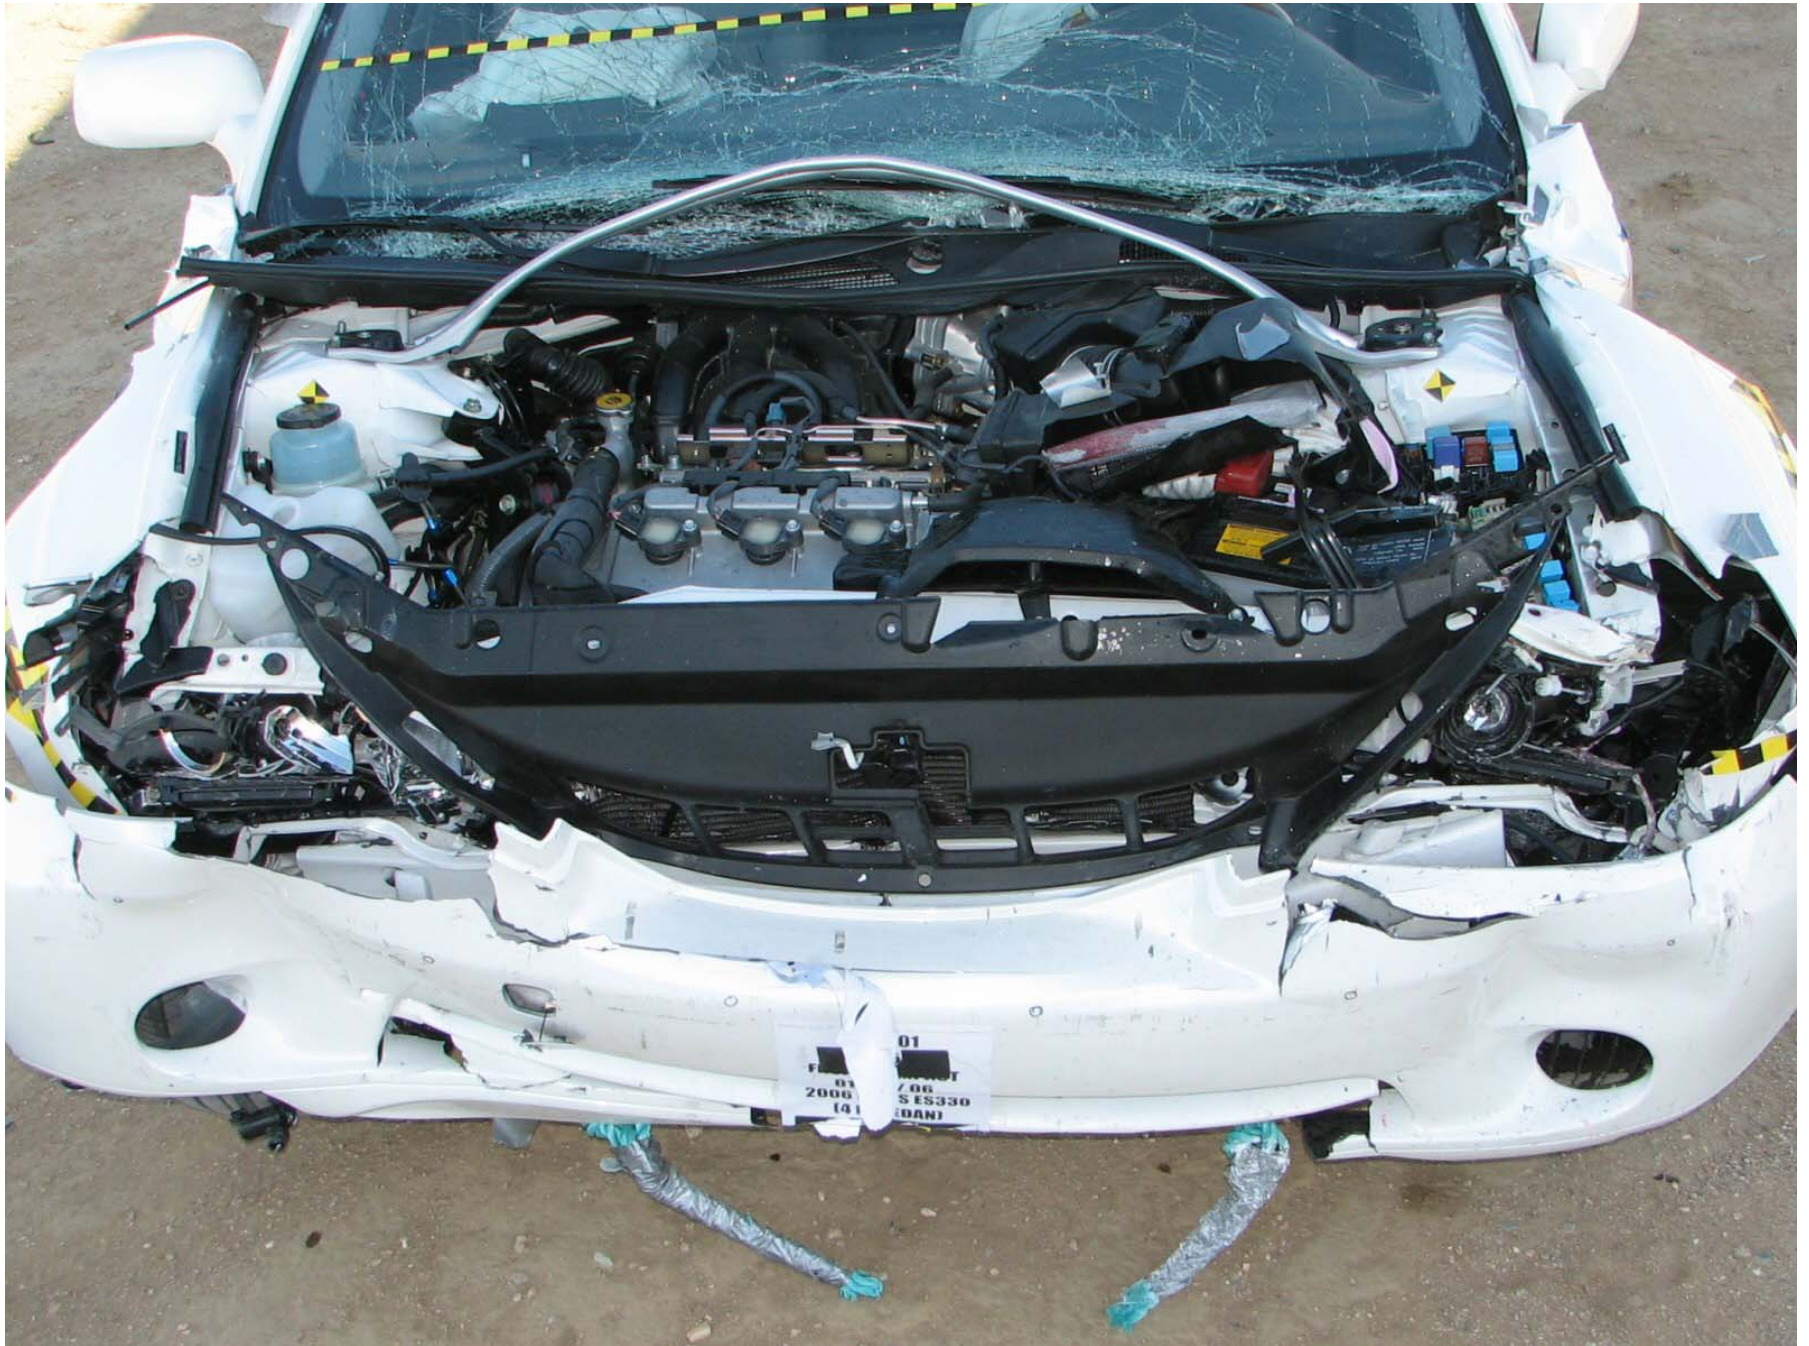
Figure A-21: Post-Test Engine Compartment (Vehicle Moved)

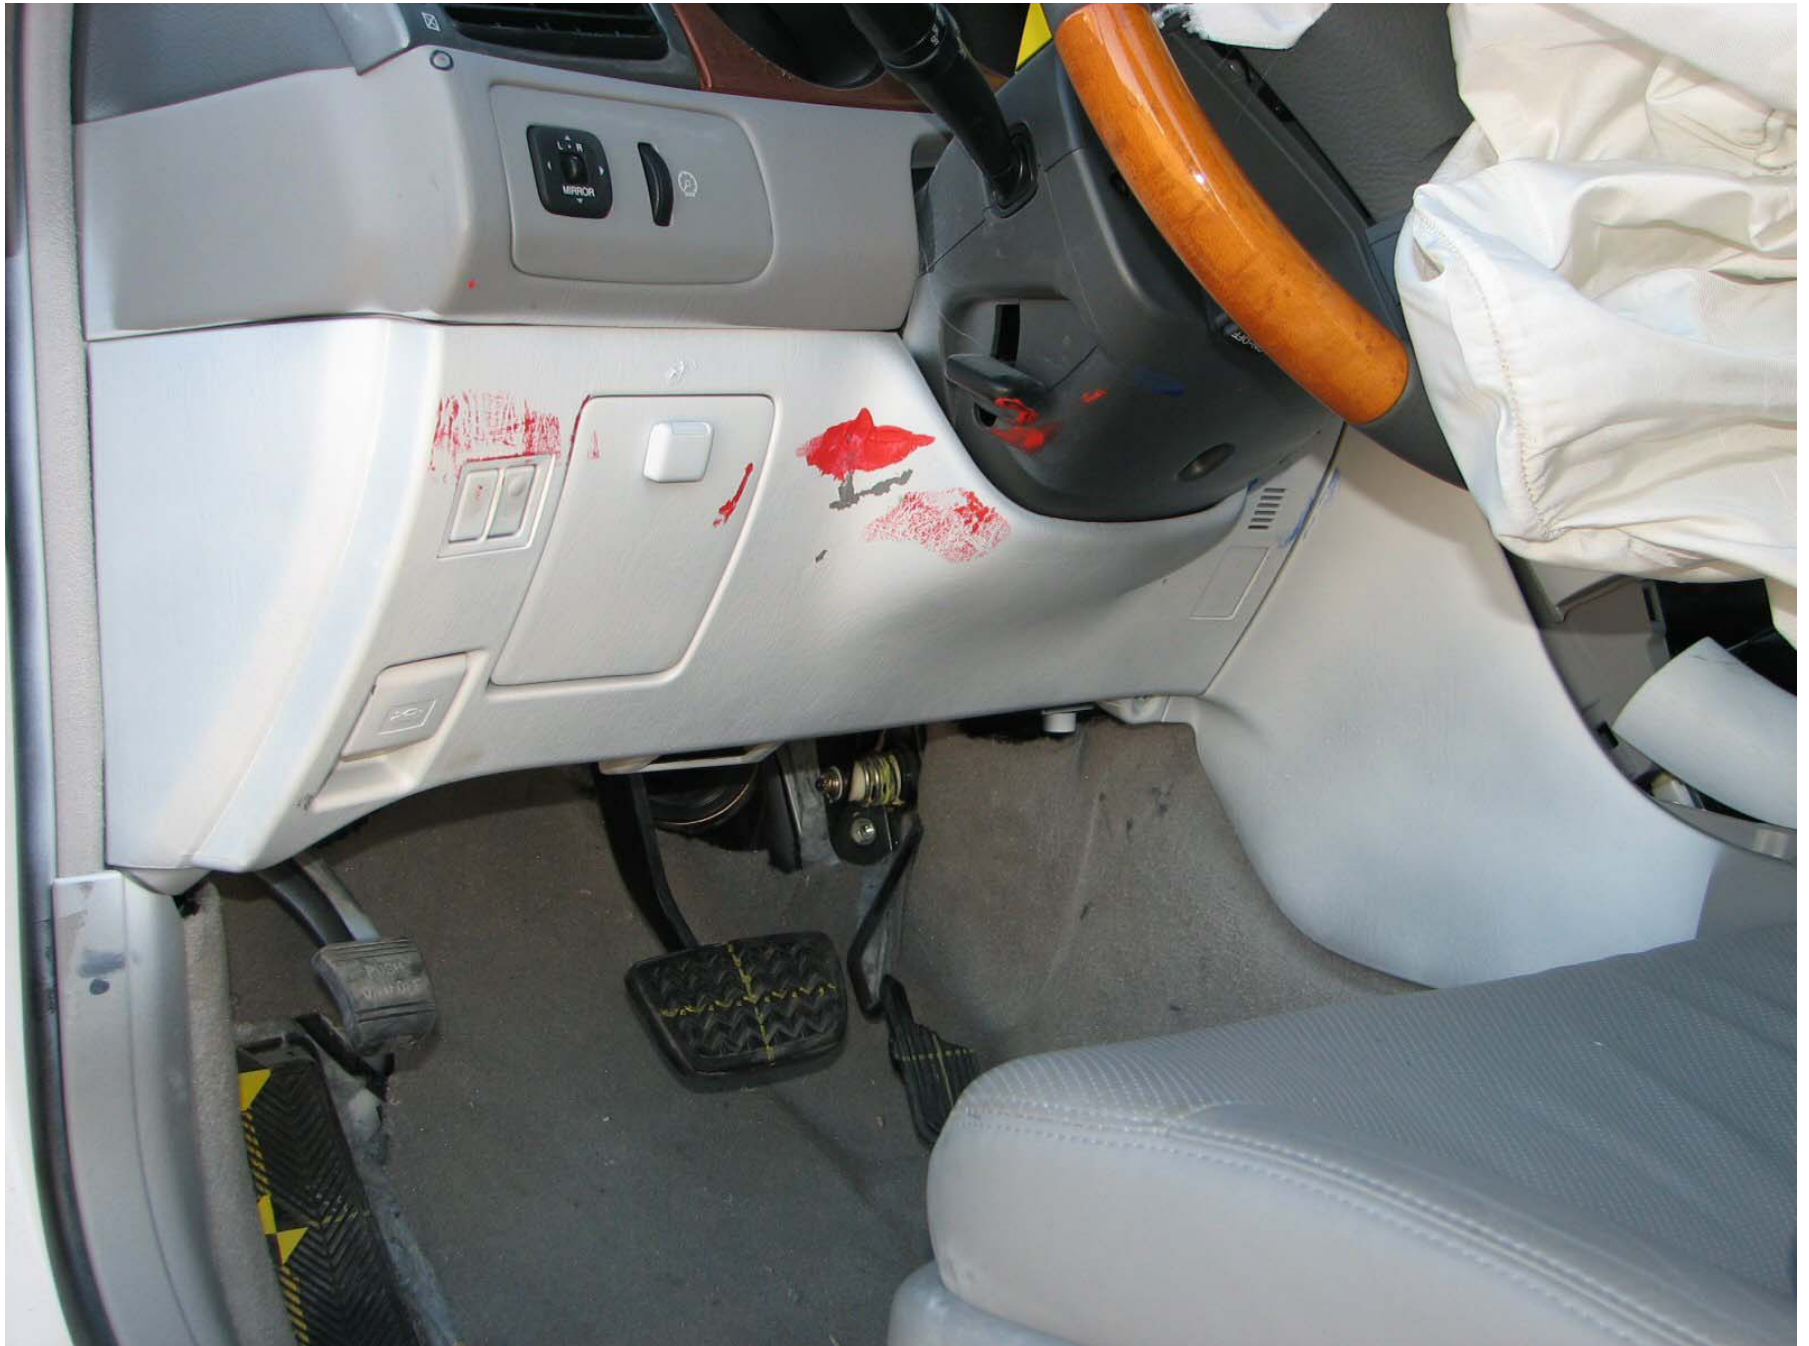
Figure A-39: Post-Test Driver Side Knee Bolster

The driver's visible contact points were as follows: The driver ATD's head and chest contacted the airbag and the abdomen had no contact. Both knees contacted the knee bolster.

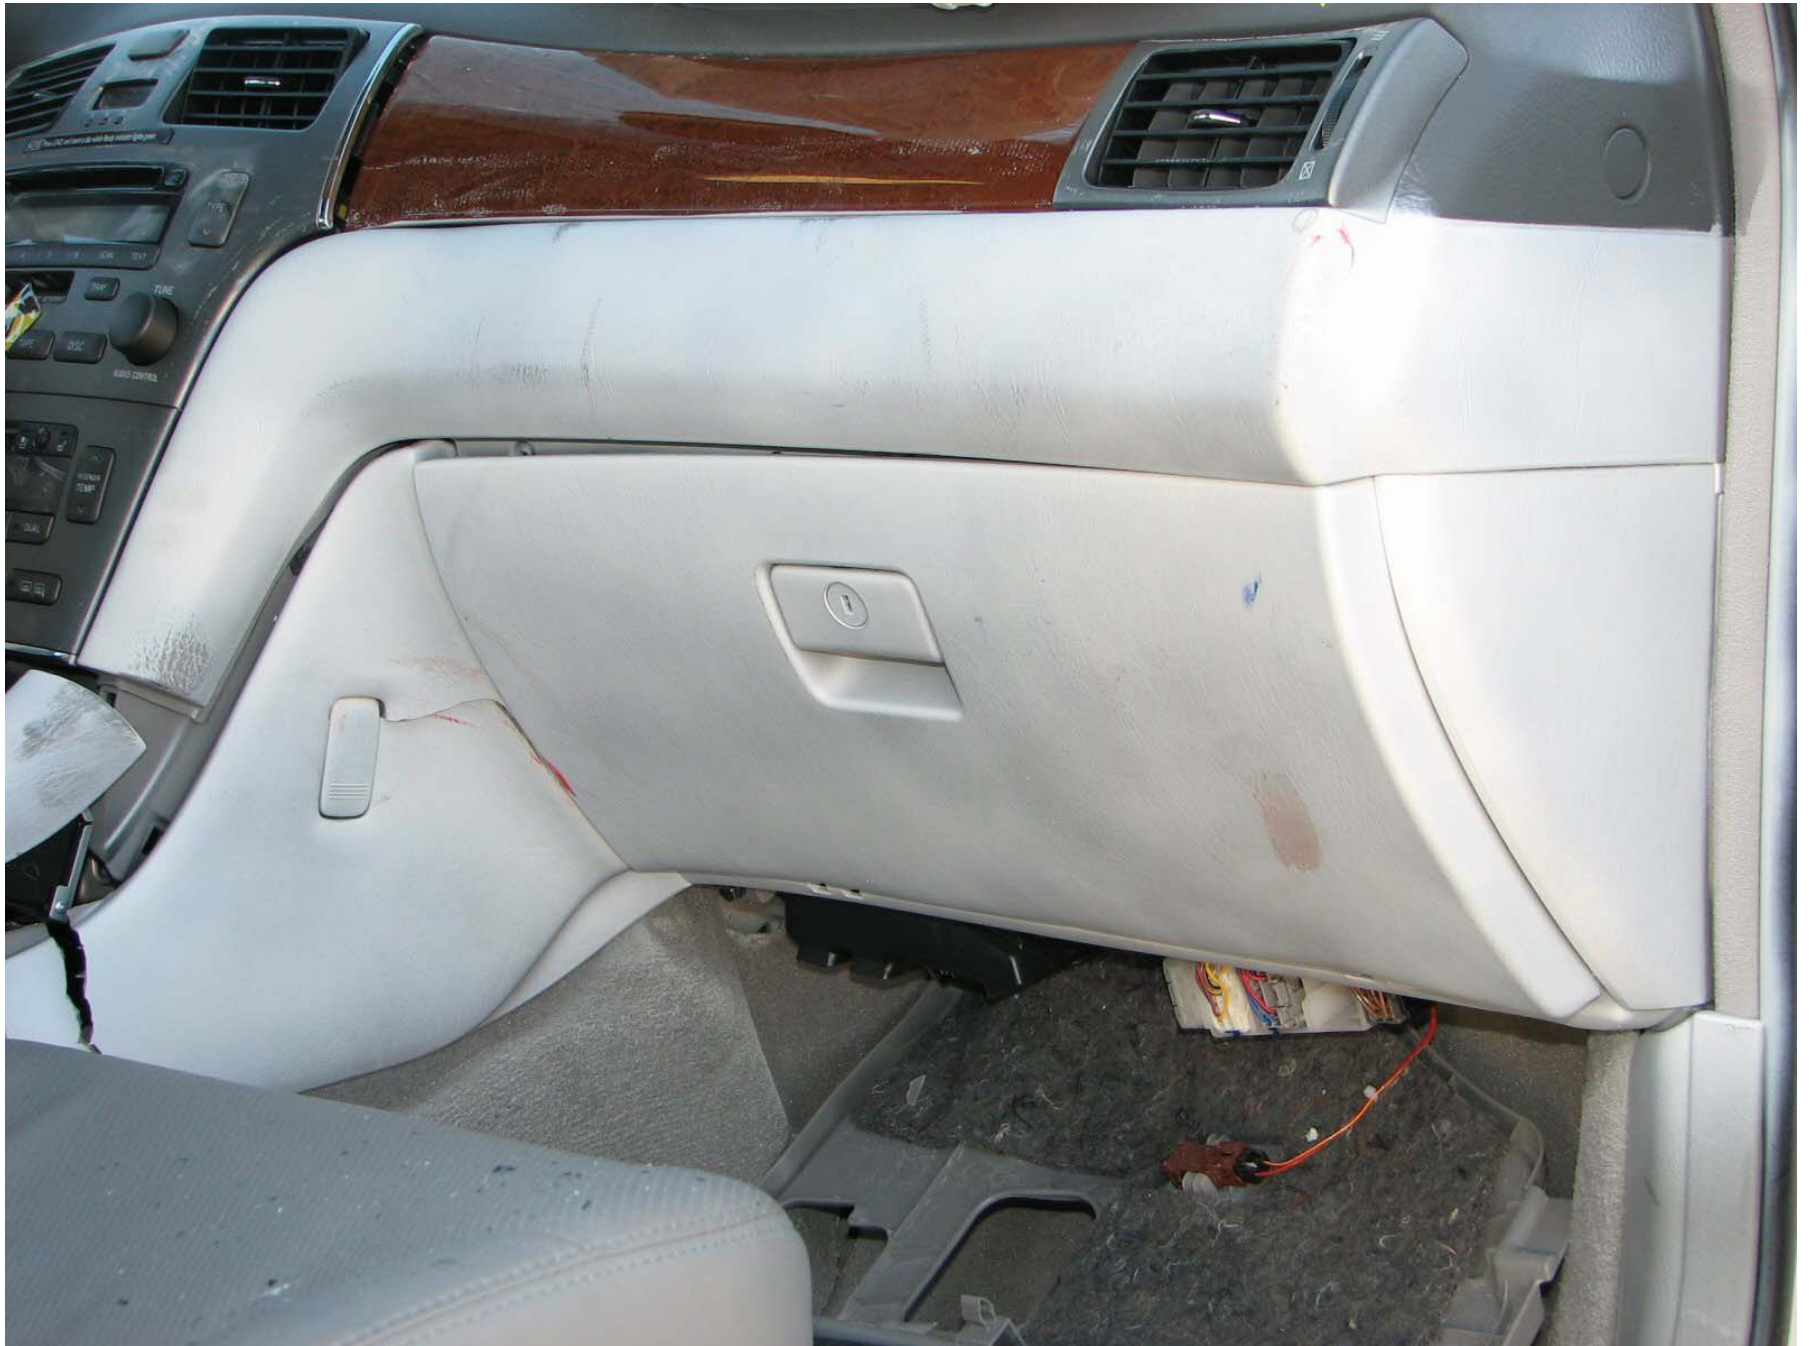
Figure A-53: Post-Test Passenger Side Glove Box

The passenger's visible contact points were as follows: The passenger ATD's head, chest contacted the airbag and the abdomen had no contact. Both knees contacted the glove box.

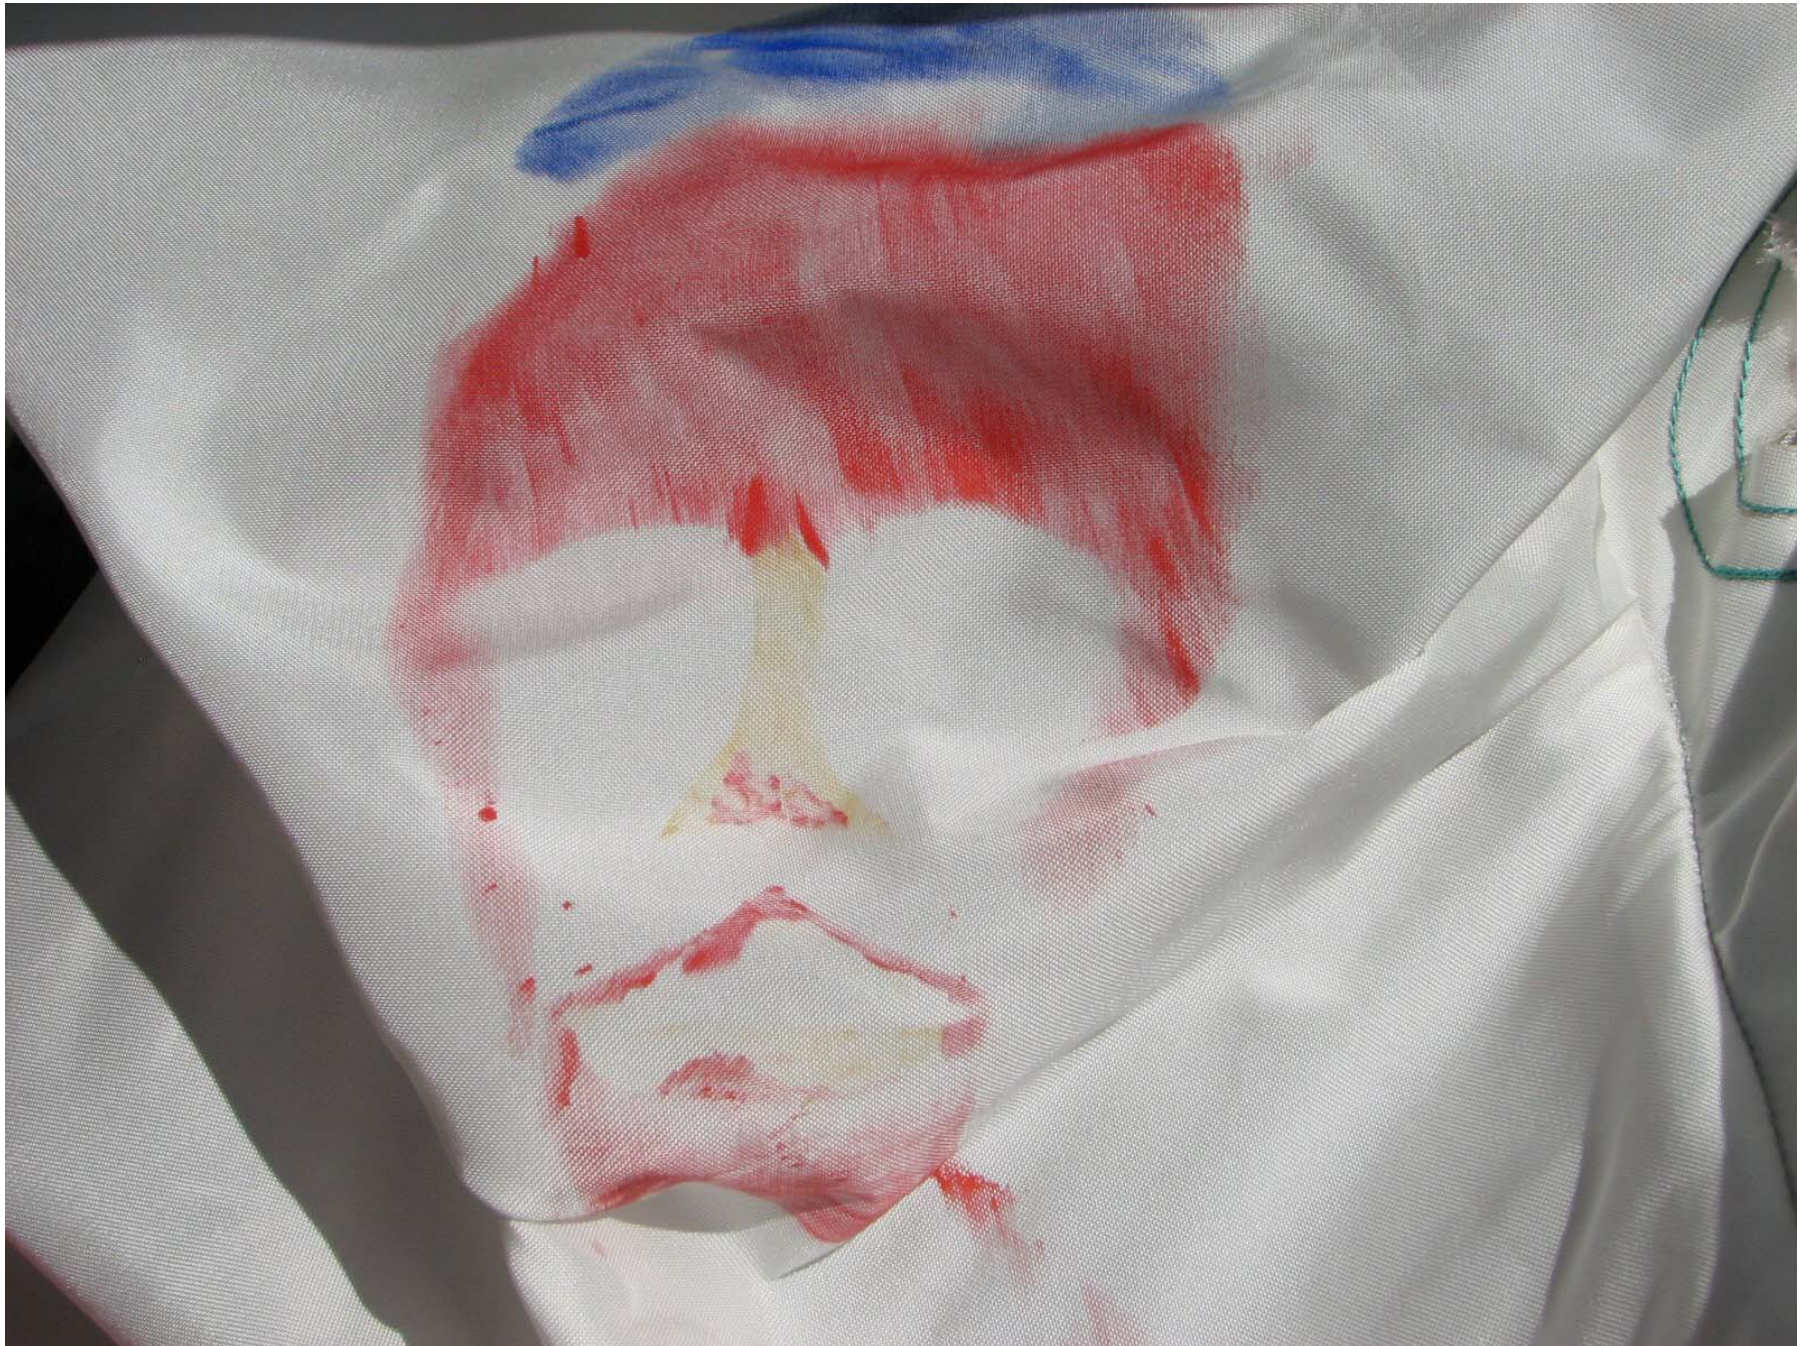
Figure A-57: Post-Test Passenger Dummy Airbag Contact
