**NEW CAR ASSESSMENT PROGRAM  
FRONTAL BARRIER IMPACT TEST**

**TOYOTA MOTOR CORPORATION  
2006 LEXUS ES330  
4-DOOR SEDAN**

**NHTSA NUMBER: M65101**

**FINAL REPORT**

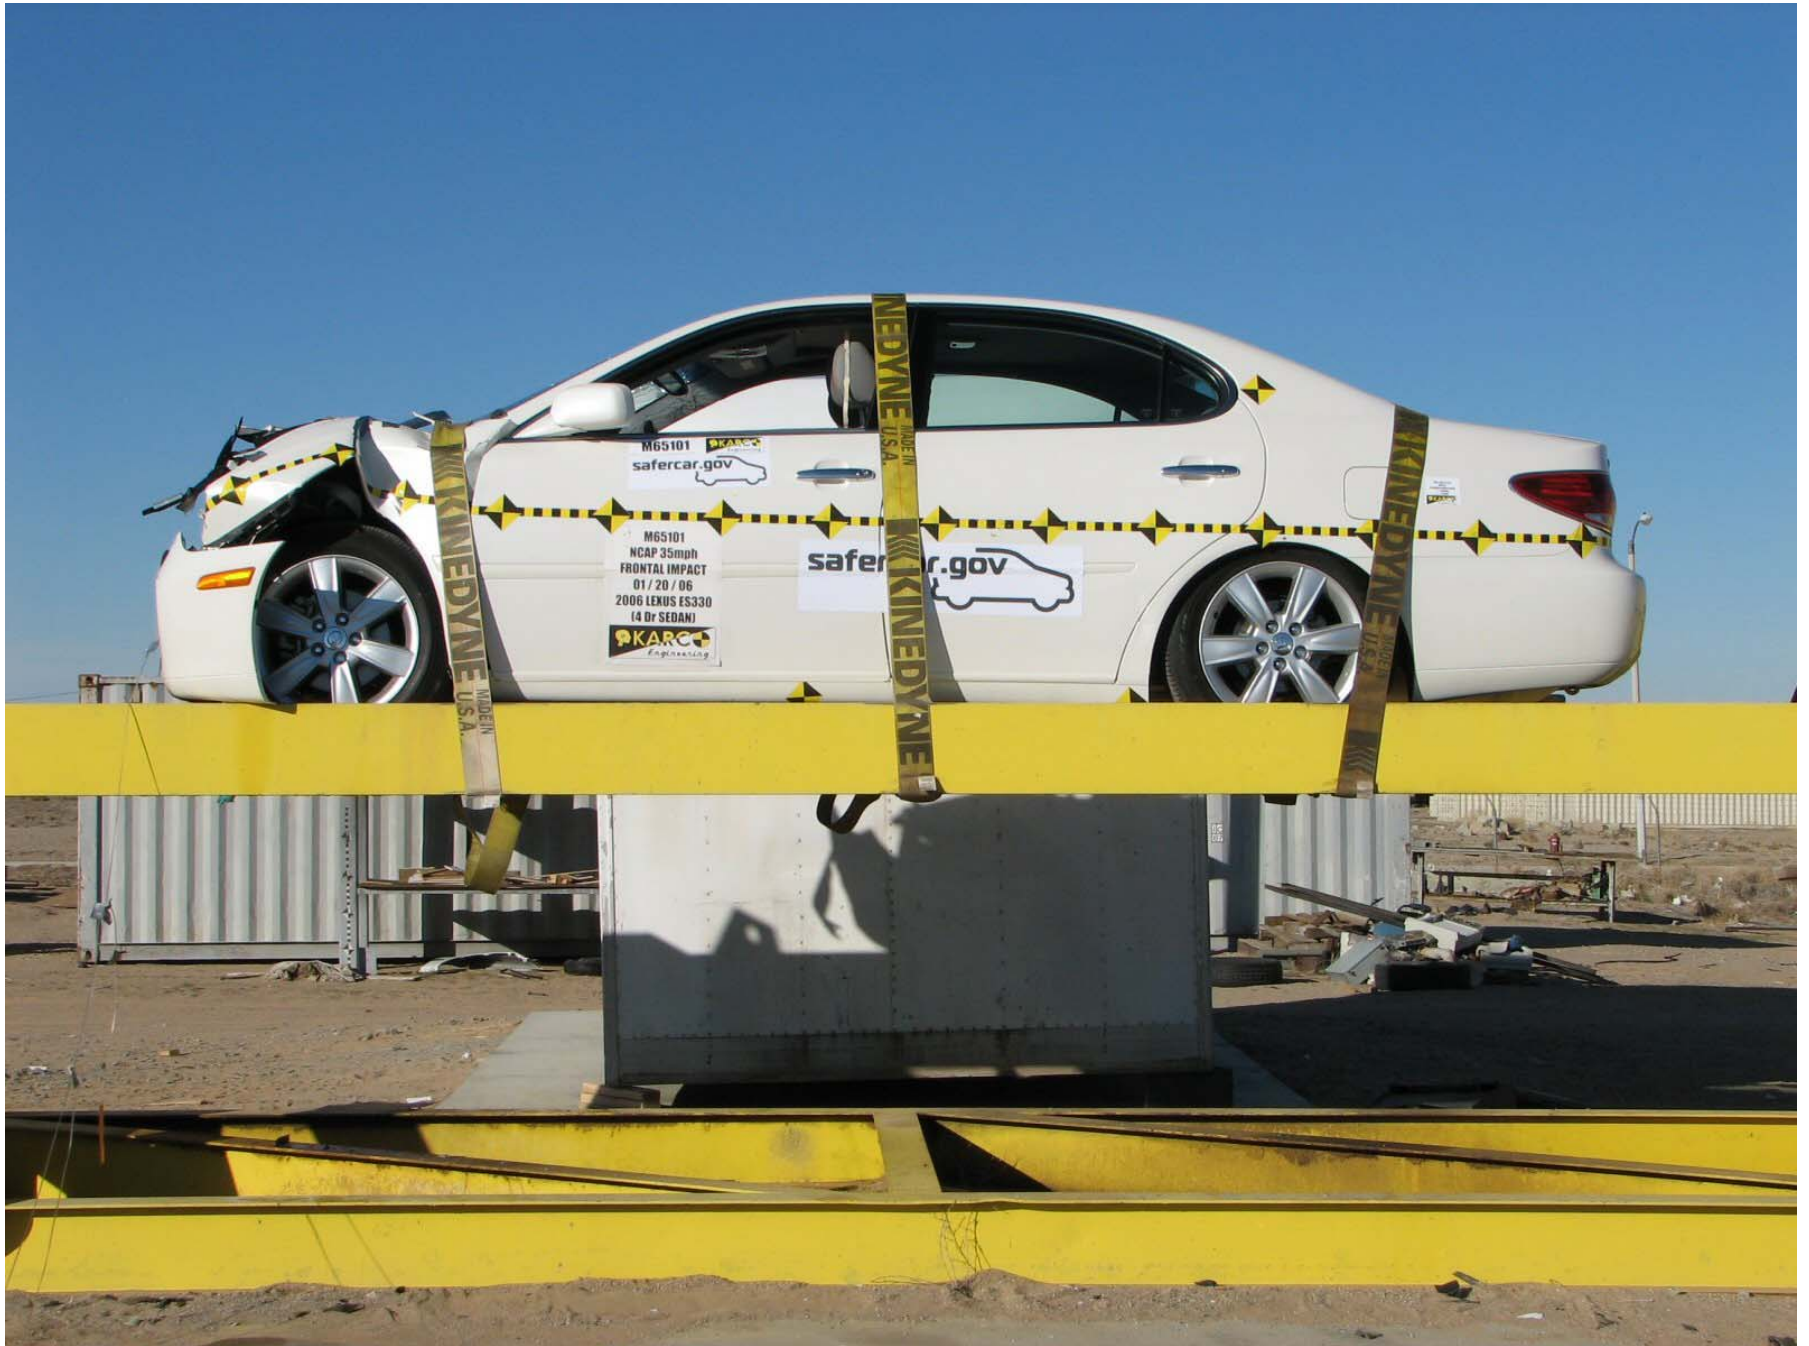
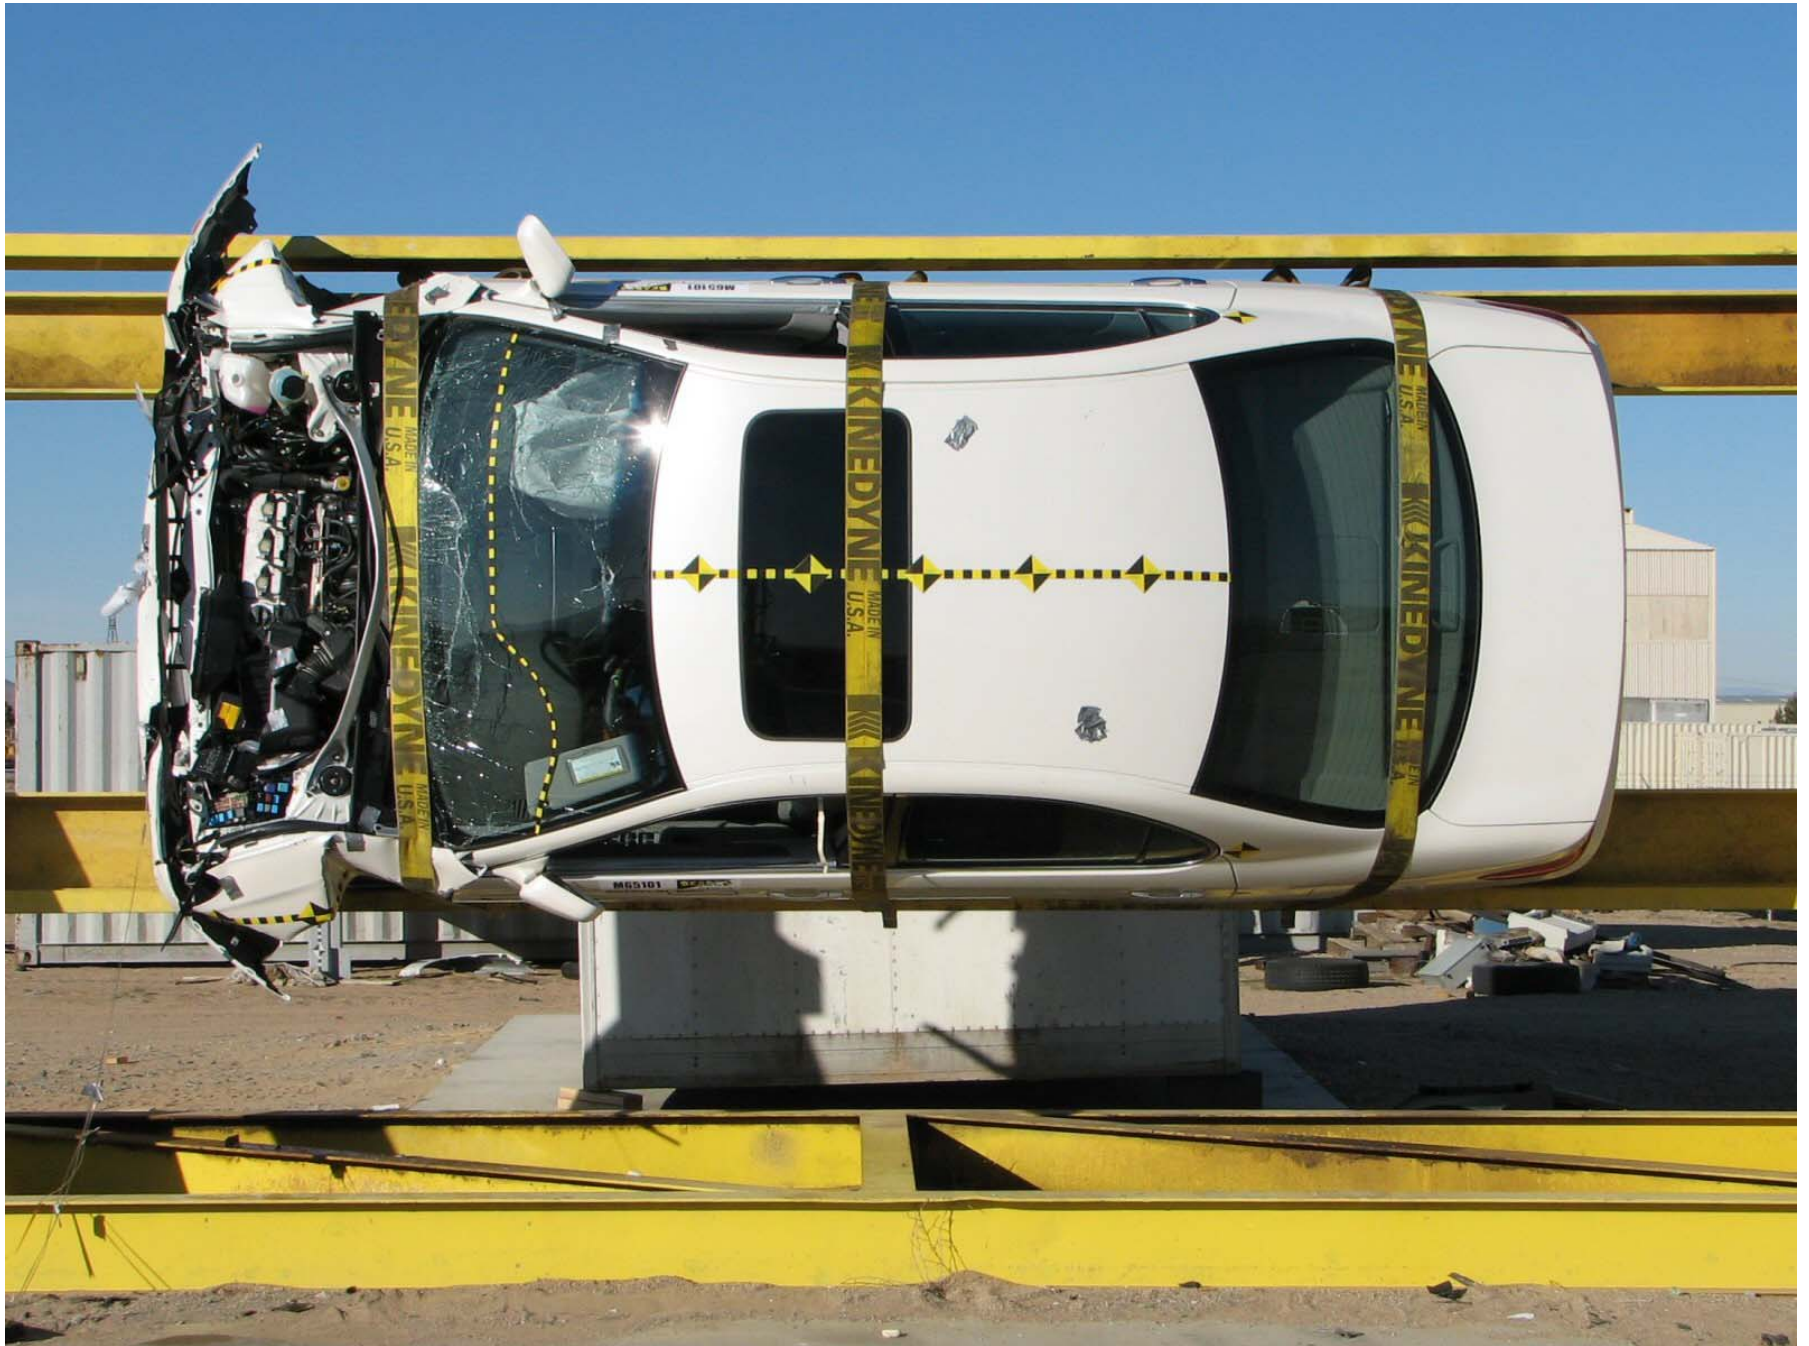
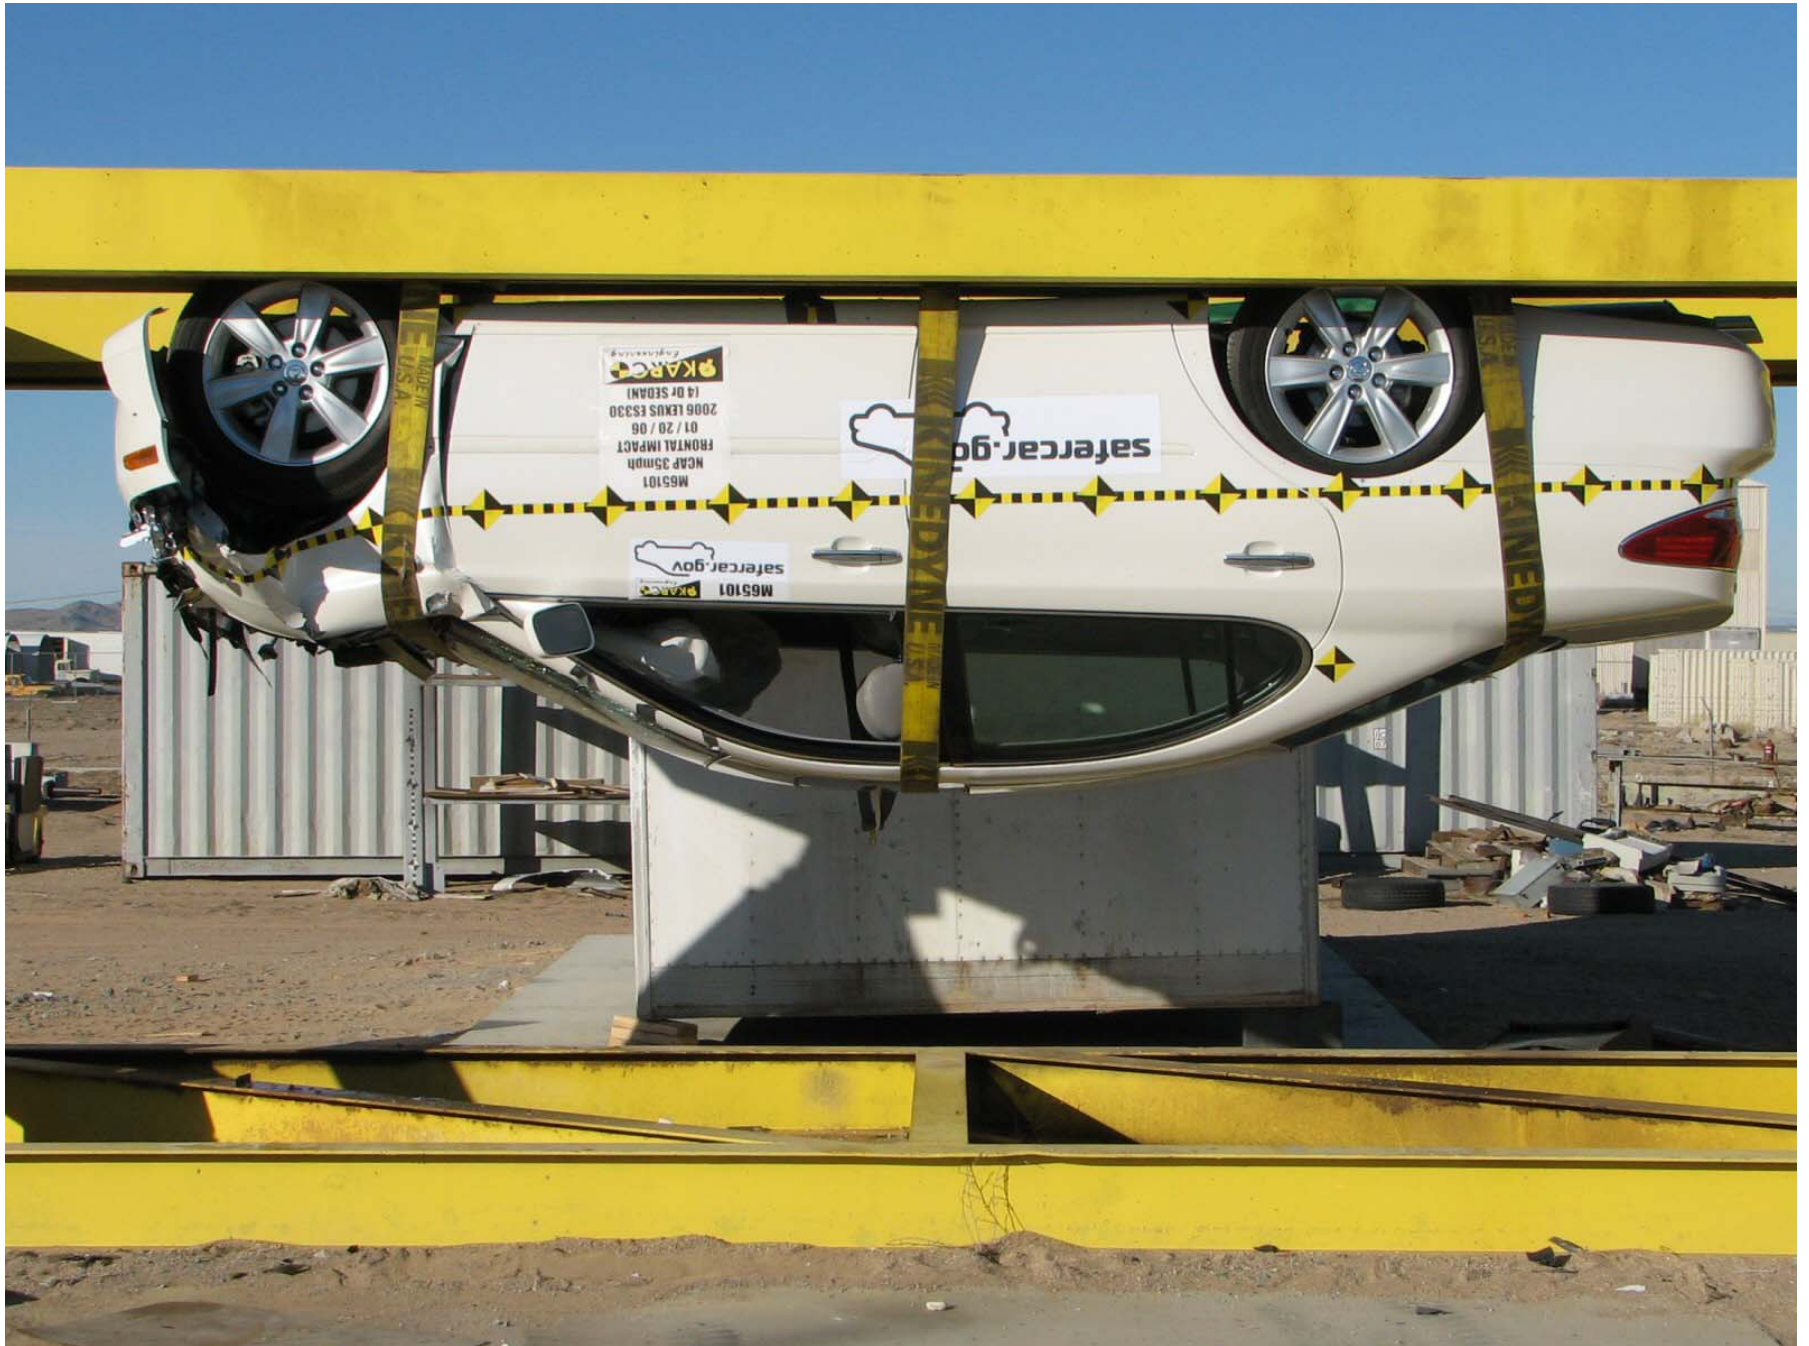
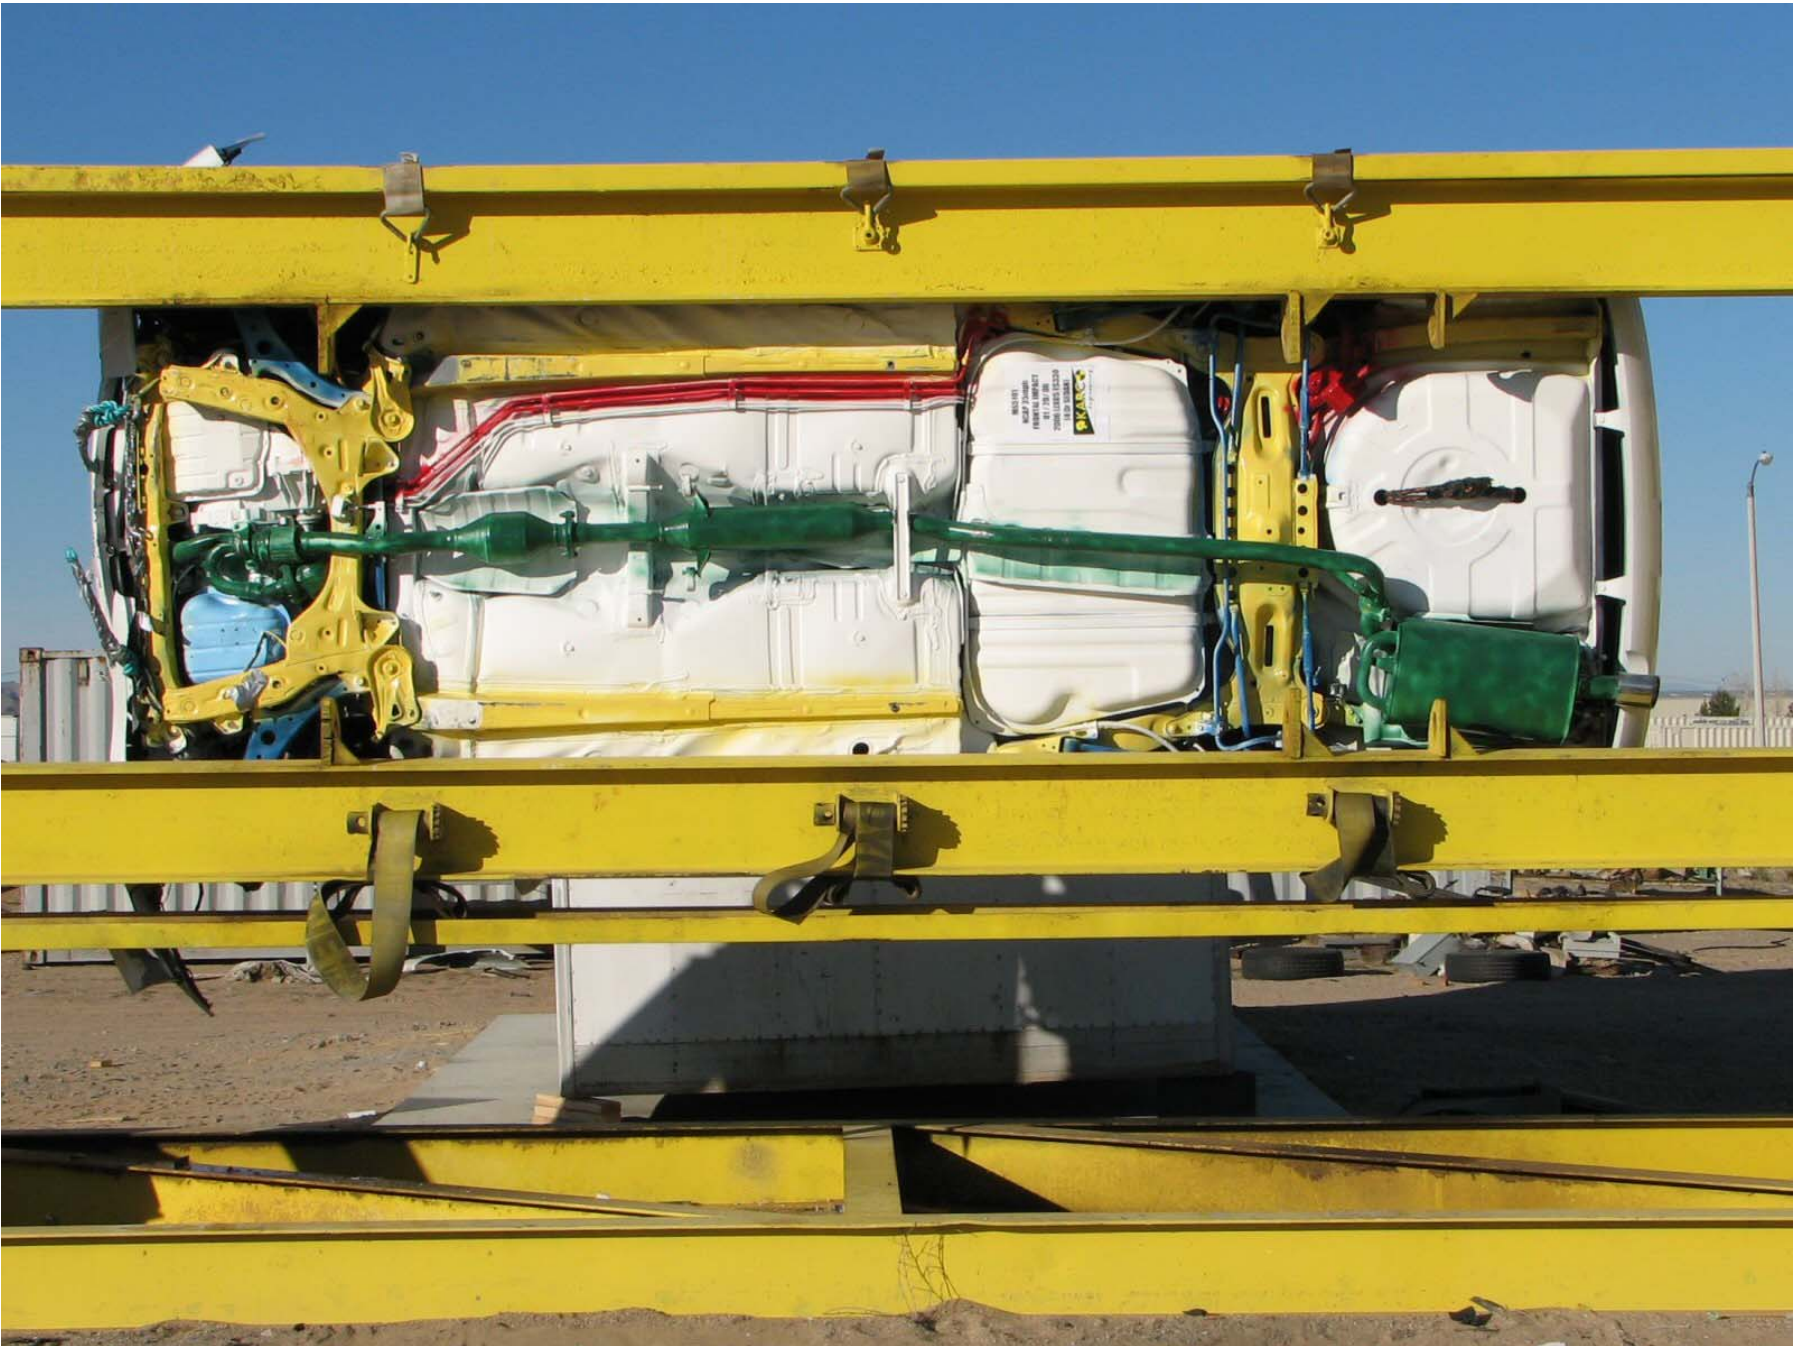
Figure A-58: Vehicle on Rollover Device (0°)

Figure A-59: Vehicle on Rollover Device (90°)

Figure A-60: Vehicle on Rollover Device (180°)

Figure A-61: Vehicle on Rollover Device (270°)

1. The specified fixture rollover rate for each 90° of rotation is 60 to 120 seconds.
2. The position hold time at each position is 300 seconds (minimum).
3. No solvent leakage occurred during rollover.

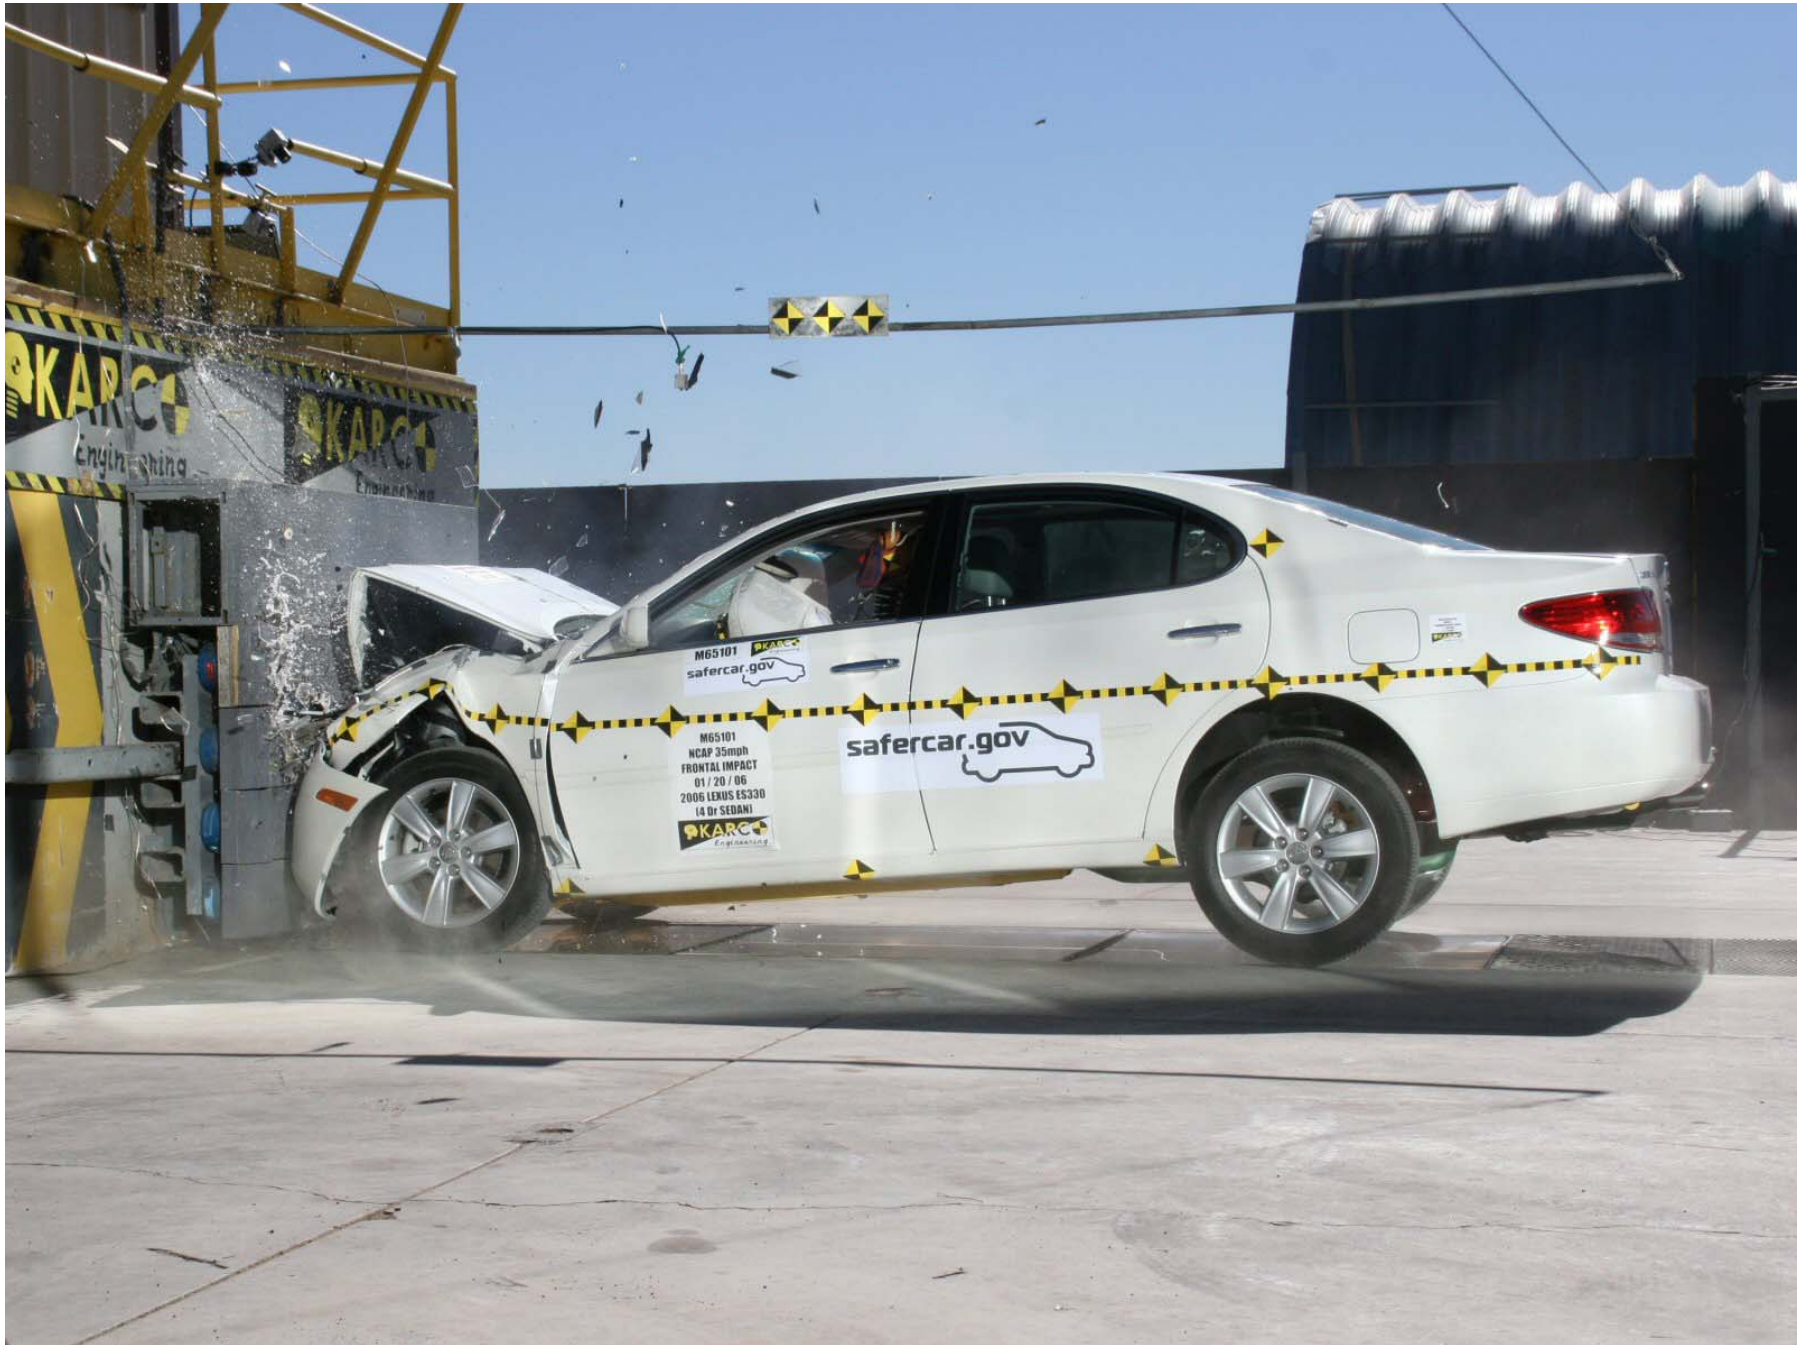
Figure A-62: Vehicle Impact

A load cell barrier consisting of 36 load cells was impacted by a 2006 Lexus ES330 4-Door Sedan at a velocity of 56.43 km/h. The test was performed at Karco Engineering, LLC on January 20, 2006.
