**REPORT NUMBER TR-P26001-09-NC**

**NEW CAR ASSESSMENT PROGRAM  
FRONTAL BARRIER IMPACT TEST**

**BAYERISCHE MOTOREN WERKE AG  
2006 BMW 325i  
4-DOOR SEDAN**

**NHTSA NUMBER: M60500**

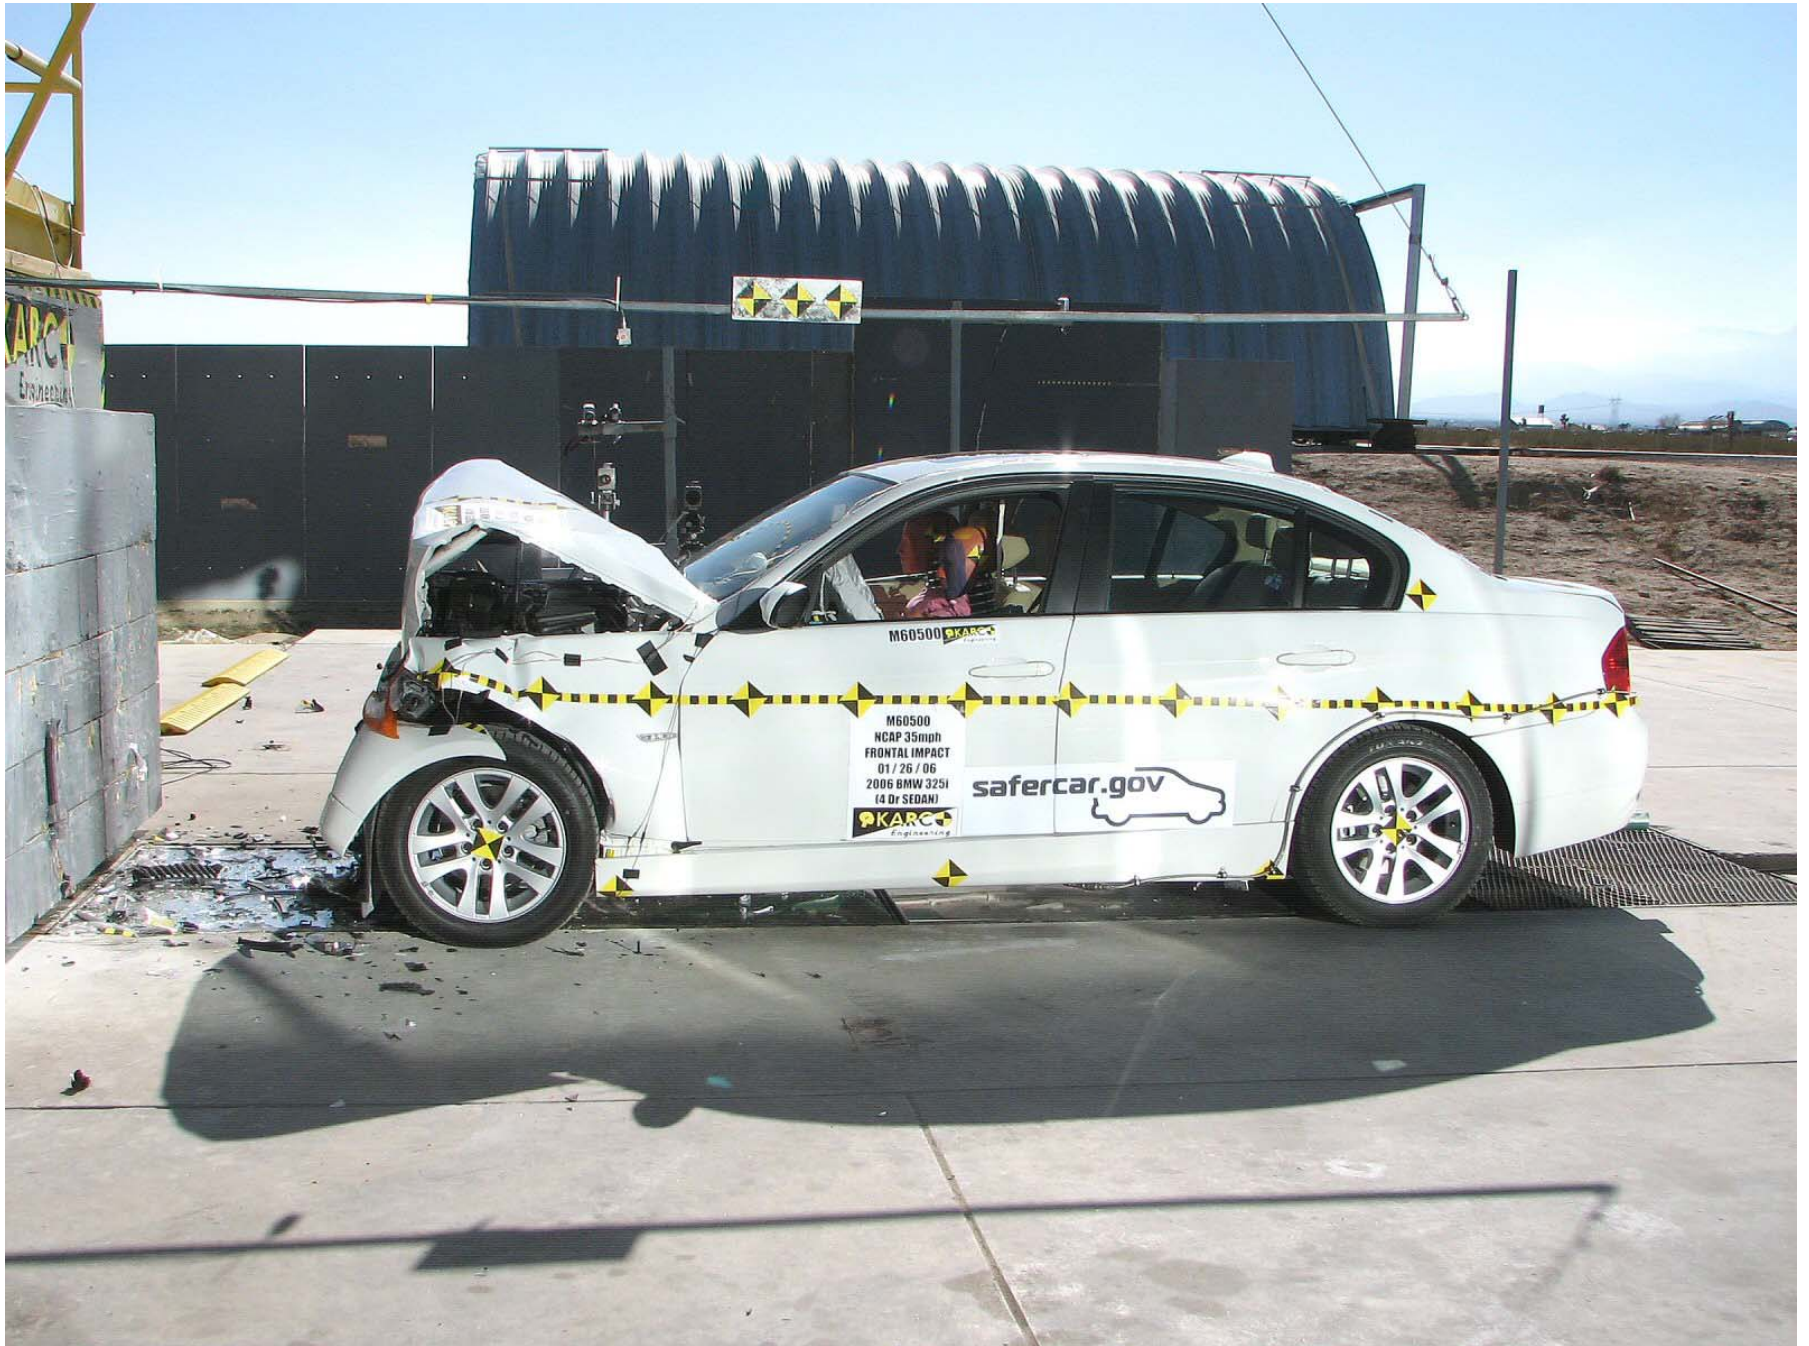
Figure A-9: Post-Test Left Side View

Collision Deformation Classification: 12FDEW6 Midpoint of Damage: Vehicle Centerline  
Damage Region Length (mm): 1517 Impact Mode: Full Frontal

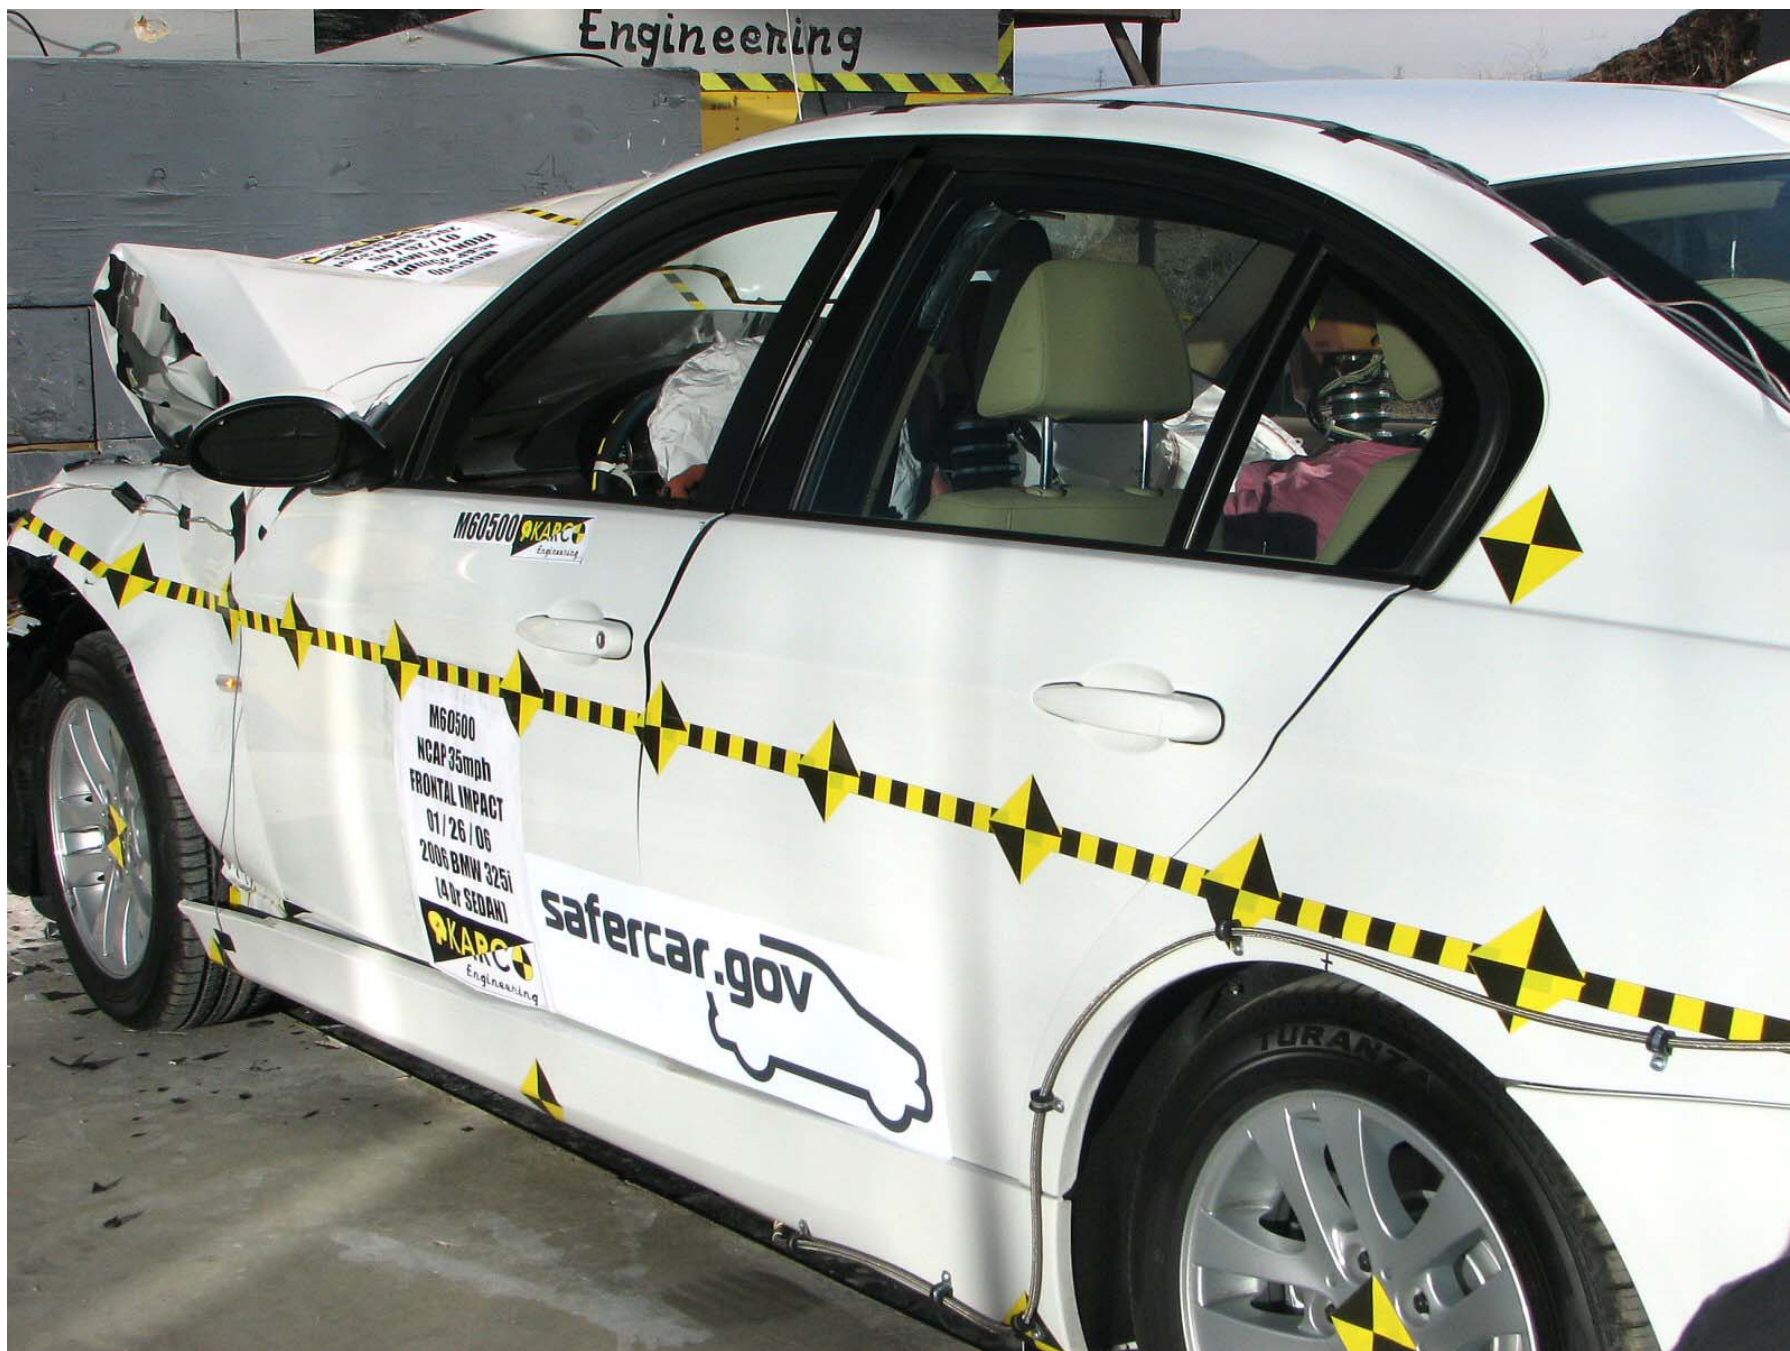
The maximum static crush of the vehicle was 423 mm at the vehicle's centerline and both the driver and the passenger side doors remained closed and latched during the impact event and were operable after the impact.

Figure A-16: Post-Test Left Side  $\frac{3}{4}$  View of Doors After Impact

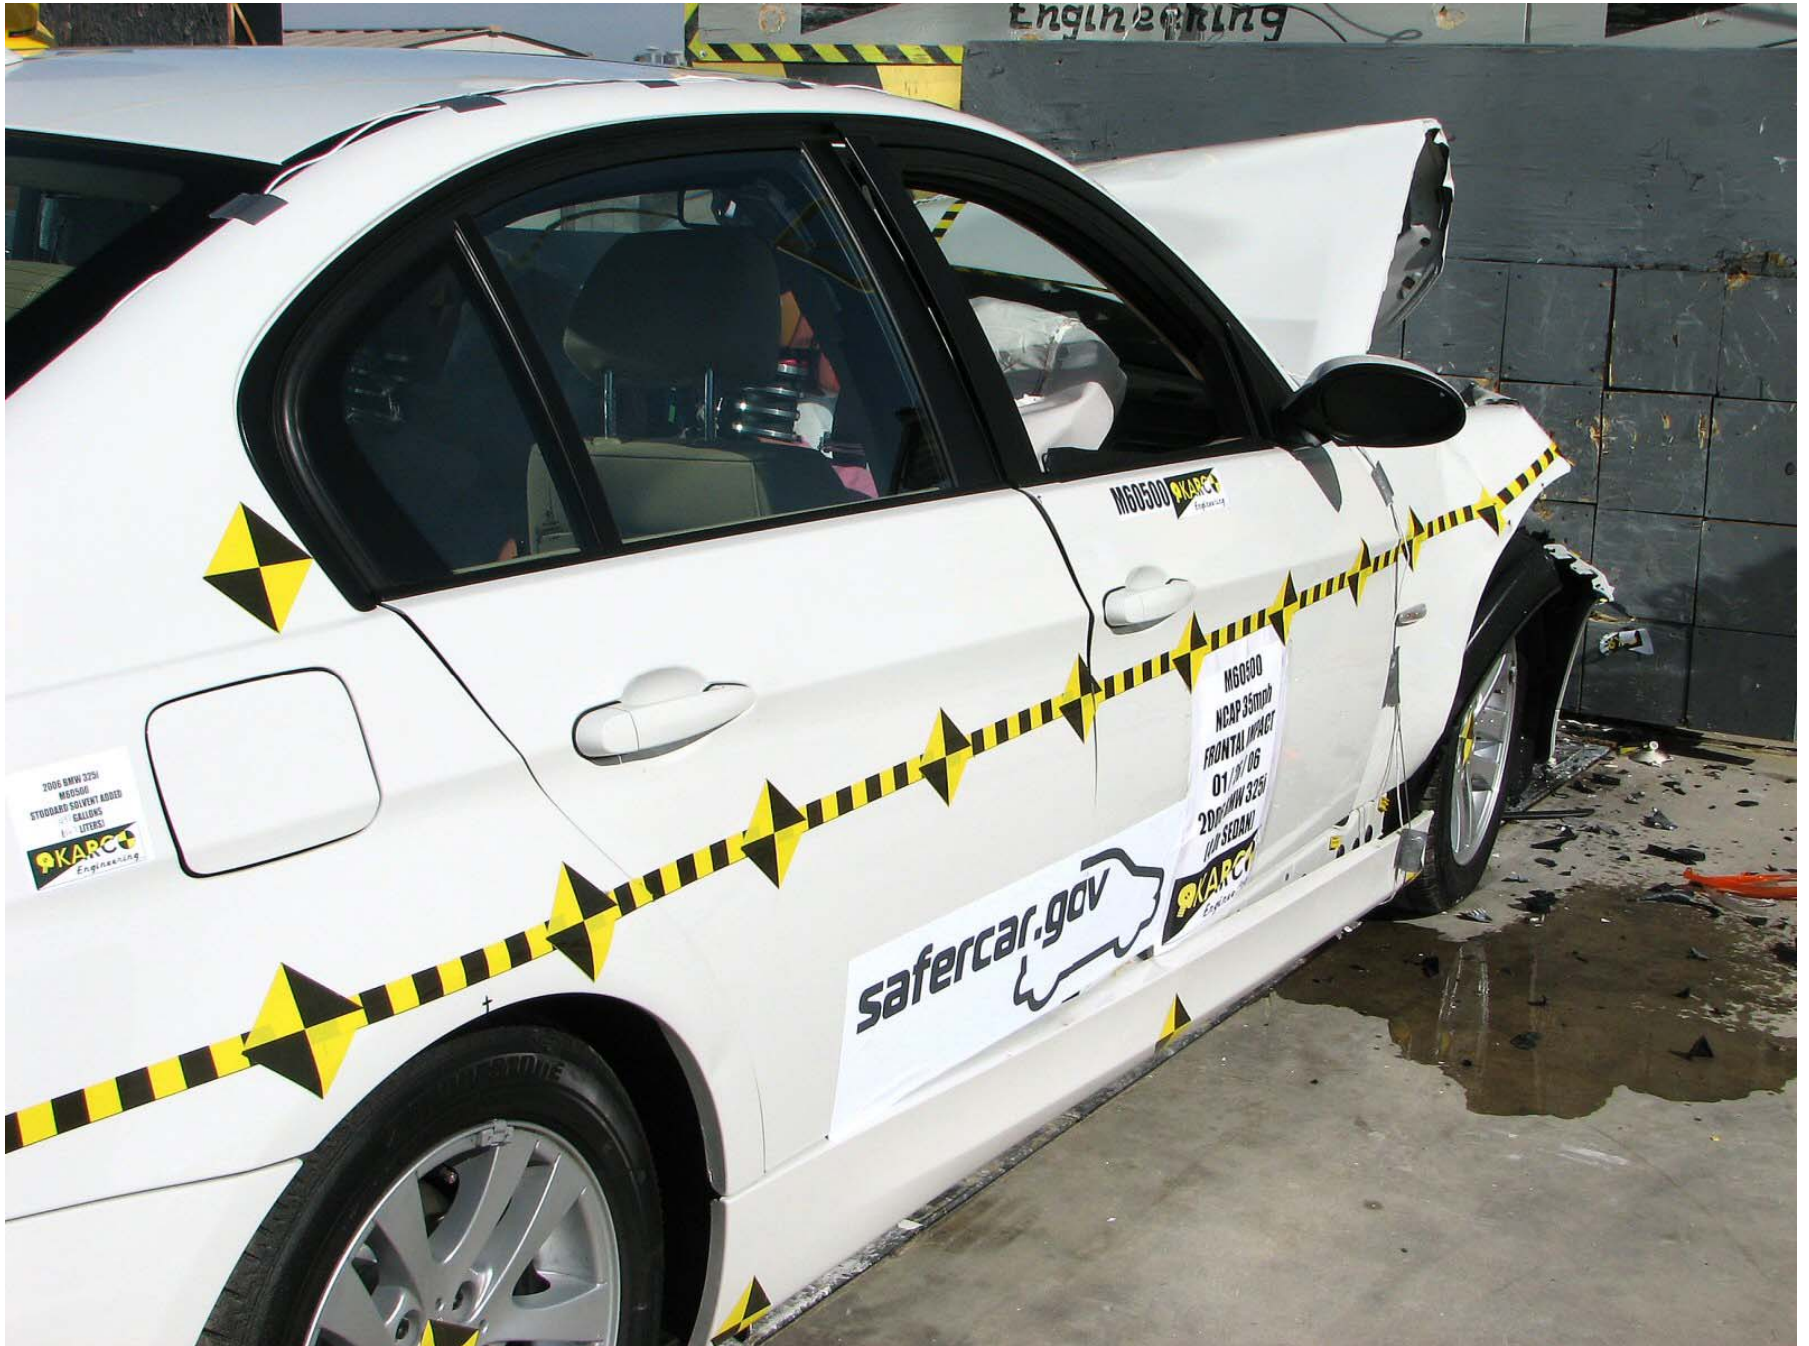
Figure A-17: Post-Test Right Side  $\frac{3}{4}$  View of Doors After Impact

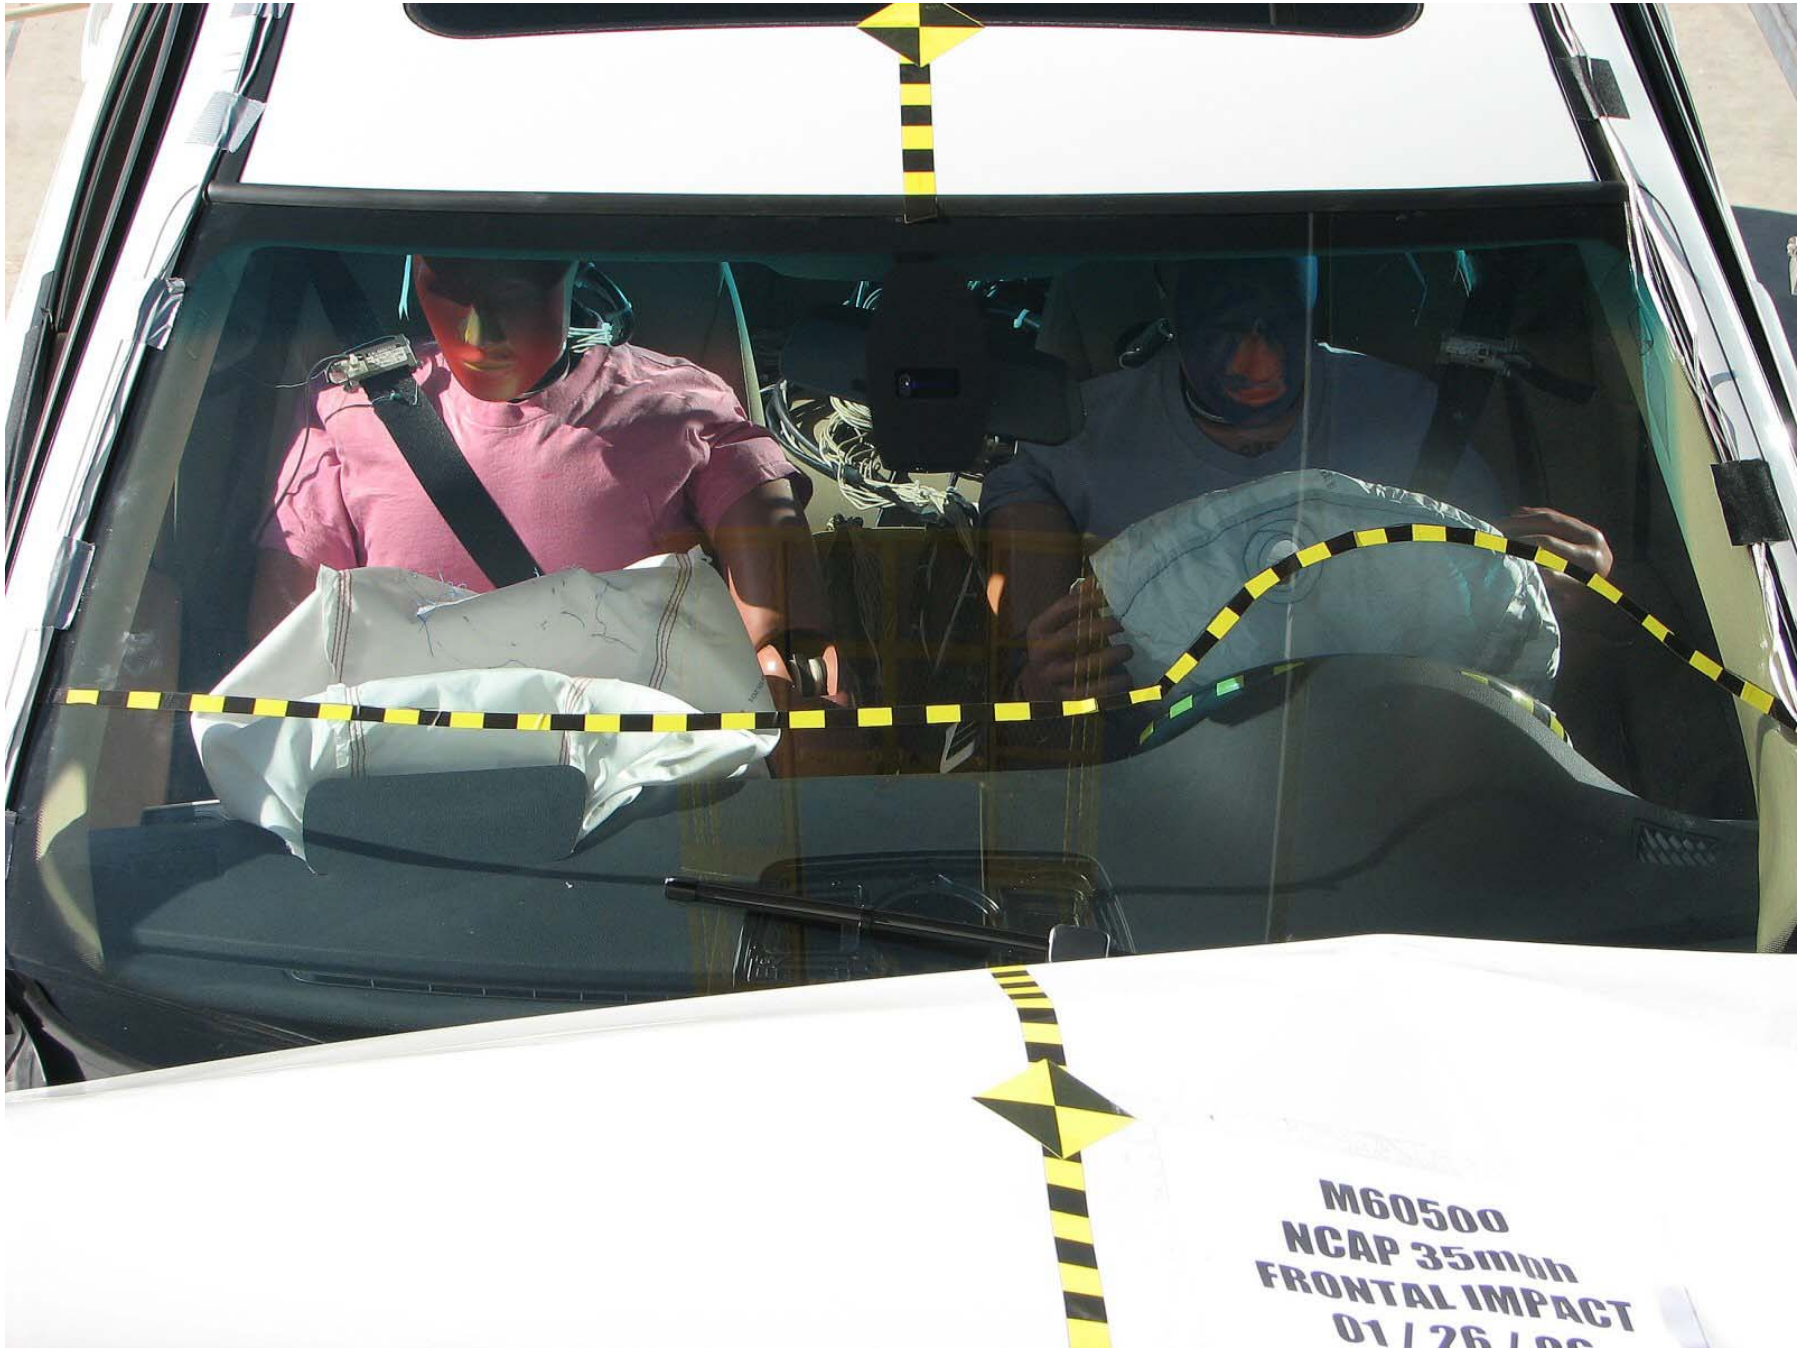
There was 100 percent windshield retention and there was no intrusion into the protected zone of the windshield during the impact event. There was no stoddard solvent leakage after the event or during any phase of the static rollover.

Figure A-19: Post-Test Windshield

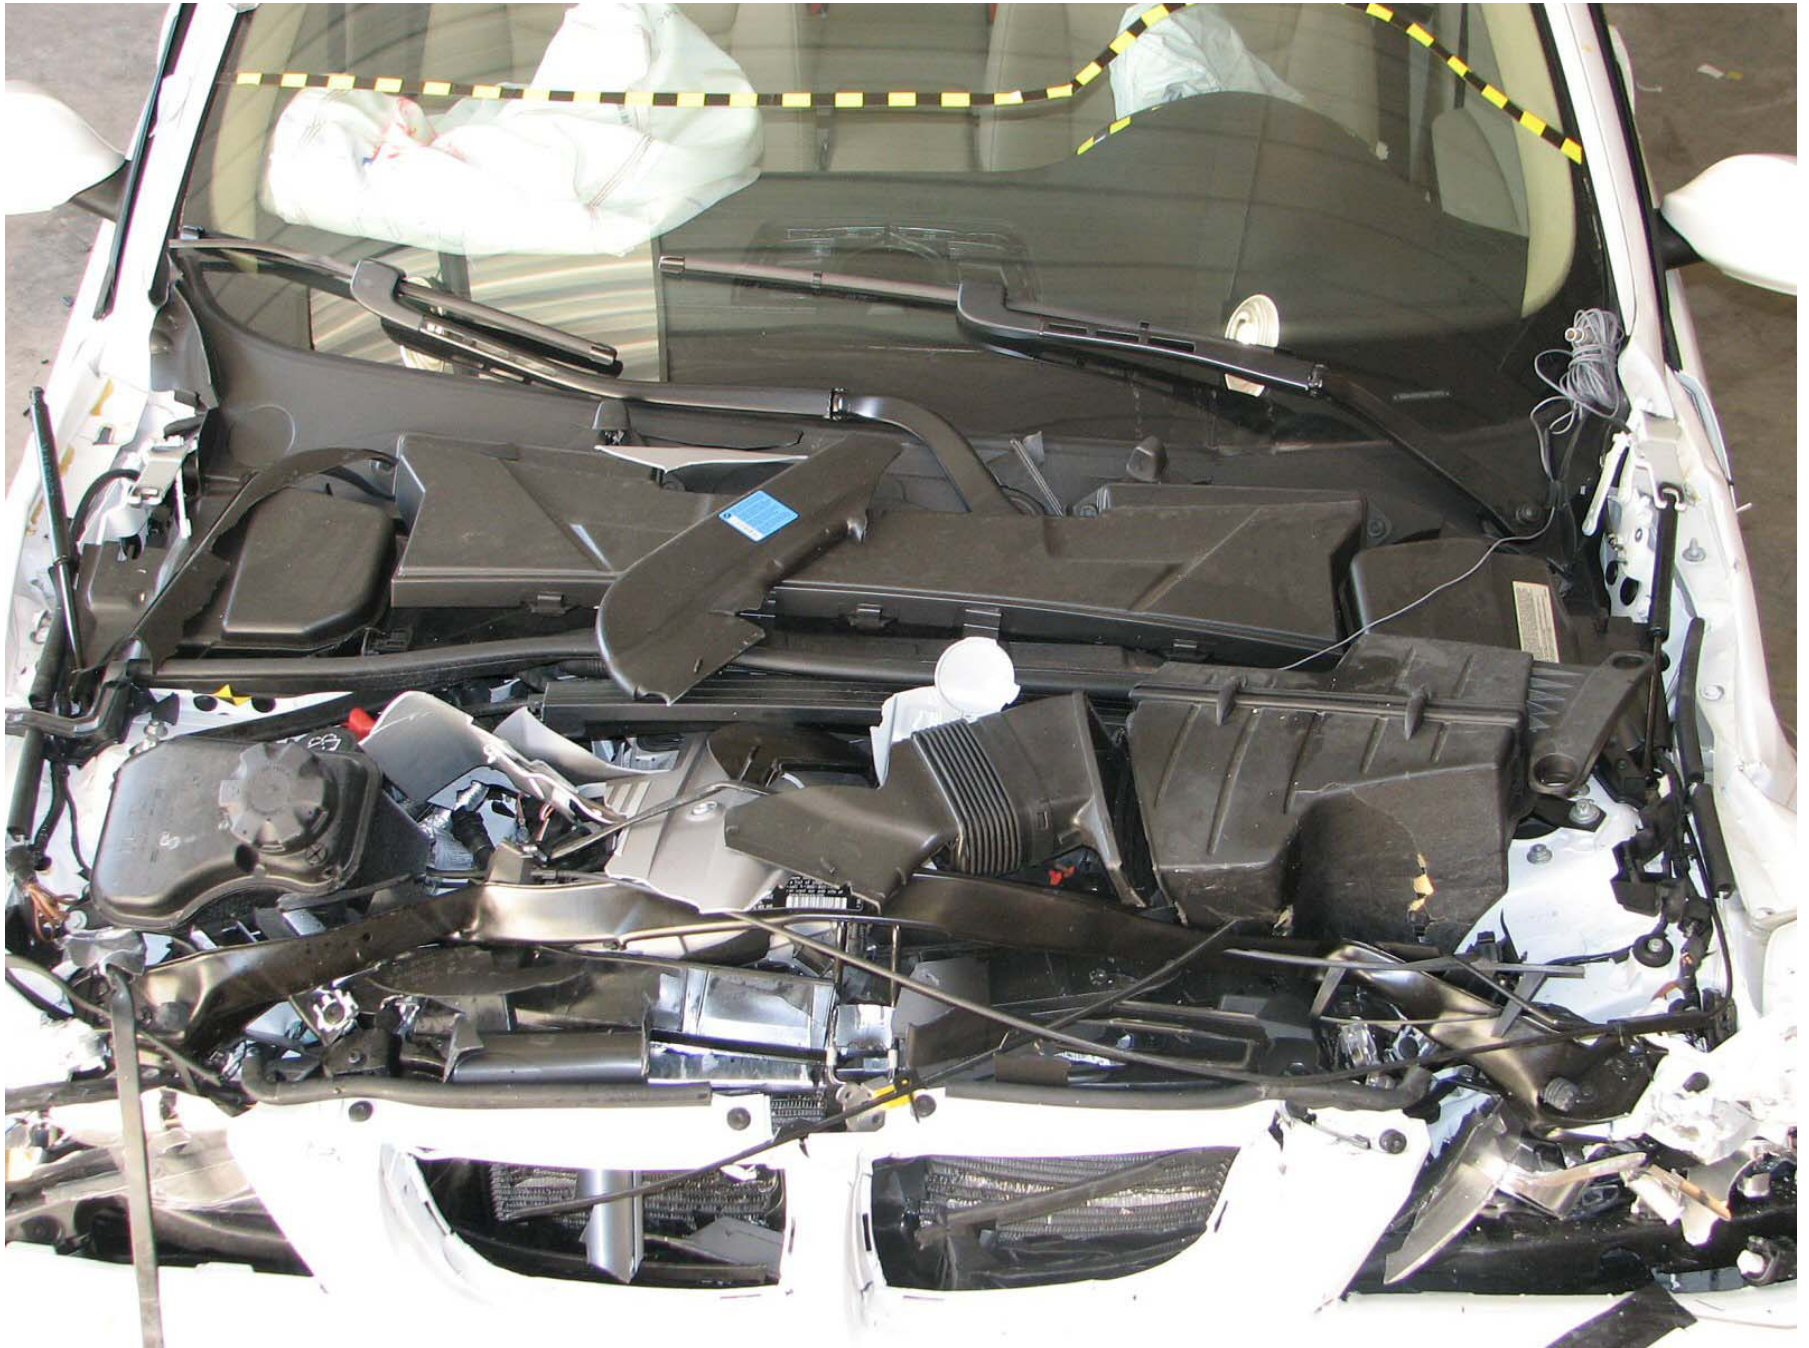
Figure A-21: Post-Test Engine Compartment (Vehicle Moved)

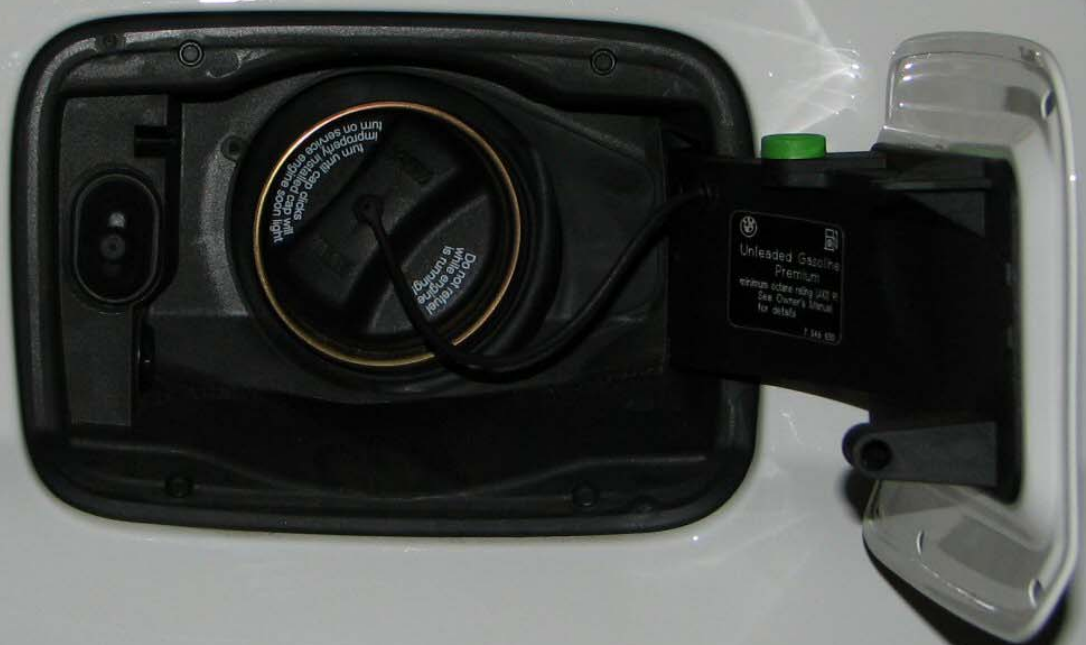
Figure A-22: Pre-Test Fuel Cap

2006 BMW 325i  
M60500  
STODDARD SOLVENT ADDED  
14.97 GALLONS  
(56.7 LITERS)  
**KARCO**  
Engineering, LLC

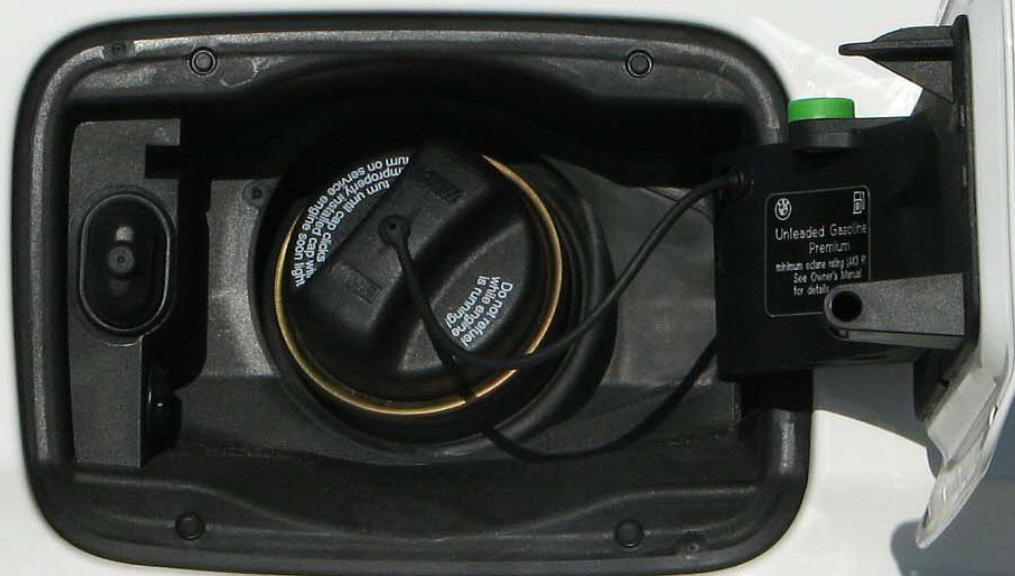
Figure A-23: Post-Test Fuel Cap

2006 BMW 325i  
M60500  
STODDARD SOLVENT ADDED  
14.97 GALLONS  
(56.7 LITERS)

- A. From impact until vehicle motion ceases: 0.0 oz.  
(Maximum Allowable = 1 ounce)
- B. For the 5 minute period after motion ceases: 0.0 oz.  
(Maximum Allowable = 5 ounces)
- C. For the following 25 minutes: 0.0 oz.  
(Maximum Allowable = 1 oz./minute)
- D. Spillage Location Details: No leakage occurred

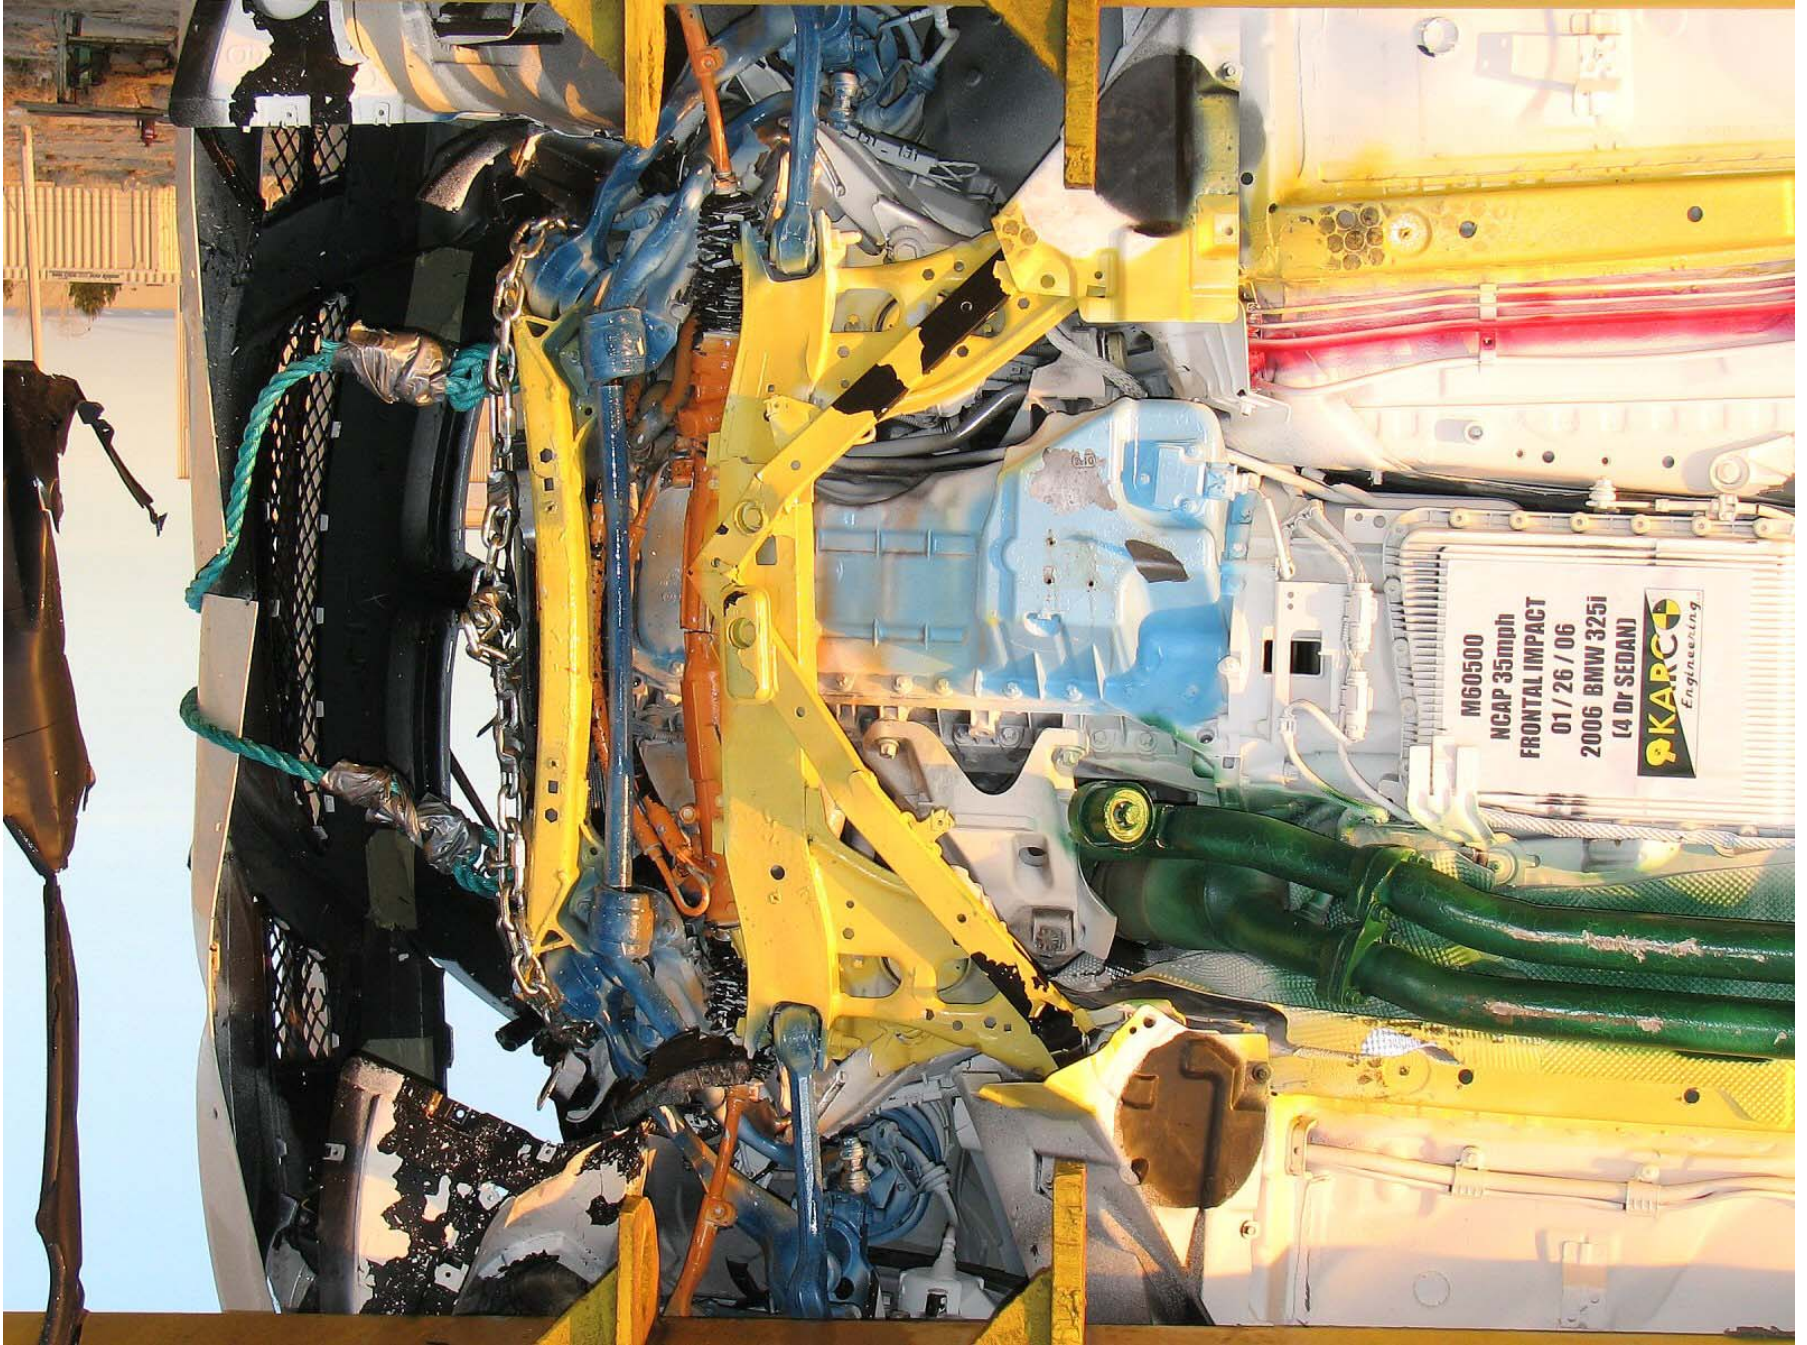
Figure A-25: Post-Test Front Underbody

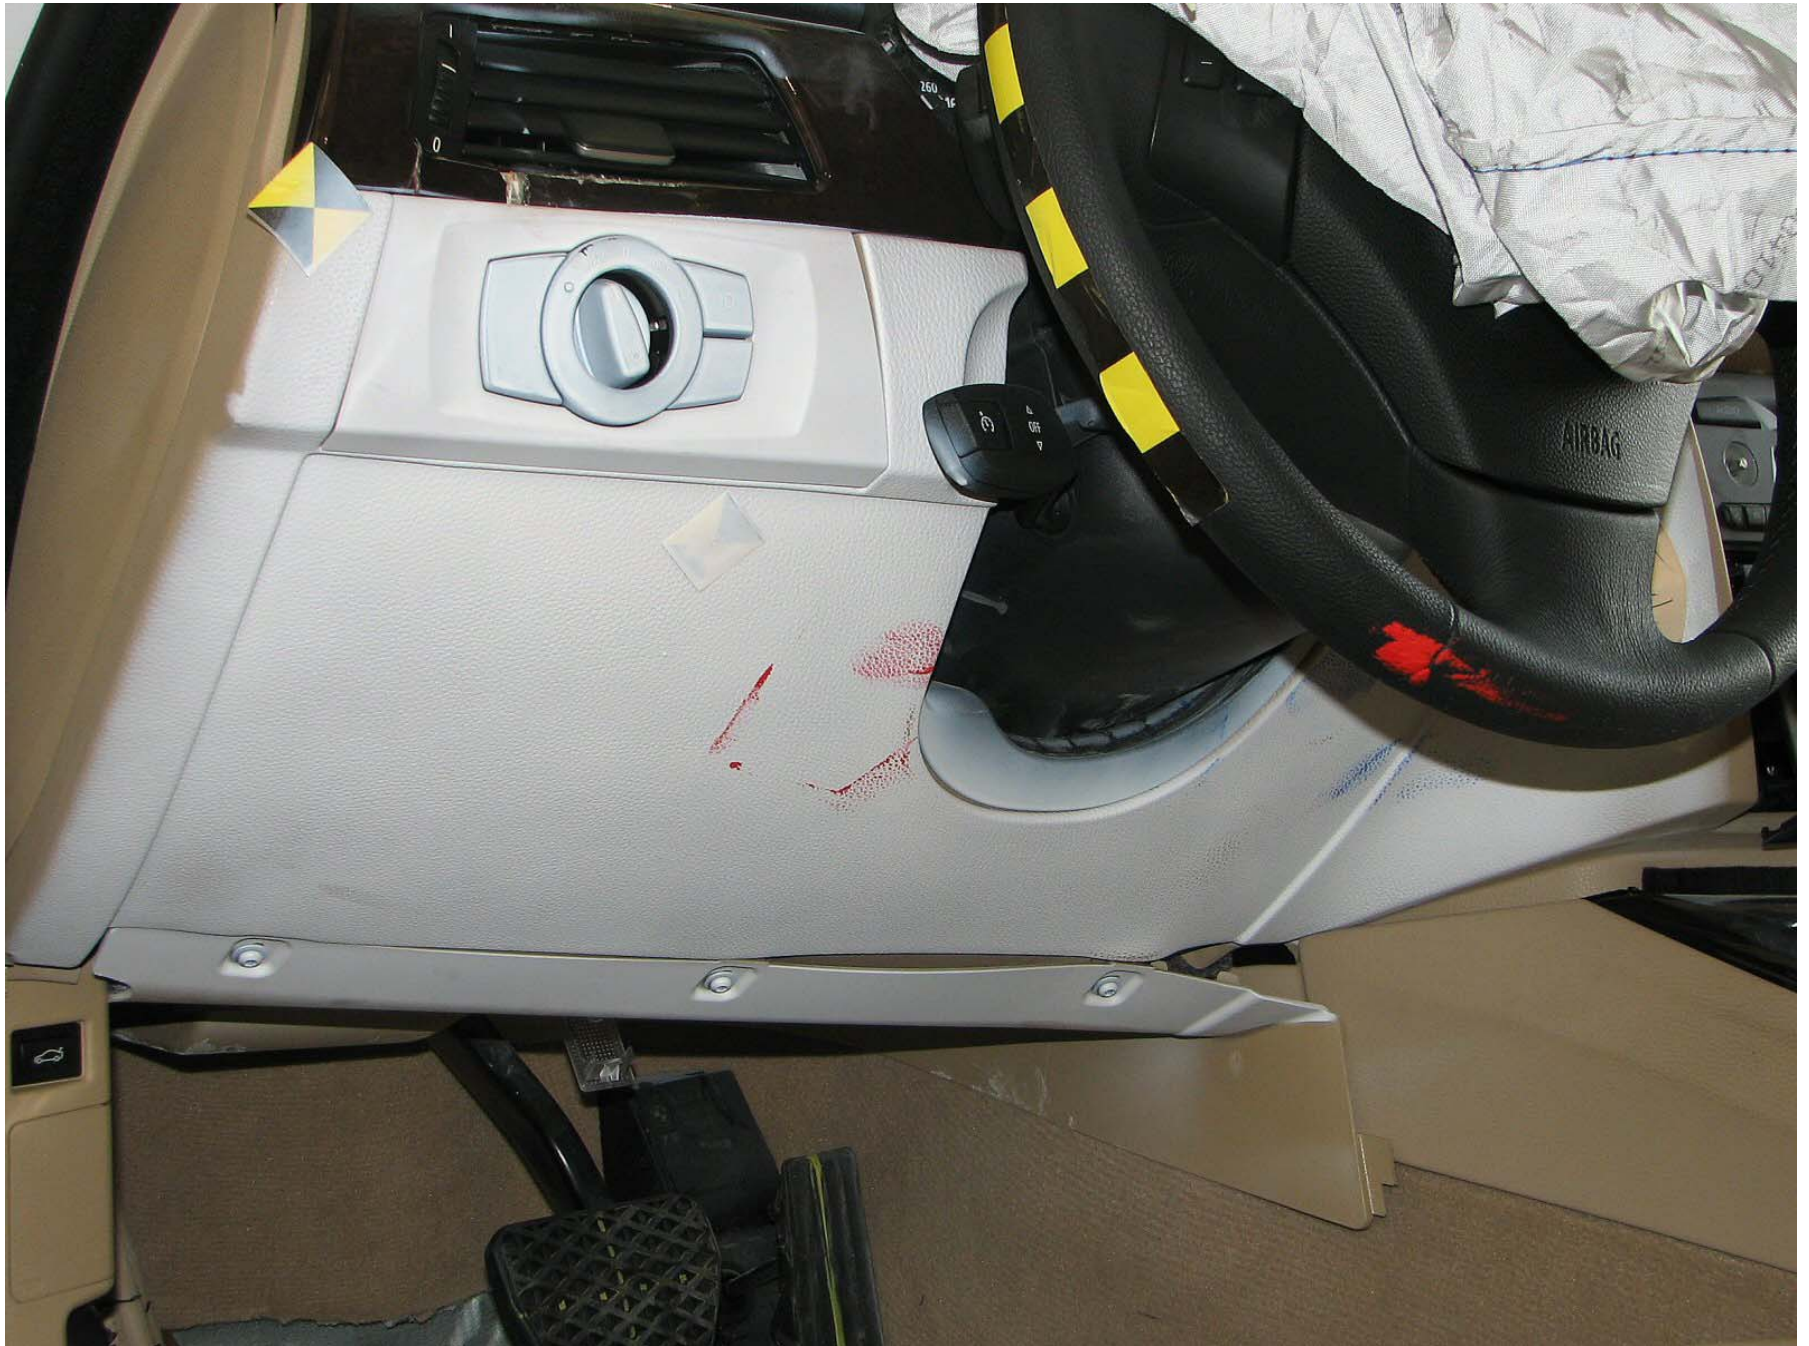
The driver's visible contact points were as follows: The driver ATD's head and chest contacted the airbag and the abdomen had no contact. Both knees contacted the knee bolster.

Figure A-39: Post-Test Driver Side Knee Bolster

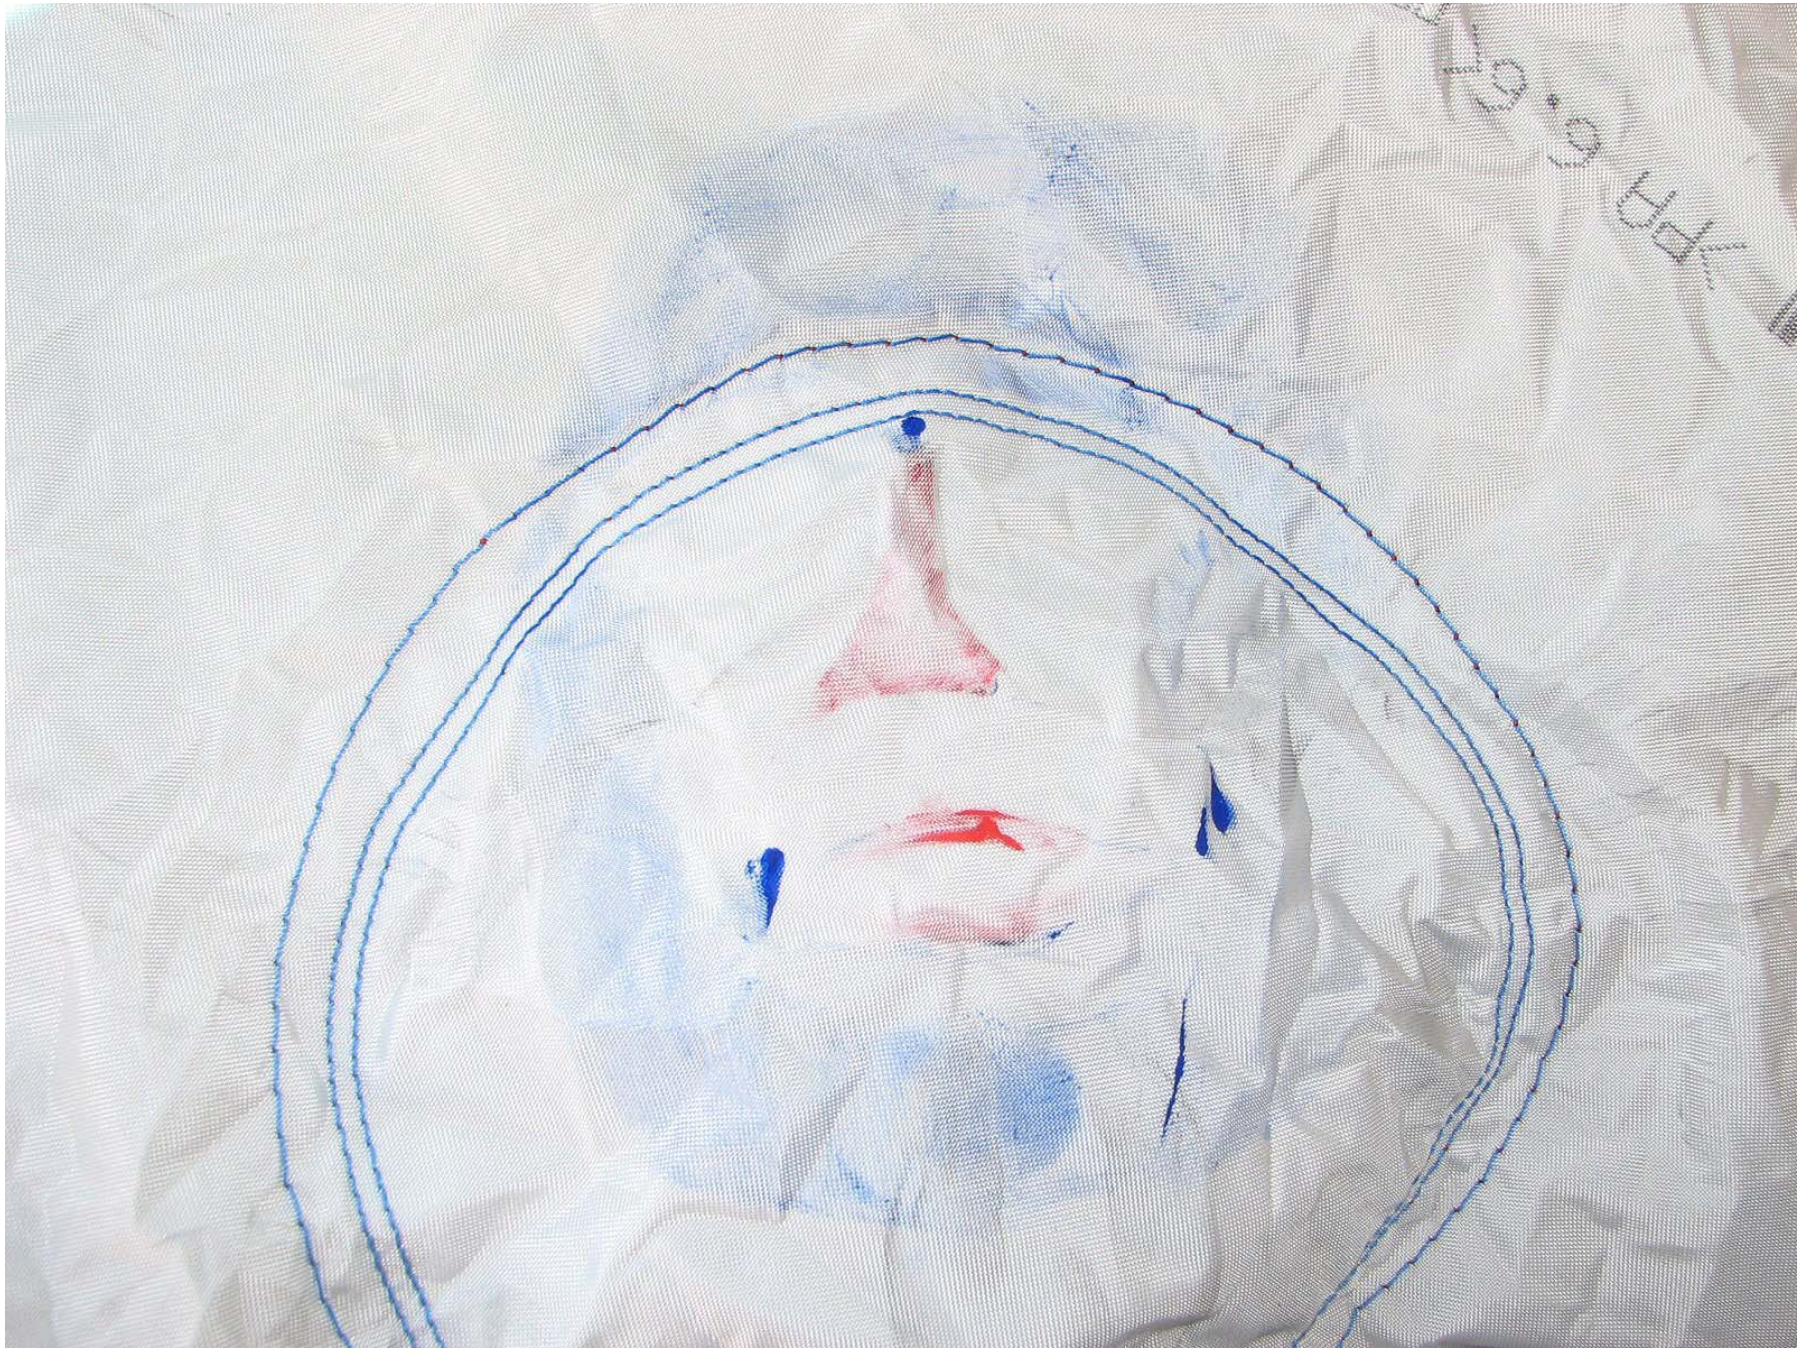
Figure A-43: Post-Test Driver Dummy Airbag Contact
