**REPORT NUMBER TR-P26001-09-NC**

**NEW CAR ASSESSMENT PROGRAM  
FRONTAL BARRIER IMPACT TEST**

**BAYERISCHE MOTOREN WERKE AG  
2006 BMW 325i  
4-DOOR SEDAN**

**NHTSA NUMBER: M60500**

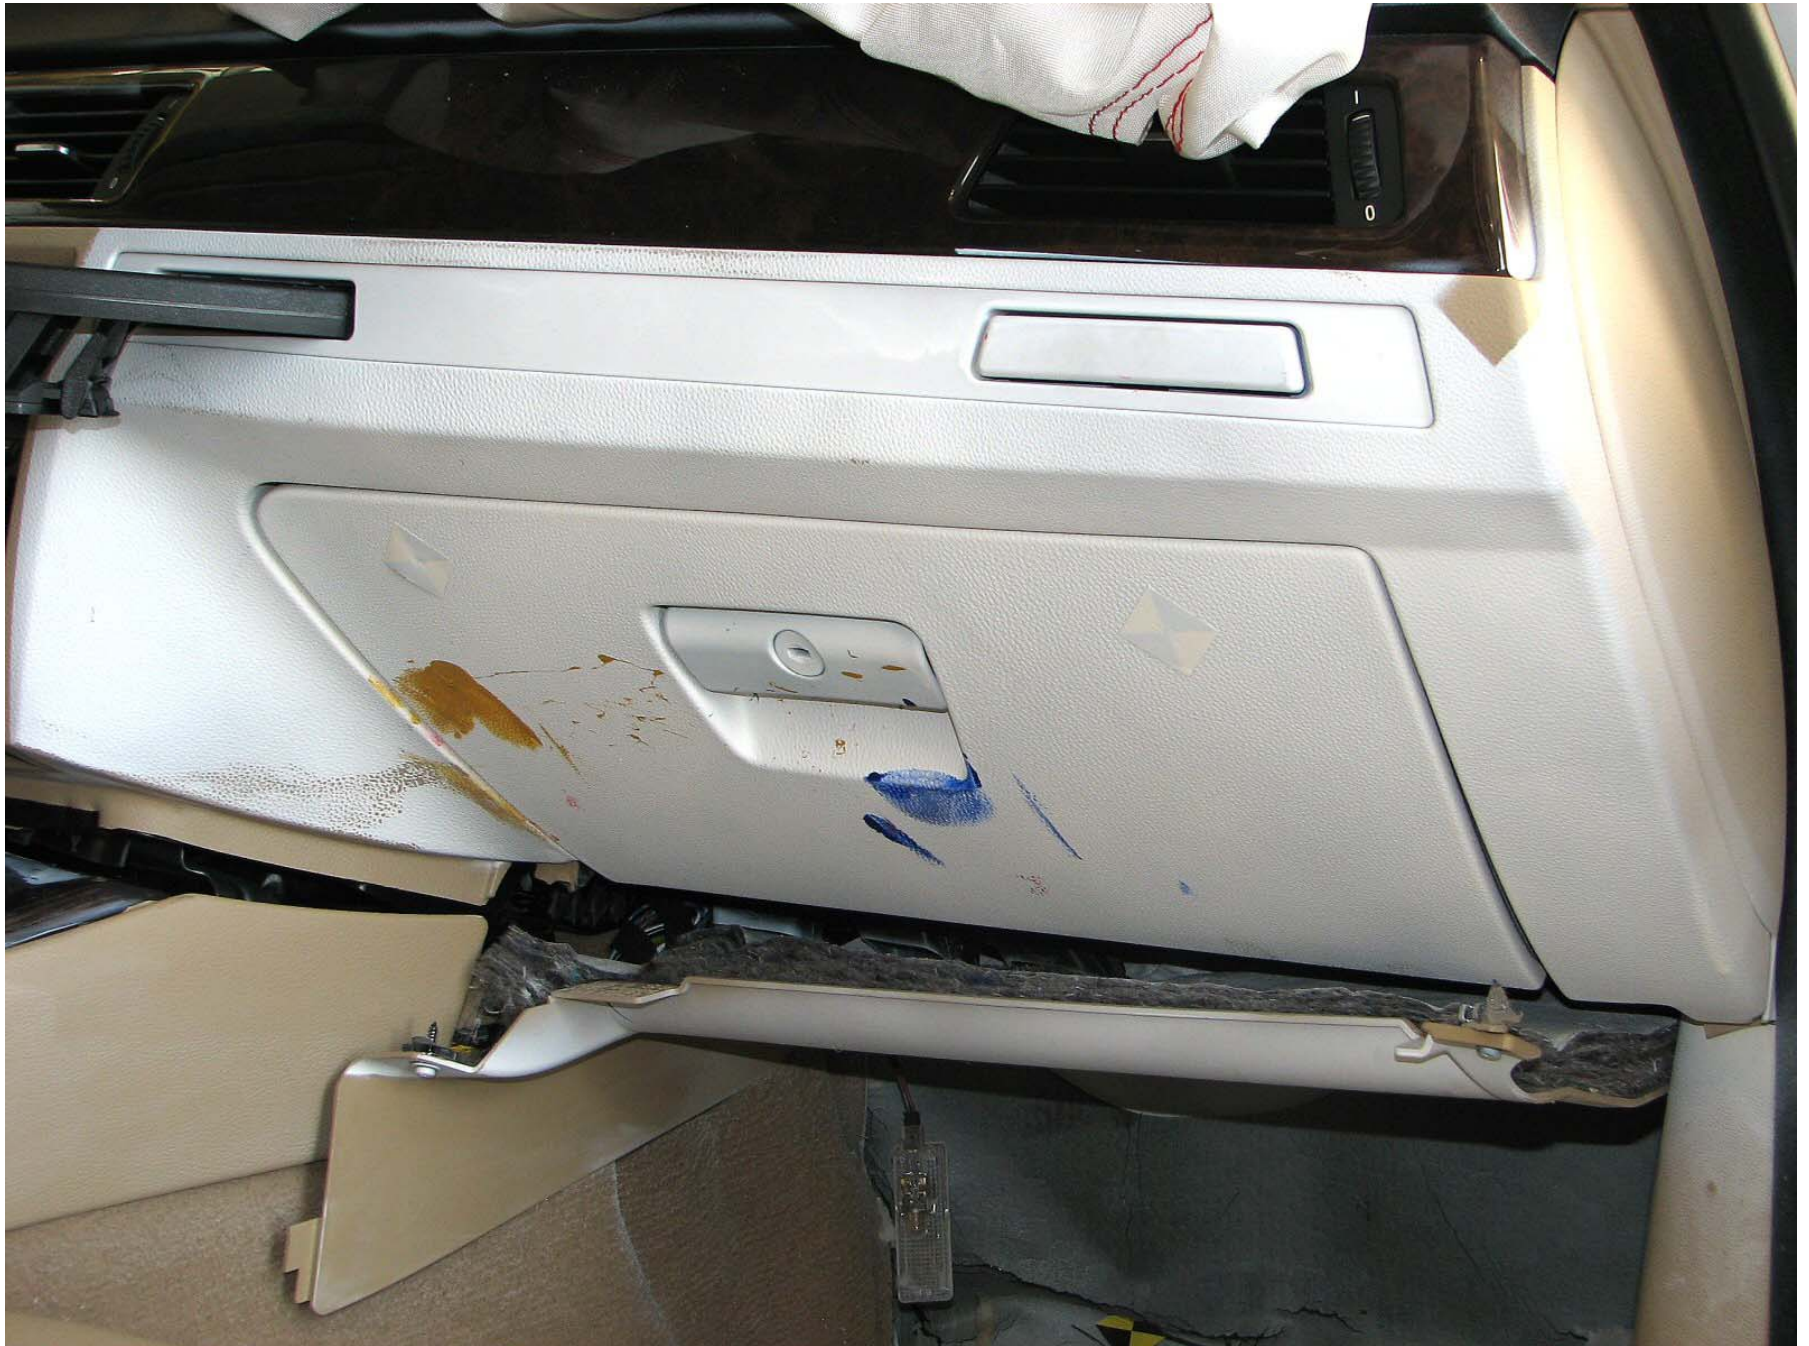
The passenger's visible contact points were as follows: The passenger ATD's head, chest and abdomen contacted the airbag. Both knees contacted the glove box.

Figure A-53: Post-Test Passenger Side Glove Box

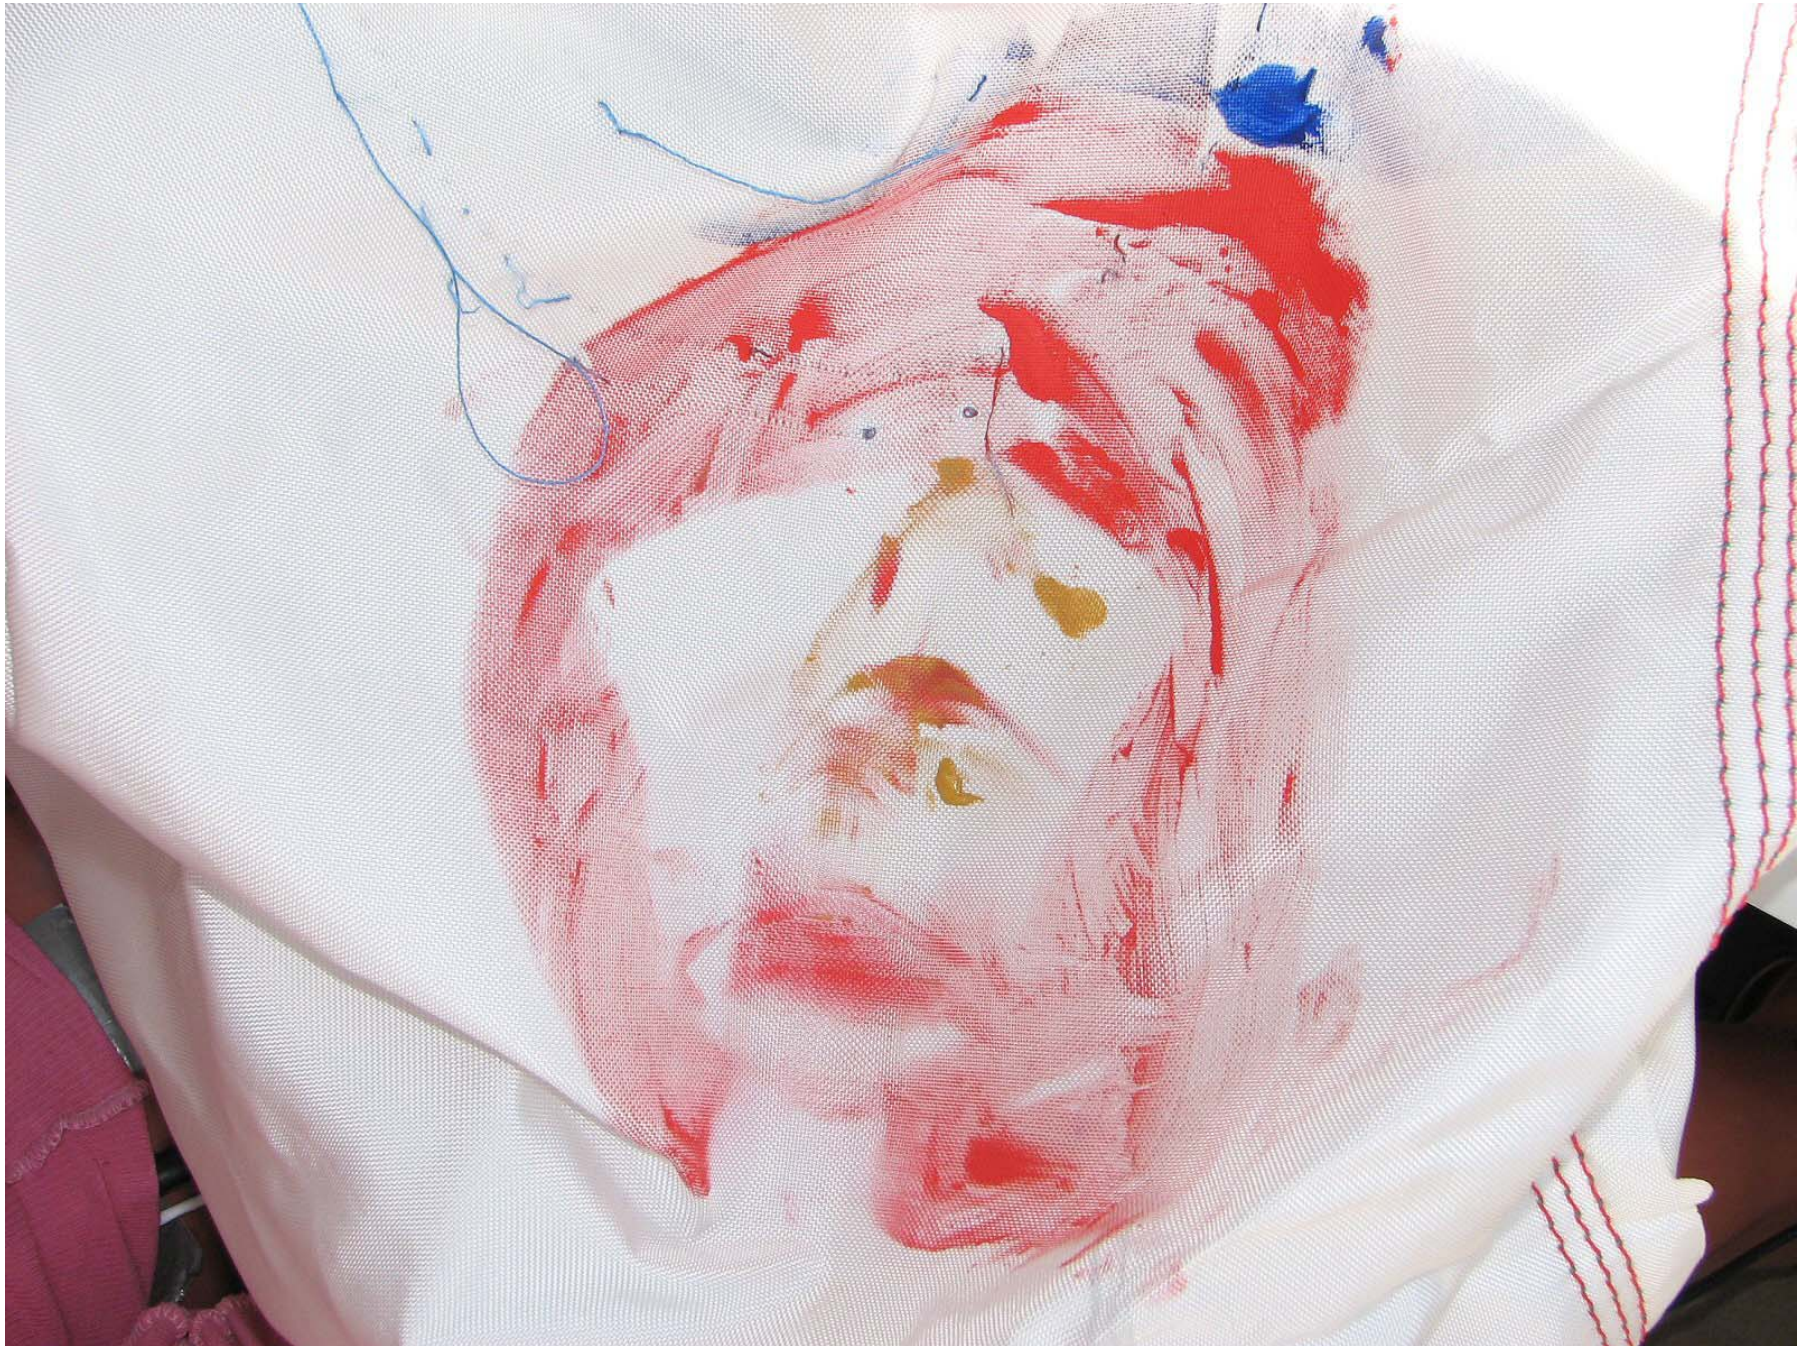
Figure A-57: Post-Test Passenger Dummy Airbag Contact

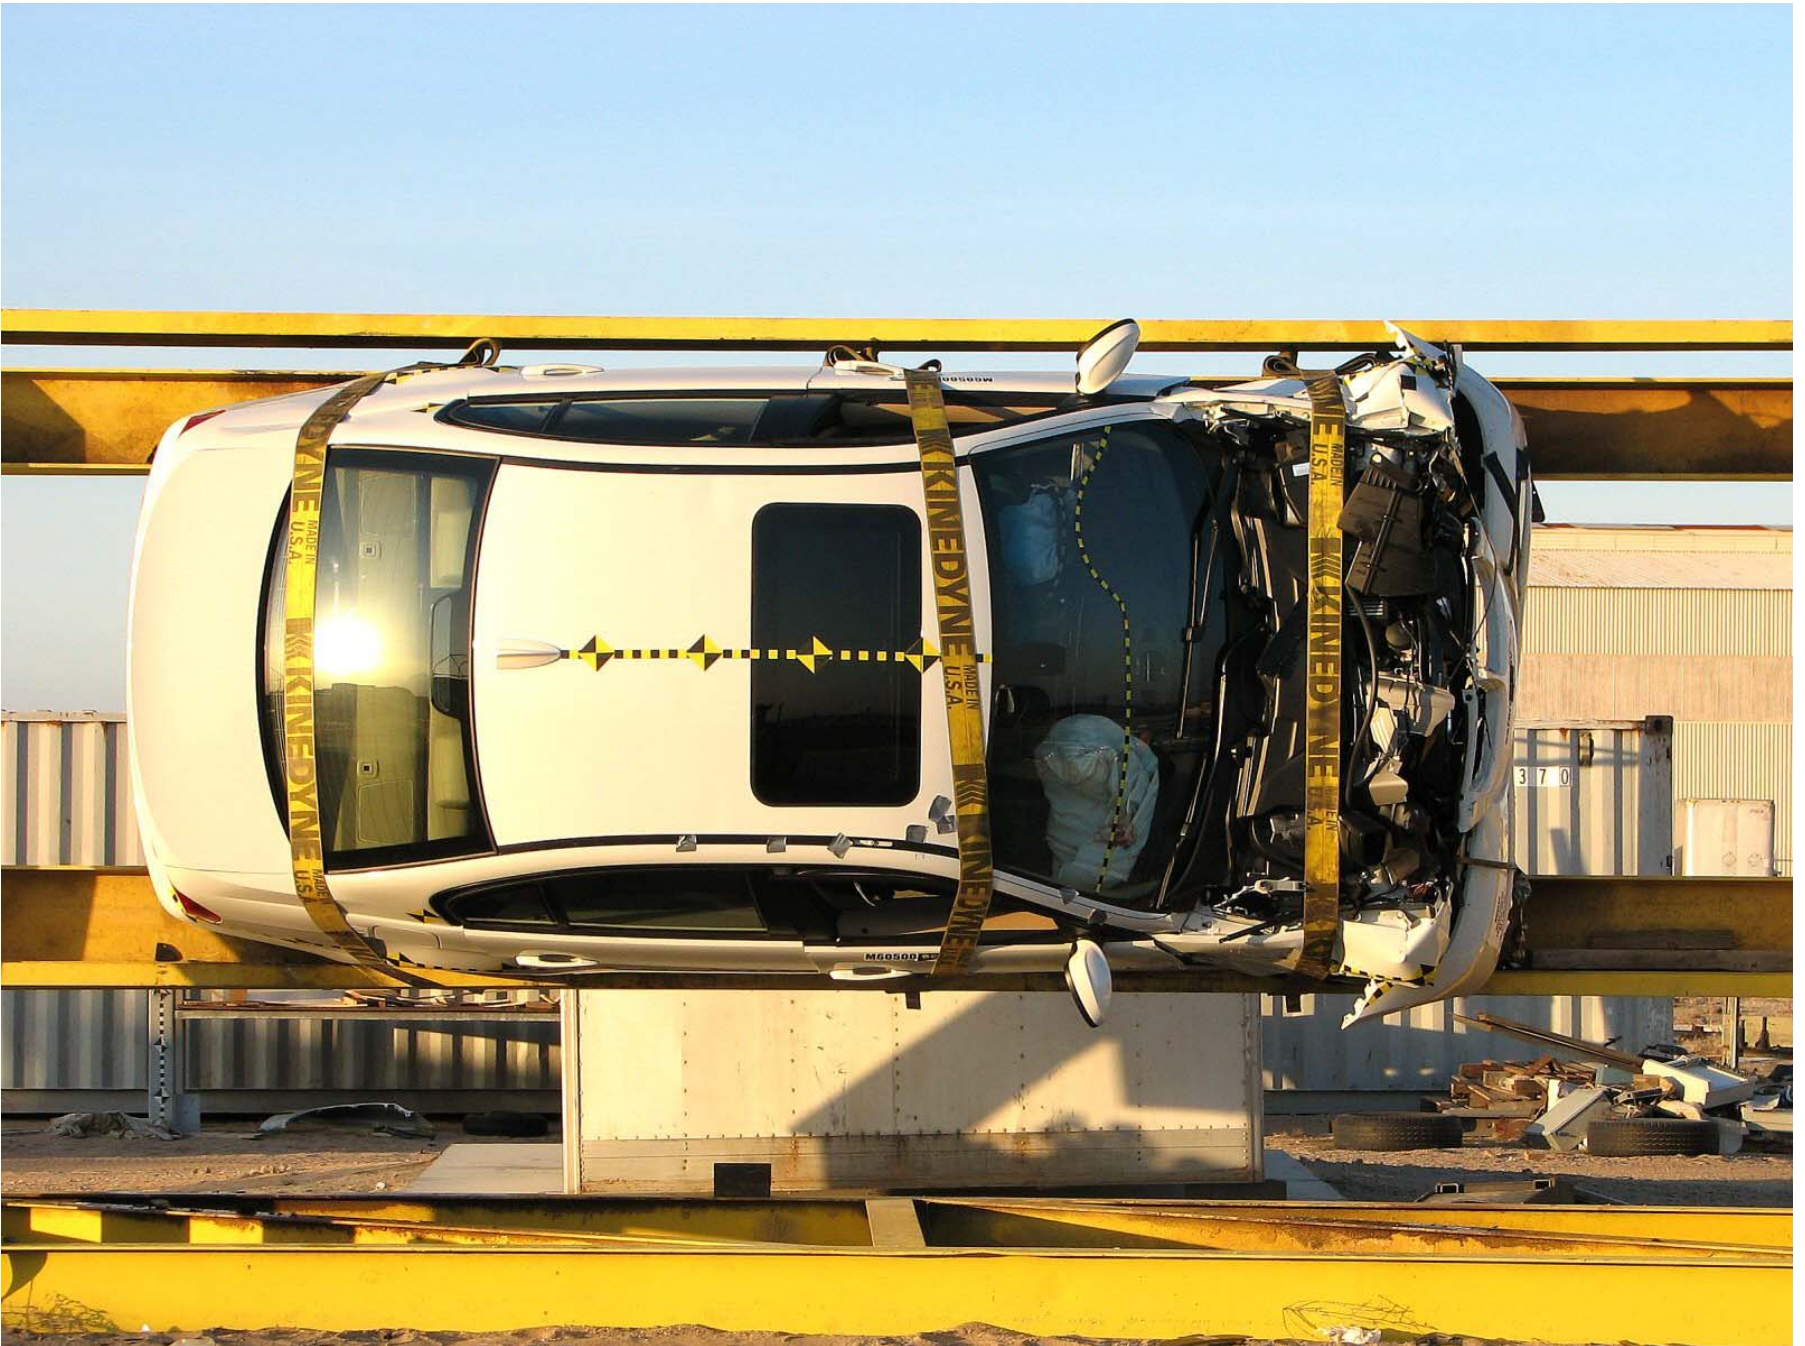
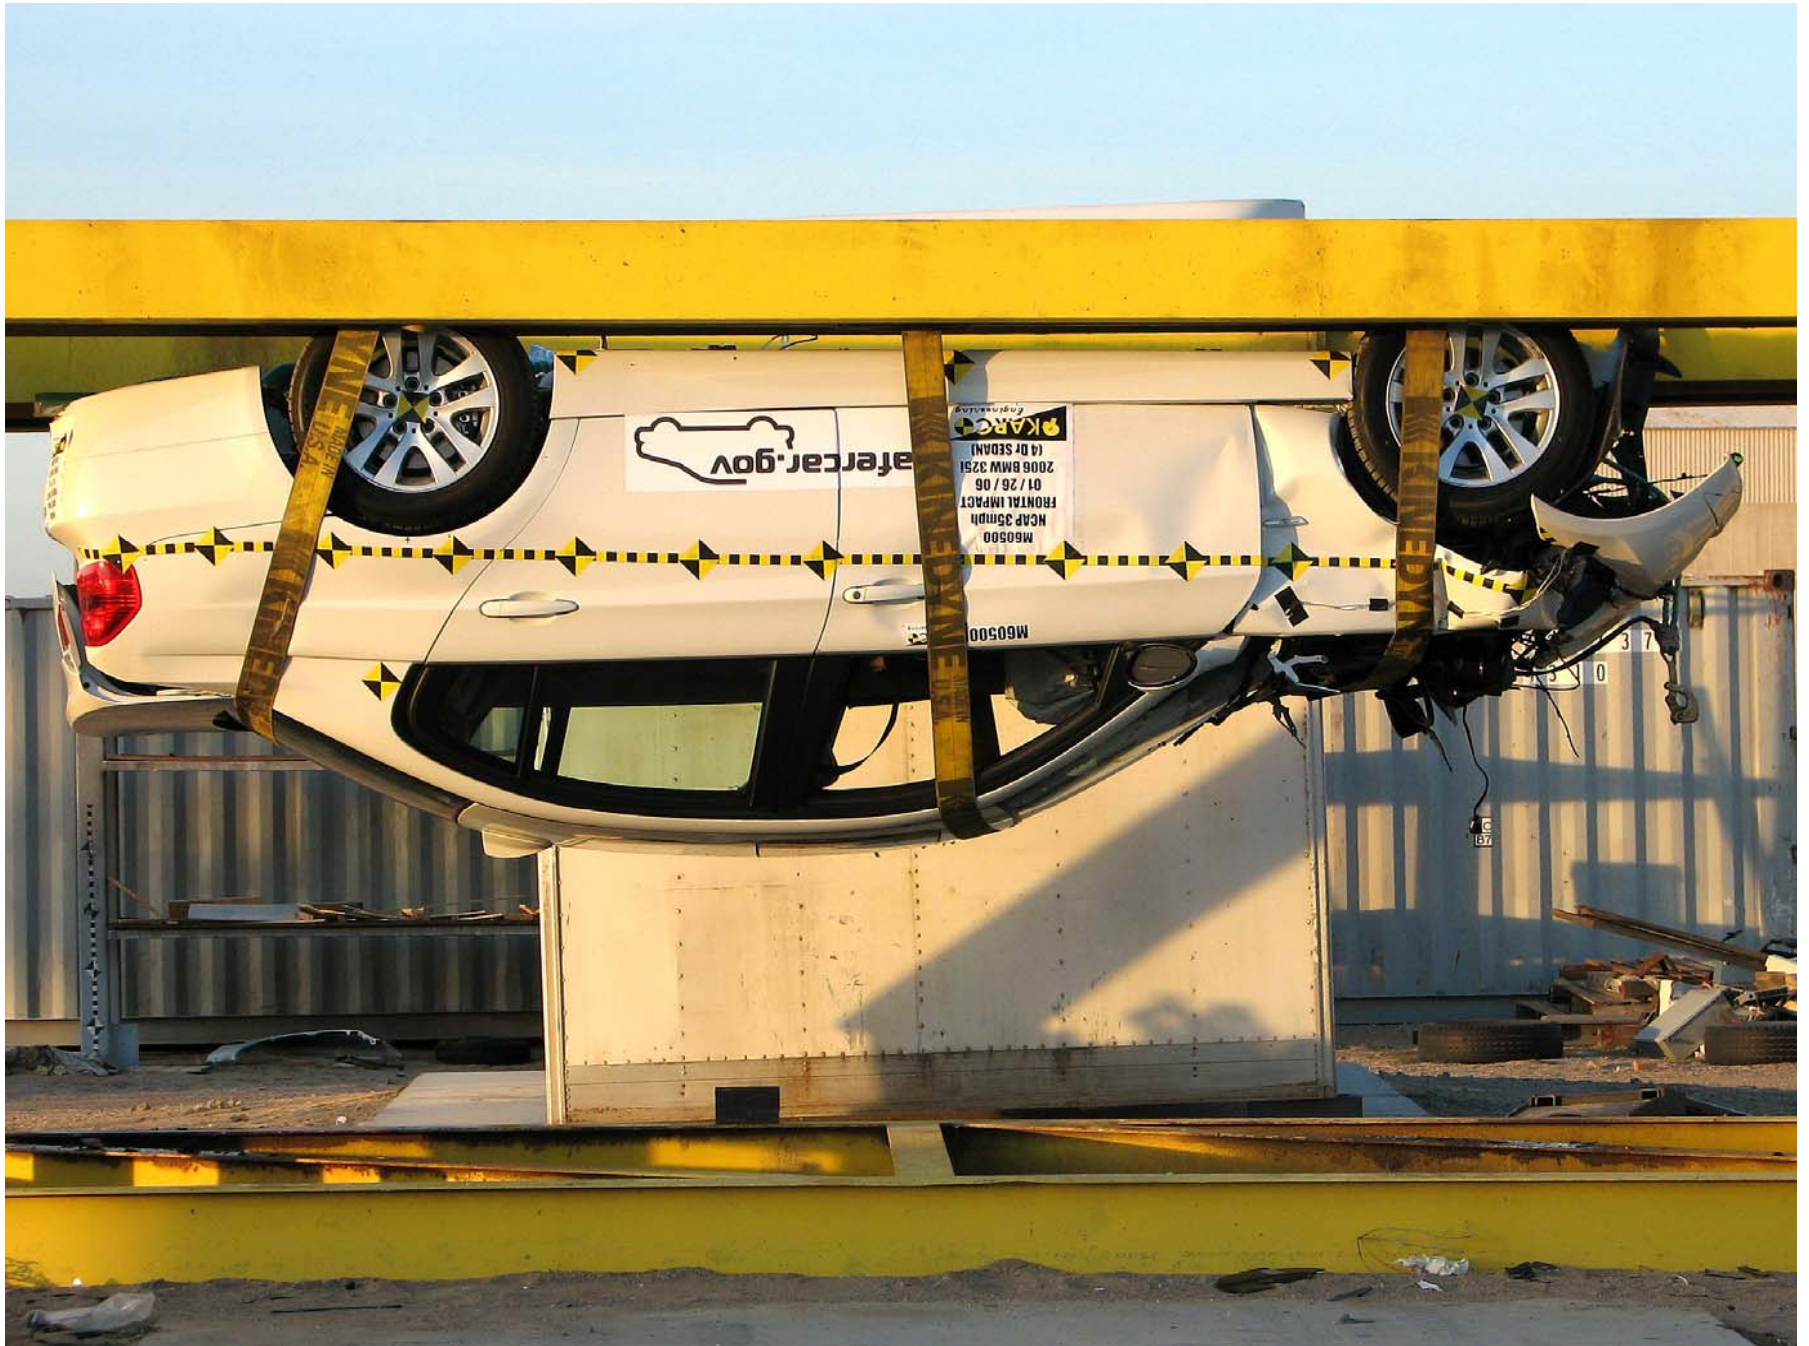
1. The specified fixture rollover rate for each 90° of rotation is 60 to 120 seconds.
2. The position hold time at each position is 300 seconds (minimum).
3. No solvent leakage occurred during rollover.

Figure A-58: Vehicle on Rollover Device (0°)

Figure A-59: Vehicle on Rollover Device (90°)

Figure A-60: Vehicle on Rollover Device (180°)

Figure A-61: Vehicle on Rollover Device (270°)

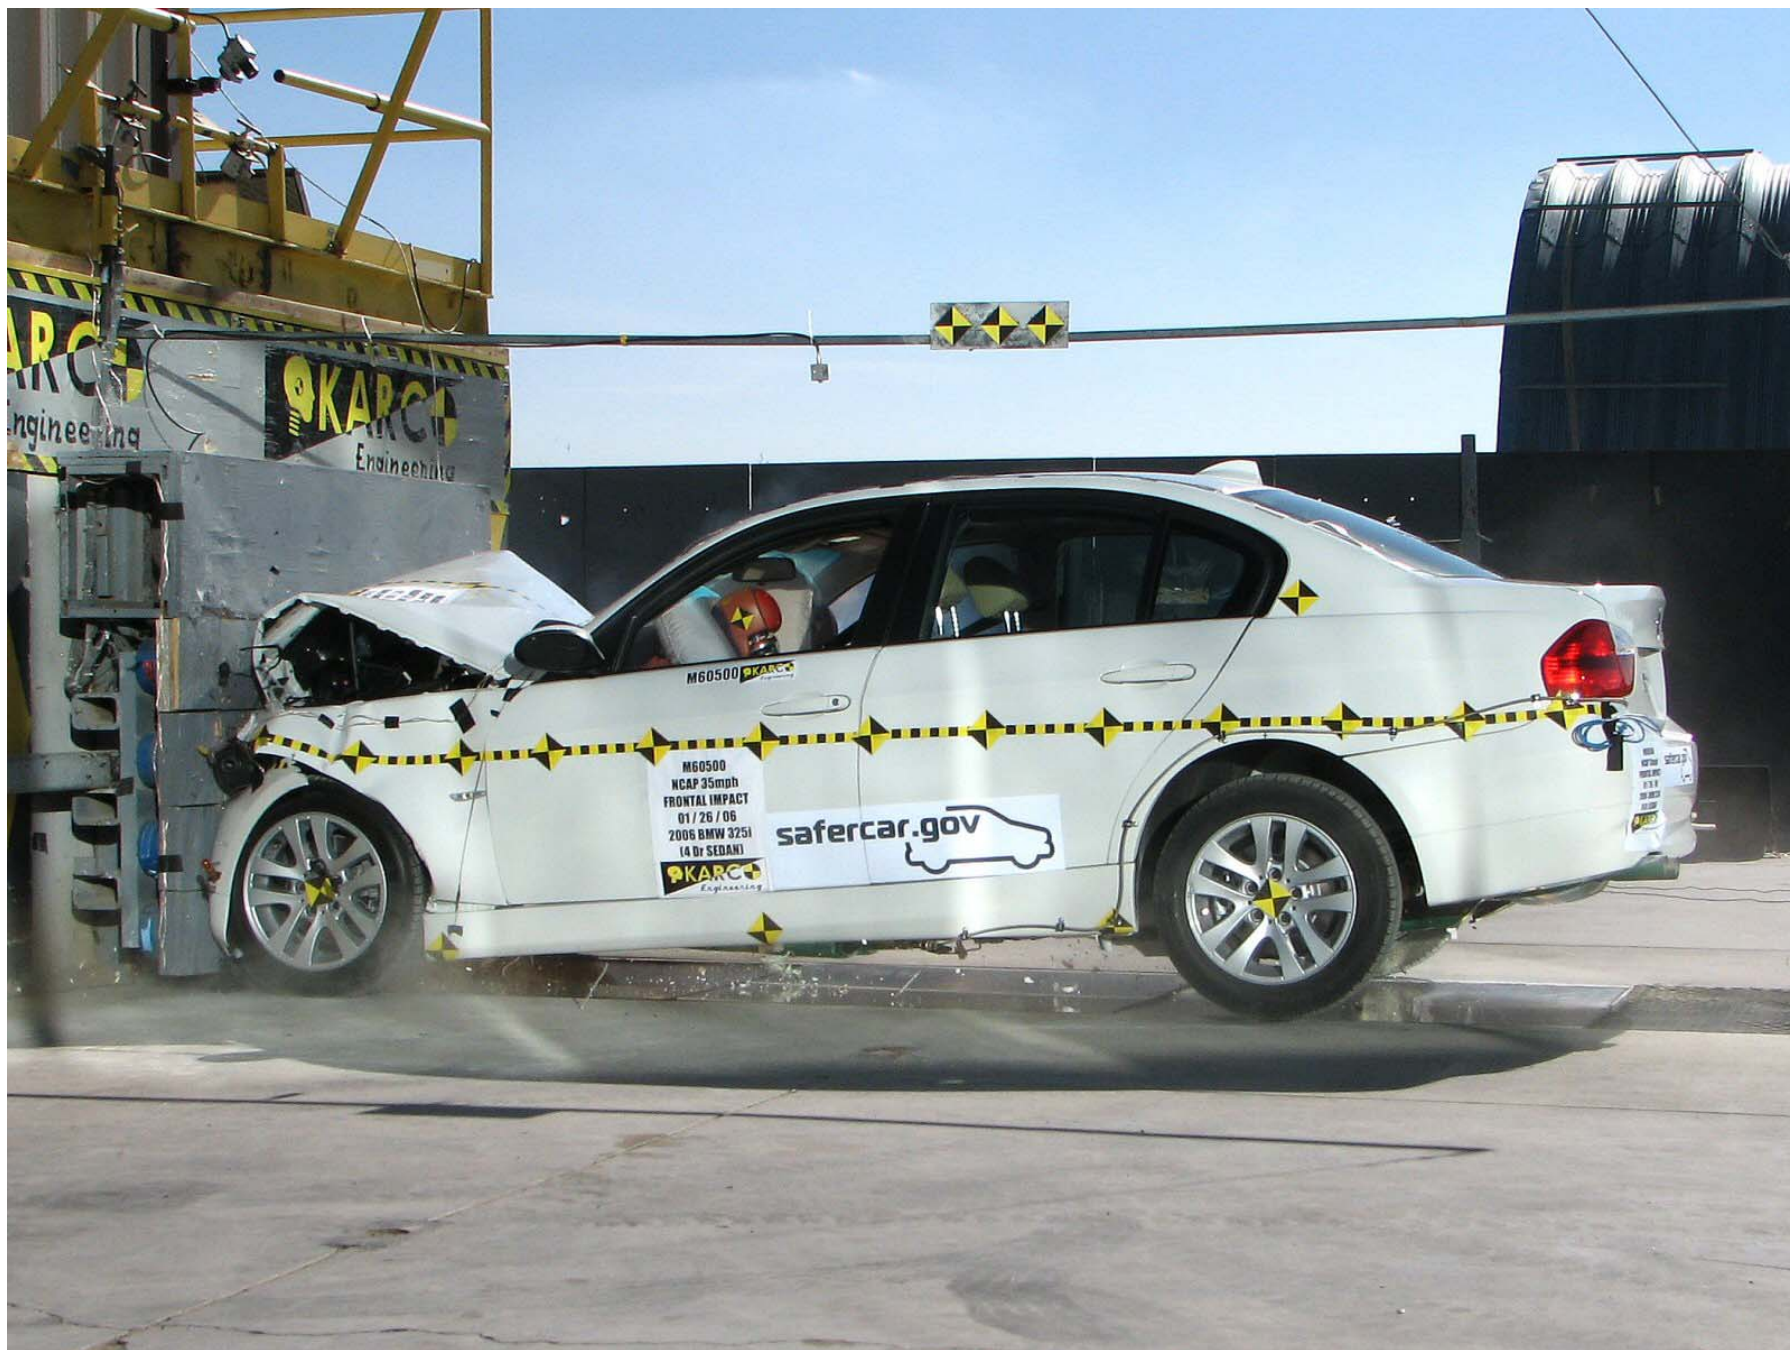
A load cell barrier consisting of 36 load cells was impacted by a 2006 BMW 325i 4-Door Sedan at a velocity of 56.02 km/h. The test was performed at Karco Engineering, LLC on January 26, 2006.

Figure A-62: Vehicle Impact

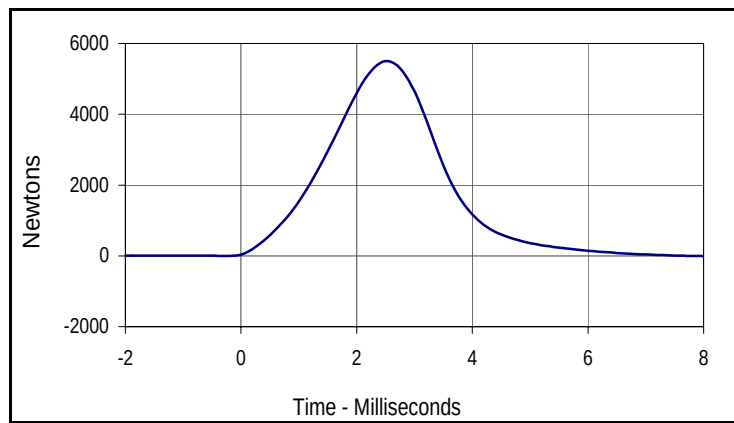
**Curve Description****Left Knee Probe Force**

| Peak Probe Force | Newtons | 4715 to 5782 | 5465 | Pass |
