REPORT NUMBER: NCAPSIDE-MGA-2006-008

**NEW CAR ASSESSMENT PROGRAM
SIDE IMPACT TEST**

**GENERAL MOTORS CORPORATION
2006 PONTIAC G6 GT
NHTSA NUMBER: M60117**

**PREPARED BY:
MGA RESEARCH CORPORATION
5000 WARREN ROAD
BURLINGTON, WI 53105**

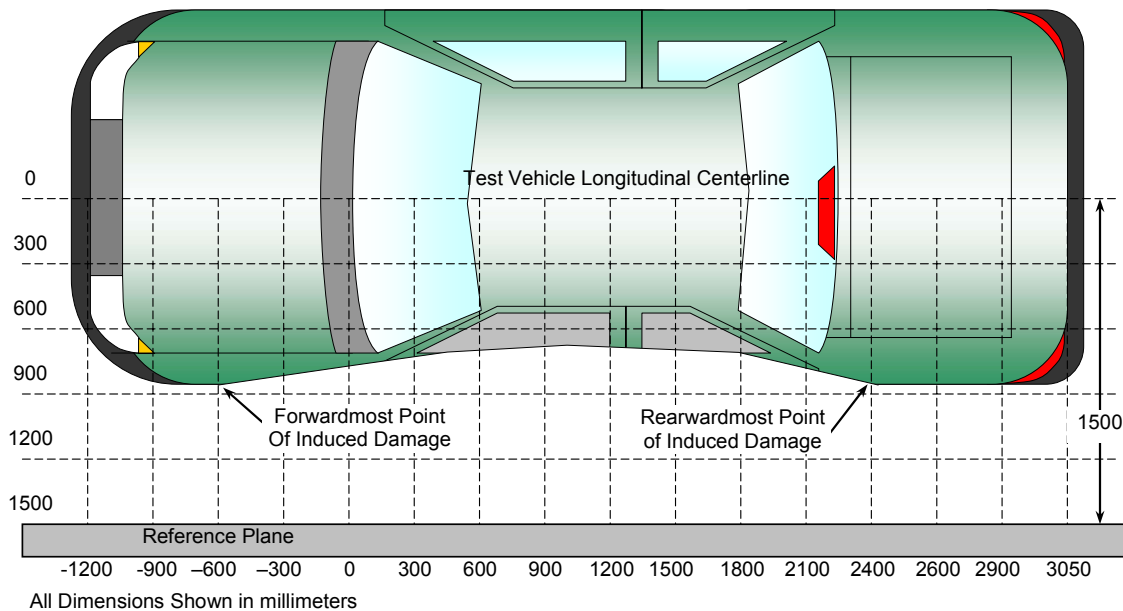
DATA SHEET NO. 11
VEHICLE DAMAGE PROFILE DISTANCES

TOP VIEW

DAMAGE PROFILE DISTANCES

The test vehicle sustained a maximum static crush of 262 mm at level 2, 600 mm rearward of the left vertical impact point. The driver and passenger SID/HIIIs, Serial Nos. 271 and 904 respectively, were calibrated just prior to this test.

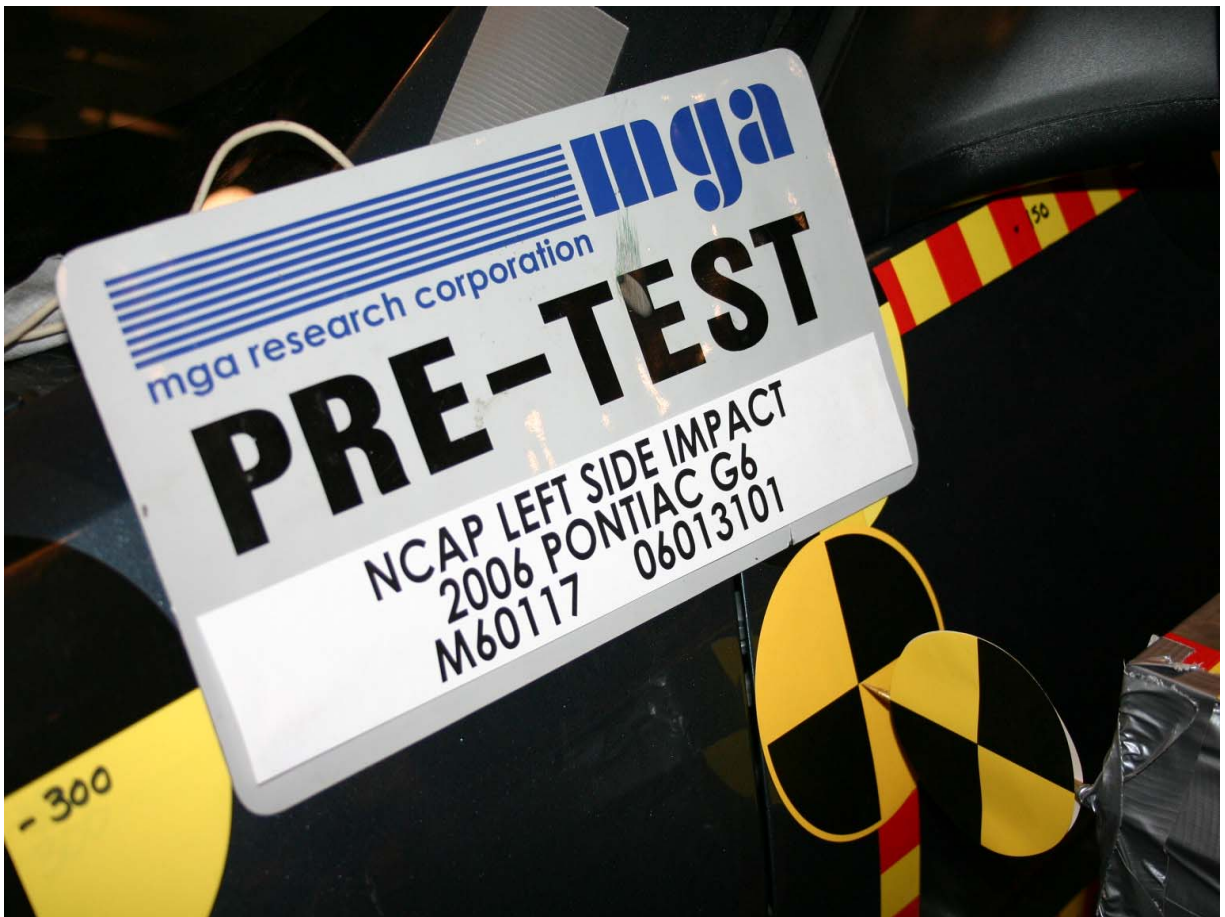
Pre-Test Left Impact Point

Post-Test Left Impact Point

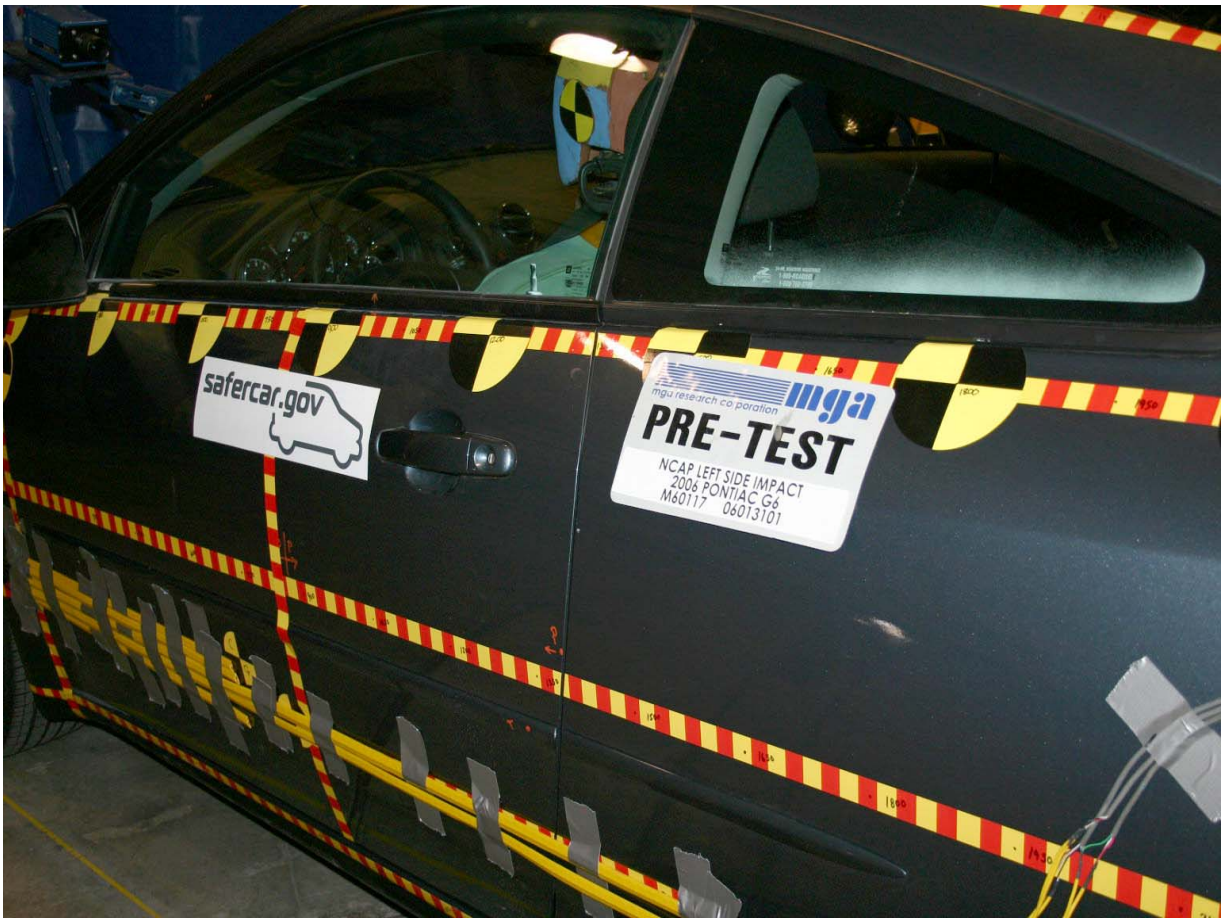
Pre-Test Left Door

Post-Test Left Door

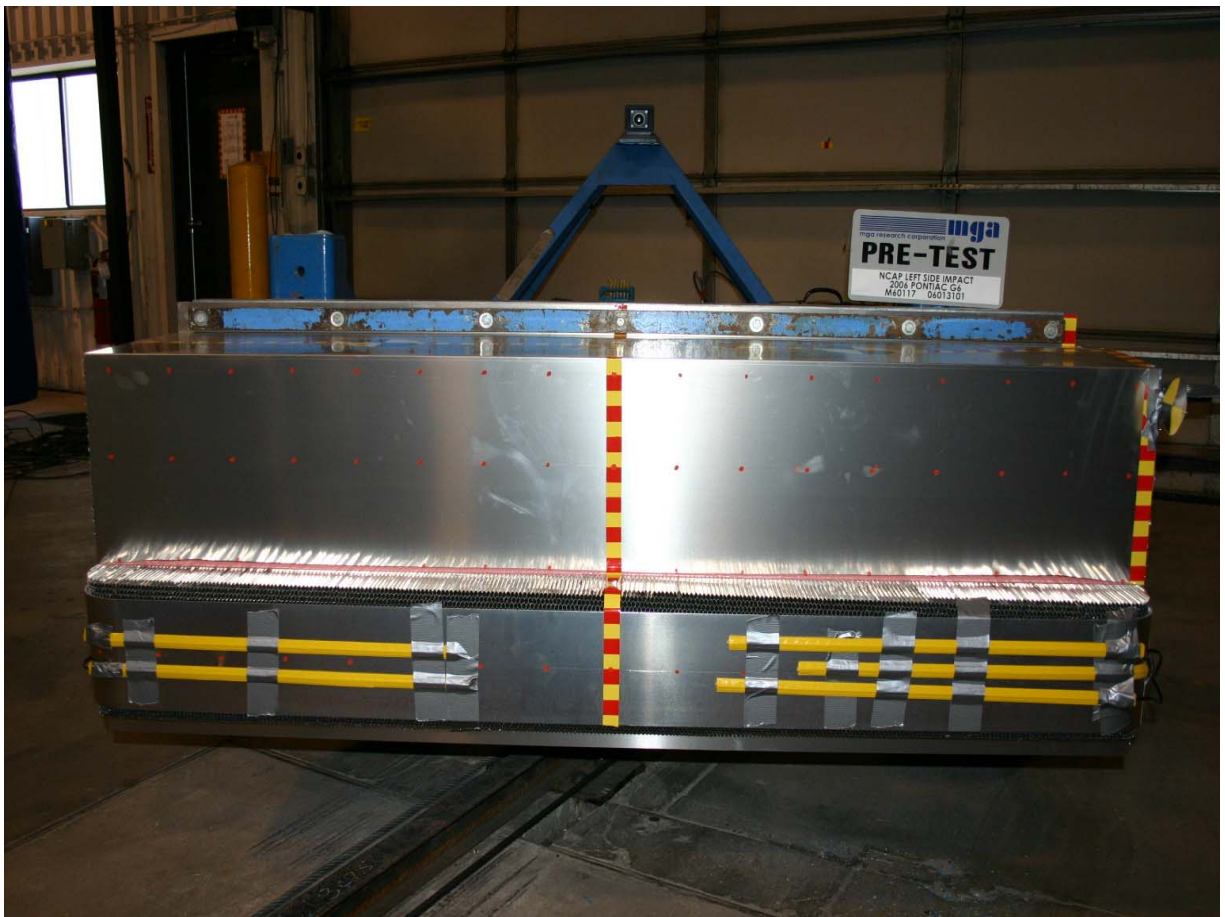
Pre-Test Front View of Deformable Barrier

Post-Test Front View of Deformable Barrier

The MDB bumper separated from the barrier and remained lodged in the vehicle.

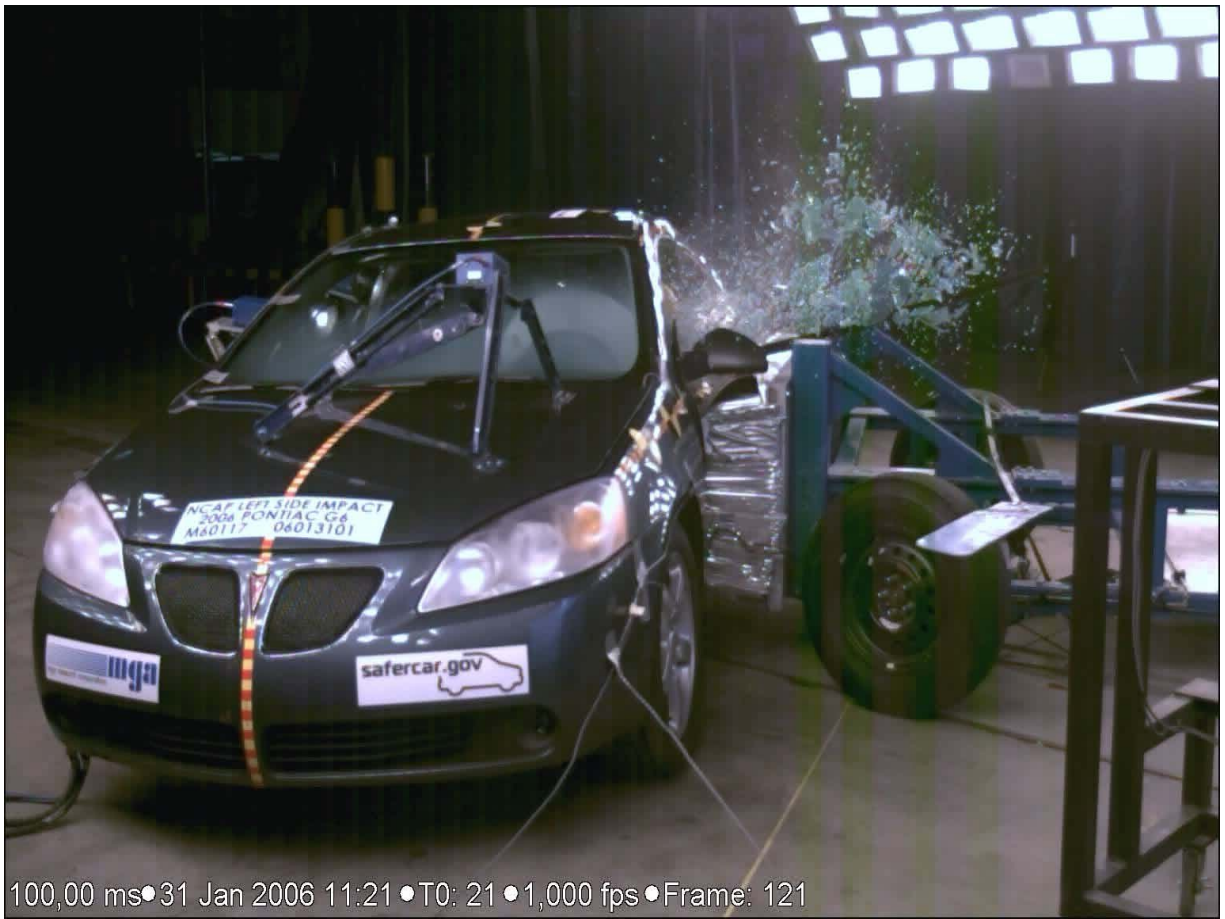
100,00 ms • 31 Jan 2006 11:21 • T0: 21 • 1,000 fps • Frame: 121

Vehicle Impact

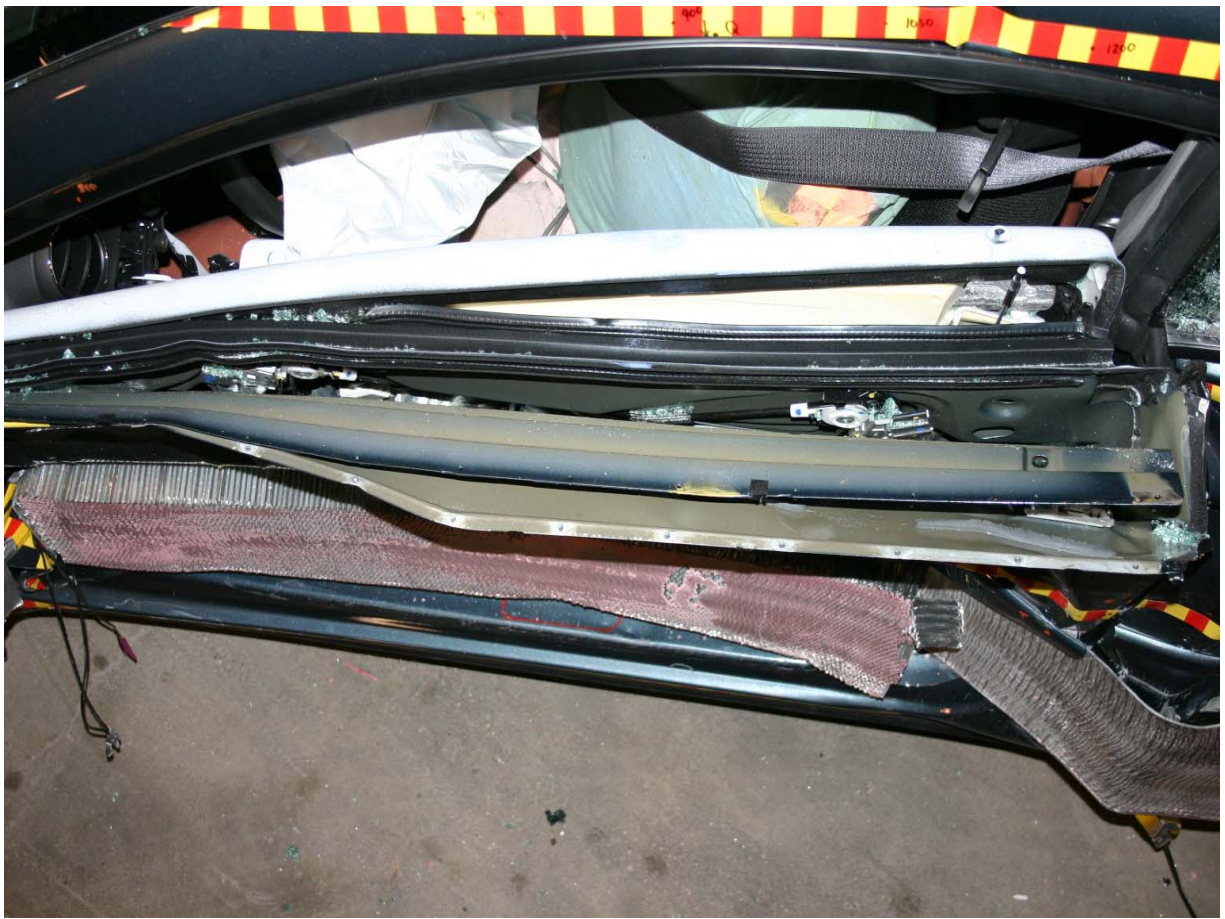
Left Door Outer Trim View #1

Critical Areas of Performance	Observations and Conclusions
Pillar Performance	No Separation
Sill Separation	None
Windshield Damage	None
Window Damage	Left Front Driver and Left Rear Passenger Window Broke
Other Notable Effects	The left front door outer trim came loose. See page A-36 for photos.

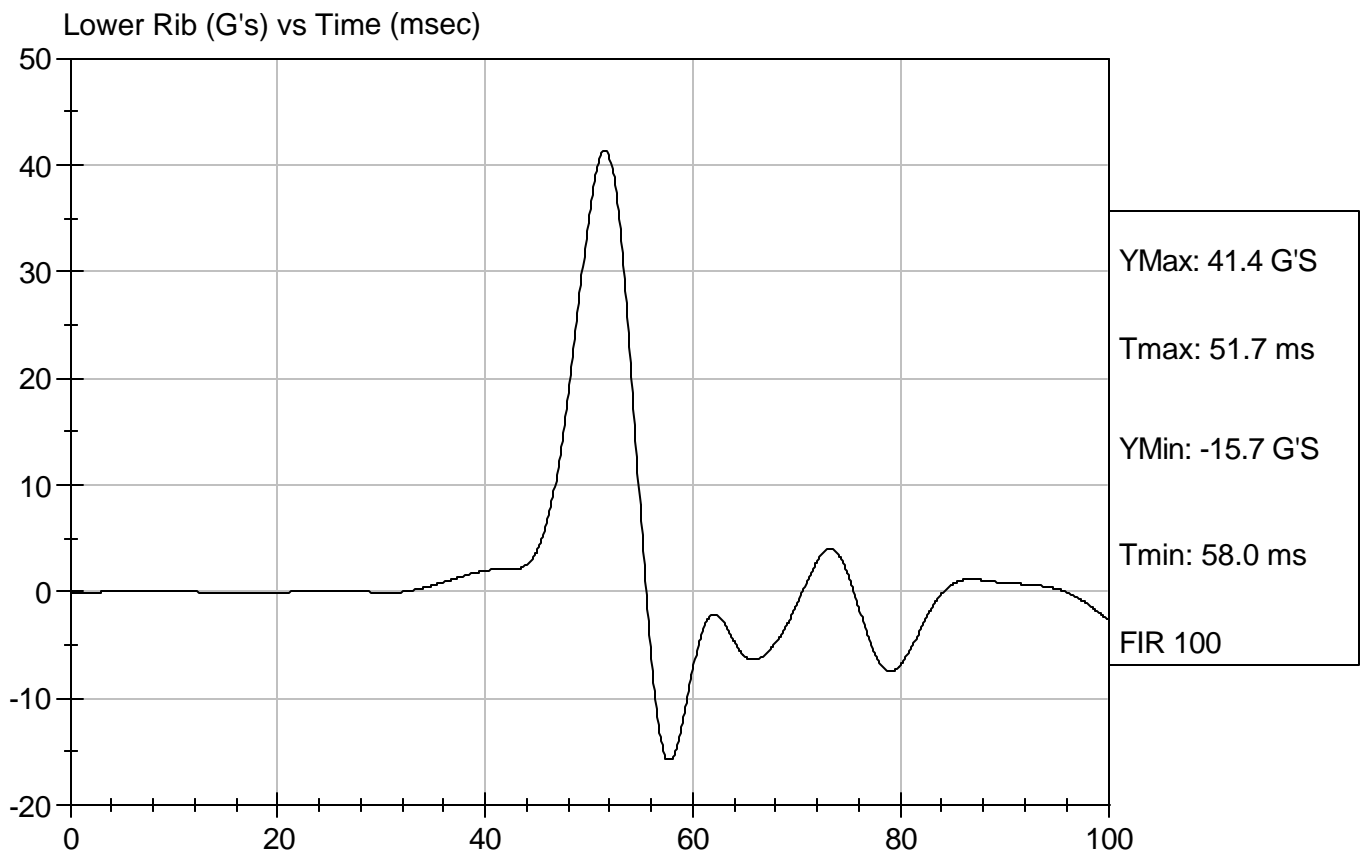
SID Calibration Data Sheet
Side Impact Dummy
Thorax Impact Test

Tested Parameter	Units	Specification	Result	Pass/Fail
Laboratory Temperature	deg C	18.9 - 25.5	20.7	Pass
Laboratory Relative Humidity	%	10 to 70	24	Pass
Probe Velocity	m/s	4.22 - 4.31	4.30	Pass
Upper Rib	G's	37 - 46	42	Pass
Lower Rib	G's	37 - 46	41	Pass
Lower Spine	G's	15 - 22	19	Pass
Overall Test Results				Pass
