REPORT NUMBER: CAL-06-12

**NEW CAR ASSESSMENT PROGRAM (NCAP)  
FRONTAL BARRIER IMPACT TEST**

SUZUKI MOTOR CORPORATION  
2006 SUZUKI GRAND VITARA  
MPV

NHTSA NUMBER: M60517

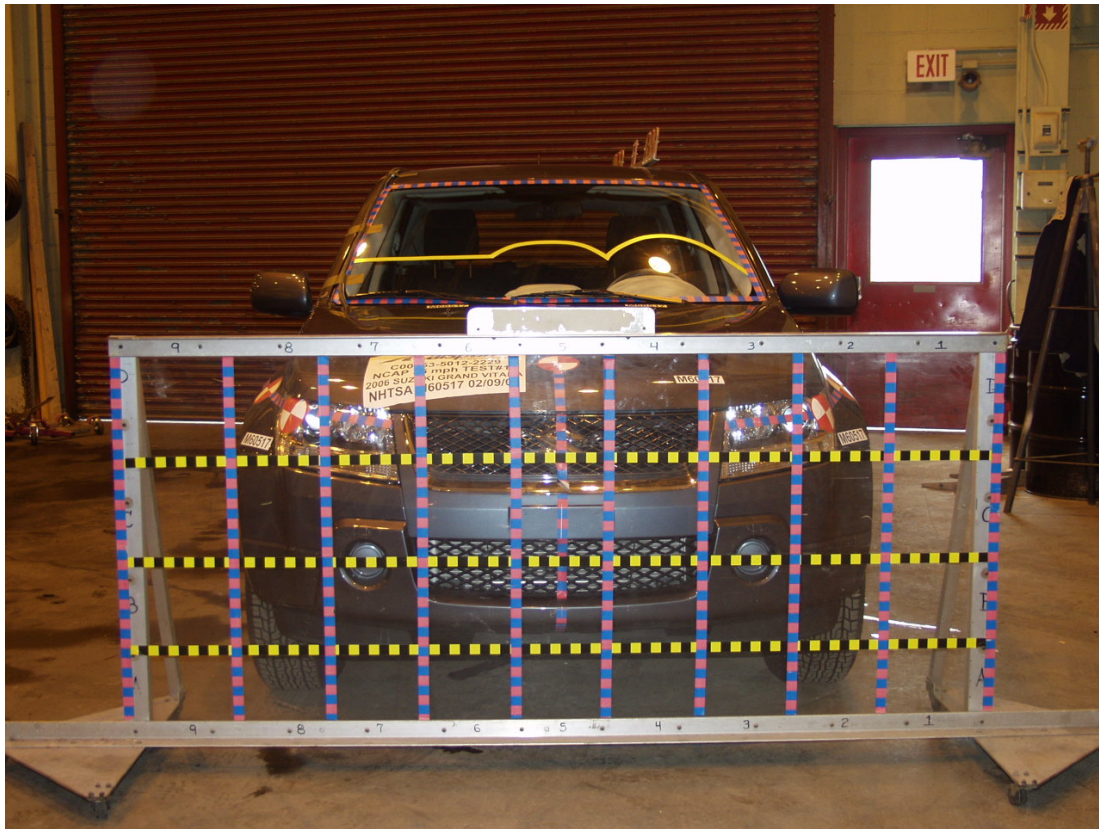
**Figure A-1: Load Cell Locations**

A load cell barrier consisting of 36 load cells was impacted by a 2006 Suzuki Grand Vitara MPV at a velocity of 56.81 kph. The test was performed at Calspan on February 9, 2006. Pre- and post-test photographs of the vehicle and dummies can be found in Appendix A.

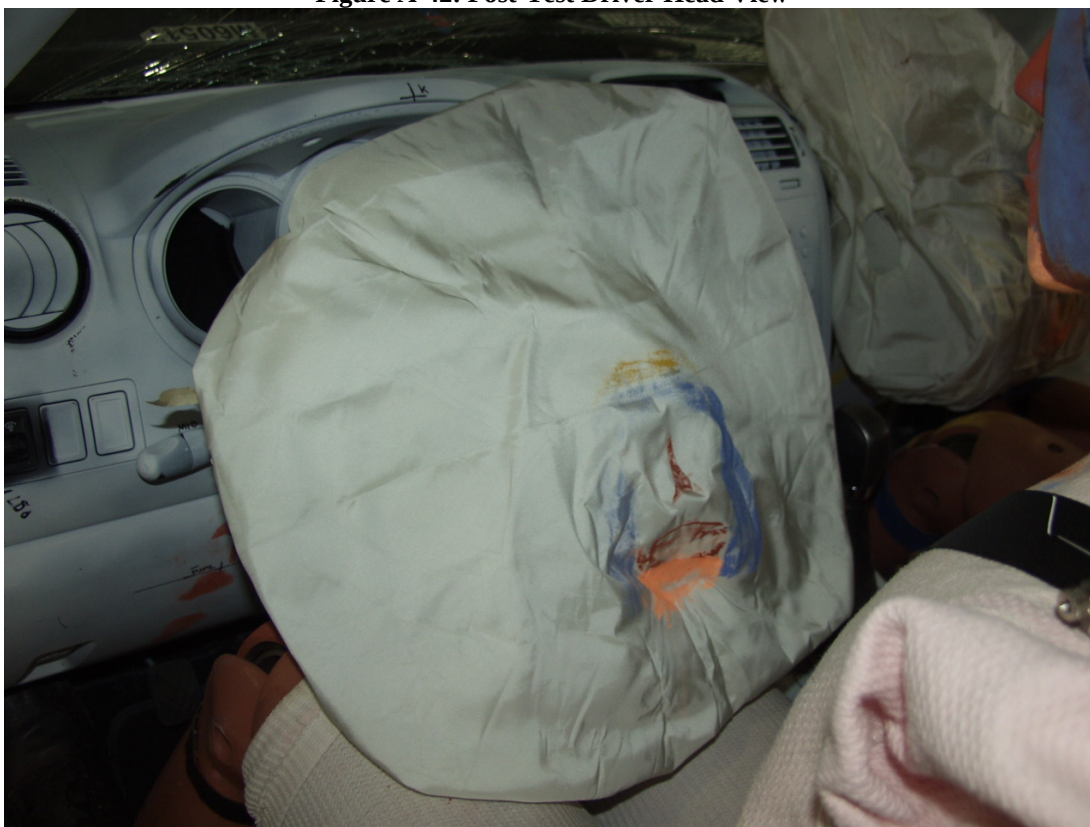
**Figure A-43: Post-Test Driver Contact to Airbag**

| | DRIVER | PASSENGER |
|---|---|---|
| Head Contact: | Face to upper half of airbag; Back of head to outboard half of head restraint | Face to center of airbag; Top of head to outboard half of sun visor |
