**NEW CAR ASSESSMENT PROGRAM (NCAP)  
FRONTAL BARRIER IMPACT TEST**

KIA MOTORS CORPORATION  
2006 KIA SEDONA  
MINIVAN

NHTSA NUMBER: M60512

CALSPAN TEST NUMBER: 8642-NCAP-69

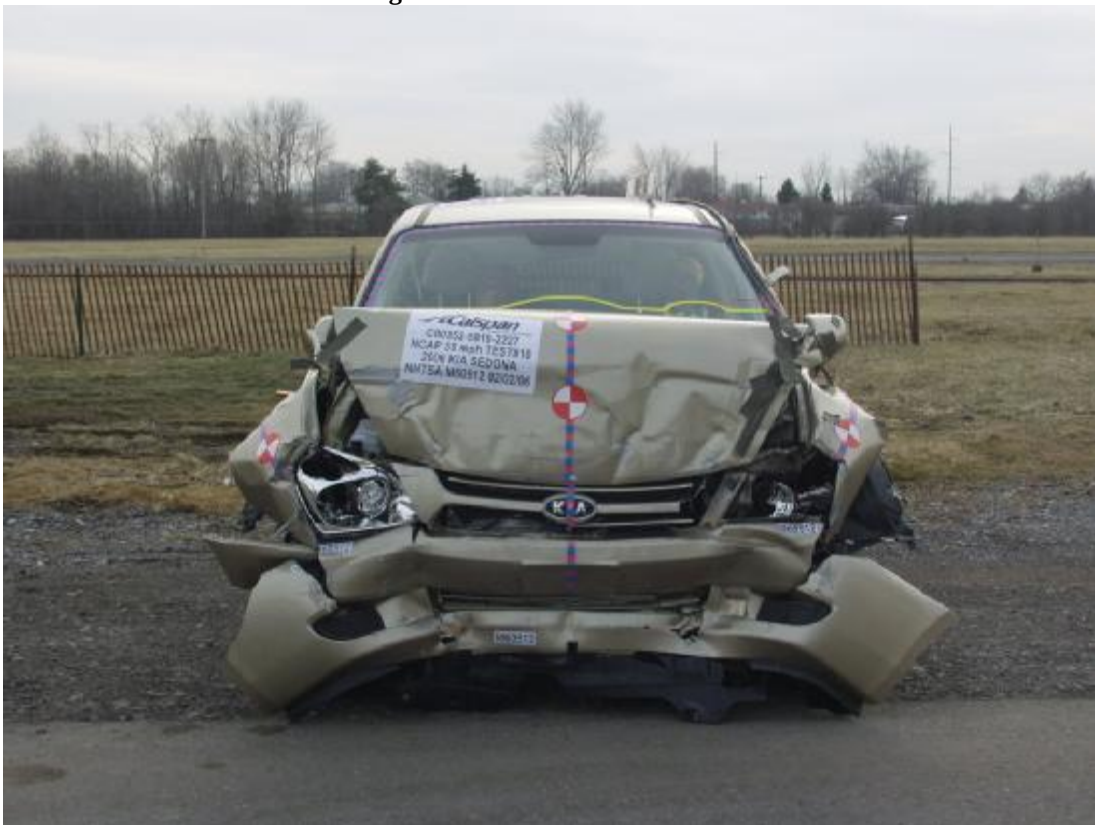
**Figure A-7: Post-Test Front View**

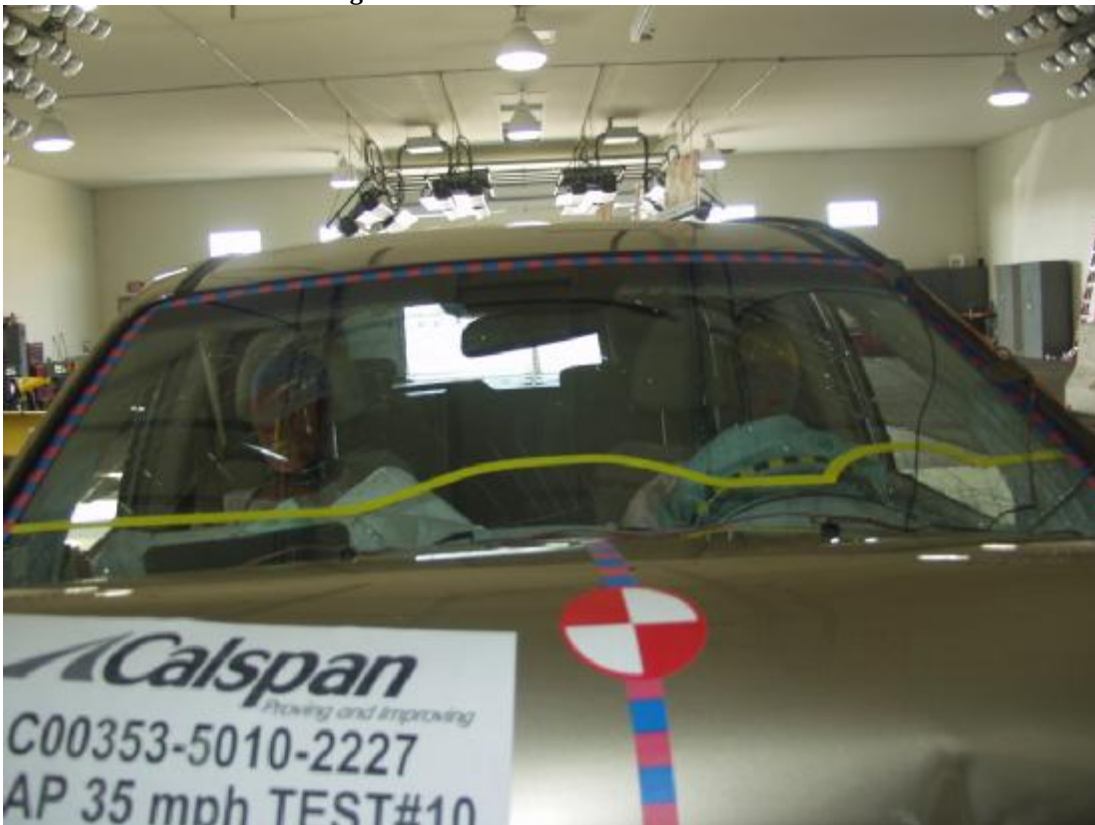
Figure A-19: Post-Test Windshield View

| Description | Driver Side | Passenger Side |
|---|---|---|
| Glazing Damage | The windshield was cracked along its bottom. | |

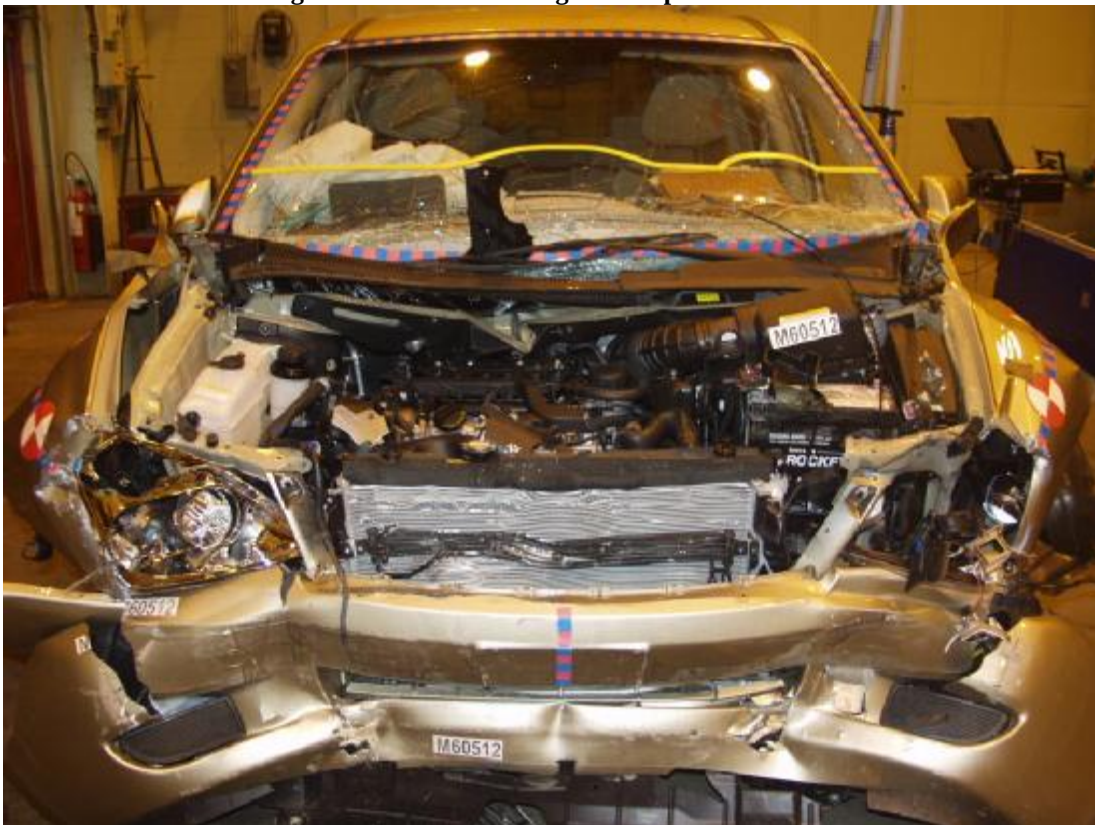
**Figure A-21: Post-Test Engine Compartment View**

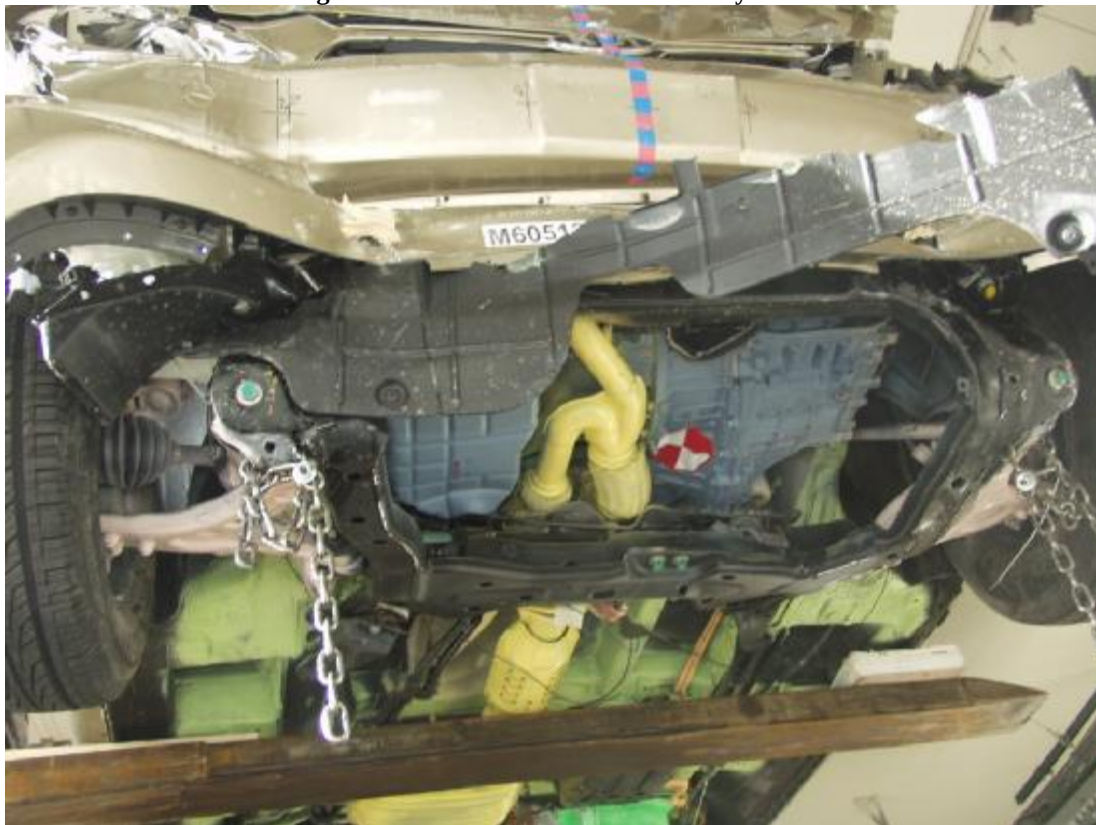
**Figure A-25: Post-Test Front Underbody View**

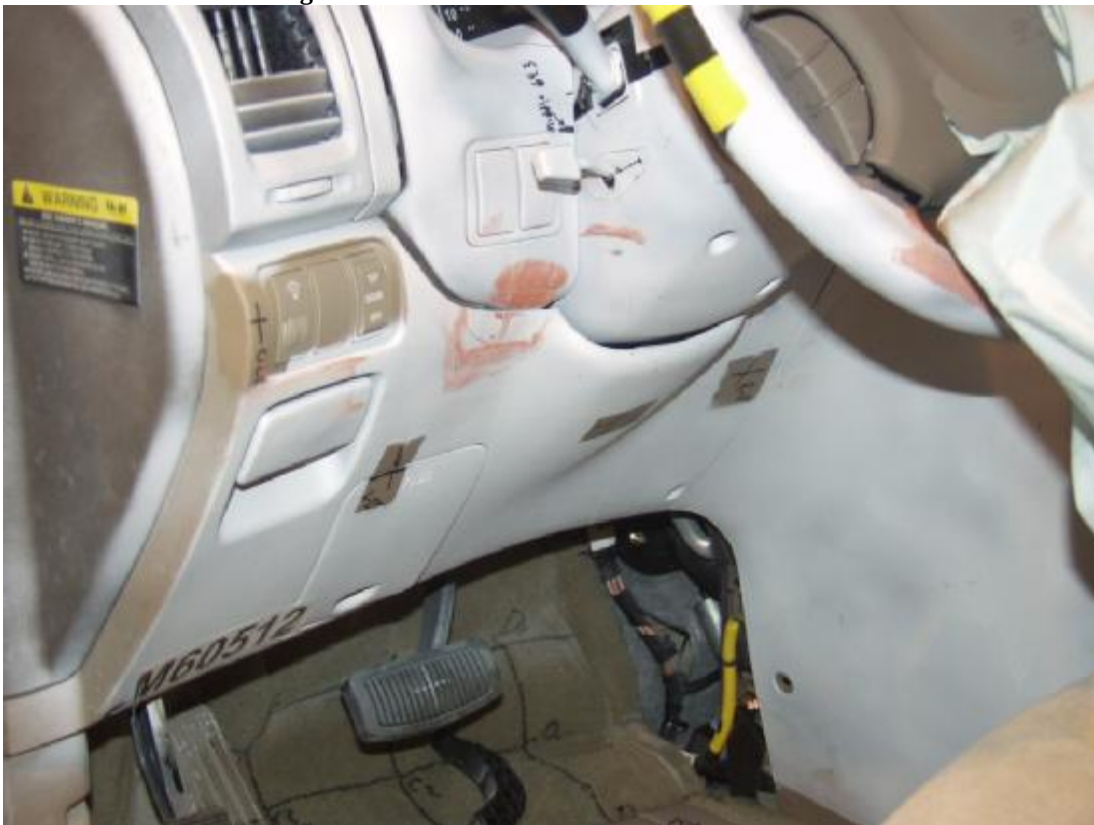
**Figure A-39: Post-Test Driver Knee Bolster View**

| | DRIVER | PASSENGER |
|---|---|---|
| Left Knee Contact: | Knee Bolster | Knee Bolster |
| Right Knee Contact: | Knee Bolster | Knee Bolster |

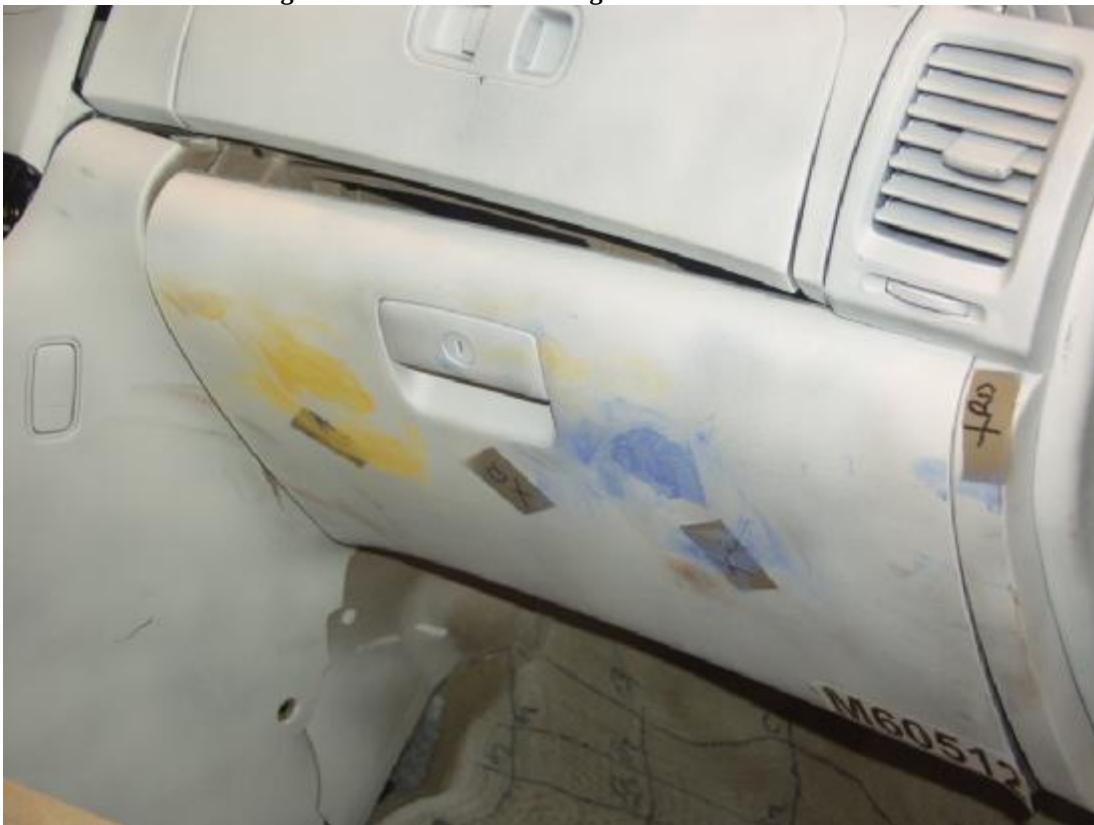
**Figure A-53: Post-Test Passenger Knee Bolster View**
