**REPORT NUMBER TR-P26001-10-NC**

**NEW CAR ASSESSMENT PROGRAM  
FRONTAL BARRIER IMPACT TEST**

**GENERAL MOTORS CORPORATION  
2006 CHEVROLET COLORADO  
4-DOOR PICKUP**

**NHTSA NUMBER: M60106**

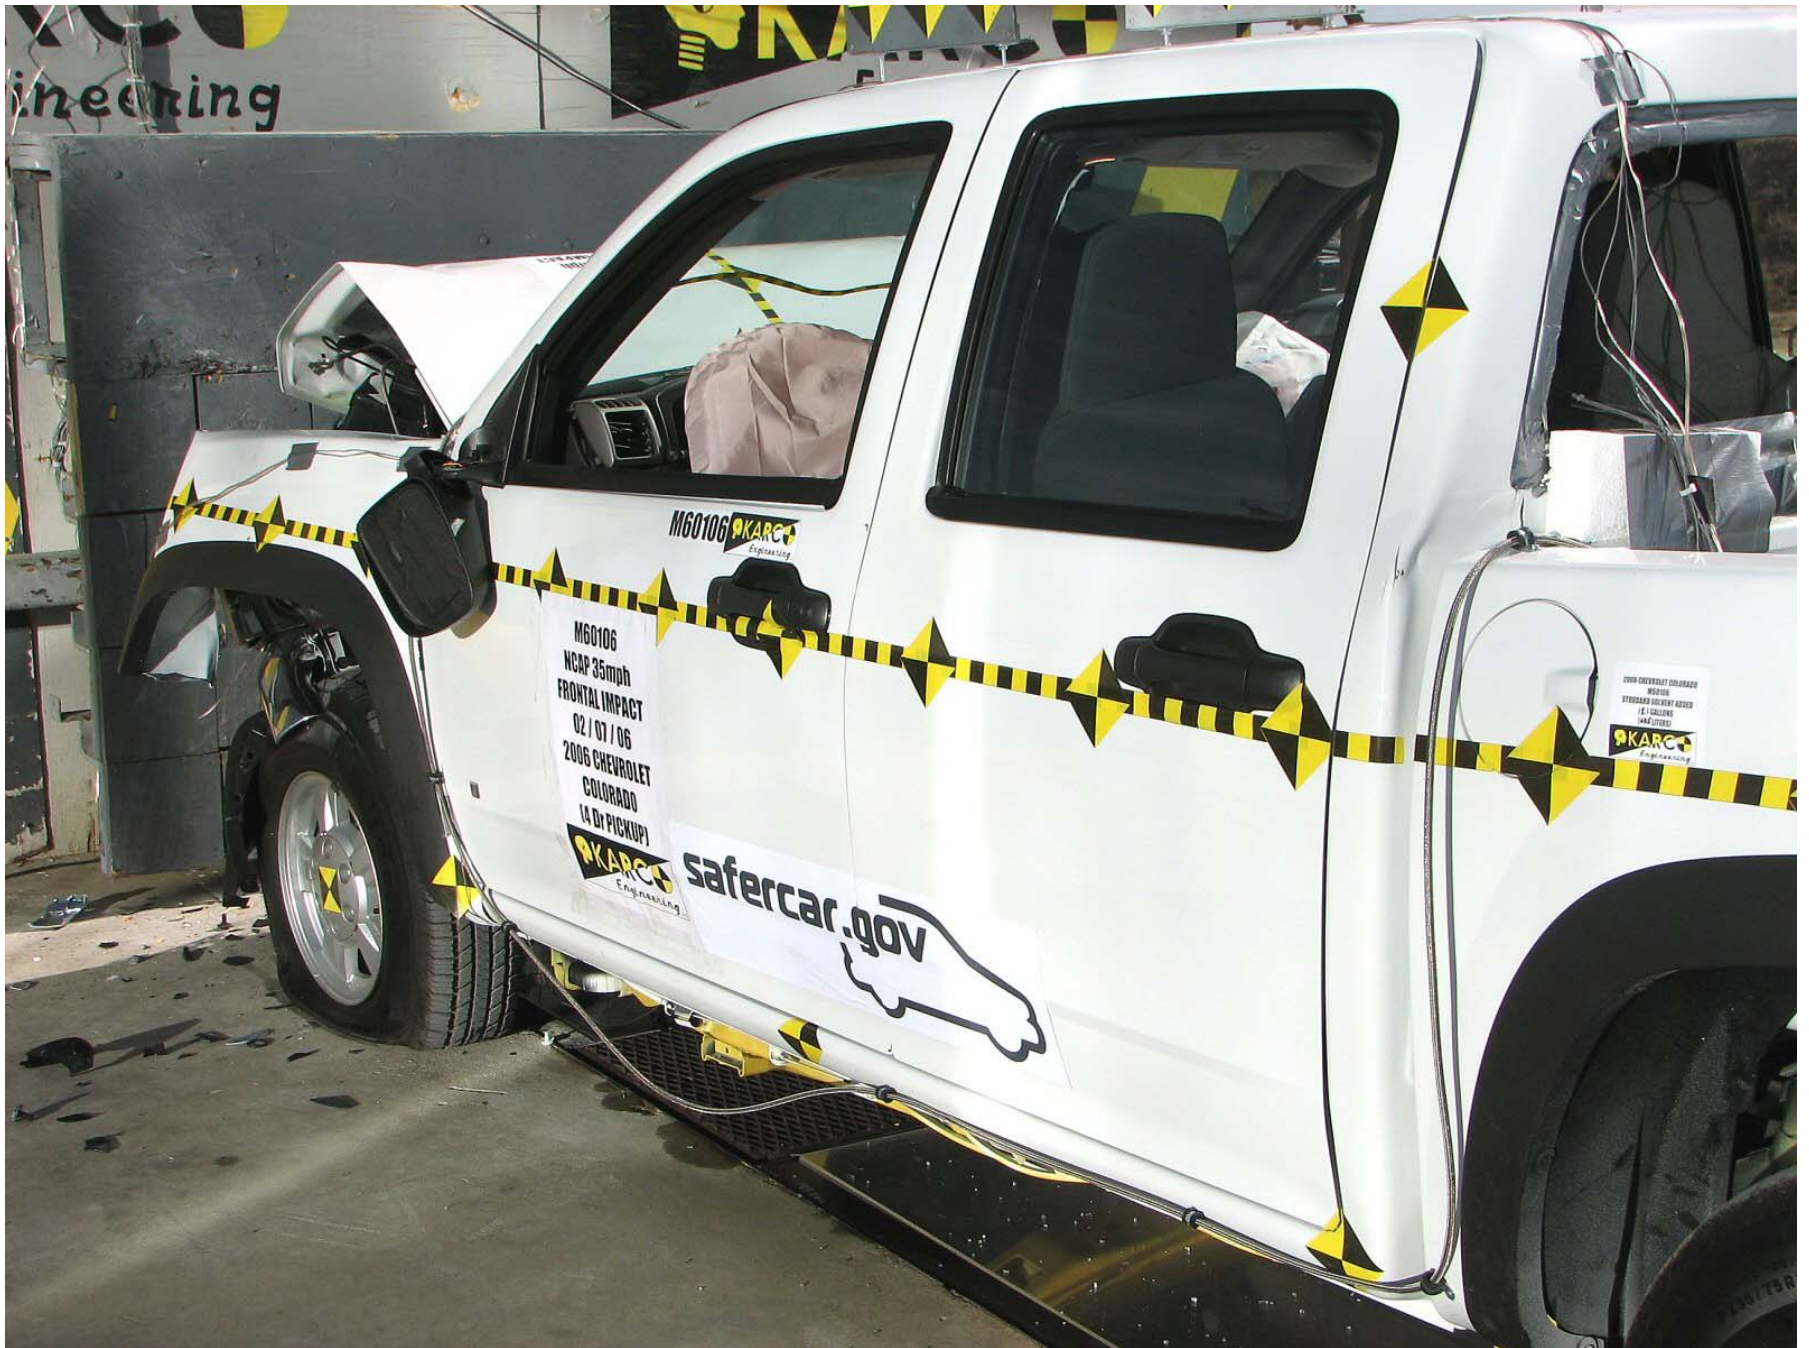
Figure A-16: Post-Test Left Side  $\frac{3}{4}$  View of Doors After Impact

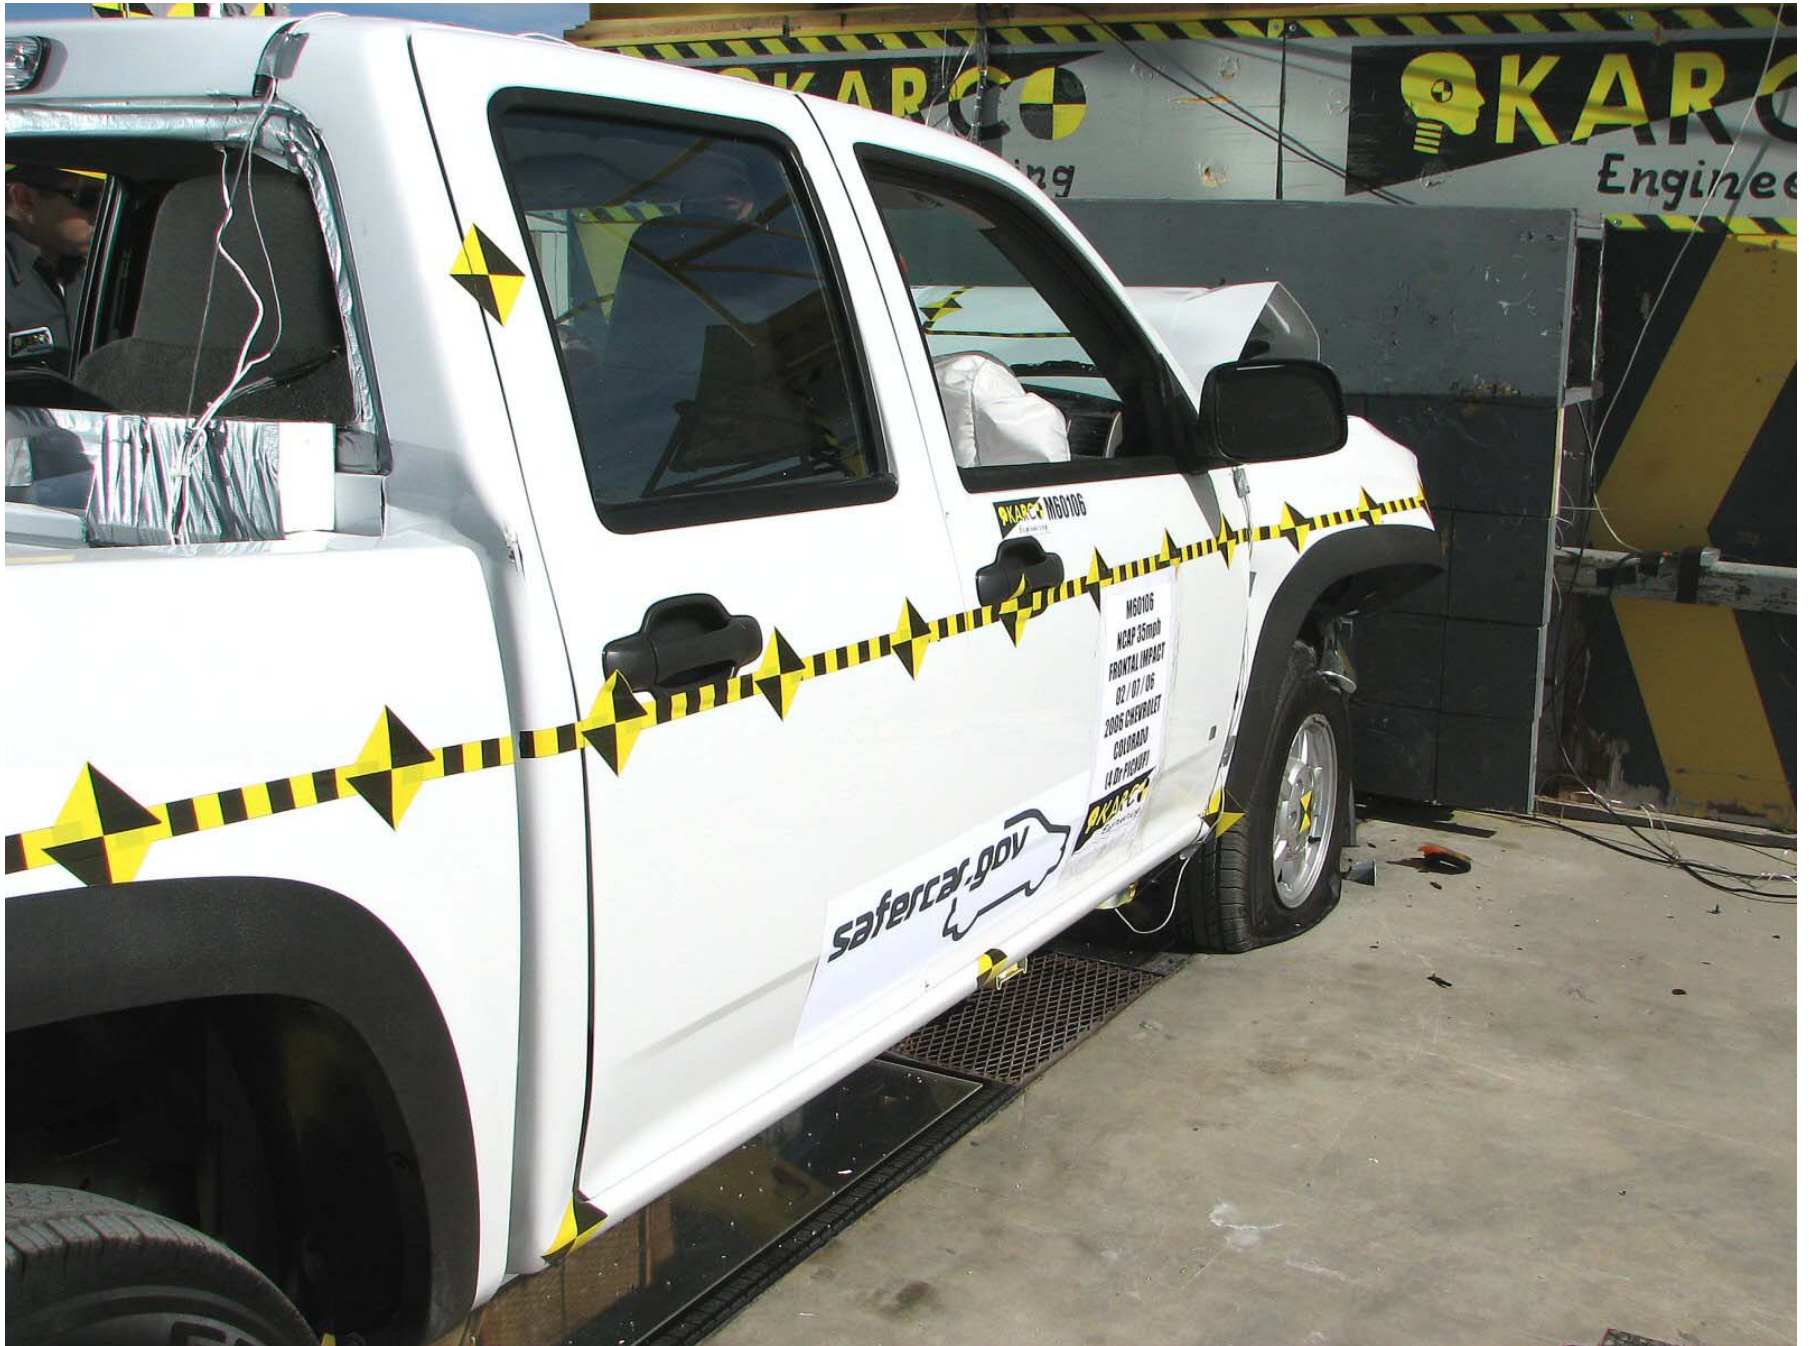
Figure A-17: Post-Test Right Side  $\frac{3}{4}$  View of Doors After Impact

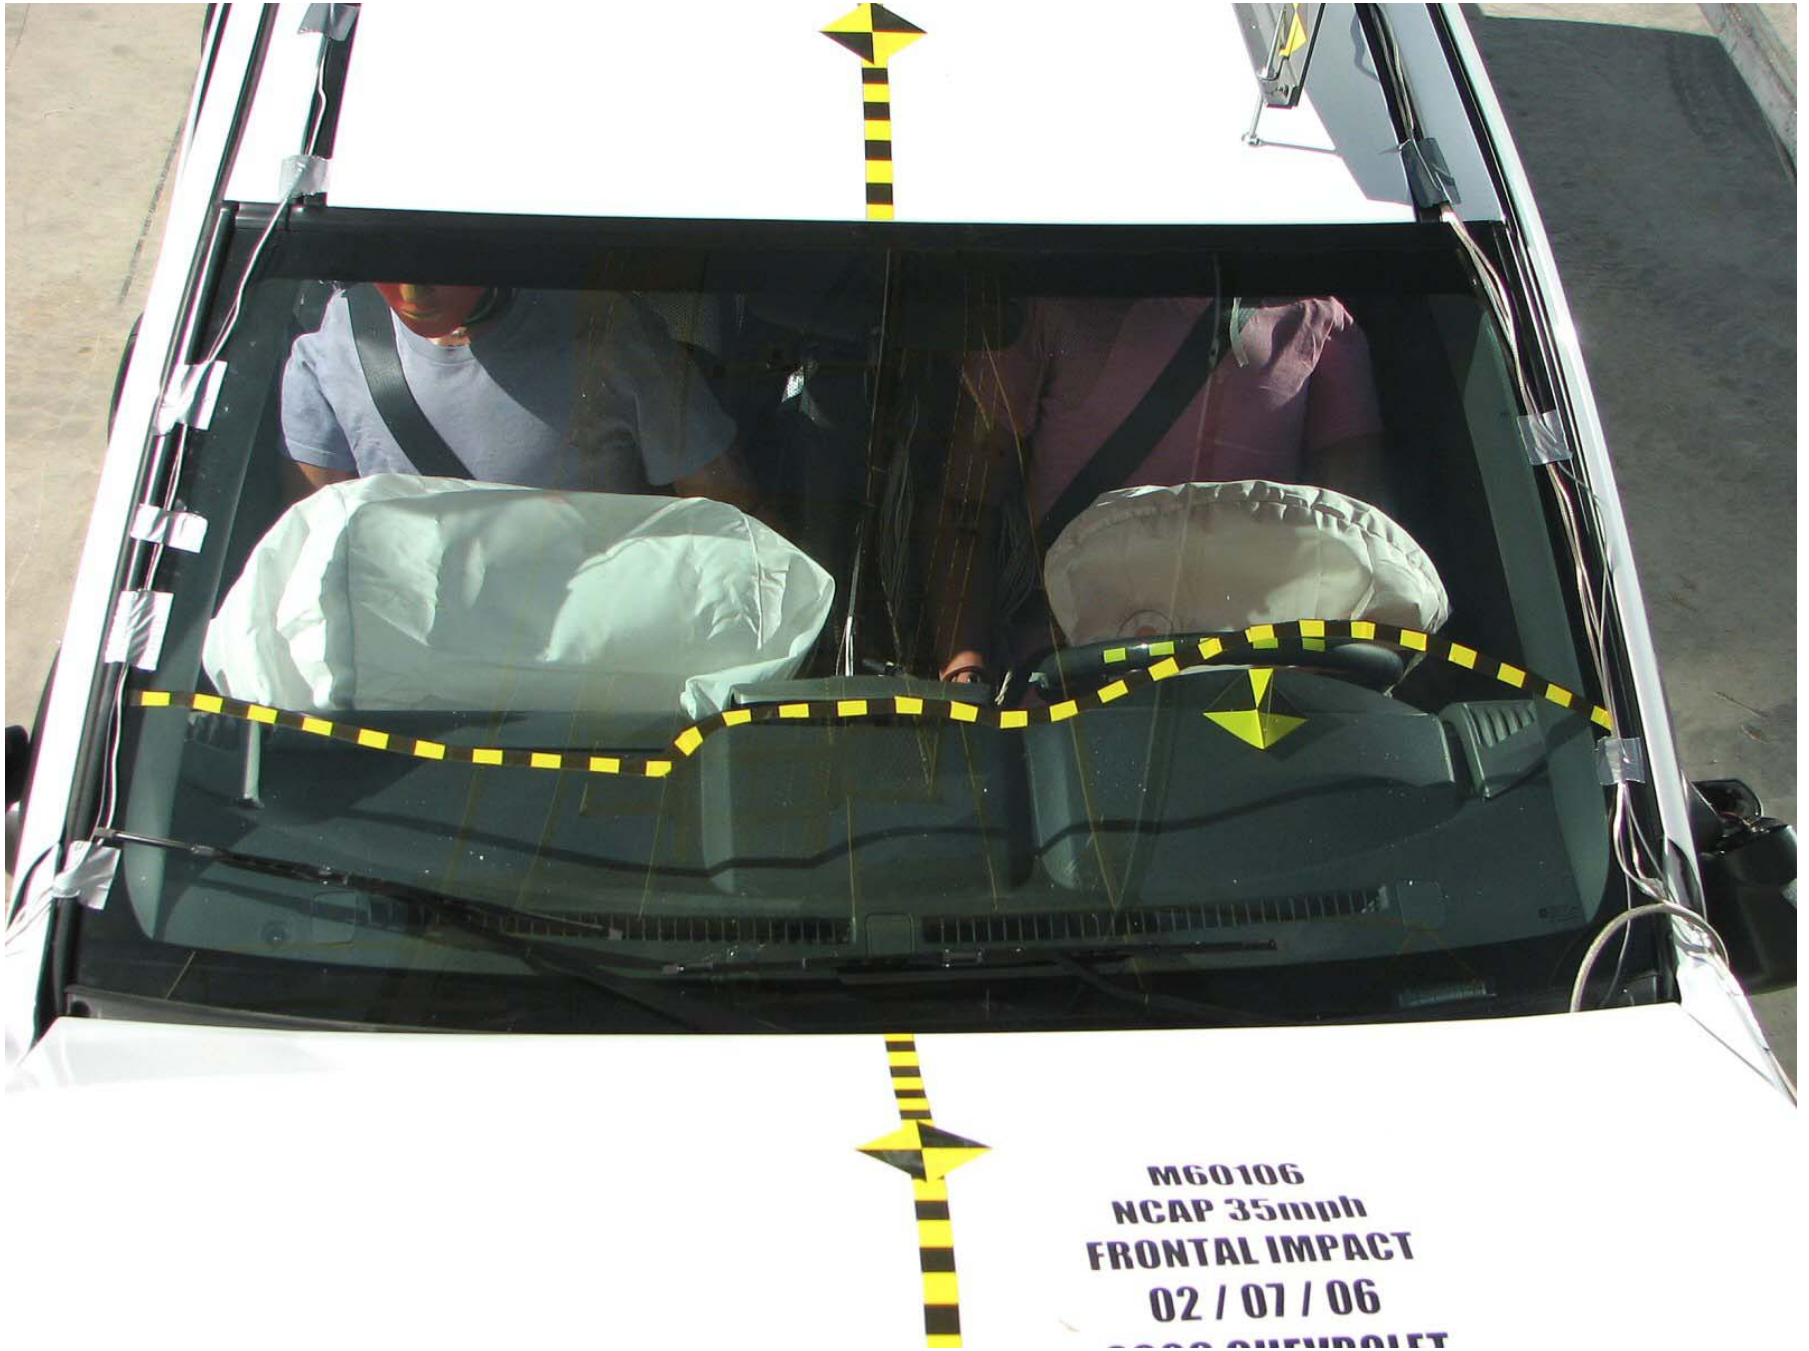
Figure A-19: Post-Test Windshield

There was 100 percent windshield retention and there was no intrusion into the protected zone of the windshield during the impact event. There was no stoddard solvent leakage after the event or during any phase of the static rollover.

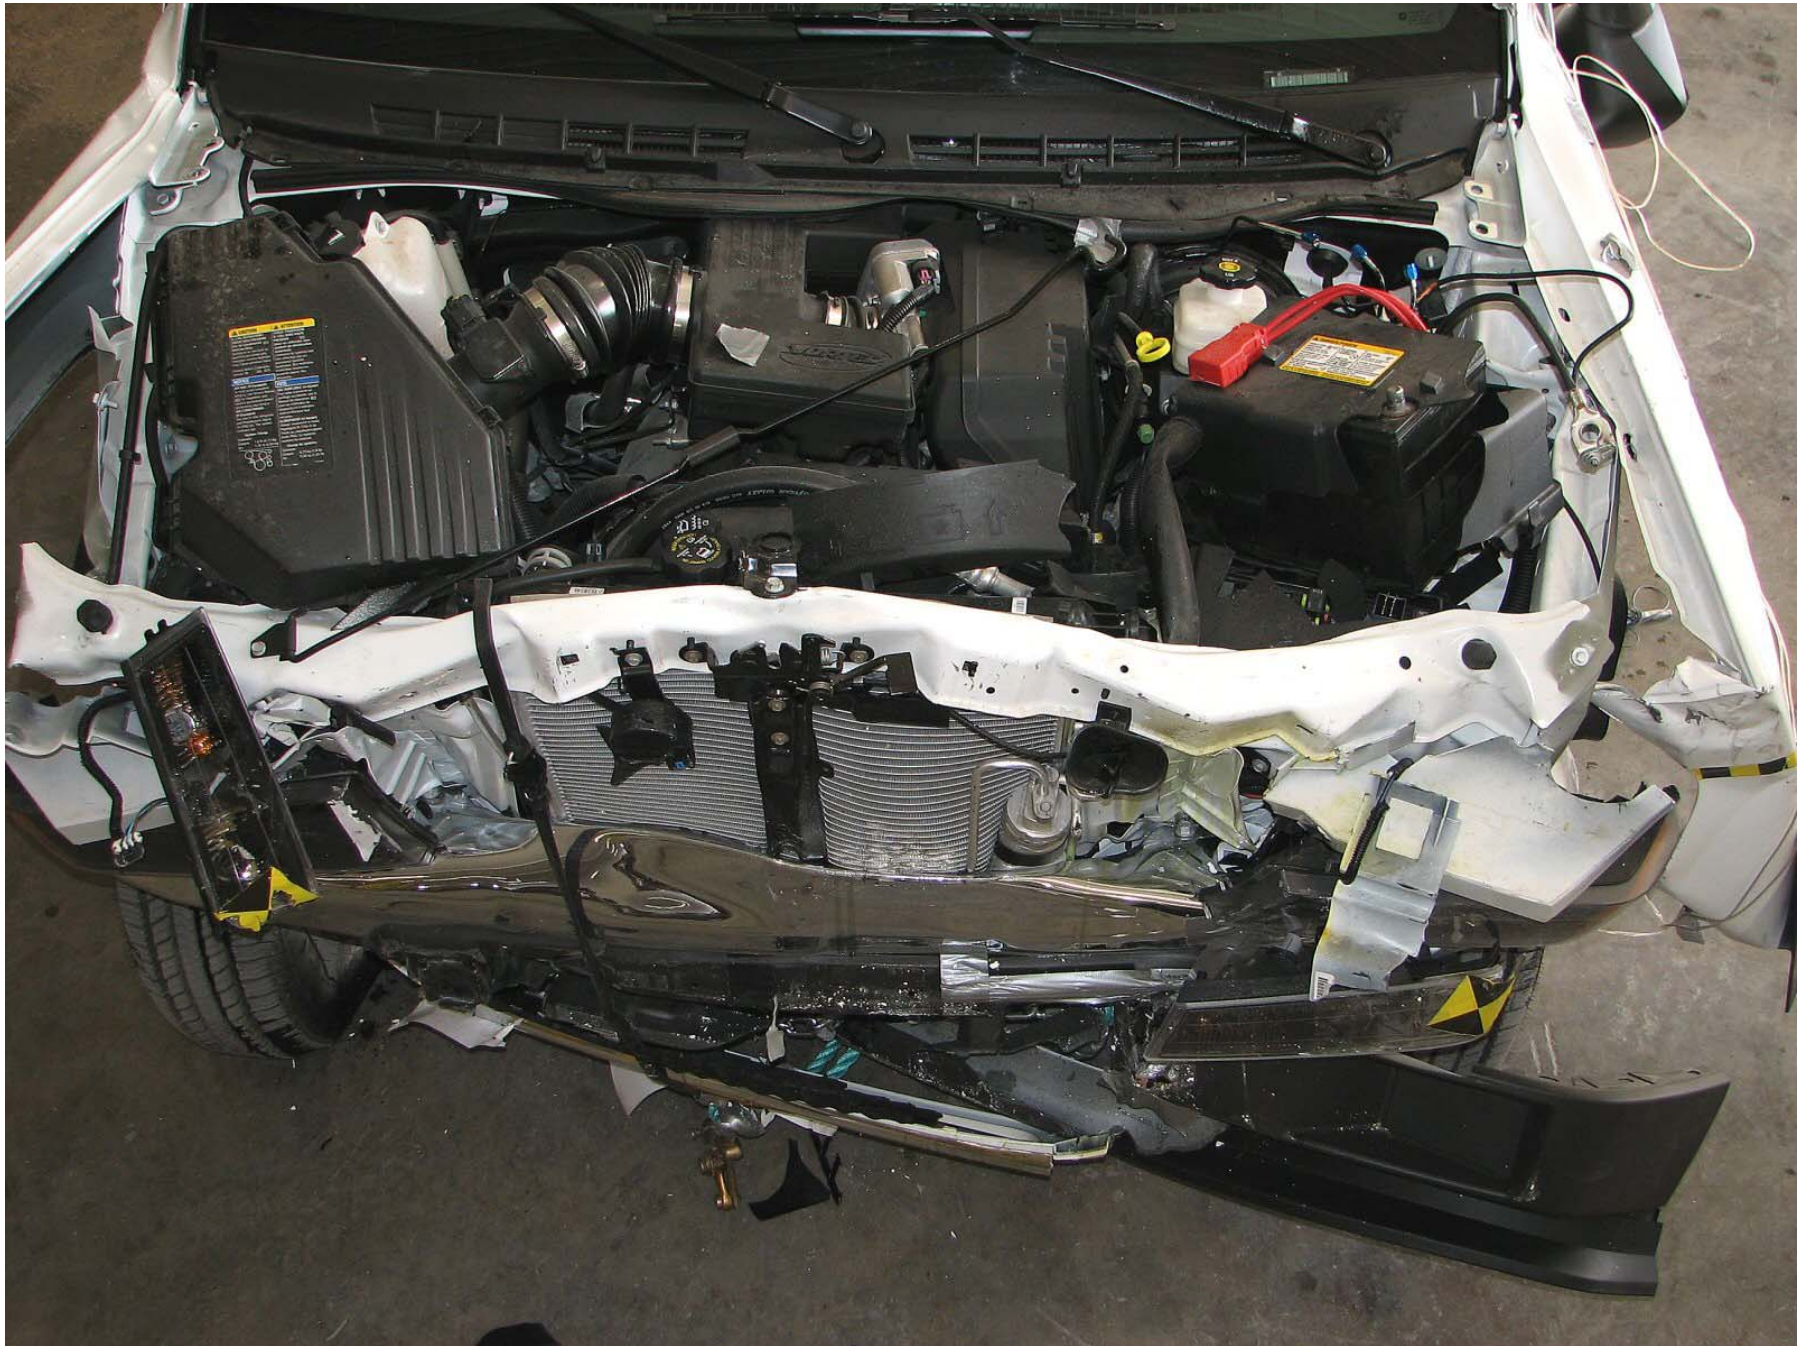
Figure A-21: Post-Test Engine Compartment (Vehicle Moved)

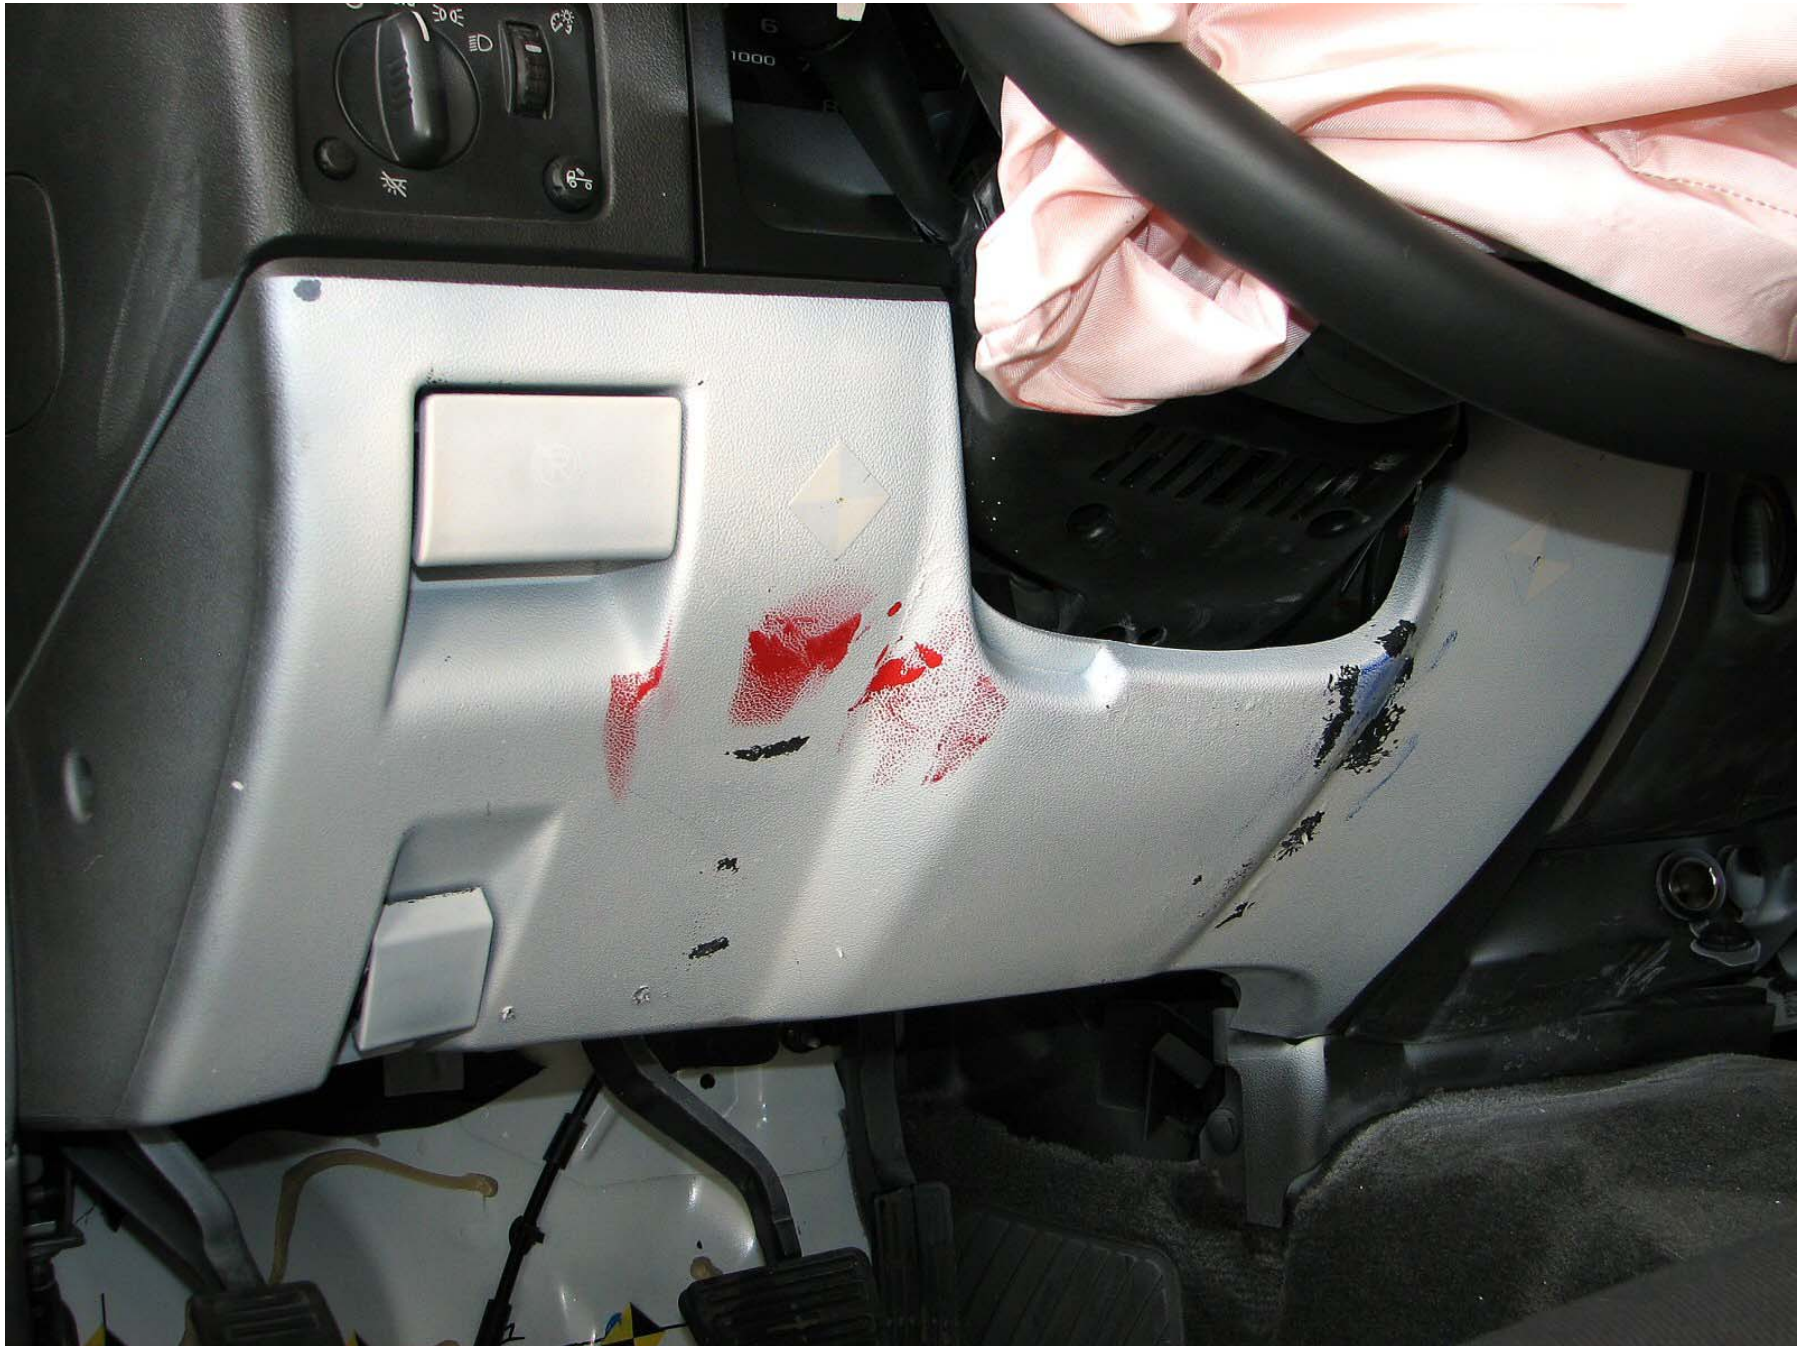
Figure A-39: Post-Test Driver Side Knee Bolster

The driver's visible contact points were as follows: The driver ATD's head and chest contacted the airbag and the abdomen had no contact. Both knees contacted the knee bolster.

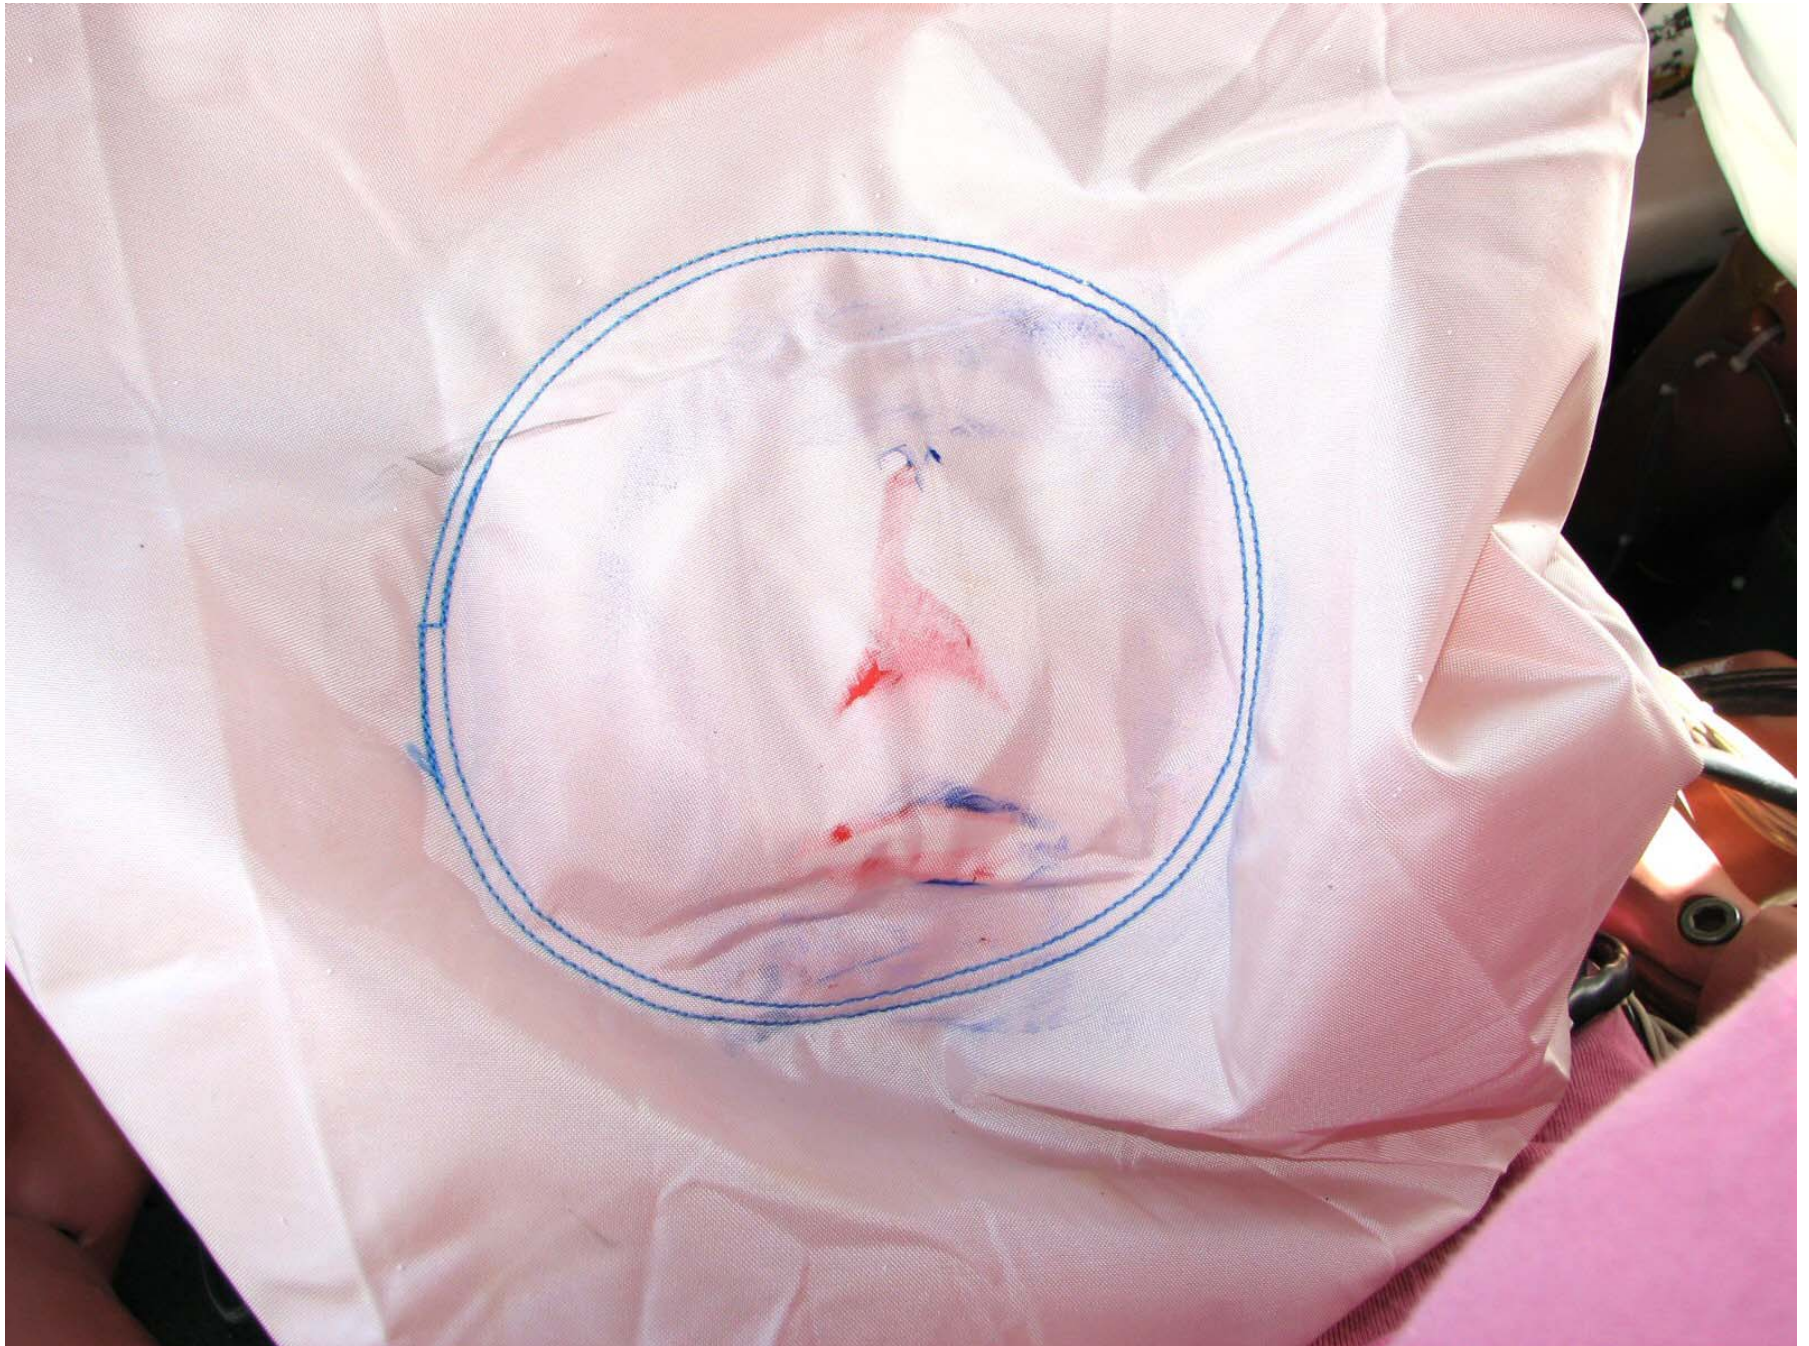
Figure A-43: Post-Test Driver Dummy Airbag Contact

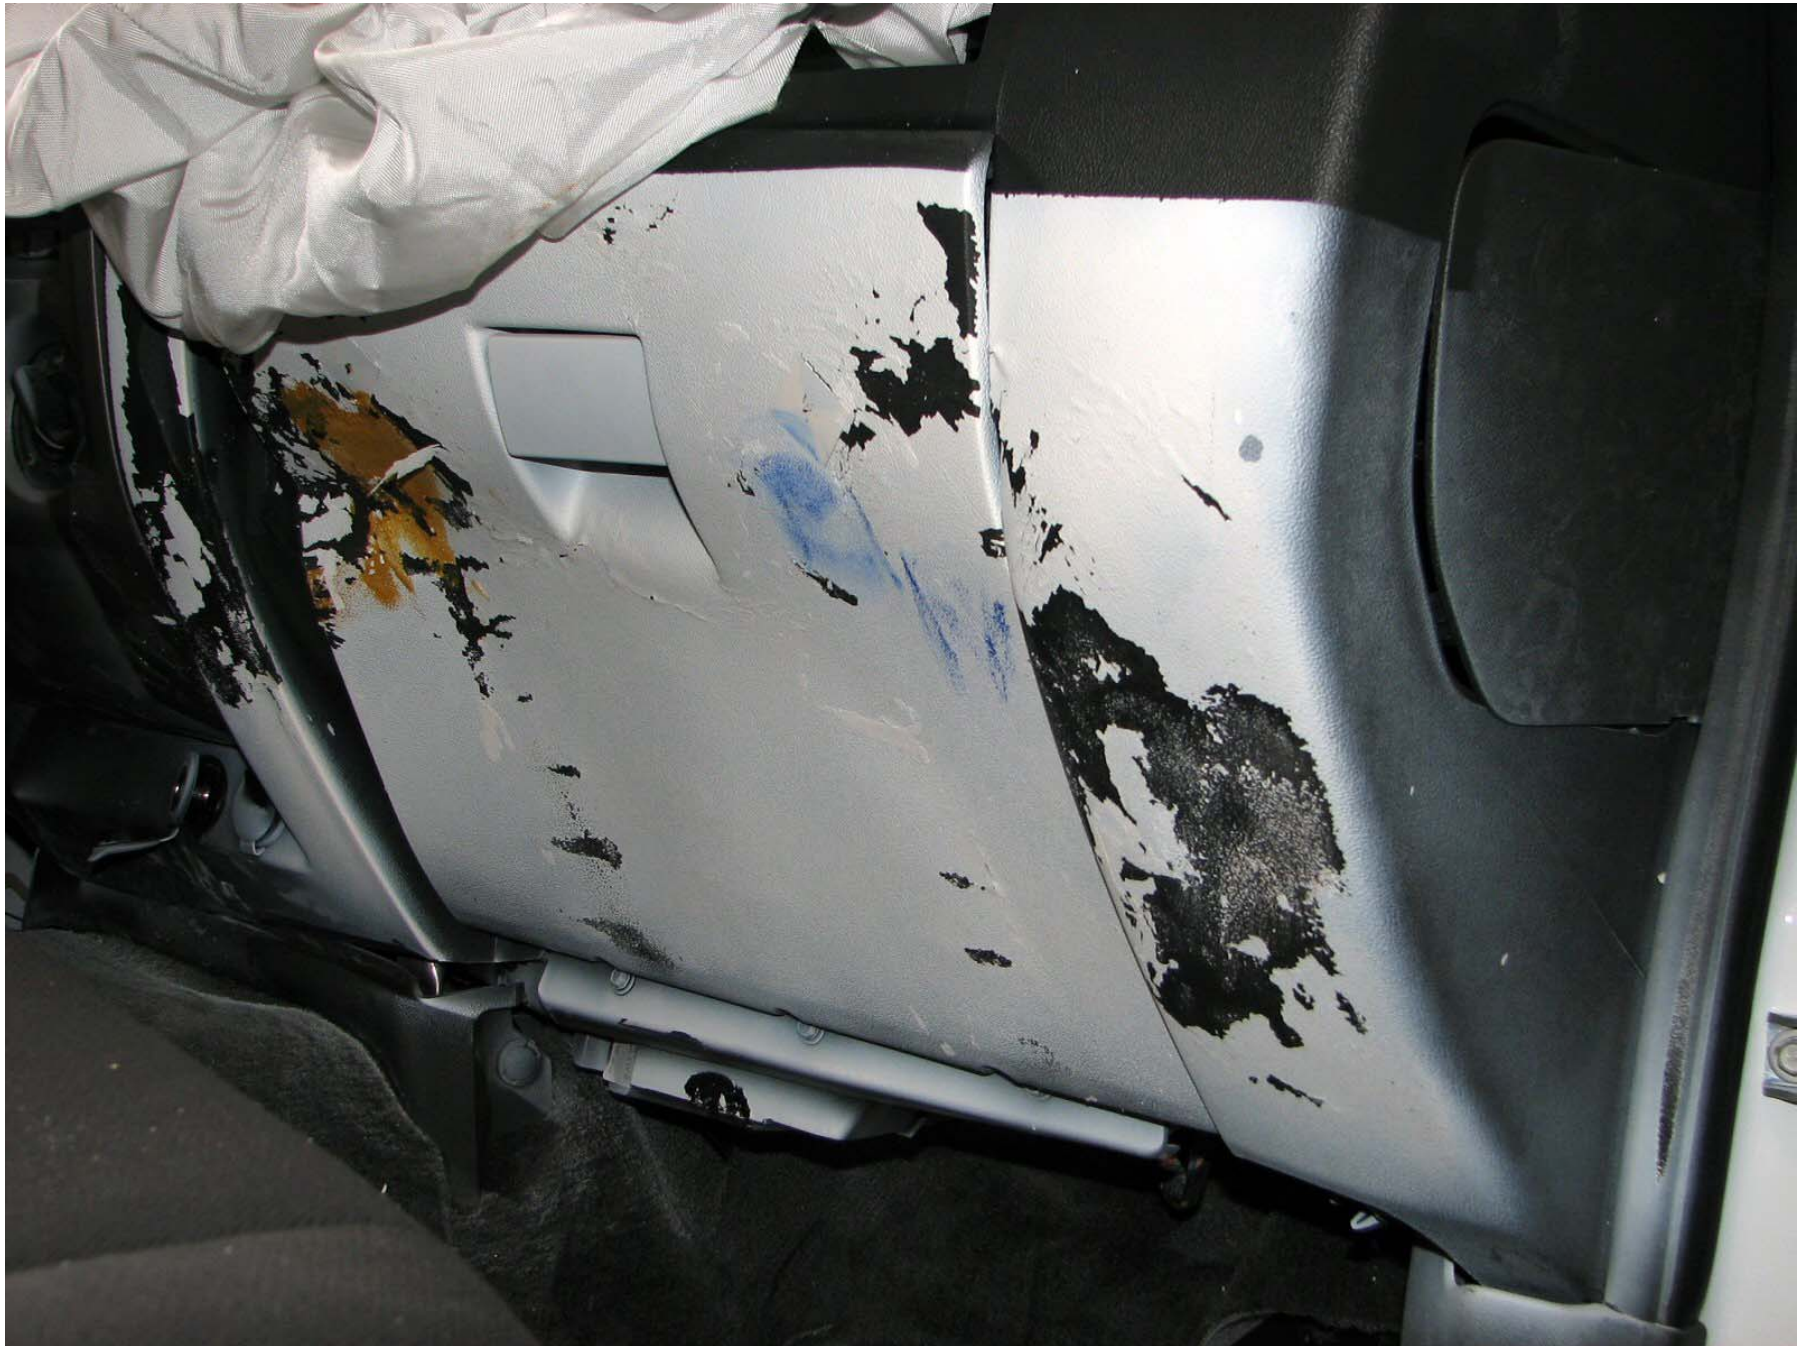
Figure A-53: Post-Test Passenger Side Glove Box

The passenger's visible contact points were as follows: The passenger ATD's head, chest and abdomen contacted the airbag. Both knees contacted the glove box.

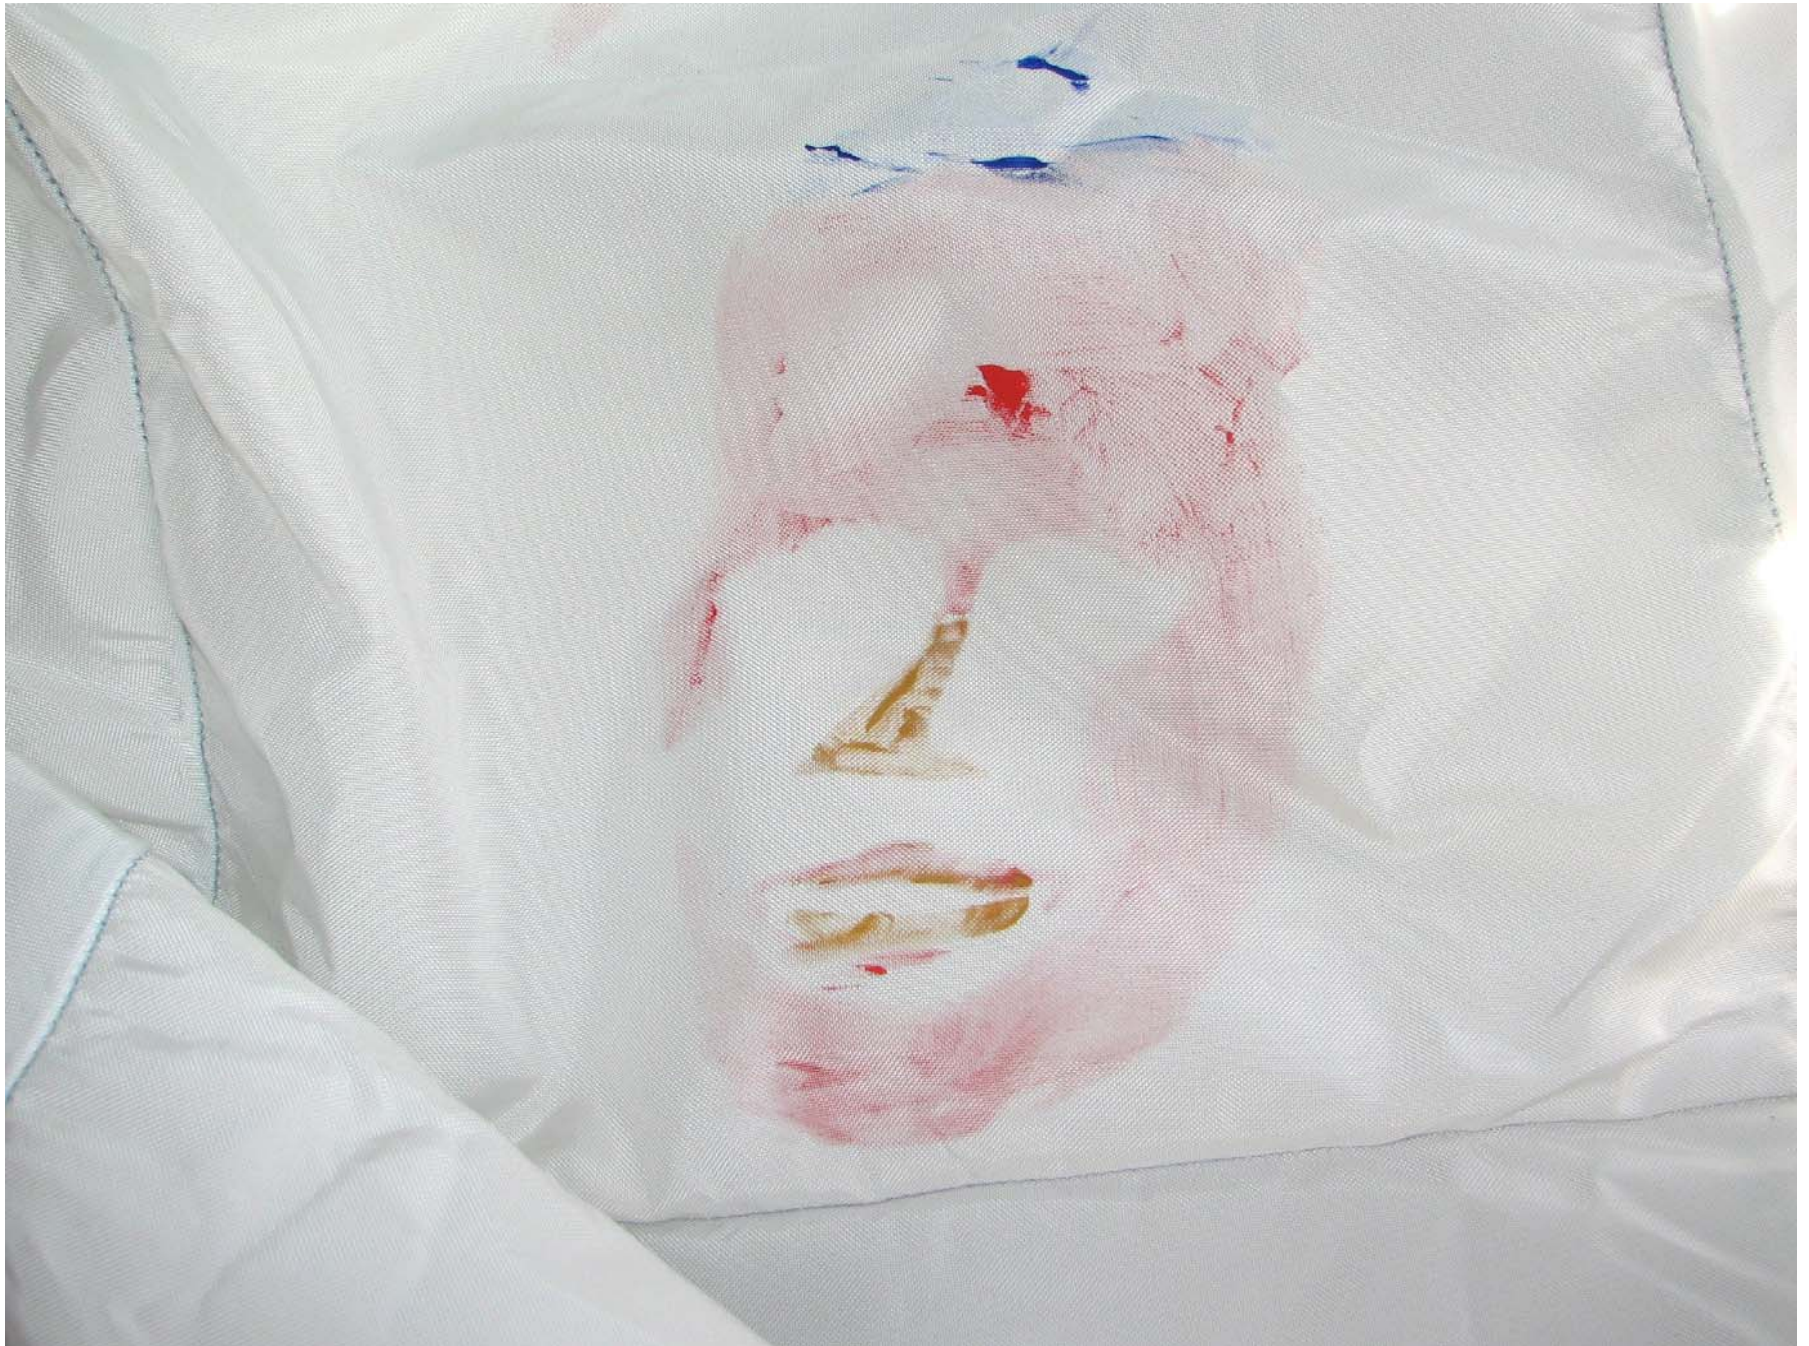
Figure A-57: Post-Test Passenger Dummy Airbag Contact

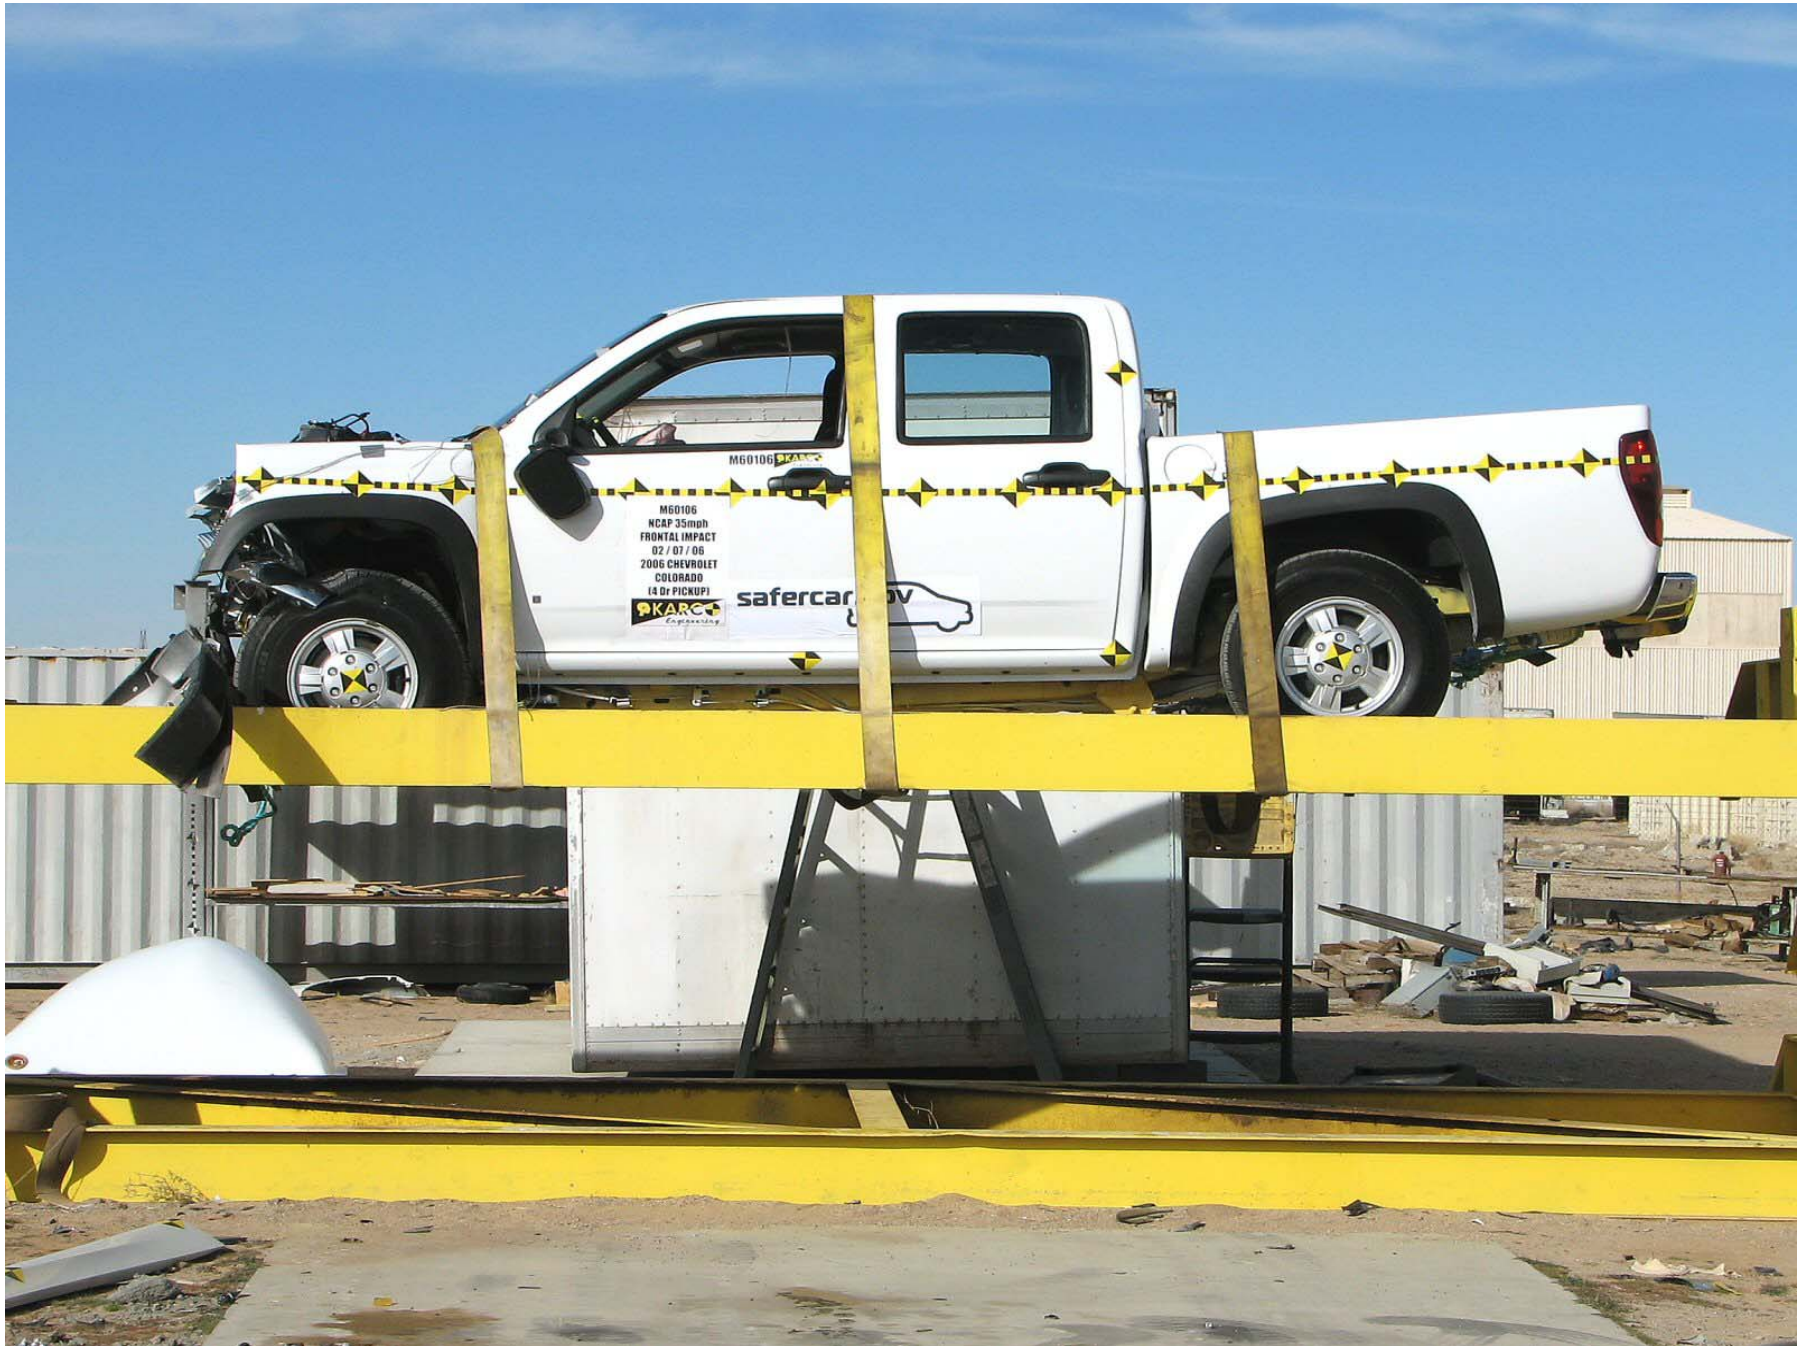
Figure A-58: Vehicle on Rollover Device (0°)

1. The specified fixture rollover rate for each 90° of rotation is 60 to 120 seconds.
2. The position hold time at each position is 300 seconds (minimum).
3. No solvent leakage occurred during rollover.
