**REPORT NUMBER TR-P26001-10-NC**

**NEW CAR ASSESSMENT PROGRAM  
FRONTAL BARRIER IMPACT TEST**

**GENERAL MOTORS CORPORATION  
2006 CHEVROLET COLORADO  
4-DOOR PICKUP**

**NHTSA NUMBER: M60106**

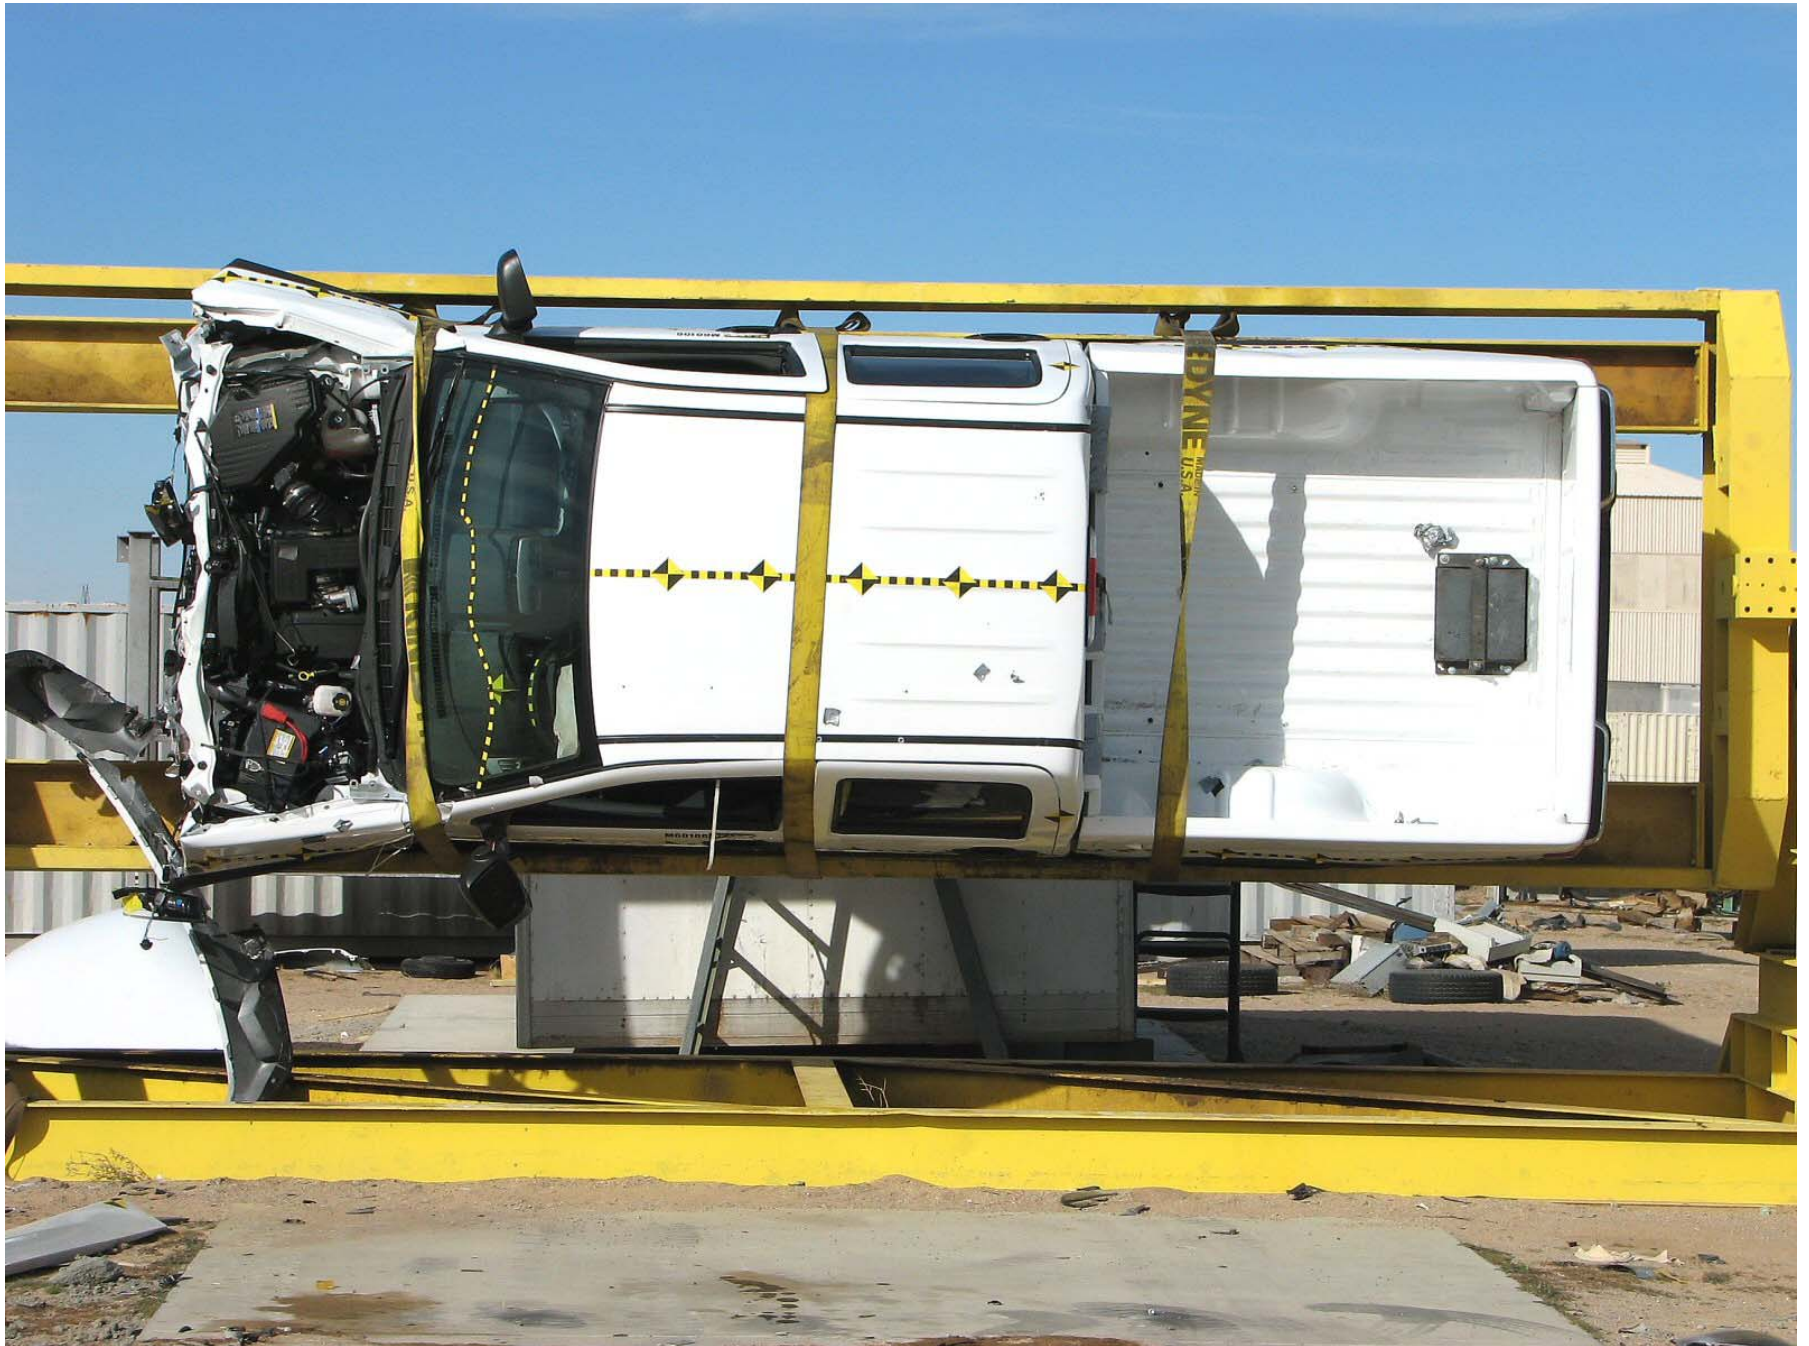
Figure A-59: Vehicle on Rollover Device (90°)

1. The specified fixture rollover rate for each 90° of rotation is 60 to 120 seconds.
2. The position hold time at each position is 300 seconds (minimum).
3. No solvent leakage occurred during rollover.

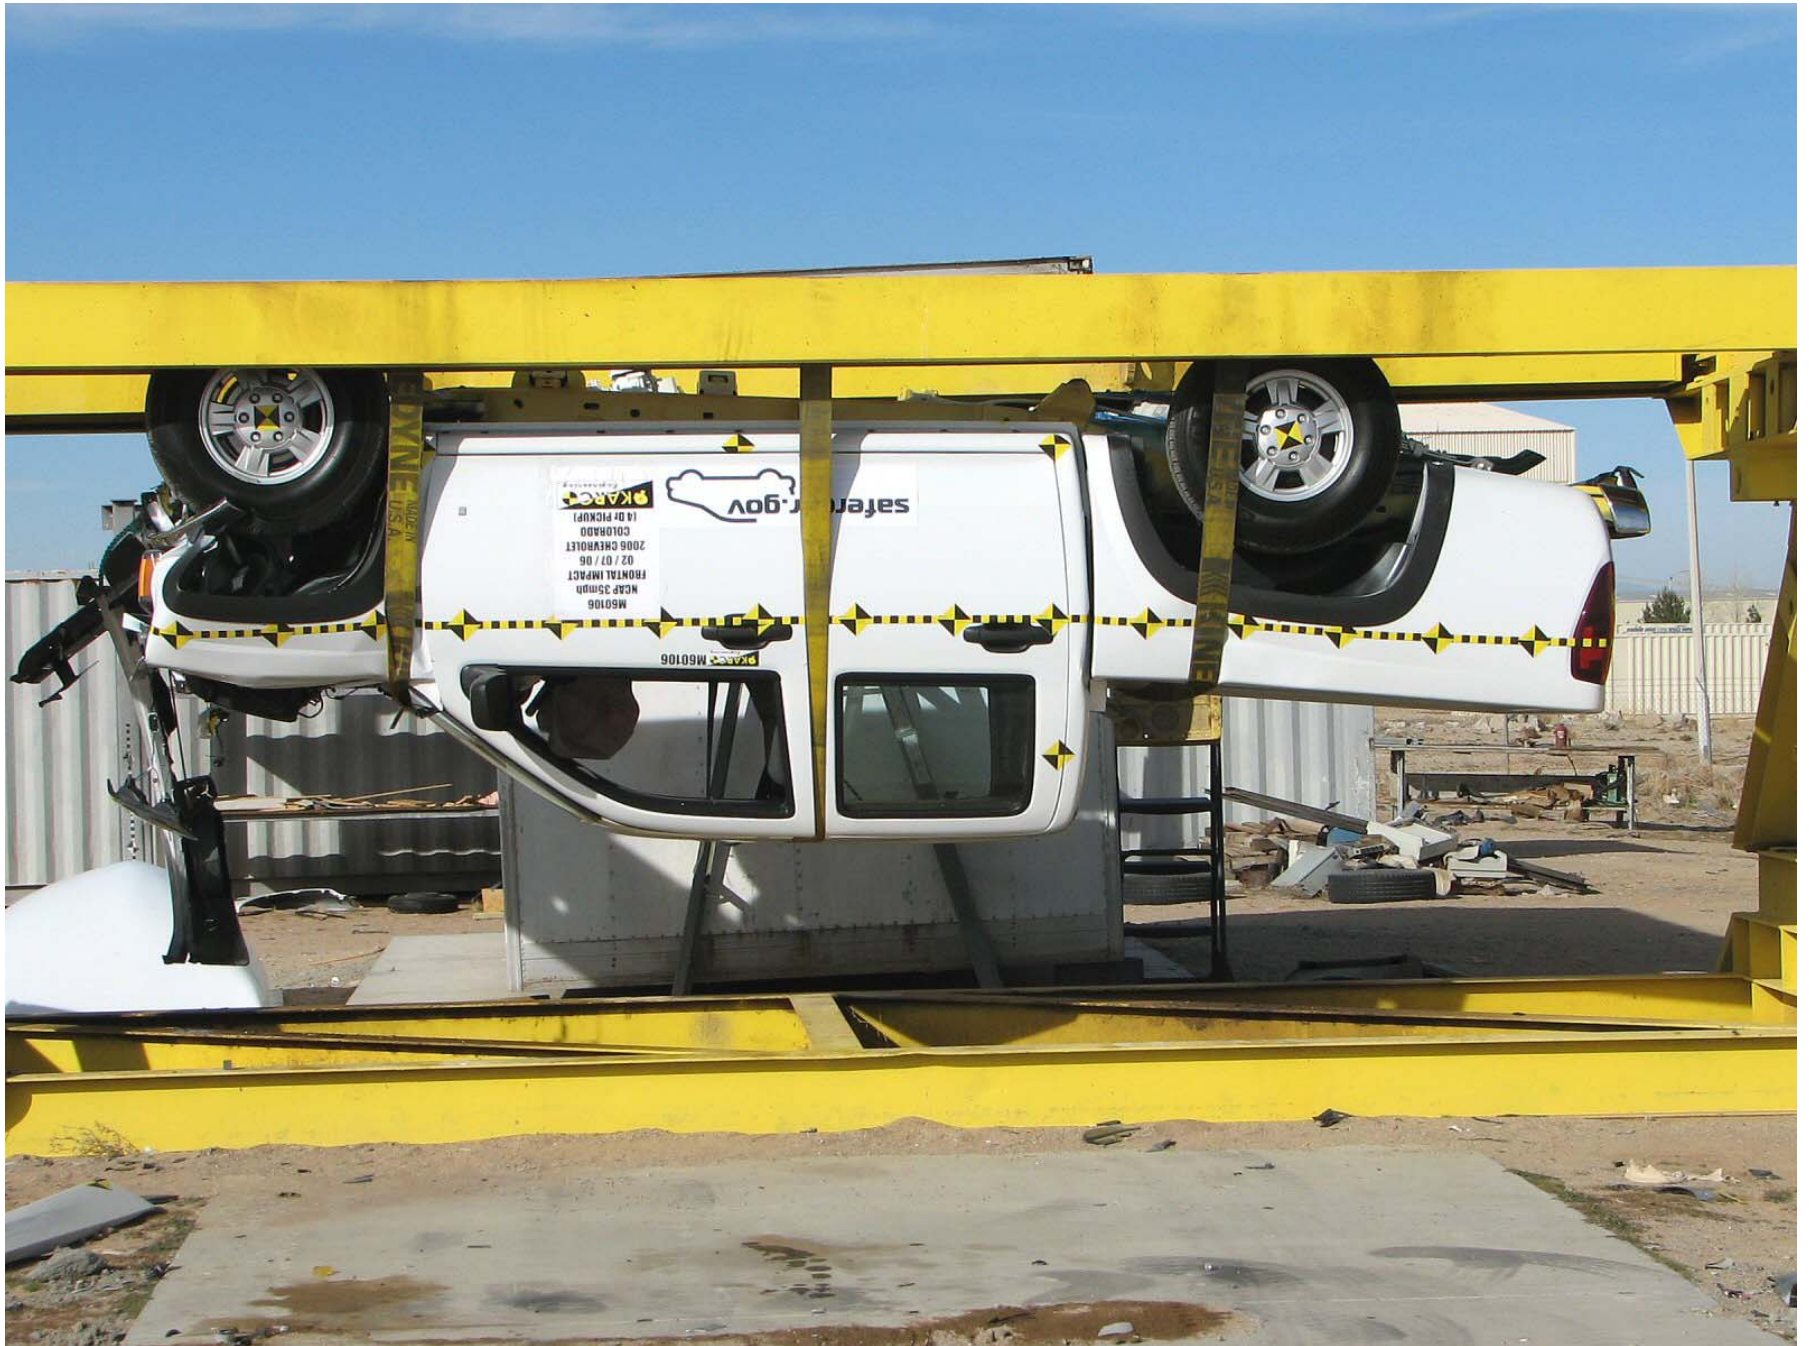
Figure A-60: Vehicle on Rollover Device (180°)

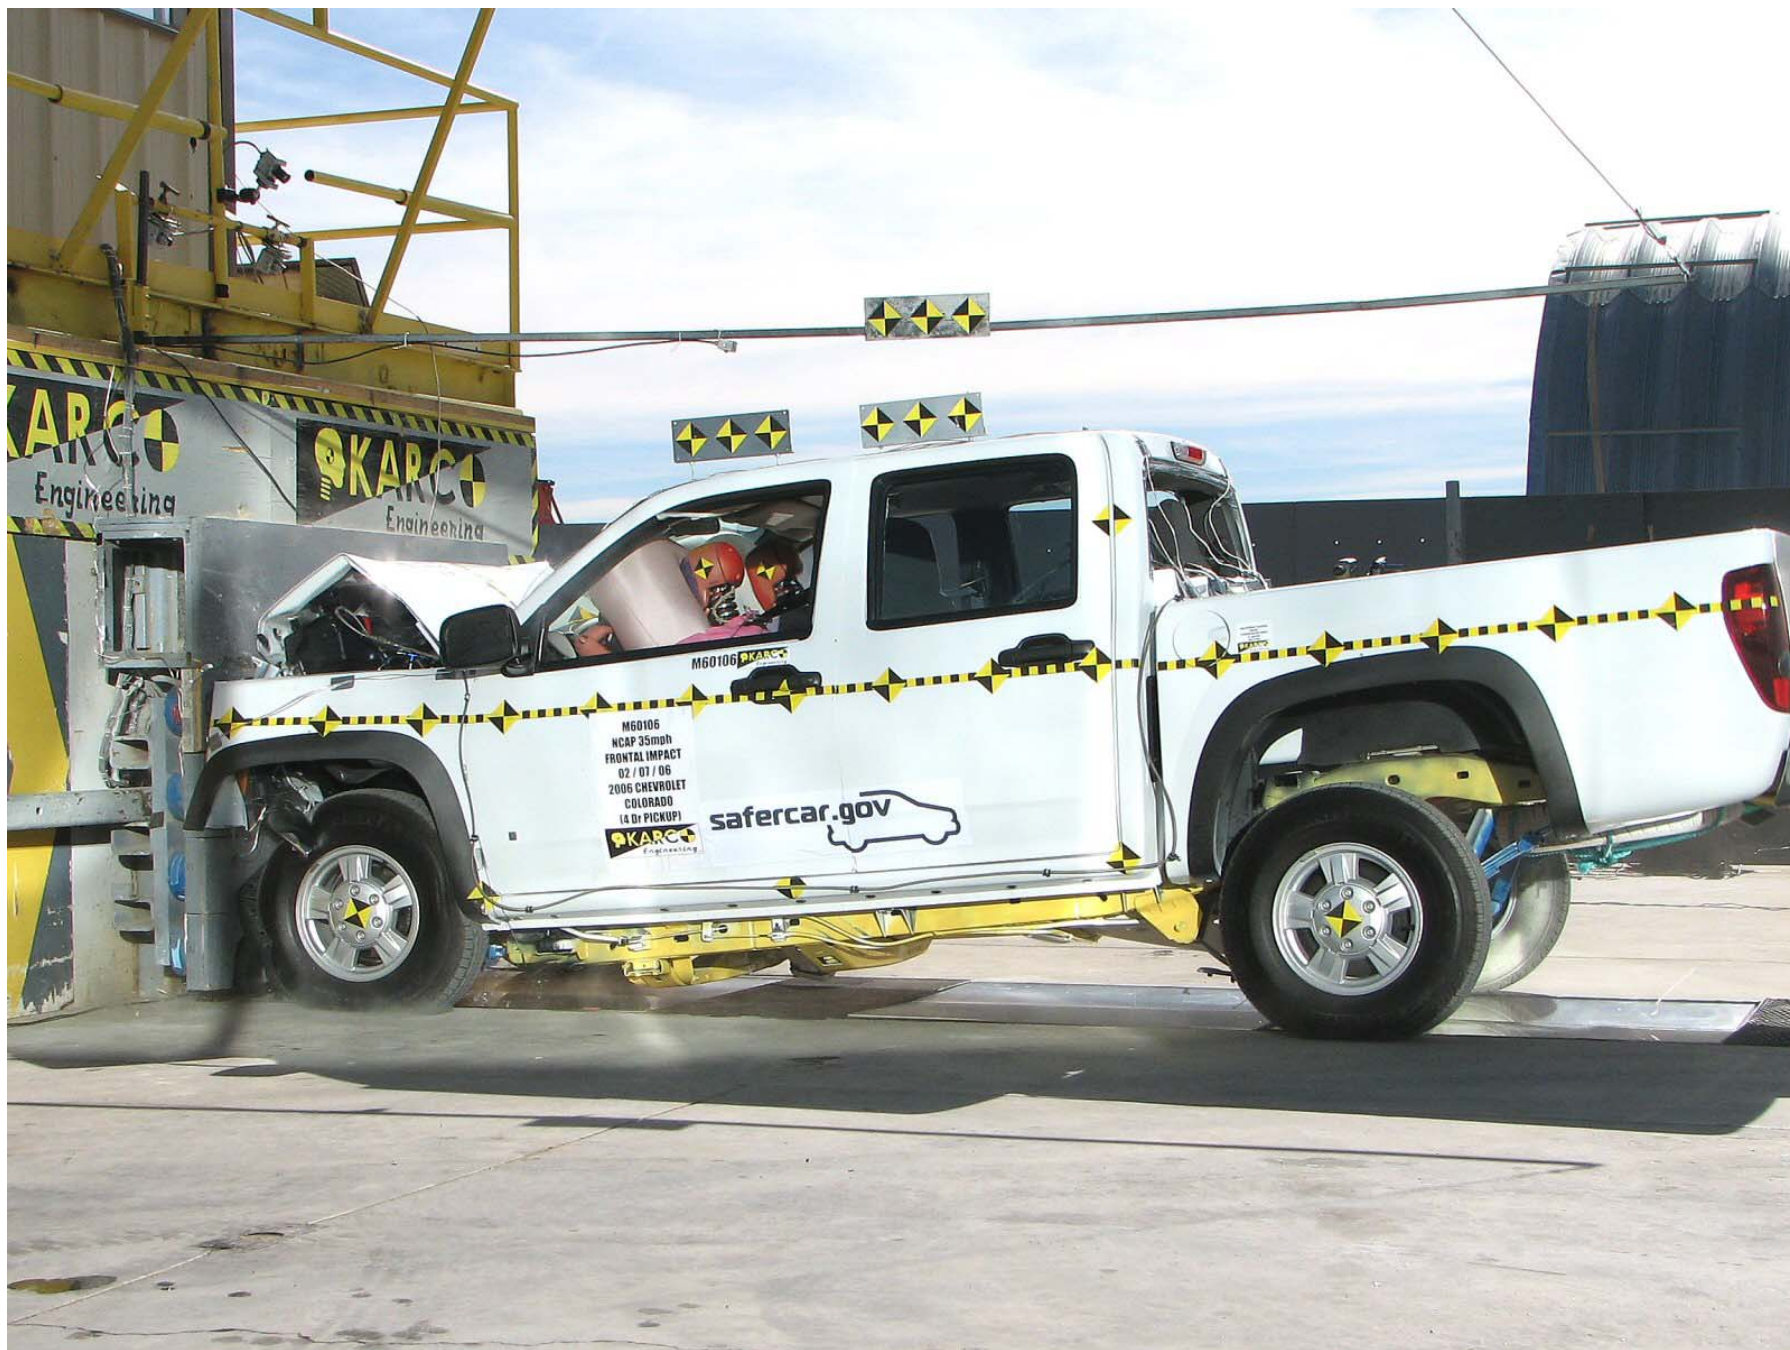
Figure A-62: Vehicle Impact
