**REPORT NUMBER: MCW-DOT-06SN02**

**NEW CAR ASSESSMENT PROGRAM  
SIDE IMPACT TEST**

**TOYOTA MOTOR CORPORATION  
2006 TOYOTA TACOMA PRERUNNER 4 DOOR PICKUP  
NHTSA NUMBER: M65108**

**FINAL REPORT**

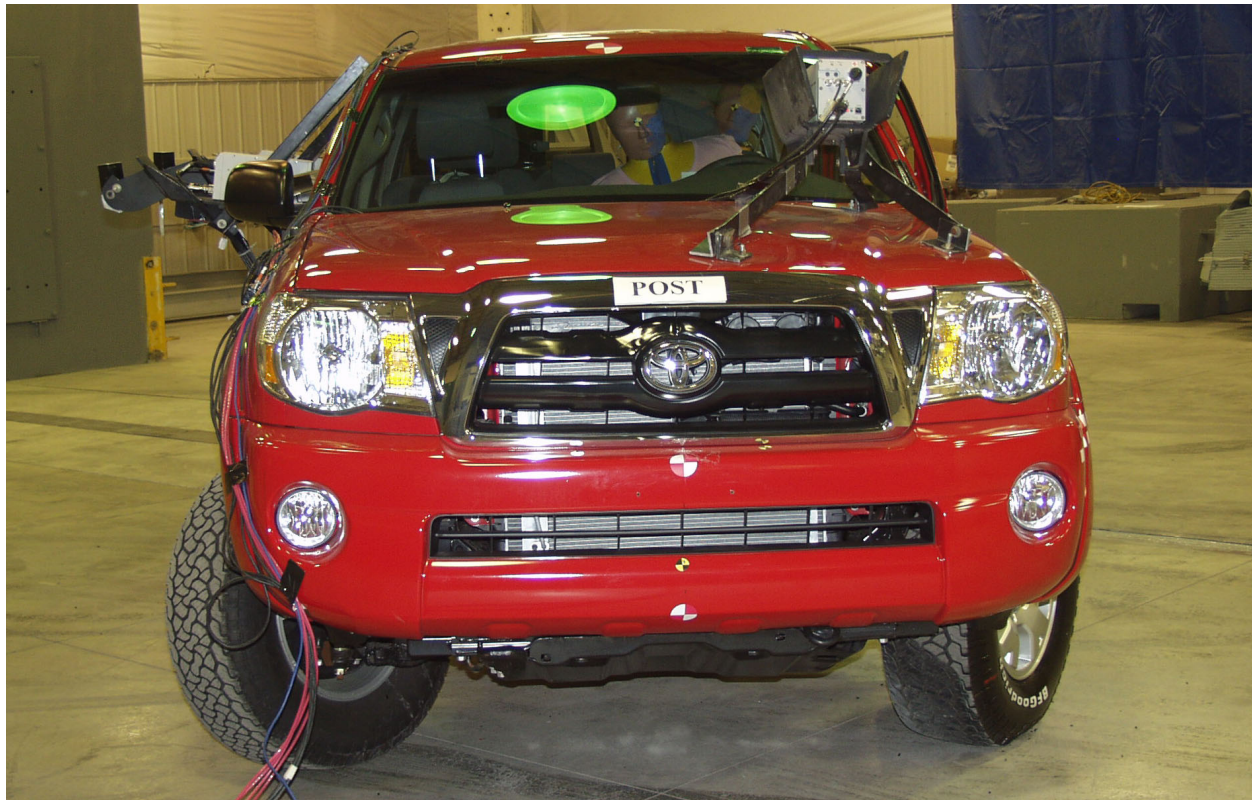
Figure A-6: Post test front view of test vehicle

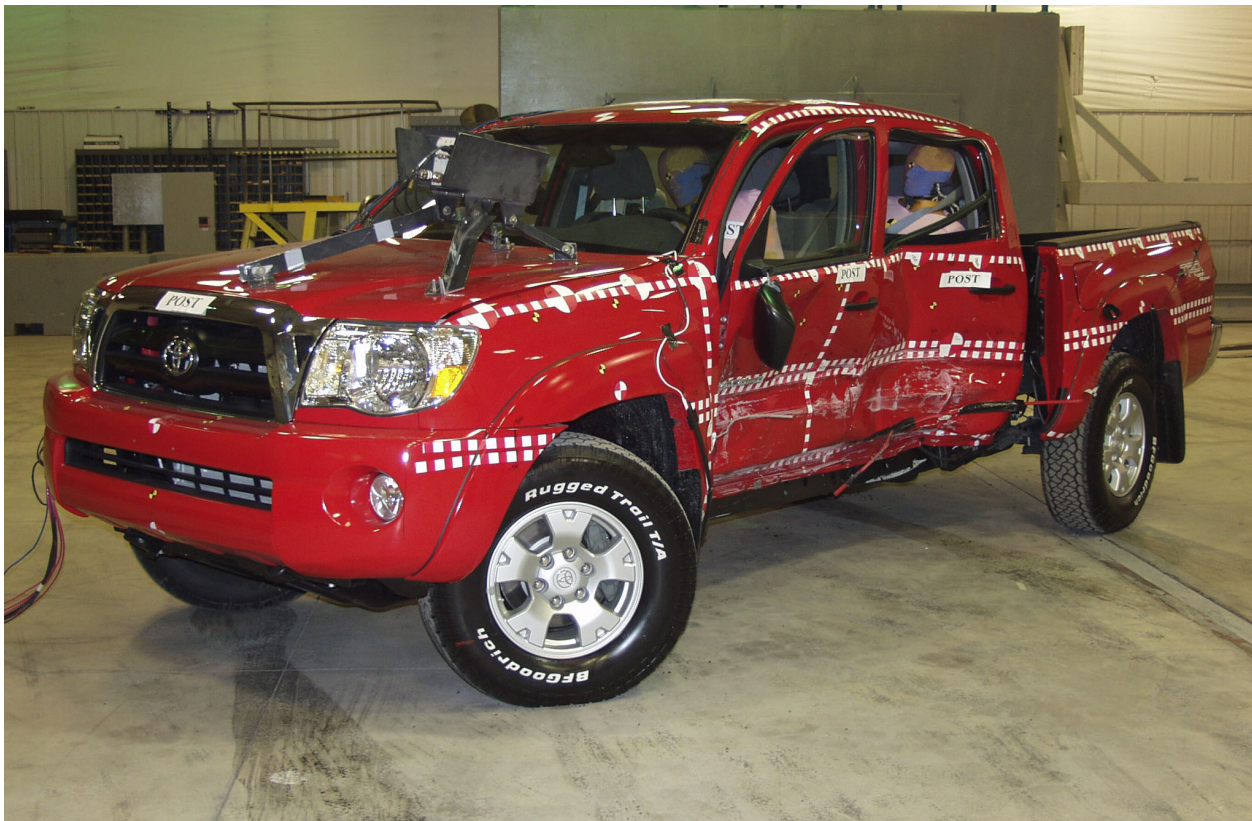
Figure A-8: Post test left front 3/4 view of test vehicle

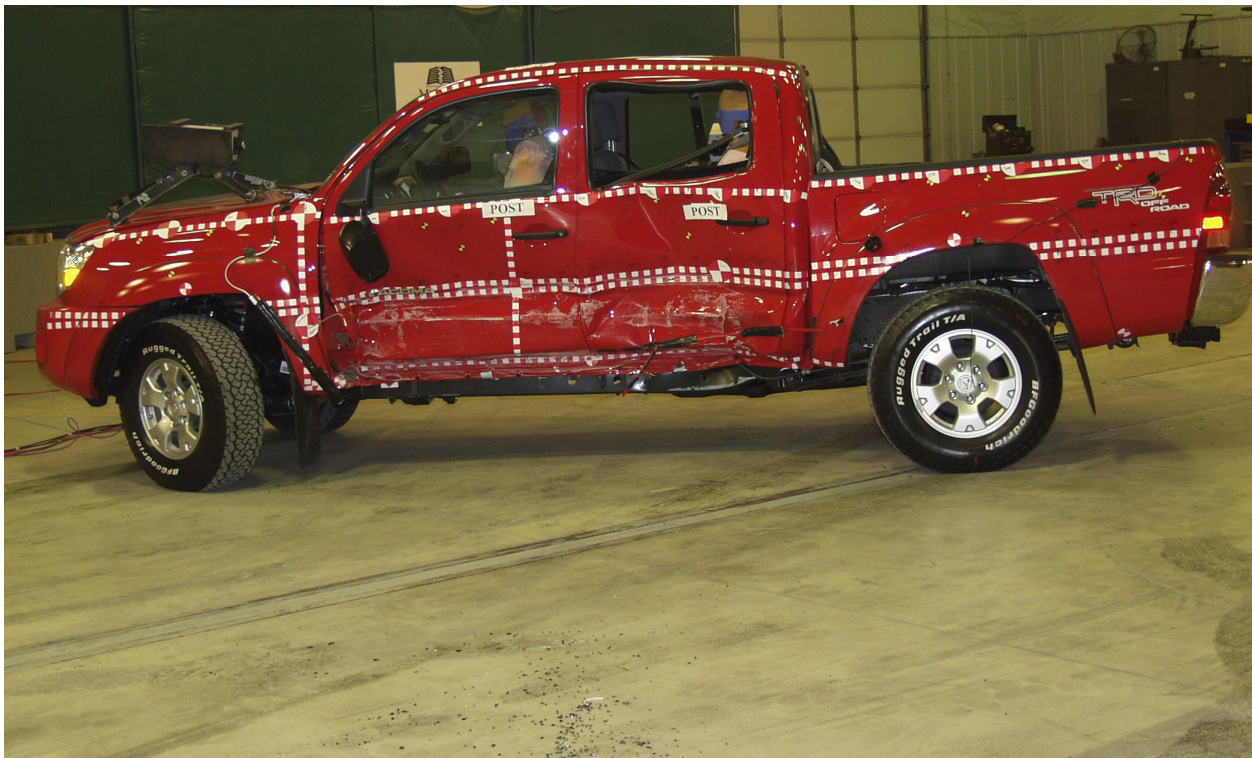
Figure A-10: Post test left side view of test vehicle

The test vehicle sustained a maximum static crush of 401 mm at level one, 1500 mm rearward of the vertical impact line.

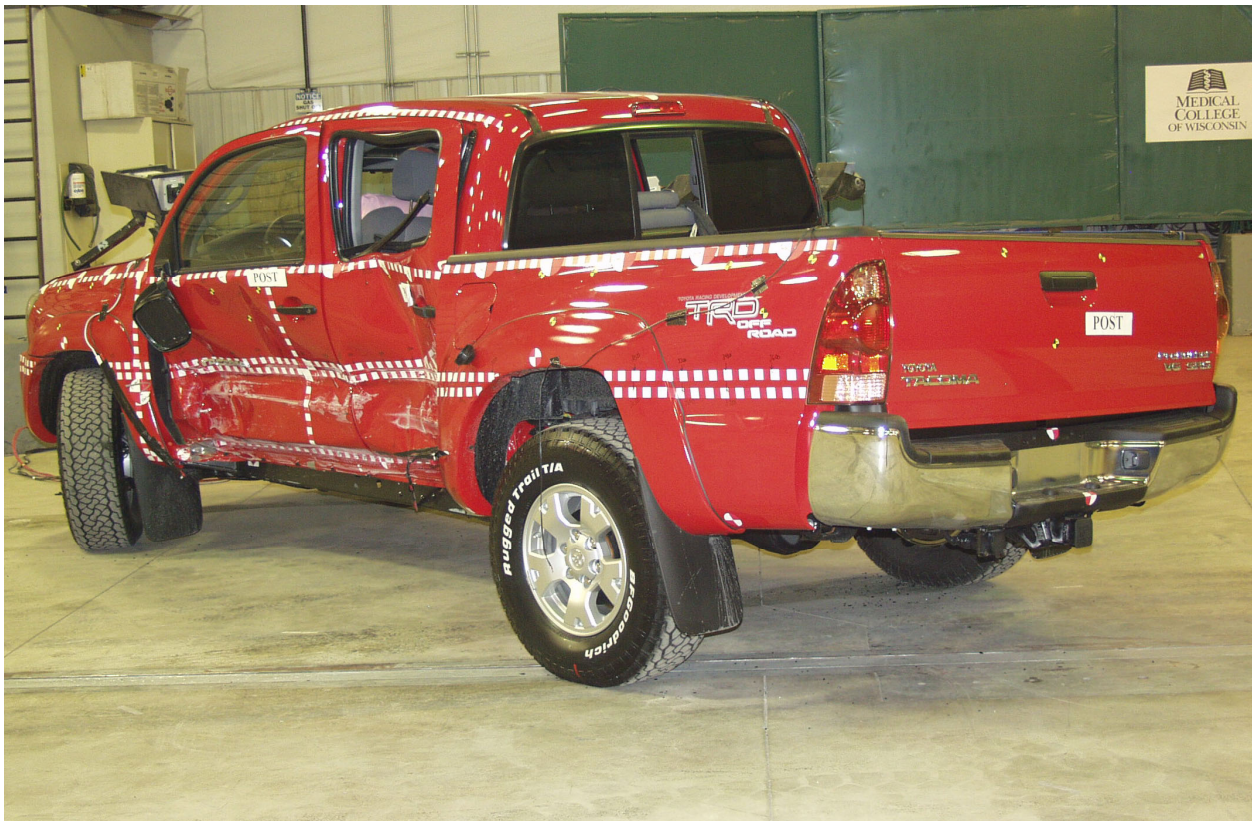
Figure A-12: Post test left rear 3/4 view of test vehicle

| <b>POST TEST STRUCTURAL OBSERVATIONS</b> | |
|---|---|
| Window damage | Left rear window shattered during impact |

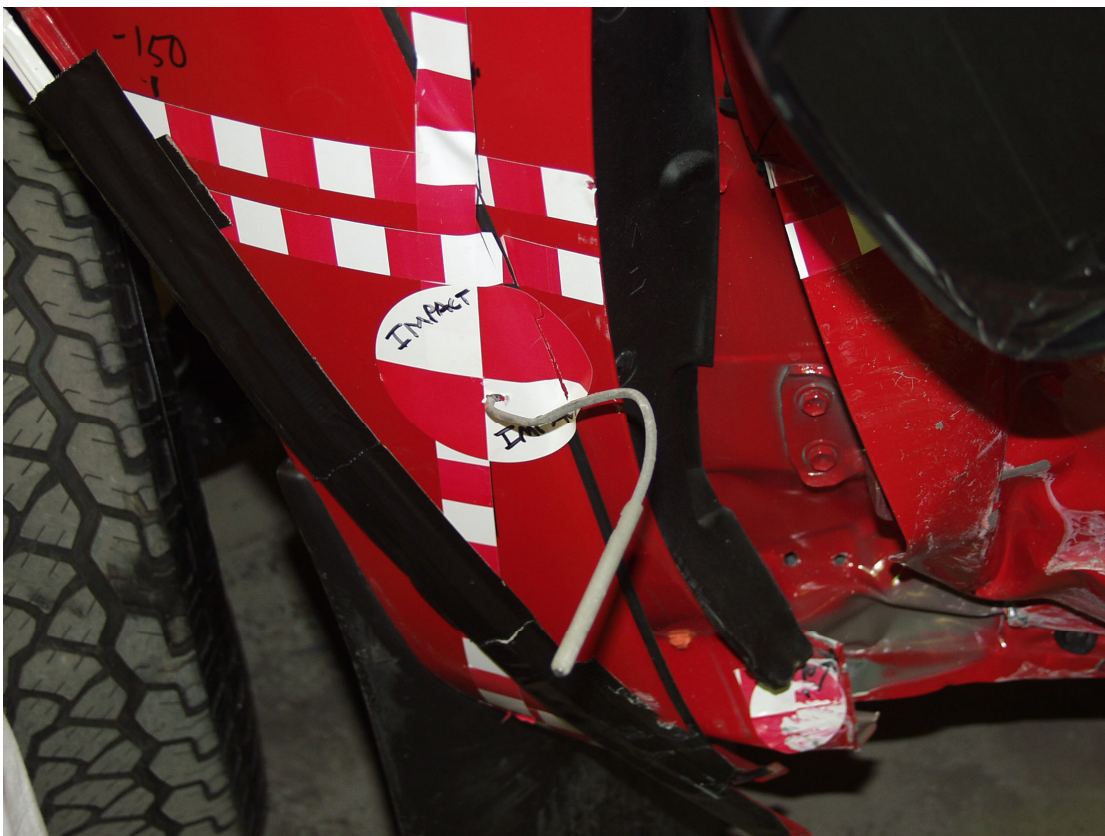
Figure A-26: Post test impact point

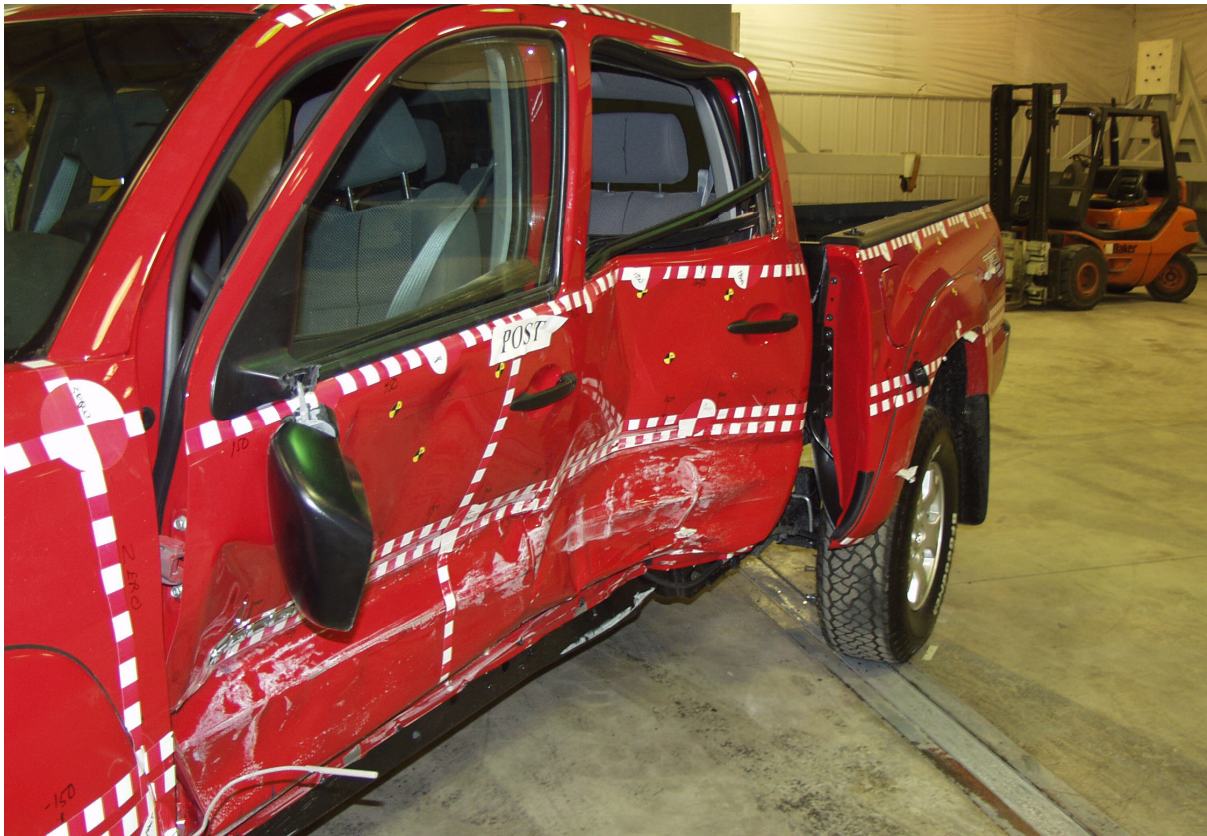
Figure A-28: Post test front 3/4 view of left side doors

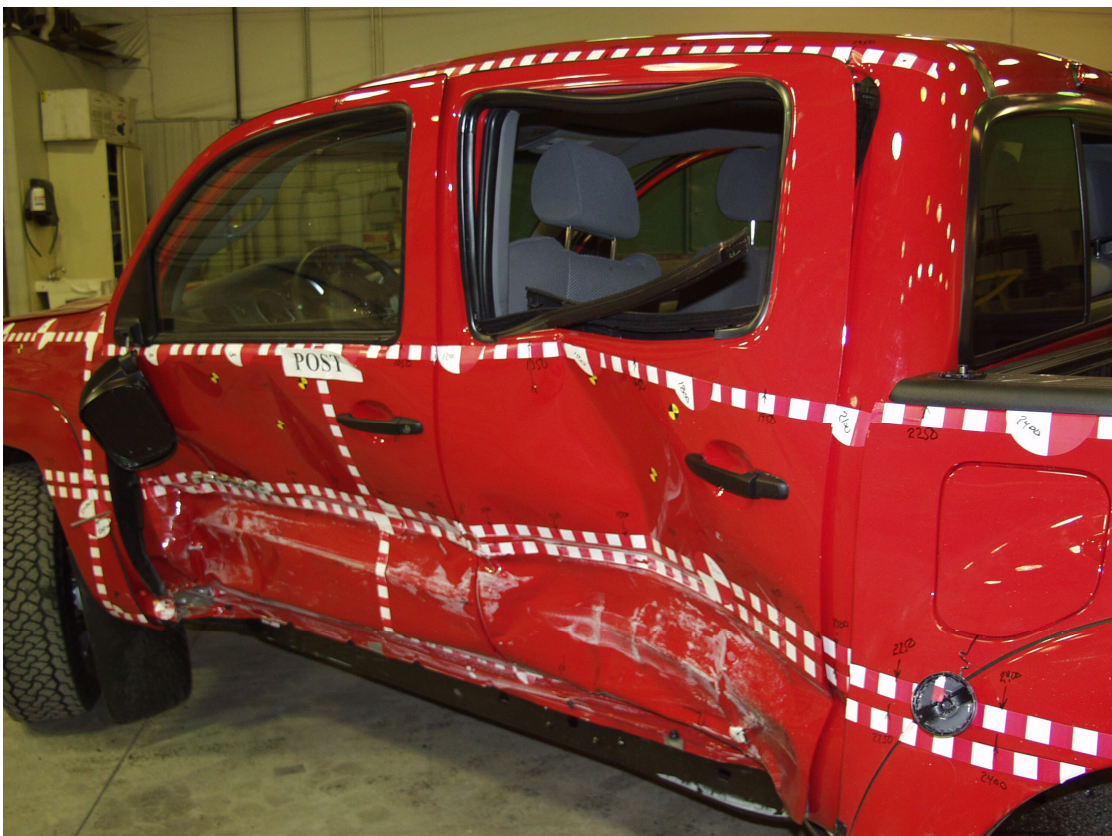
Figure A-30: Post test rear 3/4 view of left side doors

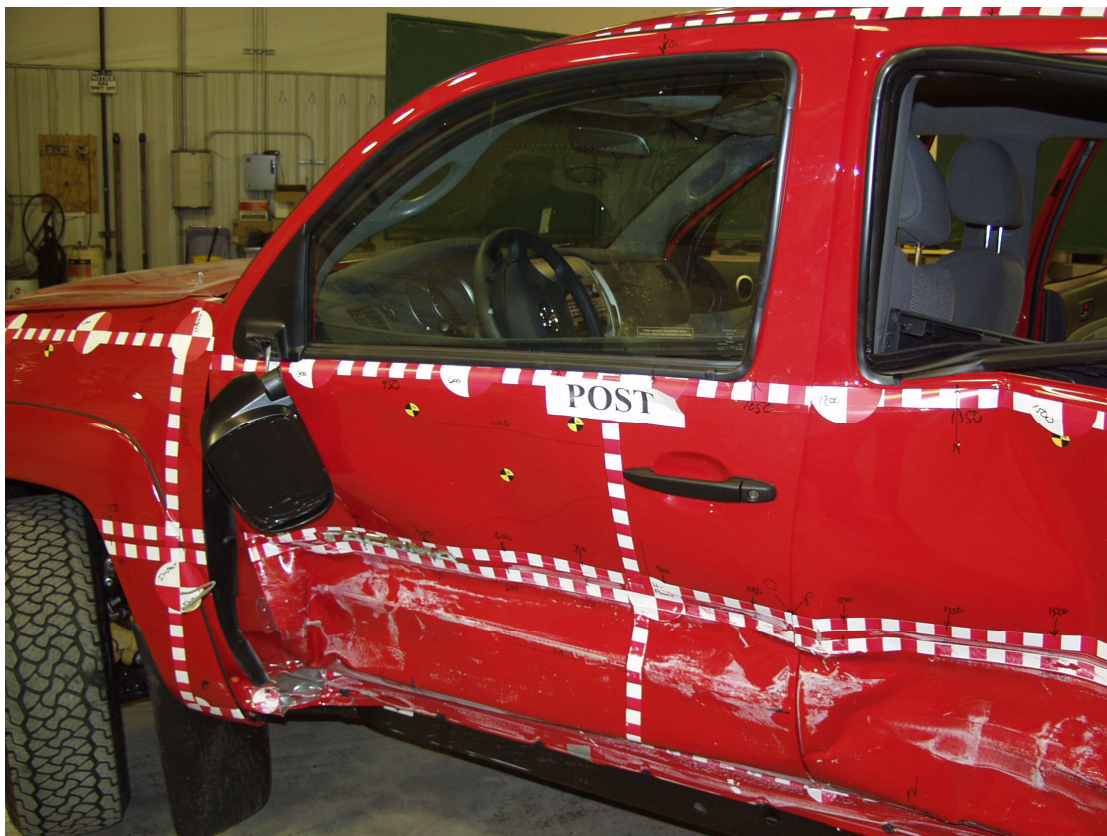
Figure A-32: Post test left front door

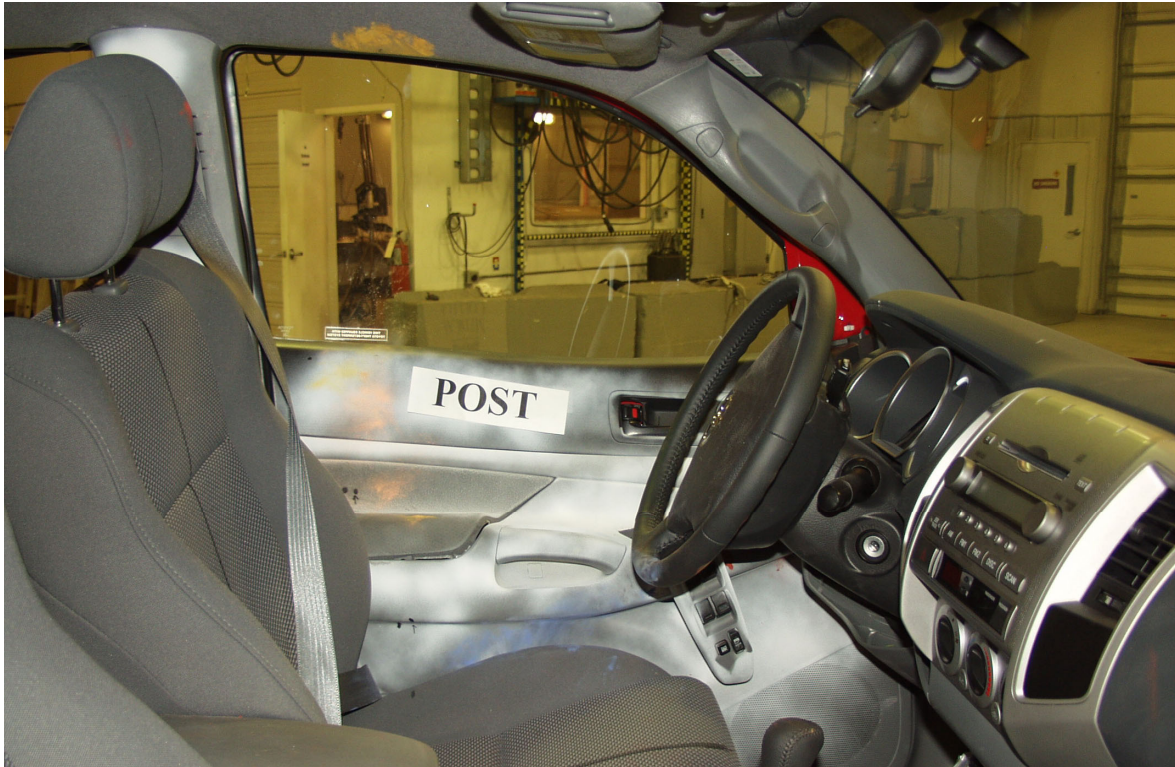
Figure A-41: Post test driver contact locations (1)

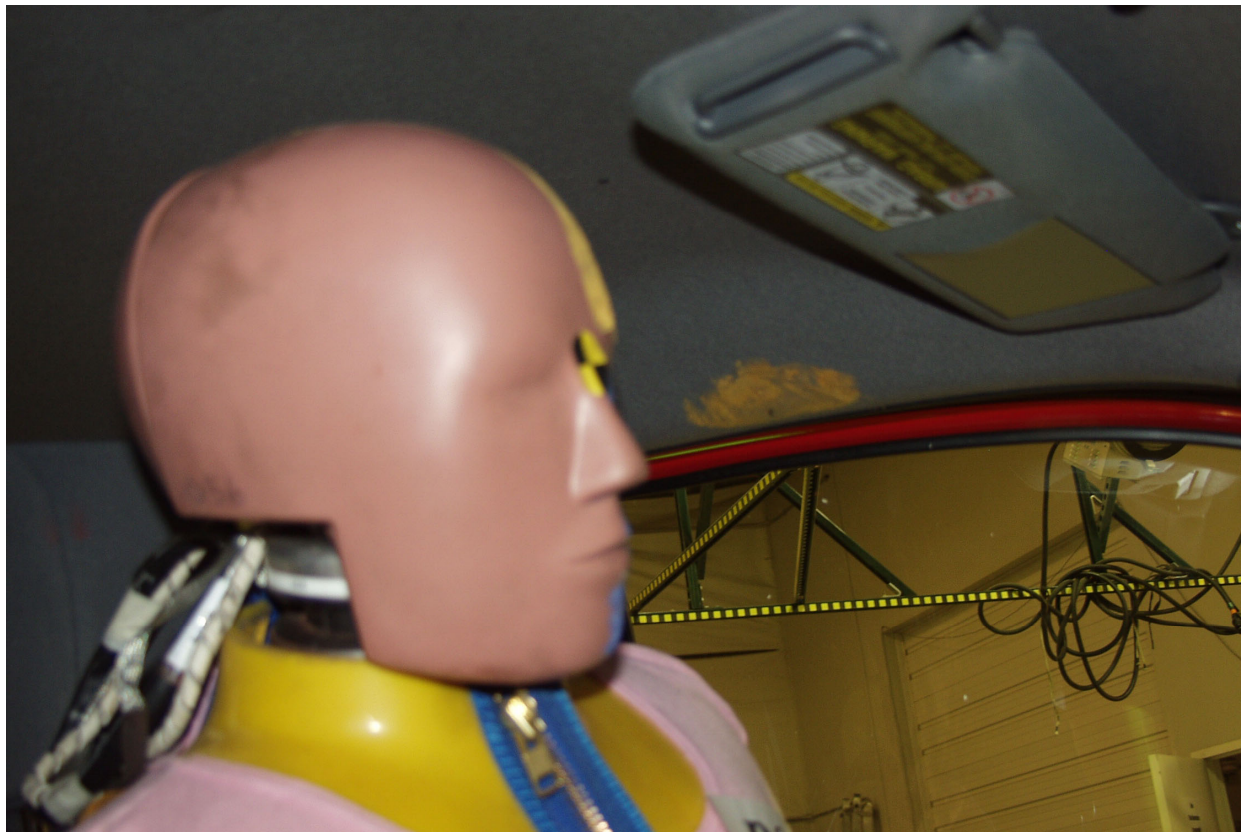
Figure A-42: Post test driver contact locations (2)

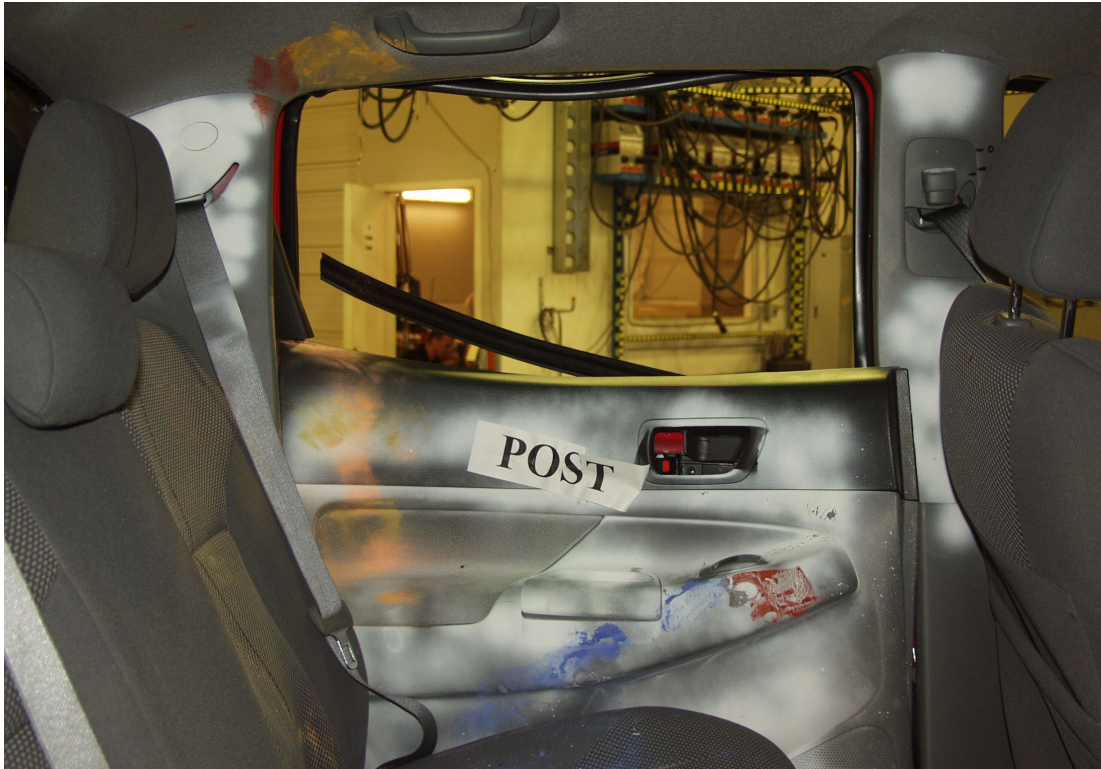
Figure A-49: Post test passenger contact locations (1)

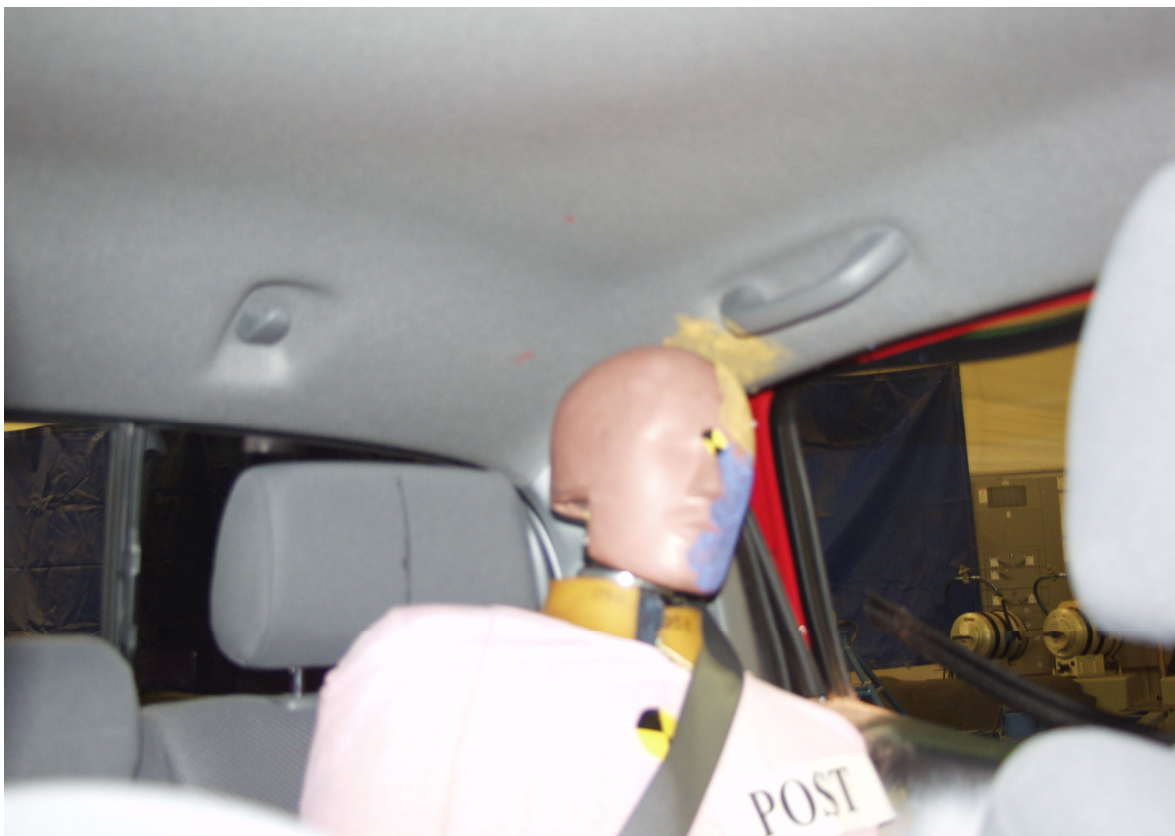
Figure A-50: Post test passenger contact locations (2)

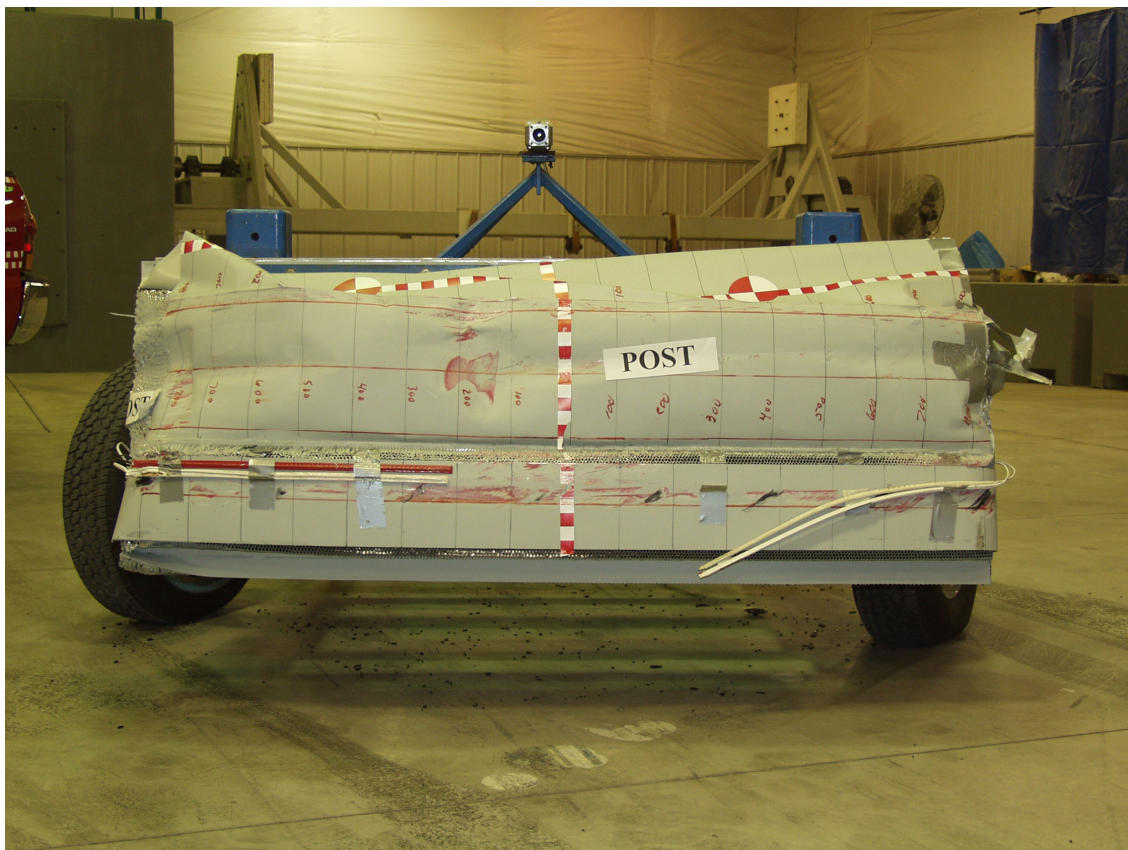
Figure A-52: Post test front view of MDB barrier face
