REPORT NUMBER: CAL-06-16

**NEW CAR ASSESSMENT PROGRAM (NCAP)  
FRONTAL BARRIER IMPACT TEST**

TOYOTA MOTOR CORPORATION  
2006 TOYOTA RAV4  
MPV

FINAL REPORT

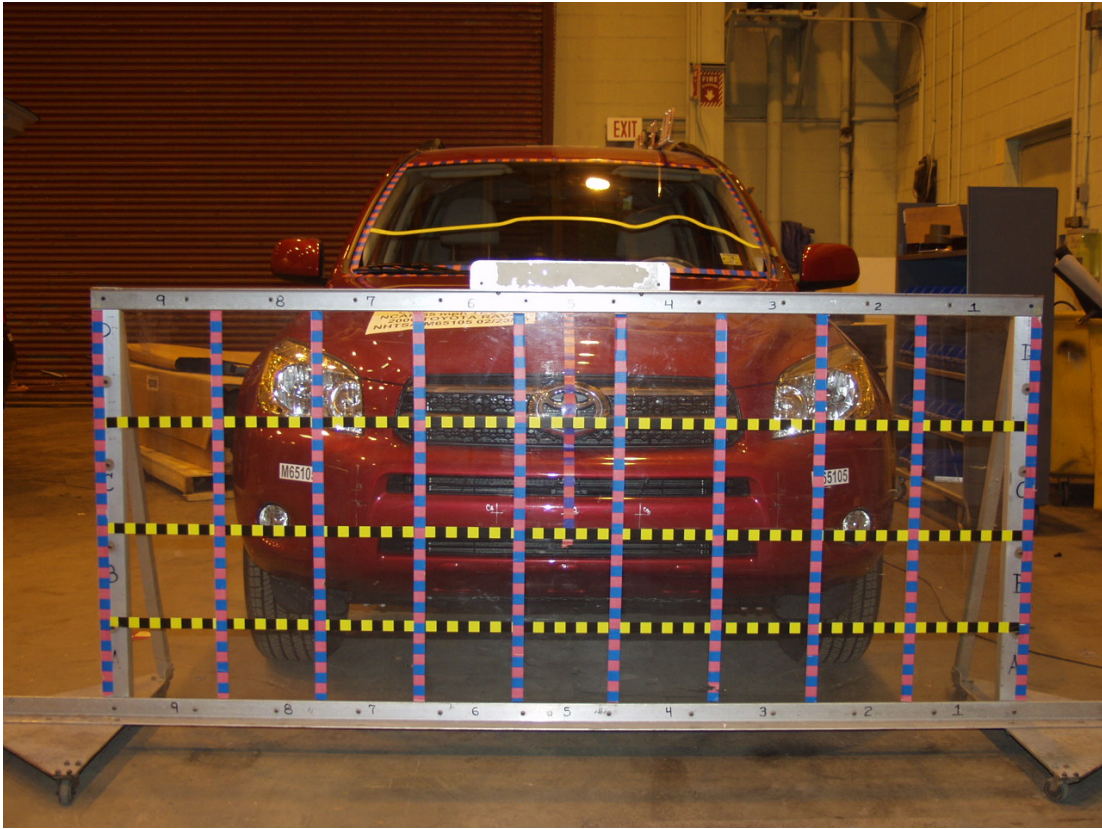
**Figure A-1: Load Cell Locations**

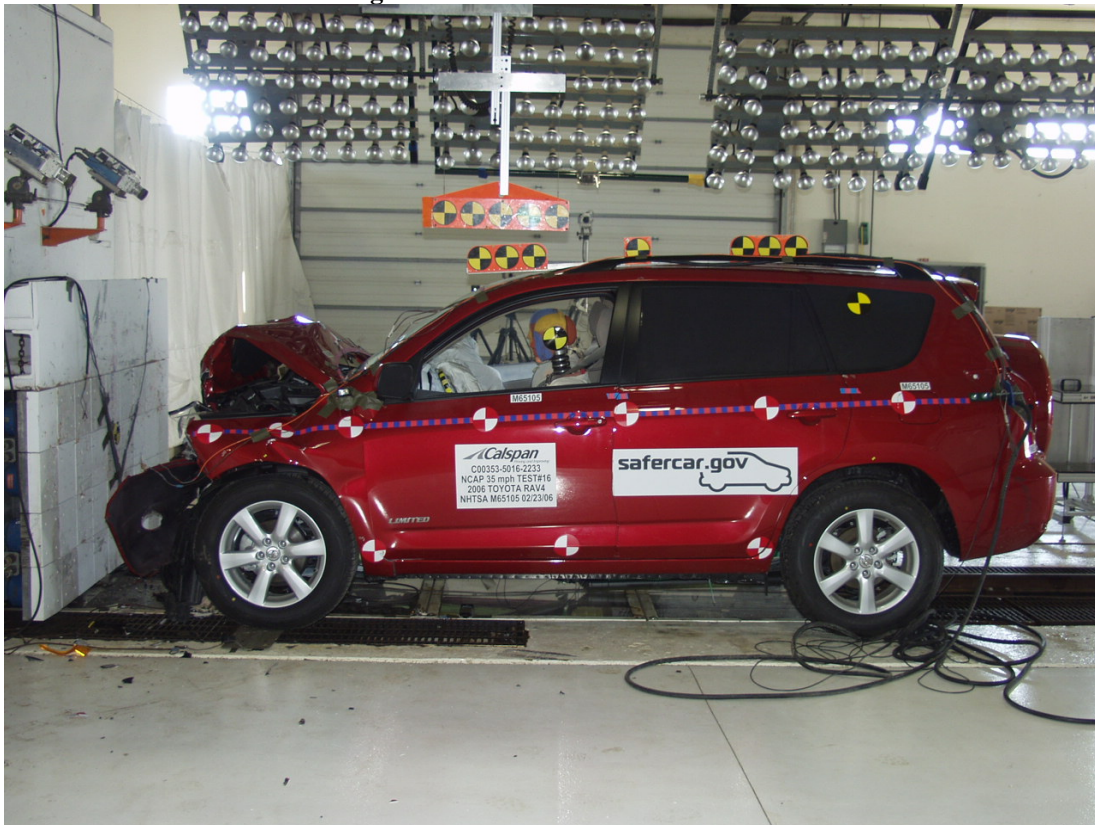
**Figure A-9: Post-Test Left Side View**

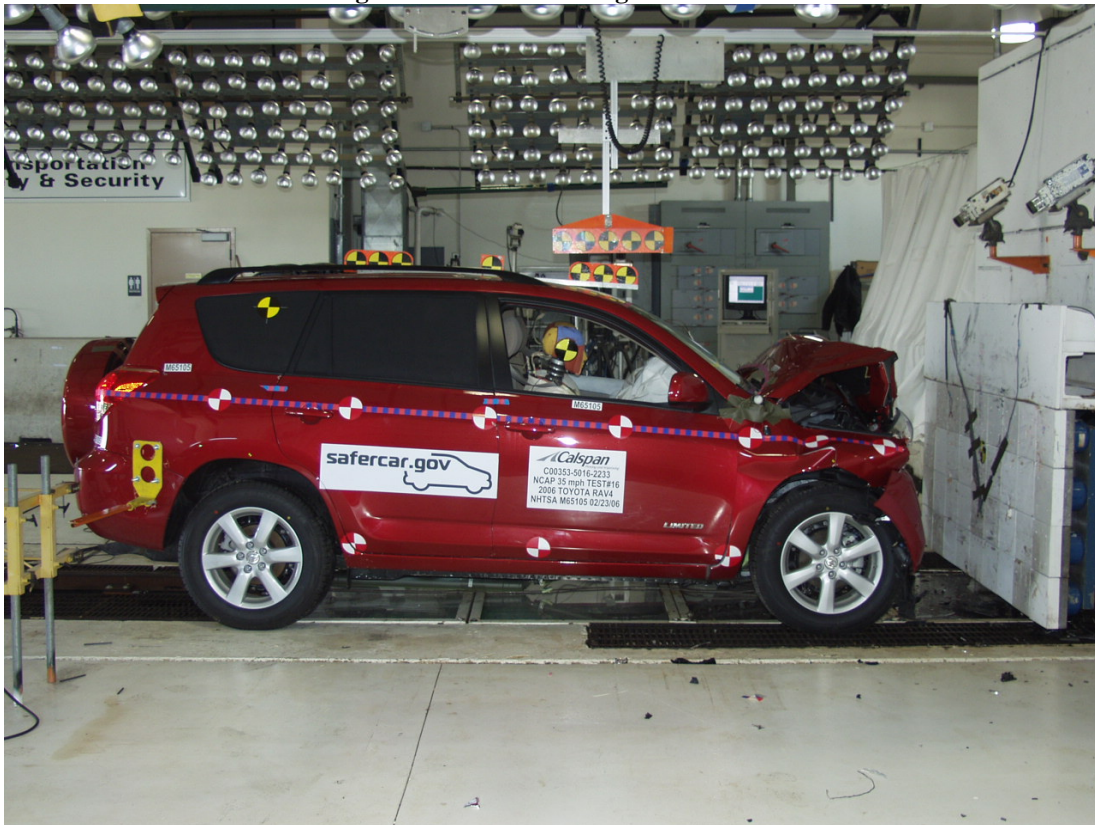
Figure A-11: Post-Test Right Side View

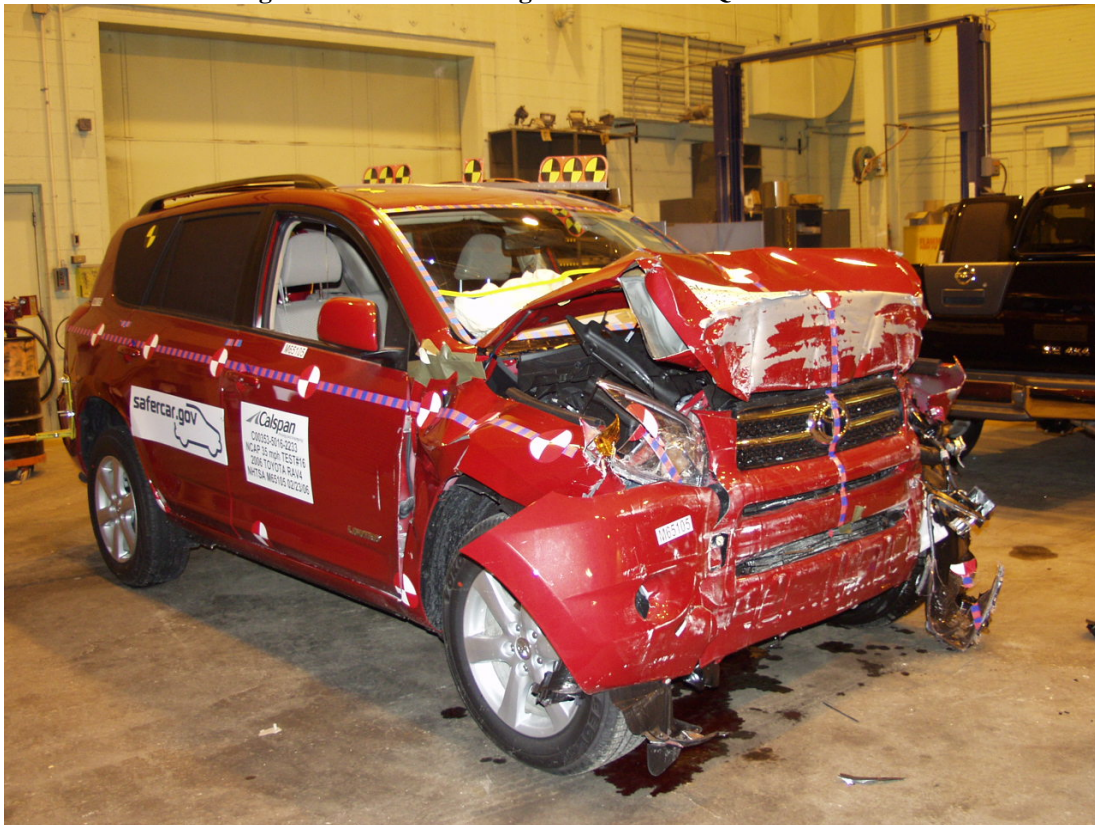
**Figure A-13: Post-Test Right Front Three-Quarter View**

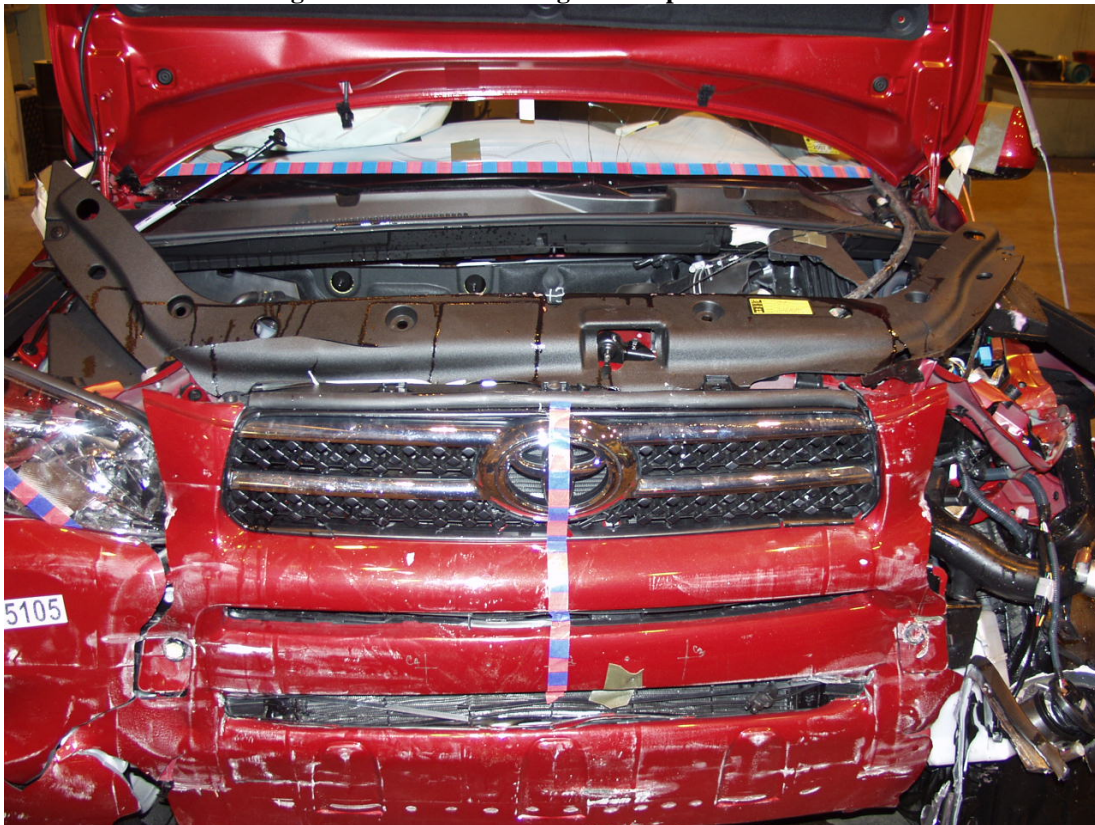
**Figure A-21: Post-Test Engine Compartment View**

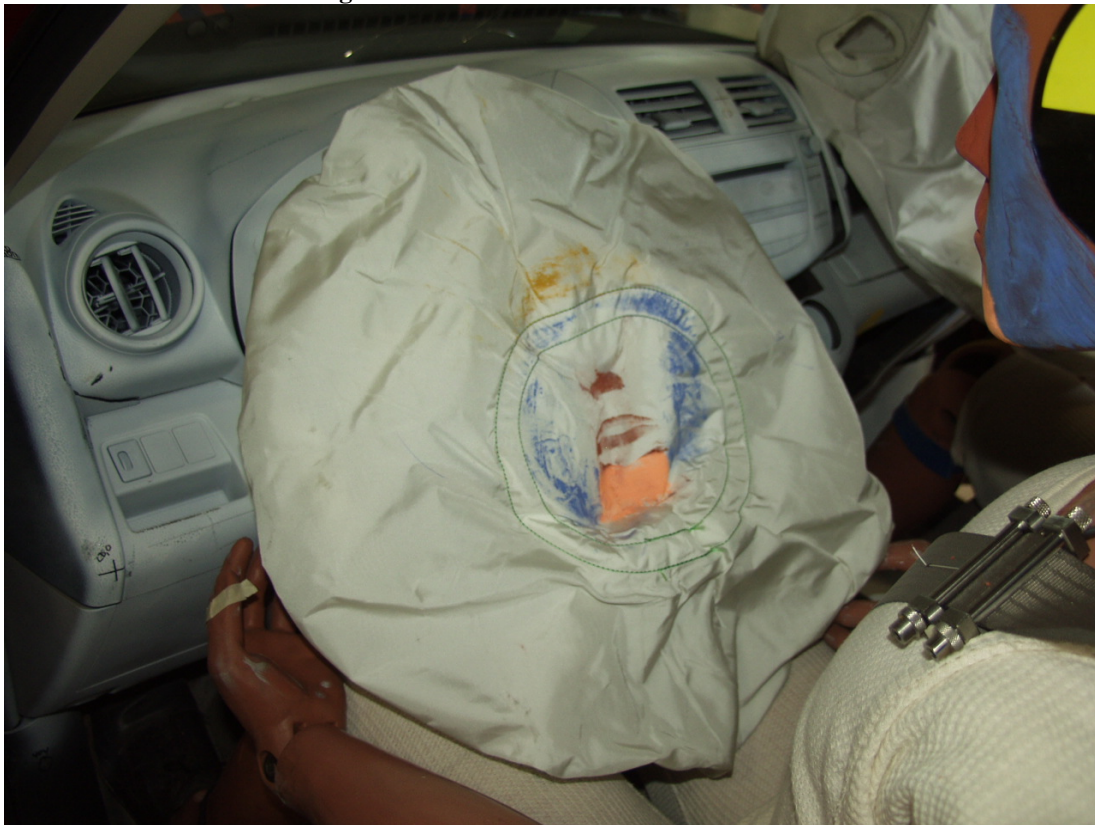
**Figure A-43: Post-Test Driver Contact to Airbag**

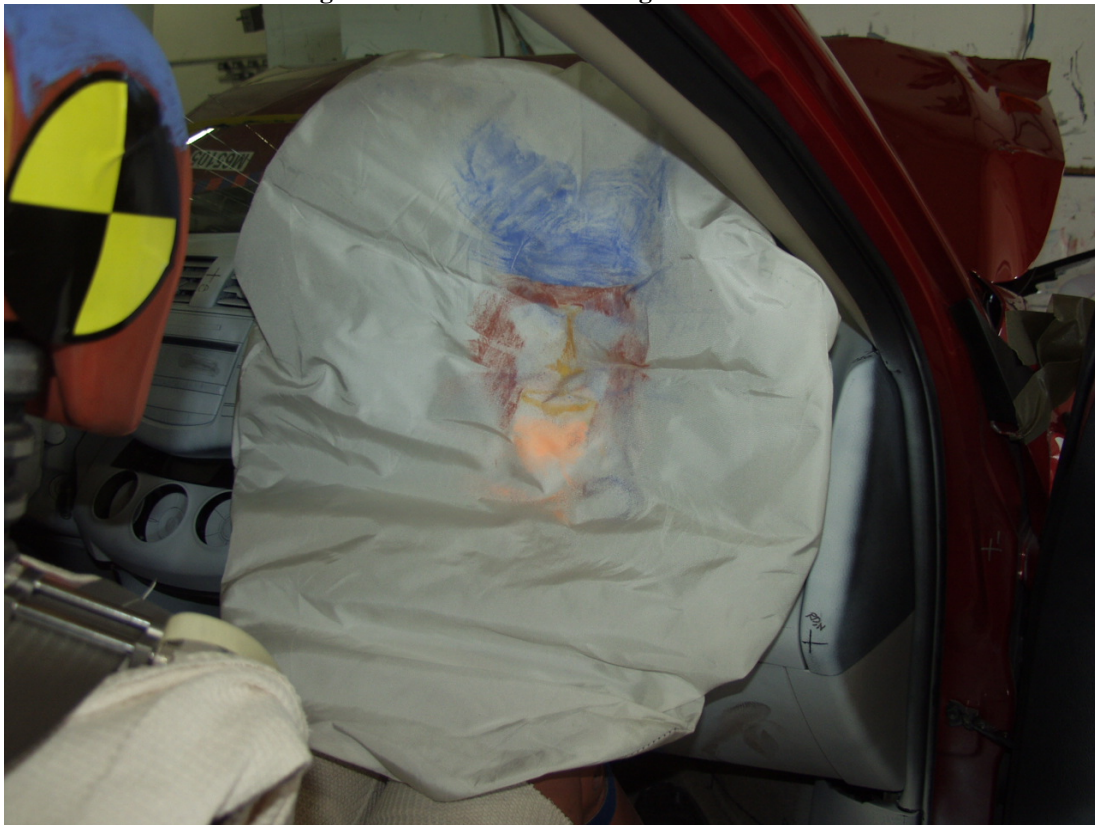
**Figure A-57: Post-Test Passenger Contact to Airbag**
