**REPORT NUMBER: SNCAP-CAL-06-07**

**NEW CAR ASSESSMENT PROGRAM  
SIDE IMPACT TEST**

**TOYOTA MOTOR CORPORATION  
2006 TOYOTA RAV4  
MPV**

**FINAL REPORT**

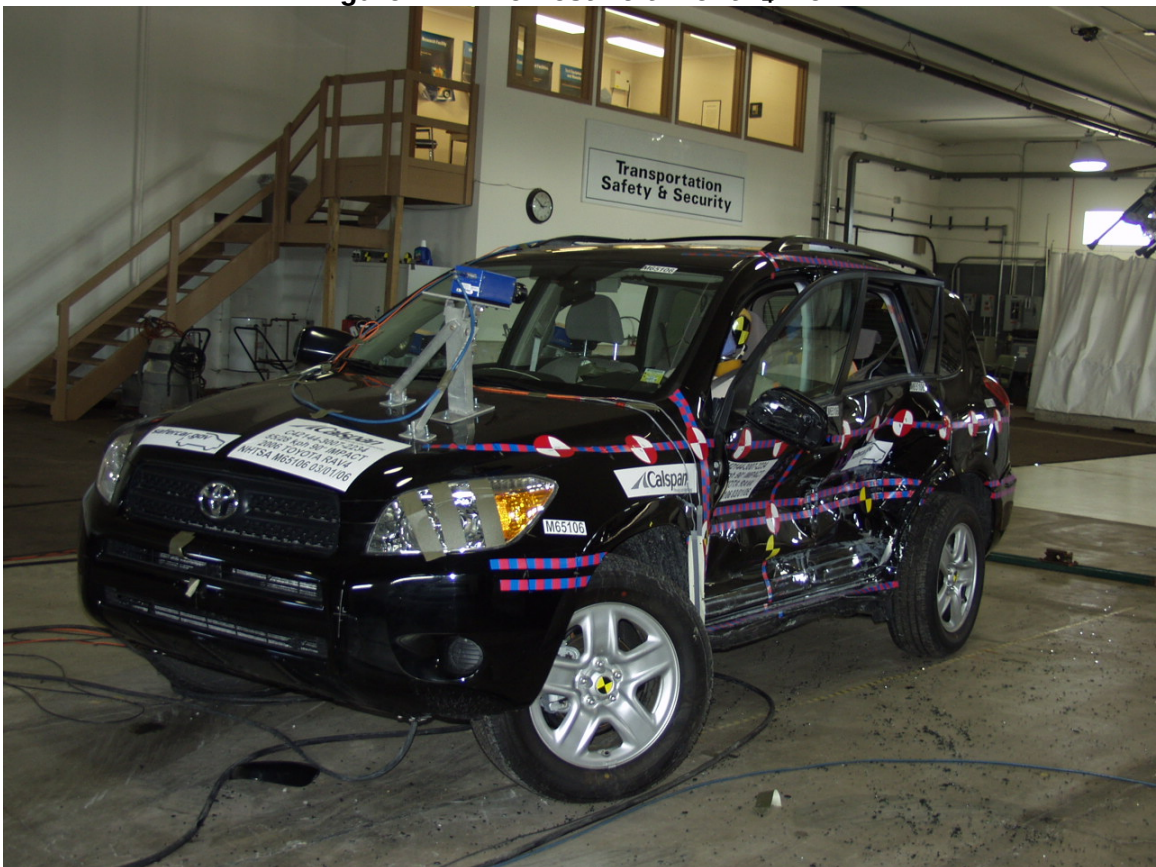
Figure A-8: Post-Test Left Front  $\frac{3}{4}$  View

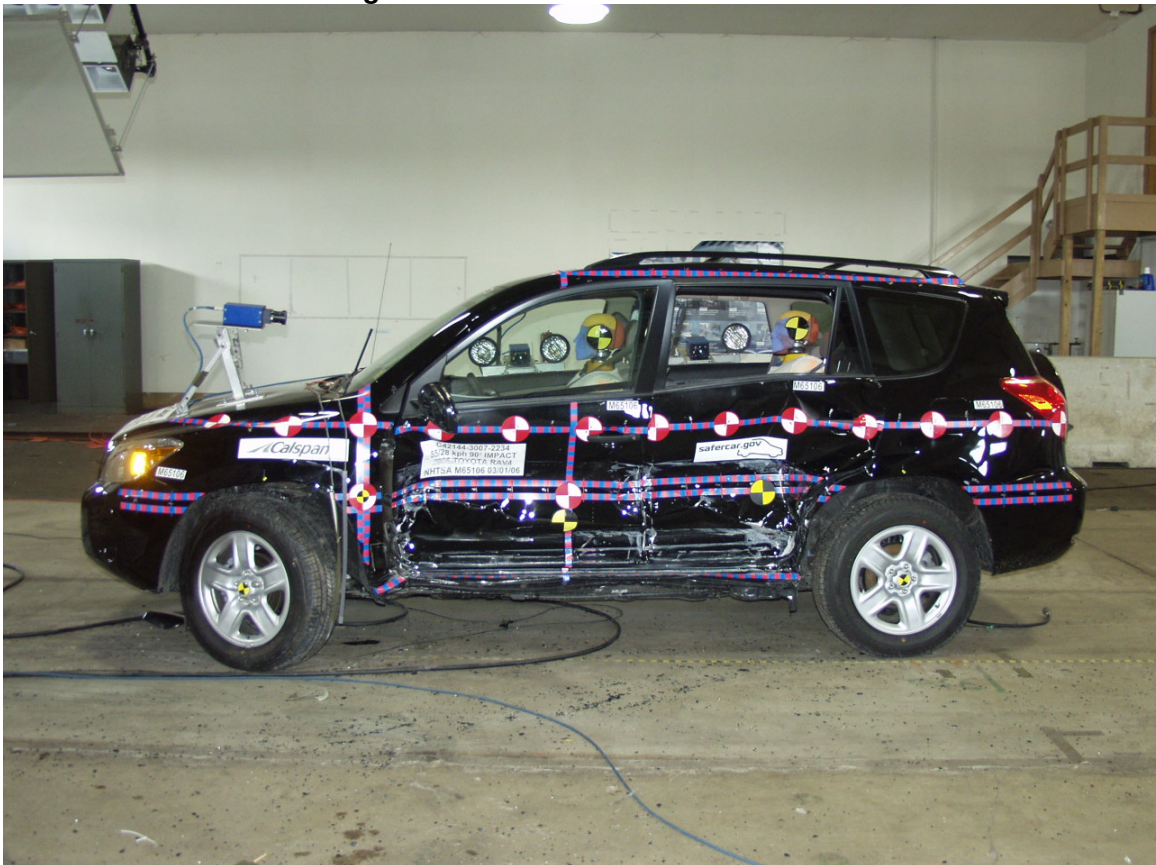
**Figure A-10: Post-Test Left Side View**

The test vehicle sustained a maximum static crush of 249 mm at level 3, 1500 mm rearward of the left vertical impact point. The driver and passenger SID/HIII's, Serial Nos. 905 and 906 respectively, were calibrated just prior to this test.

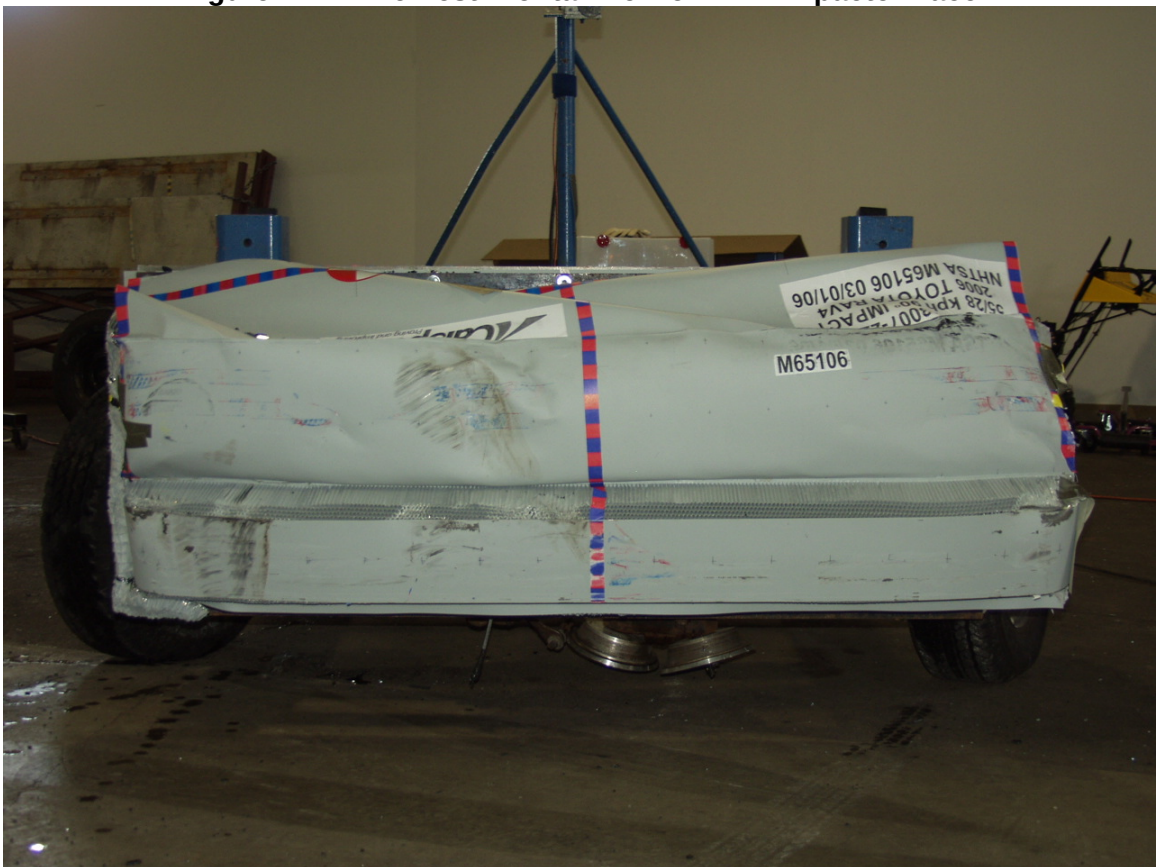
**Figure A-22: Post-Test Frontal View of MDB Impactor Face**

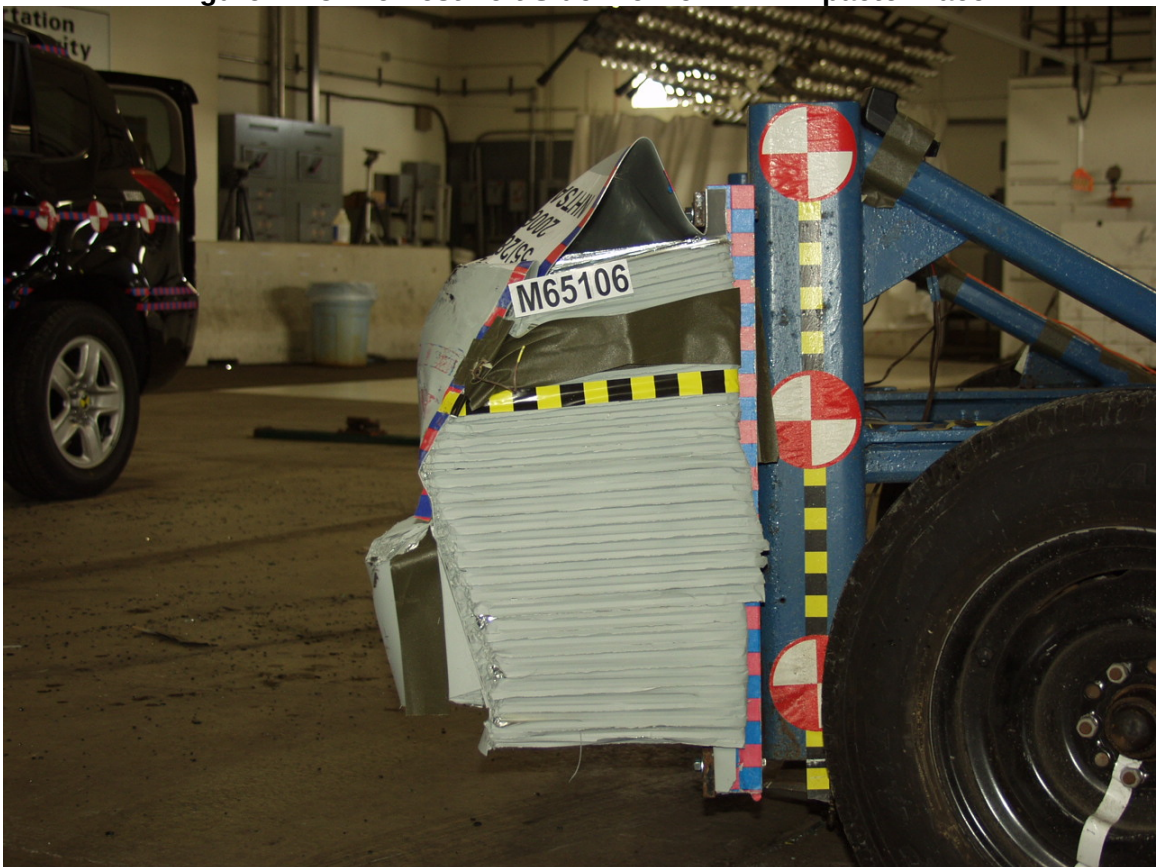
**Figure A-24: Post-Test Left Side View of MDB Impactor Face**

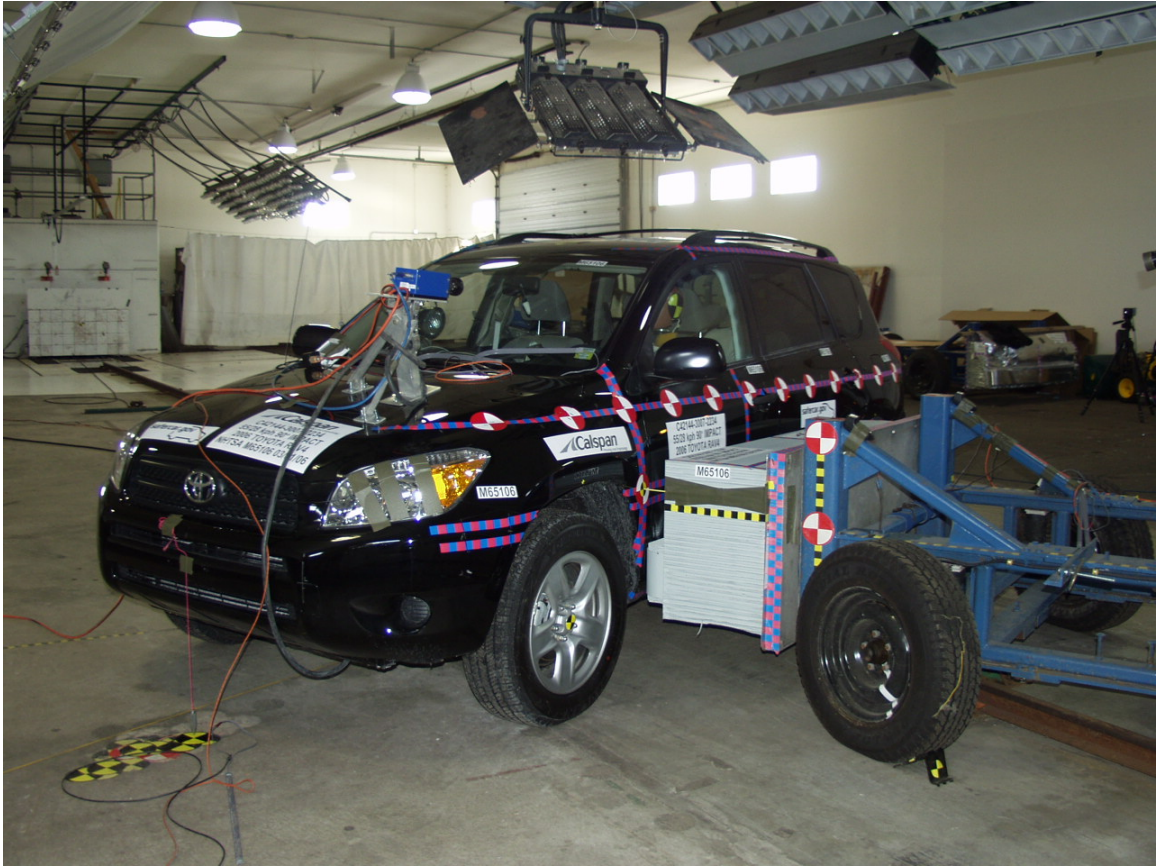
**Figure A-29: Pre-Test Left Side View of Aligned MDB and Vehicle**

A model year 2006 Toyota RAV4 MPV was impacted on the left (driver's) side by a Moving Deformable Barrier (MDB) which was moving forward in a 27° crabbed position to the tow road guidance system at a velocity of 62.12 km/h. The specified impact velocity range is from 61.1 to 62.7 km/h. The test (target) vehicle was stationary and positioned 63° to the line of forward motion. The weight of the vehicle as tested was 1710.0 kg and the test weight of the MDB was 1362.5 kg. The test was conducted at the Calspan Corporation Transportation Sciences Center on March 01, 2006.

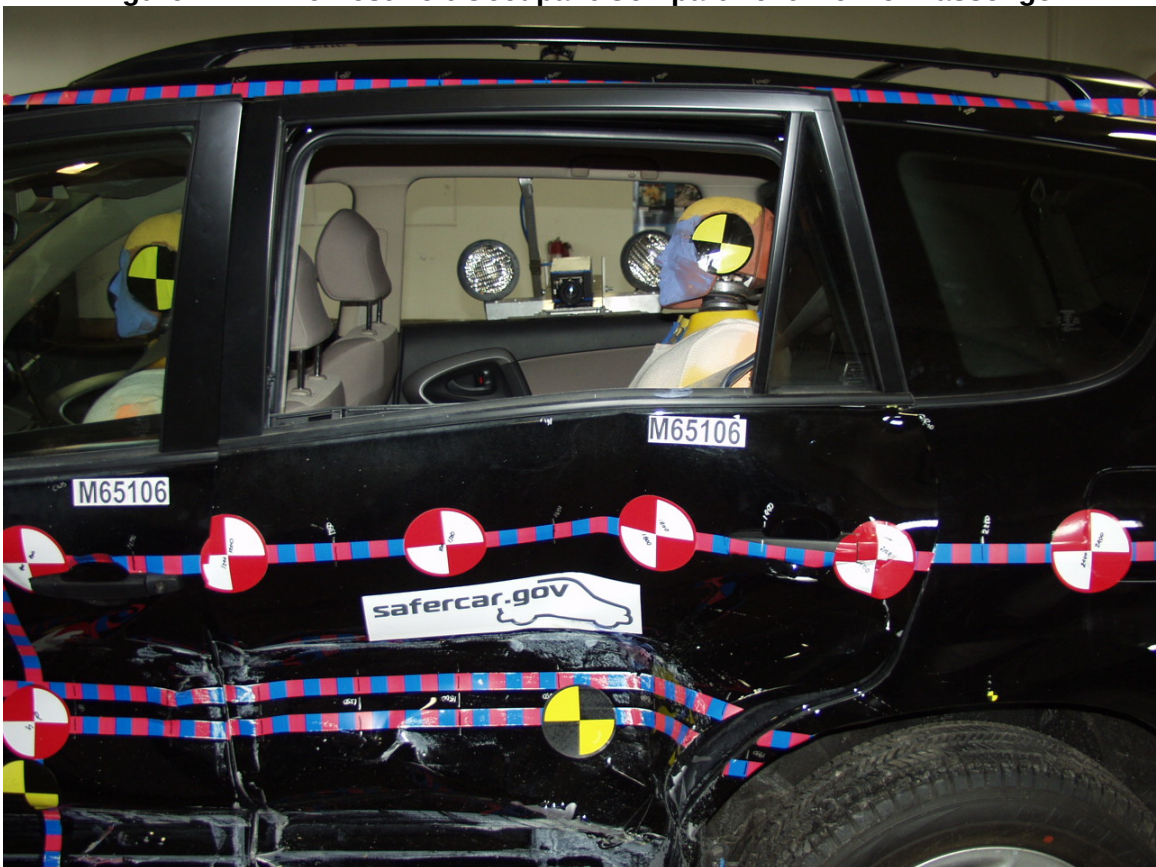
**Figure A-42: Post-Test Left Occupant Compartment View of Passenger**

| Critical Areas of Performance | Observations and Conclusions |
|---|---|
| Window Damage | Left Rear Passenger Window Broke |

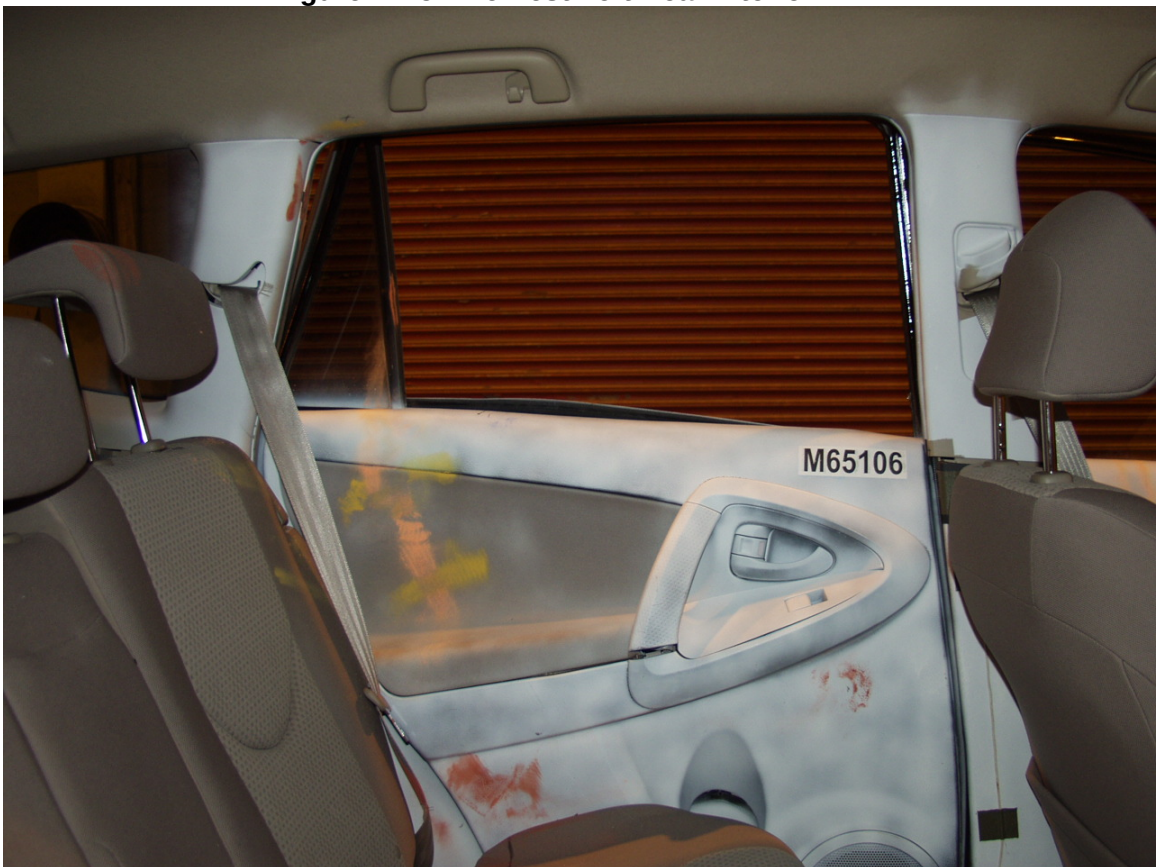
**Figure A-46: Post-Test Left Rear Interior Trim**

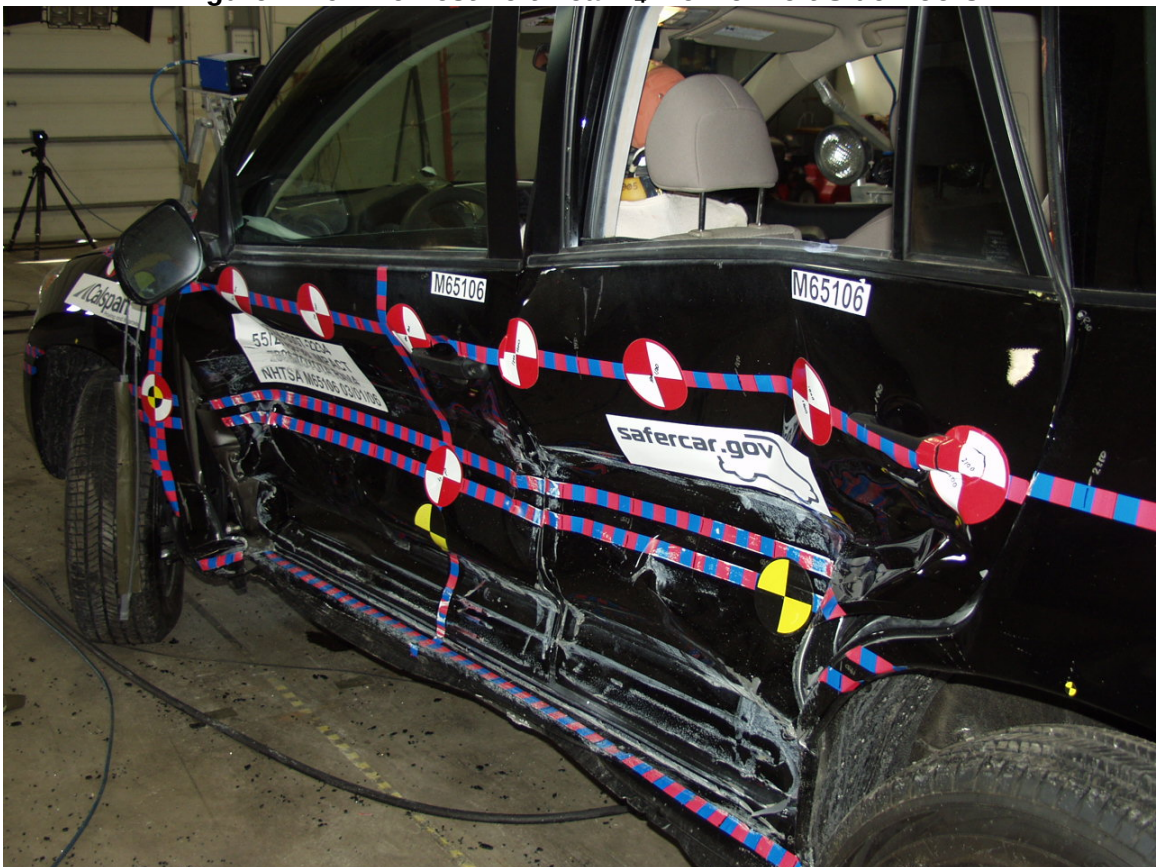
**Figure A-50: Post-Test Left Rear ¾ View of Left Side Doors**
