REPORT NUMBER: CAL-06-17

**NEW CAR ASSESSMENT PROGRAM (NCAP)  
FRONTAL BARRIER IMPACT TEST**

NISSAN MOTOR CORP.  
2006 NISSAN FRONTIER  
EXTENDED CAB PICKUP

FINAL REPORT

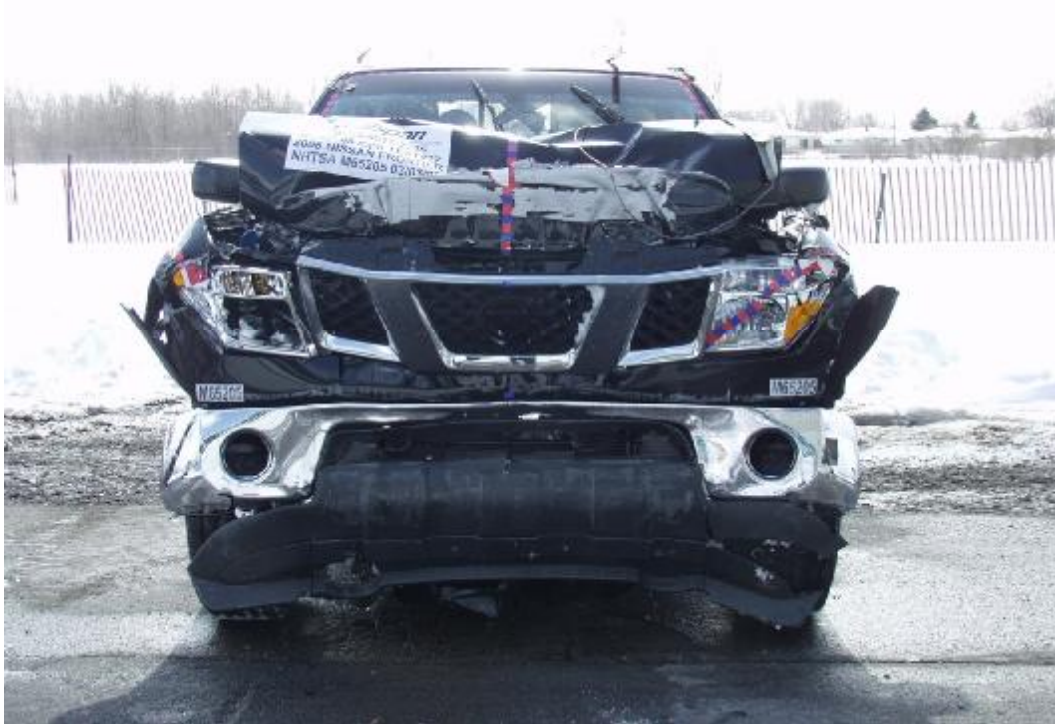
**Figure A-7: Post-Test Front View**

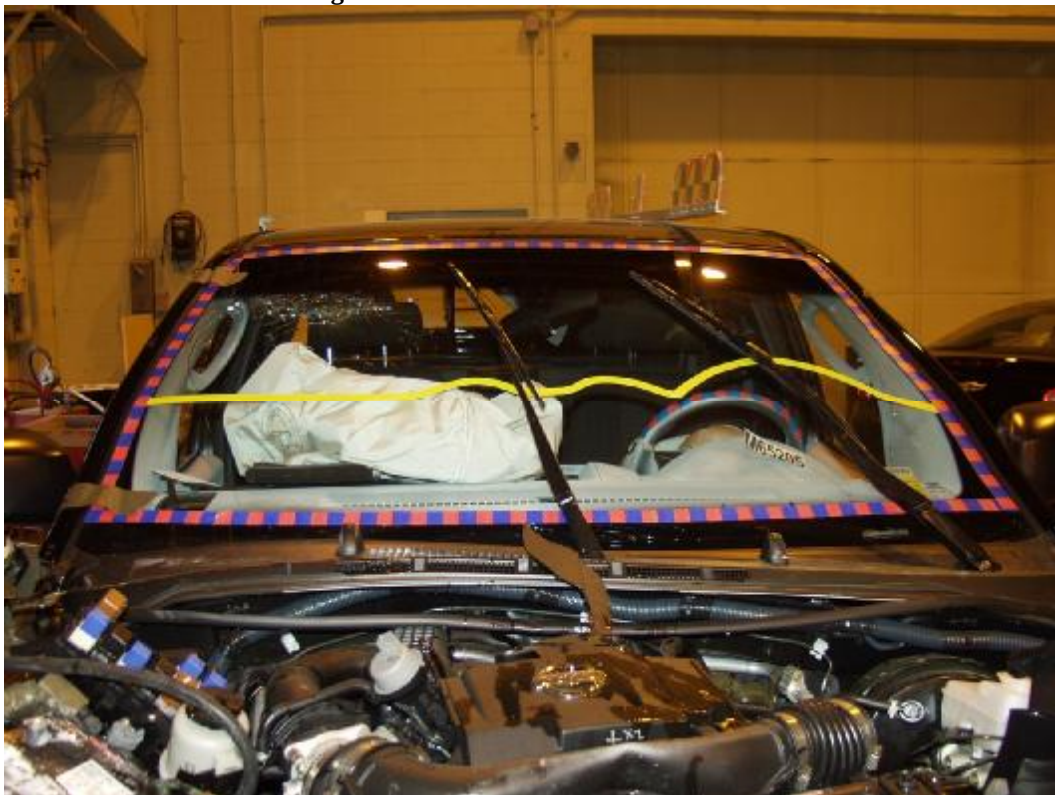
**Figure A-19: Post-Test Windshield View**

| Description | Driver Side | Passenger Side |
|---|---|---|
| Glazing Damage | The windshield cracked on the passenger side as a result of airbag deployment | |

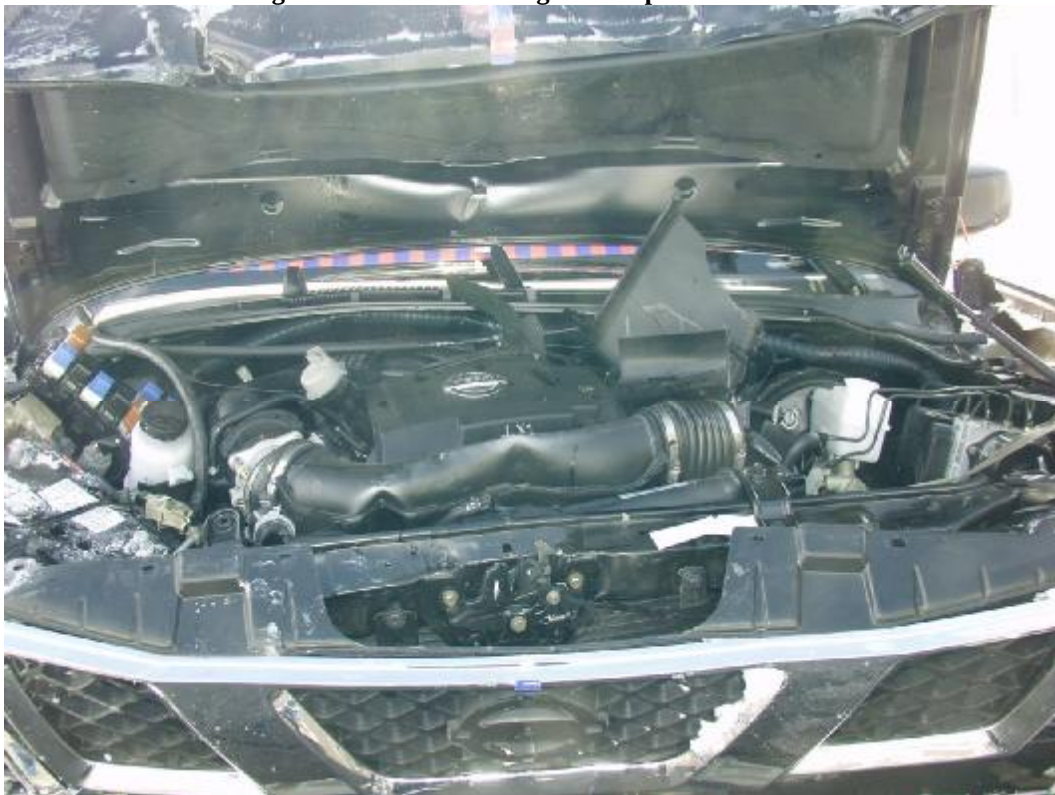
**Figure A-21: Post-Test Engine Compartment View**

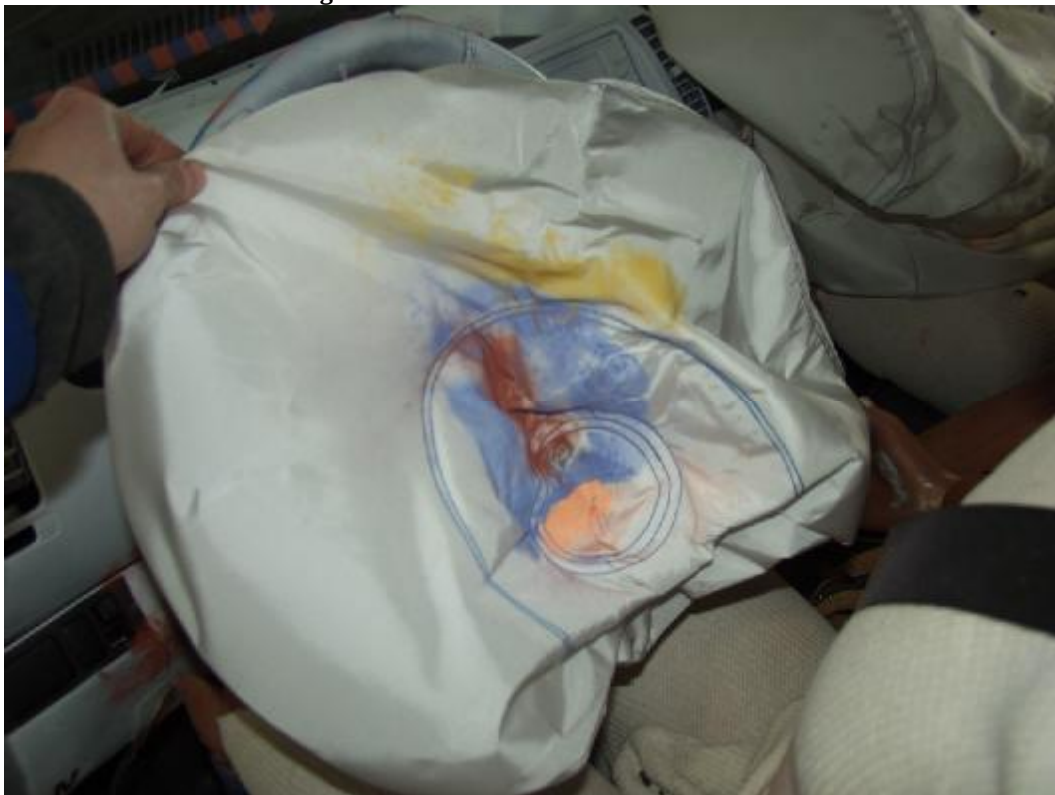
**Figure A-43: Post-Test Driver Contact to Airbag**

| | DRIVER | PASSENGER |
|---|---|---|
| Head Contact: | The face to the center of the airbag and the back of the head to the left of center of the head restraint | The face to the center of the airbag and the back of the head to the right of center of the head restraint |

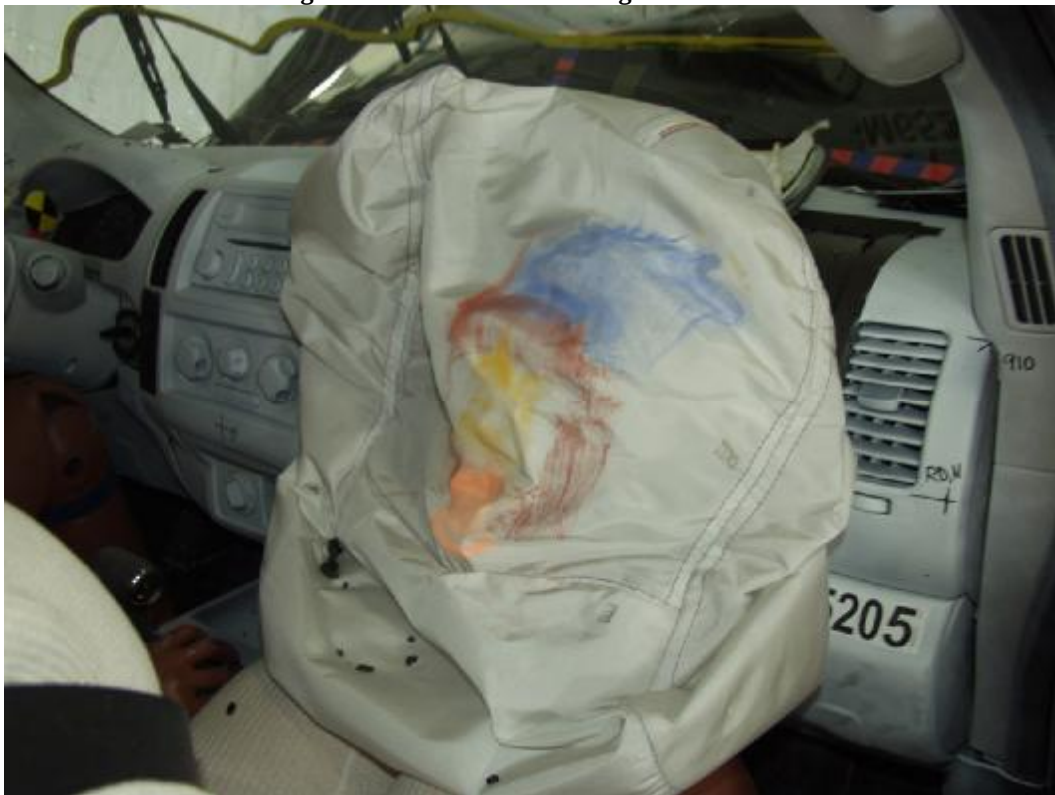
**Figure A-57: Post-Test Passenger Contact to Airbag**

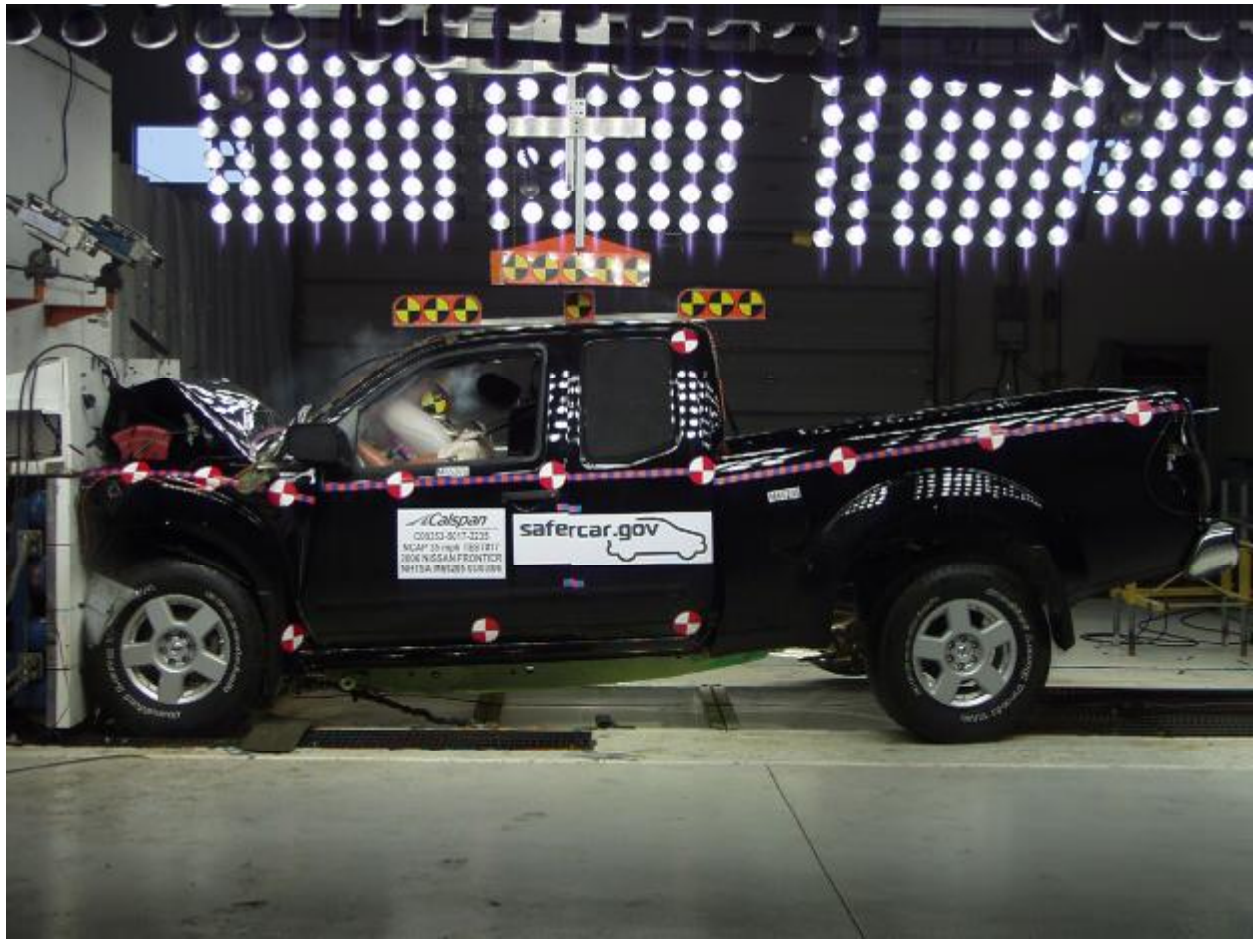
Figure A-62: Impact View

A load cell barrier consisting of 36 load cells was impacted by a 2006 Nissan Frontier Extended Cab Pickup at a velocity of 56.49 kph. The test was performed at Calspan on March 3, 2006. Pre- and post-test photographs of the vehicle and dummies can be found in Appendix A.
