**REPORT NUMBER TR-P26003-05-NC**

**NEW CAR ASSESSMENT PROGRAM  
SIDE IMPACT TEST**

**GENERAL MOTORS CORPORATION  
2006 CHEVROLET COBALT LS  
2-DOOR COUPE**

**FINAL REPORT**

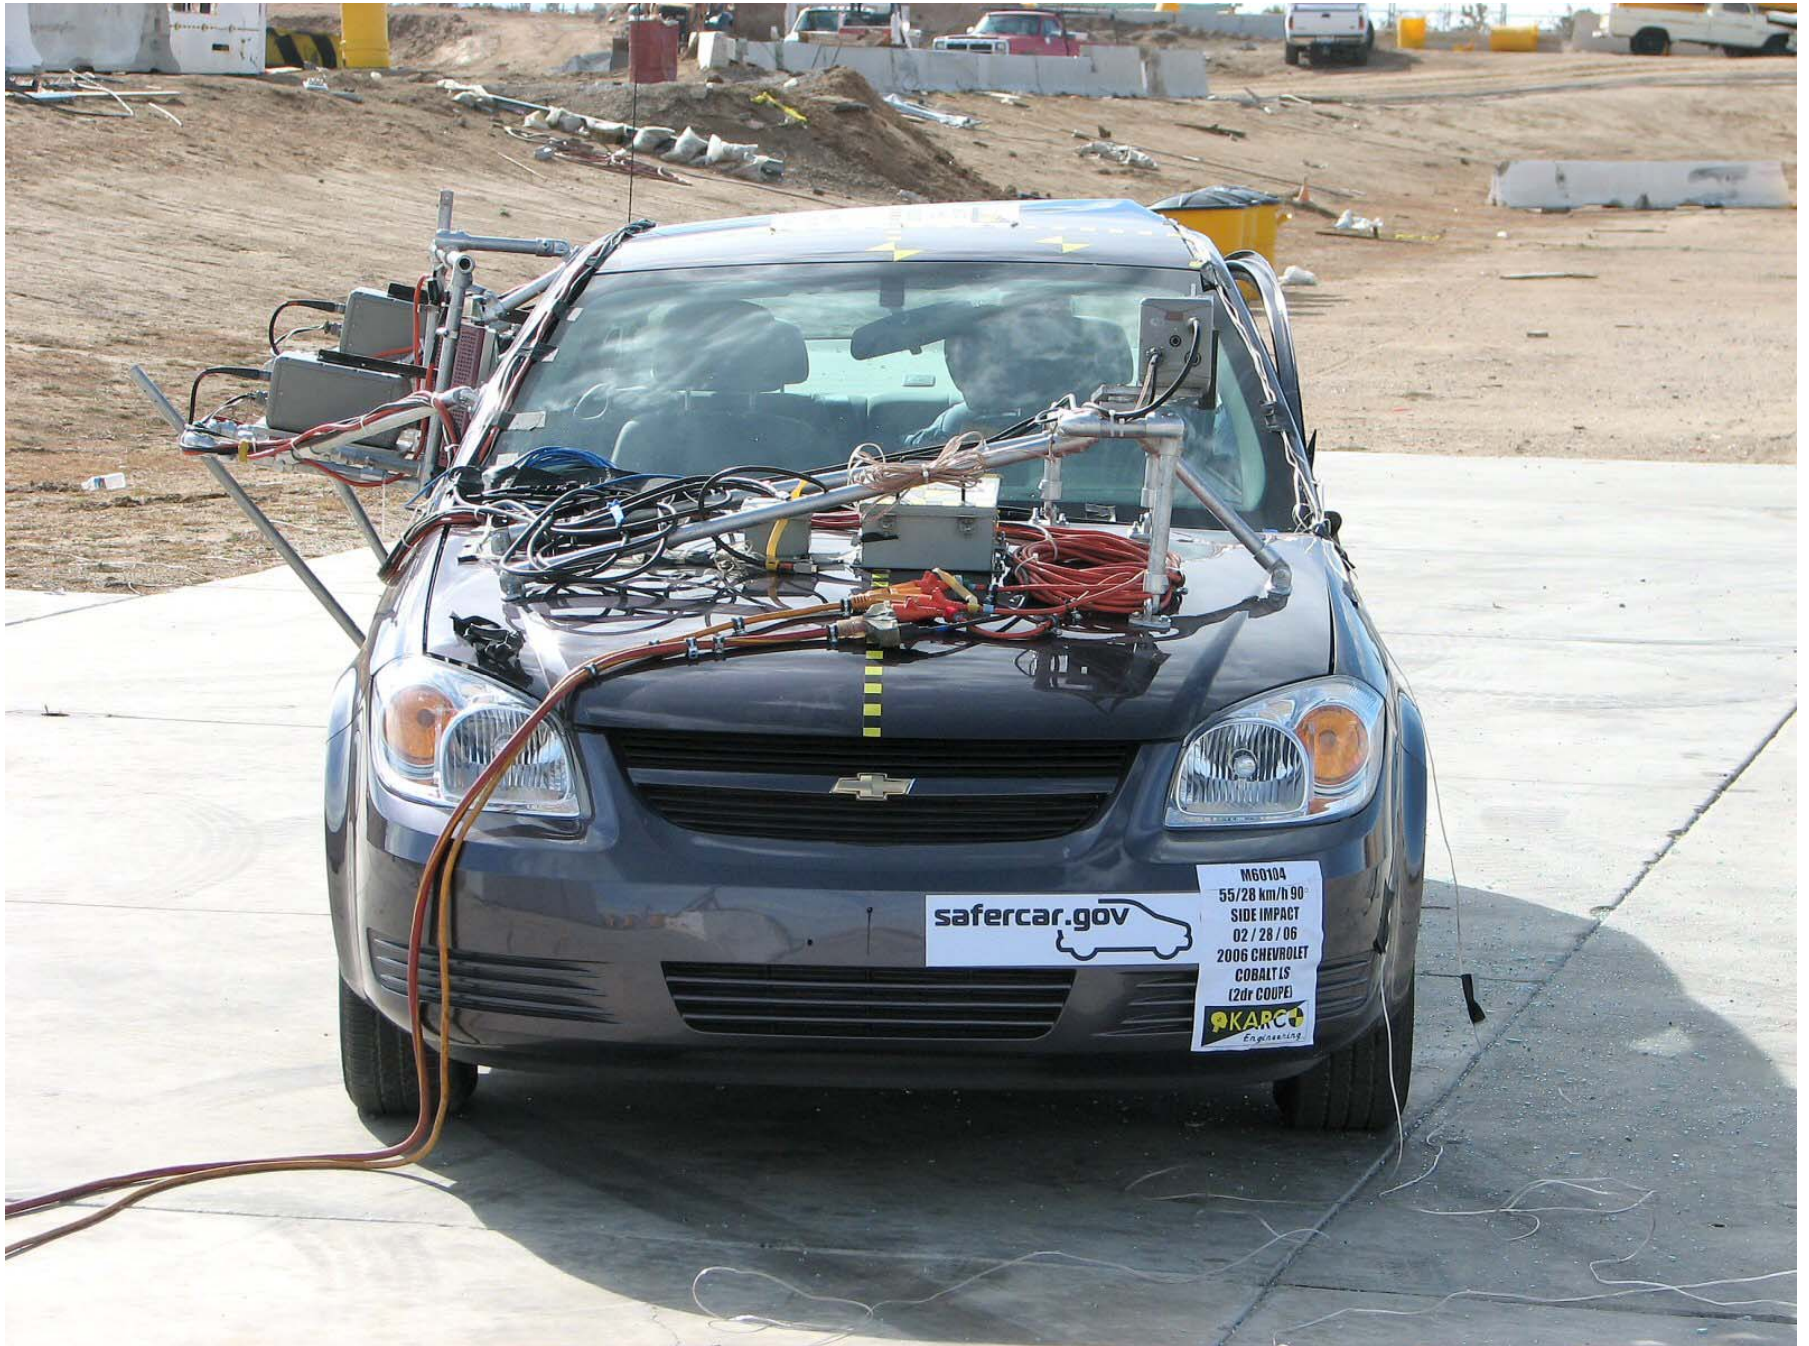
Figure A-6: Post-Test Front View

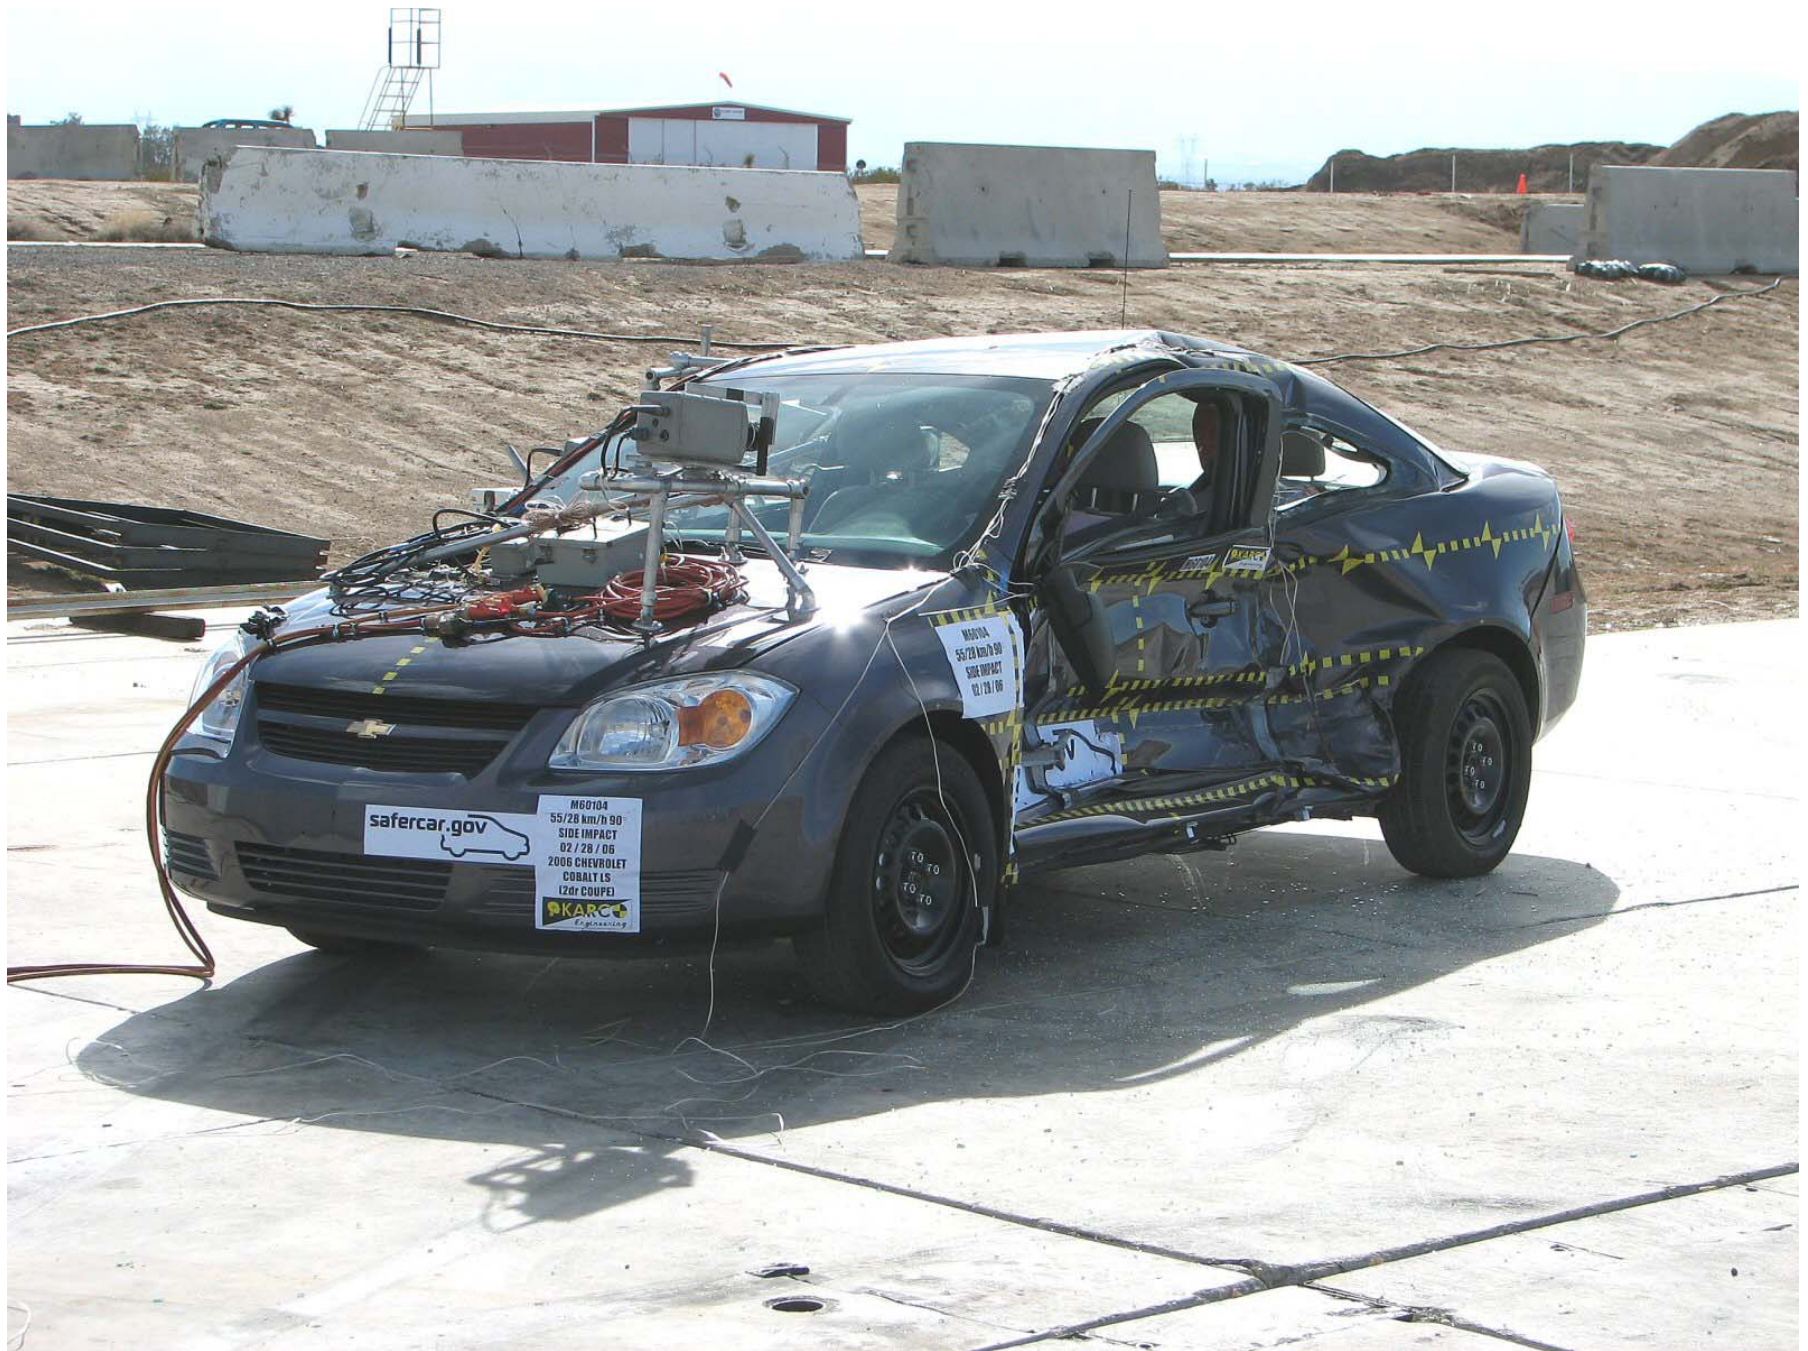
Figure A-8: Post-Test Left Front  $\frac{3}{4}$  View

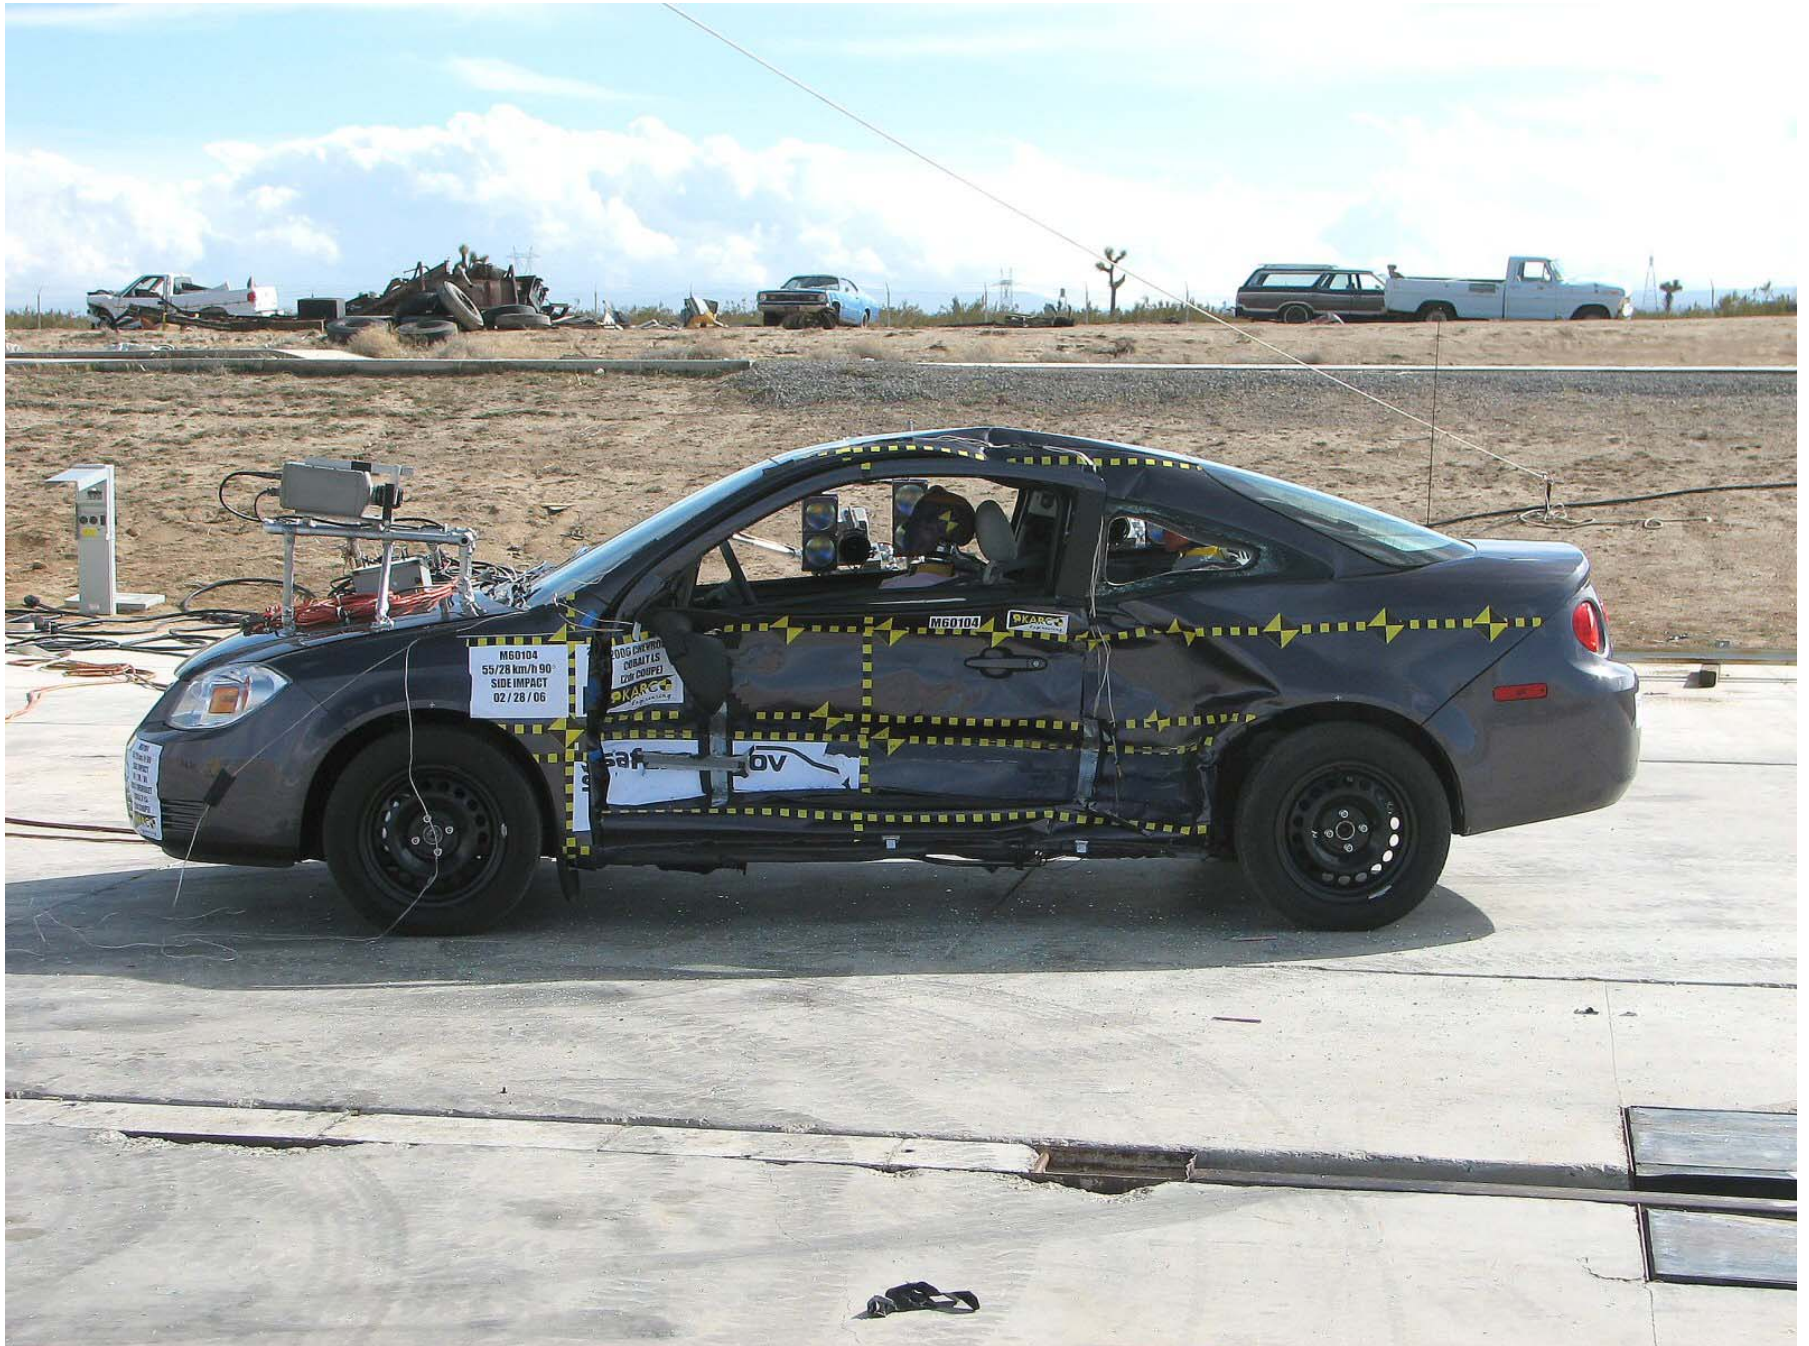
Figure A-10: Post-Test Left Side View

The driver and passenger doors remained closed during impact. The test vehicle sustained a maximum static crush of 337 mm at level 2, 1200 mm rearward of the left vertical impact point. The driver SID/Hybrid III, Serial No. 274 and the passenger SID/Hybrid III, Serial No. 275 were calibrated prior to this test. The SID/Hybrid III injury criteria is summarized as follows:

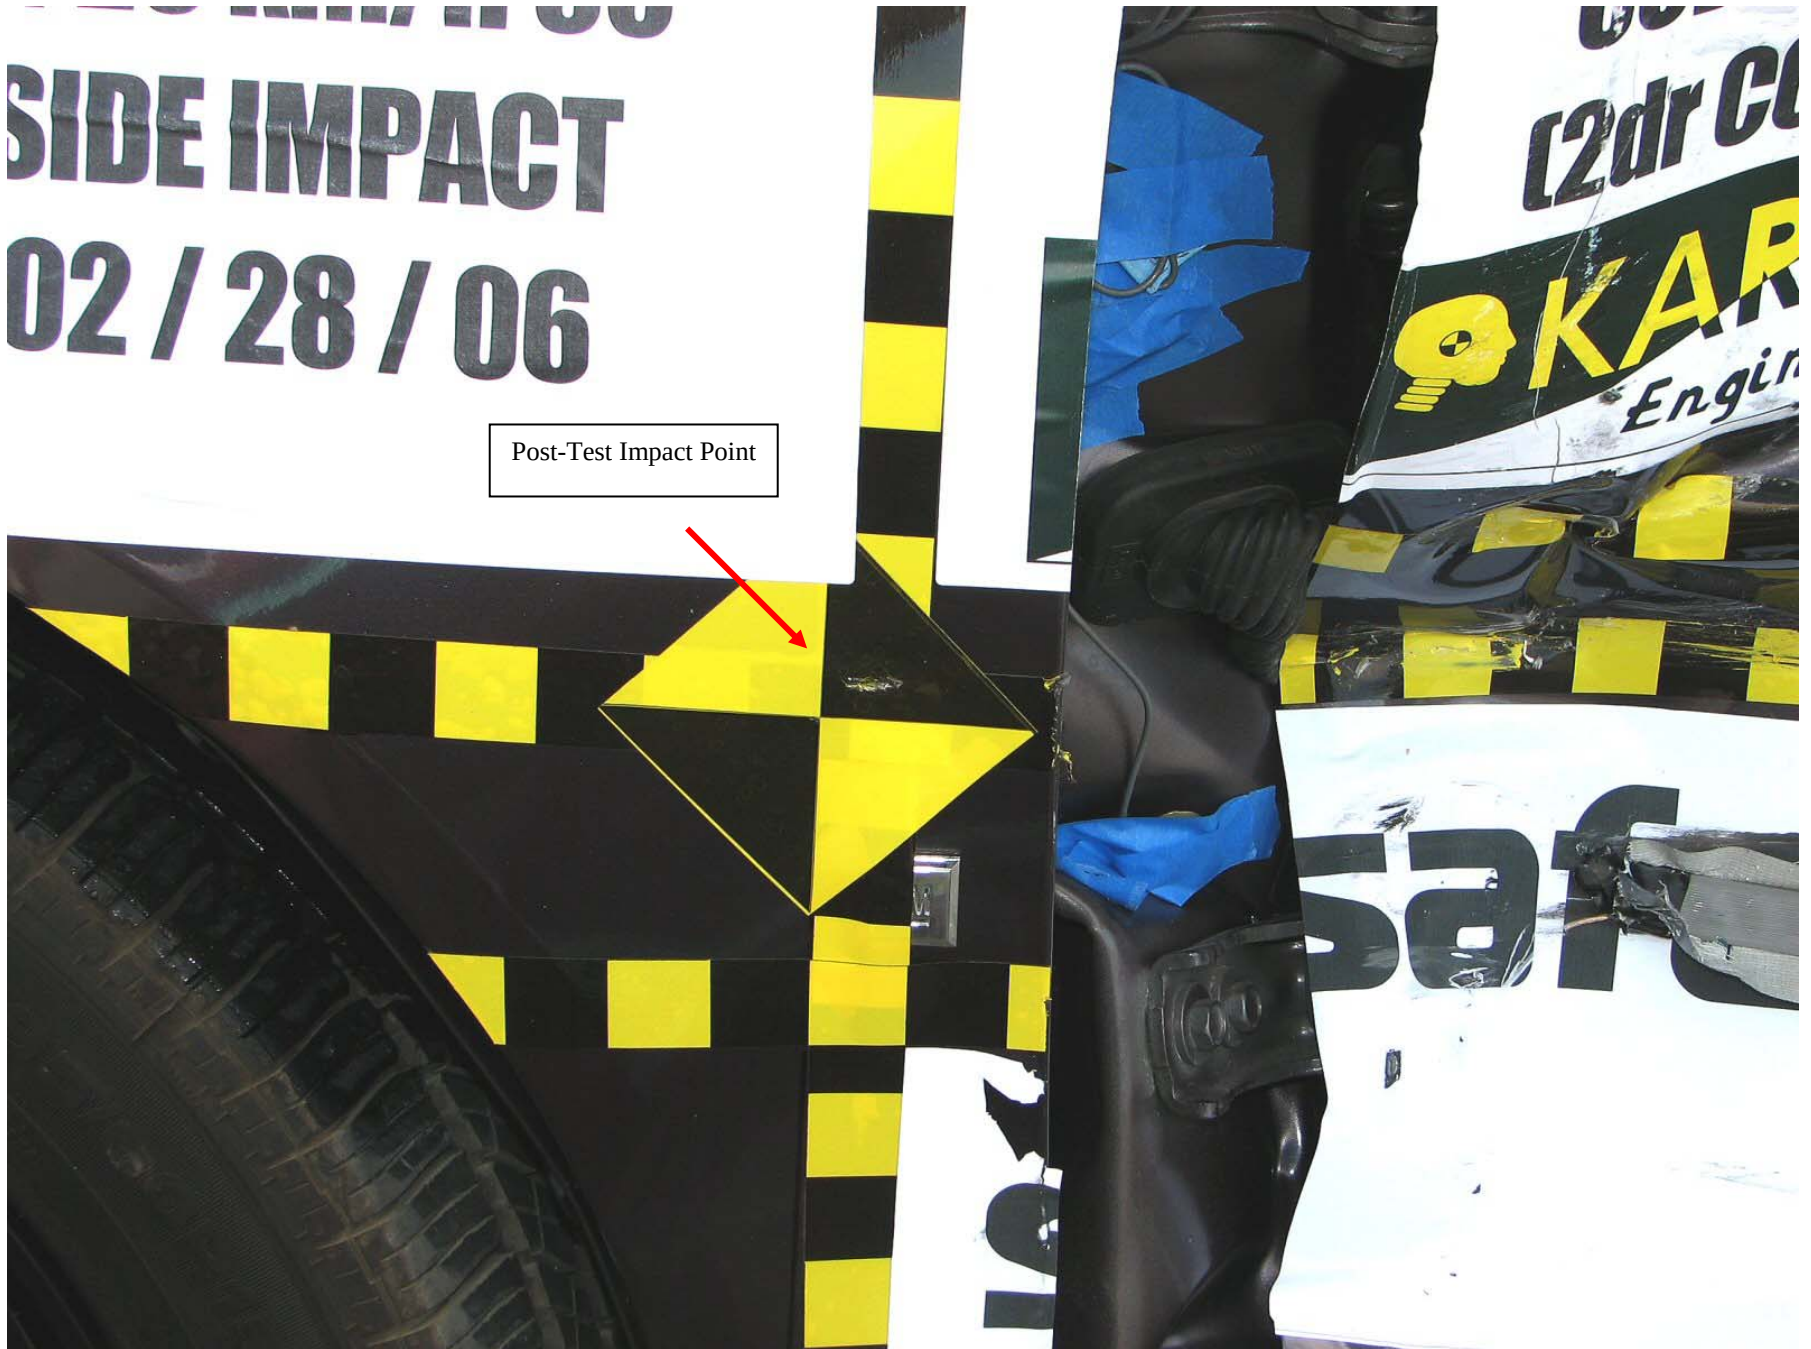
Figure A-26: Post-Test Left Impact Point

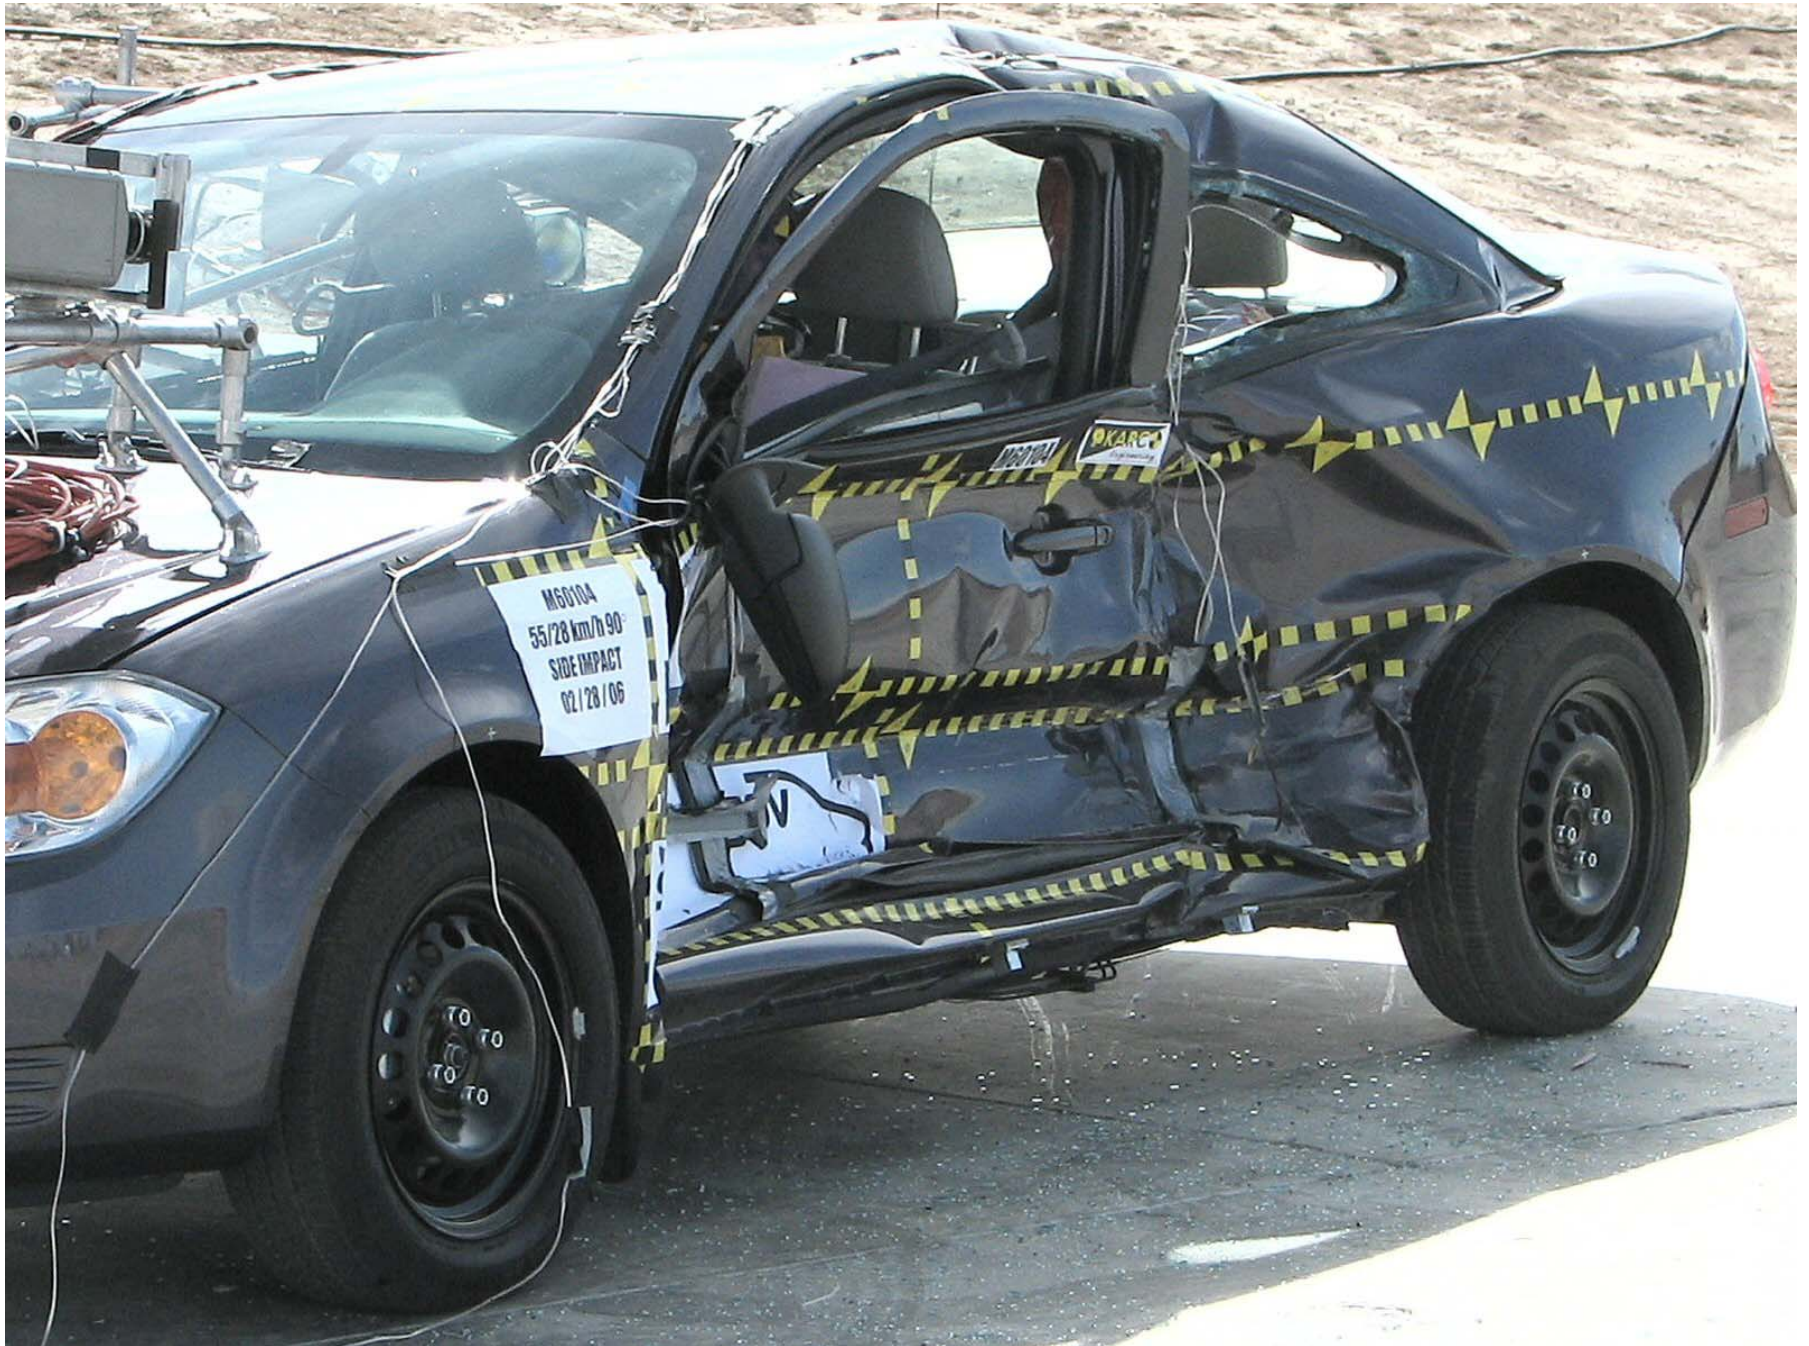
Figure A-28: Post-Test Front  $\frac{3}{4}$  View of Left Side Door

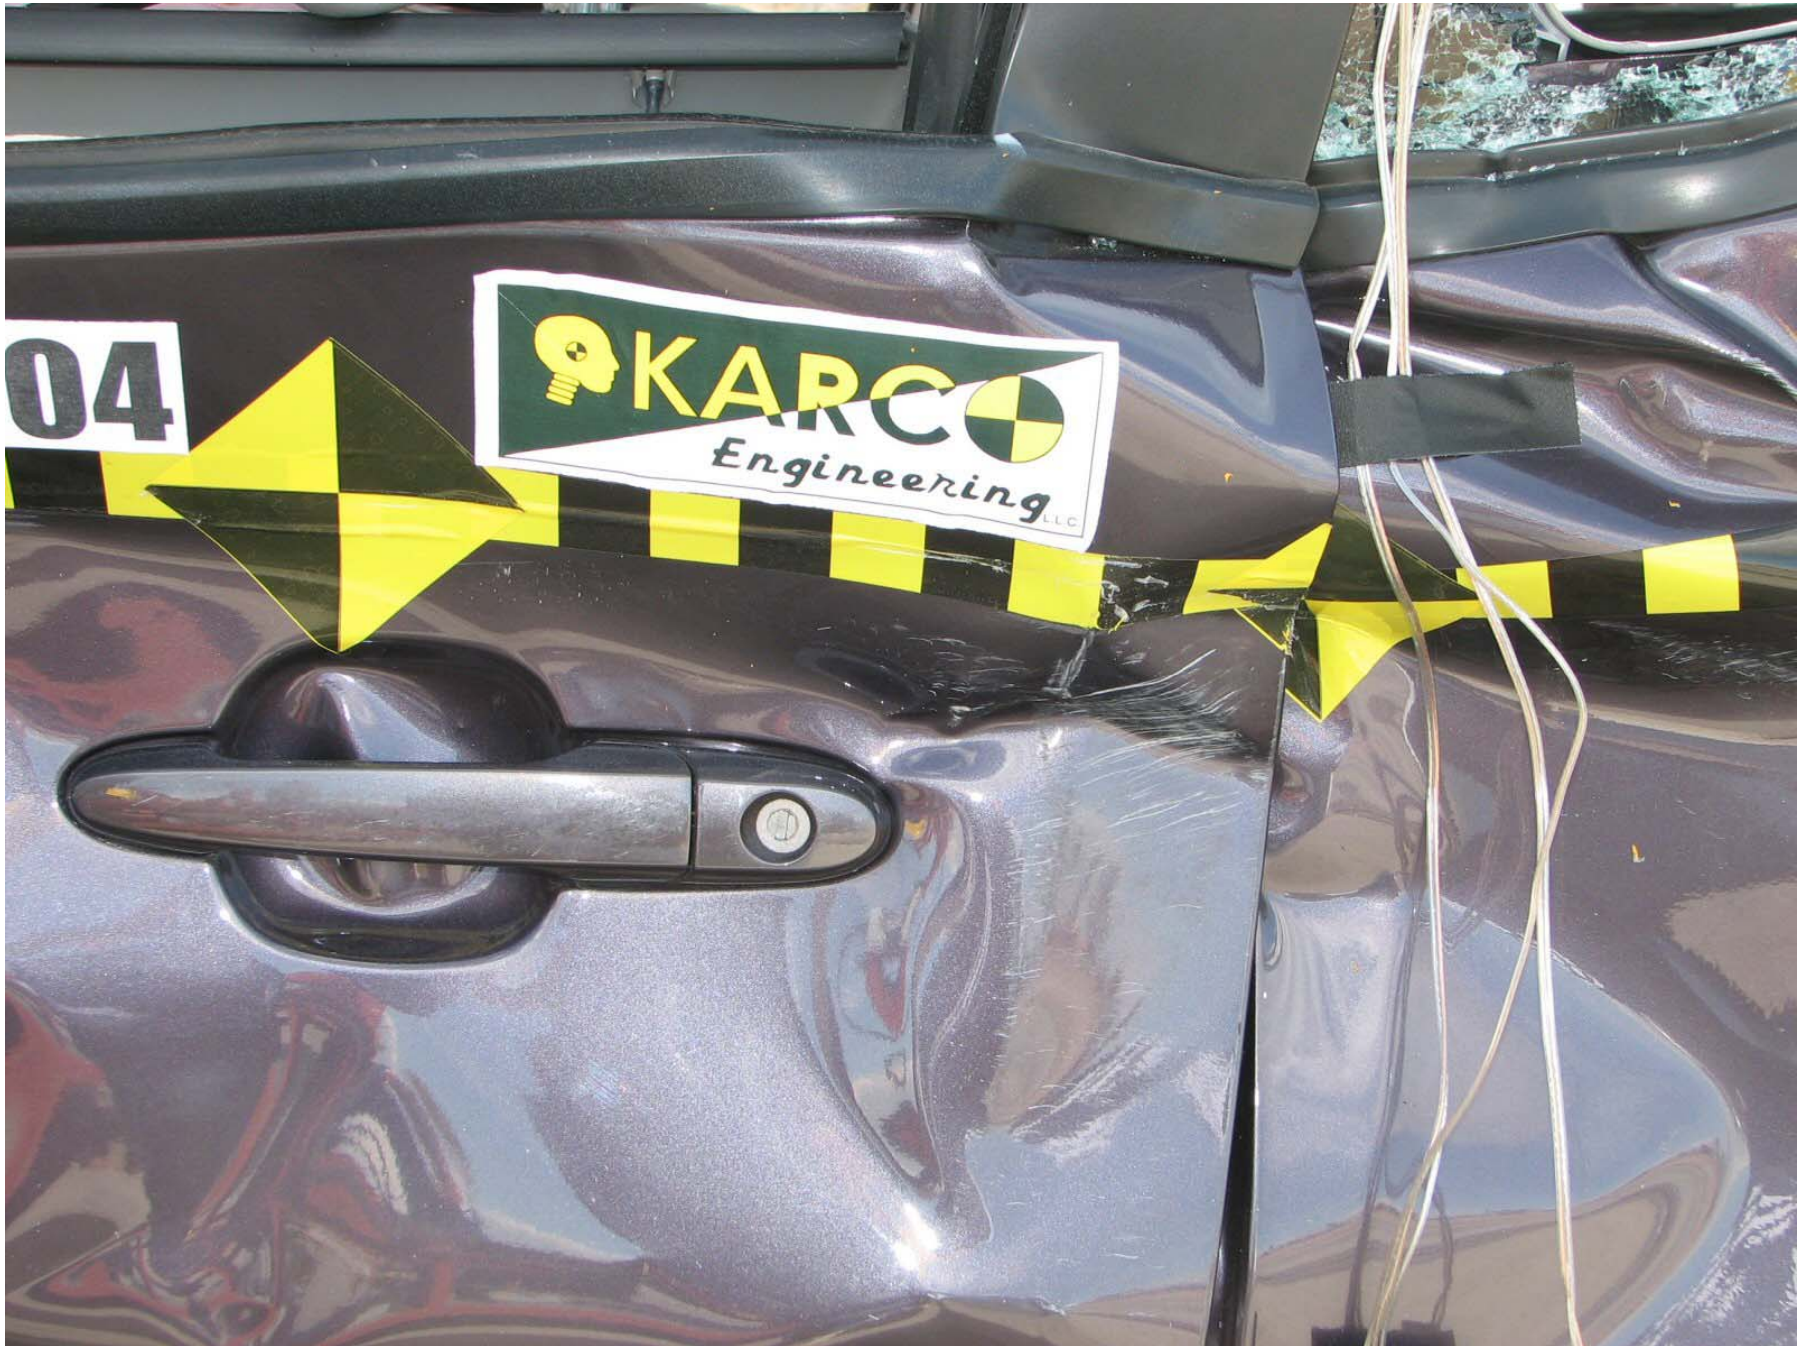
Figure A-32: Post-Test Left Front Door

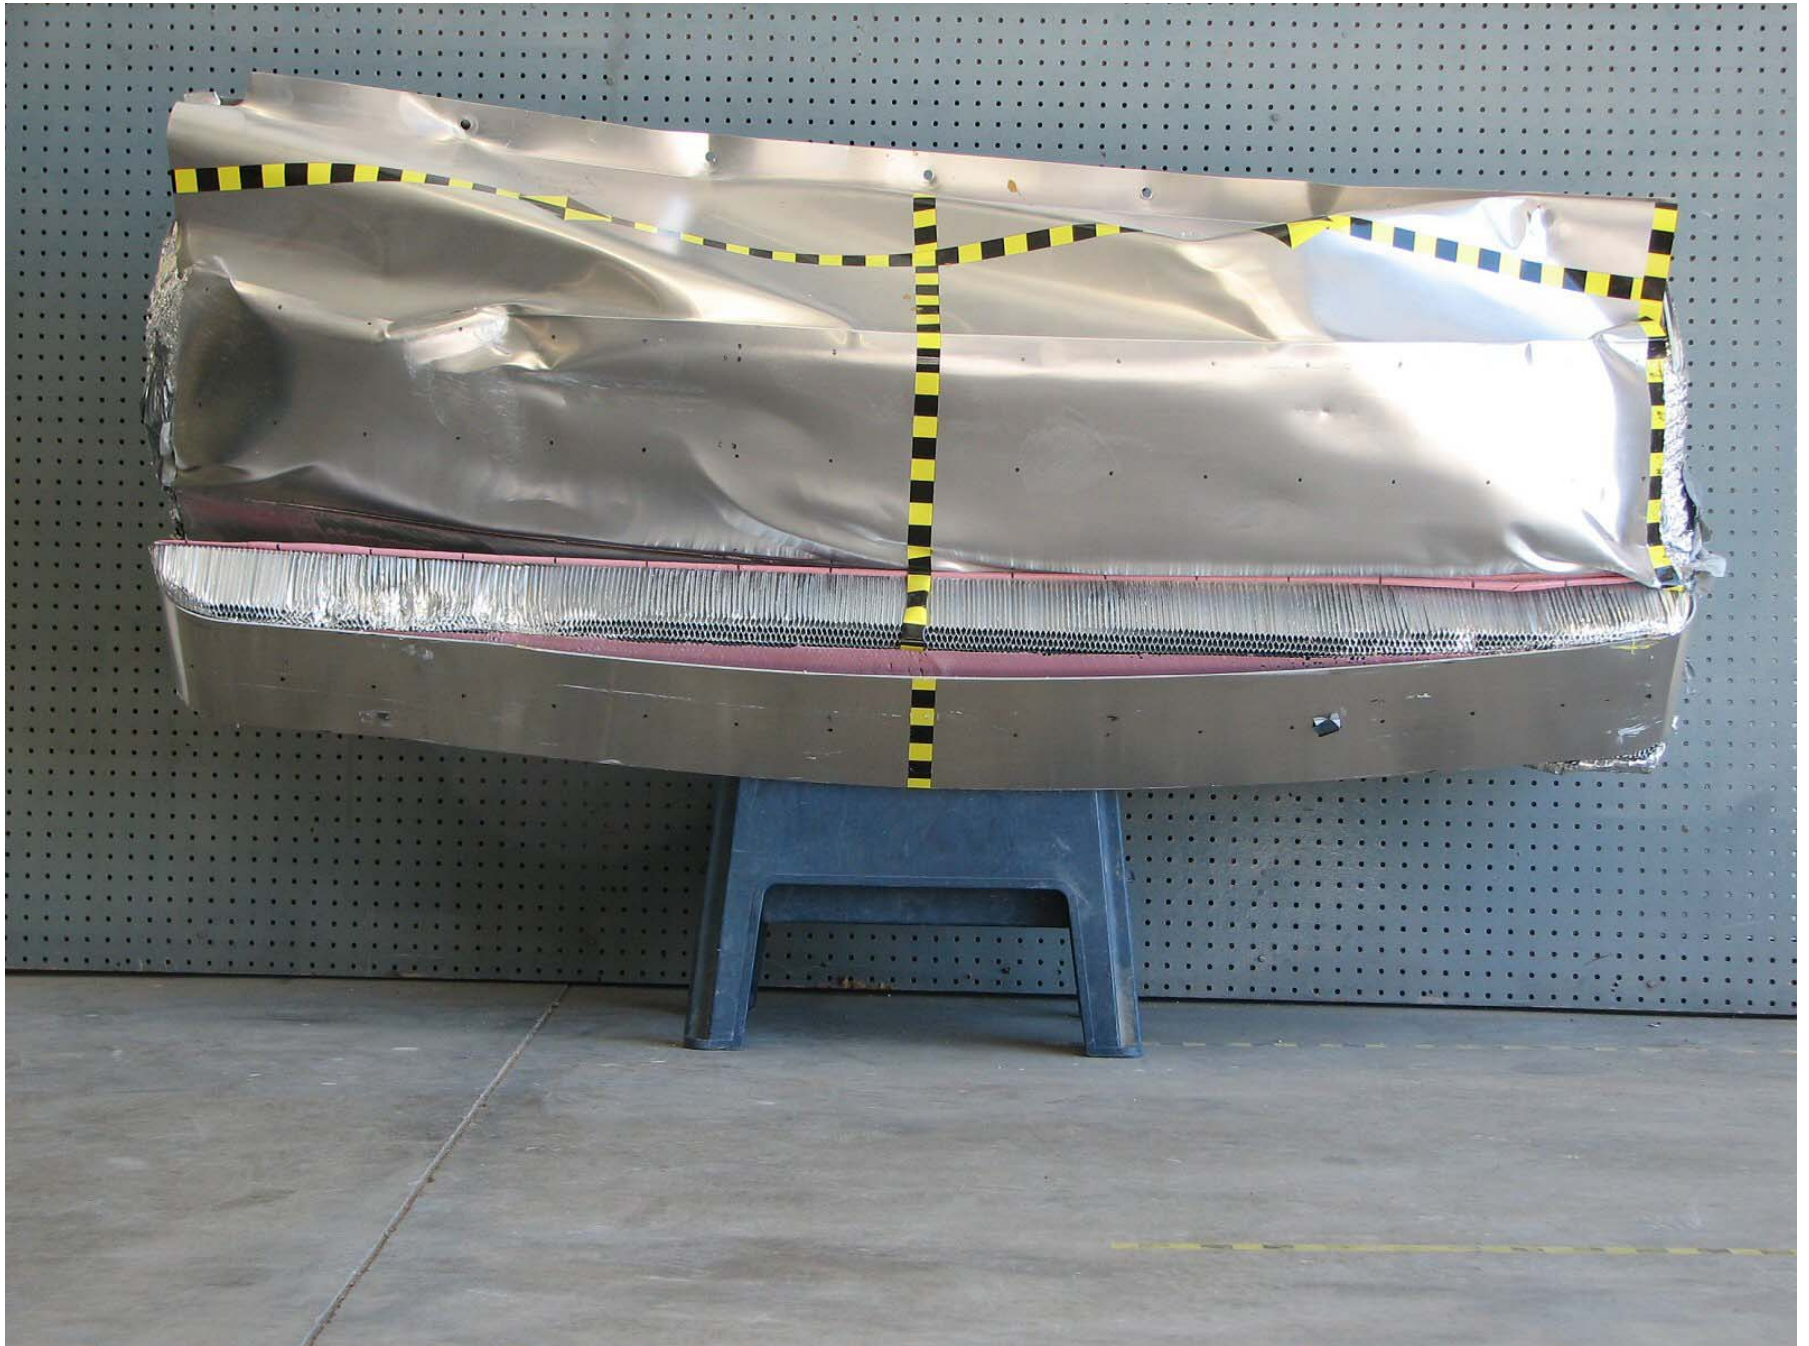
Figure A-54: Post-Test Front View of Deformable Barrier

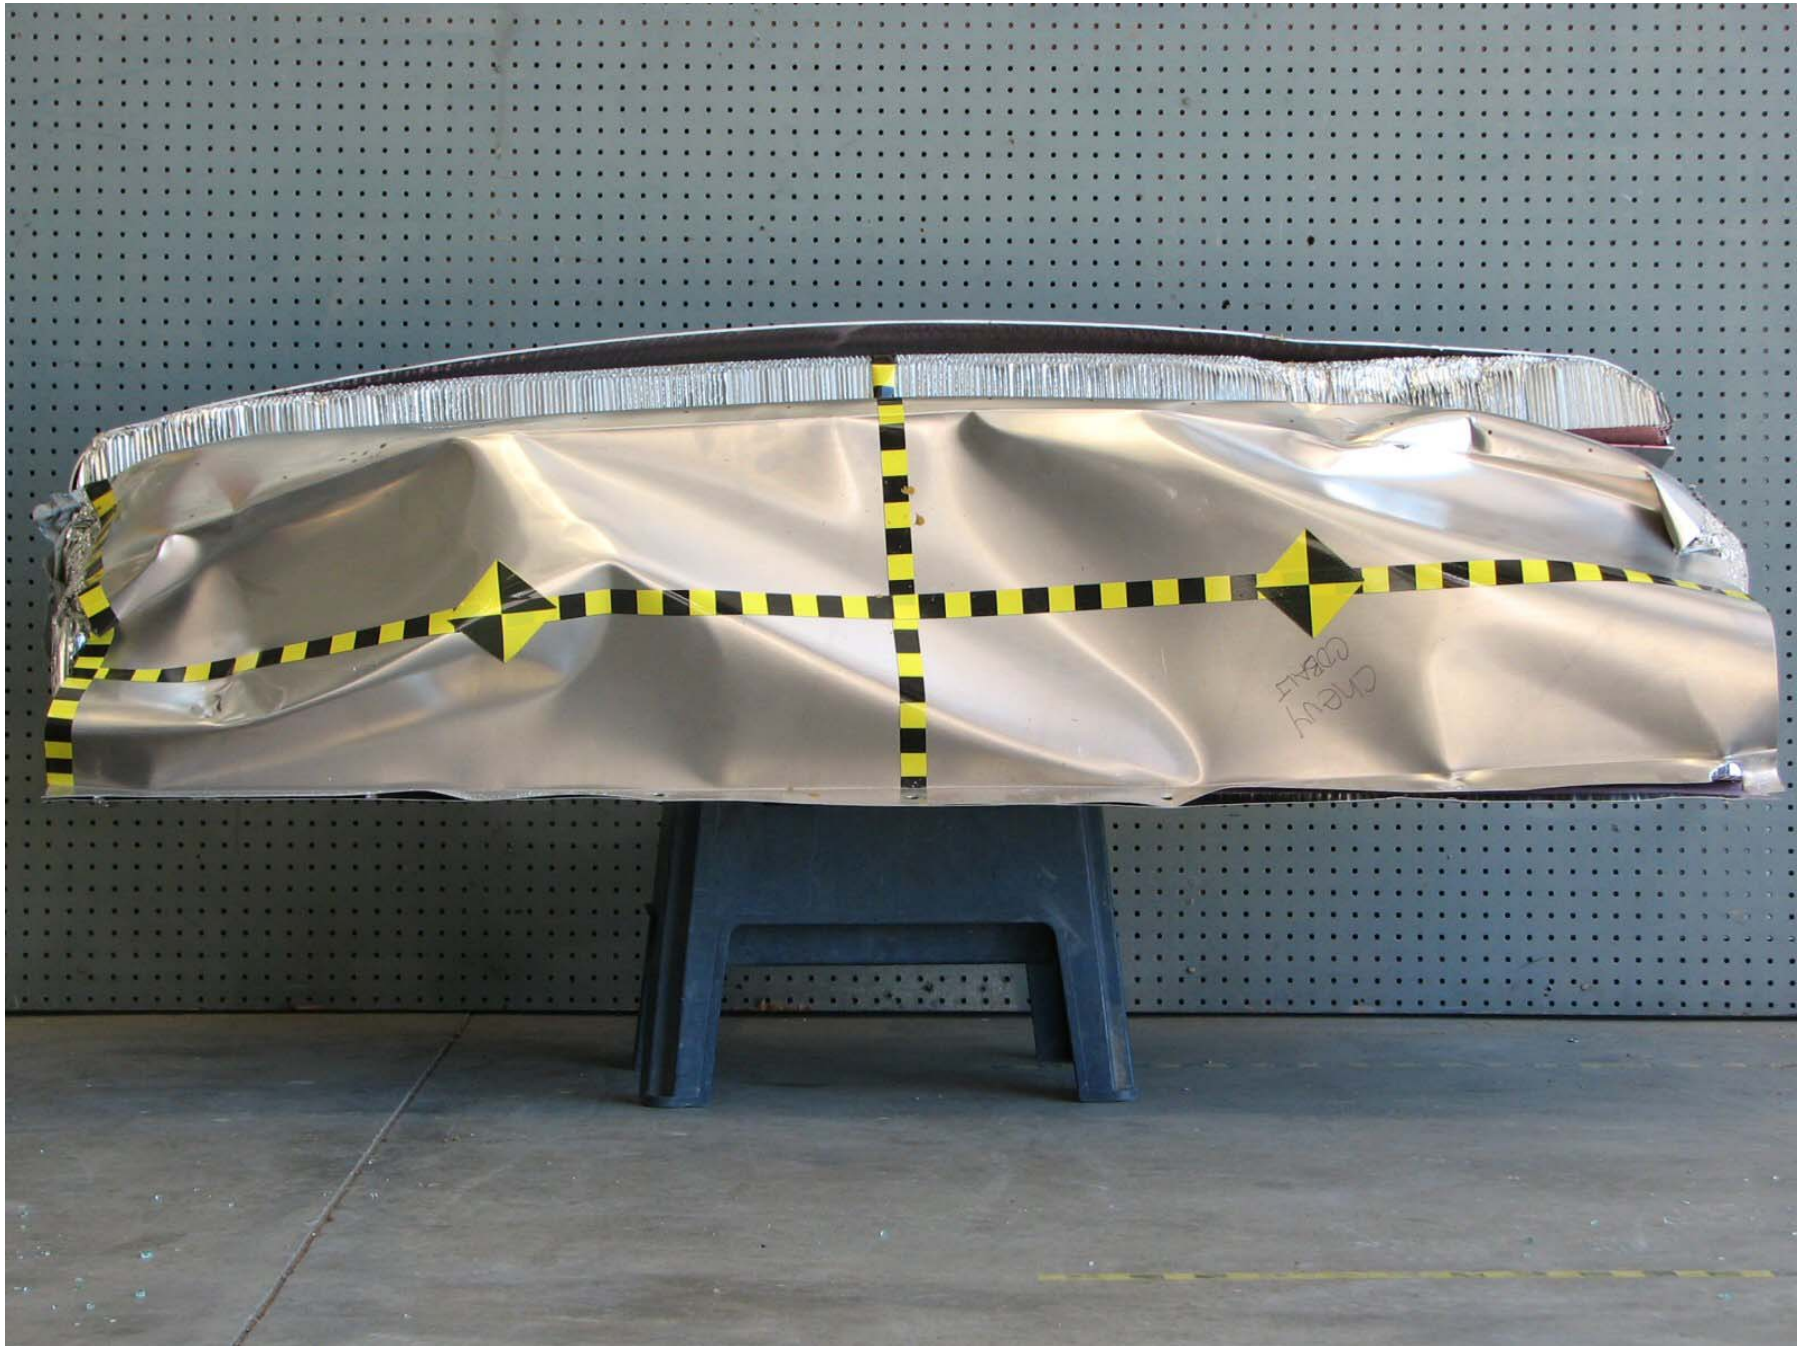
Figure A-56: Post-Test Top View of Deformable Barrier
