**Report Number: 214-TRC-06-001**

**Safety Compliance Testing For FMVSS 214**

**Side Impact Protection**

**2006 Chevrolet HHR MPV**

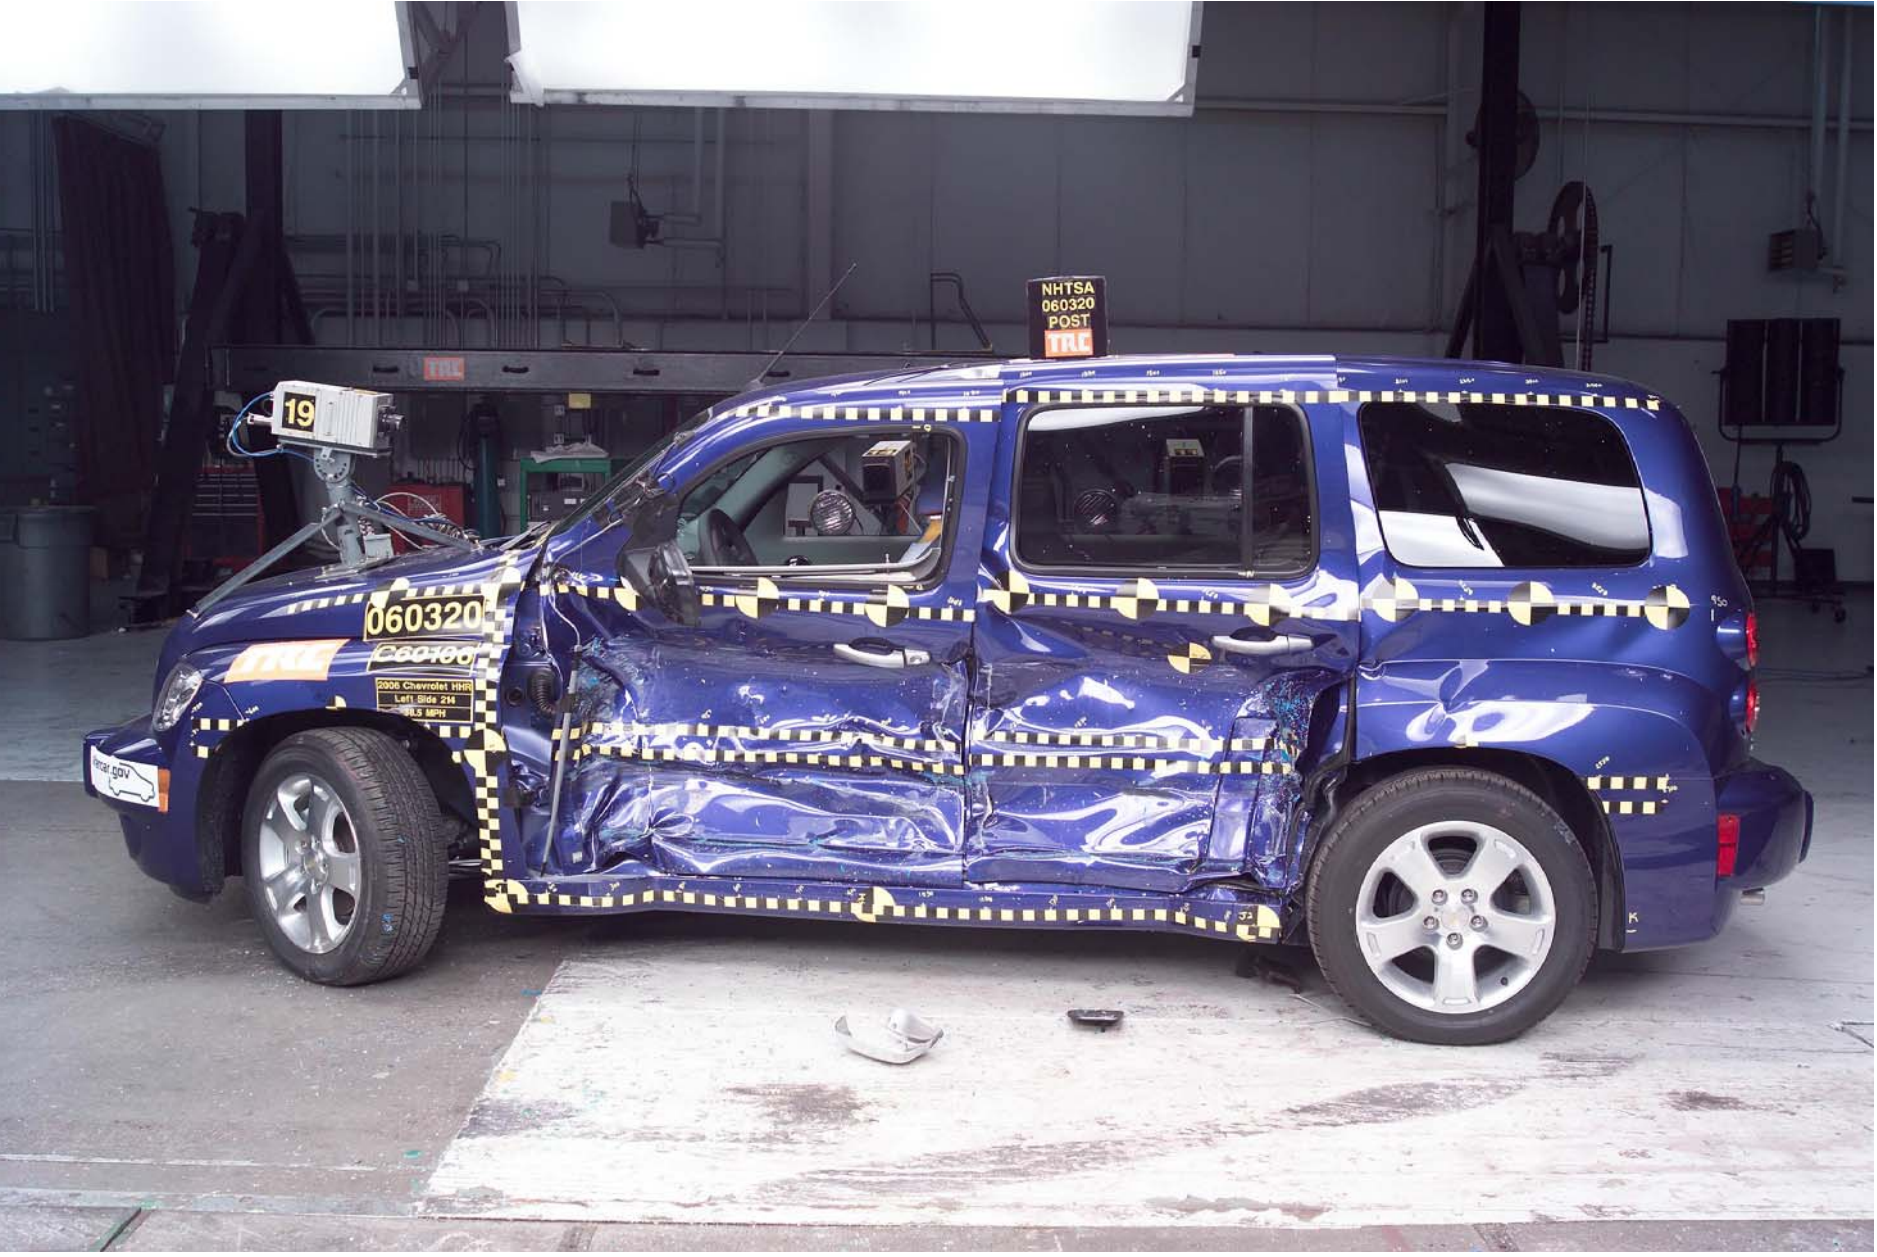
Figure A-5 Post-Test Impacted Side View of Test Vehicle  
A-9

Window: Driver's side window broken.

Full length of induced damage was 2100 mm.

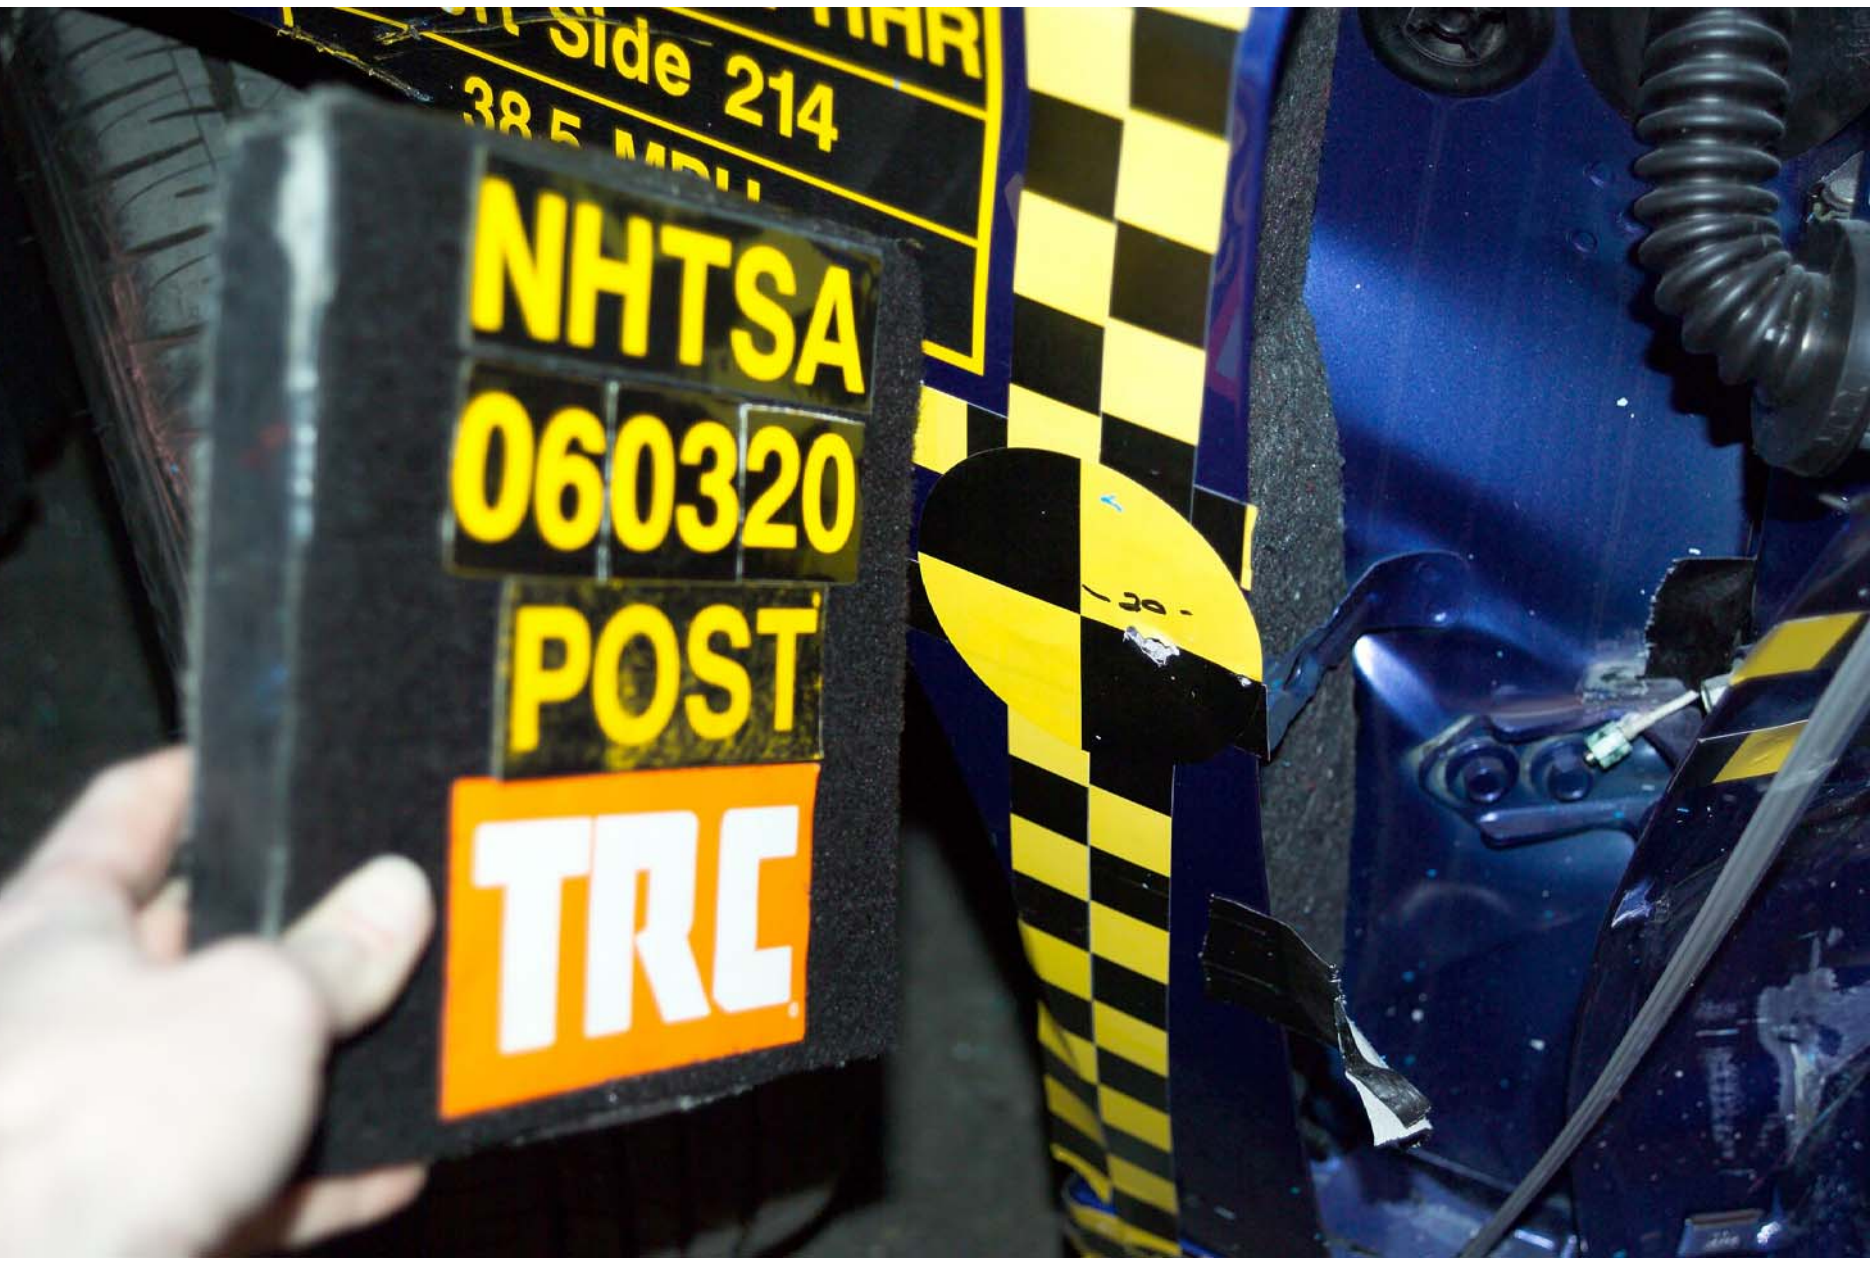
Figure A-66 Post-Test Primary Impact Point View  
A-70

Actual Impact Point is 398 millimeters rearward of front axle centerline
