**REPORT NUMBER: NCAP-MGA-2006-009**

**NEW CAR ASSESSMENT PROGRAM  
FRONTAL BARRIER IMPACT TEST**

**HONDA MOTOR CO., LTD  
2007 HONDA FIT 5-DR SPORT  
NHTSA NUMBER: M75300**

**FINAL REPORT**

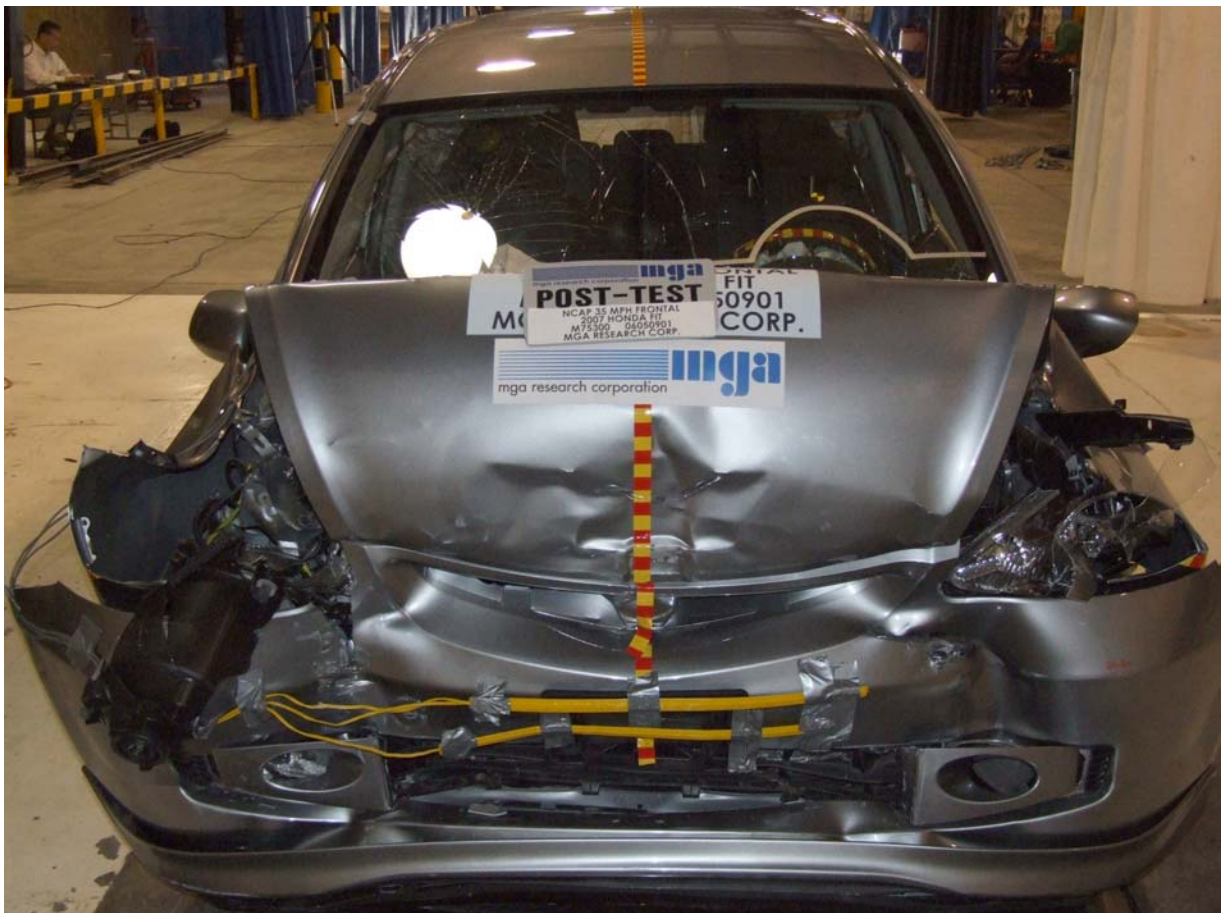
Post-Test Front View

The maximum static crush of the vehicle was 500 mm and both the driver and passenger side doors remained closed and latched during the impact event and were operable after the impact.

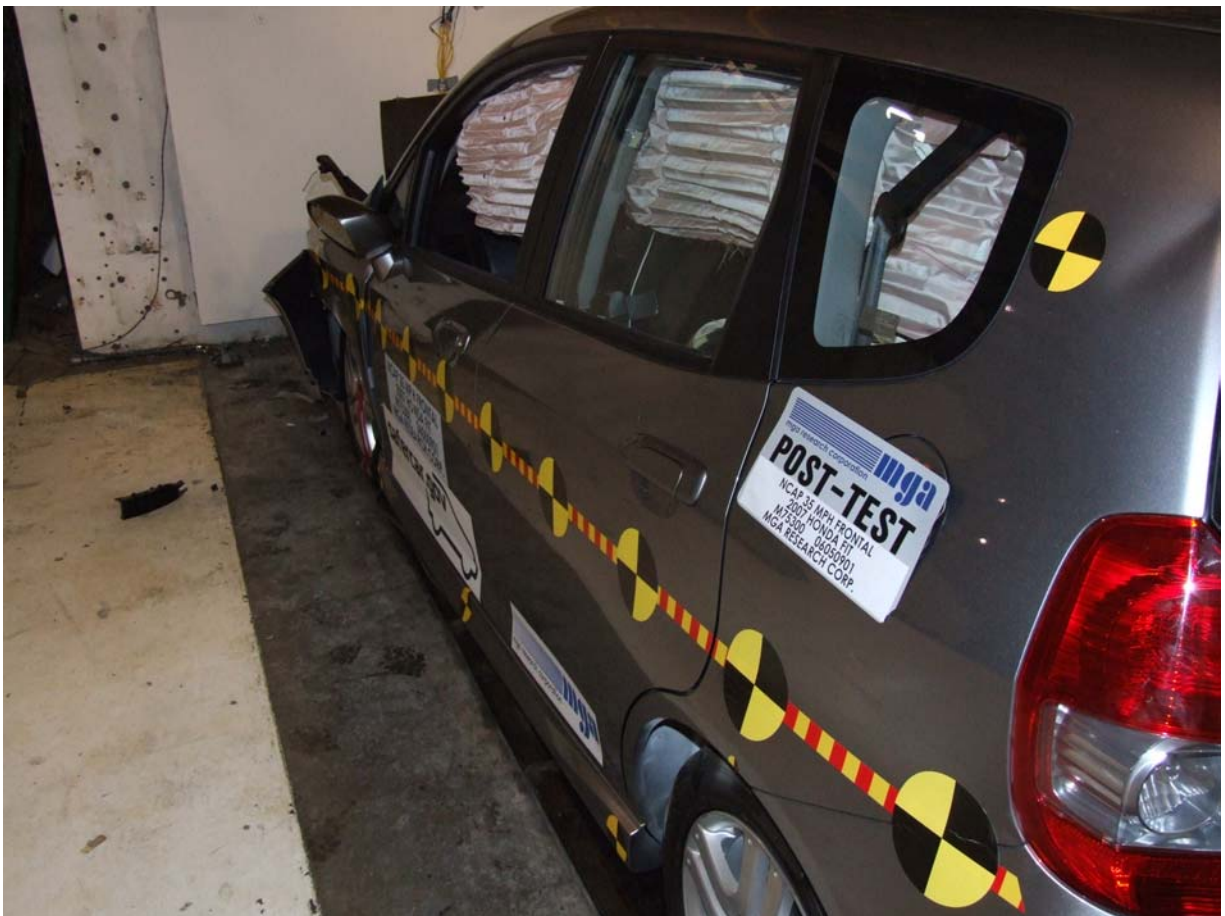
Post-Test Left Side  $\frac{3}{4}$  View of Doors After Impact

| Description | Driver | Passenger |
|---|---|---|
| Front Door Opening | Door remained closed and latched;<br>Door opened without tools | Door remained closed and latched;<br>Door opened without tools |

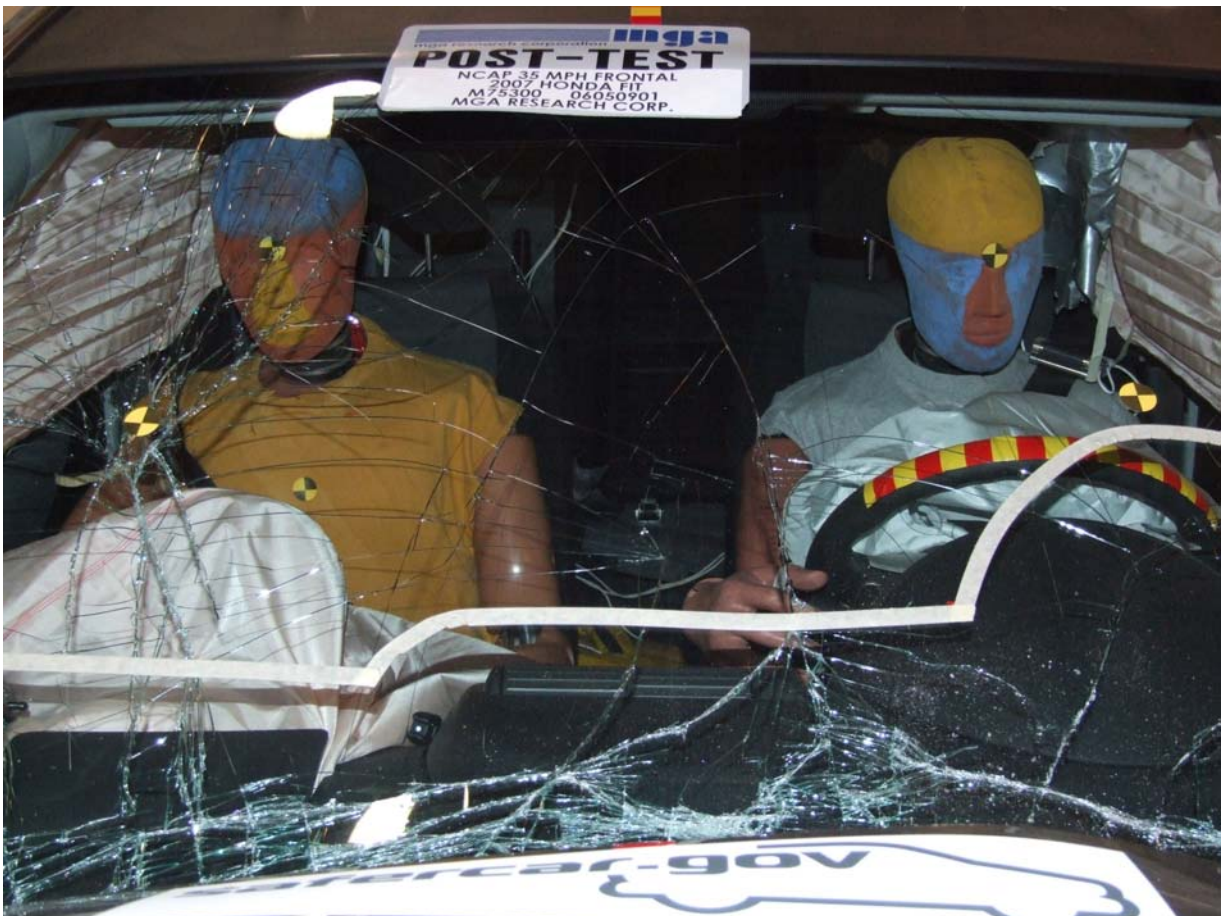
Post-Test Windshield View

There was 82.4 percent windshield retention and no intrusion into the protected zone of the windshield during the event. There was no Stoddard Solvent leakage after the event or during any phase of the static rollover.

| Description | Driver | Passenger |
|---|---|---|
| Glazing Damage | The windshield was cracked. | |

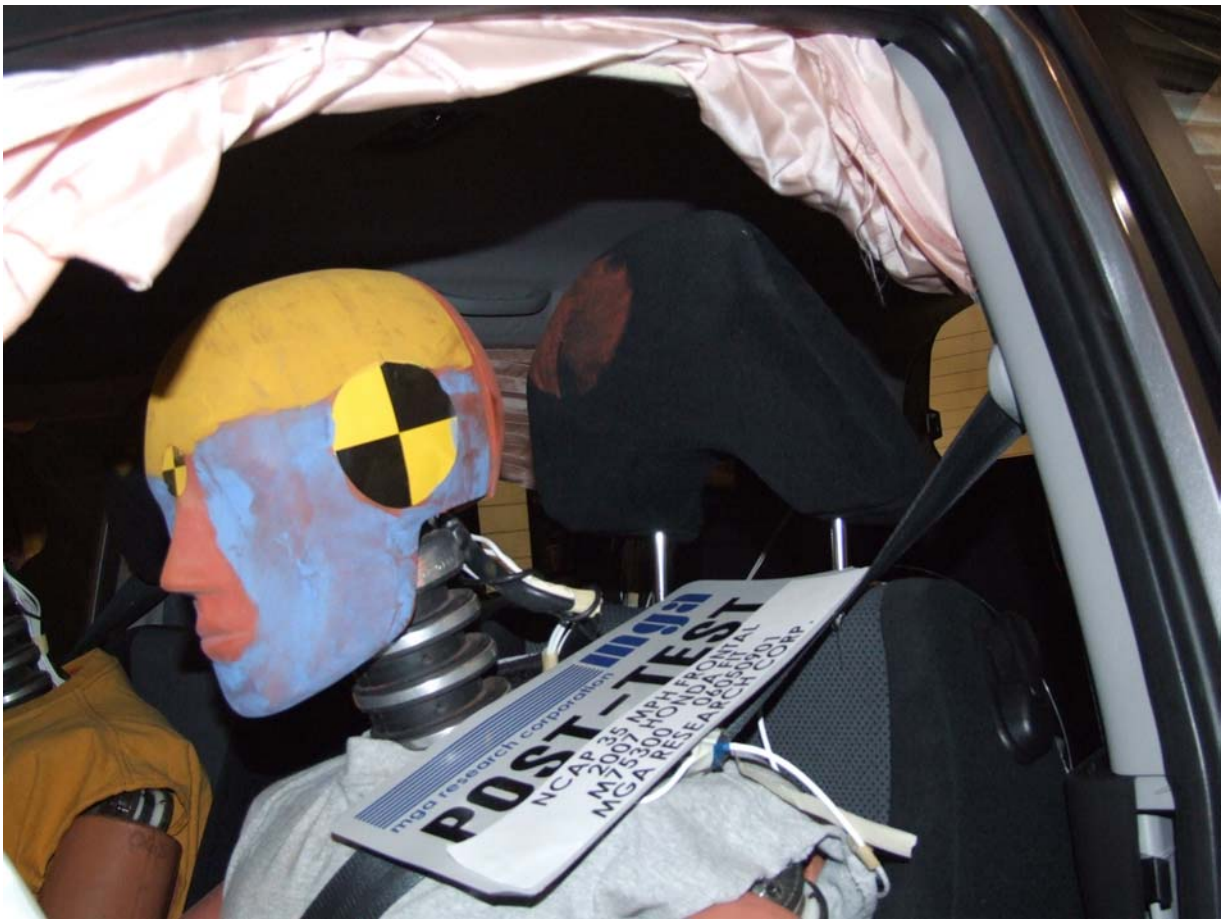
Post-Test Driver Dummy Head Contact

The driver's head and chest contacted the airbag. The driver's head also contacted the headrest. The driver's knees contacted the bolster and steering column. The passenger's head and chest contacted the airbag. The passenger's head also contacted the headrest. The passenger's knees contacted the glove box.
