**REPORT NUMBER: NCAP-MGA-2006-008**

**NEW CAR ASSESSMENT PROGRAM  
FRONTAL BARRIER IMPACT TEST**

**NISSAN MOTOR CO., LTD  
2006 INFINITI FX35 CROSSOVER  
NHTSA NUMBER: M65205**

**PREPARED BY:  
MGA RESEARCH CORPORATION  
5000 WARREN ROAD  
BURLINGTON, WI 53105**

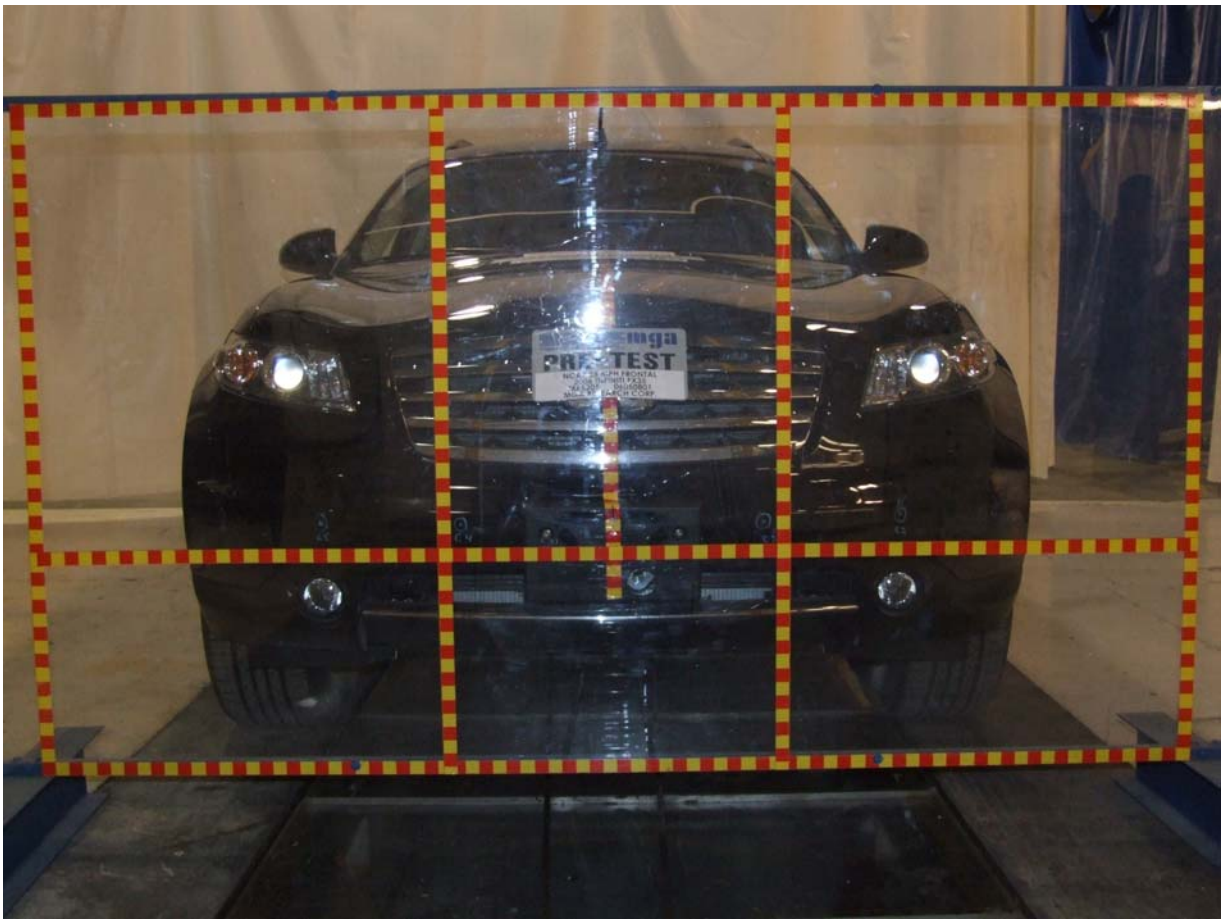
Load Cell Location

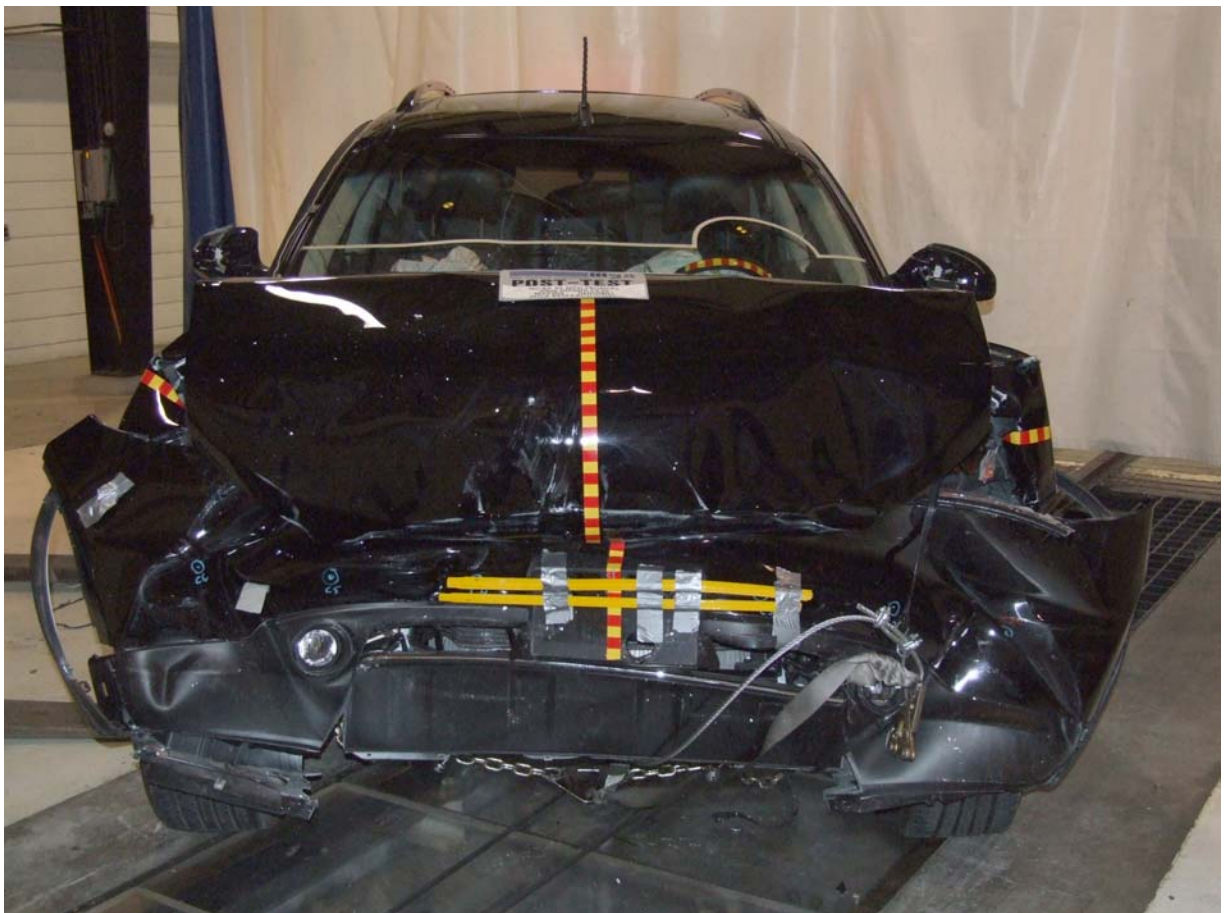
Post-Test Front View

The maximum static crush of the vehicle was 697 mm and both the driver and passenger side doors remained closed and latched during the impact event and were operable after the impact.

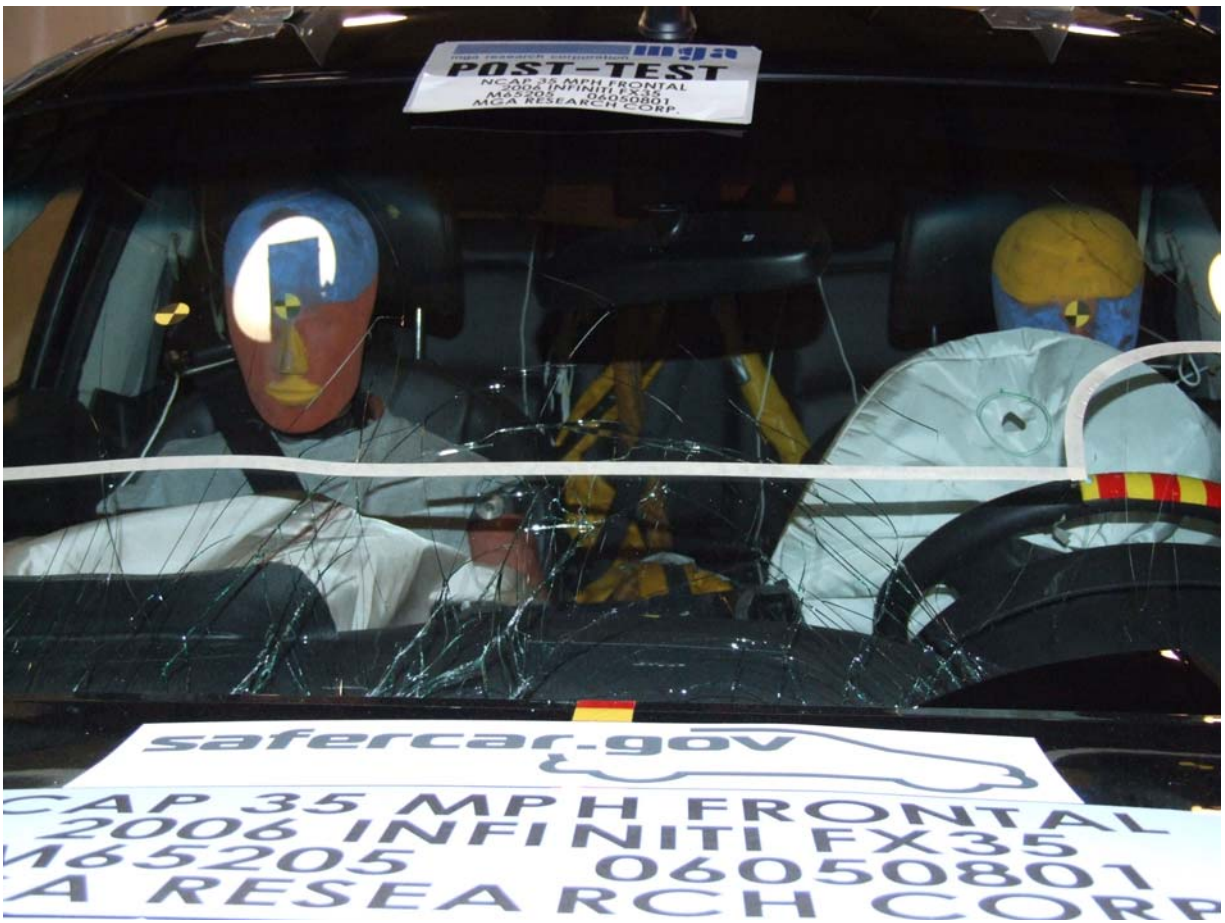
Post-Test Windshield View

There was 100 percent windshield retention and no intrusion into the protected zone of the windshield during the event. There was no Stoddard Solvent leakage after the event or during any phase of the static rollover.

| Description | Driver | Passenger |
|---|---|---|
| Glazing Damage | The windshield was cracked. | |

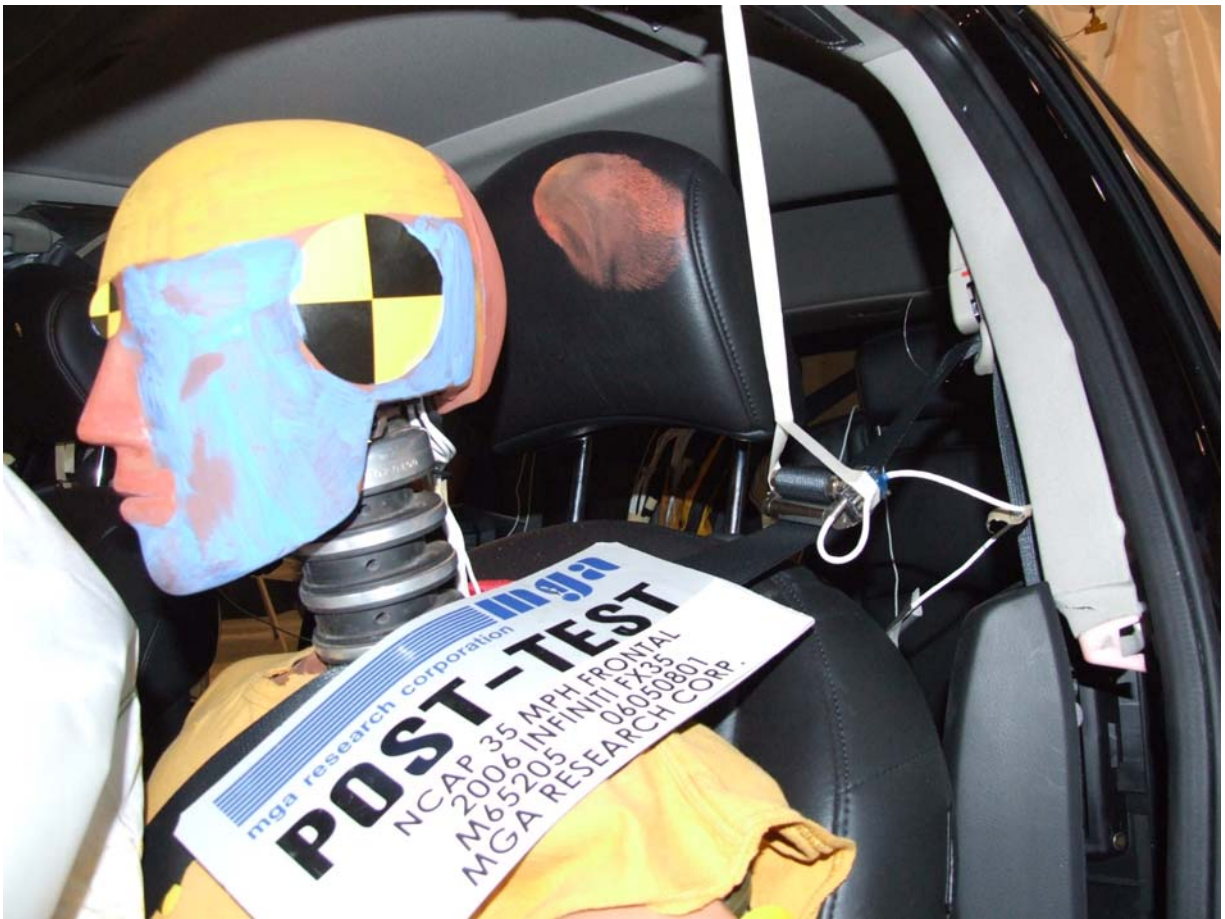
Post-Test Driver Dummy Head Contact

The driver's head and chest contacted the airbag. The driver's head also contacted the headrest. The driver's knees contacted the bolster and steering column. The passenger's head and chest contacted the airbag. The passenger's head also contacted the headrest and visor. The passenger's knees contacted the glove box.

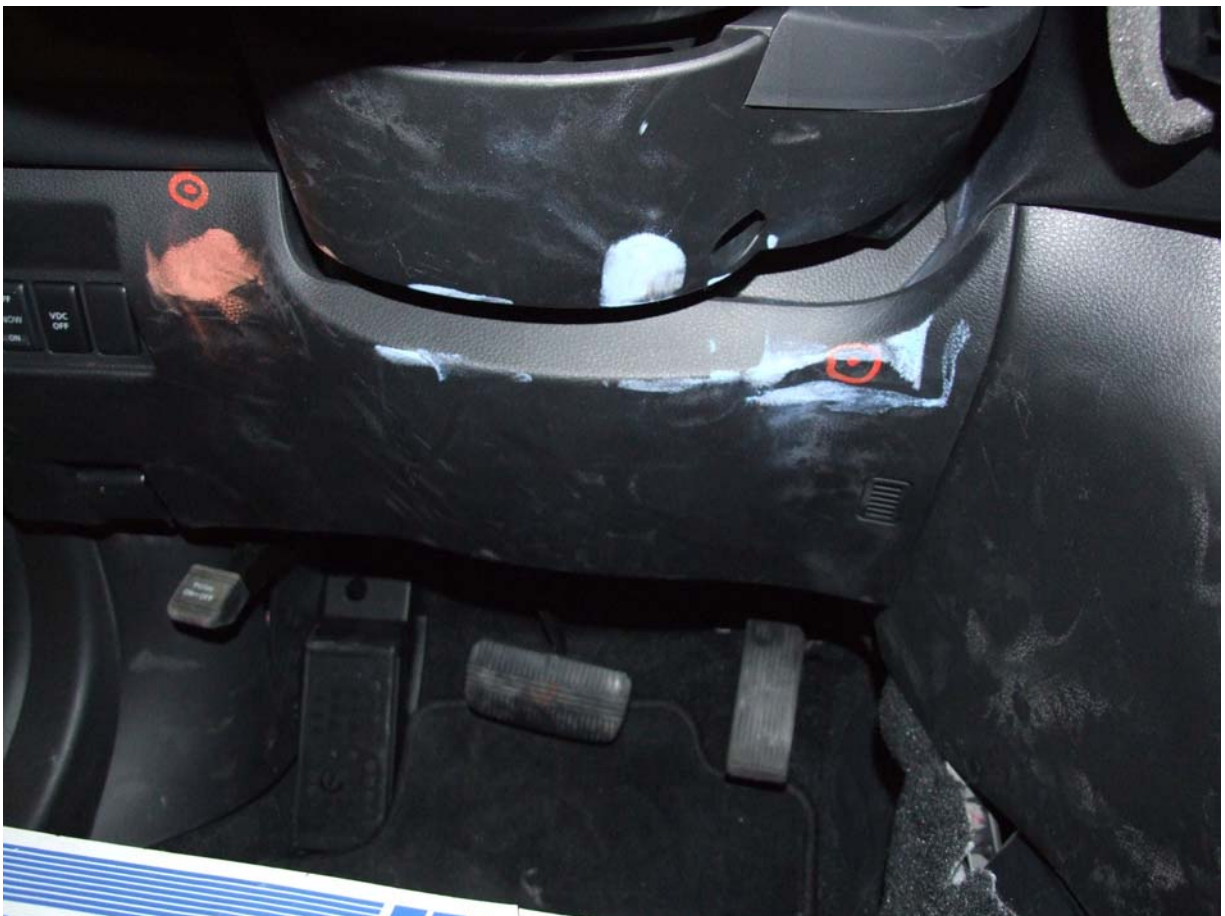
Post-Test Driver Dummy Knee Contact

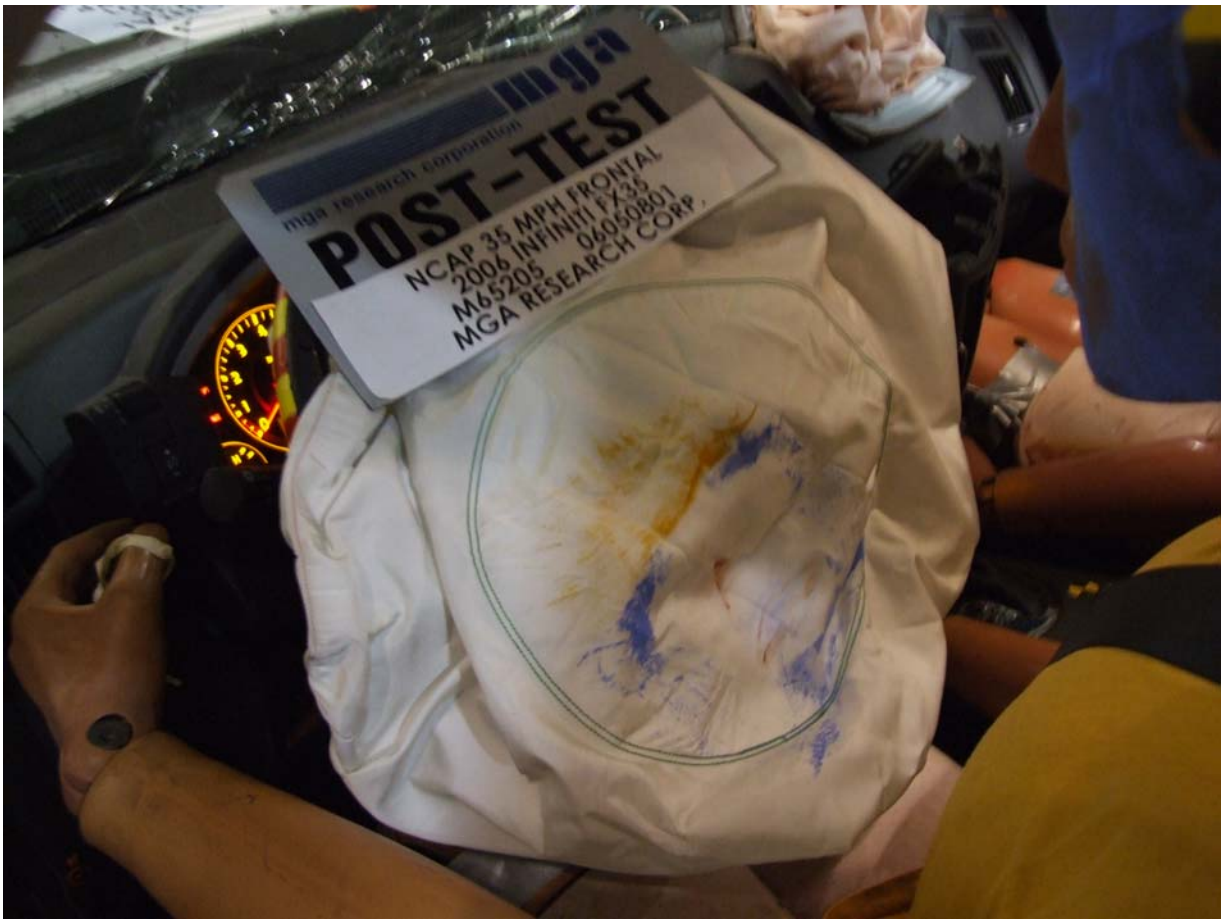
Post-Test Driver Dummy Airbag Contact

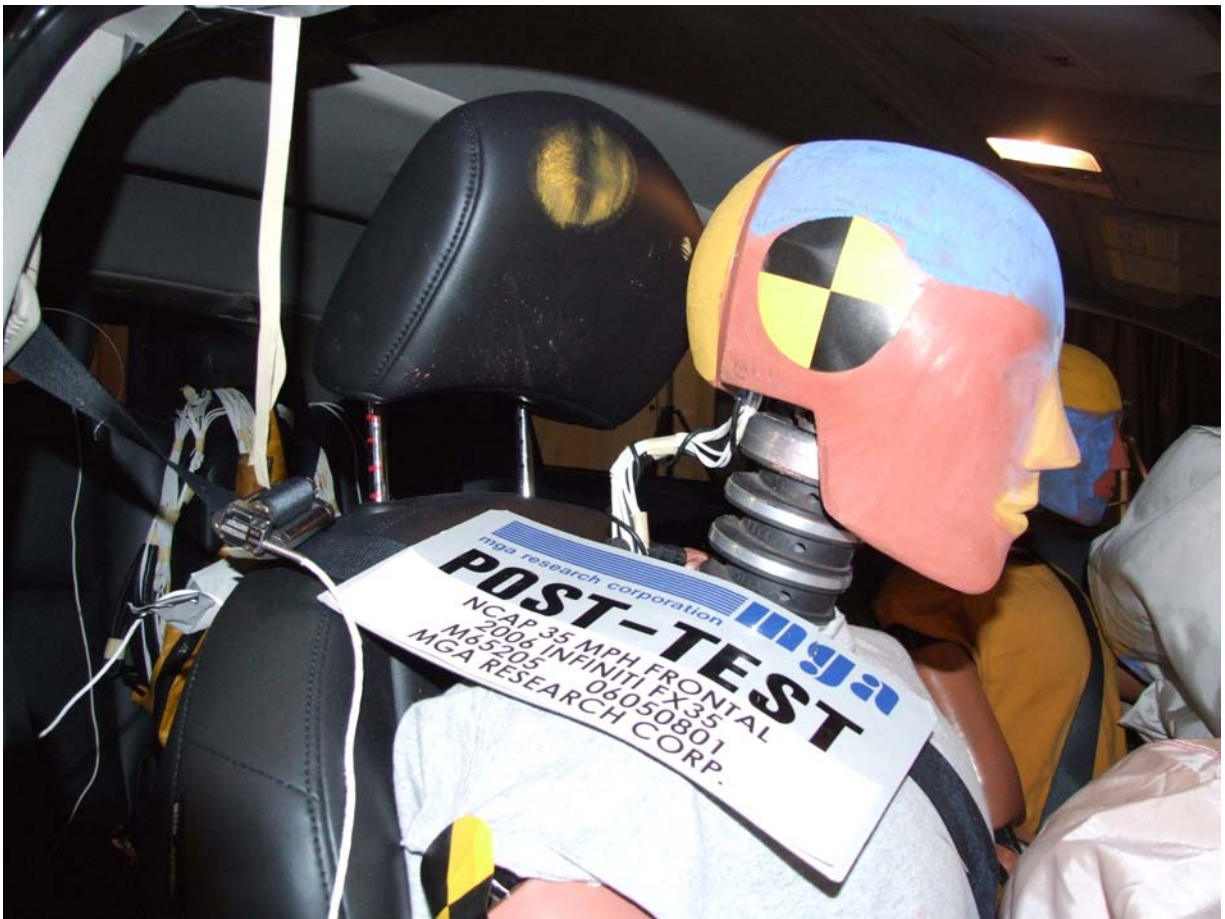
Post-Test Passenger Dummy Head Contact (headrest)

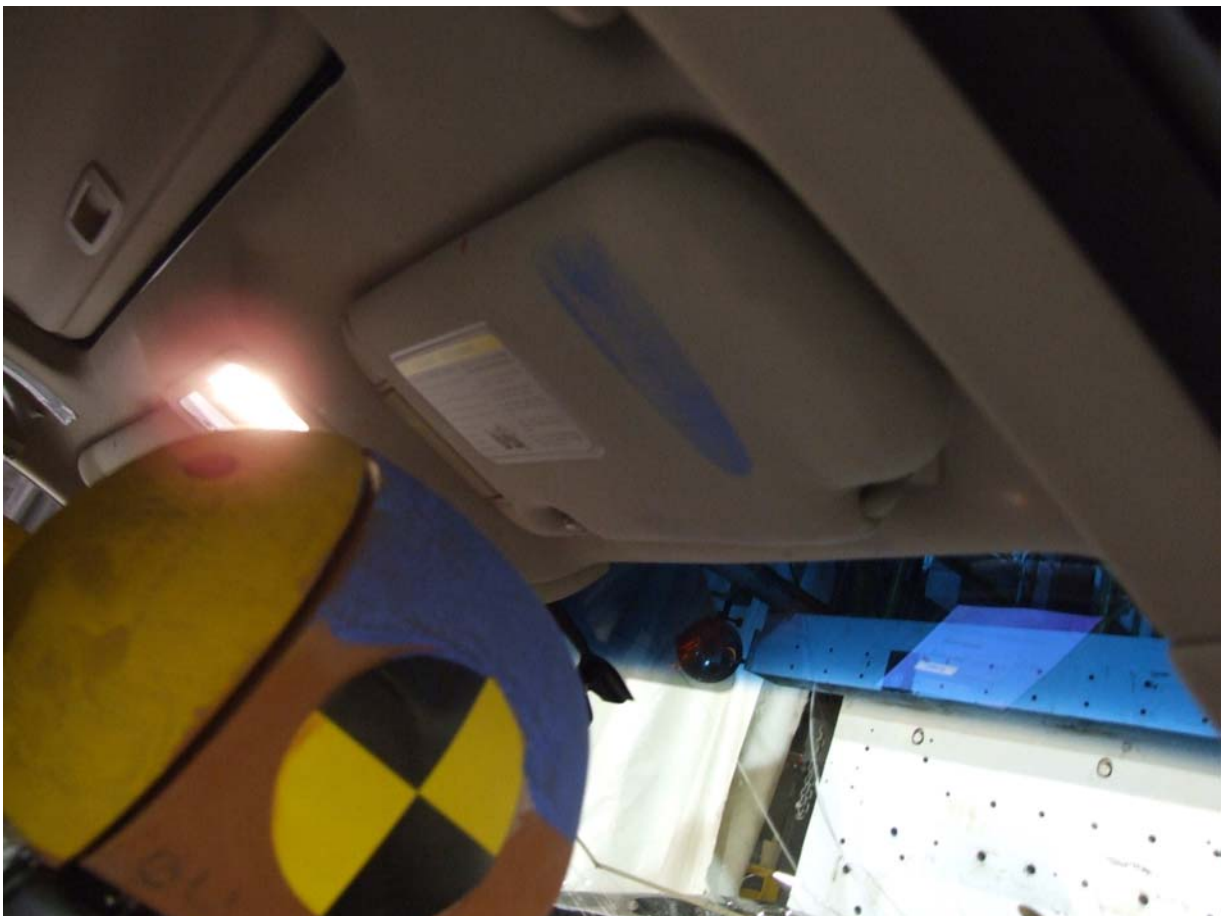
Post-Test Passenger Dummy Head Contact (visor)

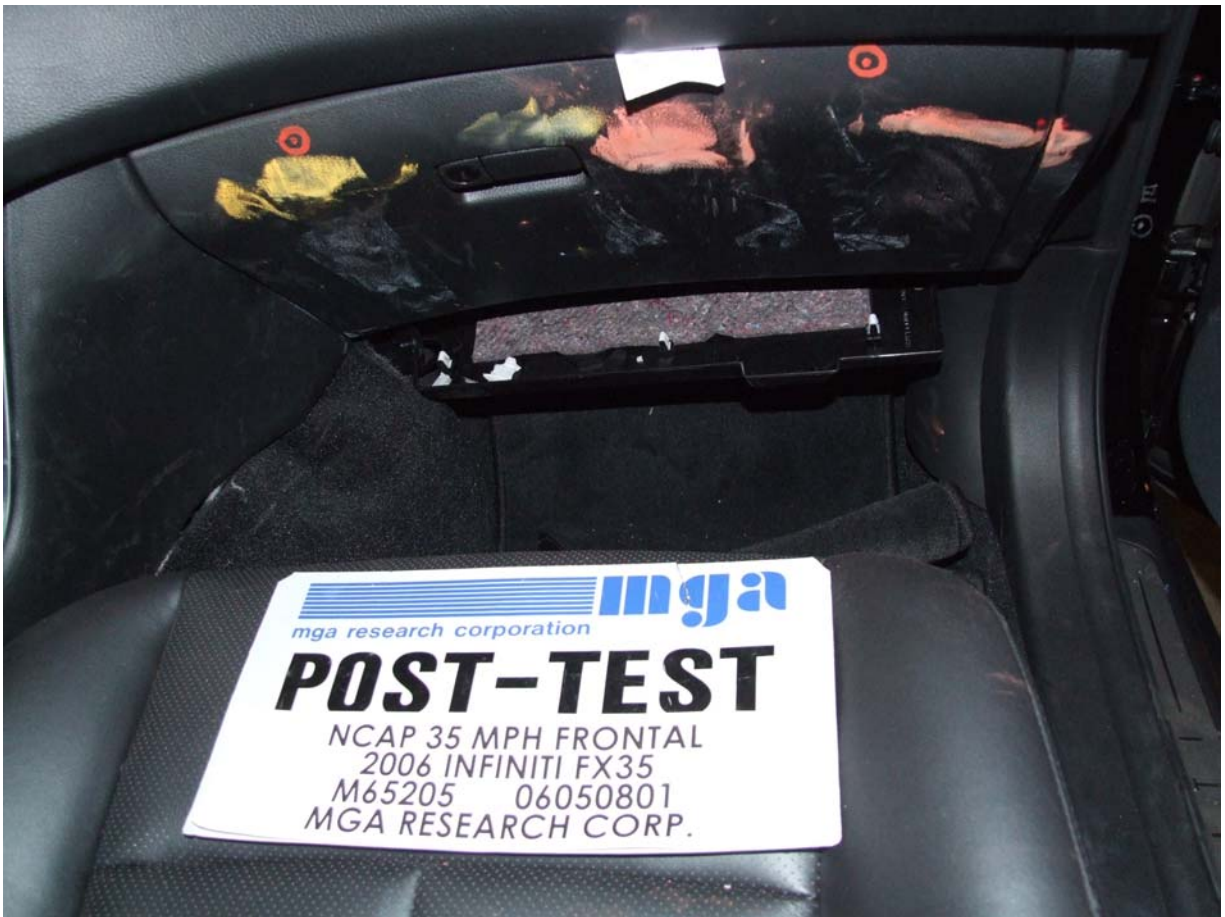
Post-Test Passenger Dummy Knee Contact

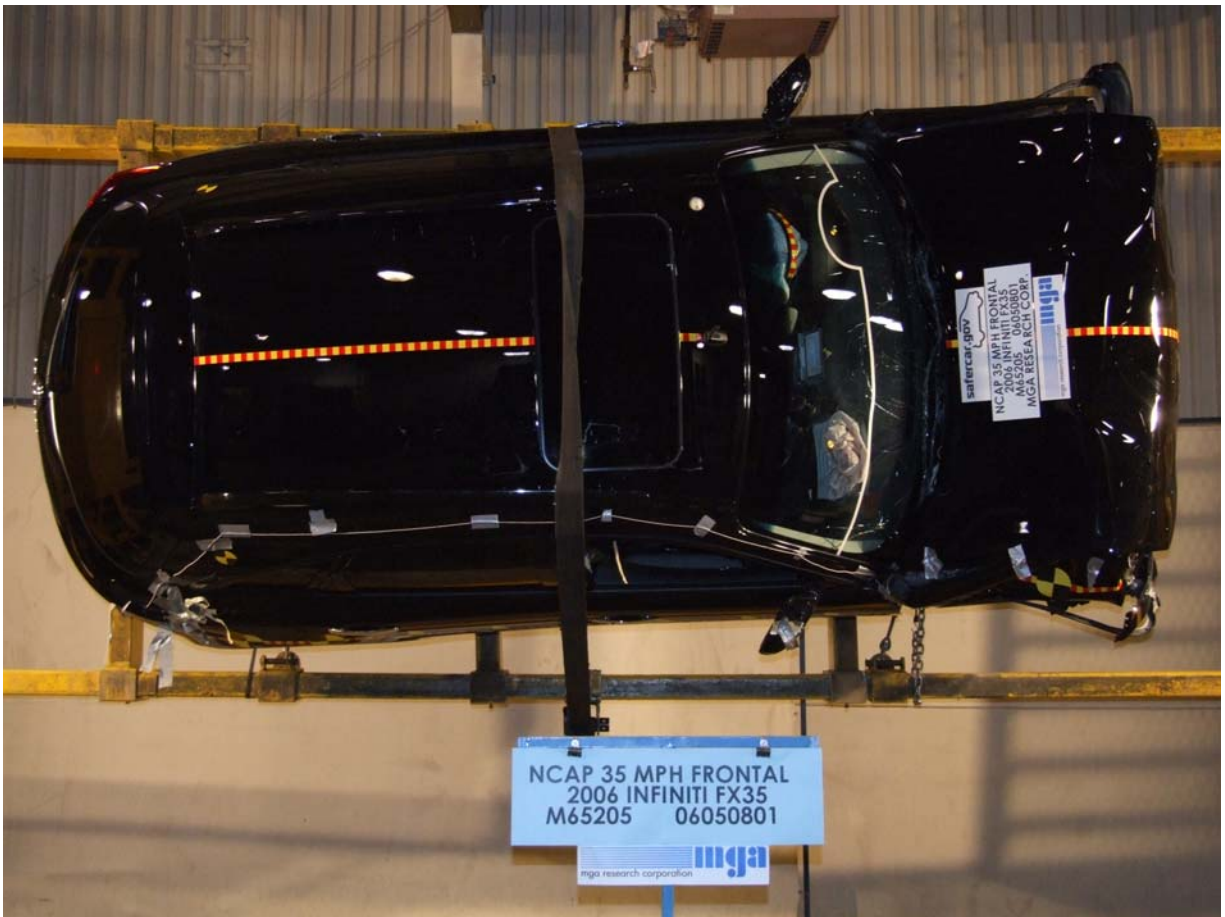
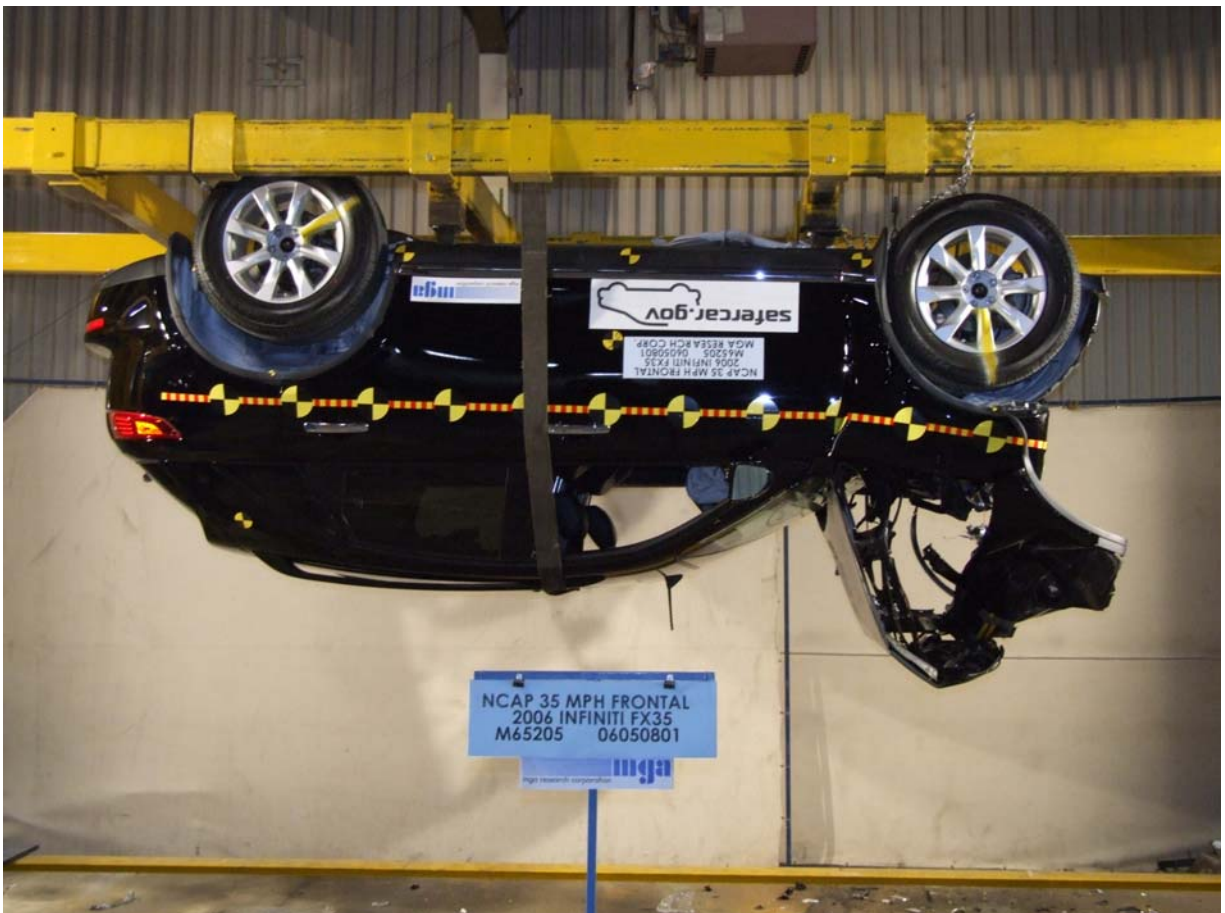
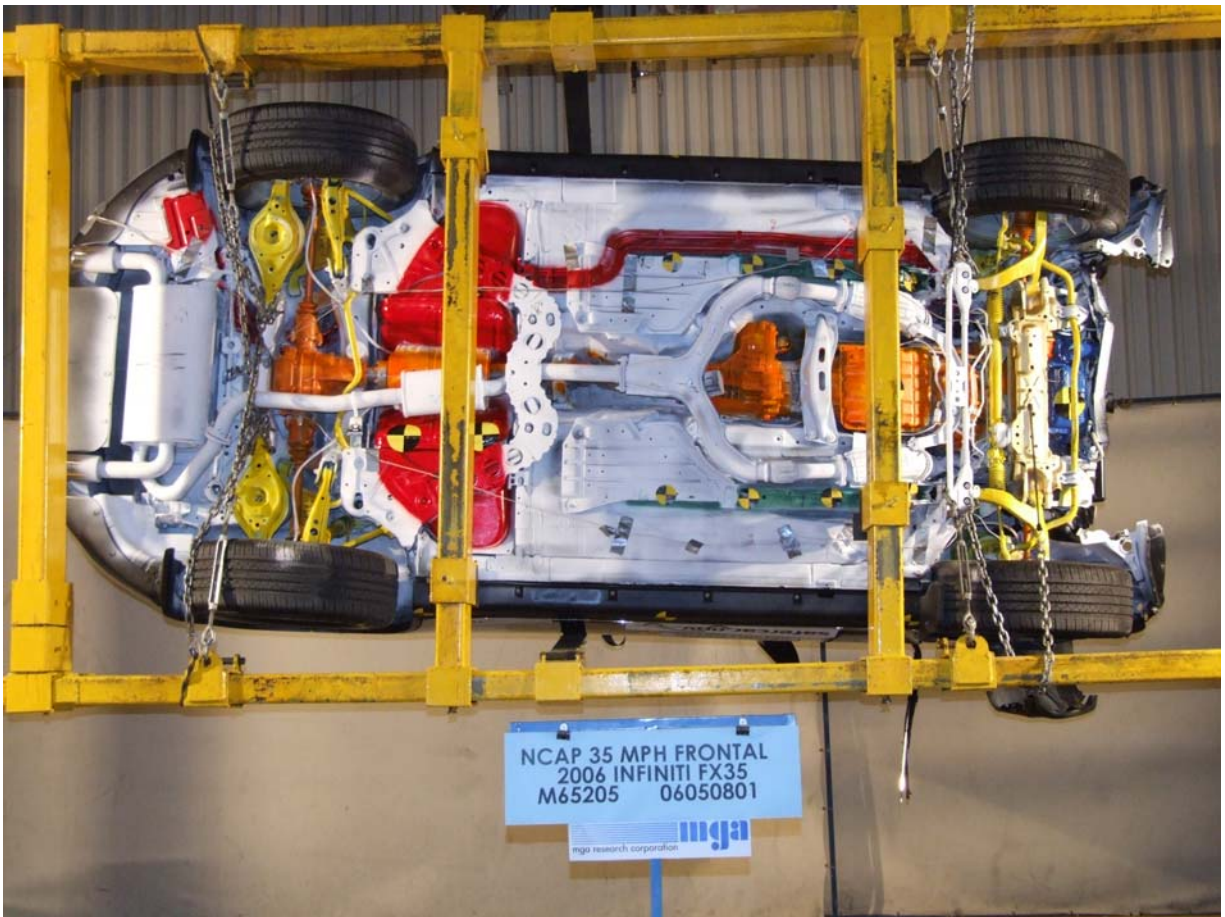
Vehicle on Rollover Device at 90 Degrees

Vehicle on Rollover Device at 180 Degrees

Vehicle on Rollover Device at 270 Degrees

Vehicle on Rollover Device at 360 Degrees
