**REPORT NUMBER: NCAPSIDE-MGA-2006-009**

**NEW CAR ASSESSMENT PROGRAM  
SIDE IMPACT TEST**

**HONDA MOTOR CO., LTD  
2007 HONDA FIT 5-DR SPORT  
NHTSA NUMBER: M75301**

**FINAL REPORT**

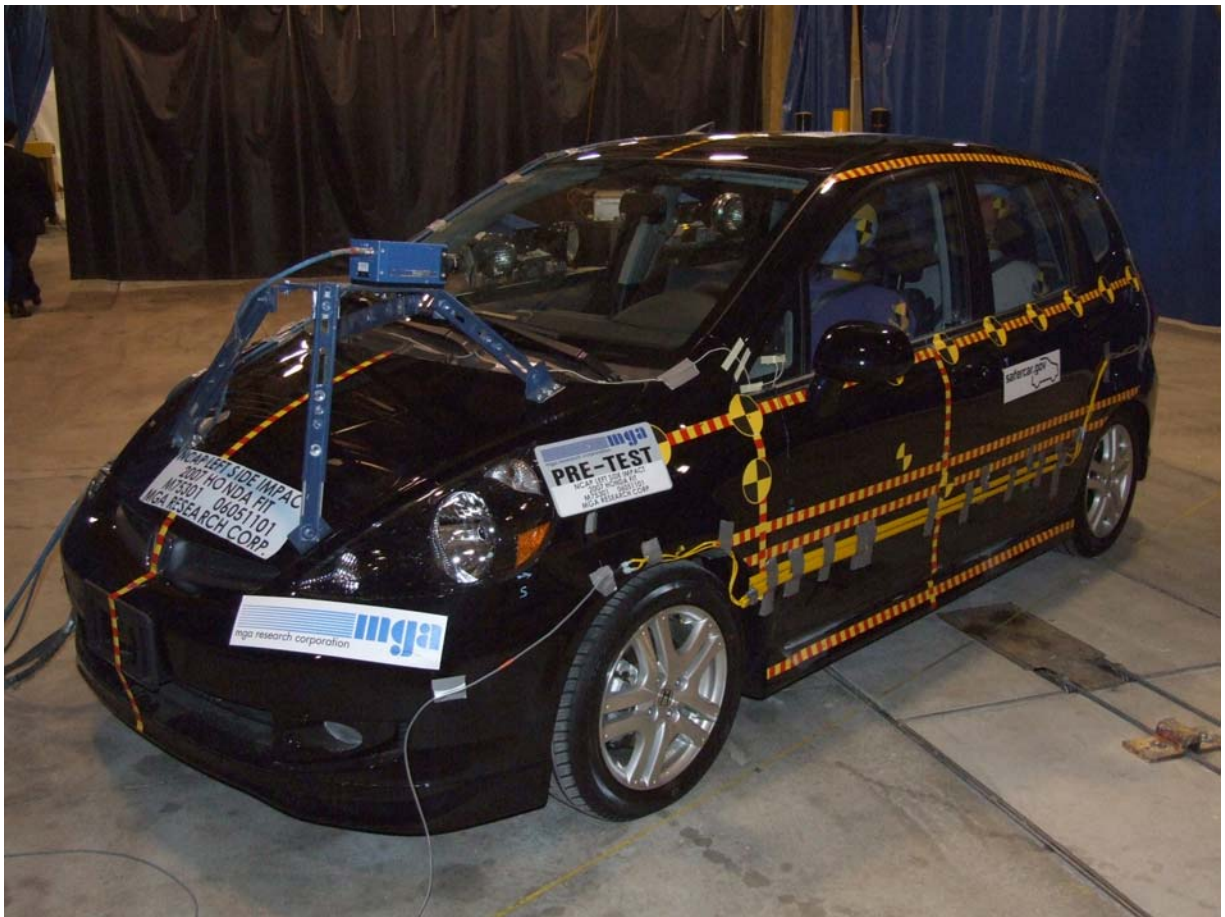
Post-Test Left Front  $\frac{3}{4}$  View

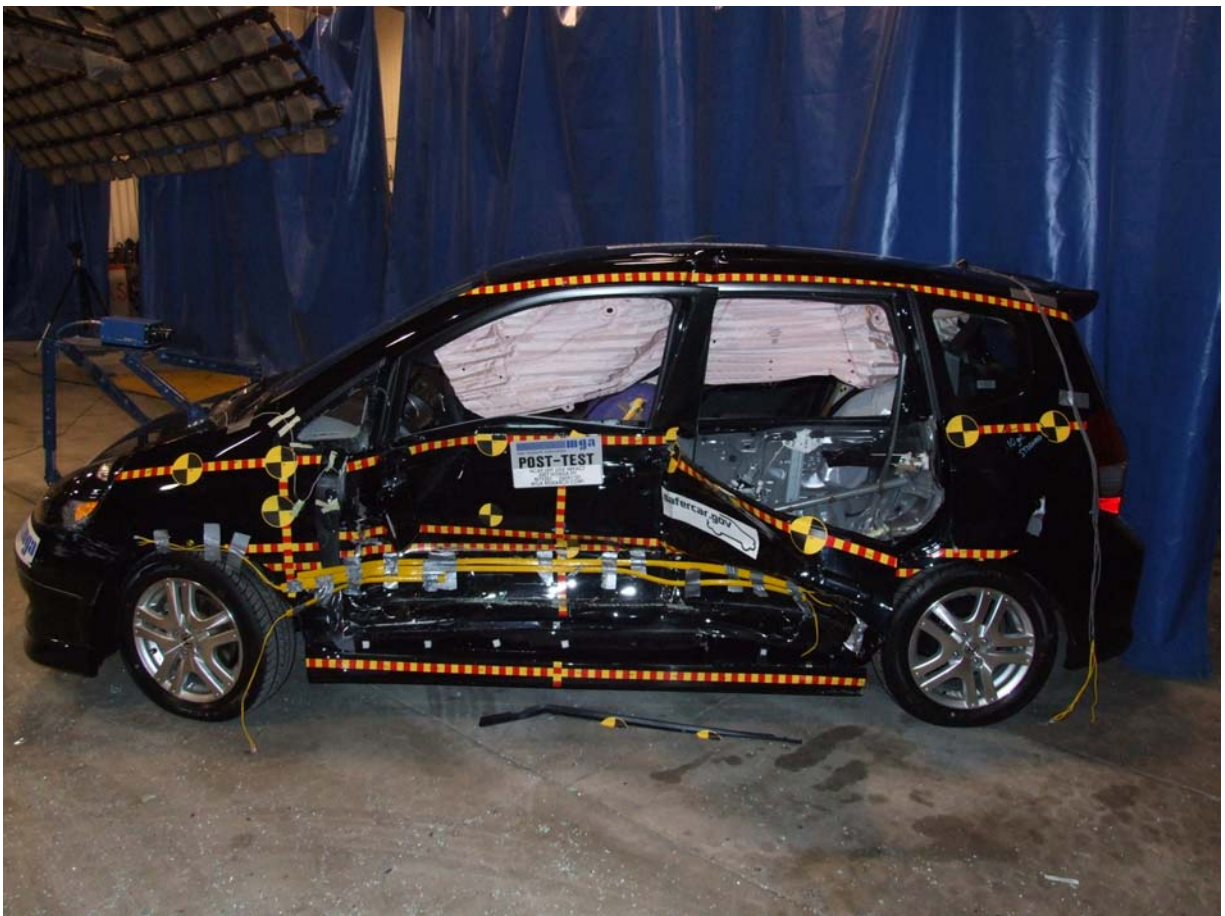
Post-Test Left Side View

The test vehicle sustained a maximum static crush of 284 mm at level 2, 1200 mm rearward of the left vertical impact point. The driver and passenger SID/HIIIs, Serial Nos. 272 and 904 respectively, were calibrated just prior to this test.

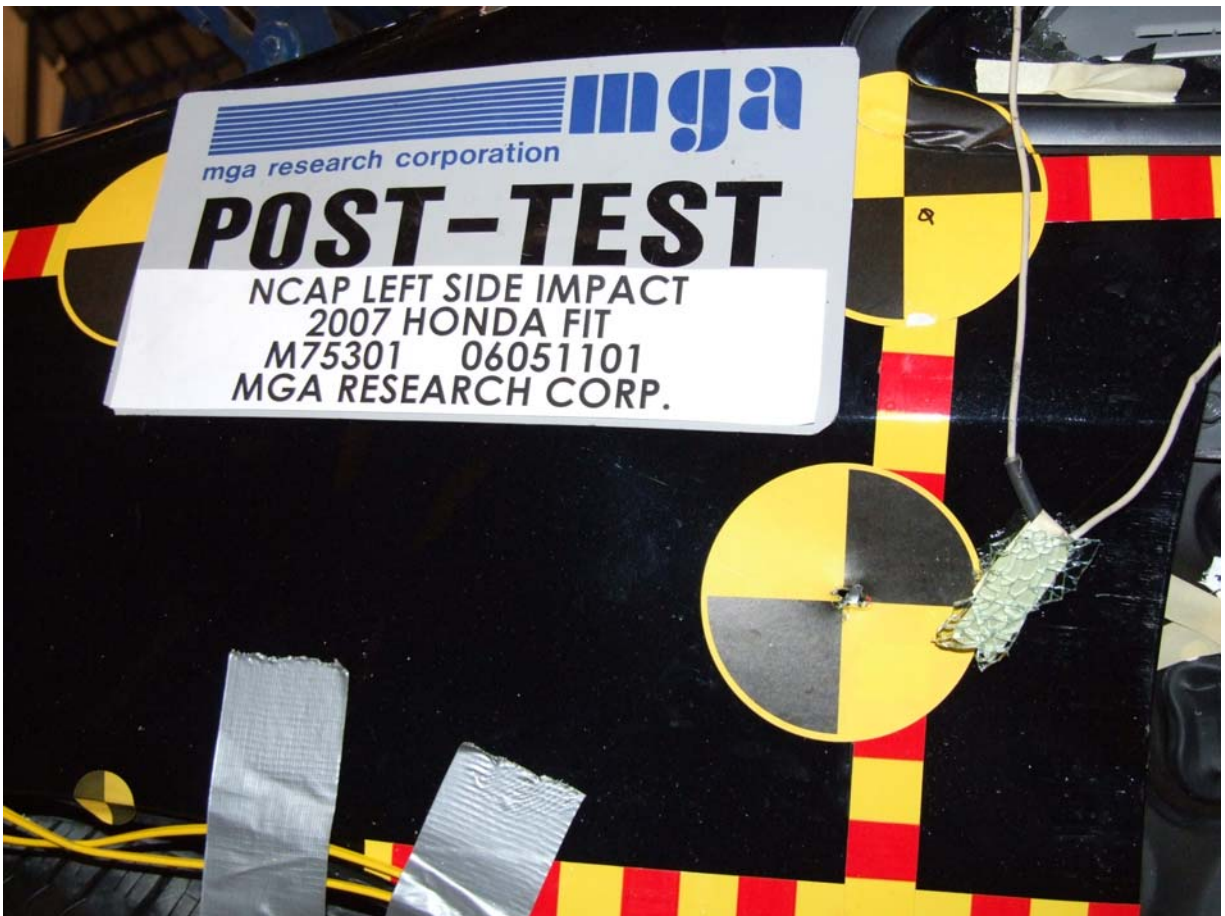
Post-Test Left Impact Point

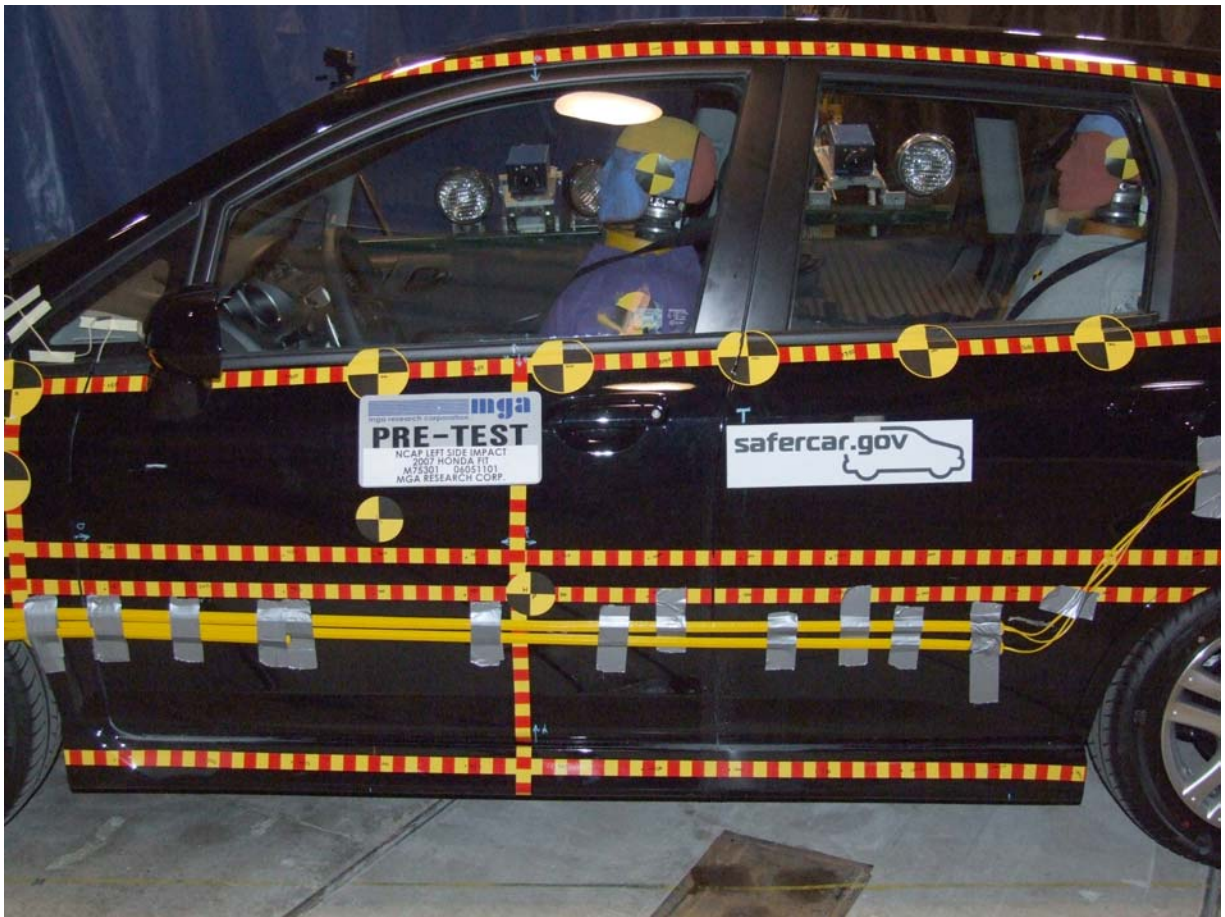
Pre-Test Left Impact Zone

Post-Test Left Impact Zone

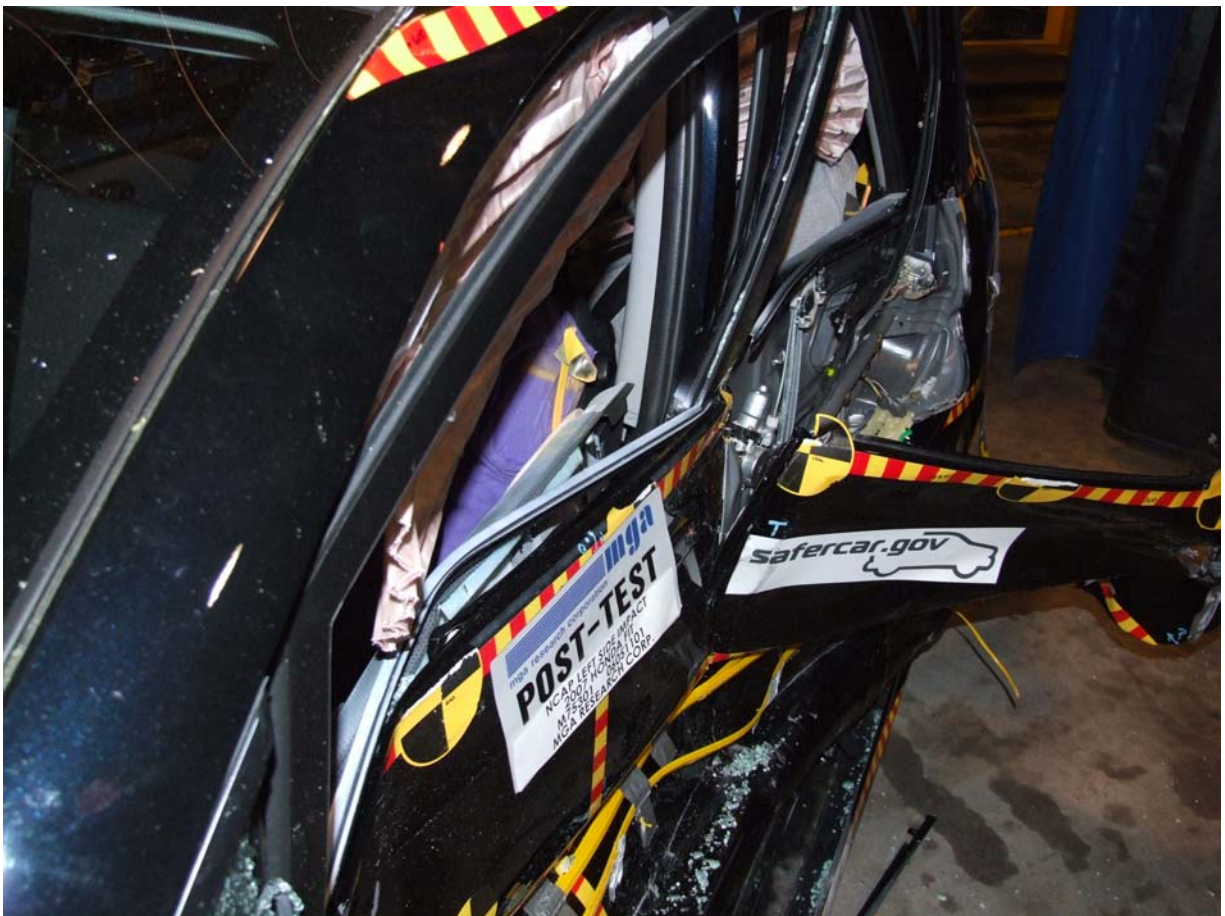
Post-Test Front  $\frac{3}{4}$  View of Left Side Door

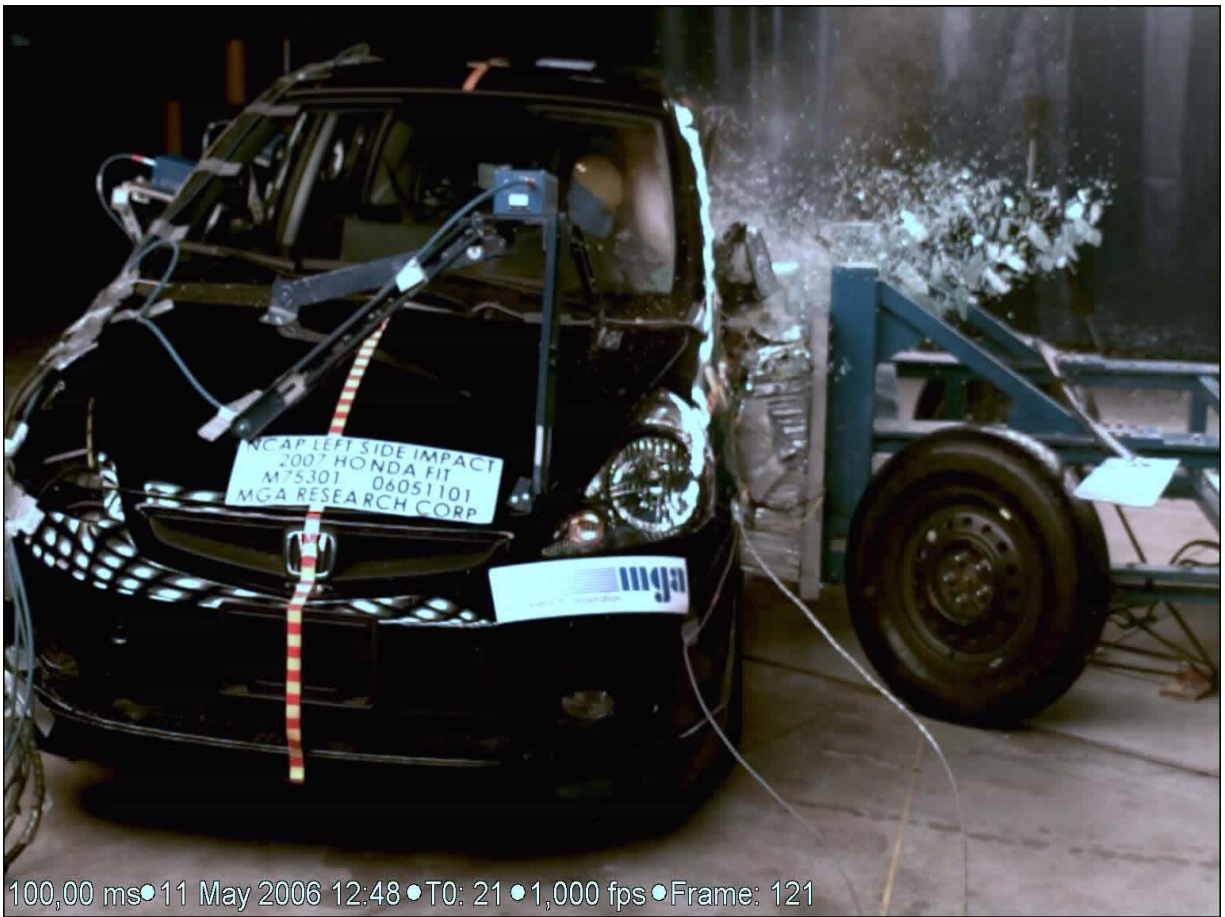
Vehicle Impact

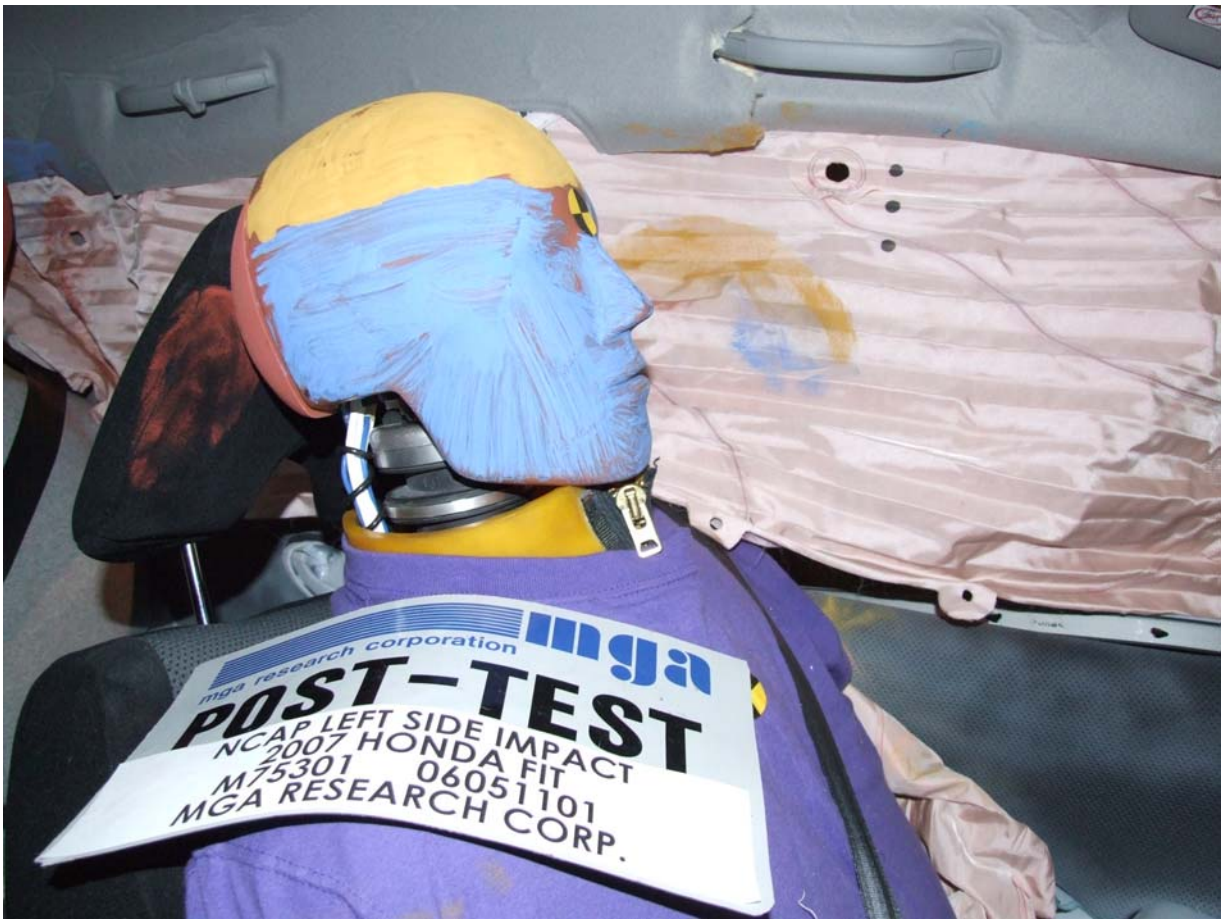
Post-Test Driver Dummy Head Contact

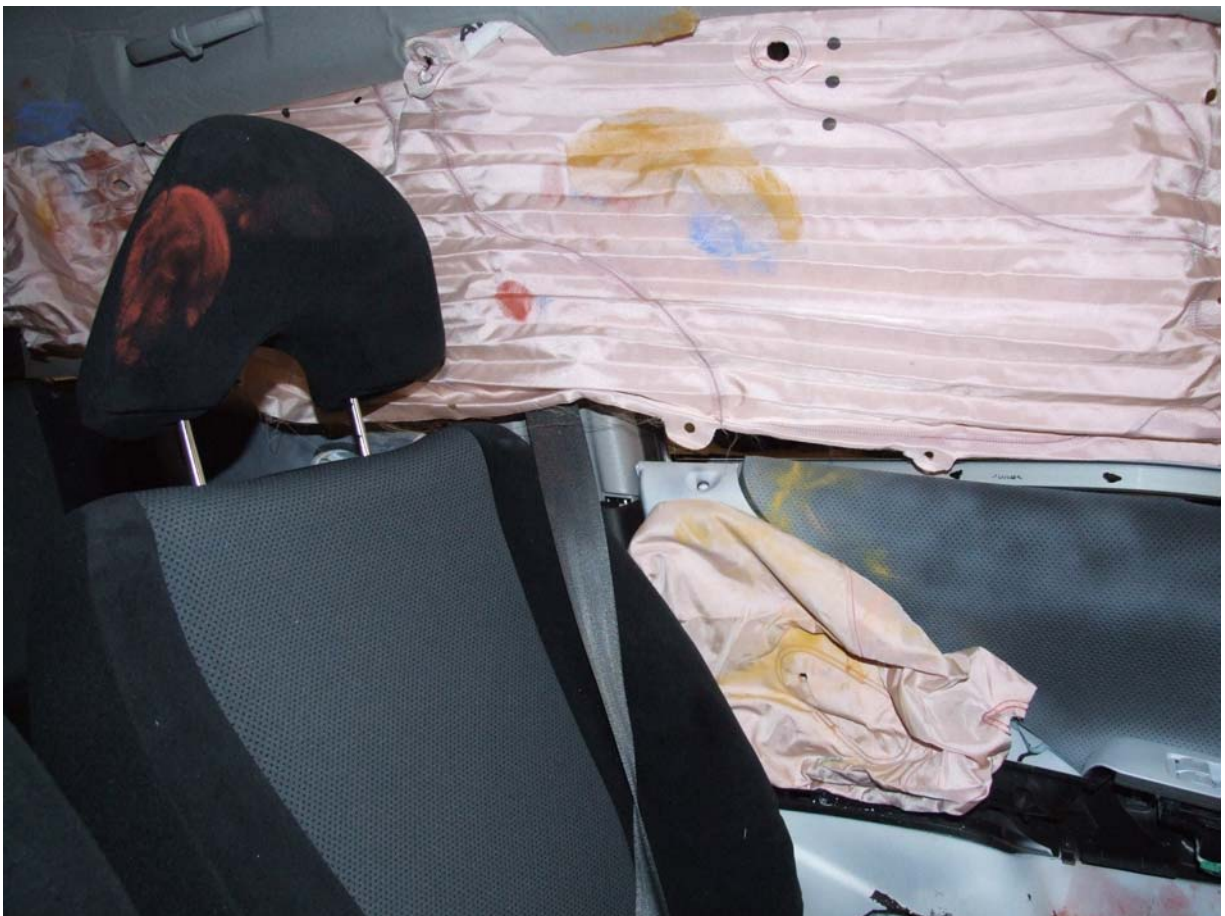
Post-Test Driver Dummy Head/Torso Contact
