**REPORT NUMBER TR-P26087-01-NC**

**NEW CAR ASSESSMENT PROGRAM  
SIDE IMPACT TEST**

**GENERAL MOTORS CORPORATION  
2006 CHEVROLET MONTE CARLO LS  
2-DOOR COUPE**

**Prepared By:  
KARCO ENGINEERING, LLC  
9270 HOLLY ROAD  
ADELANTO, CALIFORNIA 92301**

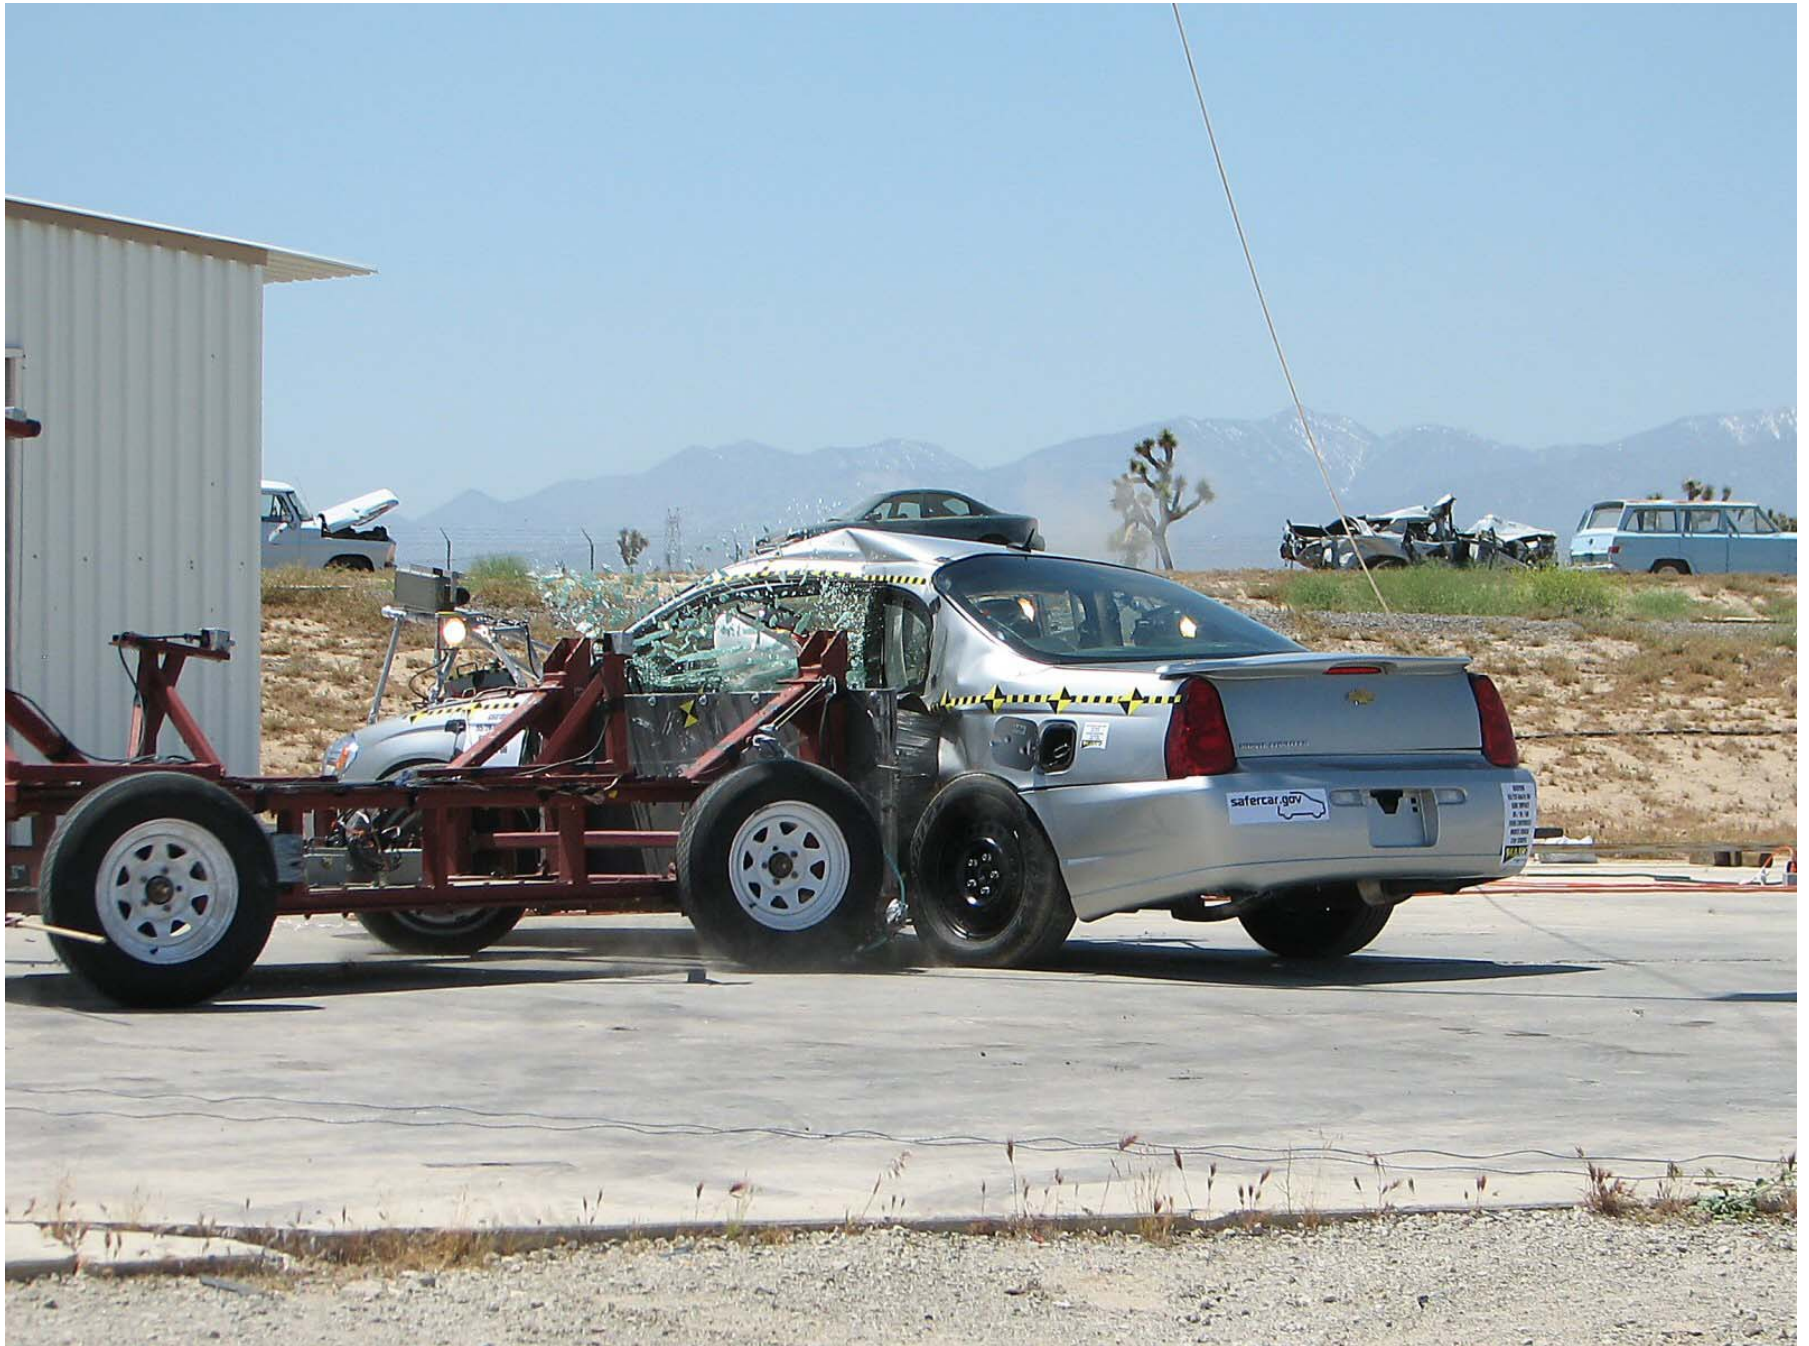
Figure A-65: Vehicle Impact

A model year 2006 Chevrolet Monte Carlo LS 2-Door Coupe was impacted on the left (driver's) side by a Moving Deformable Barrier (MDB) which was moving forward in a 27° crabbed position to the tow road guidance system at a velocity of 62.09 km/h. The specified impact velocity range is from 61.14 to 62.75 km/h. The test (target) vehicle was stationary and positioned 63° to the line of forward motion. The weight of the vehicle as tested was 1781 kg and the test weight of the MDB was 1361 kg. The test was conducted at KARCO Engineering, LLC in Adelanto, California, on May 16, 2006.
