**REPORT NUMBER: NCAPSIDE-MGA-2006-011**

**NEW CAR ASSESSMENT PROGRAM  
SIDE IMPACT TEST**

**TOYOTA MOTOR CORPORATION  
2007 TOYOTA FJ CRUISER 4X4  
NHTSA NUMBER: M75105**

**FINAL REPORT**

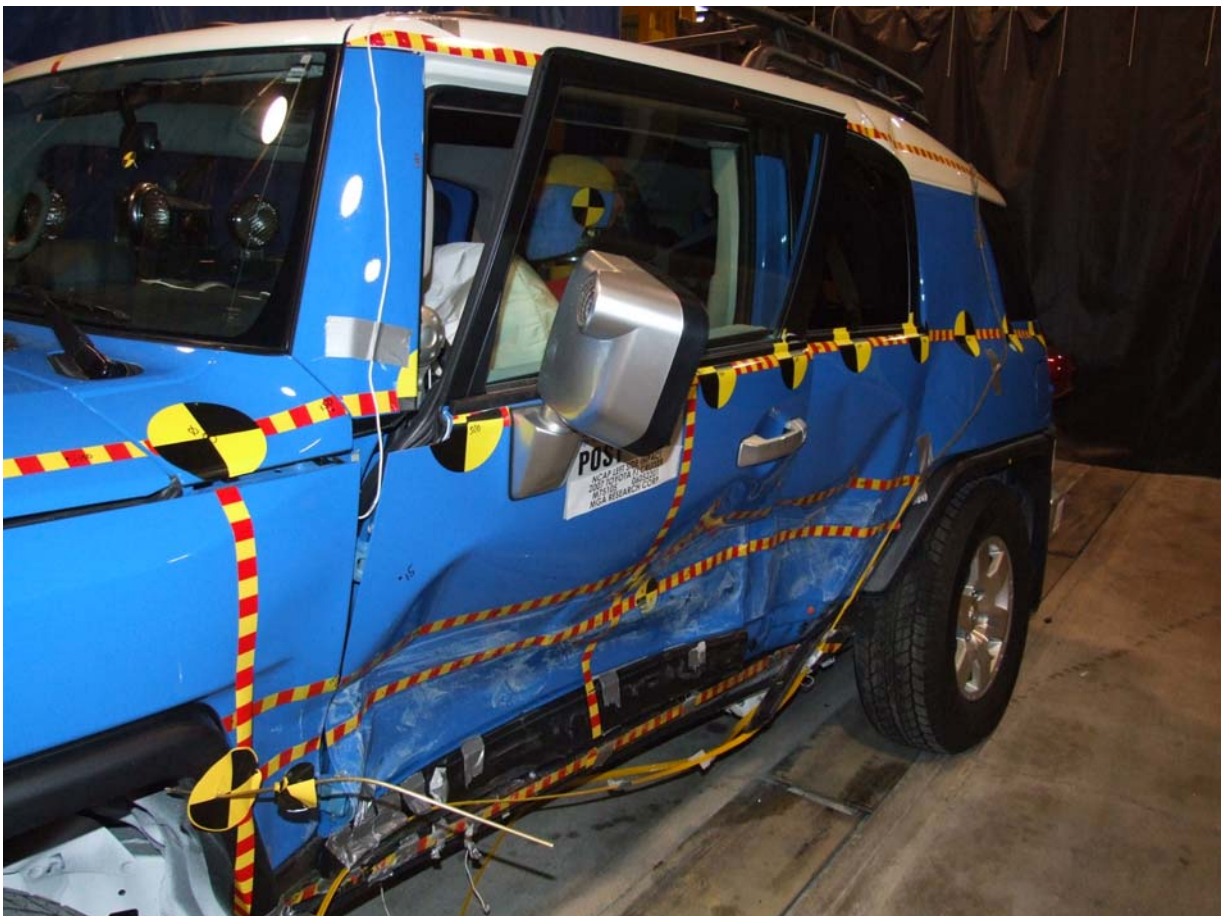
Post-Test Front  $\frac{3}{4}$  View of Left Side Door

The driver door had an 6-8 inch opening at the door/window top.

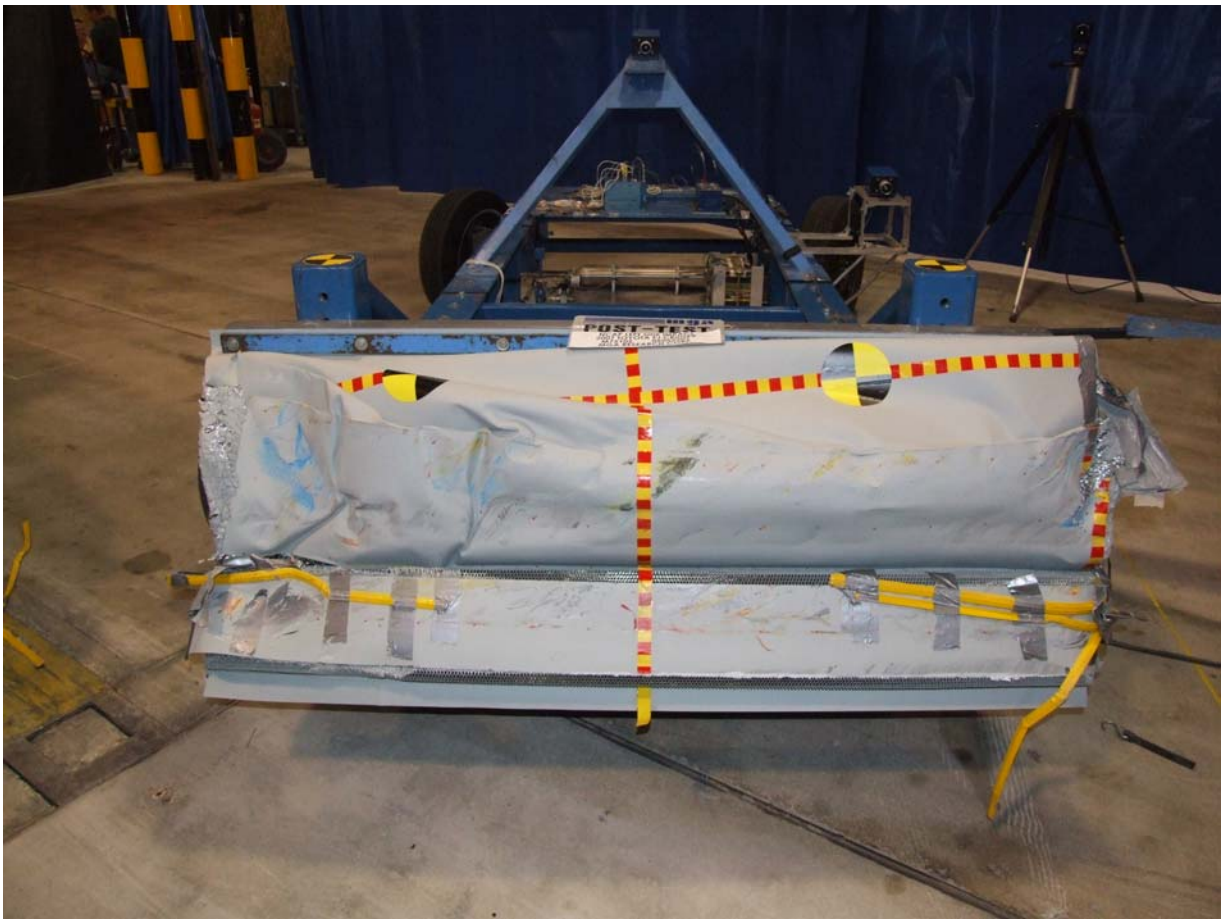
Post-Test Front View of Deformable Barrier

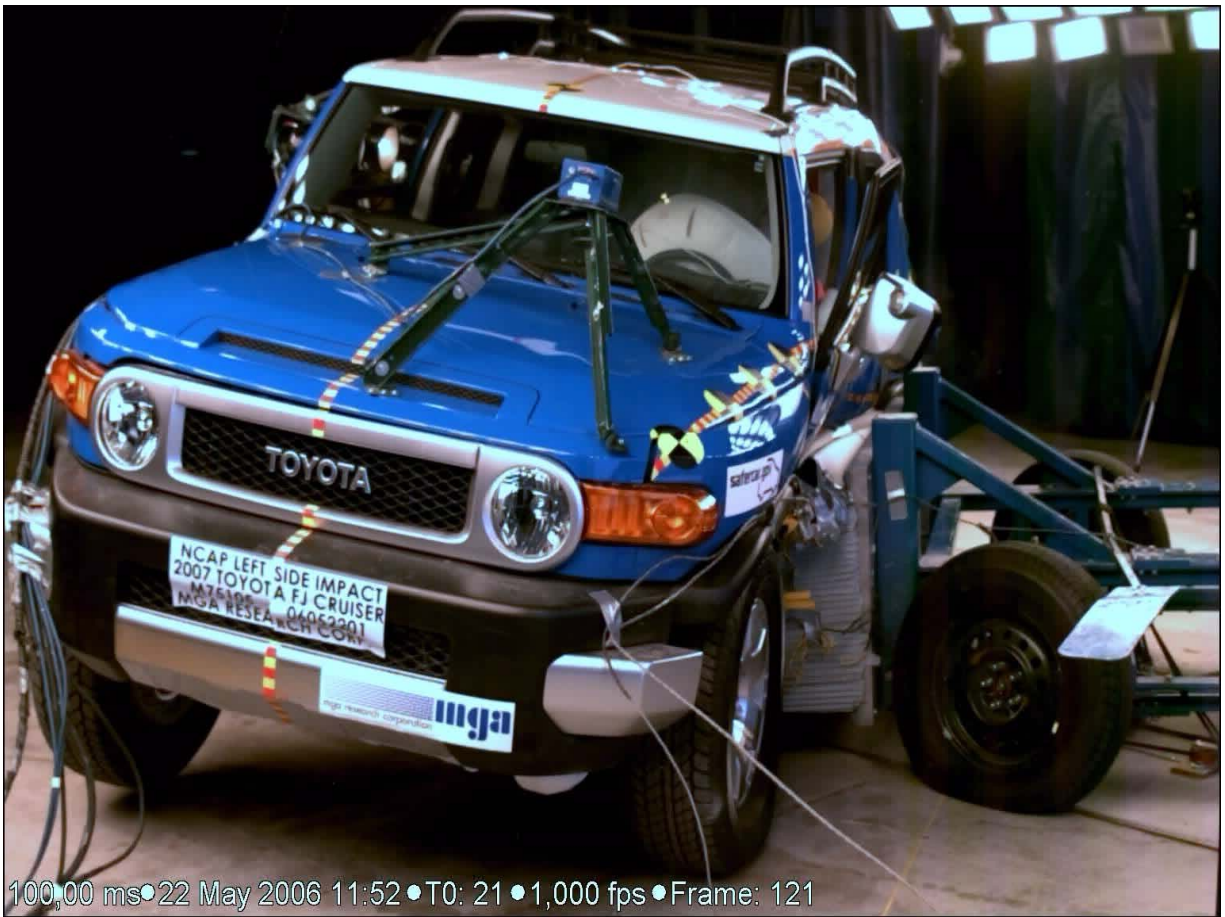
100,00 ms • 22 May 2006 11:52 • T0: 21 • 1,000 fps • Frame: 121

Vehicle Impact
