**NEW CAR ASSESSMENT PROGRAM (NCAP)**  
SIDE AIRBAG OUT-OF-POSITION INJURY TESTING

2006 HYUNDAI AZERA  
FOUR DOOR SEDAN

NHTSA NUMBER: M60504TWG2

CALSPAN CORPORATION TEST NUMBER: 8642-TWG-22

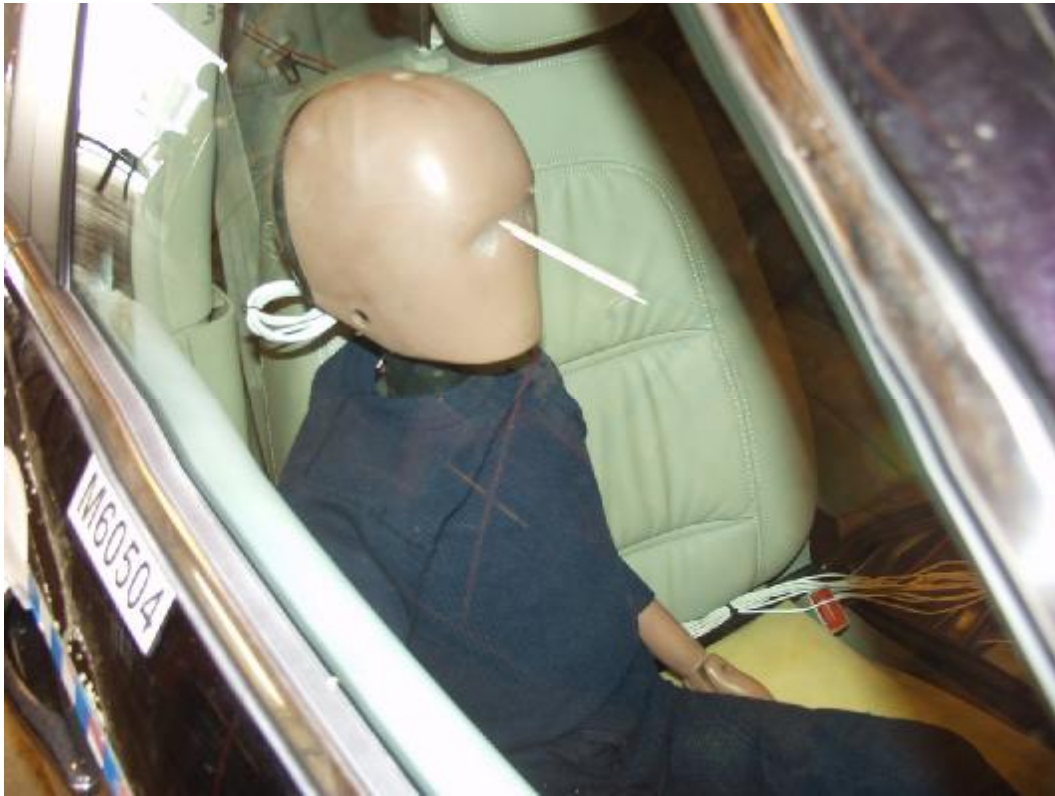
Figure A-5: Pre-Test Dummy Frontal View

The six-year old child dummy was placed on the outboard edge of foam block, aligning the upper spine with the deployment trajectory of the airbag. The dummy's head was placed in between the seat bolster and pillar trim to minimize the fore-aft clearance between the neck and the seatback. The head remained in its neutral orientation. The legs were aligned such that they crossed the heel placement points but the feet did overhang the seat cushion. The dummy was then positioned so the dummy's neck/torso junction was aligned vertically with the top edge of the airbag module. While maintaining the neck/torso top of the airbag module alignment, the vehicle door was closed and the pelvis was moved outboard until it made contact the door trim/armrest. The outboard forearm was placed on the armrest. The inboard arm was positioned such that the upper arm contacted the seat back and the fingertips contacted the booster seat. The dummy's arms were then bent at the elbow until the fingers contacted the booster seat. This orientation complies with section 3.3.3.5 of the TWG Recommended Procedures for Evaluating Occupant Injury Risk from Deploying Side Airbags as defined by Lund, et al and the Technical Working Group First Revision dated July, 2003.

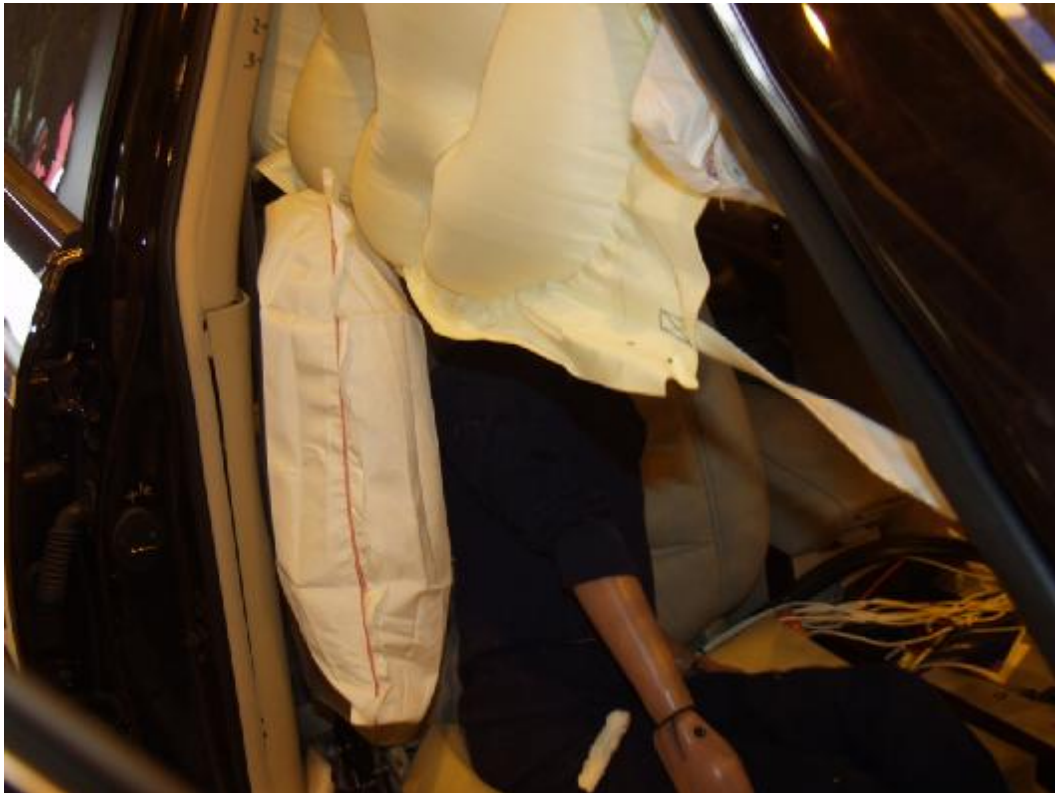
Figure A-6: Post-Test Dummy Frontal View

The Hybrid III six-year-old child dummy's visible contact points were as follows: The seat airbag to the right scapula and right side of the posterior thorax and pelvis and the curtain airbag to the top and the back of the head.
