REPORT NUMBER: TWG-CAL06-02

**NEW CAR ASSESSMENT PROGRAM (NCAP)**  
SIDE AIRBAG OUT-OF-POSITION INJURY TESTING

2006 TOYOTA 4RUNNER  
FOUR DOOR MULTIPURPOSE VEHICLE

NHTSA NUMBER: M65104TWG2

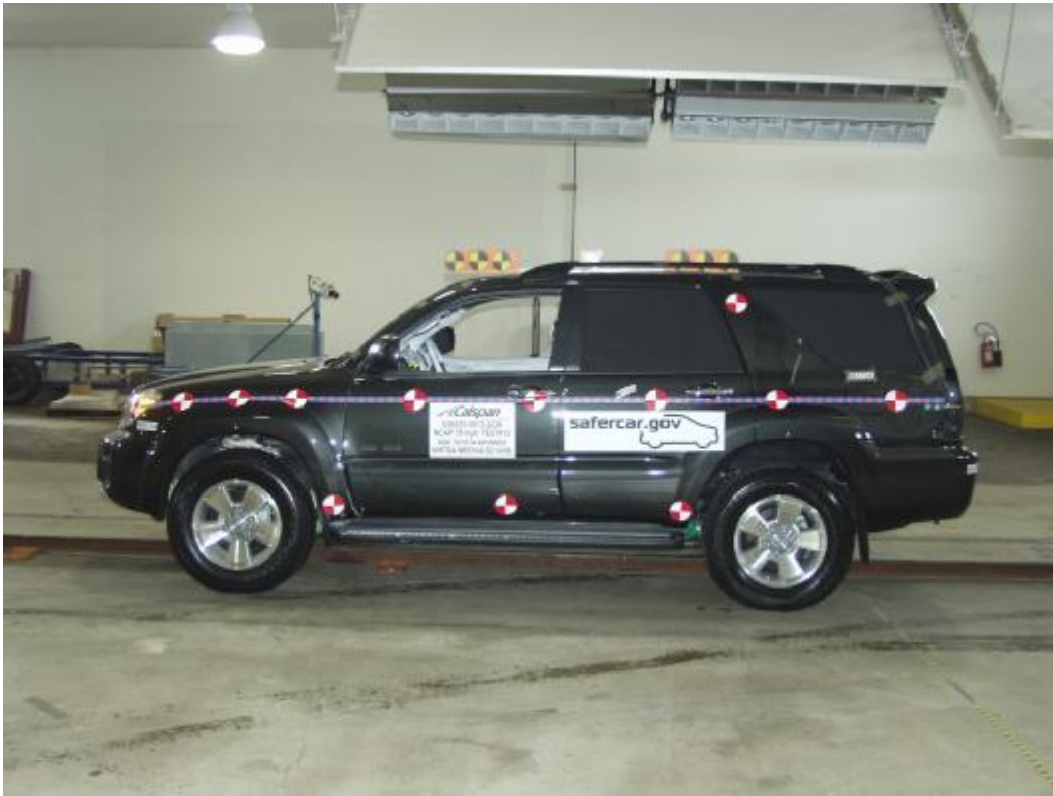
Figure A-1: Pre-Test Vehicle Left Side View

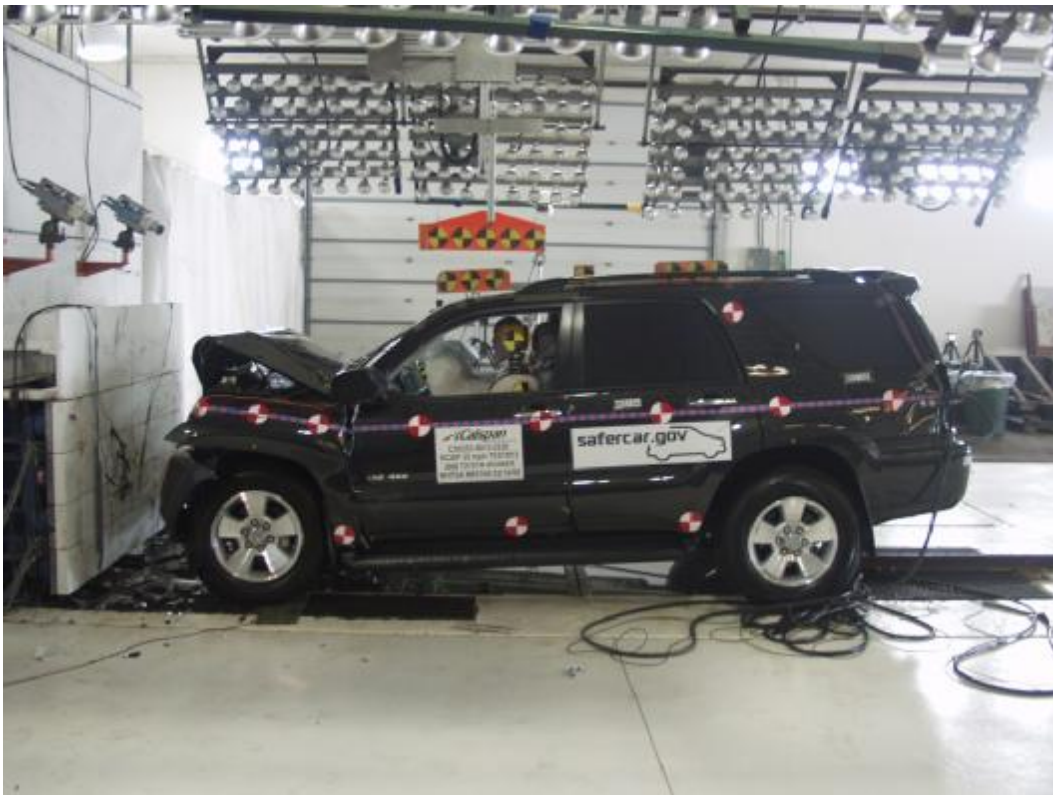
Figure A-2: Post-Test Vehicle Left Side View

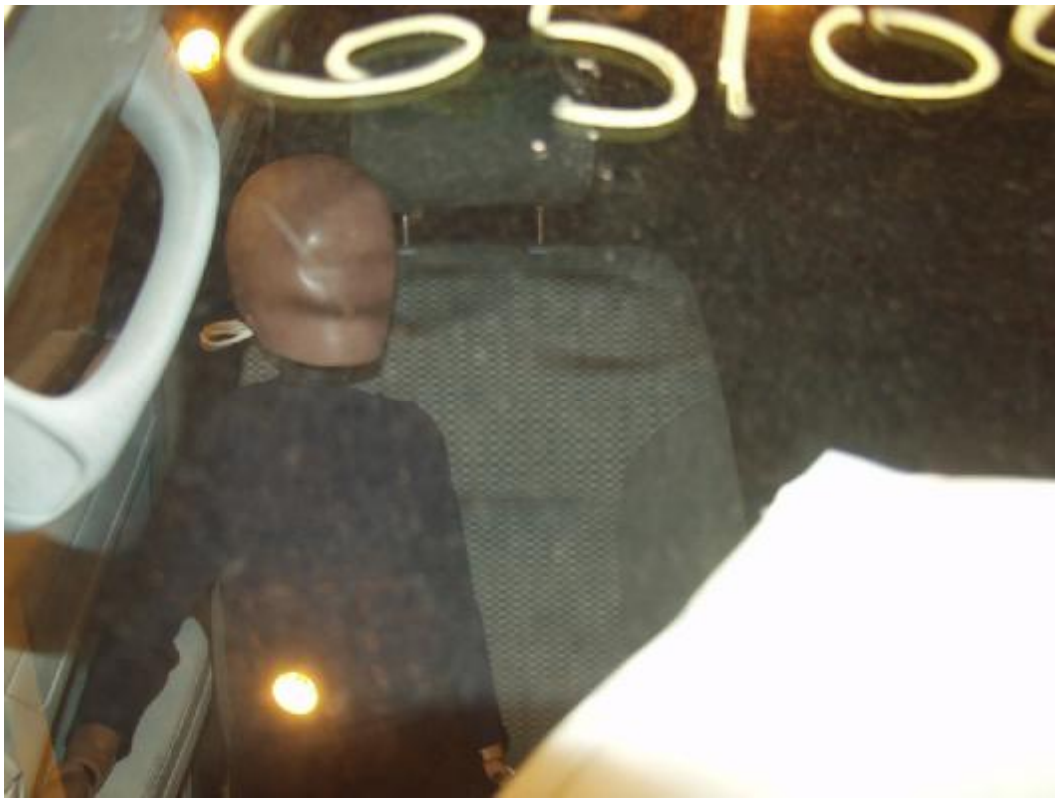
Figure A-5: Pre-Test Dummy Frontal View

The six-year old child dummy was placed on the outboard edge of foam block, aligning the upper spine with the deployment trajectory of the airbag. The dummy's head was placed in between the seat bolster and pillar trim to minimize the fore-aft clearance between the neck and the seatback. The head remained in its neutral orientation. The legs were aligned such that they crossed the heel placement points but the feet did overhang the seat cushion. The dummy was then positioned so the dummy's neck/torso junction was aligned vertically with the top edge of the airbag module. While maintaining the neck/torso top of the airbag module alignment, the vehicle door was closed and the pelvis was moved outboard until it made contact the door trim/armrest. The outboard forearm was placed on the armrest. The inboard arm was positioned such that the upper arm contacted the seat back and the fingertips contacted the booster seat. The dummy's arms were then bent at the elbow until the fingers contacted the booster seat. This orientation complies with section 3.3.3.5 of the TWG Recommended Procedures for Evaluating Occupant Injury Risk from Deploying Side Airbags as defined by Lund, et al and the Technical Working Group First Revision dated July, 2003.

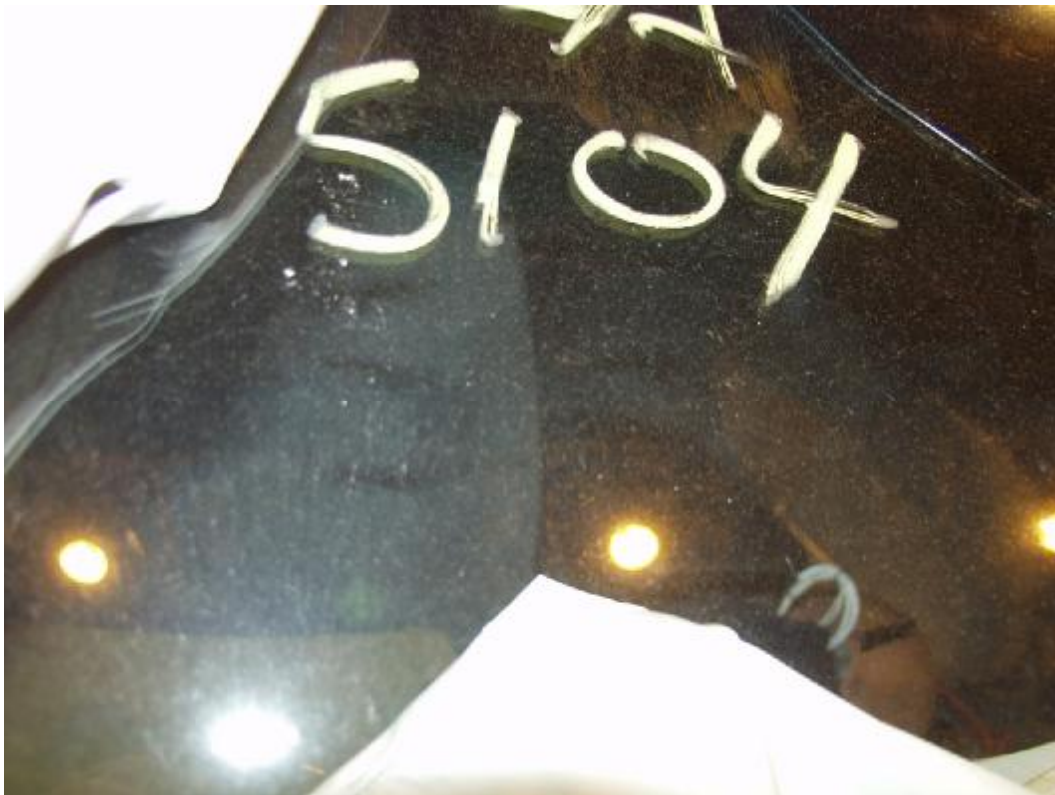
Figure A-6: Post-Test Dummy Frontal View

The Hybrid III six-year-old child dummy's visible contact points were as follows: The seat airbag to the right scapula and right side of the posterior thorax and pelvis and the curtain airbag to the top and the back of the head.

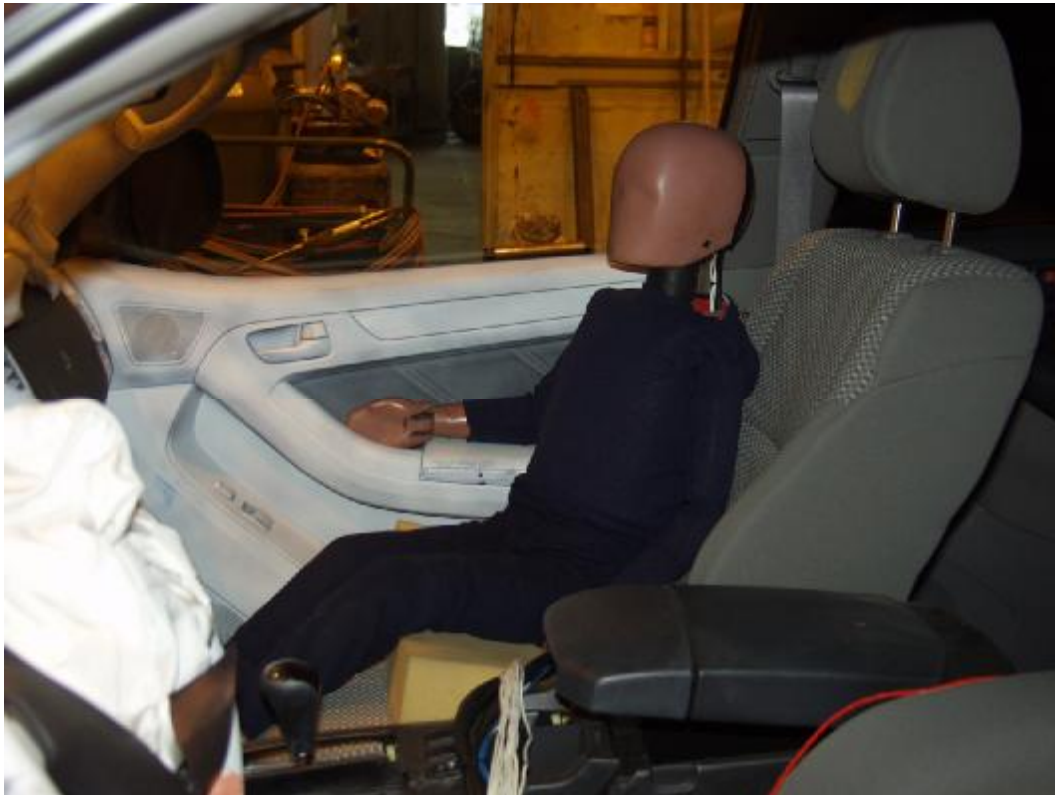
Figure A-7: Pre-Test Left Side of Dummy View

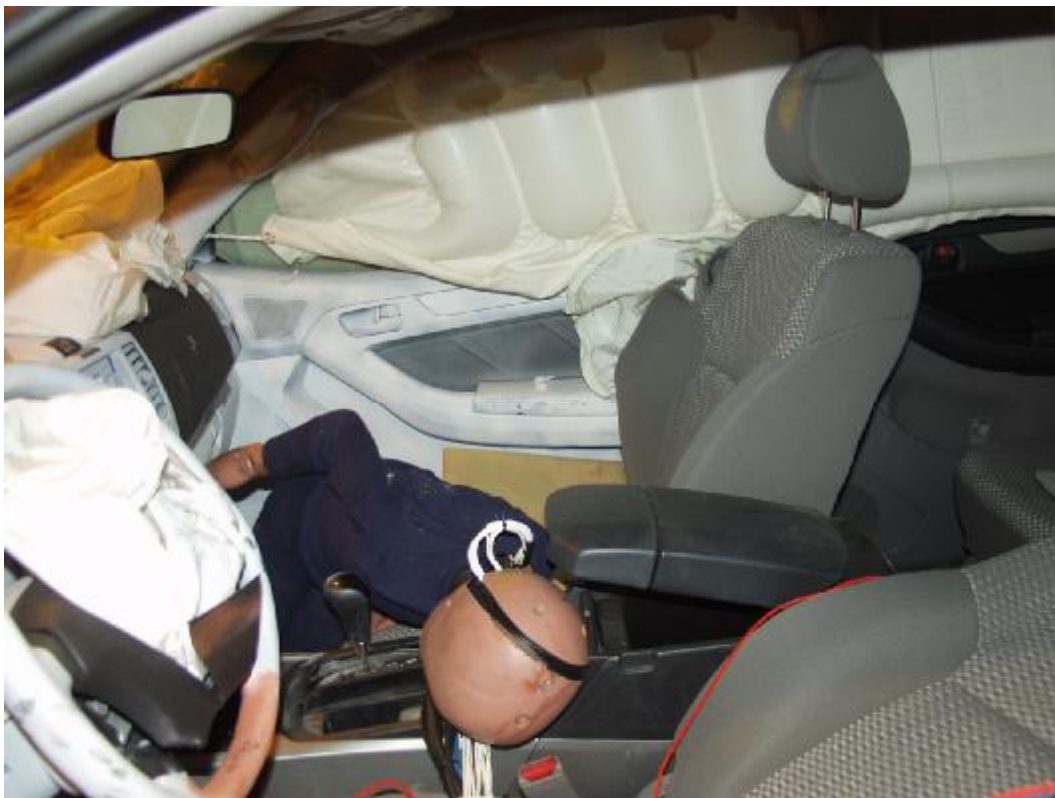
Figure A-8: Post-Test Left Side of Dummy View

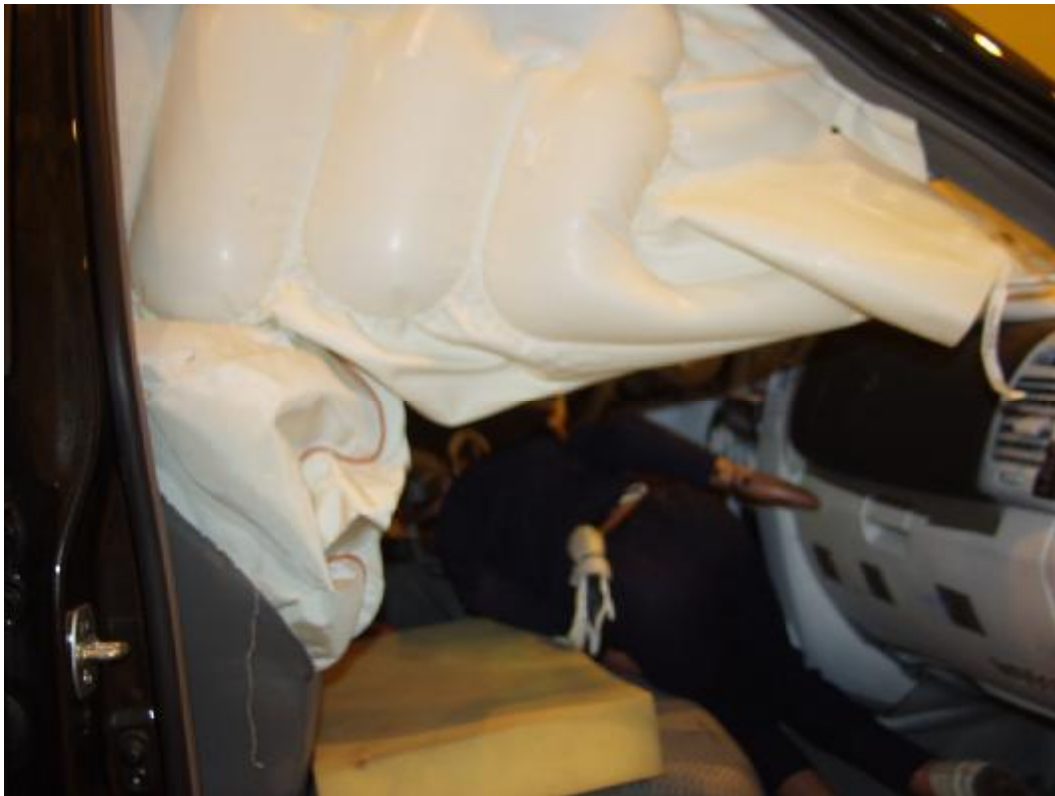
Figure A-10: Post-Test Right Side of Dummy View

| <b>Upper Torso Contact:</b> | Side airbag to the right scapula and right side of the posterior thorax |
| <b>Lower Torso Contact:</b> | Side airbag to the right side of the pelvis (ilium) |
