**Report Number: 214-TRC-06-003**

**Safety Compliance Testing For FMVSS 214**

**Side Impact Protection**

**Suzuki Motor Corporation  
2006 Suzuki Grand Vitara MPV**

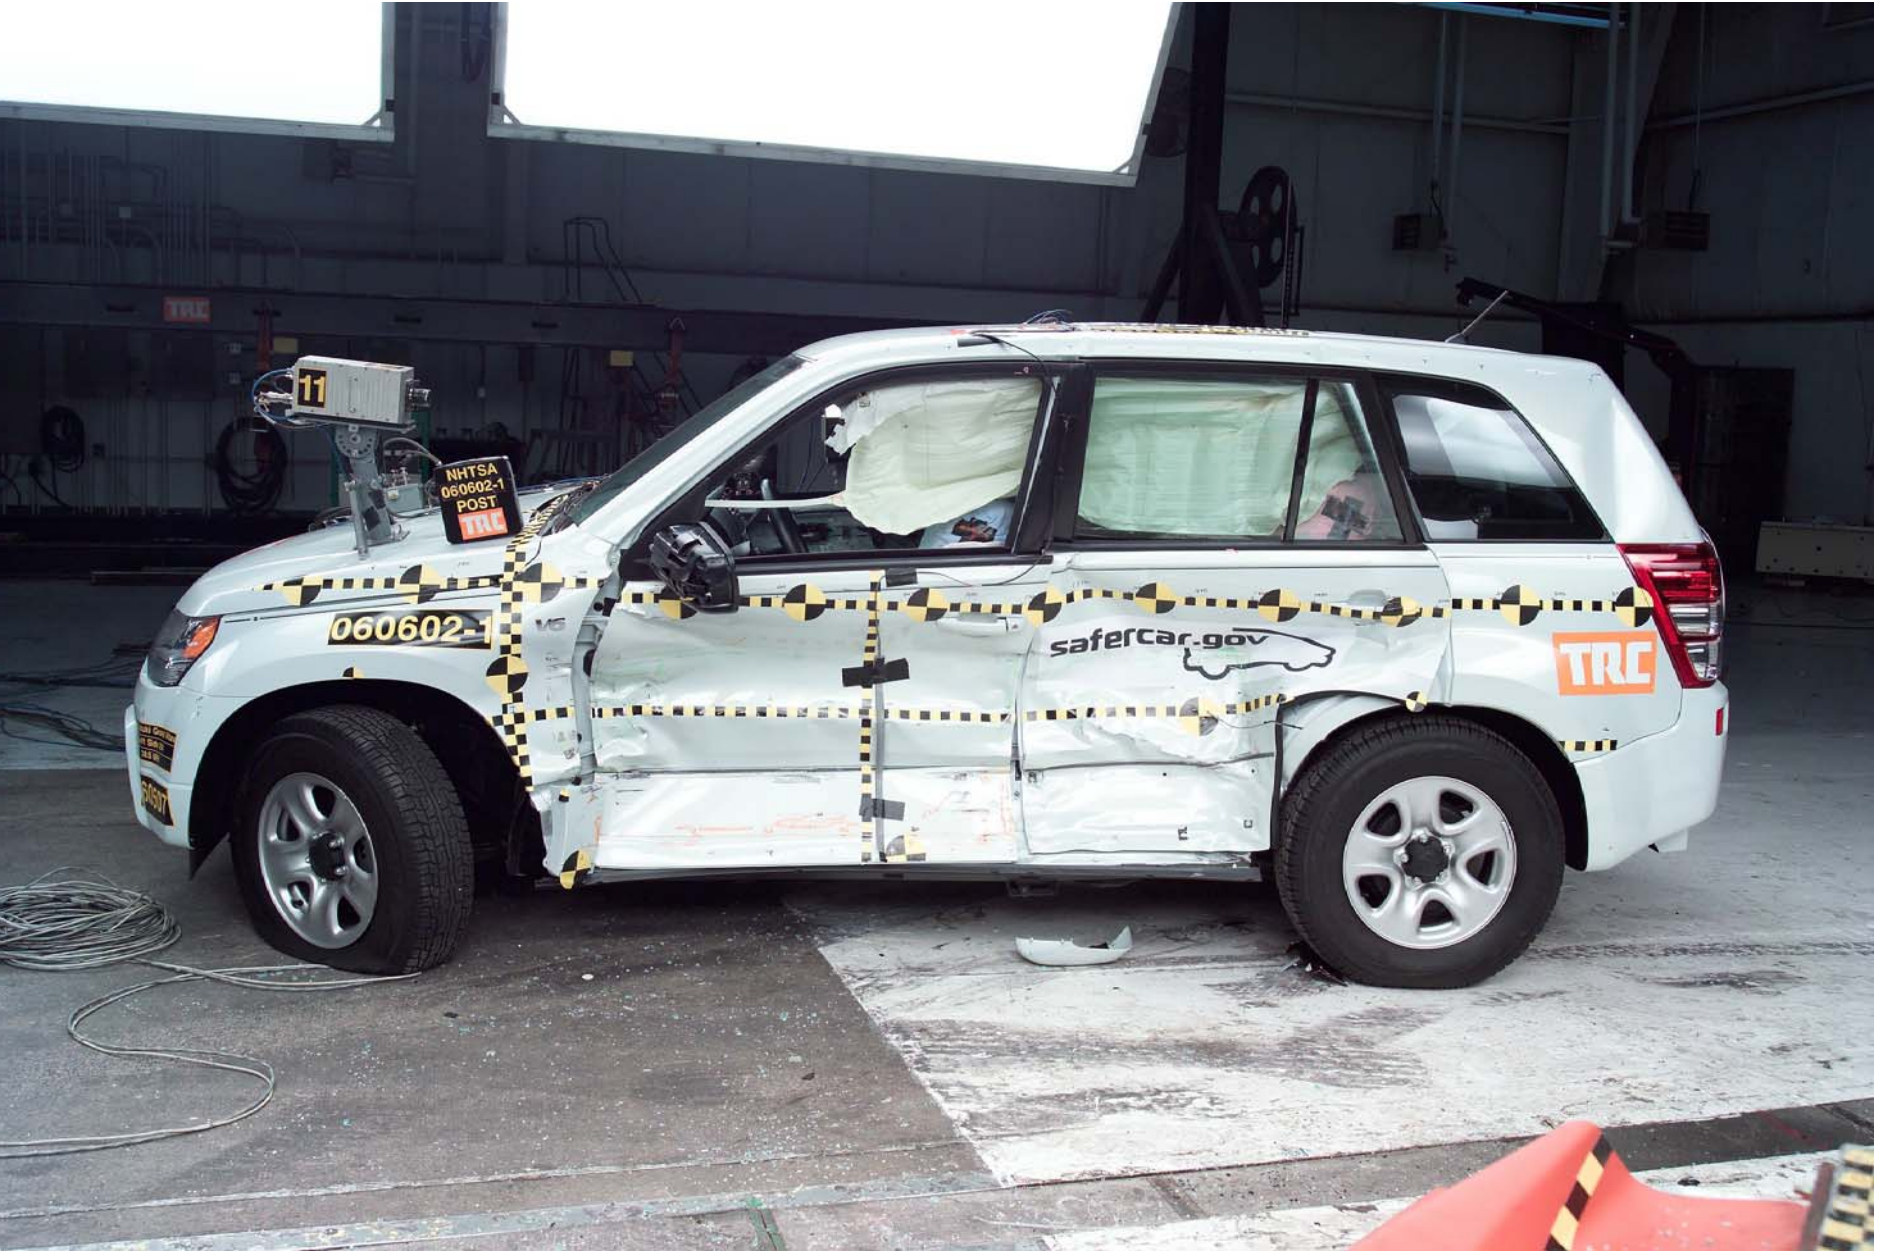
Figure A-6 Post-Test Impacted Side View of Test Vehicle

Full length of induced damage was 1950 mm.

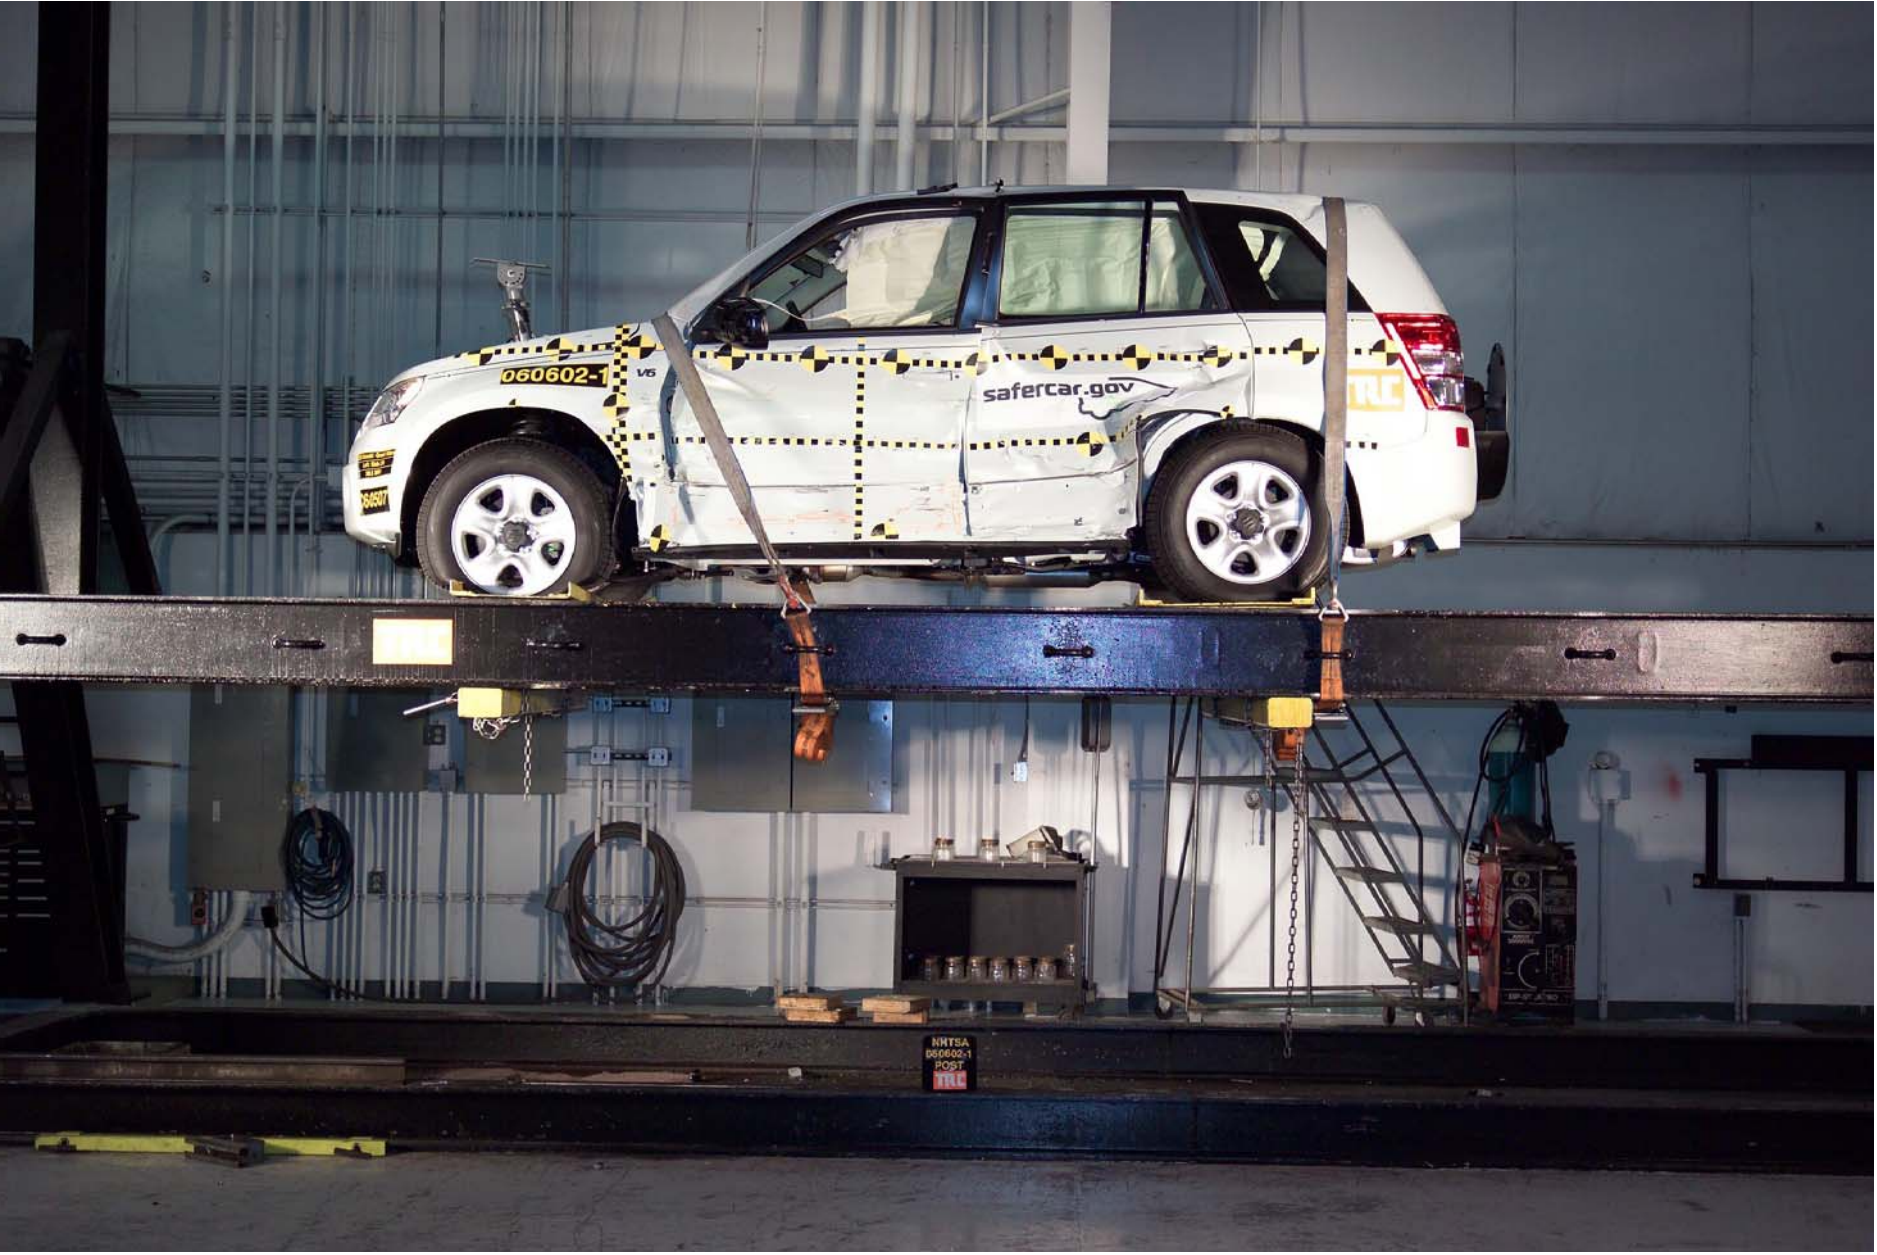
Figure A-81 FMVSS 301 Rollover View at 90°

Figure A-82 FMVSS 301 Rollover View at 180°

Figure A-83 FMVSS 301 Rollover View at 270°

Figure A-84 FMVSS 301 Rollover View at 360°
