REPORT NUMBER: TWG-CAL06-04

**NEW CAR ASSESSMENT PROGRAM (NCAP)**  
SIDE AIRBAG OUT-OF-POSITION INJURY TESTING

2006 SUZUKI GRAND VITARA  
FOUR DOOR MULTIPURPOSE VEHICLE

NHTSA NUMBER: M60517TWG2

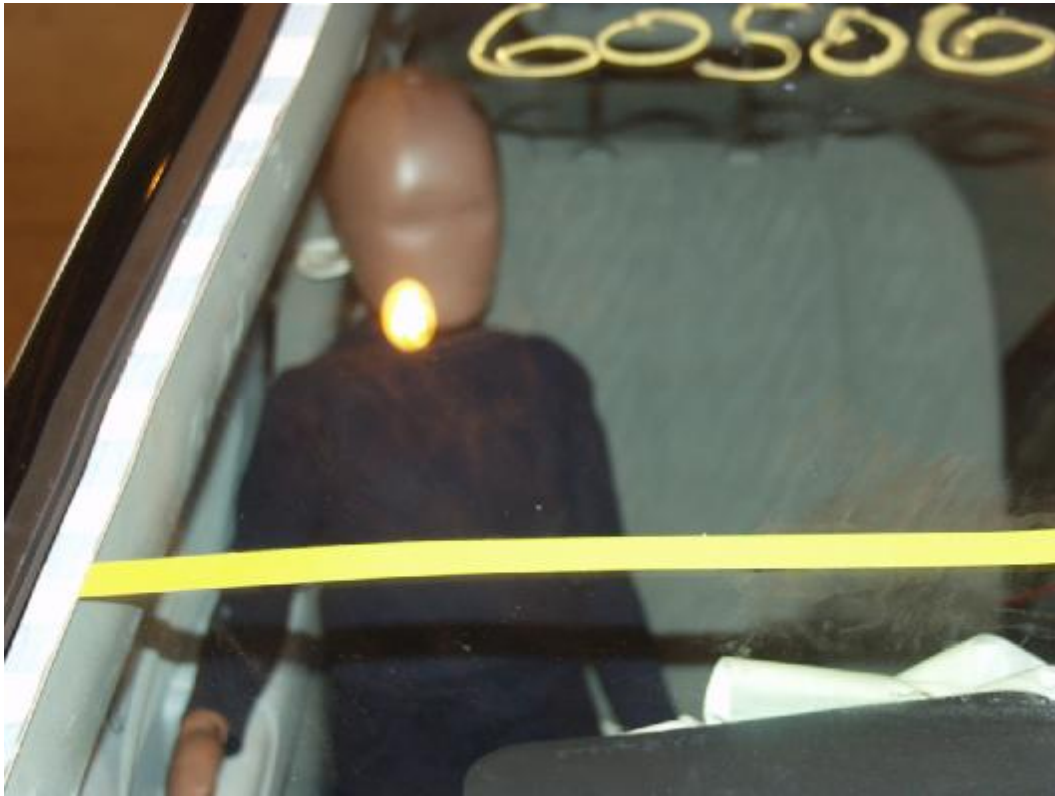
Figure A-5: Pre-Test Dummy Frontal View

The six-year old child dummy was placed on the outboard edge of foam block, aligning the upper spine with the deployment trajectory of the airbag. The dummy's head was placed in between the seat bolster and pillar trim to minimize the fore-aft clearance between the neck and the seatback. The head remained in its neutral orientation. The legs were aligned such that they crossed the heel placement points but the feet did overhang the seat cushion. The dummy was then positioned so the dummy's neck/torso junction was aligned vertically with the top edge of the airbag module. While maintaining the neck/torso top of the airbag module alignment, the vehicle door was closed and the pelvis was moved outboard until it made contact the door trim/armrest. The outboard forearm was placed on the armrest. The inboard arm was positioned such that the upper arm contacted the seat back and the fingertips contacted the booster seat. The dummy's arms were then bent at the elbow until the fingers contacted the booster seat. This orientation complies with section 3.3.3.5 of the TWG Recommended Procedures for Evaluating Occupant Injury Risk from Deploying Side Airbags as defined by Lund, et al and the Technical Working Group First Revision dated July, 2003.

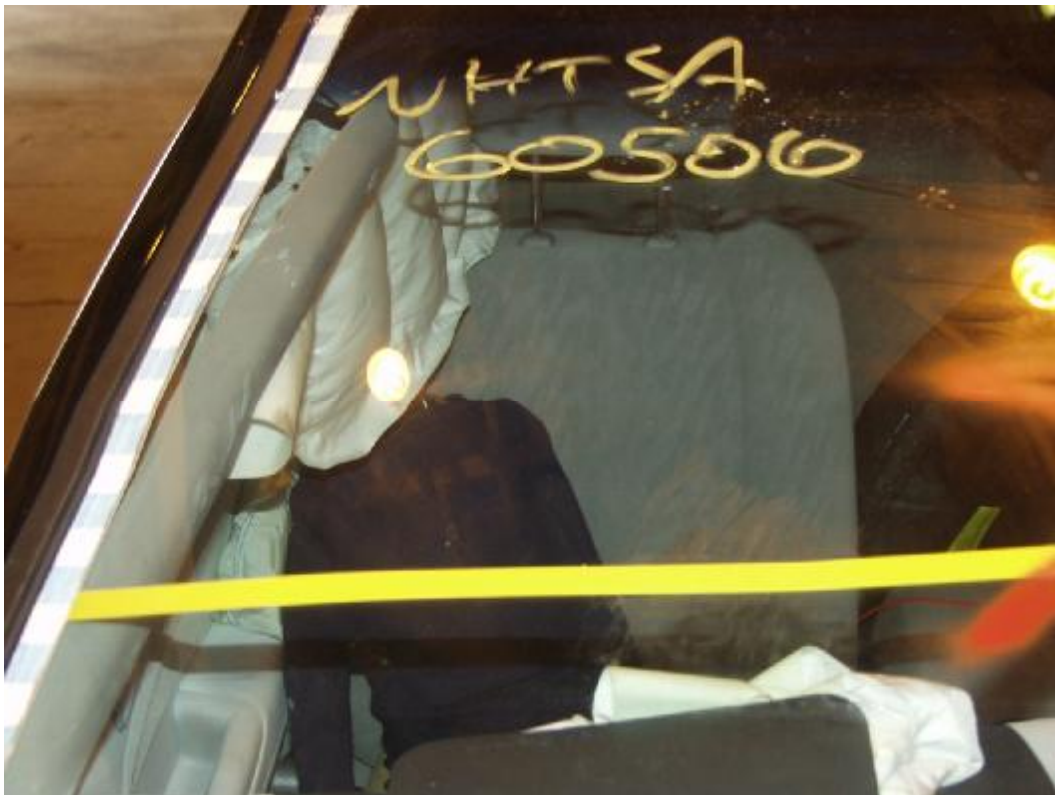
Figure A-6: Post-Test Dummy Frontal View

The Hybrid III six-year-old child dummy's visible contact points were as follows: The seat airbag to the right scapula and right side of the posterior thorax and pelvis and the curtain airbag to the top and the back of the head.

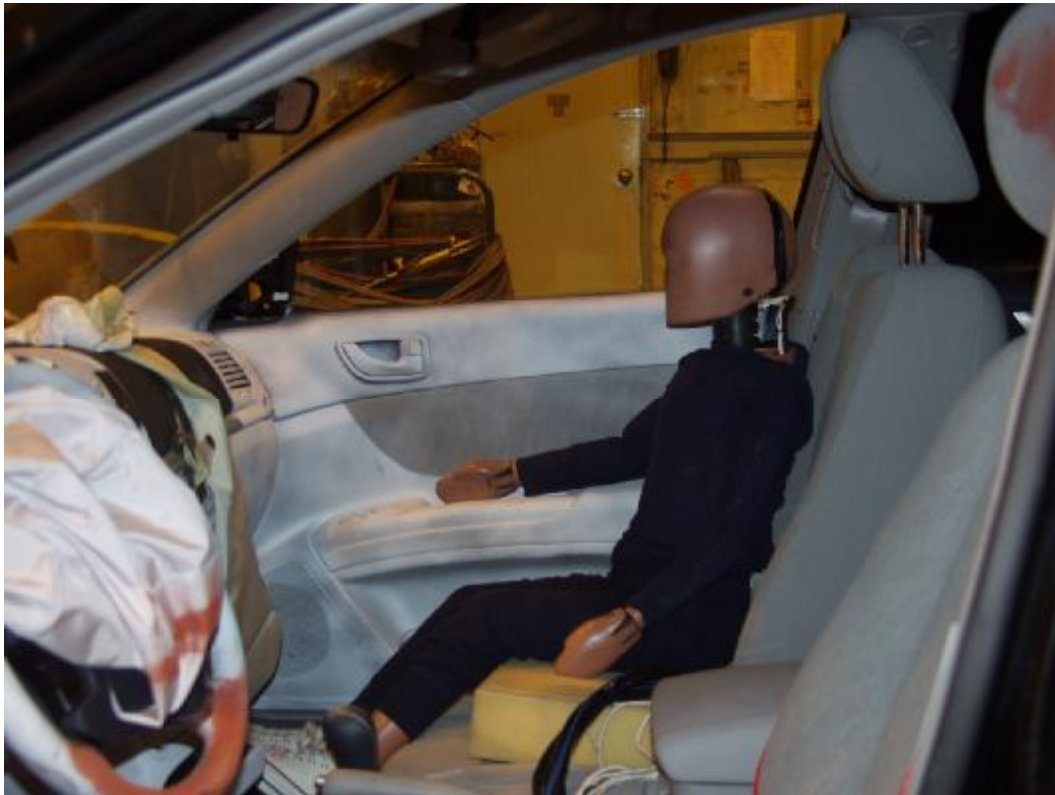
Figure A-7: Pre-Test Left Side of Dummy View

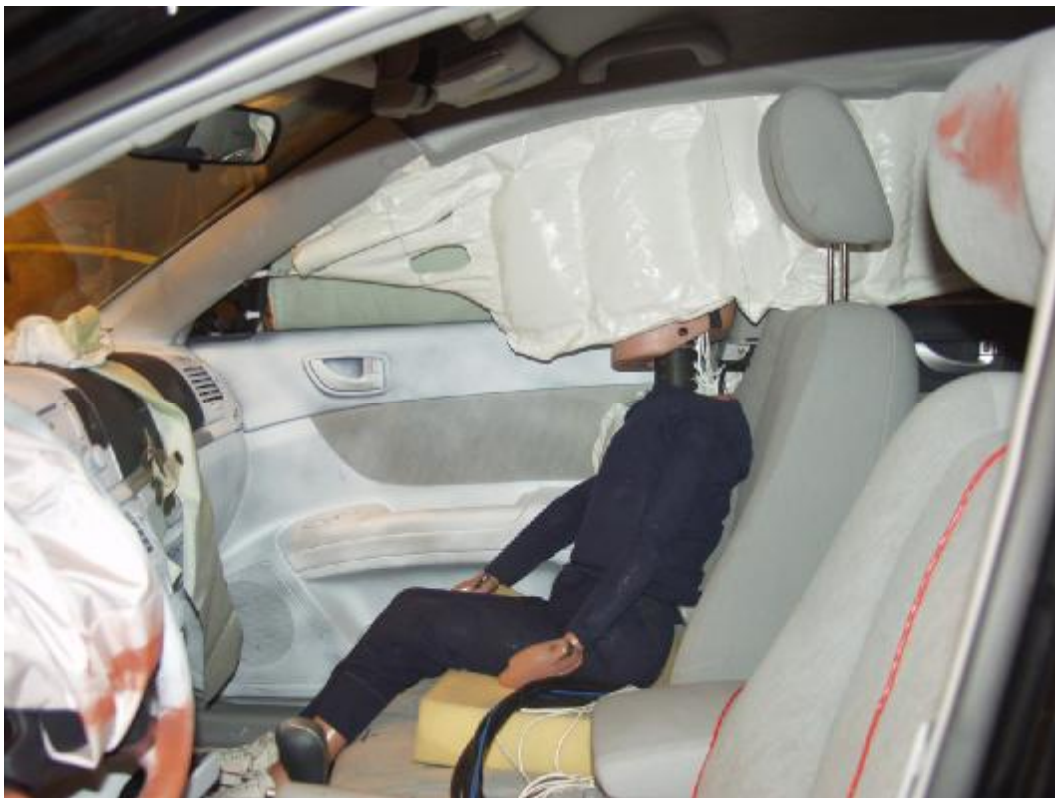
Figure A-8: Post-Test Left Side of Dummy View

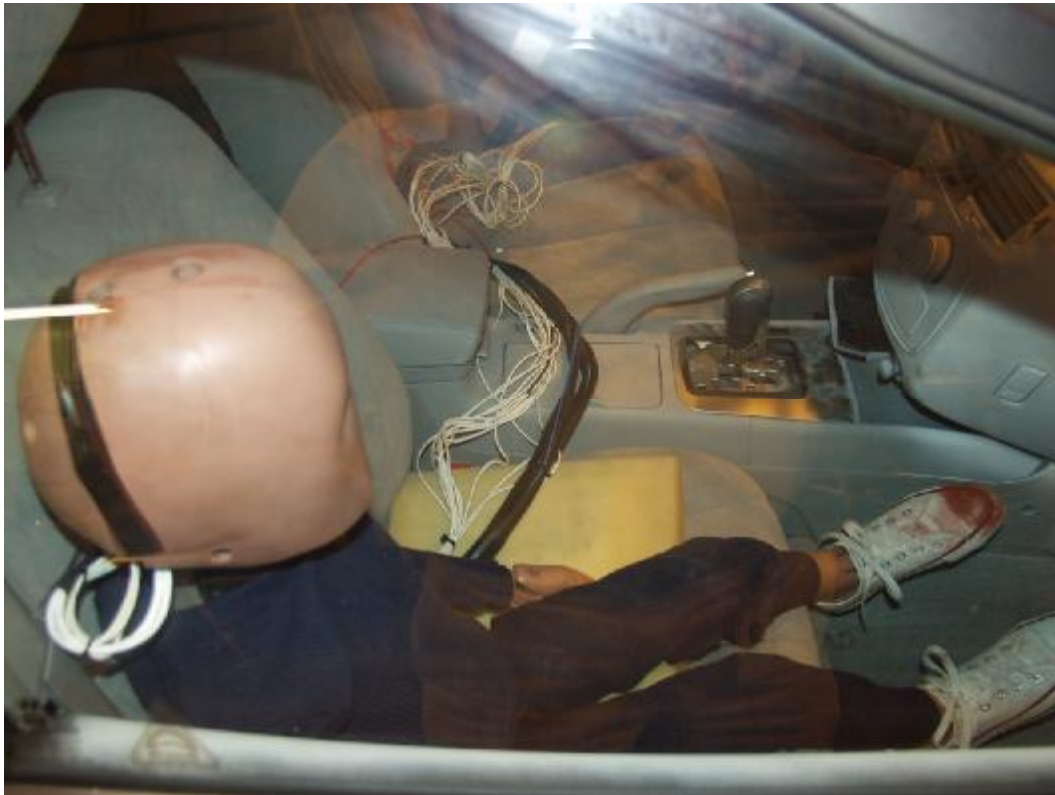
Figure A-9: Pre-Test Right Side of Dummy View

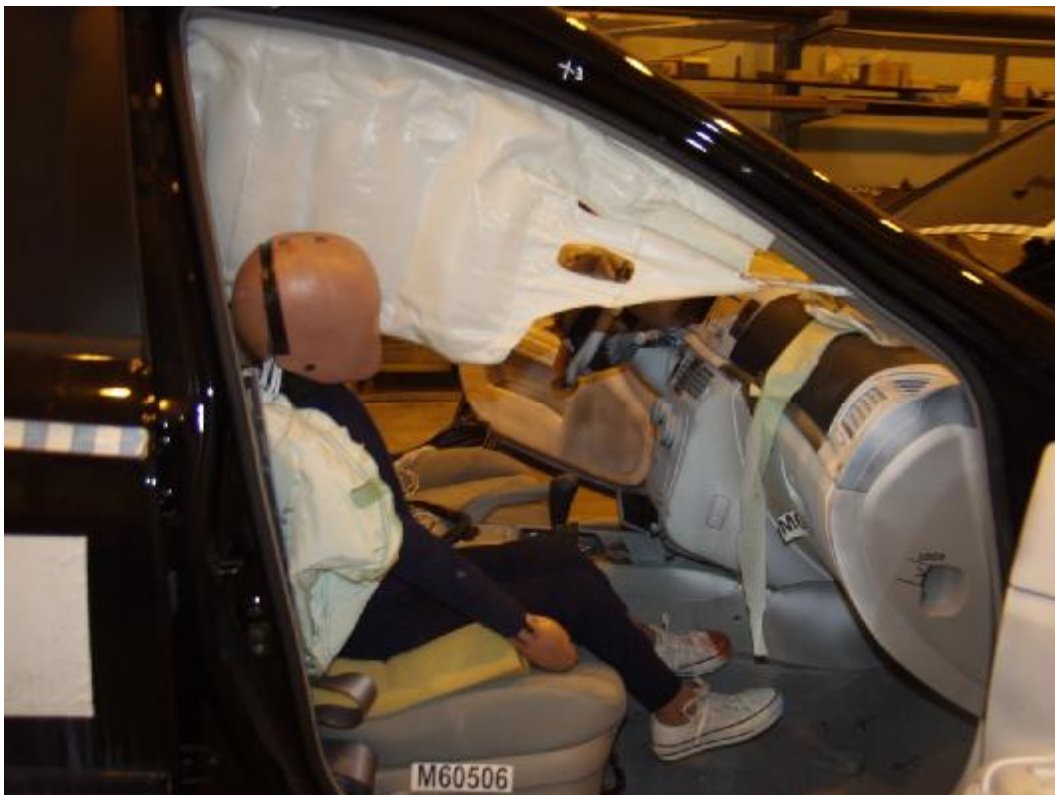
Figure A-10: Post-Test Right Side of Dummy View
