**DTS-TRC-06-005**

**40% Offset Vehicle to Deformable**

**Barrier Crash Test**

**2006 Mitsubishi Galant DE 4-door sedan**

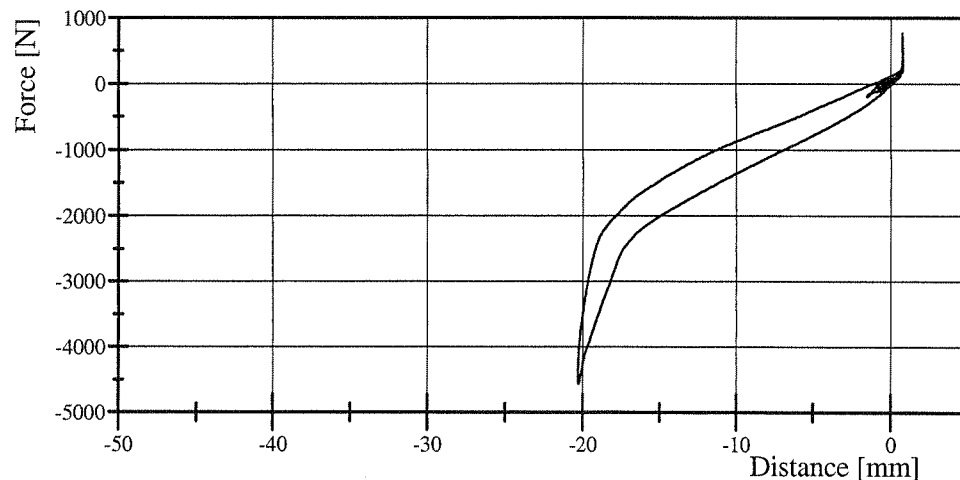
Date: 06/30/2006  
Time: 18:05

Filter Class: CFC\_600  
Max: 763.5 N at 0.7 mm  
Min: -4,563.1 N at -20.3 mm
