REPORT NUMBER: CAL-07-01

**NEW CAR ASSESSMENT PROGRAM (NCAP)  
FRONTAL BARRIER IMPACT TEST**

MAZDA MOTOR CORPORATION  
2007 MAZDA CX-7  
MPV

CALSPAN TEST NUMBER: 8642-NCAP-78

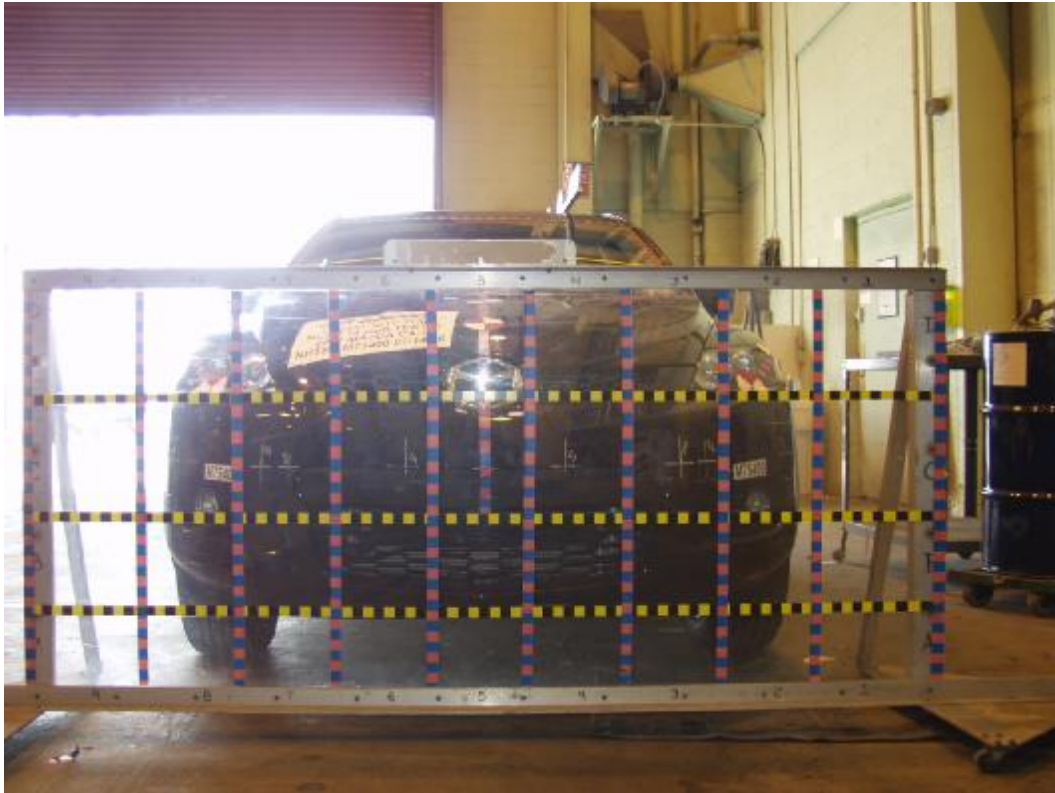
**Figure A-1: Load Cell Locations**

A load cell barrier consisting of 36 load cells was impacted by a 2007 Mazda CX-7 MPV at a velocity of 56.65 kph. The test was performed at Calspan on July 14, 2006. Pre- and post-test photographs of the vehicle and dummies can be found in Appendix A.

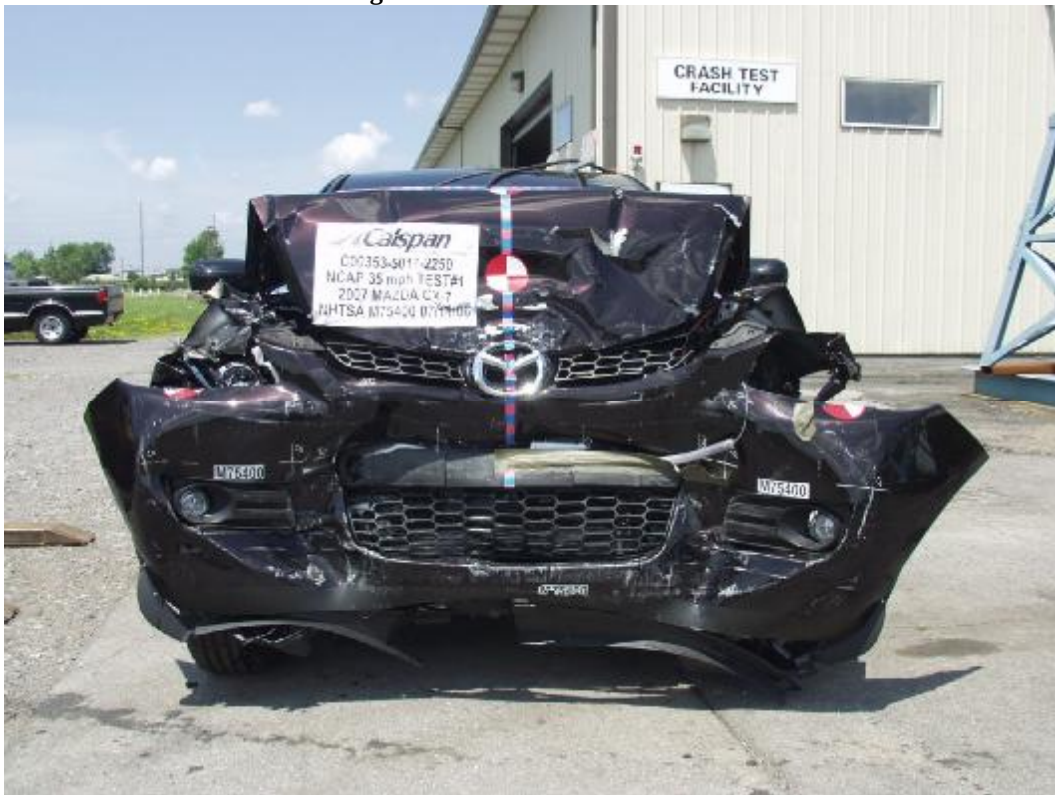
**Figure A-7: Post-Test Front View**

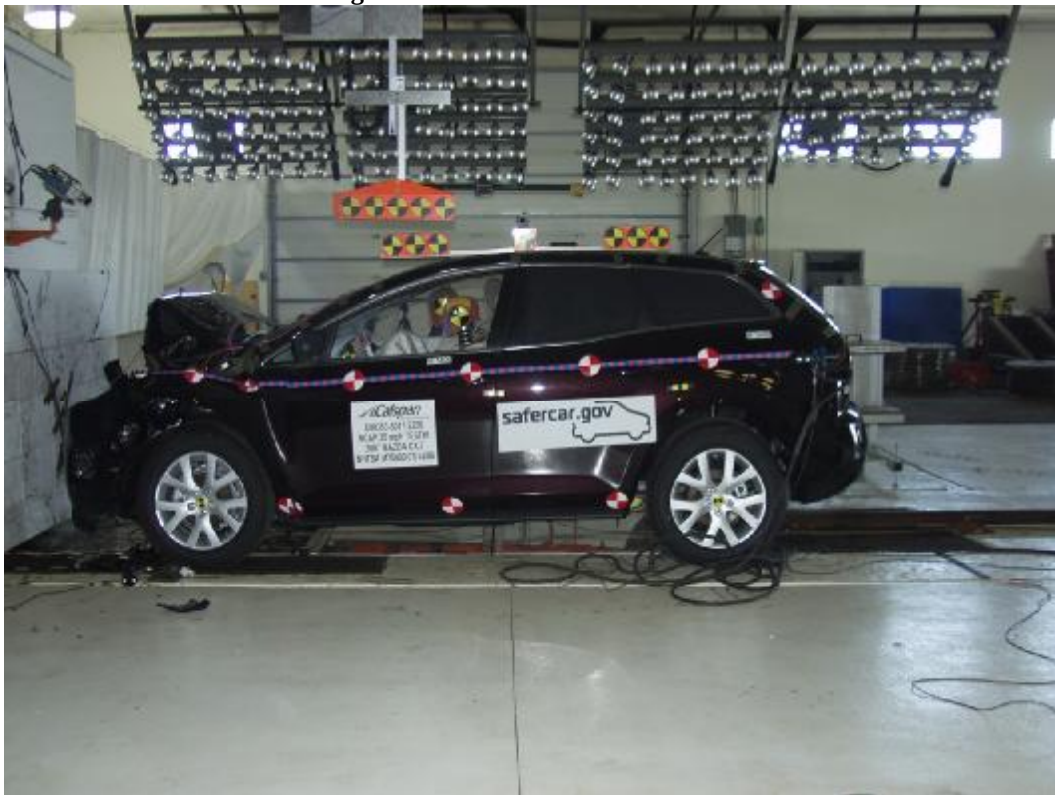
**Figure A-9: Post-Test Left Side View**

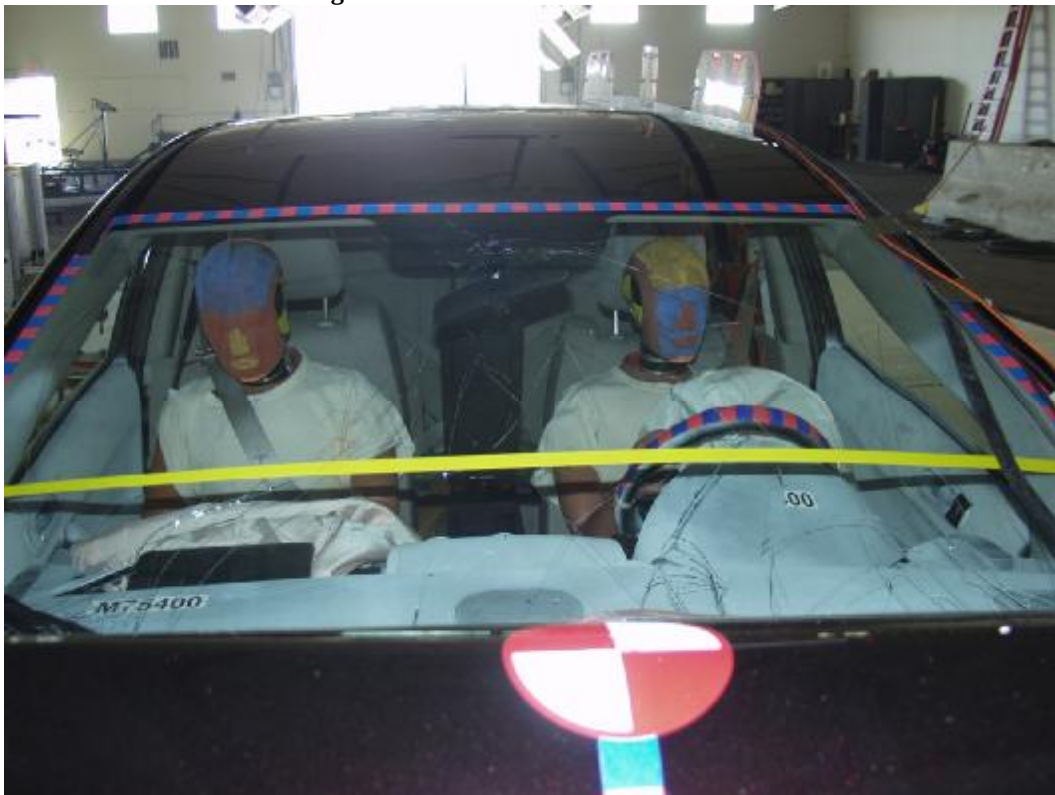
Figure A-19: Post-Test Windshield View

| Description | Driver Side | Passenger Side |
|---|---|---|
| Glazing Damage | The windshield crack from the passenger airbag deployment | |

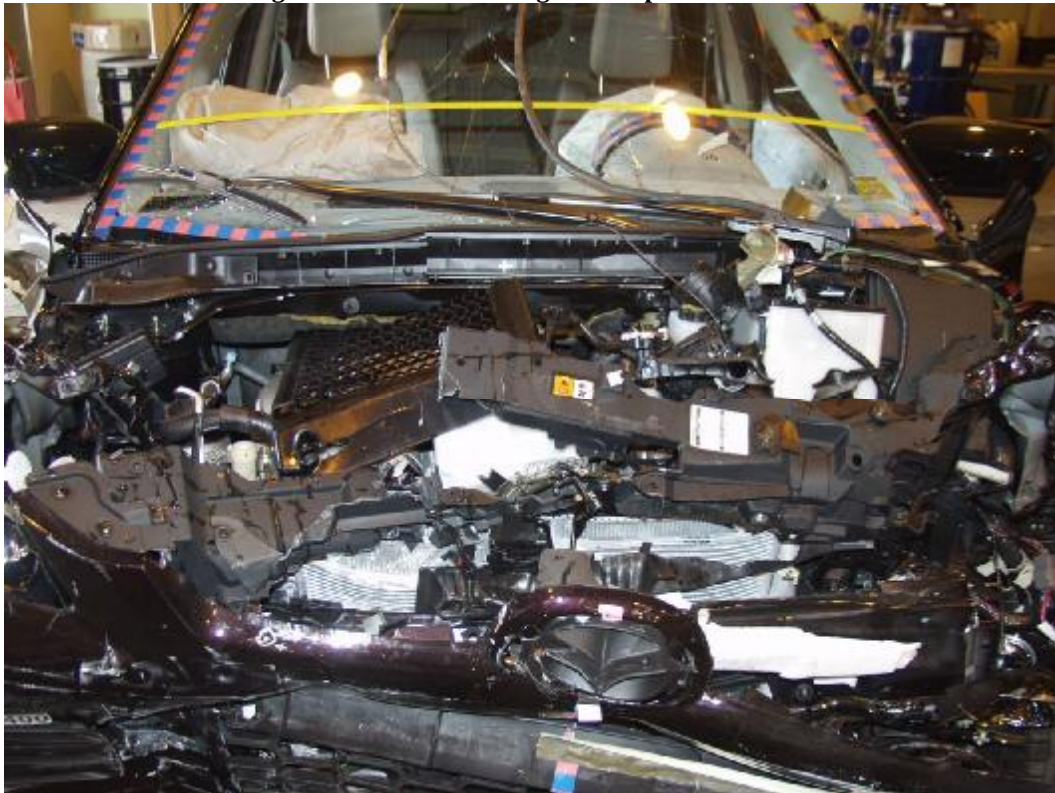
**Figure A-21: Post-Test Engine Compartment View**

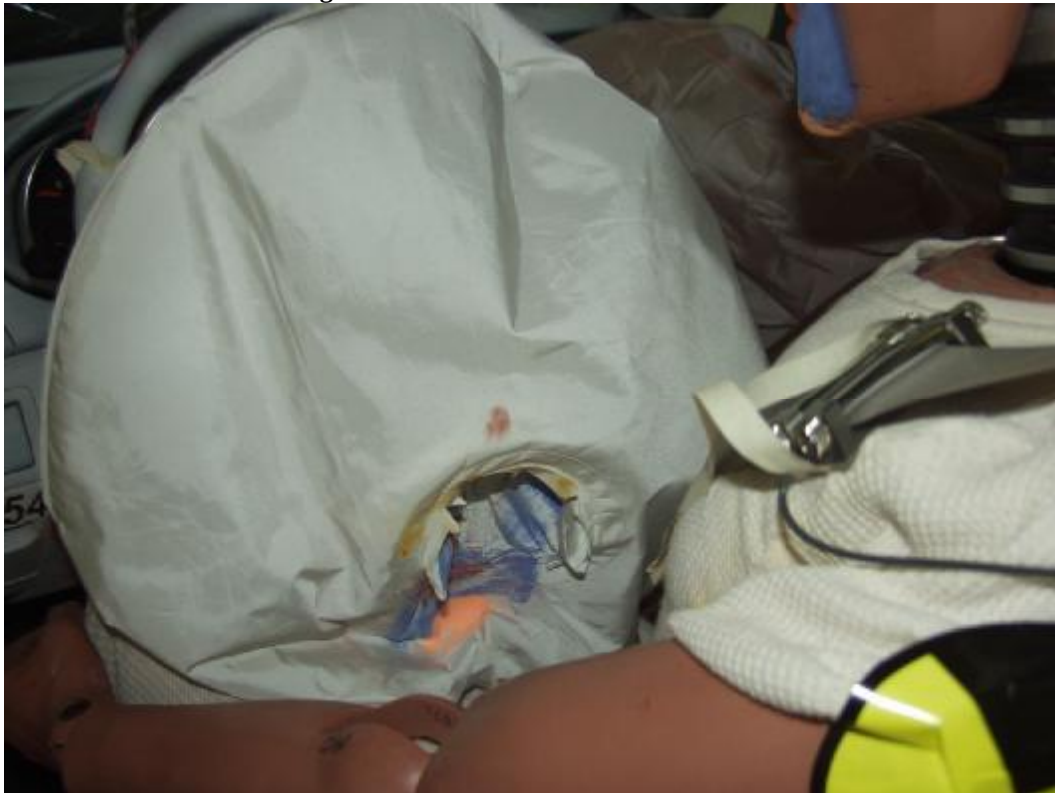
**Figure A-43: Post-Test Driver Contact to Airbag**

| | DRIVER | PASSENGER |
|---|---|---|
| Head Contact: | The face to the center of the airbag, the top of the head to the sunvisor and the back of the head to the center of the head restraint | The face to the center of the airbag, the top of the head to the sunvisor and the back of the head to the center of the head restraint |

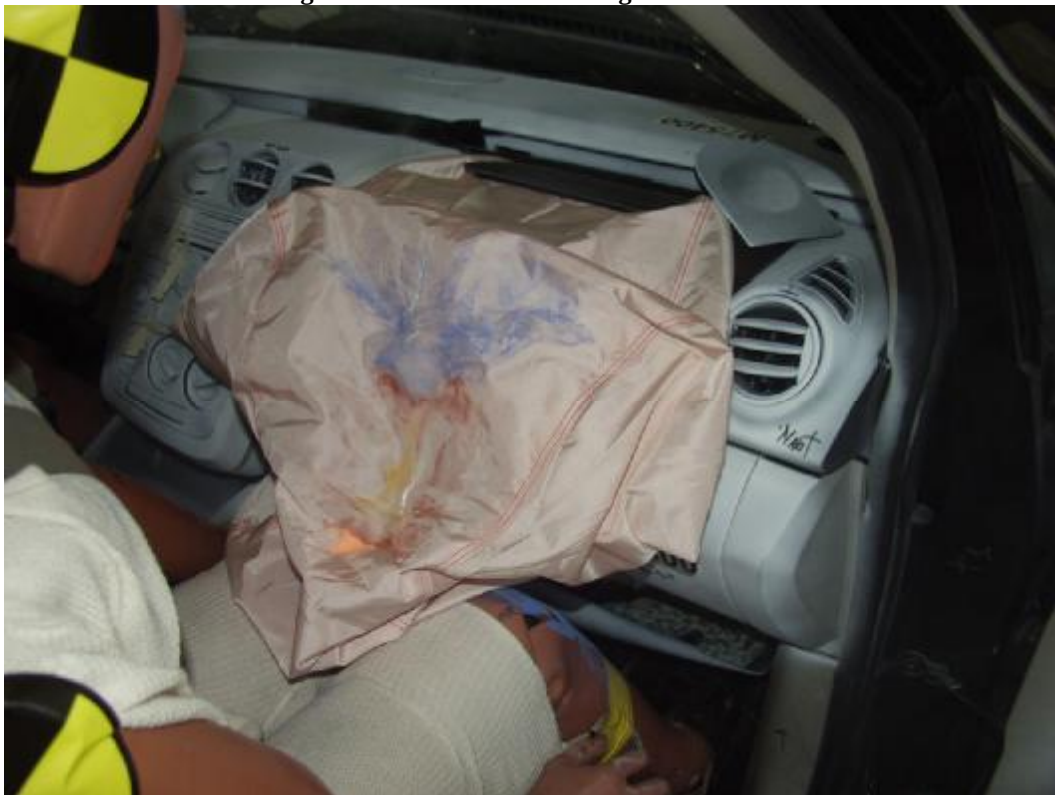
**Figure A-57: Post-Test Passenger Contact to Airbag**
