**REPORT NUMBER TR-P26002-06-NC**

**SIDE AIRBAG OCCUPANT RISK PROGRAM  
OCCUPANT OUT-OF-POSITION TESTS**

**HYUNDAI MOTOR COMPANY  
2005 HYUNDAI TUCSON  
5-DOOR MPV**

**NHTSA NUMBER: M50508TWG2**

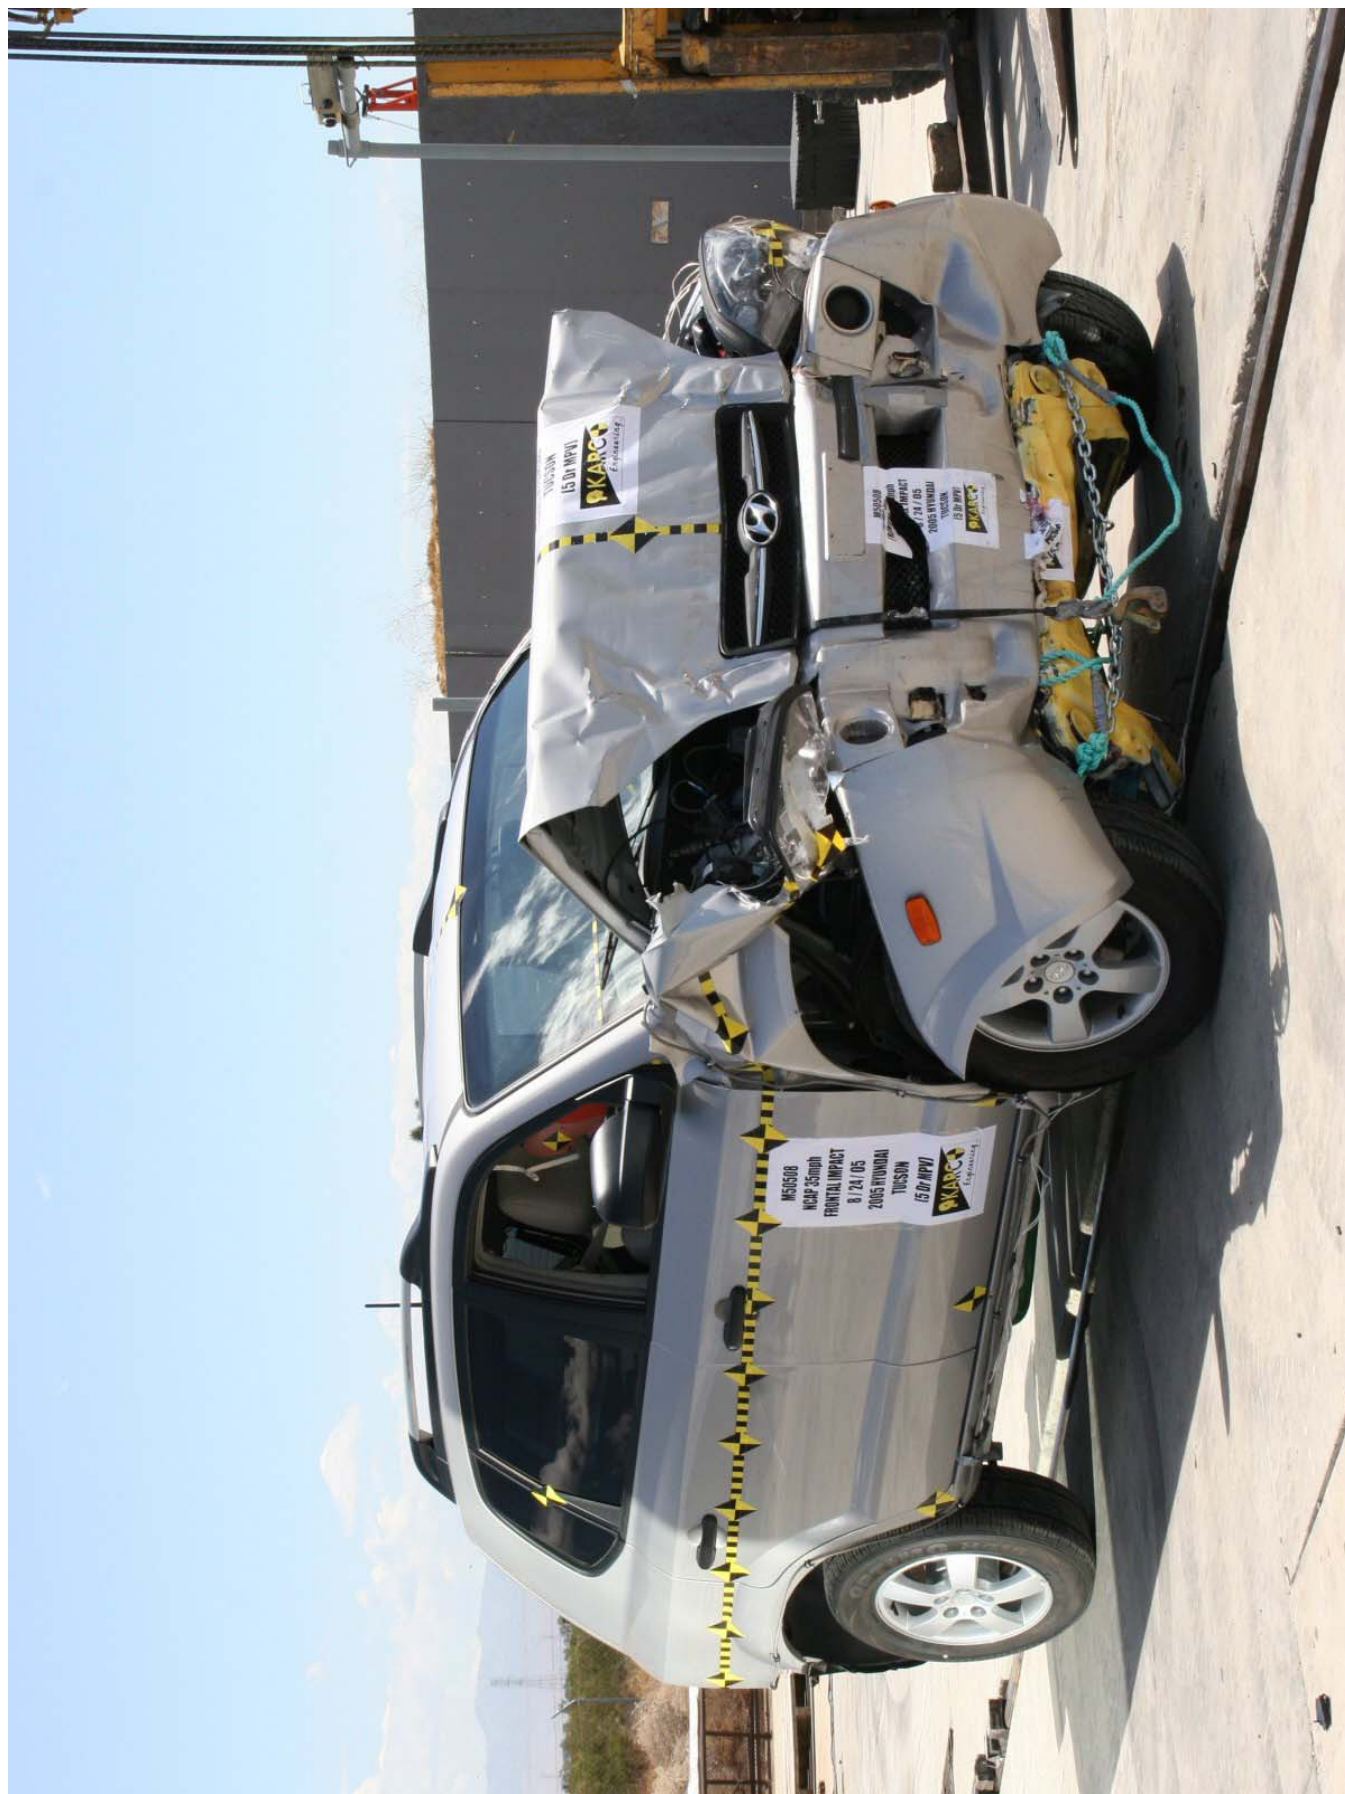
Figure A-3: Post-Test Right Front  $\frac{3}{4}$  View of Frontal NCAP Test

\* Vehicle had undergone New Car Assessment Program Frontal Impact Testing on August 24, 2005

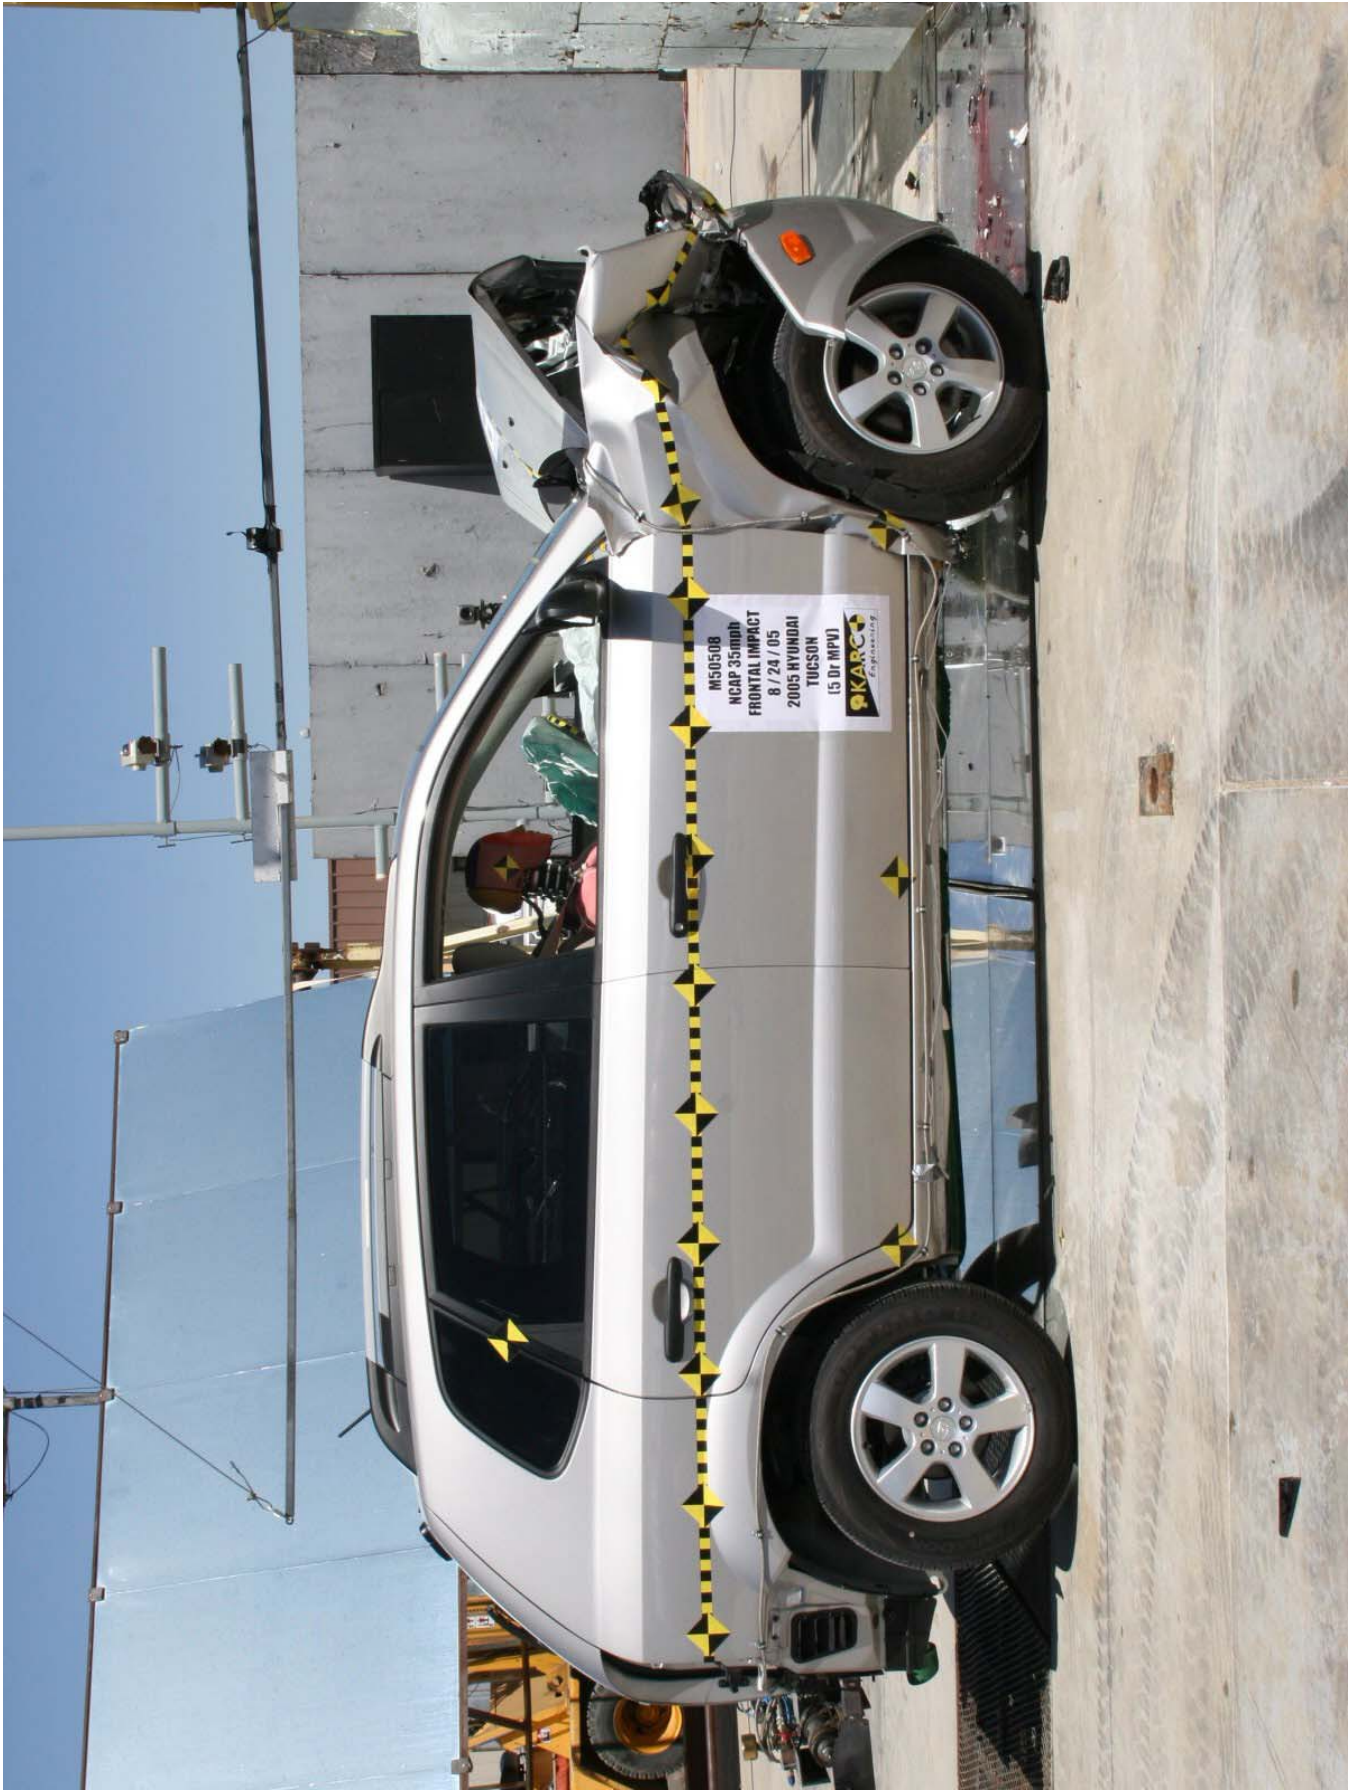
Figure A-4: Post-Test Right Side View of Frontal NCAP Test

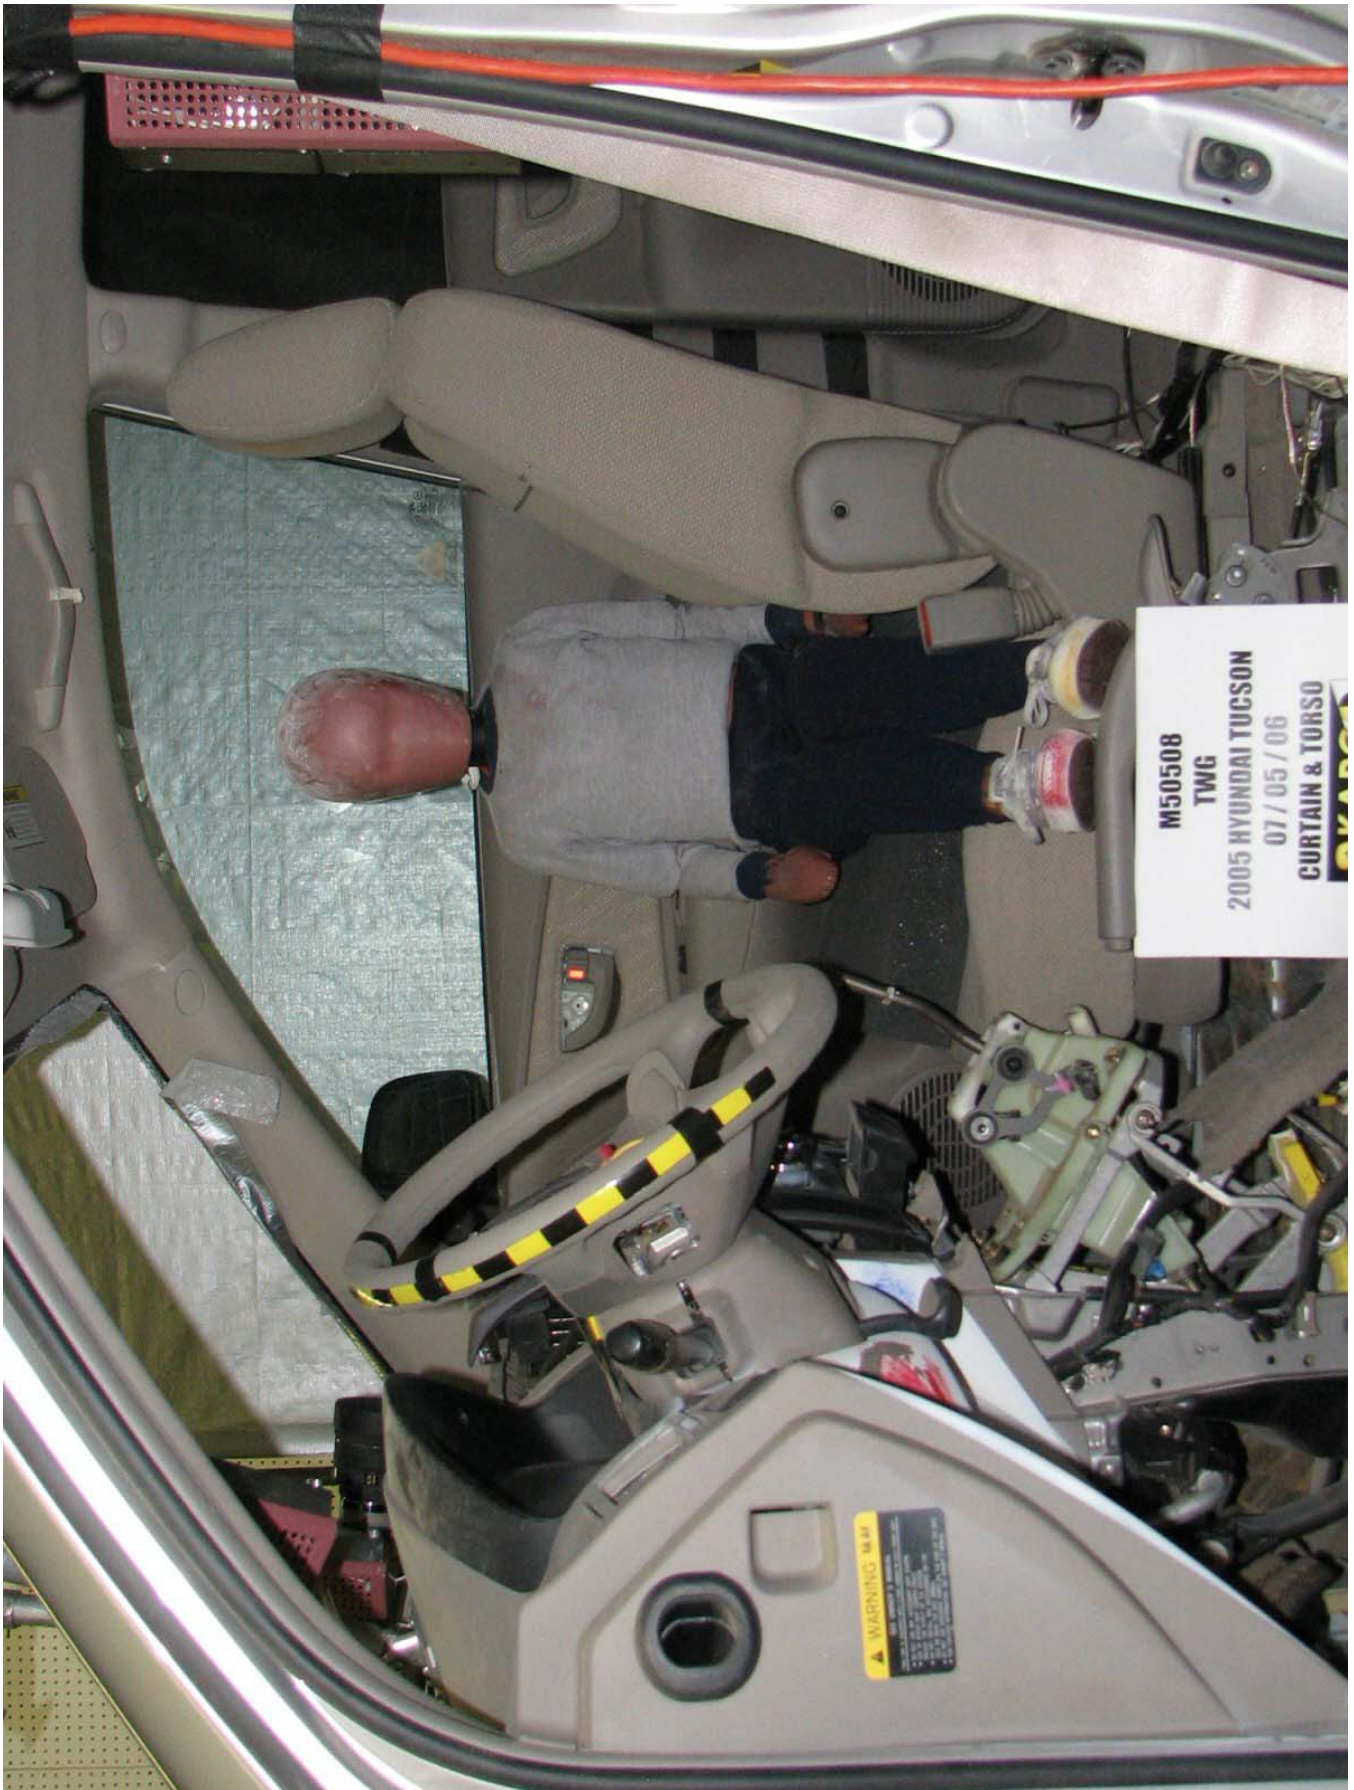
Figure A-5: Pre-Test Dummy Position, Left Side View

Orientation of the Hybrid III 6 Year-old Child Dummy was in the inboard facing position leaning against the front passenger door. The dummy's spine was aligned with the deploying trajectory of the curtain and torso airbag. The lower legs were extended. Synthetic foam was used to raise the dummy. This orientation complies with section 3.3.5.1 of the Technical Working Group (TWG) recommendation in the Recommended Procedures for Evaluating Occupant Injury Risk from Deploying Side Airbags.

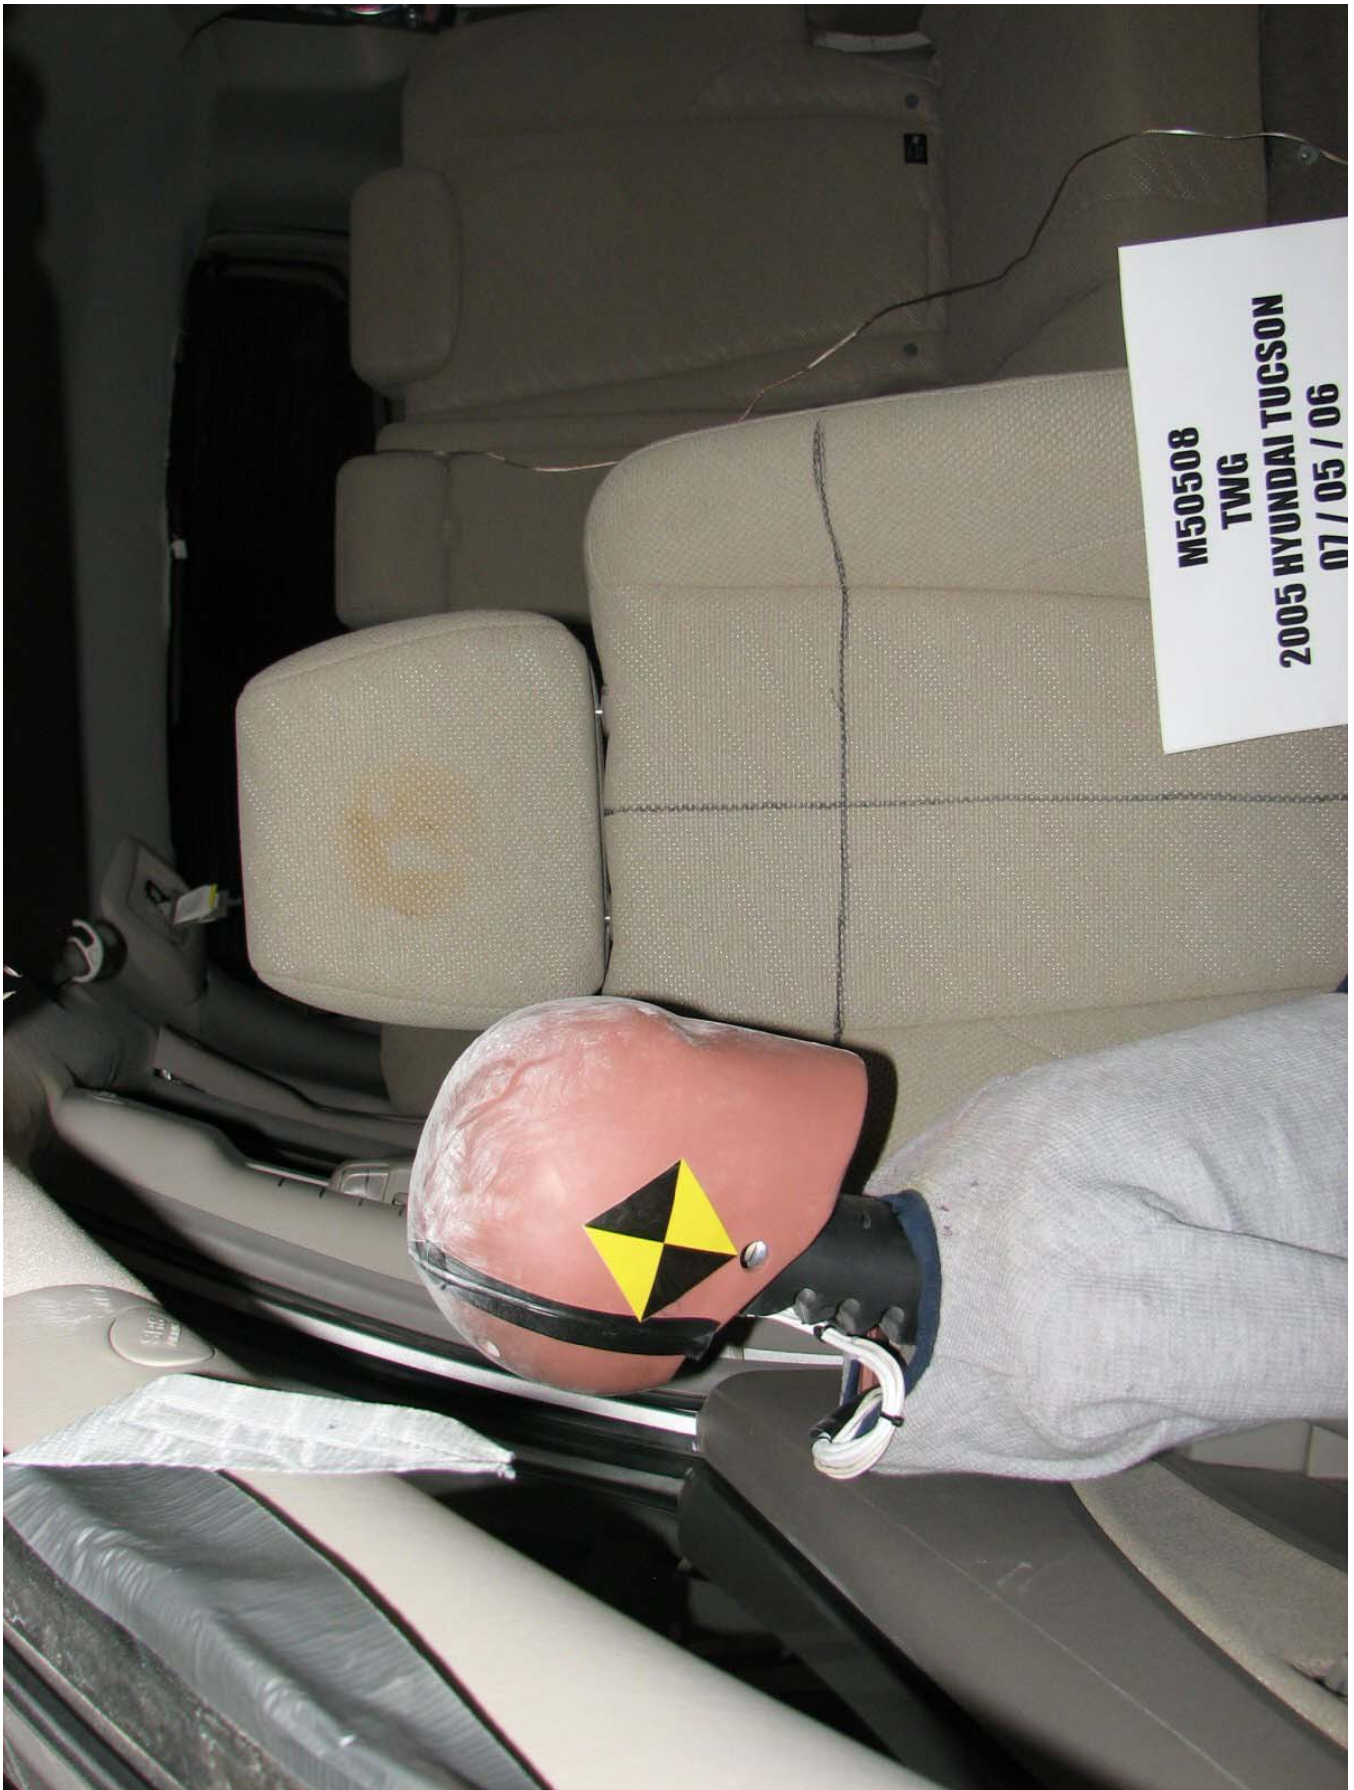
Figure A-7: Pre-Test Dummy Position, Front View

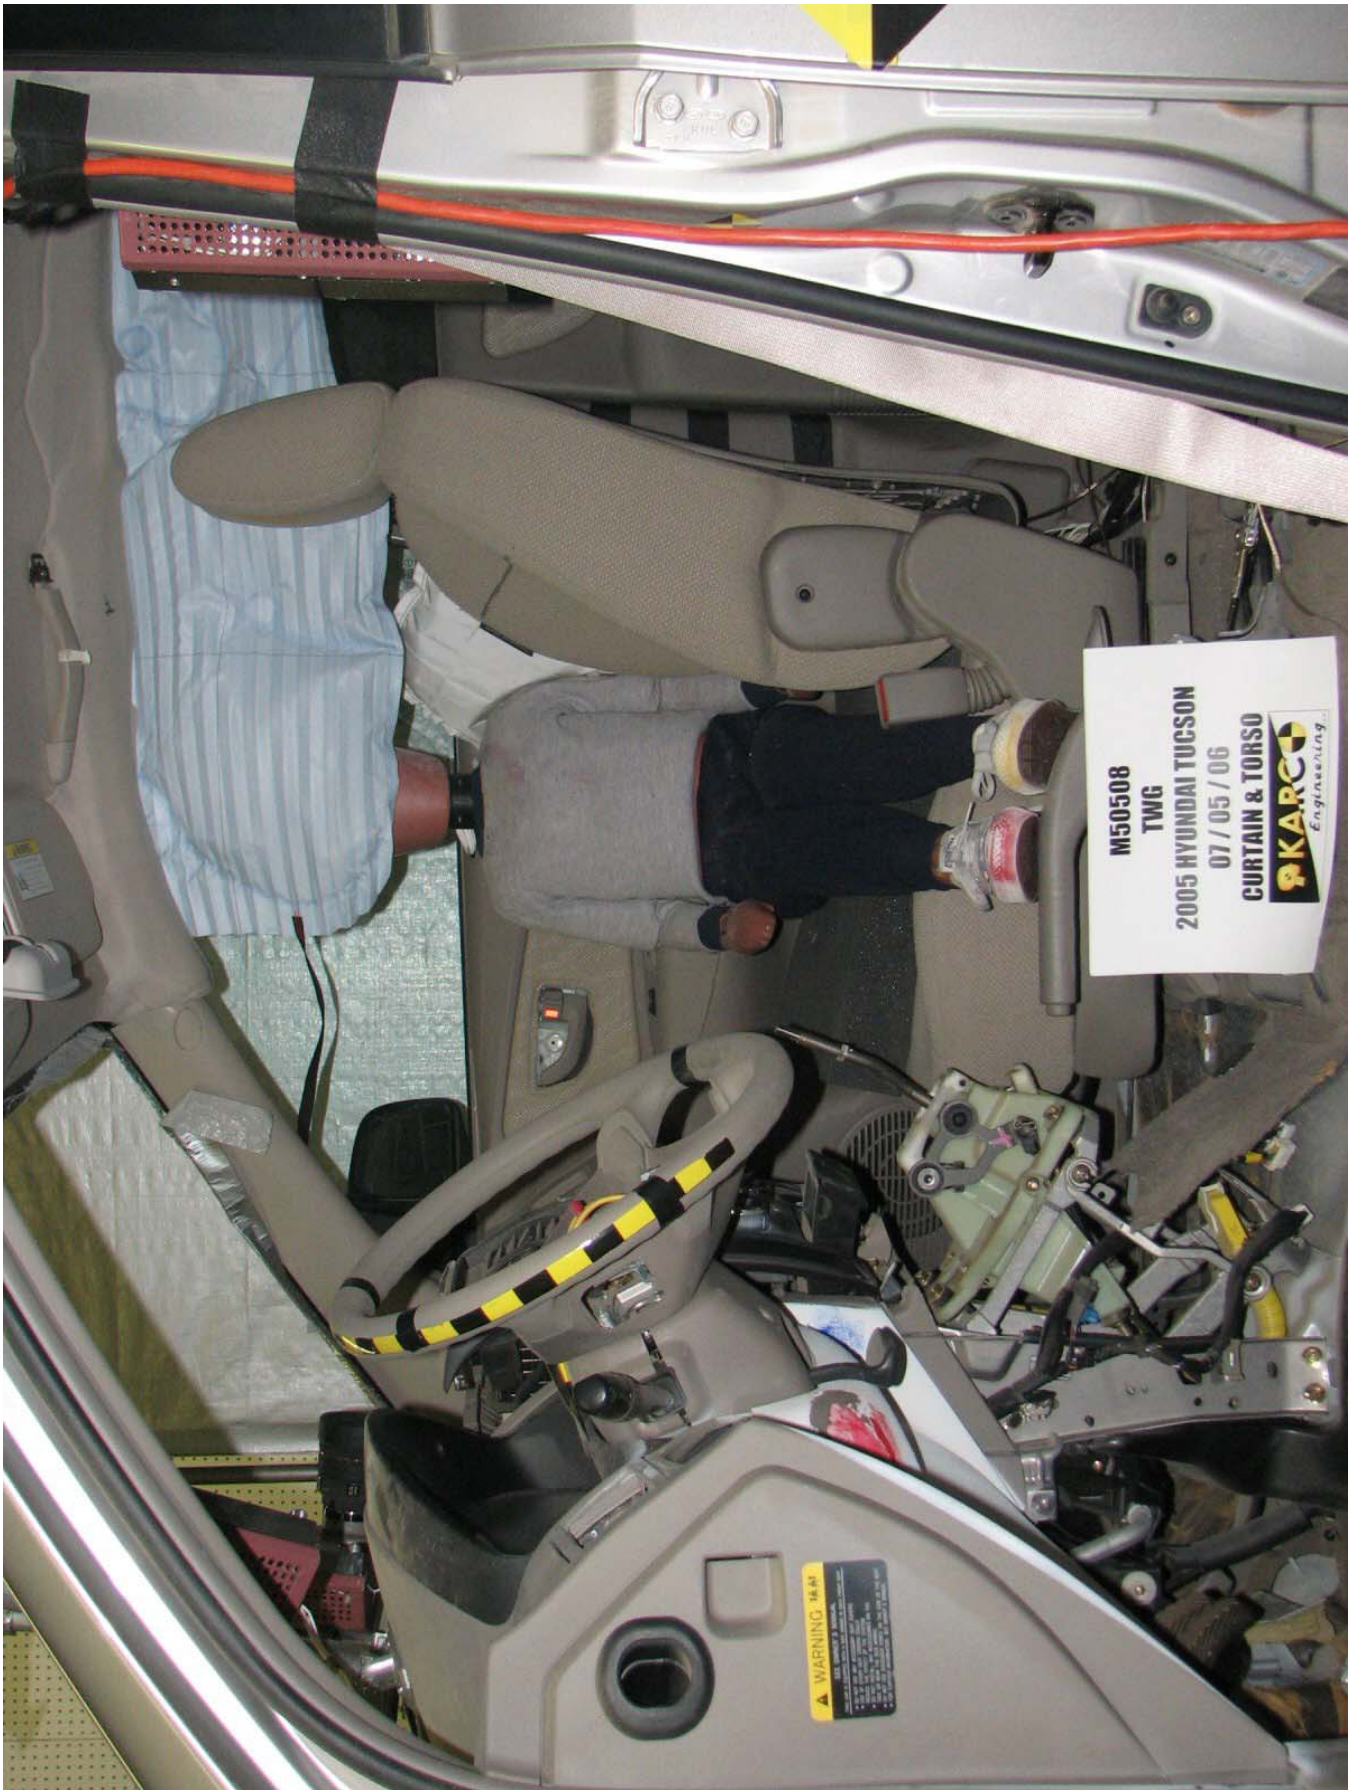
Figure A-8: Post-Test Dummy Position and Airbags, Left Side View

The Hybrid III 6-Year-Old Child Dummy's visible contact points were as follows: The curtain airbag contacted the top of the ATD's head. The torso airbag contacted the left arm and left side of the chest and abdomen.

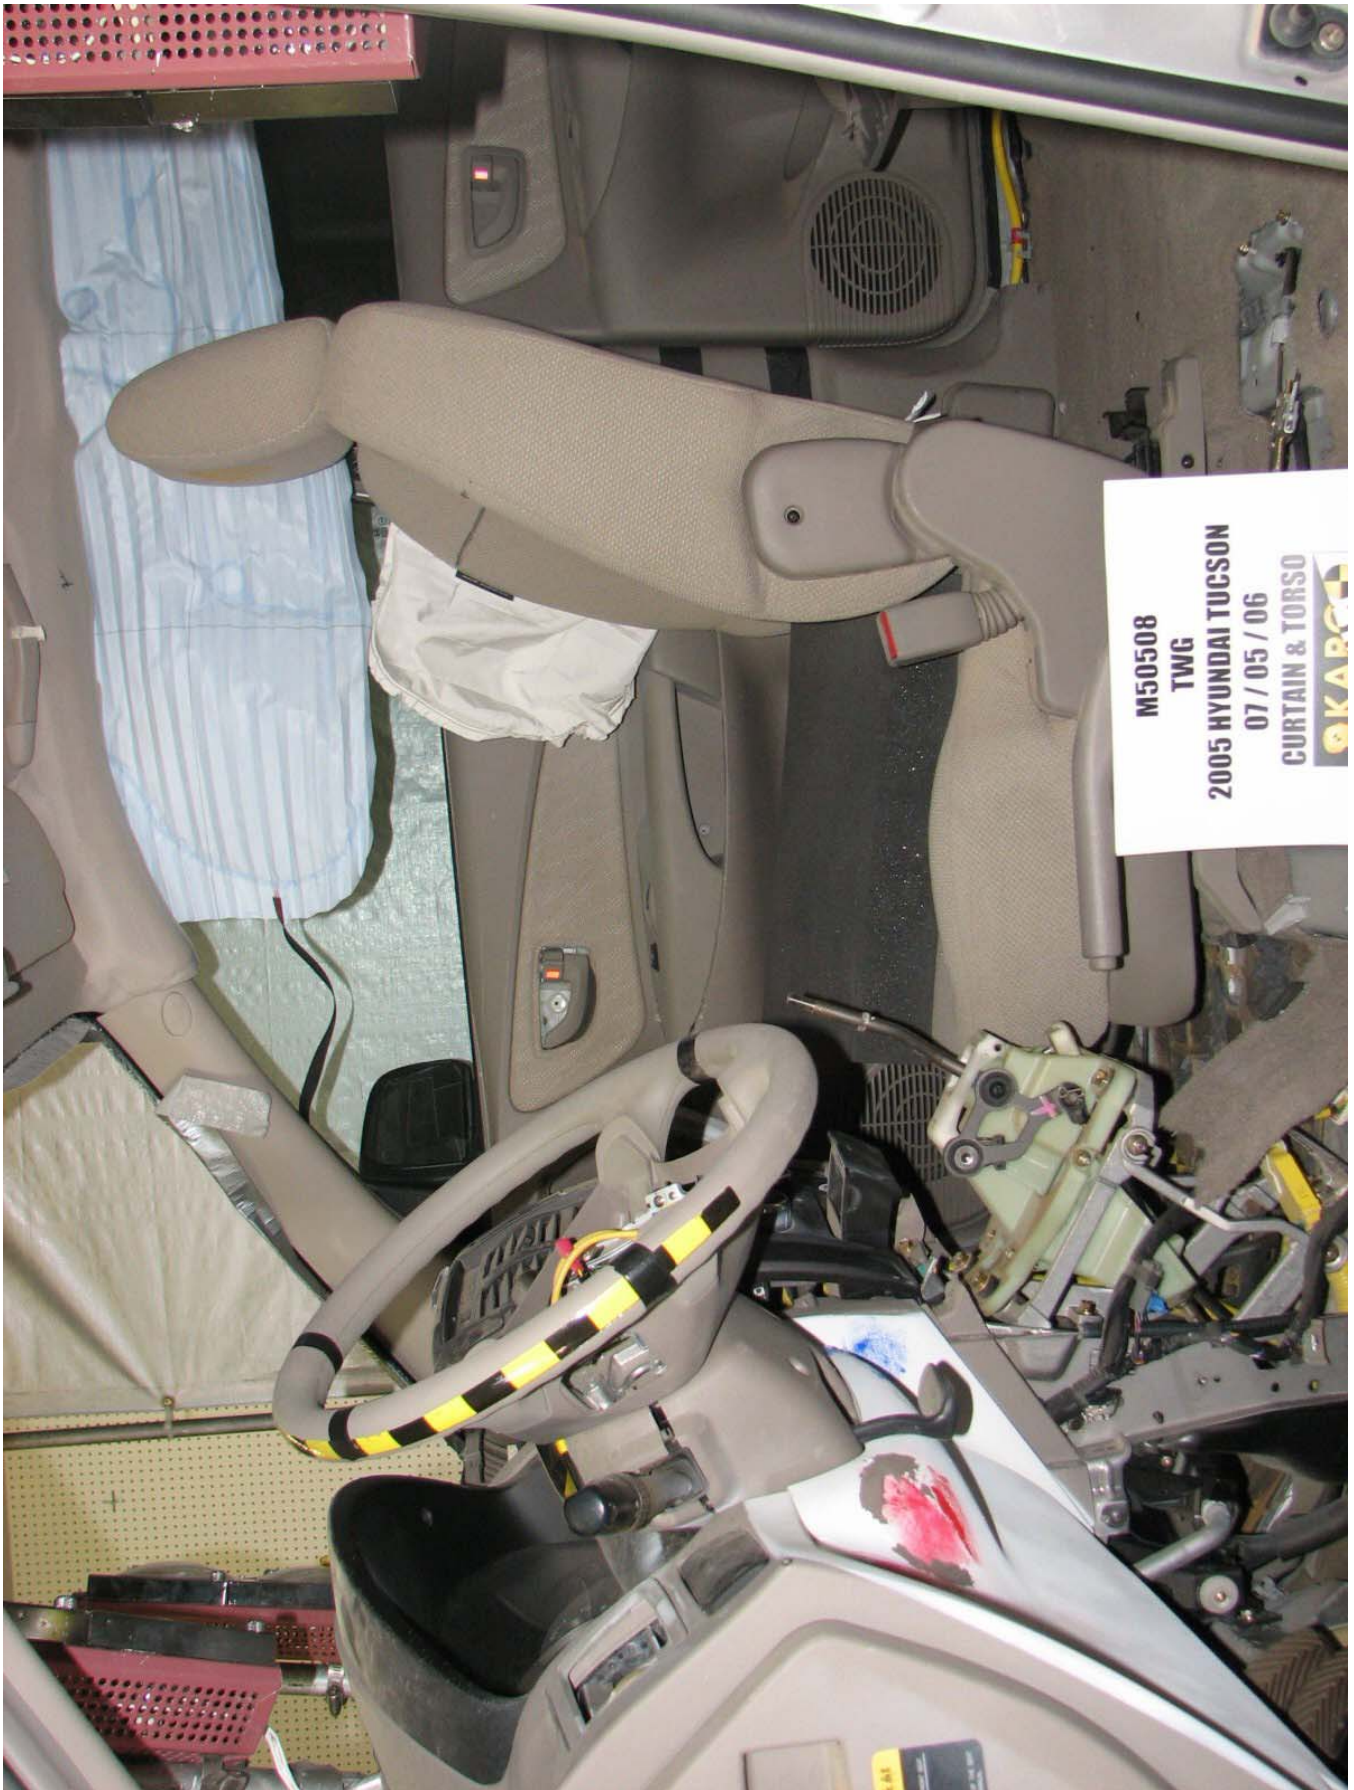
Figure A-9: Post-Test Airbags, Left Side View

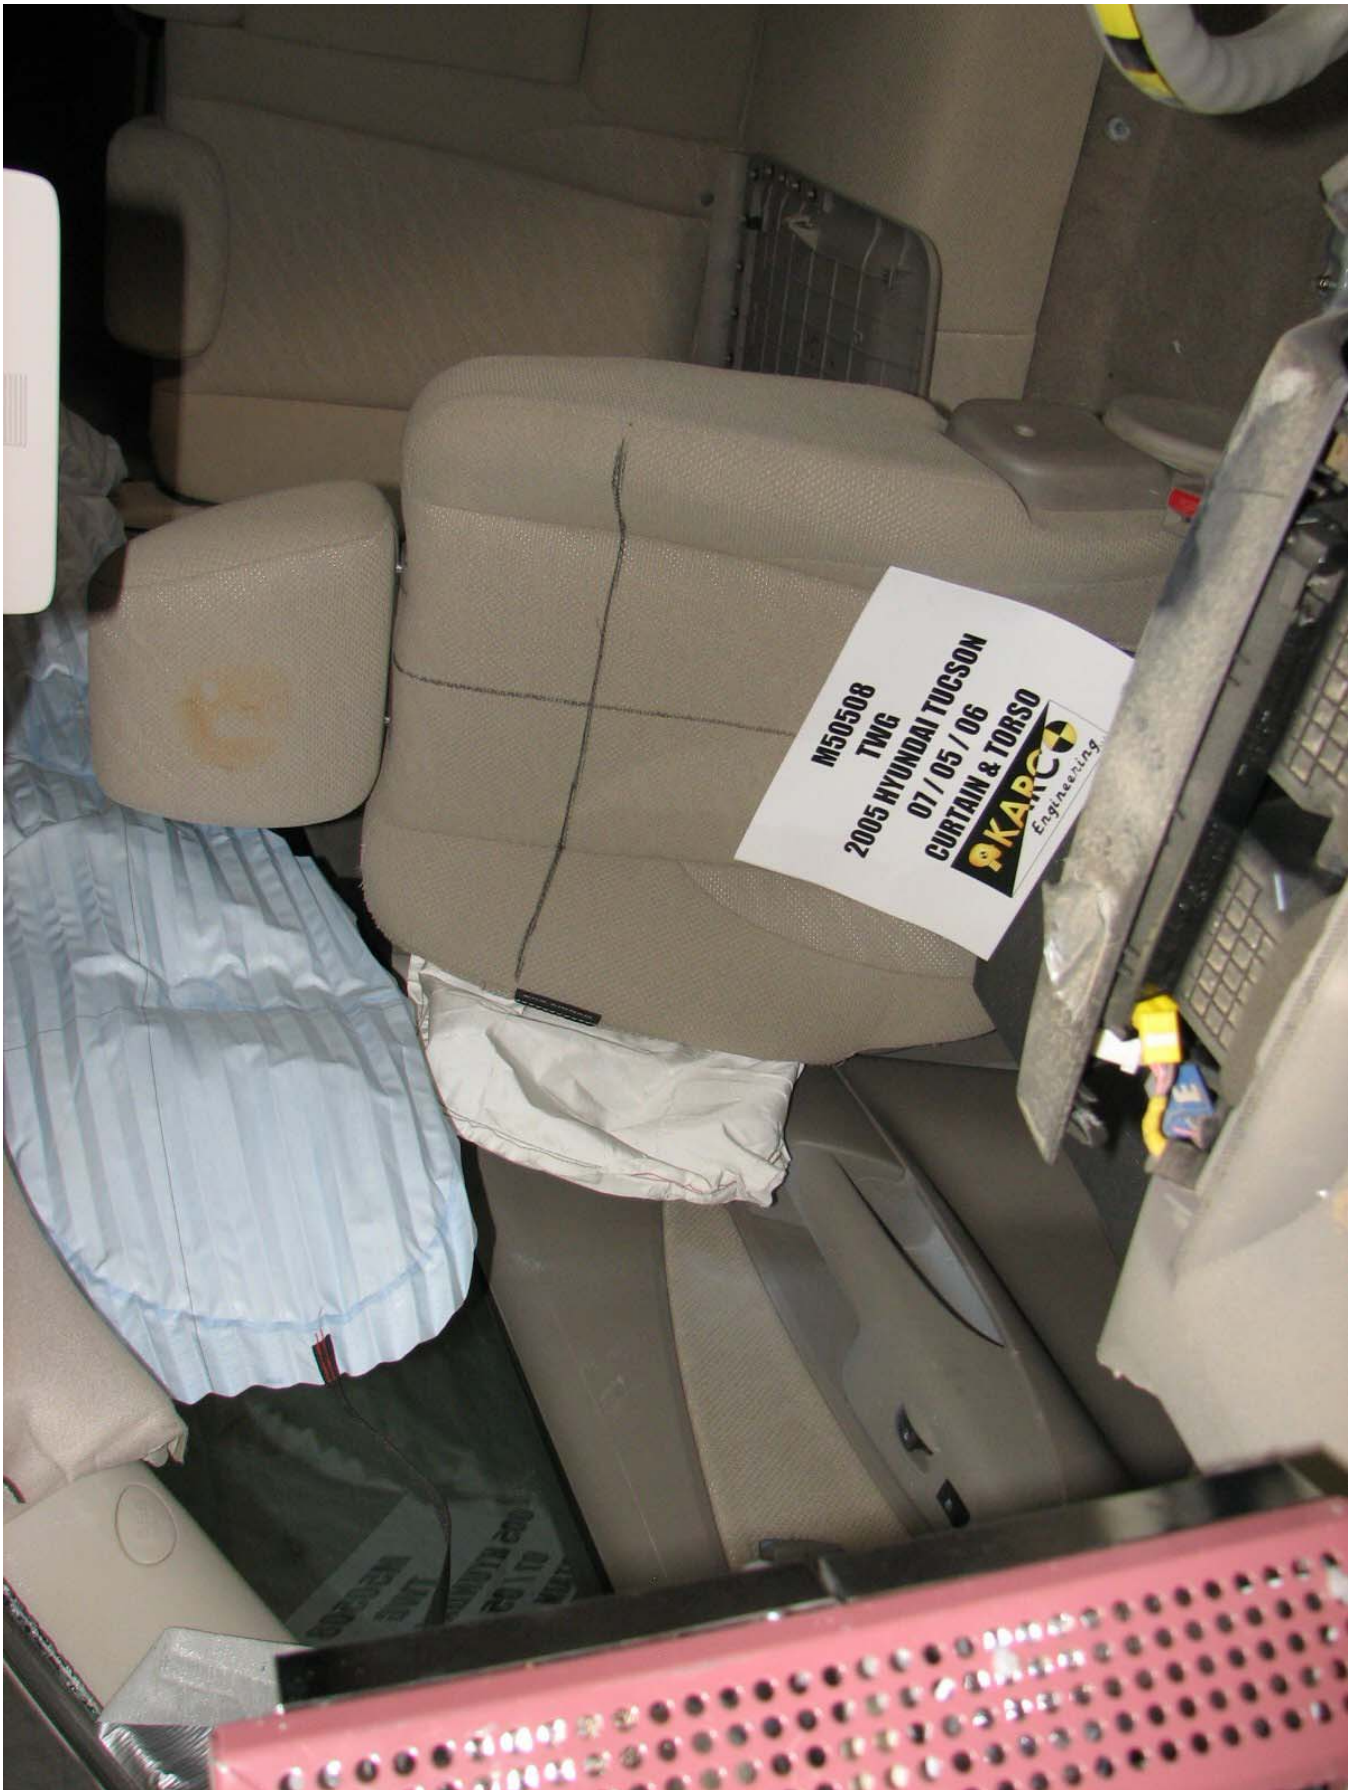
Figure A-10: Post-Test Airbags, Close-up View
