**REPORT NUMBER TR-P26002-02-NC**

**SIDE AIRBAG OCCUPANT RISK PROGRAM  
OCCUPANT OUT-OF-POSITION TESTS**

**GENERAL MOTORS CORPORATION  
2006 CHEVROLET HHR LT  
5-DOOR MPV**

**NHTSA NUMBER: M60108TWG3**

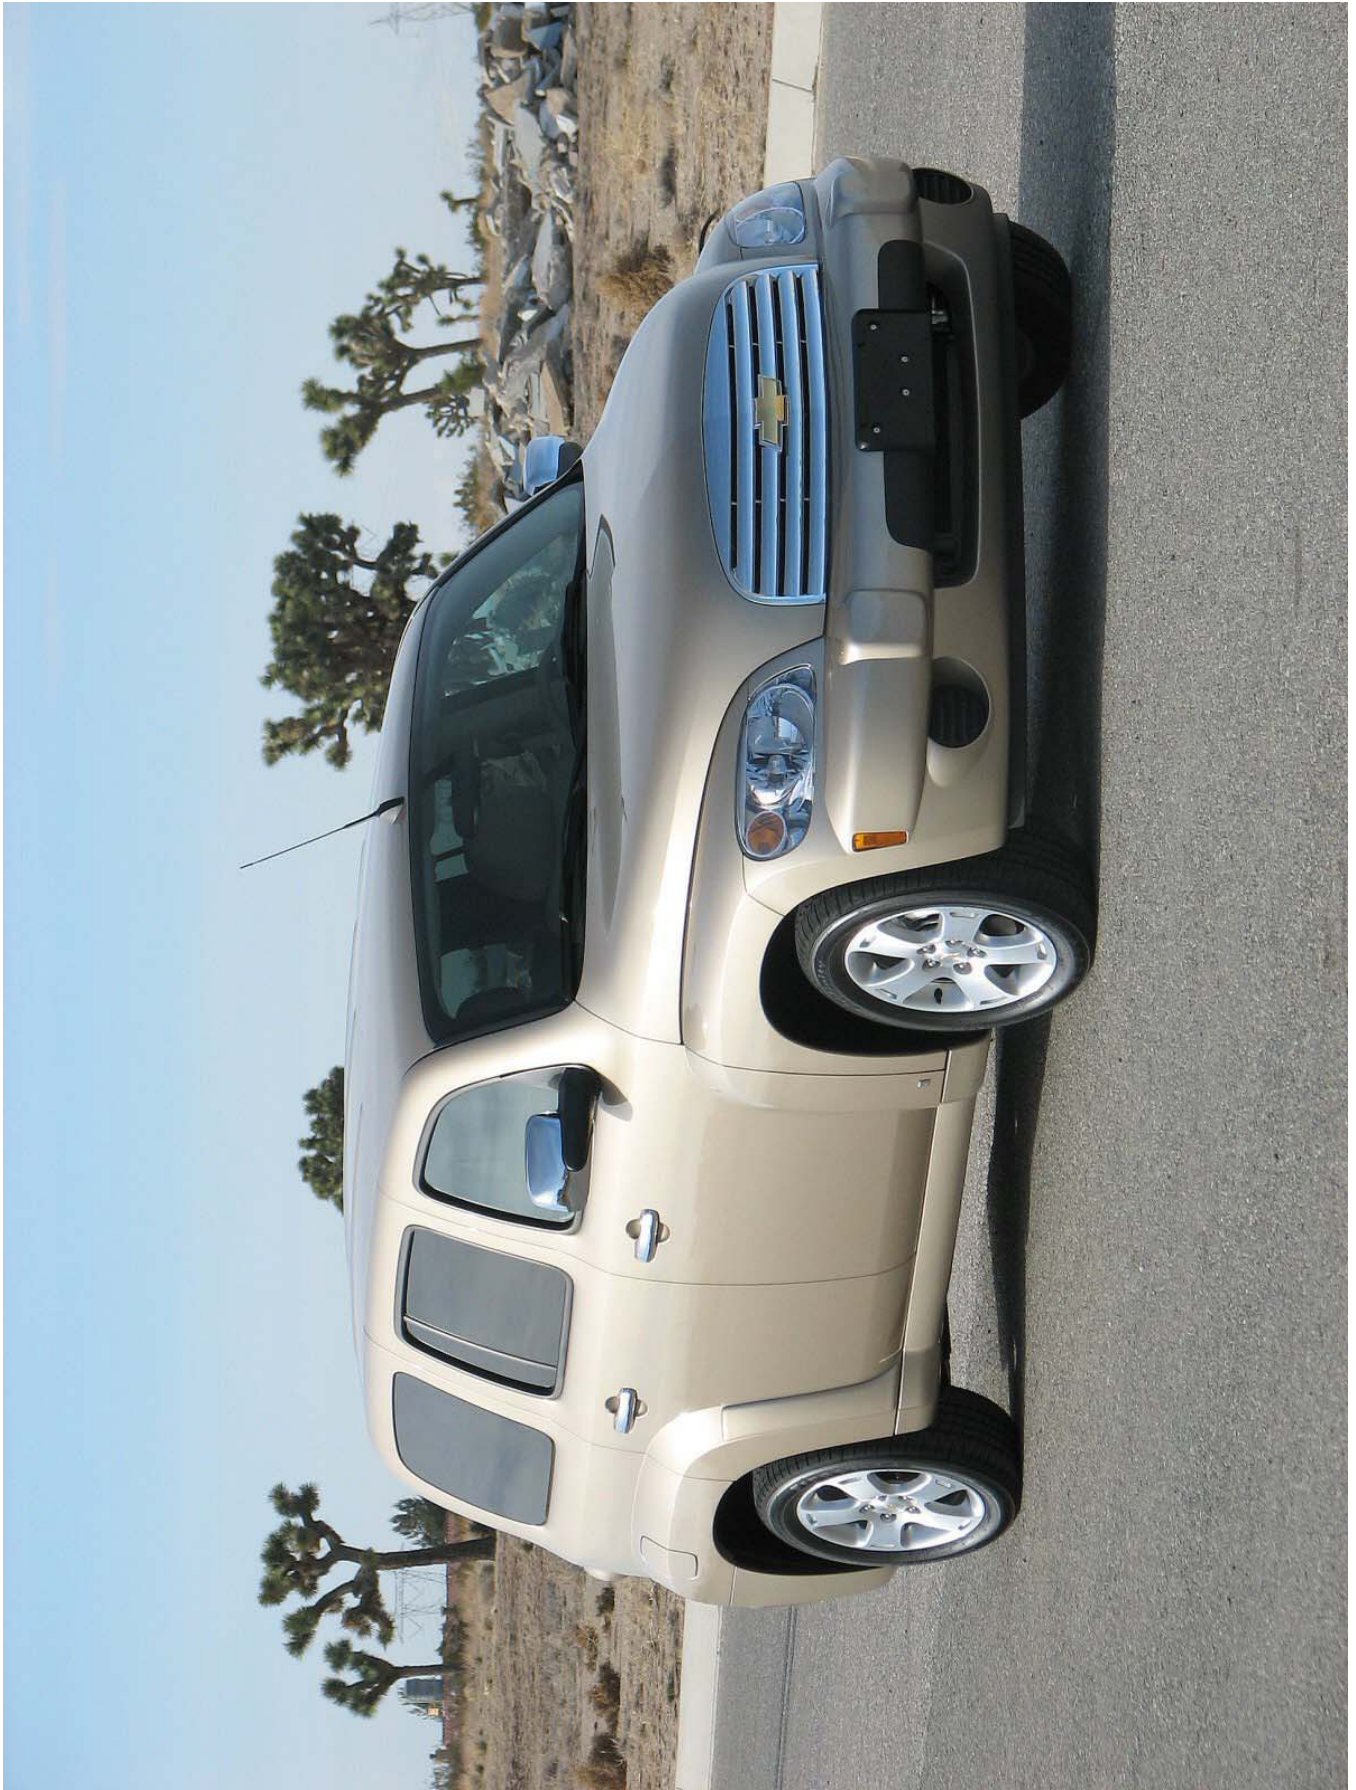
Figure A-1: Right Front  $\frac{3}{4}$  View, As Received

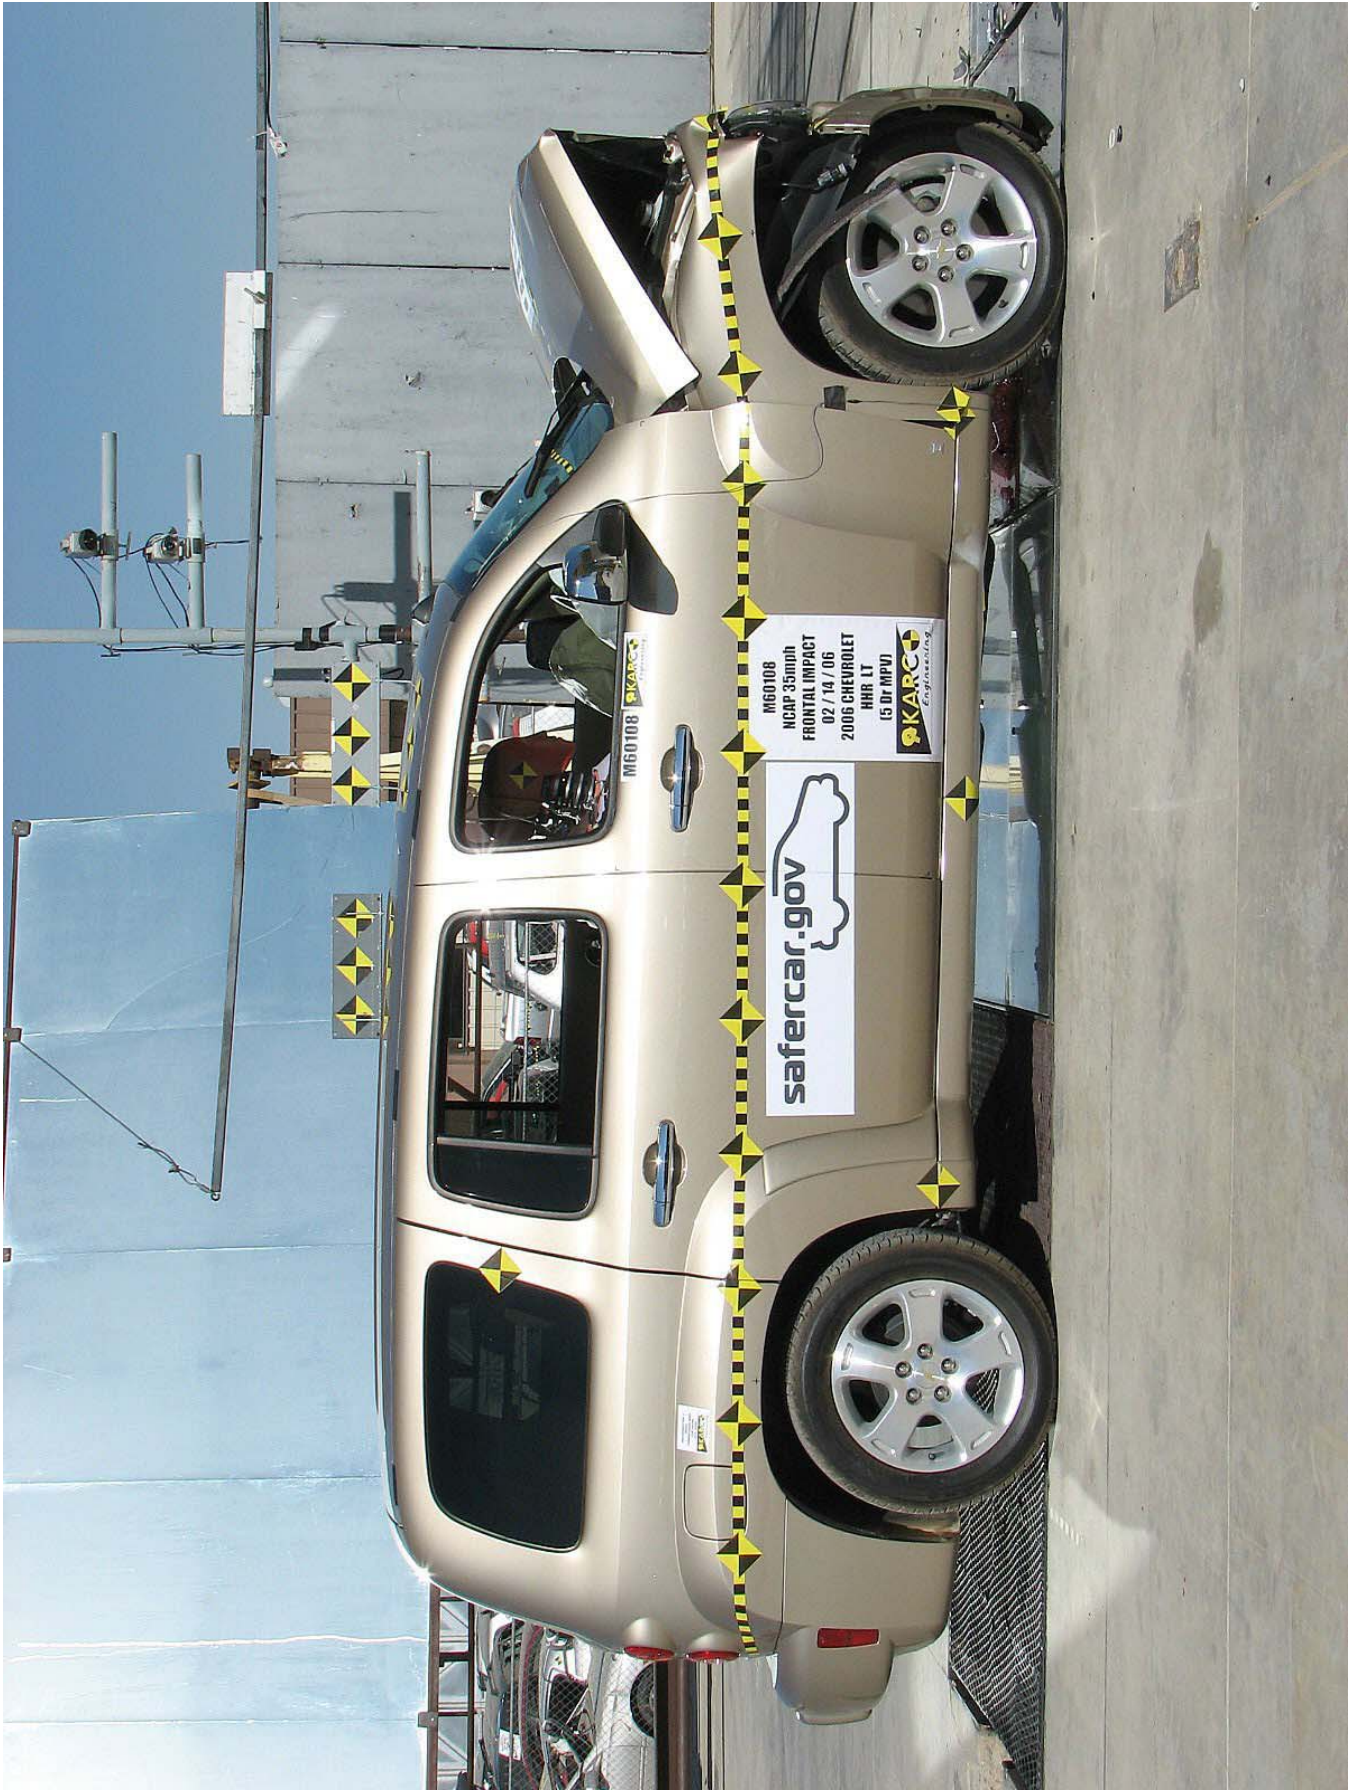
Figure A-4: Post-Test Right Side View of Frontal NCAP Test

\* Vehicle had undergone New Car Assessment Program Frontal Impact Testing on February 14, 2006

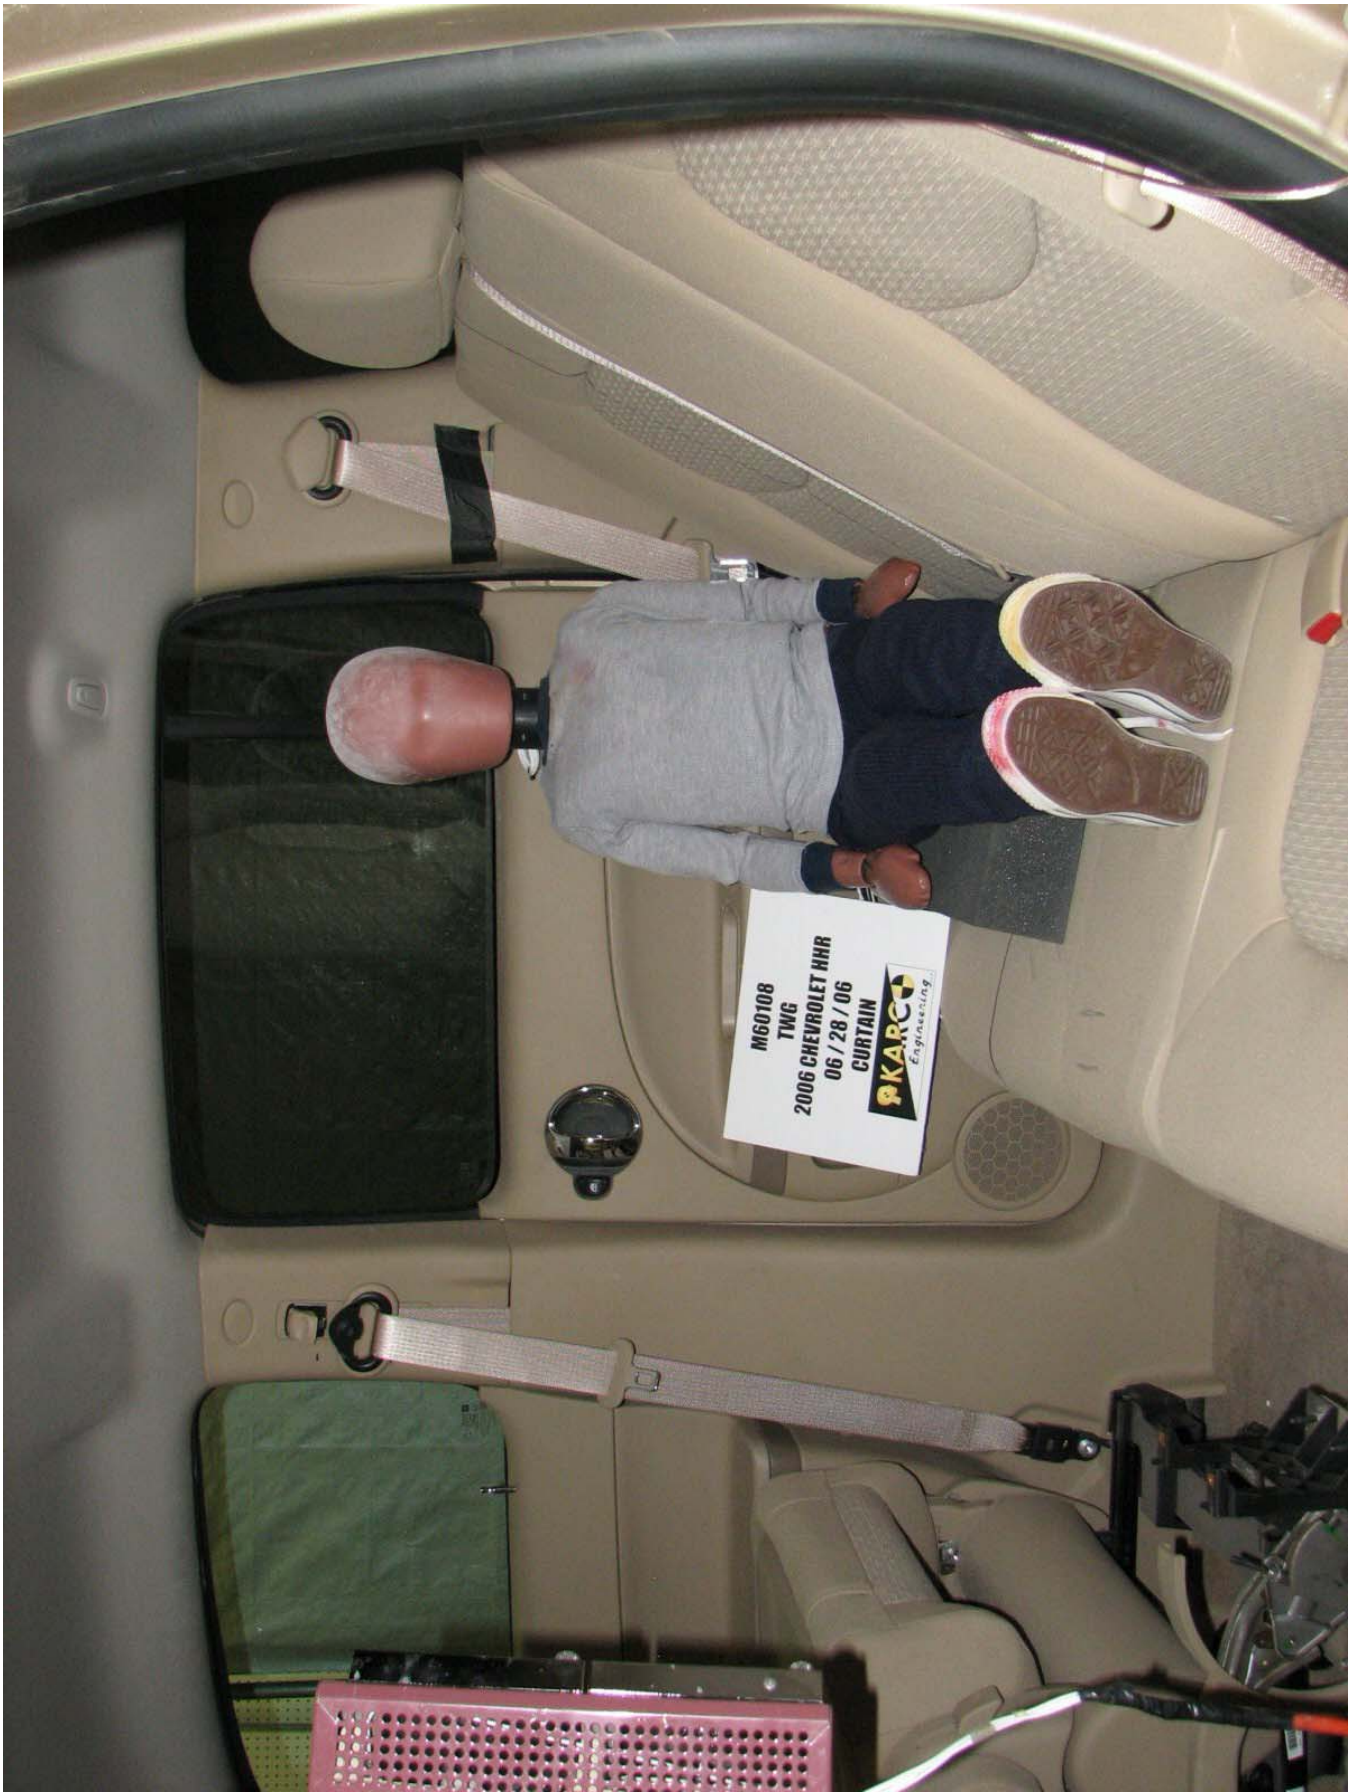
Figure A-5: Pre-Test Dummy Position, Left Side View

Orientation of the Hybrid III 6 Year-old Child Dummy was in the inboard facing position leaning against the right rear passenger door. The dummy's spine was aligned with the deploying trajectory of the airbag. The lower legs were extended. Synthetic foam was used to raise the dummy. This orientation complies with section 3.3.5.1 of the Technical Working Group (TWG) recommendation in the Recommended Procedures for Evaluating Occupant Injury Risk from Deploying Side Airbags.

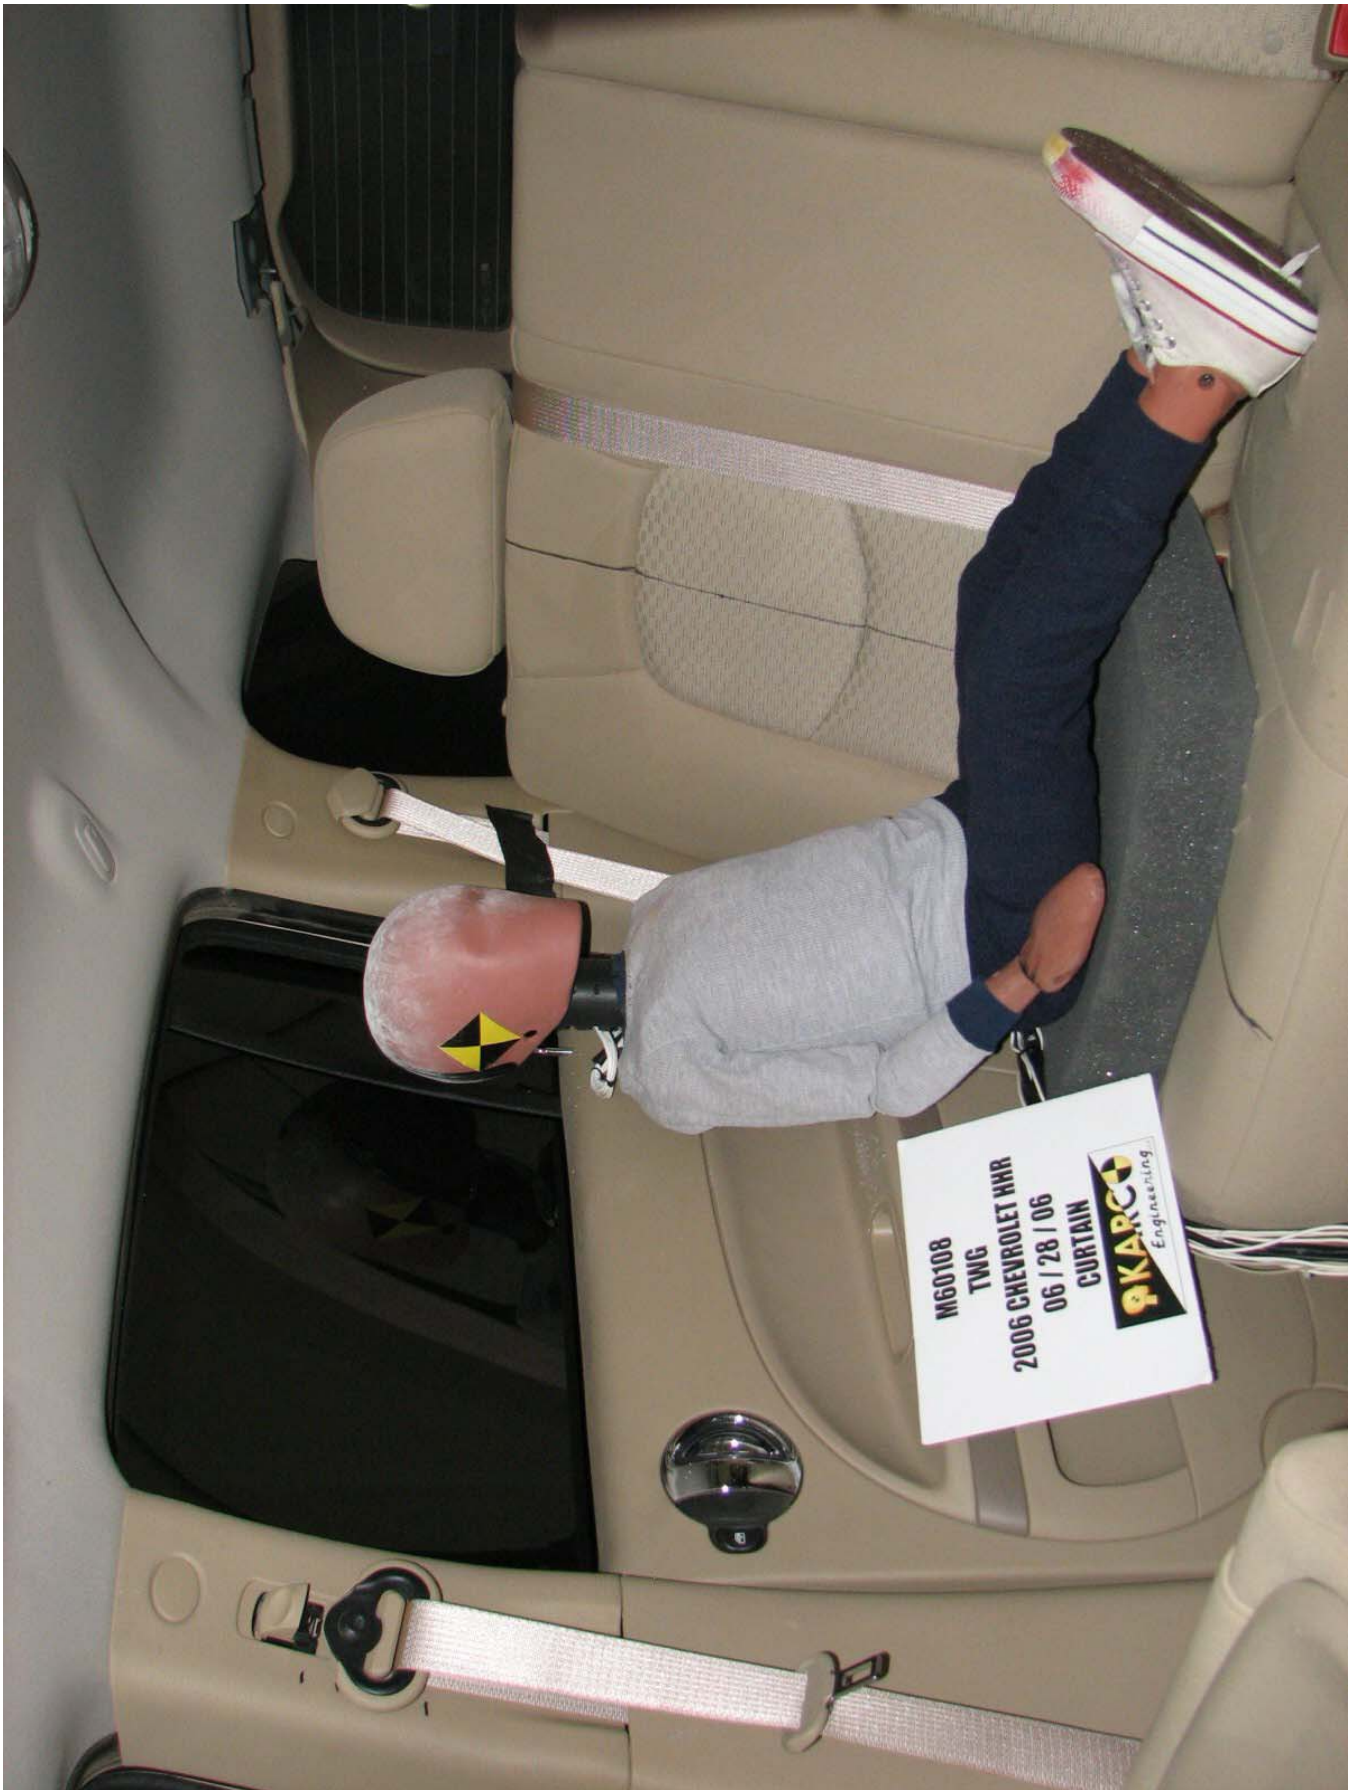
Figure A-6: Pre-Test Dummy Position,  $\frac{3}{4}$  View

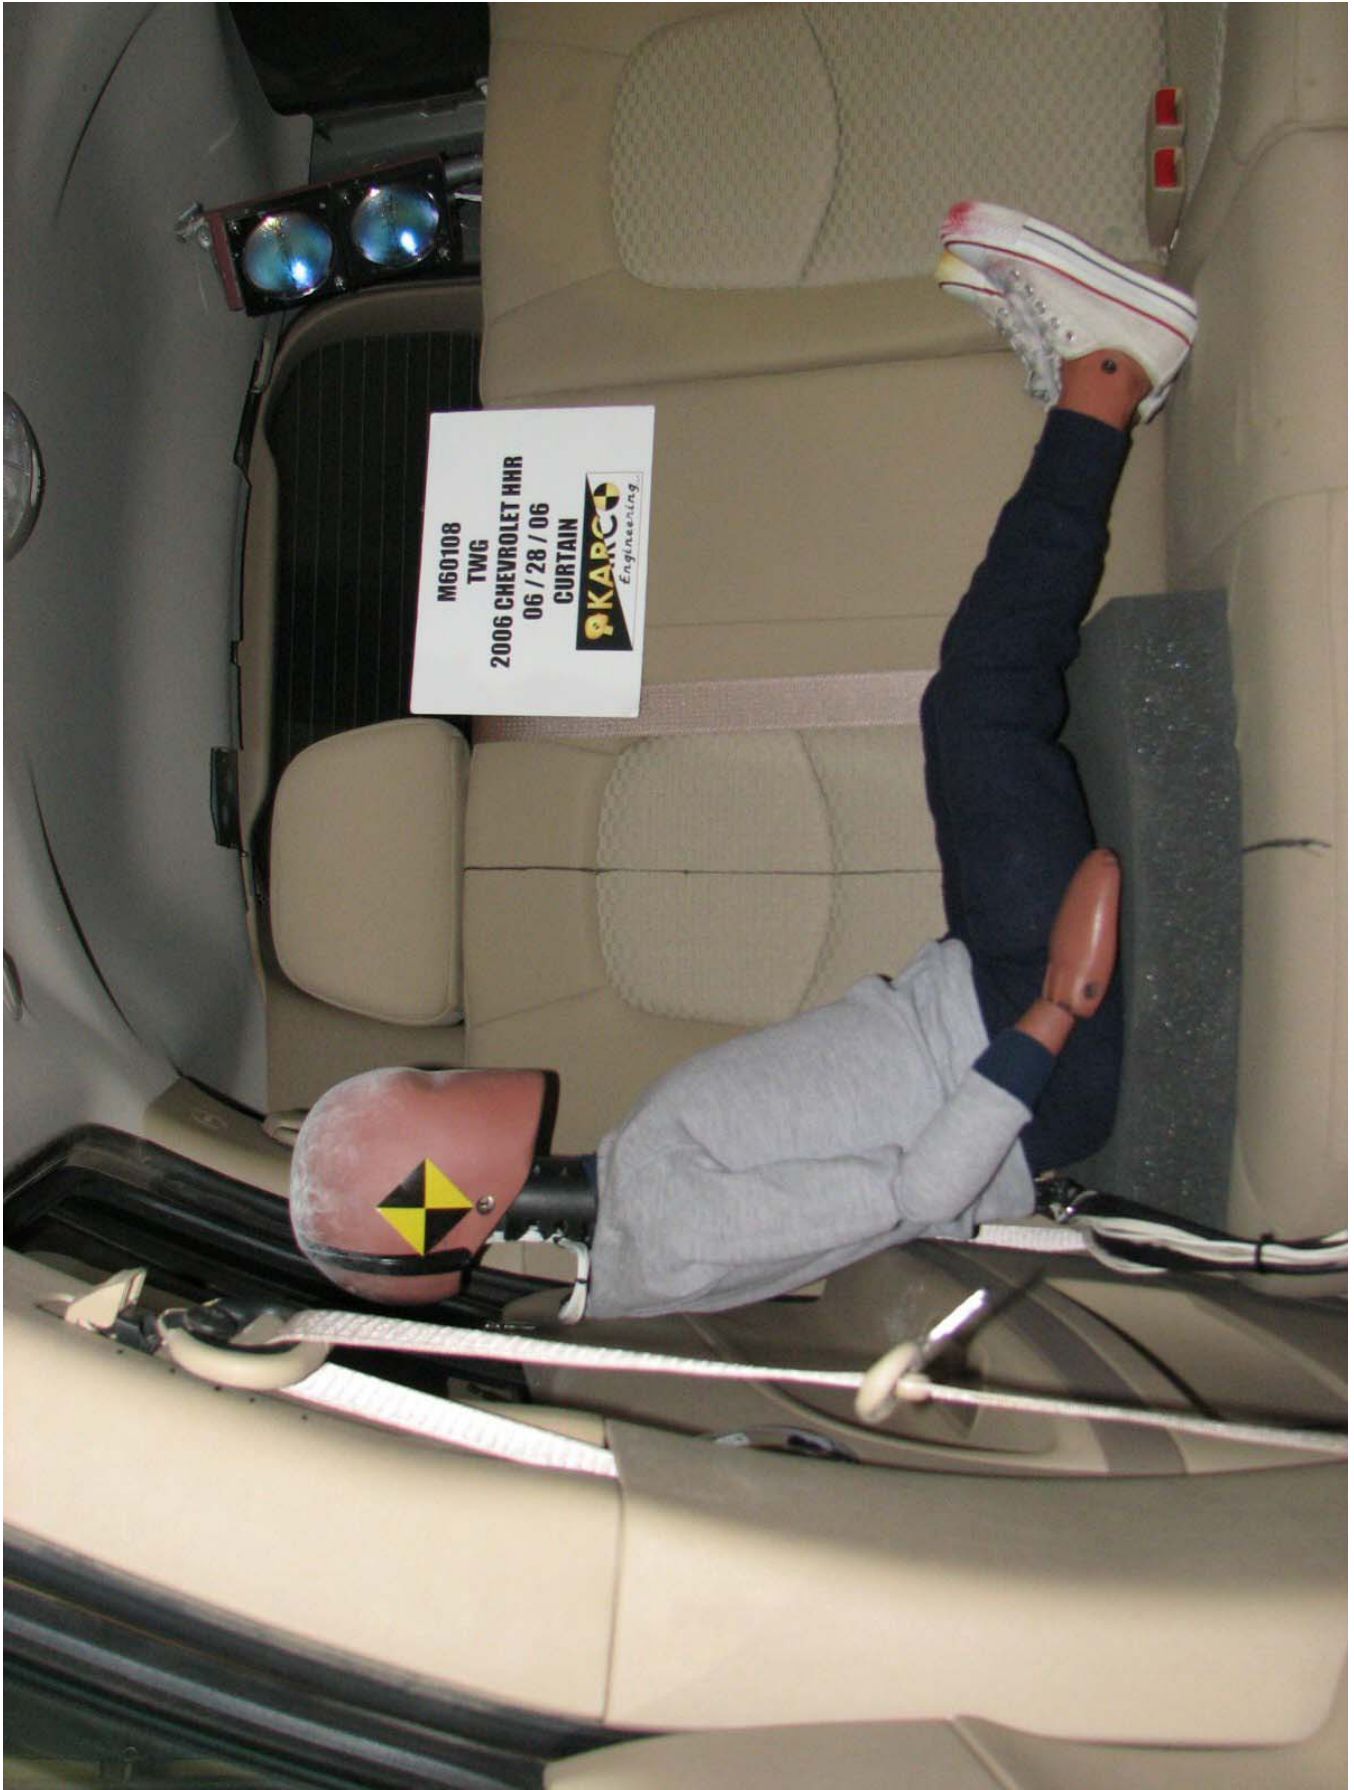
Figure A-7: Pre-Test Dummy Position, Front View

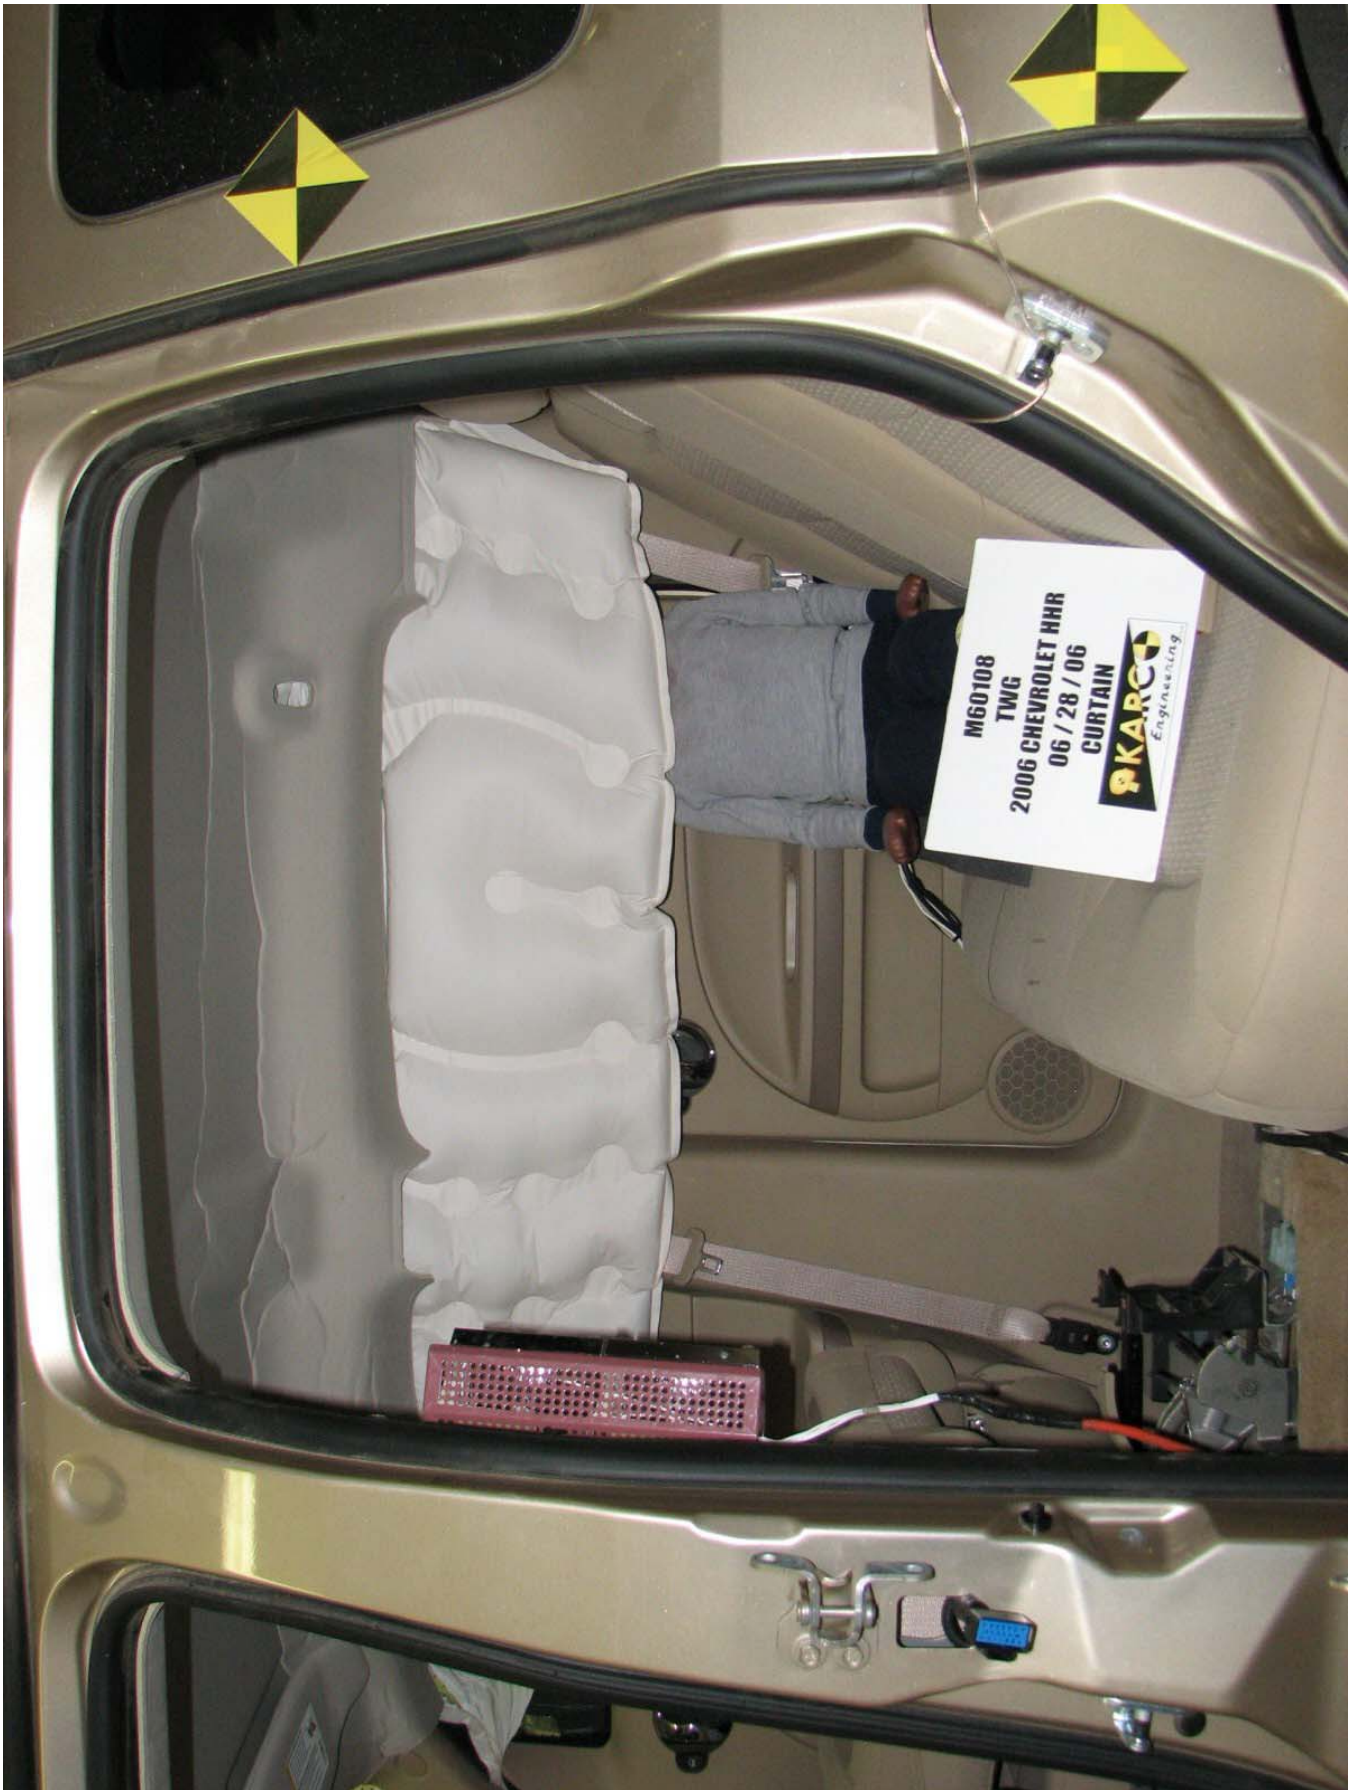
Figure A-8: Post-Test Dummy Position and Airbags, Left Side View

The Hybrid III 6-Year-Old Child Dummy's visible contact points were as follows: The curtain airbag contacted the top of the ATD's head.

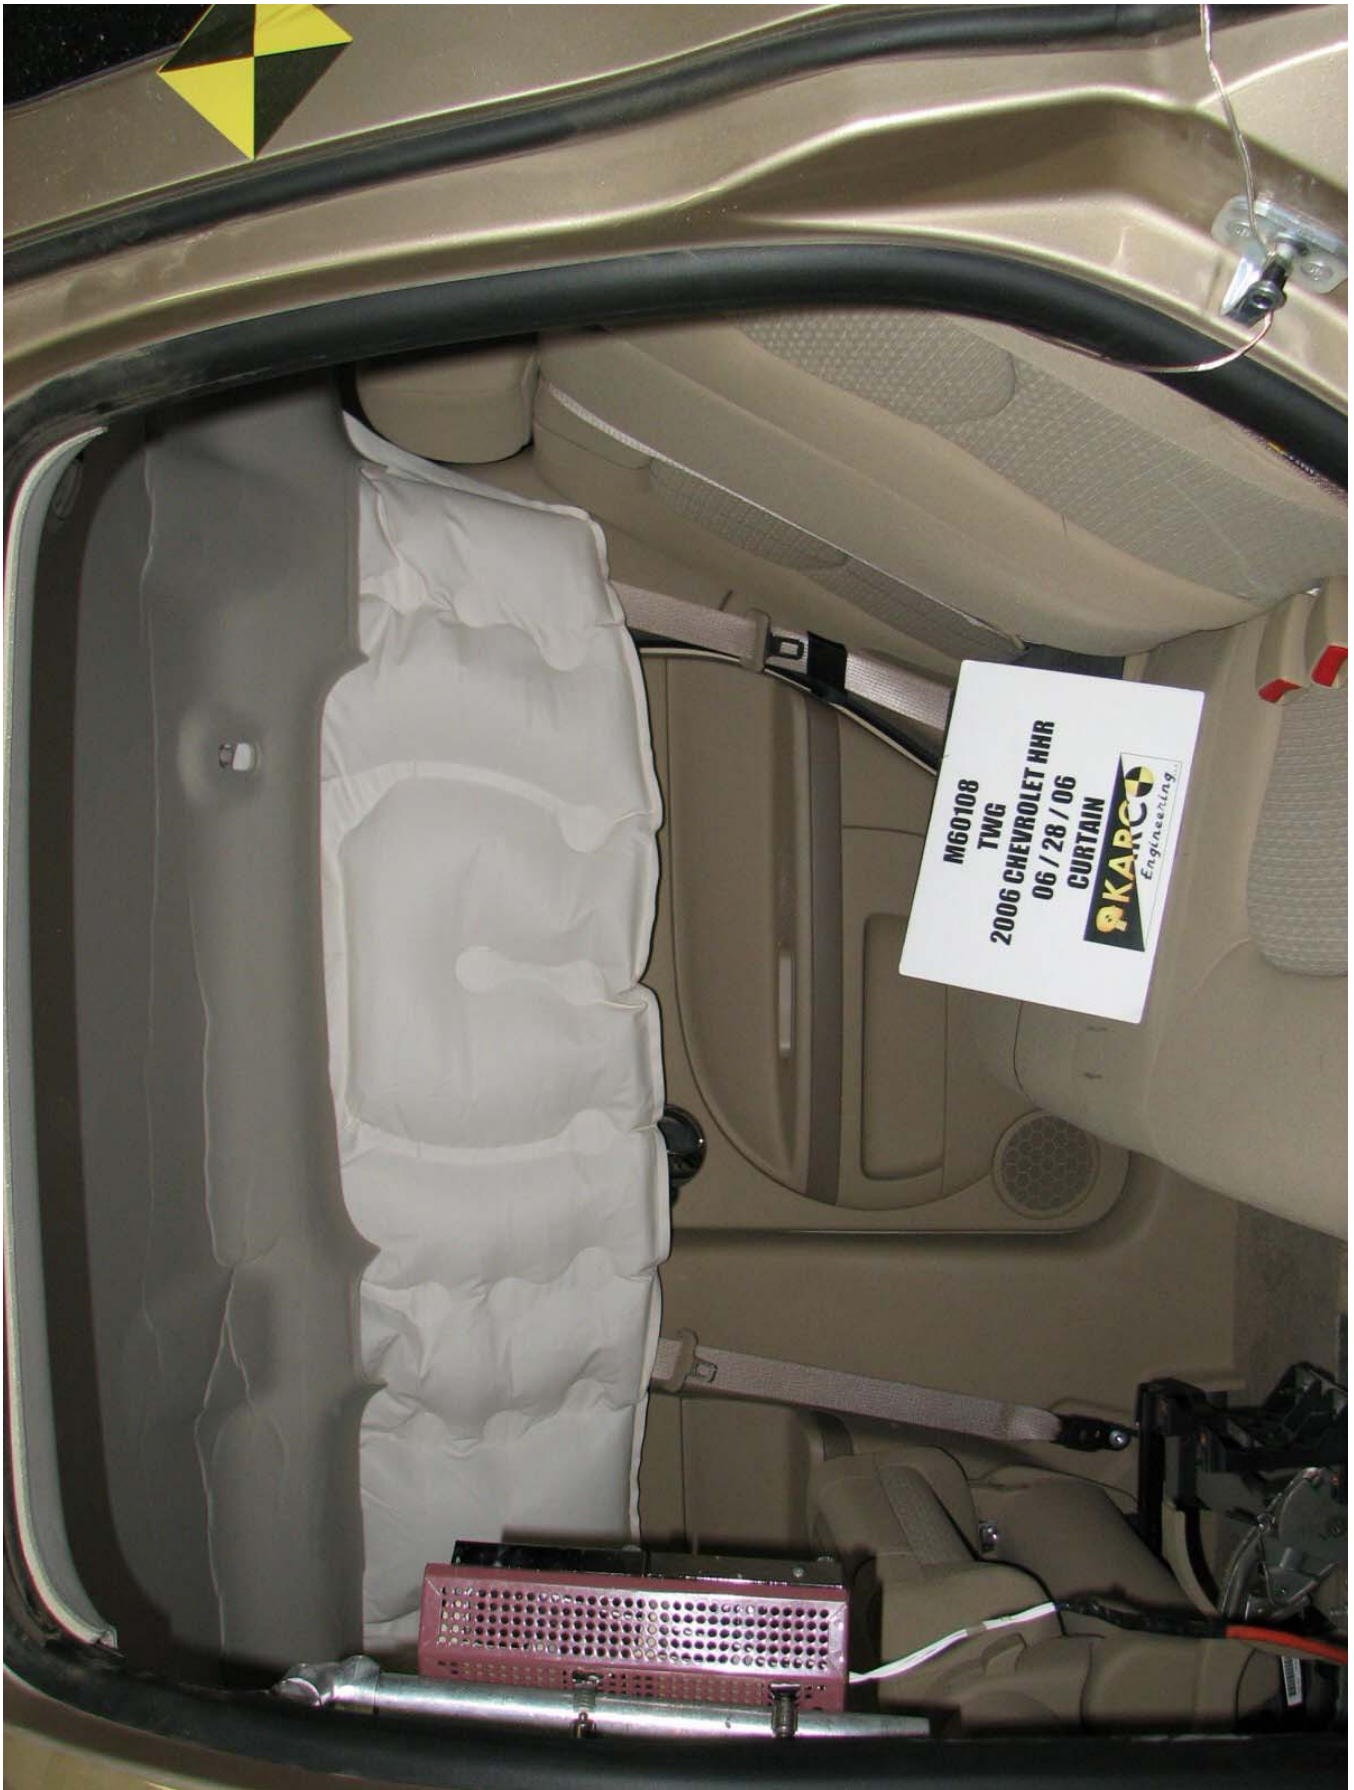
Figure A-9: Post-Test Airbags, Left Side View

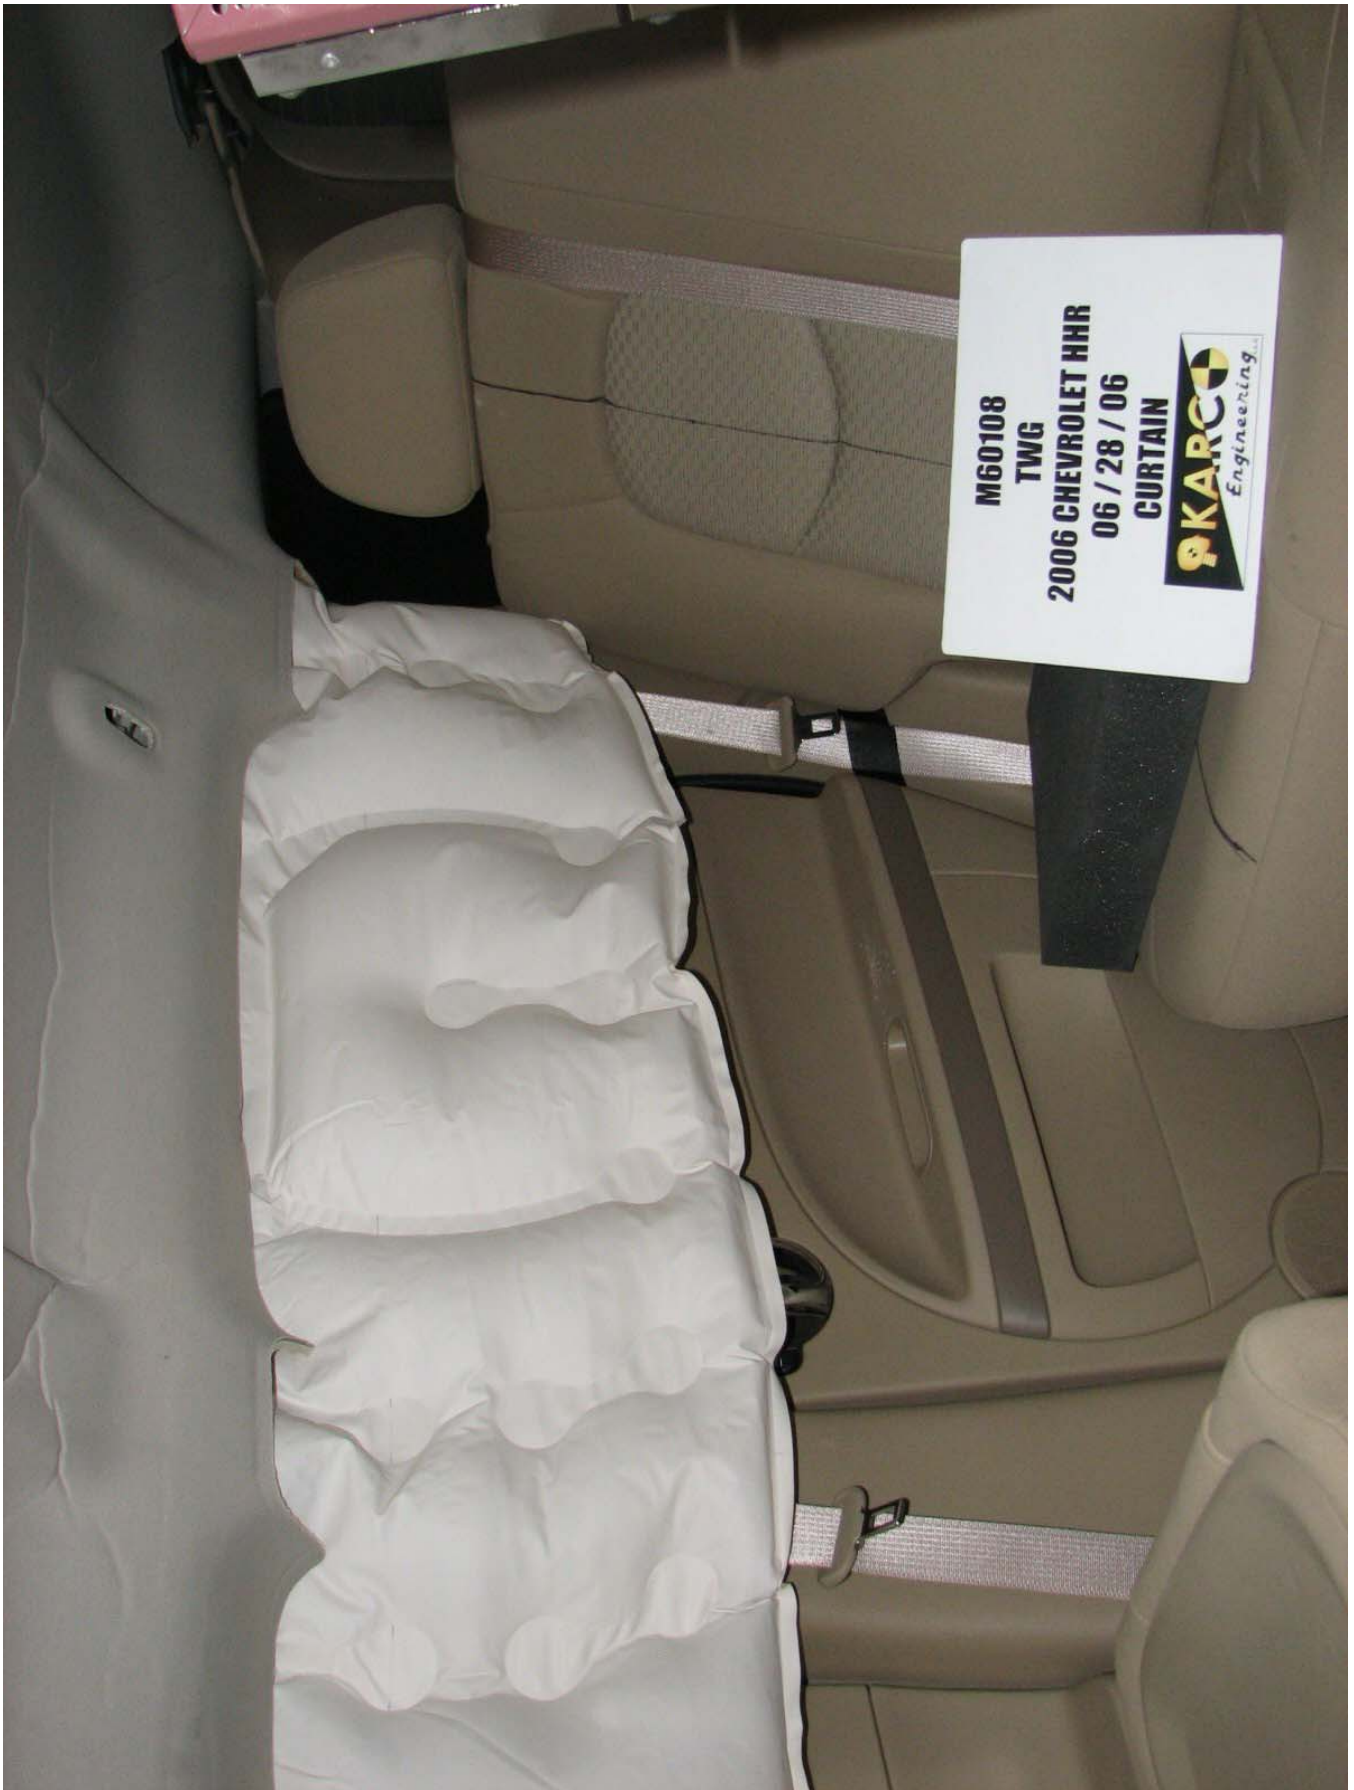
Figure A-10: Post-Test Airbags, Close-up View
