**REPORT NUMBER: TWG-MGA-2006-003**

**NEW CAR ASSESSMENT PROGRAM  
SIDE AIRBAG OUT-OF-POSITION INJURY TESTING**

**NISSAN MOTOR CO., LTD  
2006 INFINITI FX35 CROSSOVER  
NHTSA NUMBER: M65205TWG2**

**PREPARED BY:  
MGA RESEARCH CORPORATION  
5000 WARREN ROAD  
BURLINGTON, WI 53105**

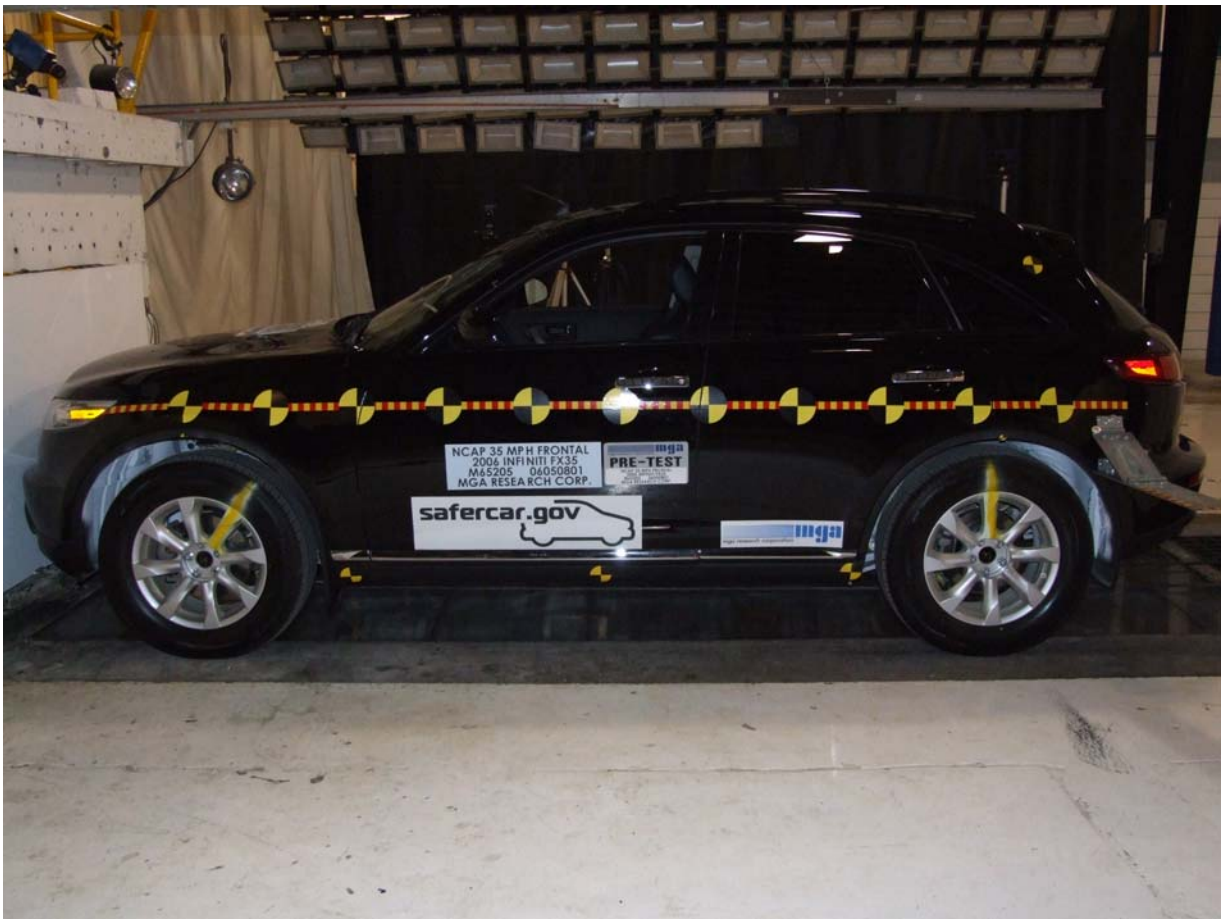
Pre-Test Vehicle Left Side View

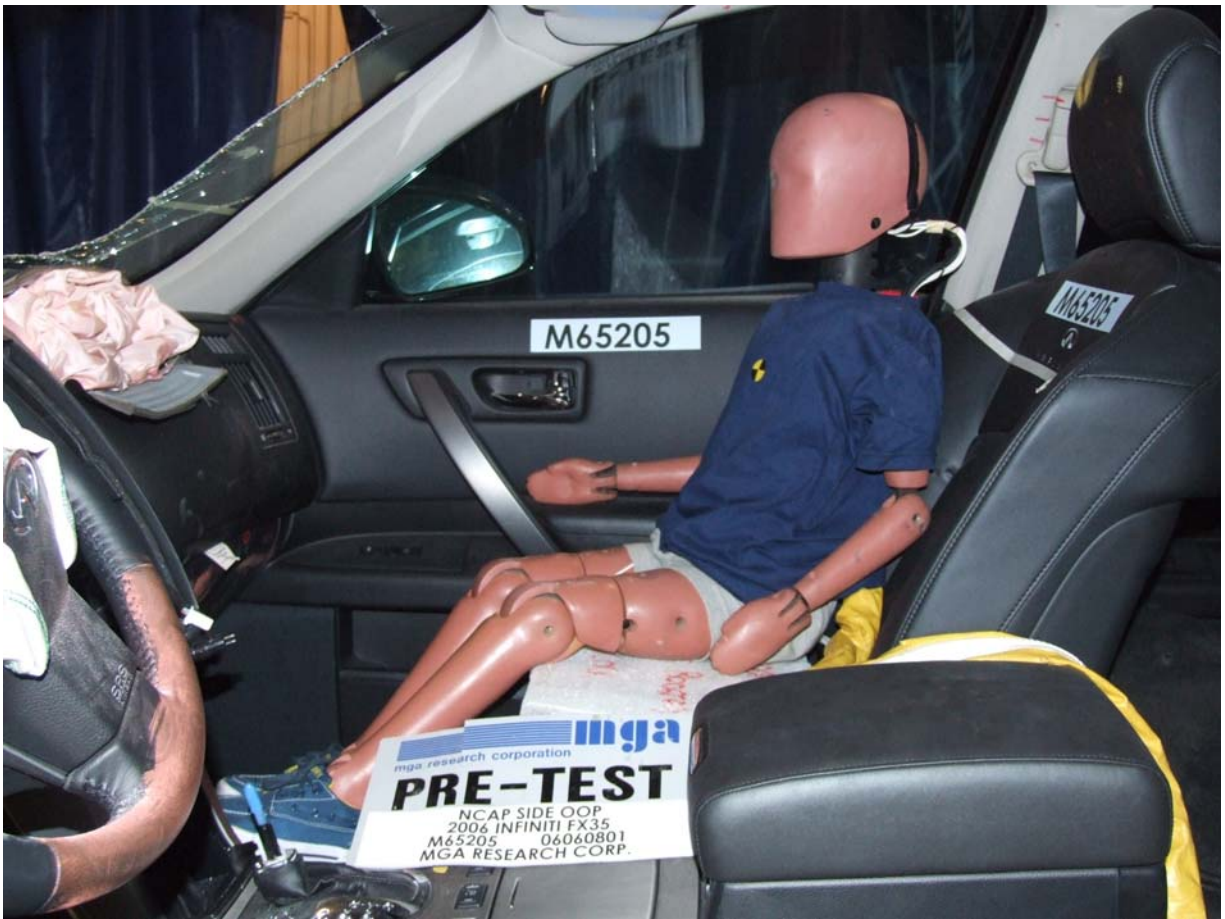
Pre-Test Child Dummy Left Side View

The HIII 6-year-old child dummy was placed on the outboard edge of the foam block, aligning the upper spine with the deployment trajectory of the airbag. The dummy's head was placed in between the seat bolster and pillar trim to minimize the fore-aft clearance between the neck and the seatback. The head remained in its neutral orientation. The legs were aligned such that they crossed the heel placement points. The dummy was then positioned so the dummy's neck/torso junction was aligned vertically with the top edge of the airbag module. While maintaining the neck/torso top of the airbag module alignment, the vehicle door was closed and the pelvis was moved outboard until it made contact with the door trim/armrest. The outboard forearm was placed on the armrest. The inboard arm was positioned such that the upper arm

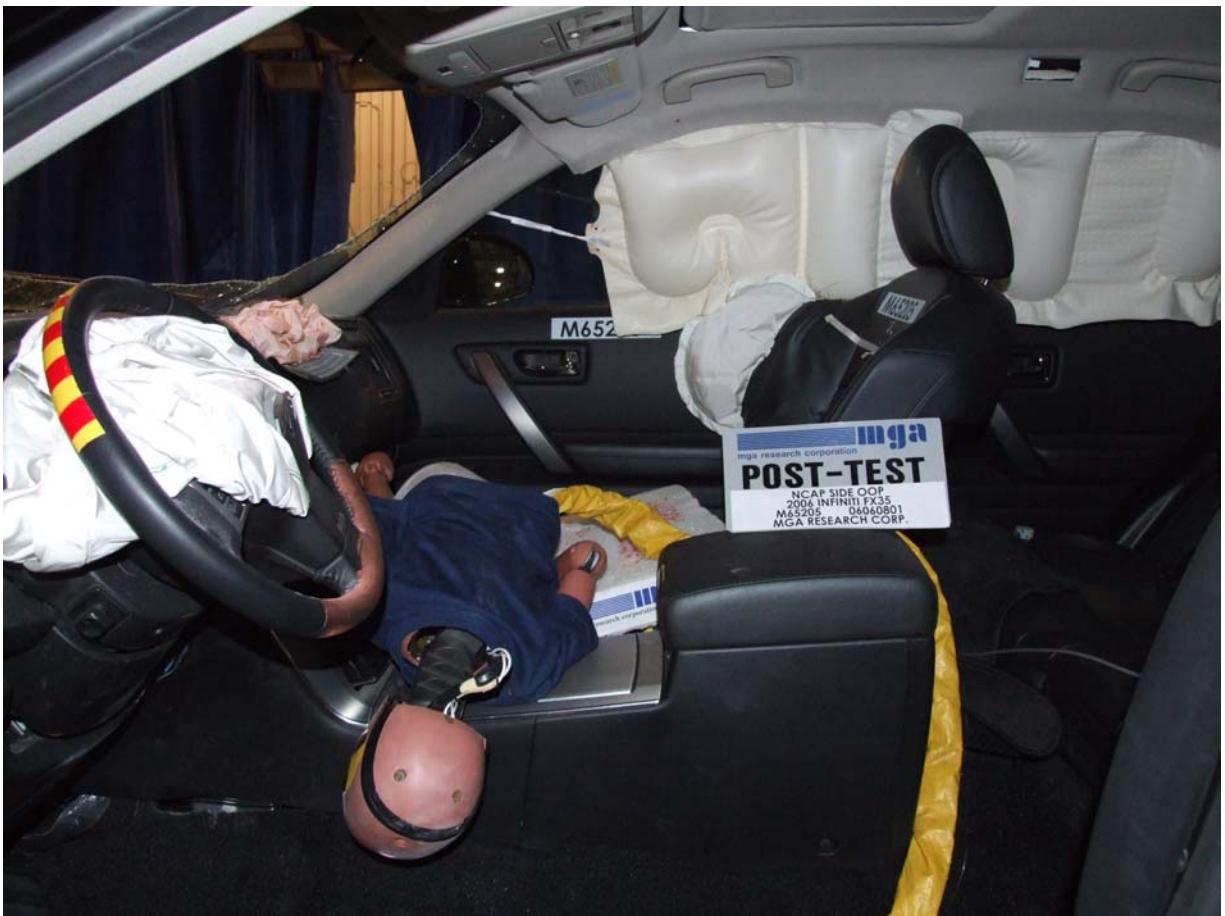
Post-Test Child Dummy Left Side View

The HIII 6-year-old child dummy's visible contact points were as follows: The seat airbag to the right scapula and right side of the posterior thorax and pelvis and the curtain airbag to the top of the head.

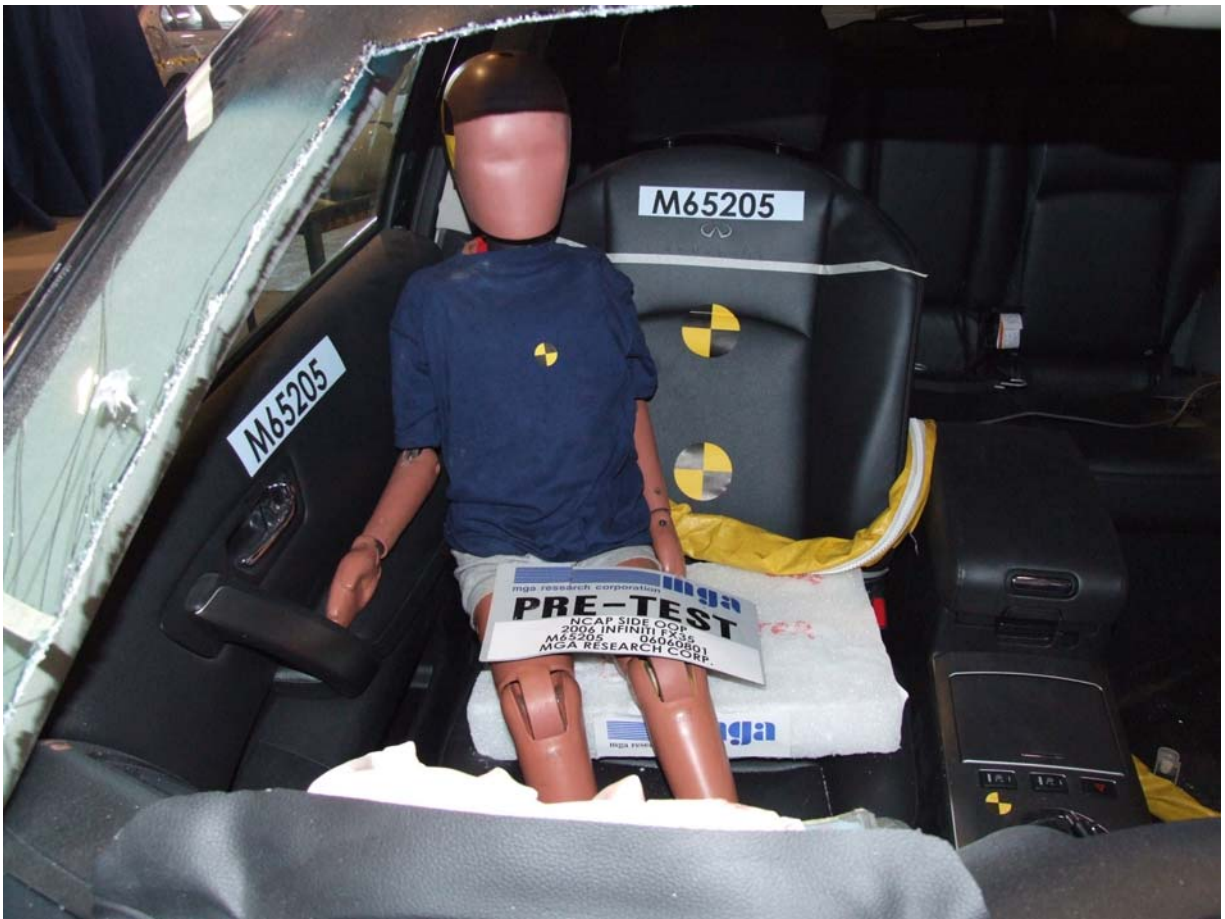
Pre-Test Child Dummy Frontal View

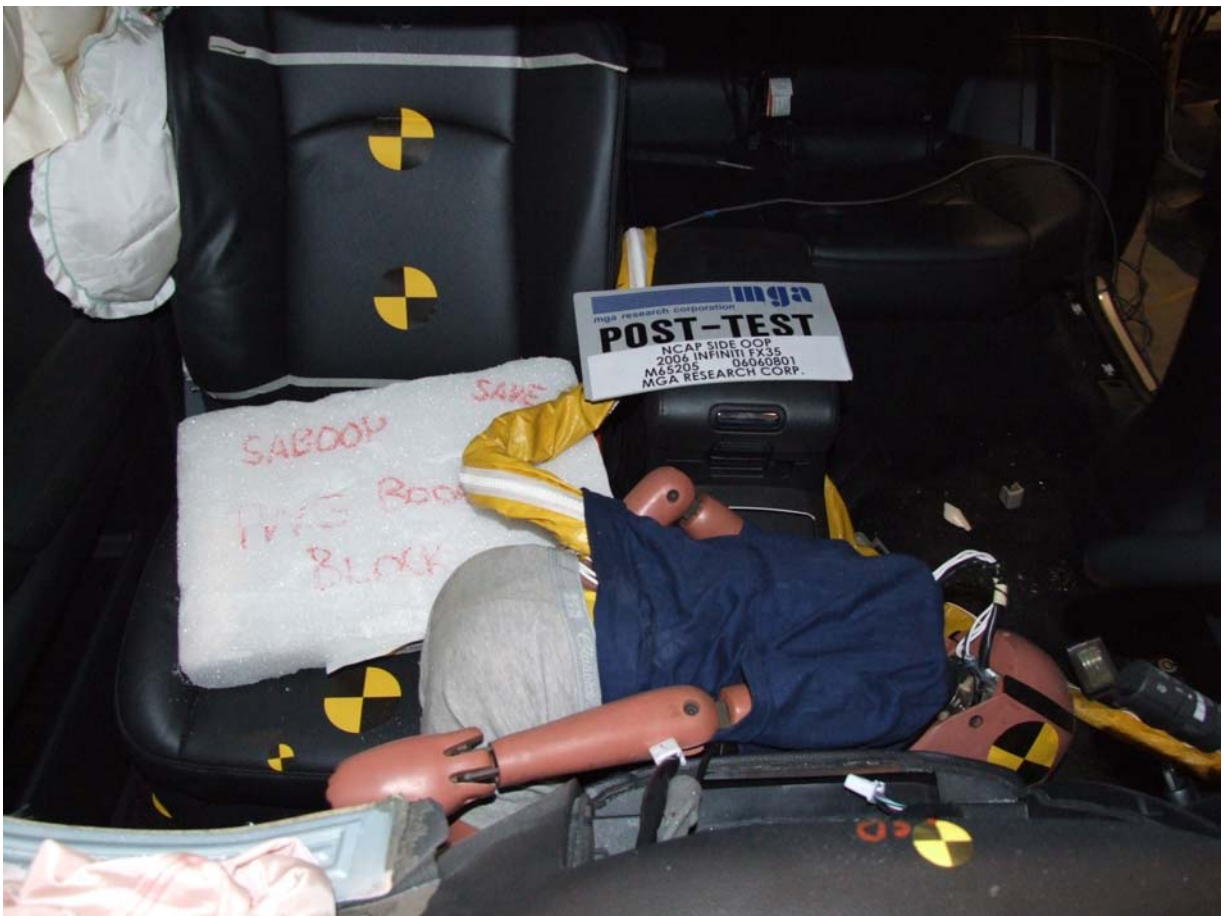
Post-Test Child Dummy Frontal View

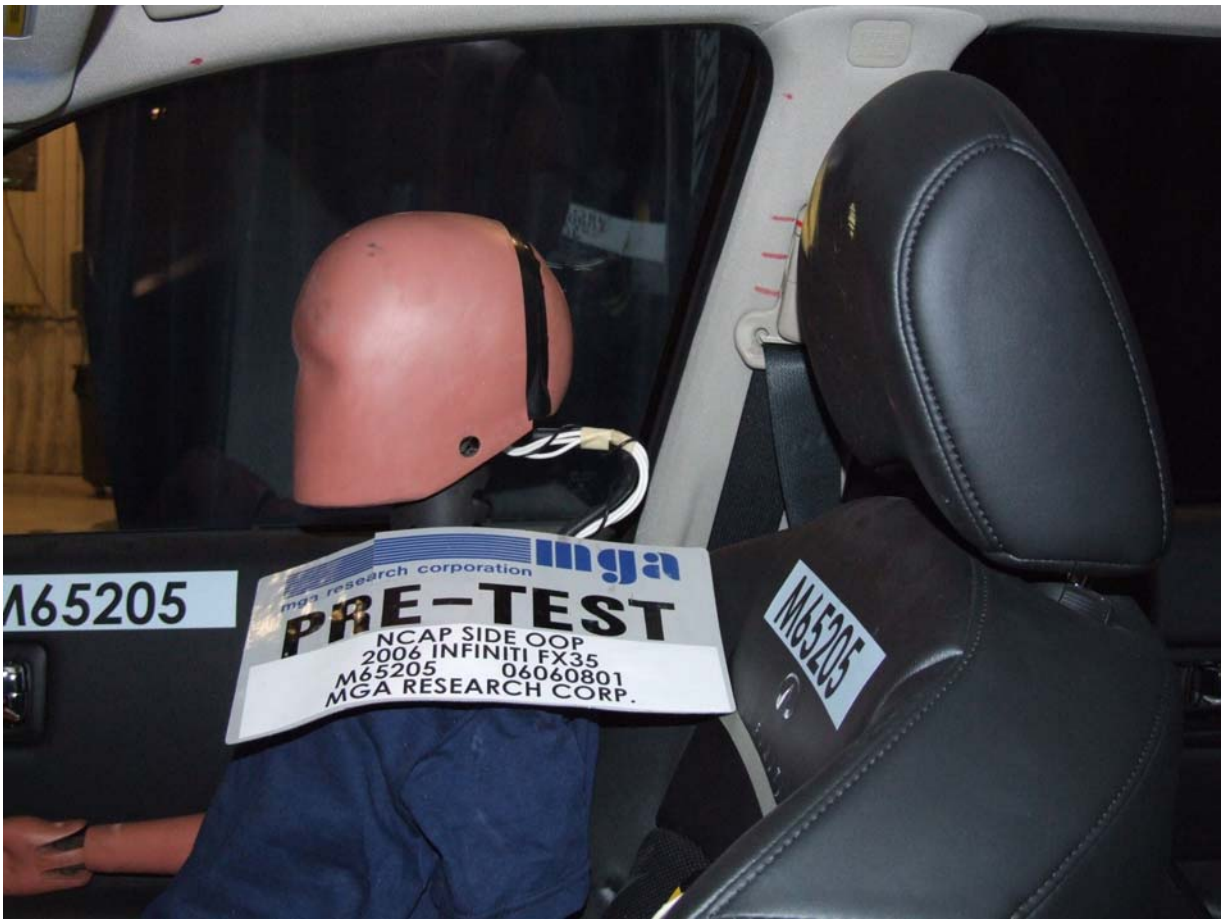
Pre-Test Child Dummy Head View

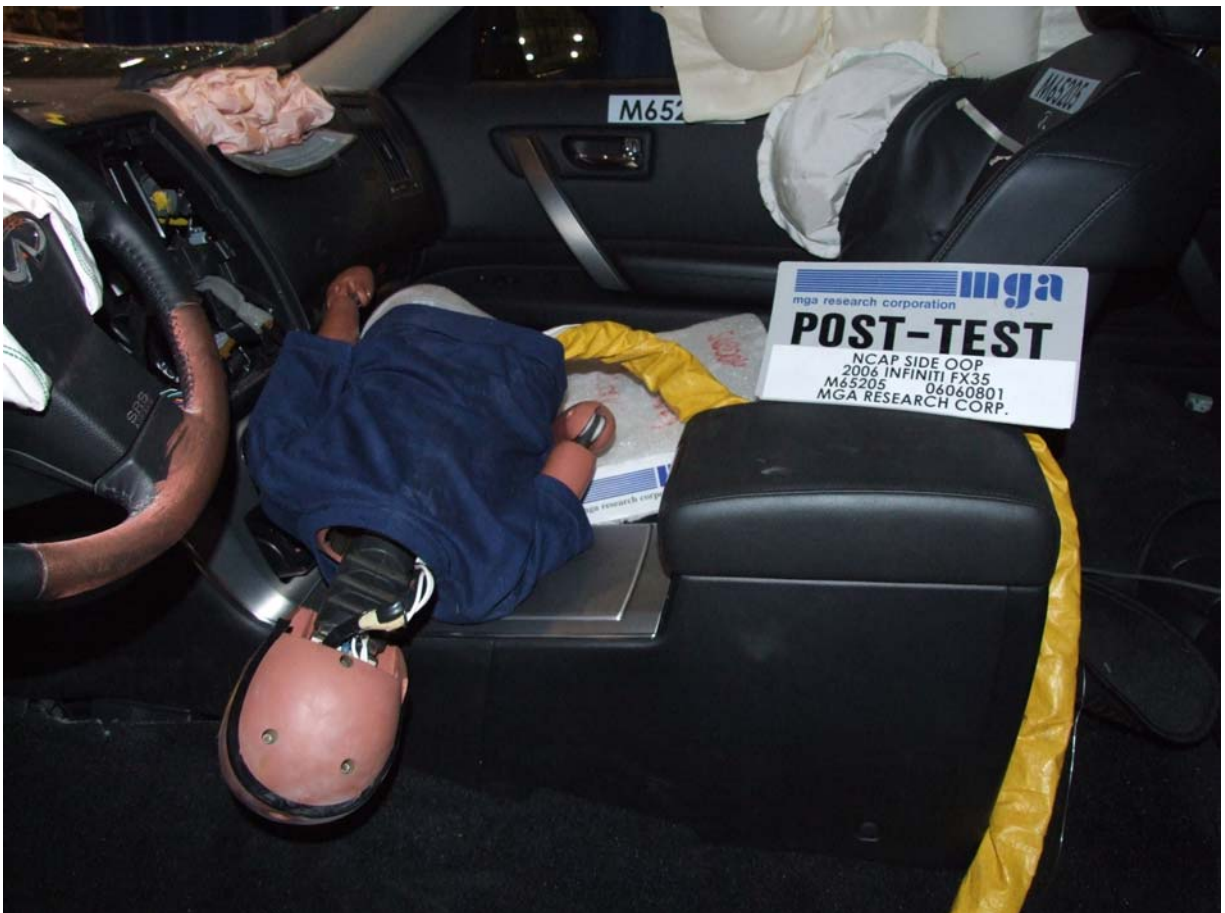
Post-Test Child Dummy Head View

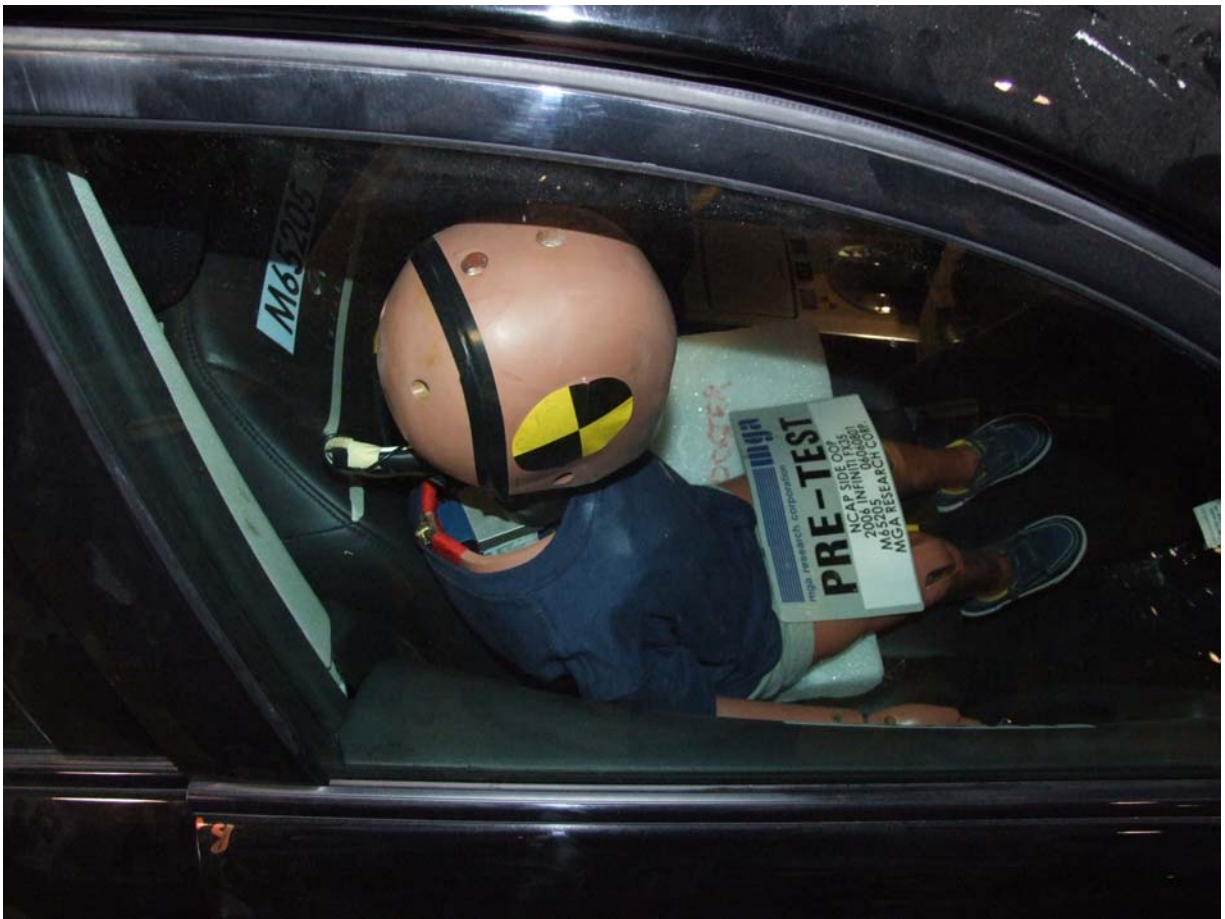
Pre-Test Child Dummy Head View (Through Window)

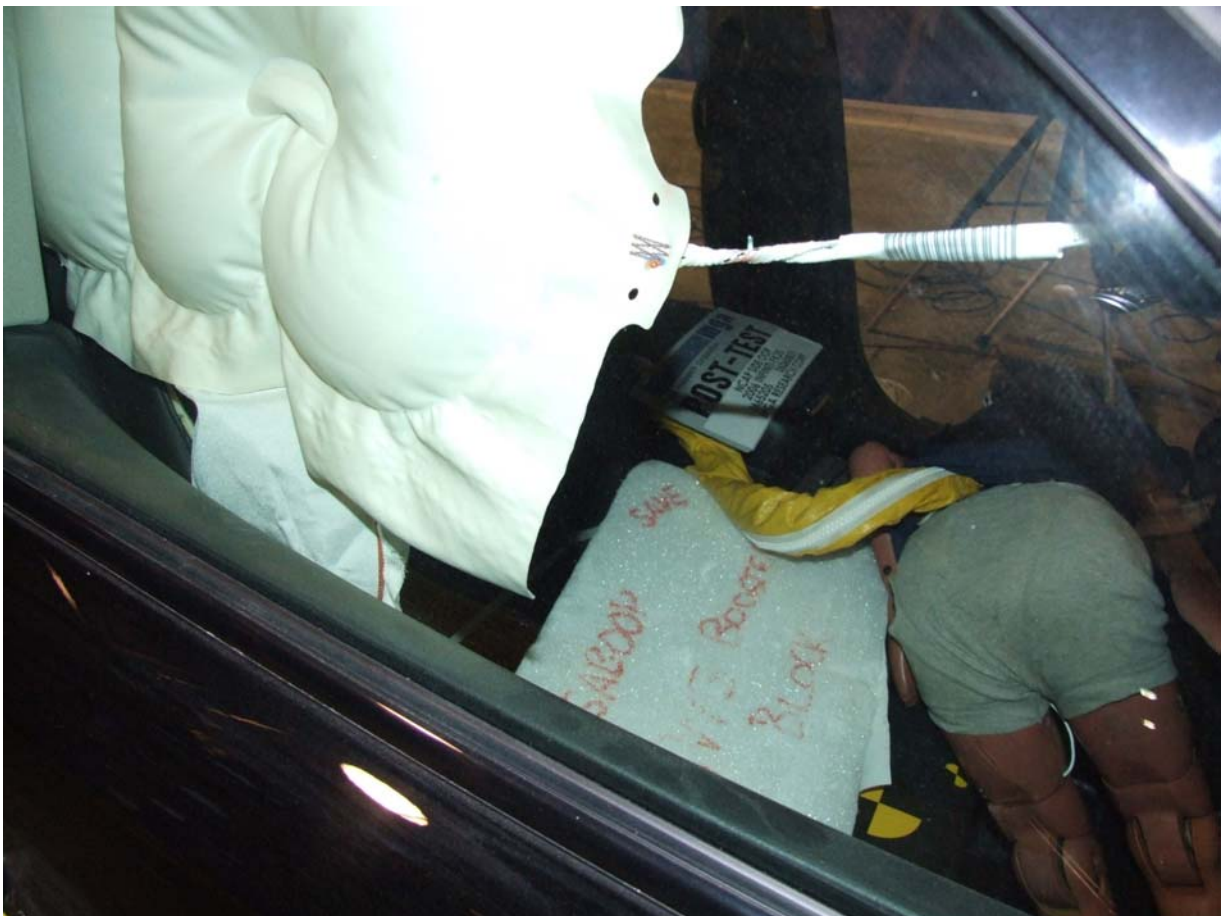
Post-Test Child Dummy Head View (Through Window)
