**REPORT NUMBER: TWG-MGA-2006-005**

**NEW CAR ASSESSMENT PROGRAM  
SIDE AIRBAG OUT-OF-POSITION INJURY TESTING**

**NISSAN MOTOR CORPORATION LTD.  
2006 NISSAN ARMADA  
NHTSA NUMBER: M65200TWG2**

**PREPARED BY:  
MGA RESEARCH CORPORATION  
5000 WARREN ROAD  
BURLINGTON, WI 53105**

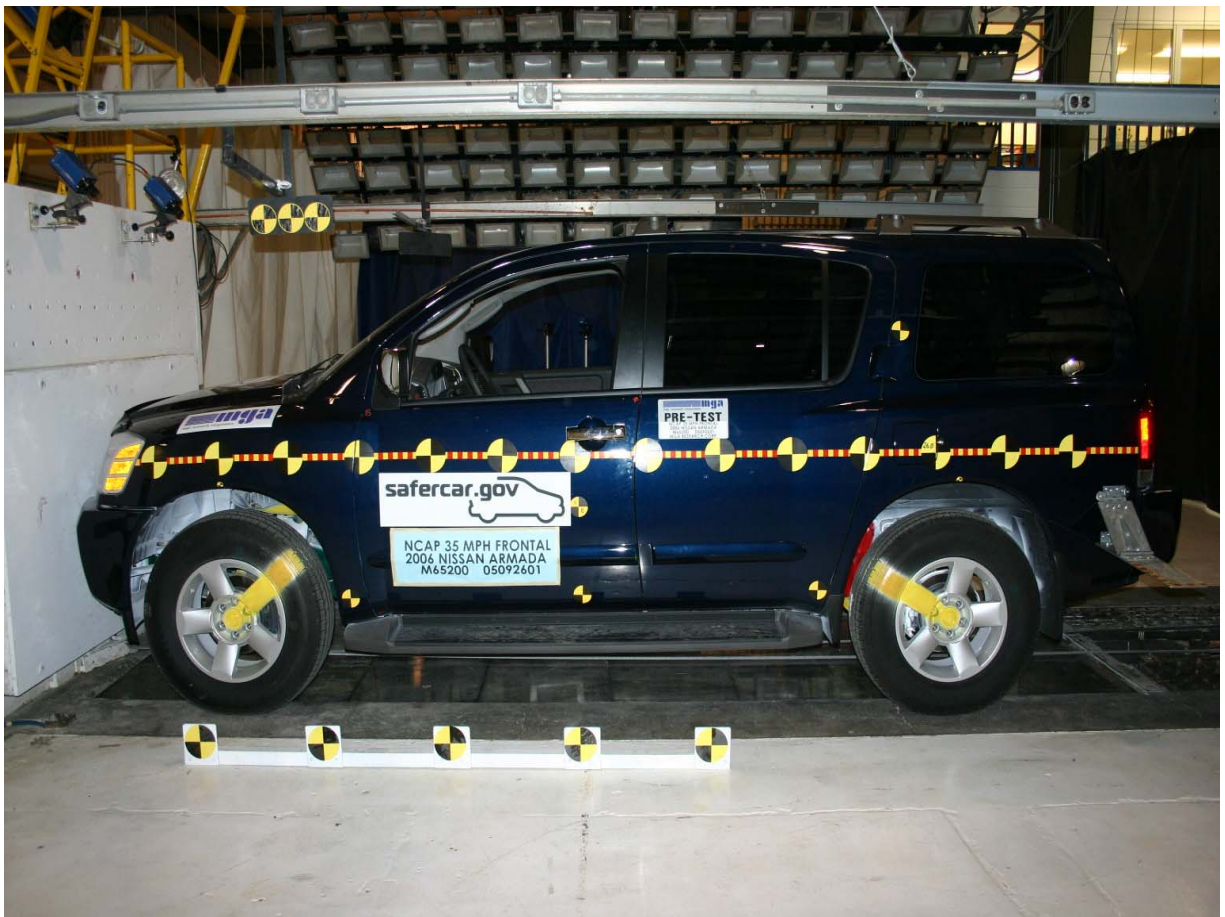
Pre-Test Vehicle Left Side View

| | | <u>Page No.</u> |
|---|---|---|
| Photo No. 1. | Pre-Test Vehicle Left Side View | A-2 |

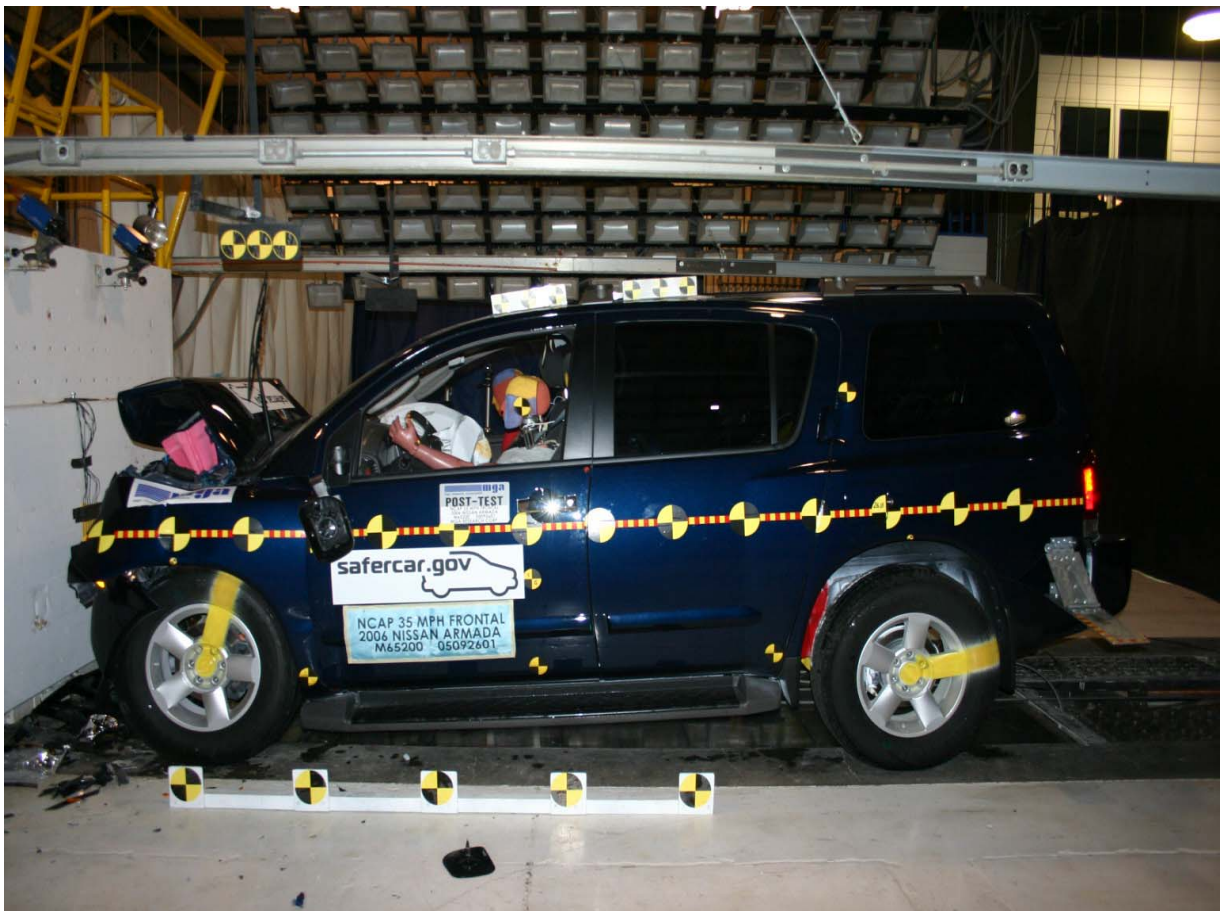
Post-Test Vehicle Left Side View

| | | <u>Page No.</u> |
|---|---|---|
| Photo No. 2. | Post-Test Vehicle Left Side View | A-2 |

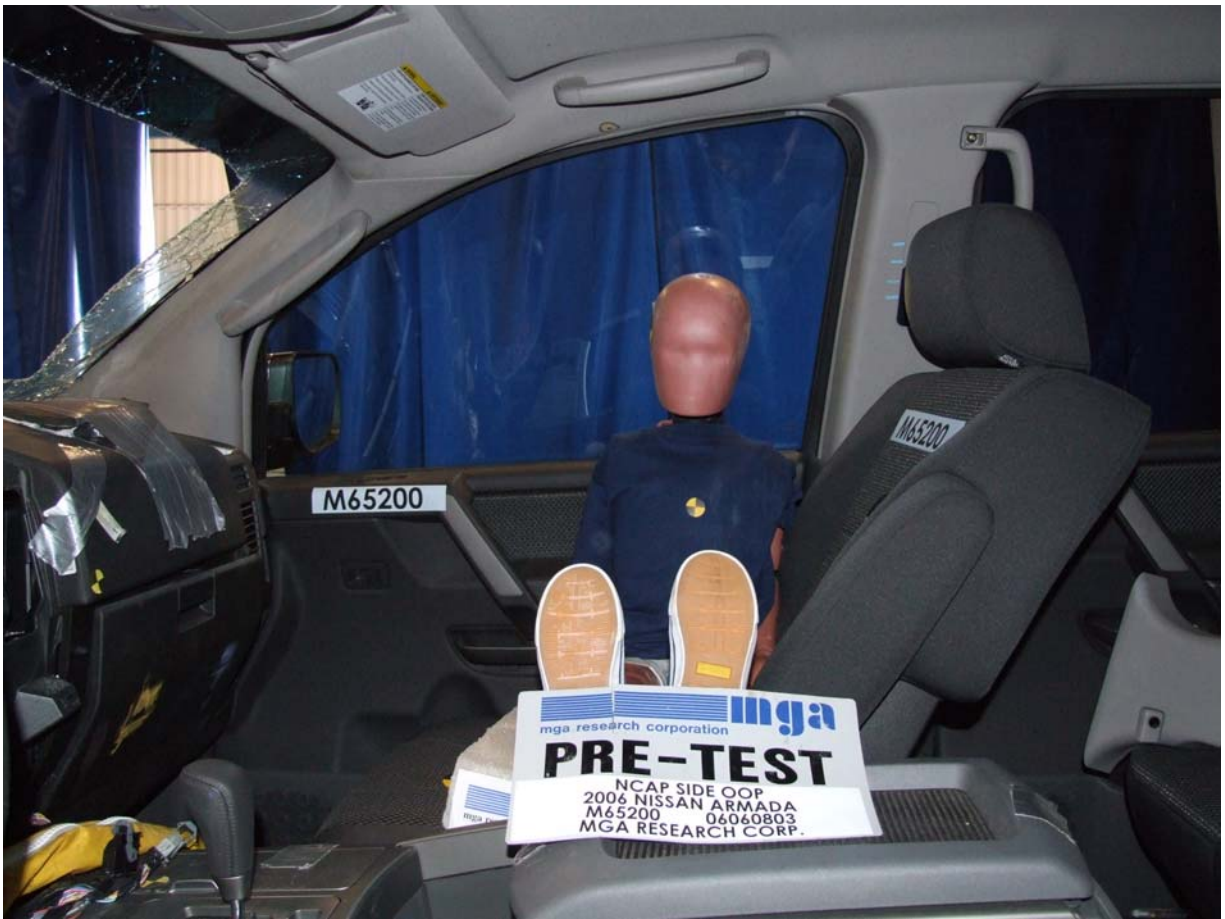
Pre-Test Child Dummy Frontal View

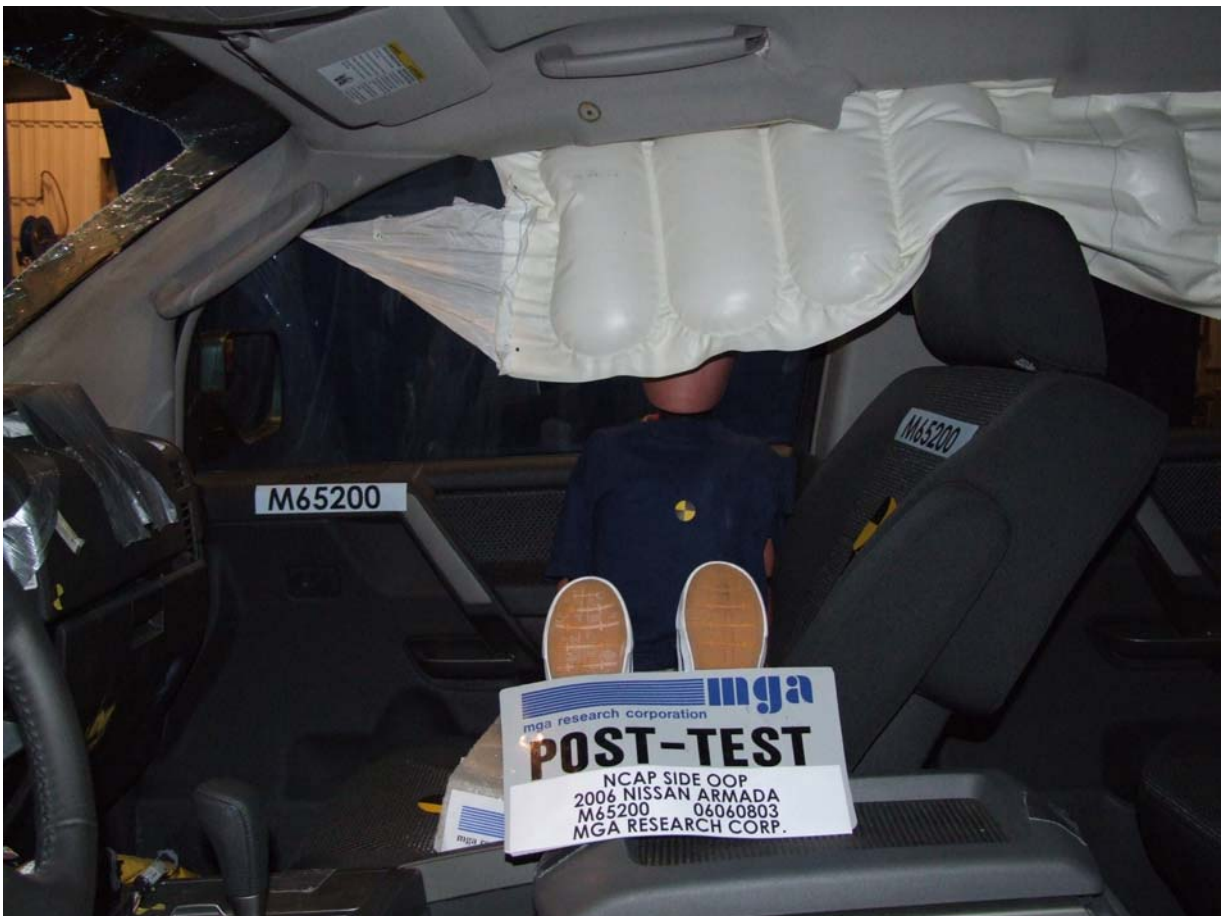
Post-Test Child Dummy Frontal View

The HIII 6-year-old child dummy's visible contact points were as follows: The curtain airbag to the top of the head and face.

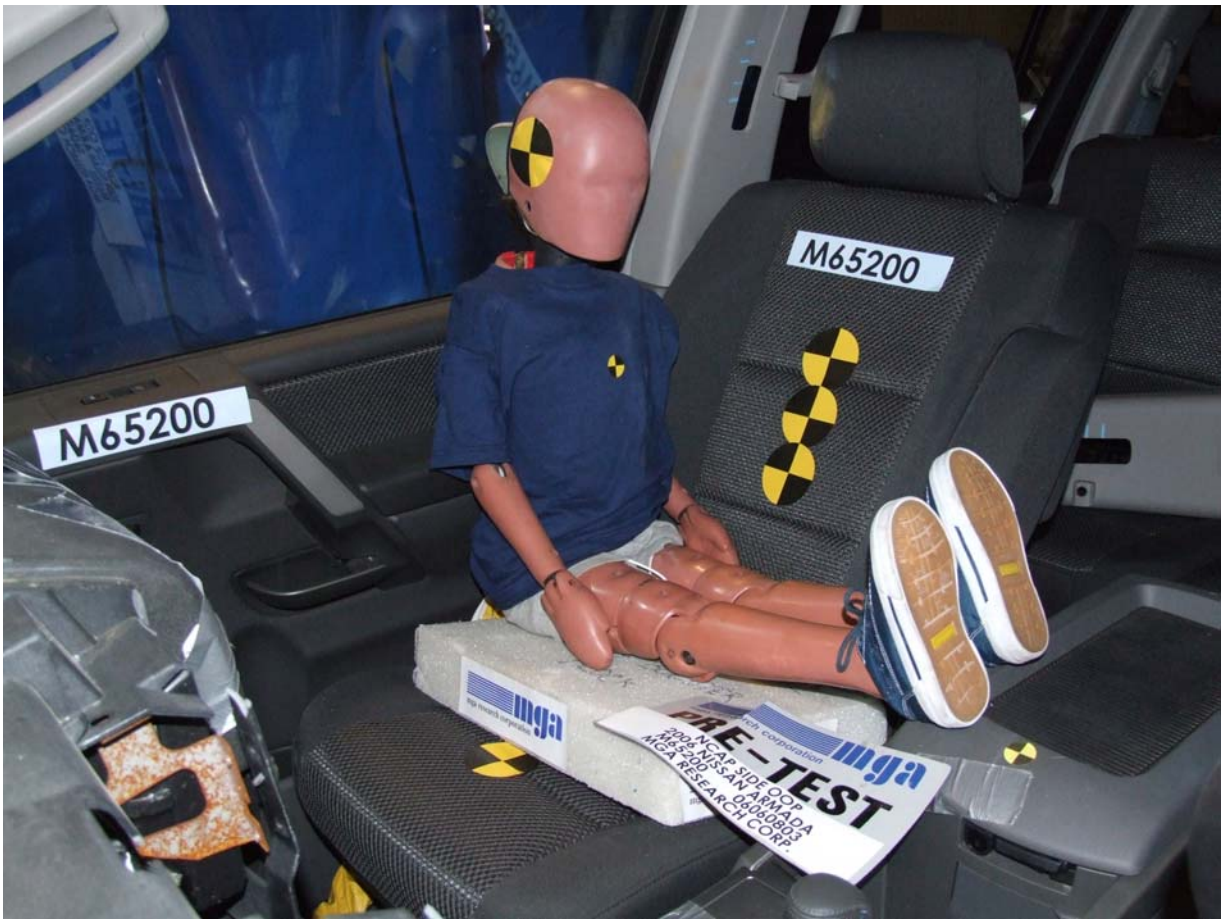
Pre-Test Child Dummy Right ¾ Side View

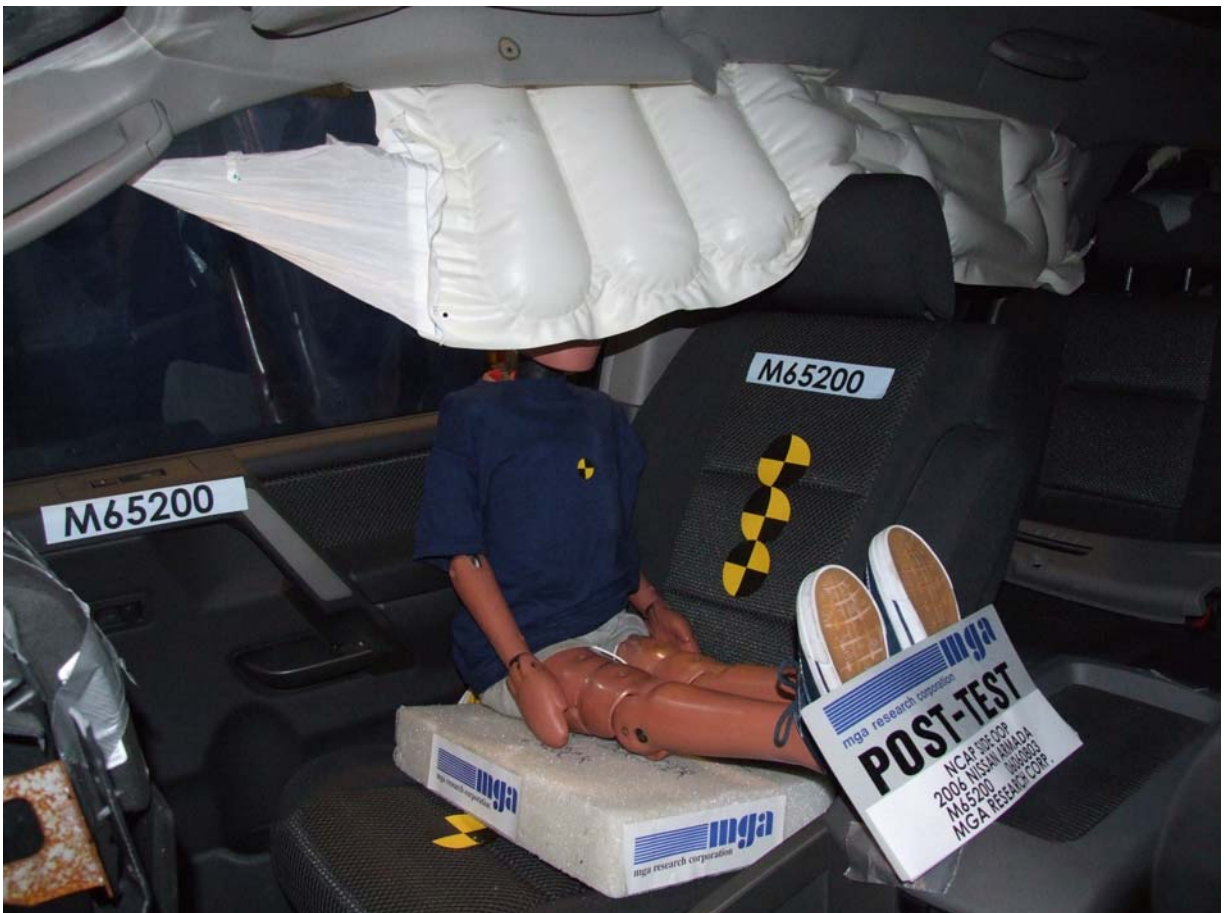
Post-Test Child Dummy Right ¾ Side View

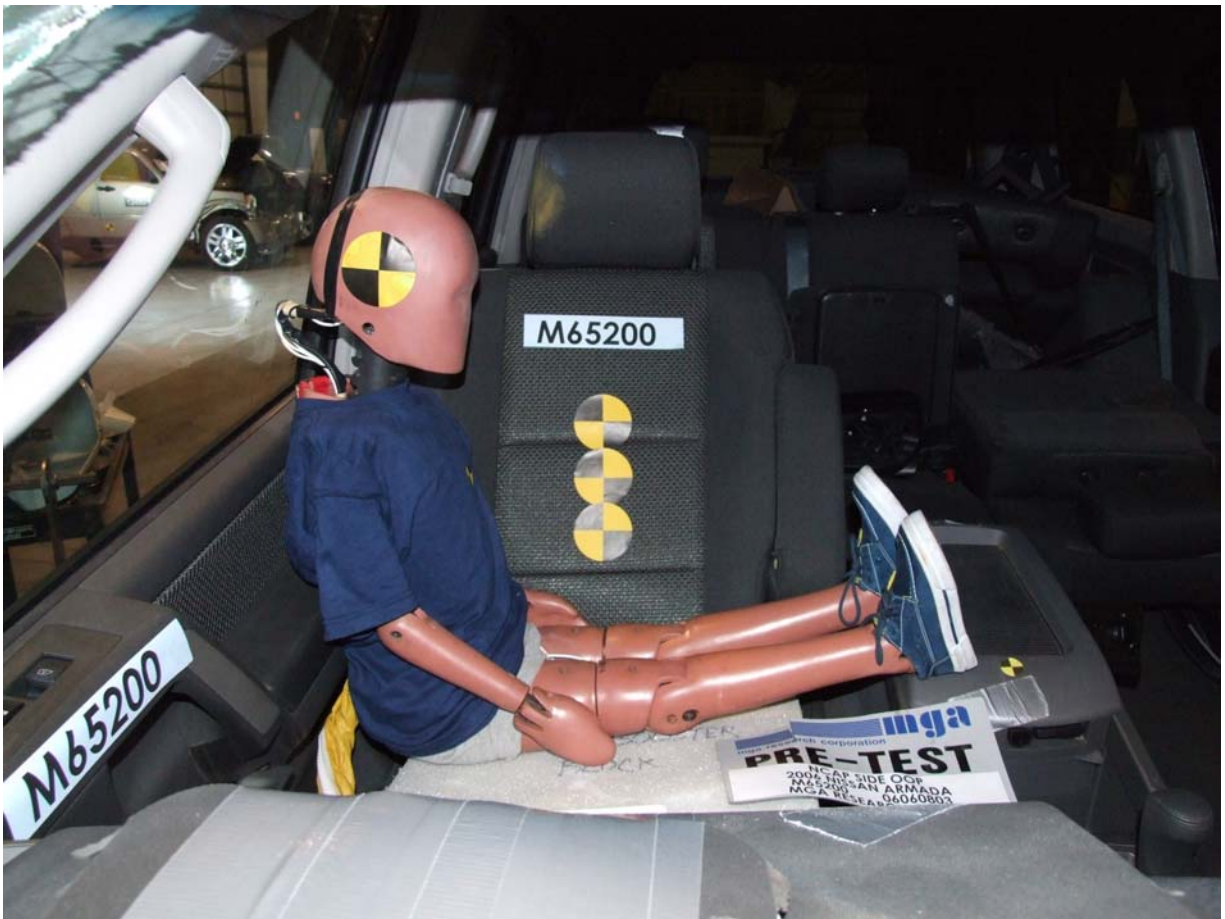
Pre-Test Child Dummy Right Side View

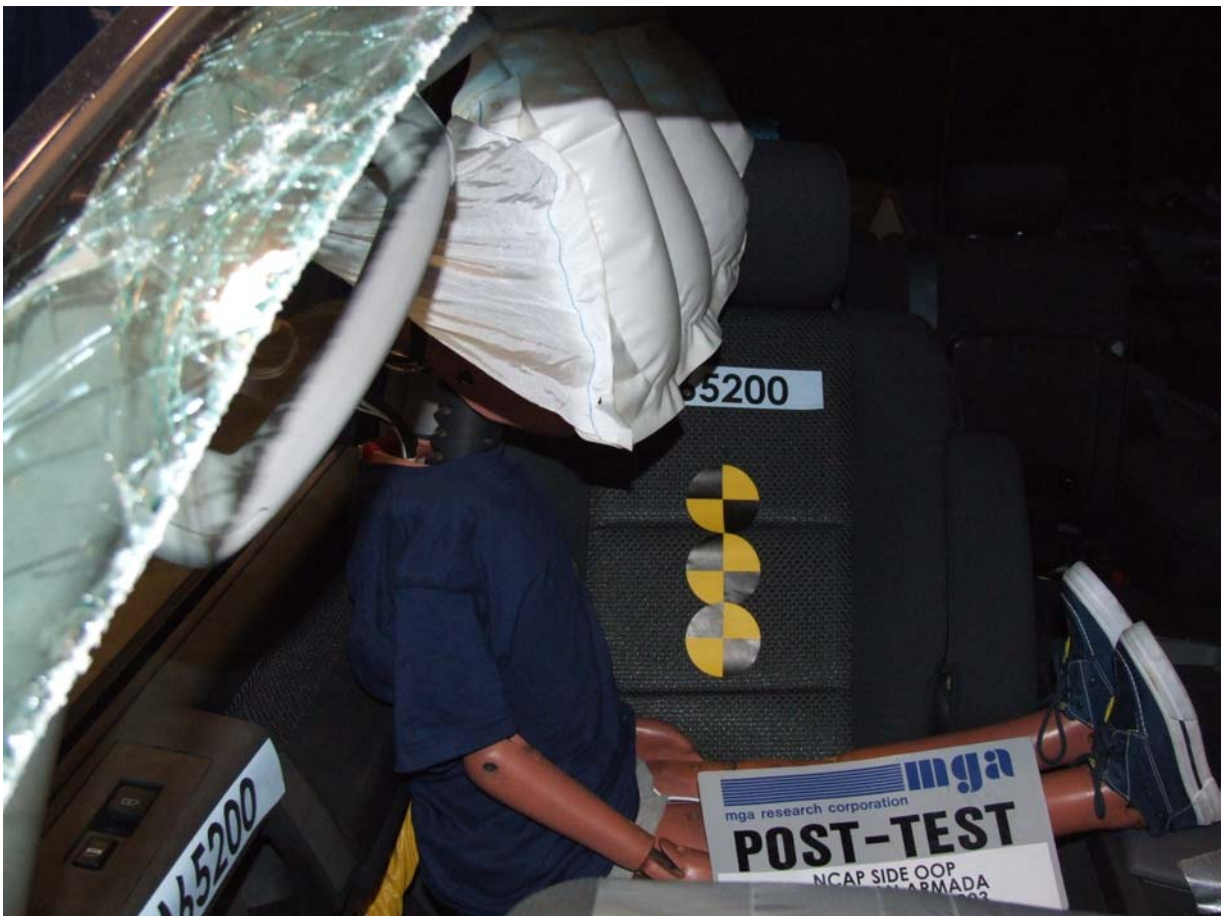
Post-Test Child Dummy Right Side View

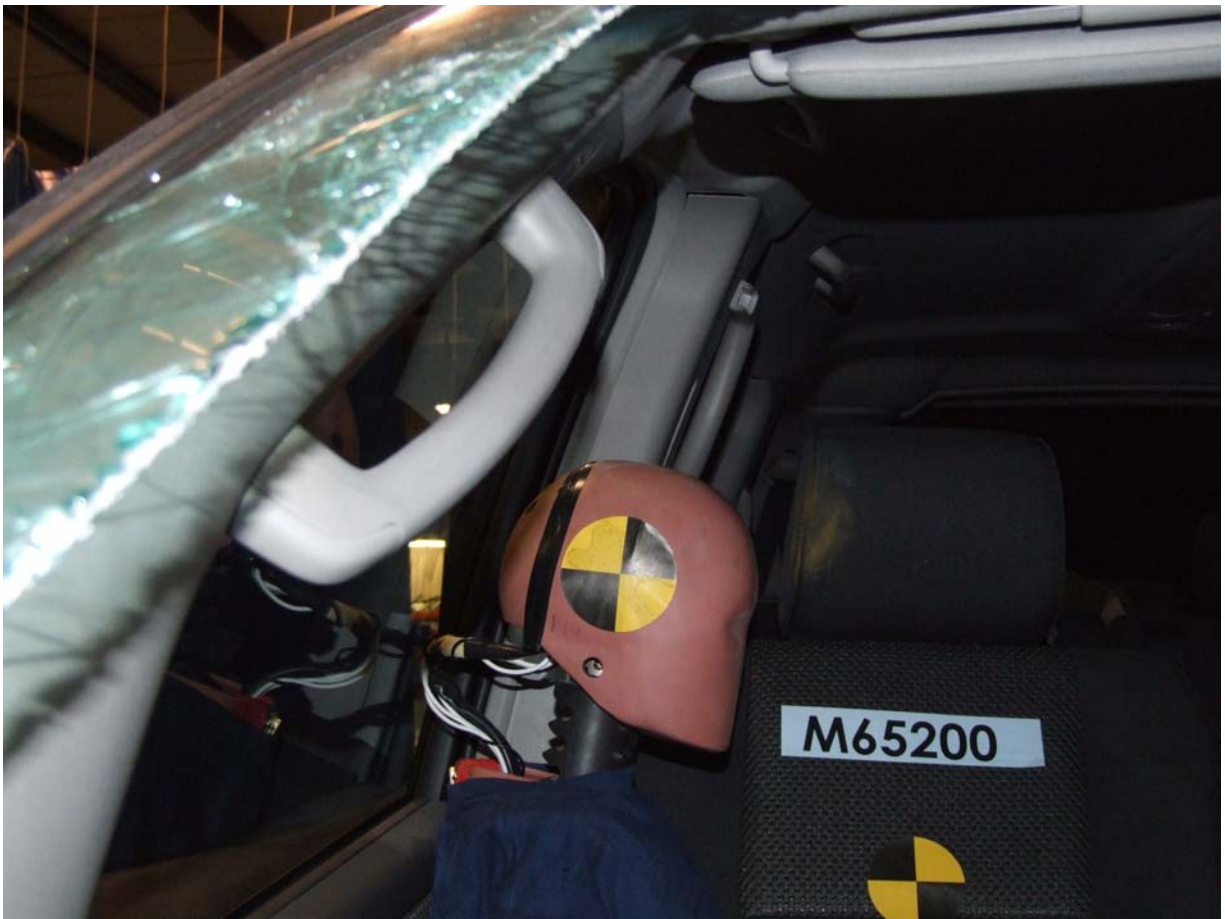
Pre-Test Child Dummy Head View

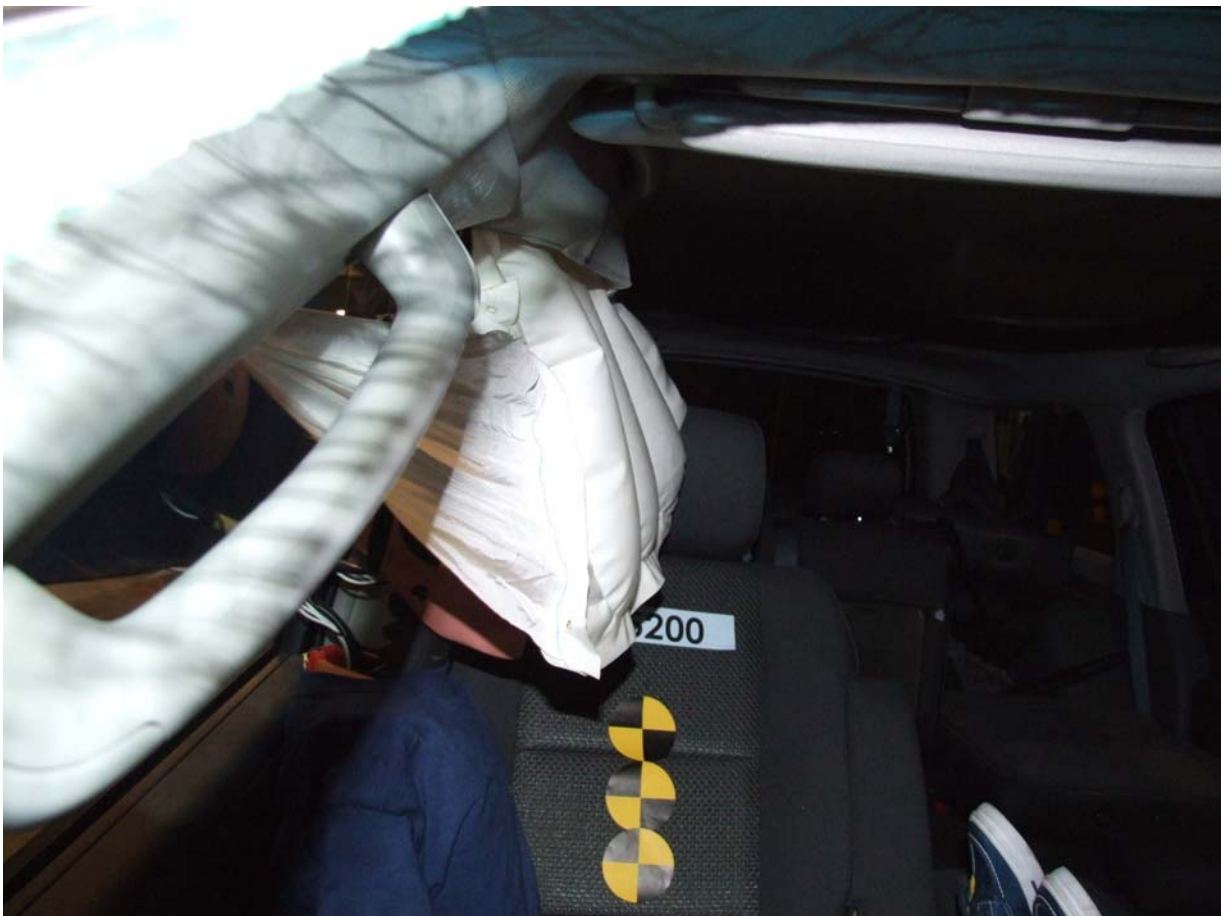
Post-Test Child Dummy Head View

| Visible Dummy Contact Points | |
|---|---|
| Head Contact | Curtain airbag to the top of the head |

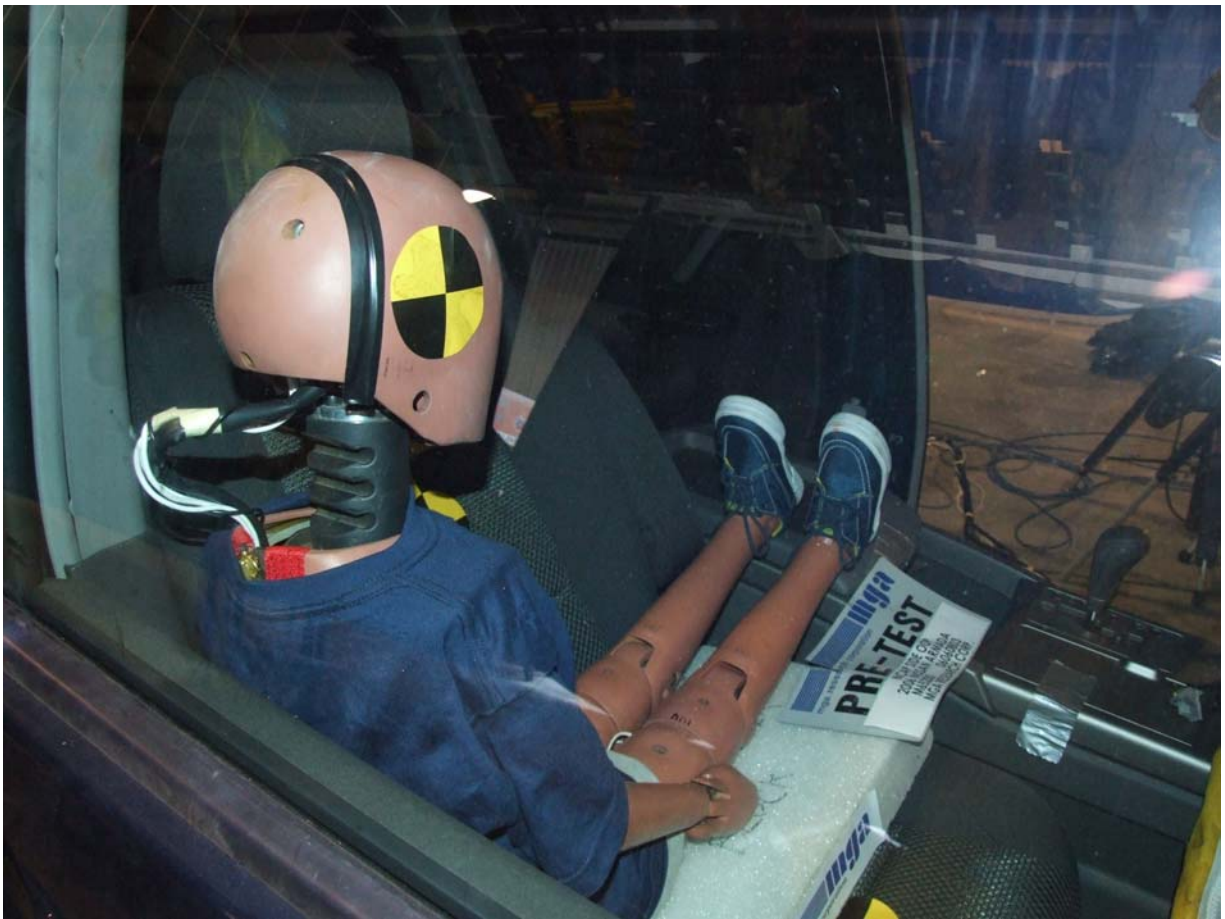
Pre-Test Child Dummy Head View (Through Window)

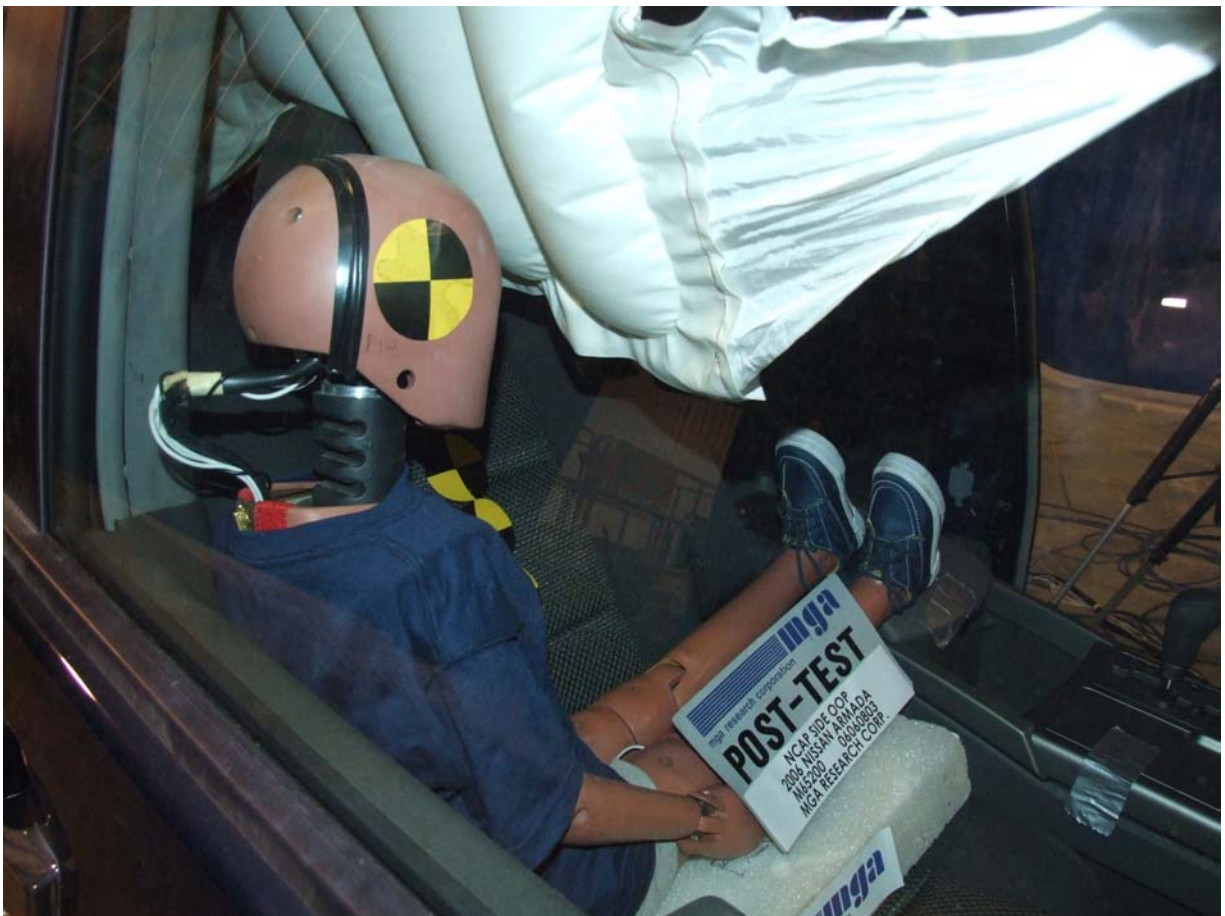
Post-Test Child Dummy Head View (Through Window)

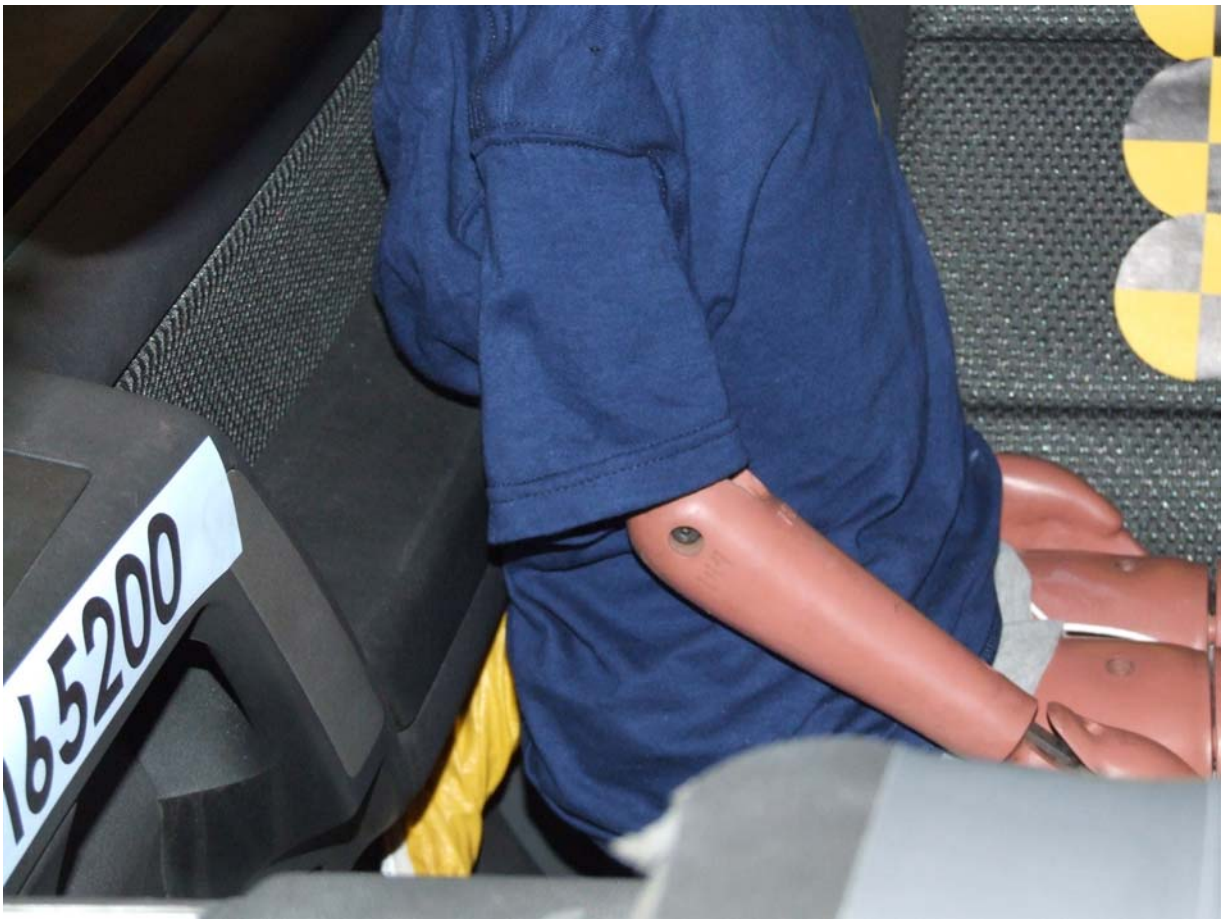
Pre-Test Child Dummy Torso View

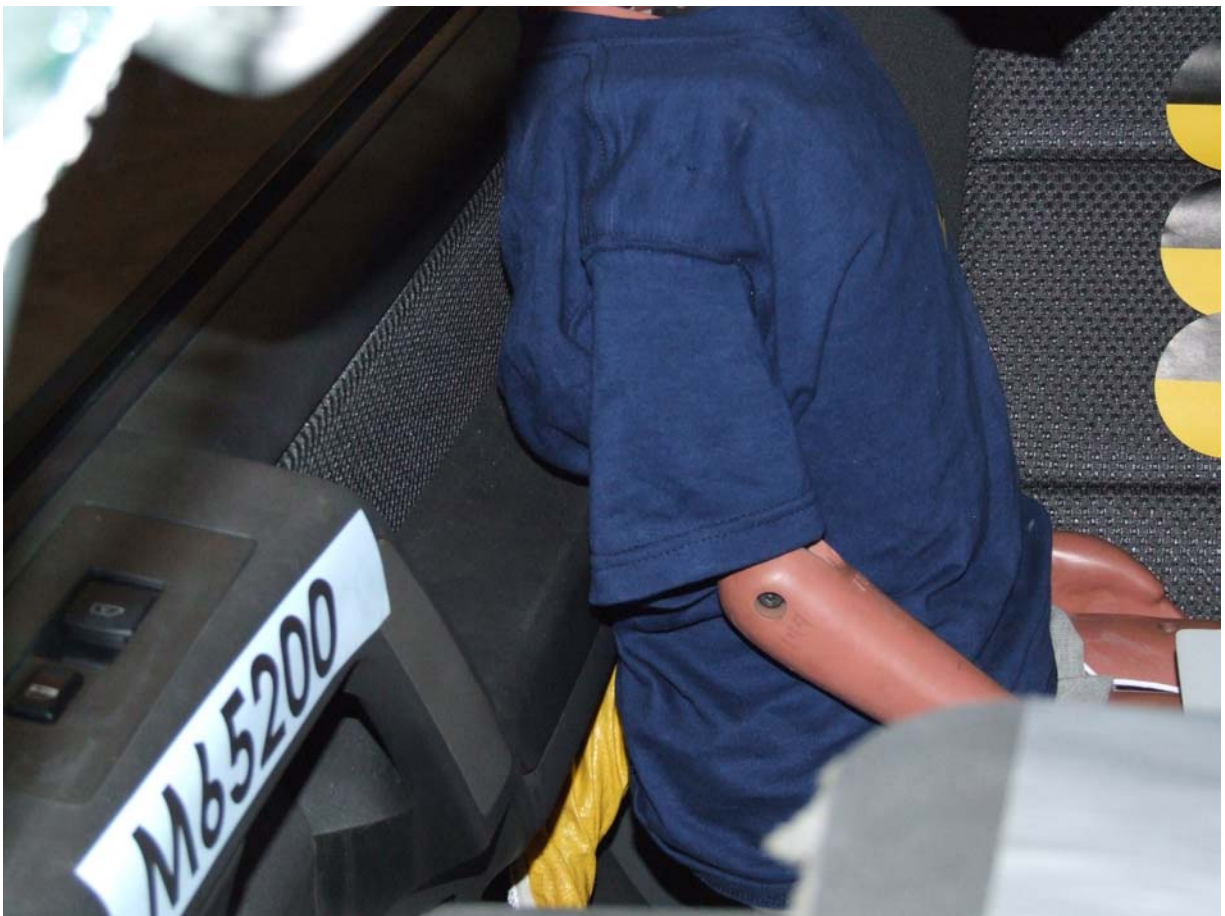
Post-Test Child Dummy Torso View

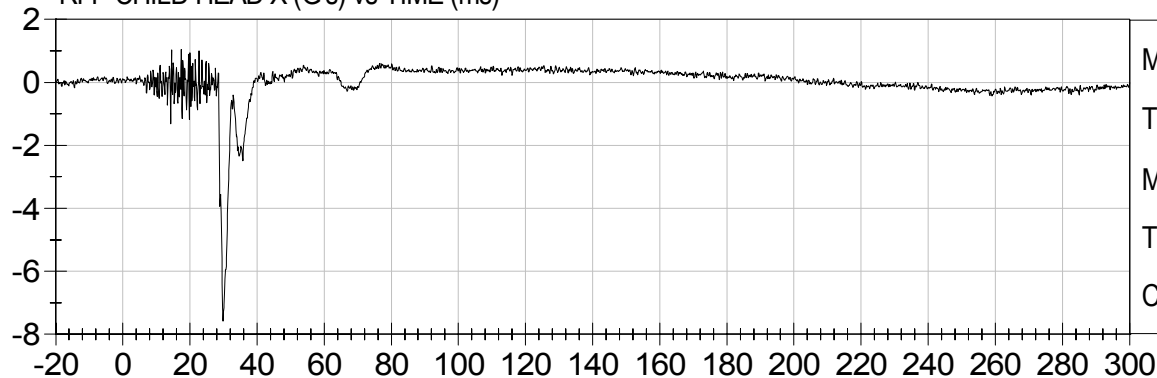
RFP CHILD HEAD X (G's) vs TIME (ms)

Max: 1.1 G's  
Tmax: 17.4 ms  
Min: -7.6 G's  
Tmin: 29.8 ms  
CFC 1000

| | | MAXIMUM VALUE | | | |
|---|---|---|---|---|---|
| Head X | g | 1.1 | 17.4 | -7.6 | 29.8 |

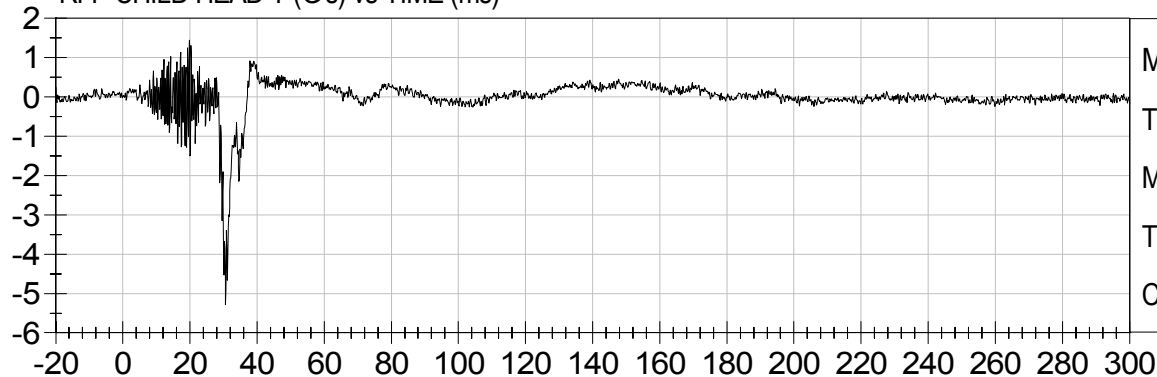
RFP CHILD HEAD Y (G's) vs TIME (ms)

Max: 1.4 G's  
Tmax: 19.8 ms  
Min: -5.3 G's  
Tmin: 30.6 ms  
CFC 1000

| | | MAXIMUM VALUE | | | |
|---|---|---|---|---|---|
| Head Y | g | 1.4 | 19.8 | -5.3 | 30.6 |

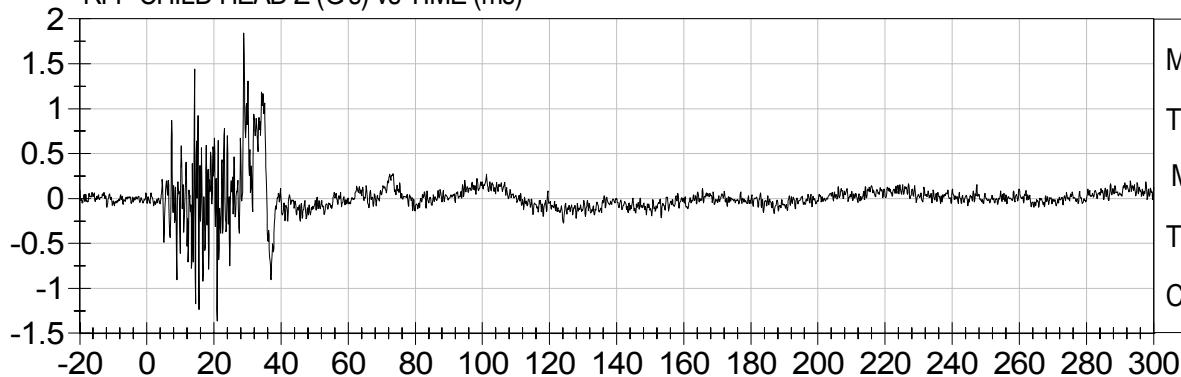
RFP CHILD HEAD Z (G's) vs TIME (ms)

Max: 1.8 G's  
Tmax: 28.9 ms  
Min: -1.4 G's  
Tmin: 21.0 ms  
CFC 1000

| | | MAXIMUM VALUE | | | |
|---|---|---|---|---|---|
| Head Z | g | 1.8 | 28.9 | -1.4 | 21.0 |

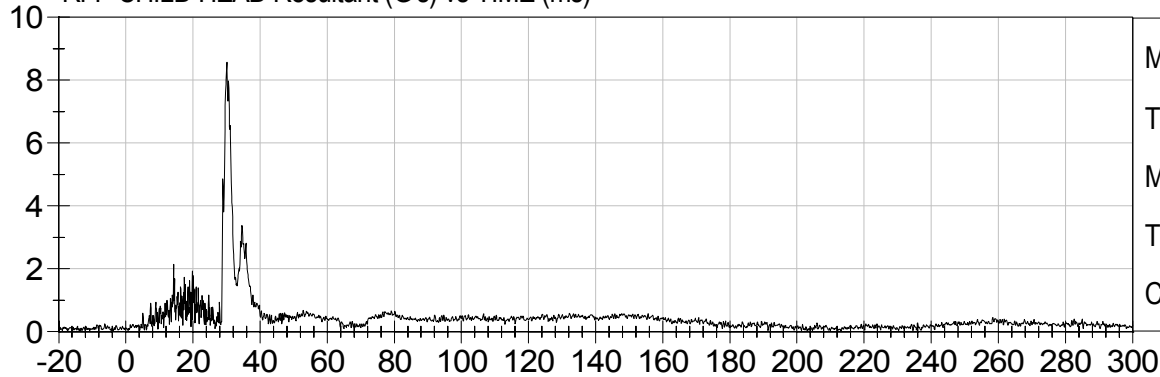
RFP CHILD HEAD Resultant (G's) vs TIME (ms)

Max: 8.6 G's  
Tmax: 30.1 ms  
Min: 0.0 G's  
Tmin: 0.0 ms  
CFC 1000

| | | MAXIMUM VALUE | | | |
|---|---|---|---|---|---|
| Head Resultant | g | 8.6 | 30.1 | 0.0 | 0.0 |
