**REPORT NUMBER TR-P27003-02-NC**

**NEW CAR ASSESSMENT PROGRAM  
SIDE IMPACT TEST**

**TOYOTA MOTOR CORPORATION  
2007 LEXUS ES 350  
4-DOOR SEDAN**

**FINAL REPORT**

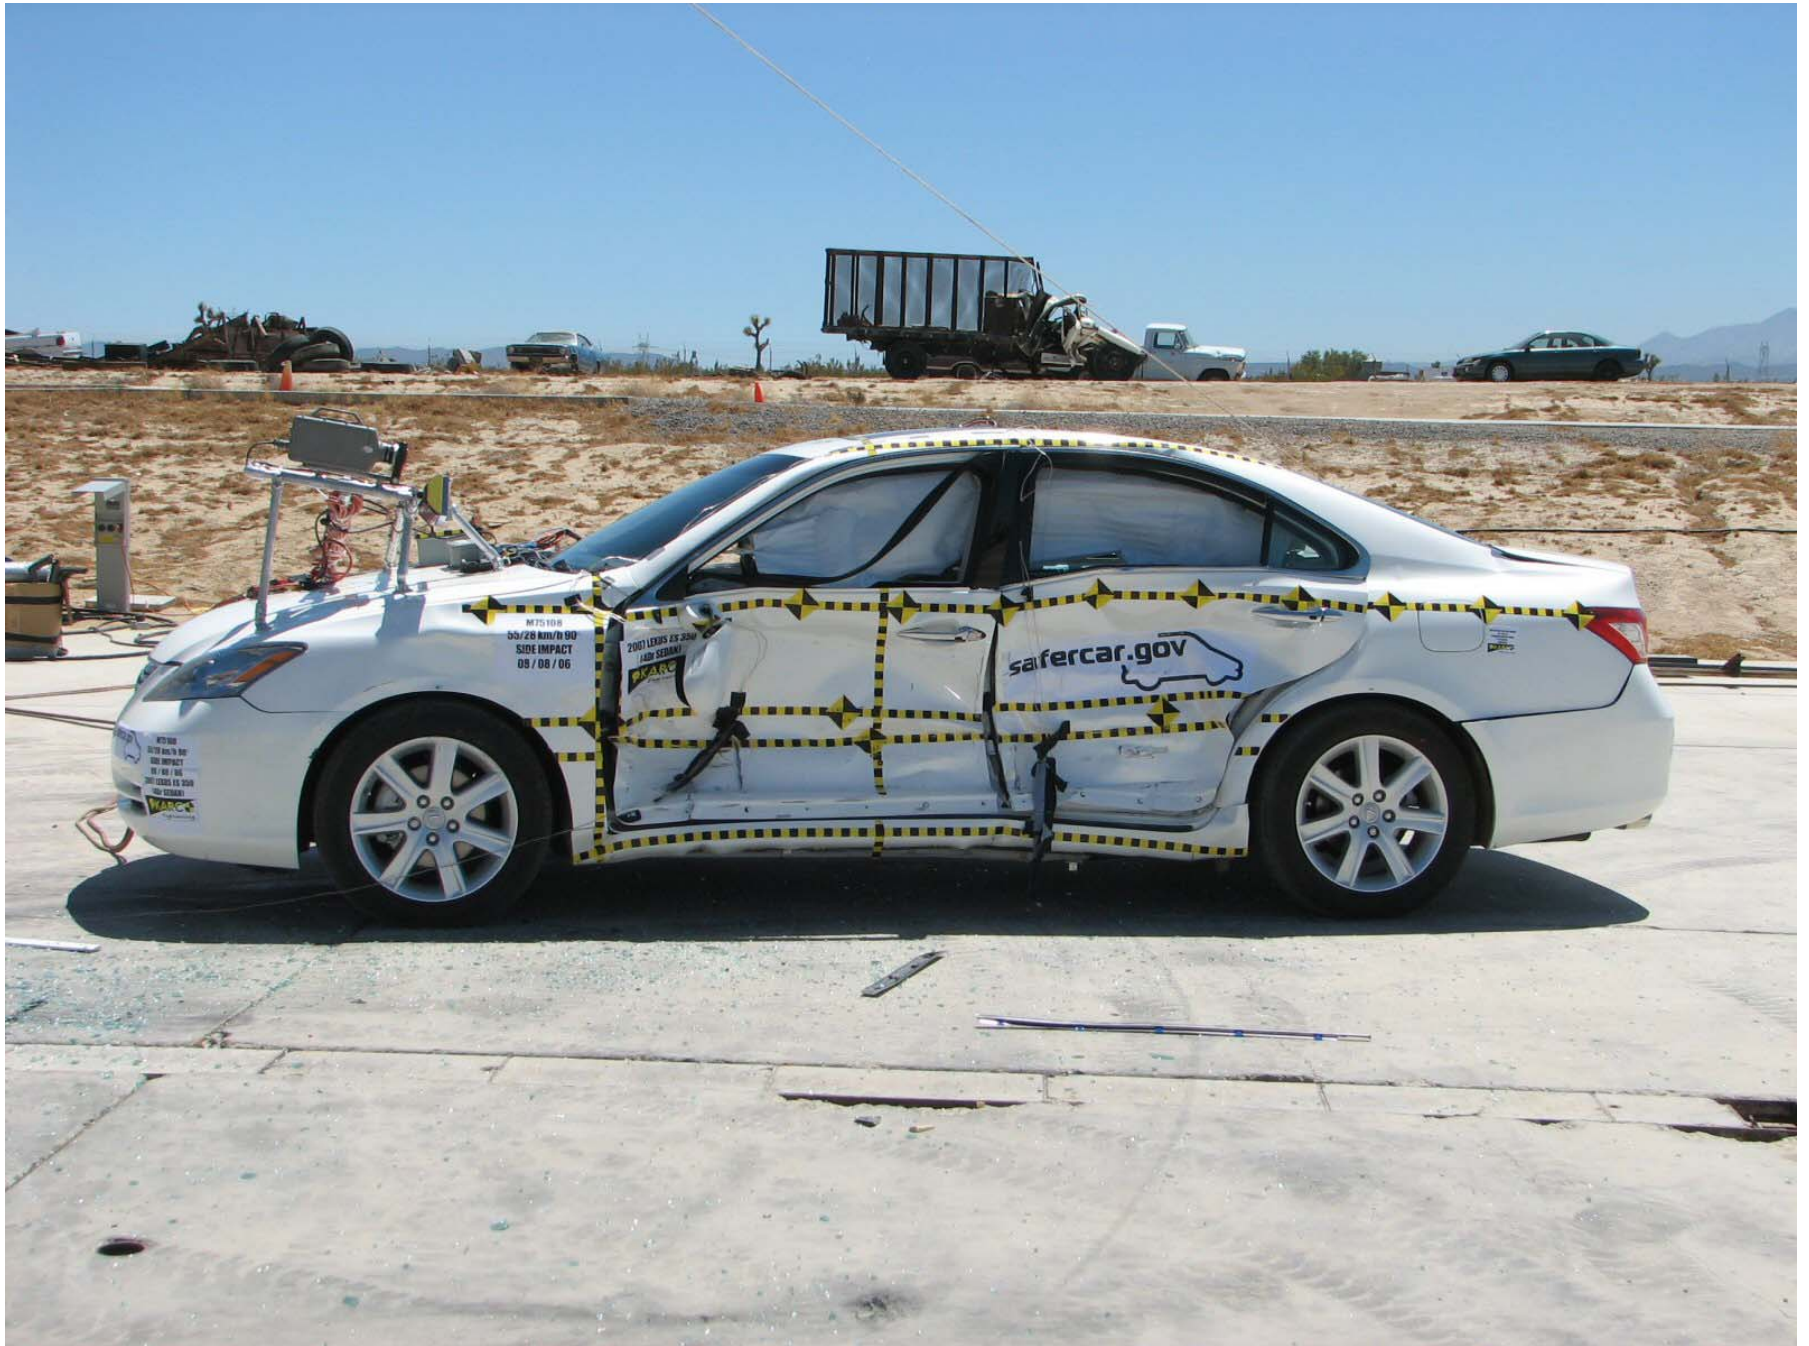
Figure A-10: Post-Test Left Side View

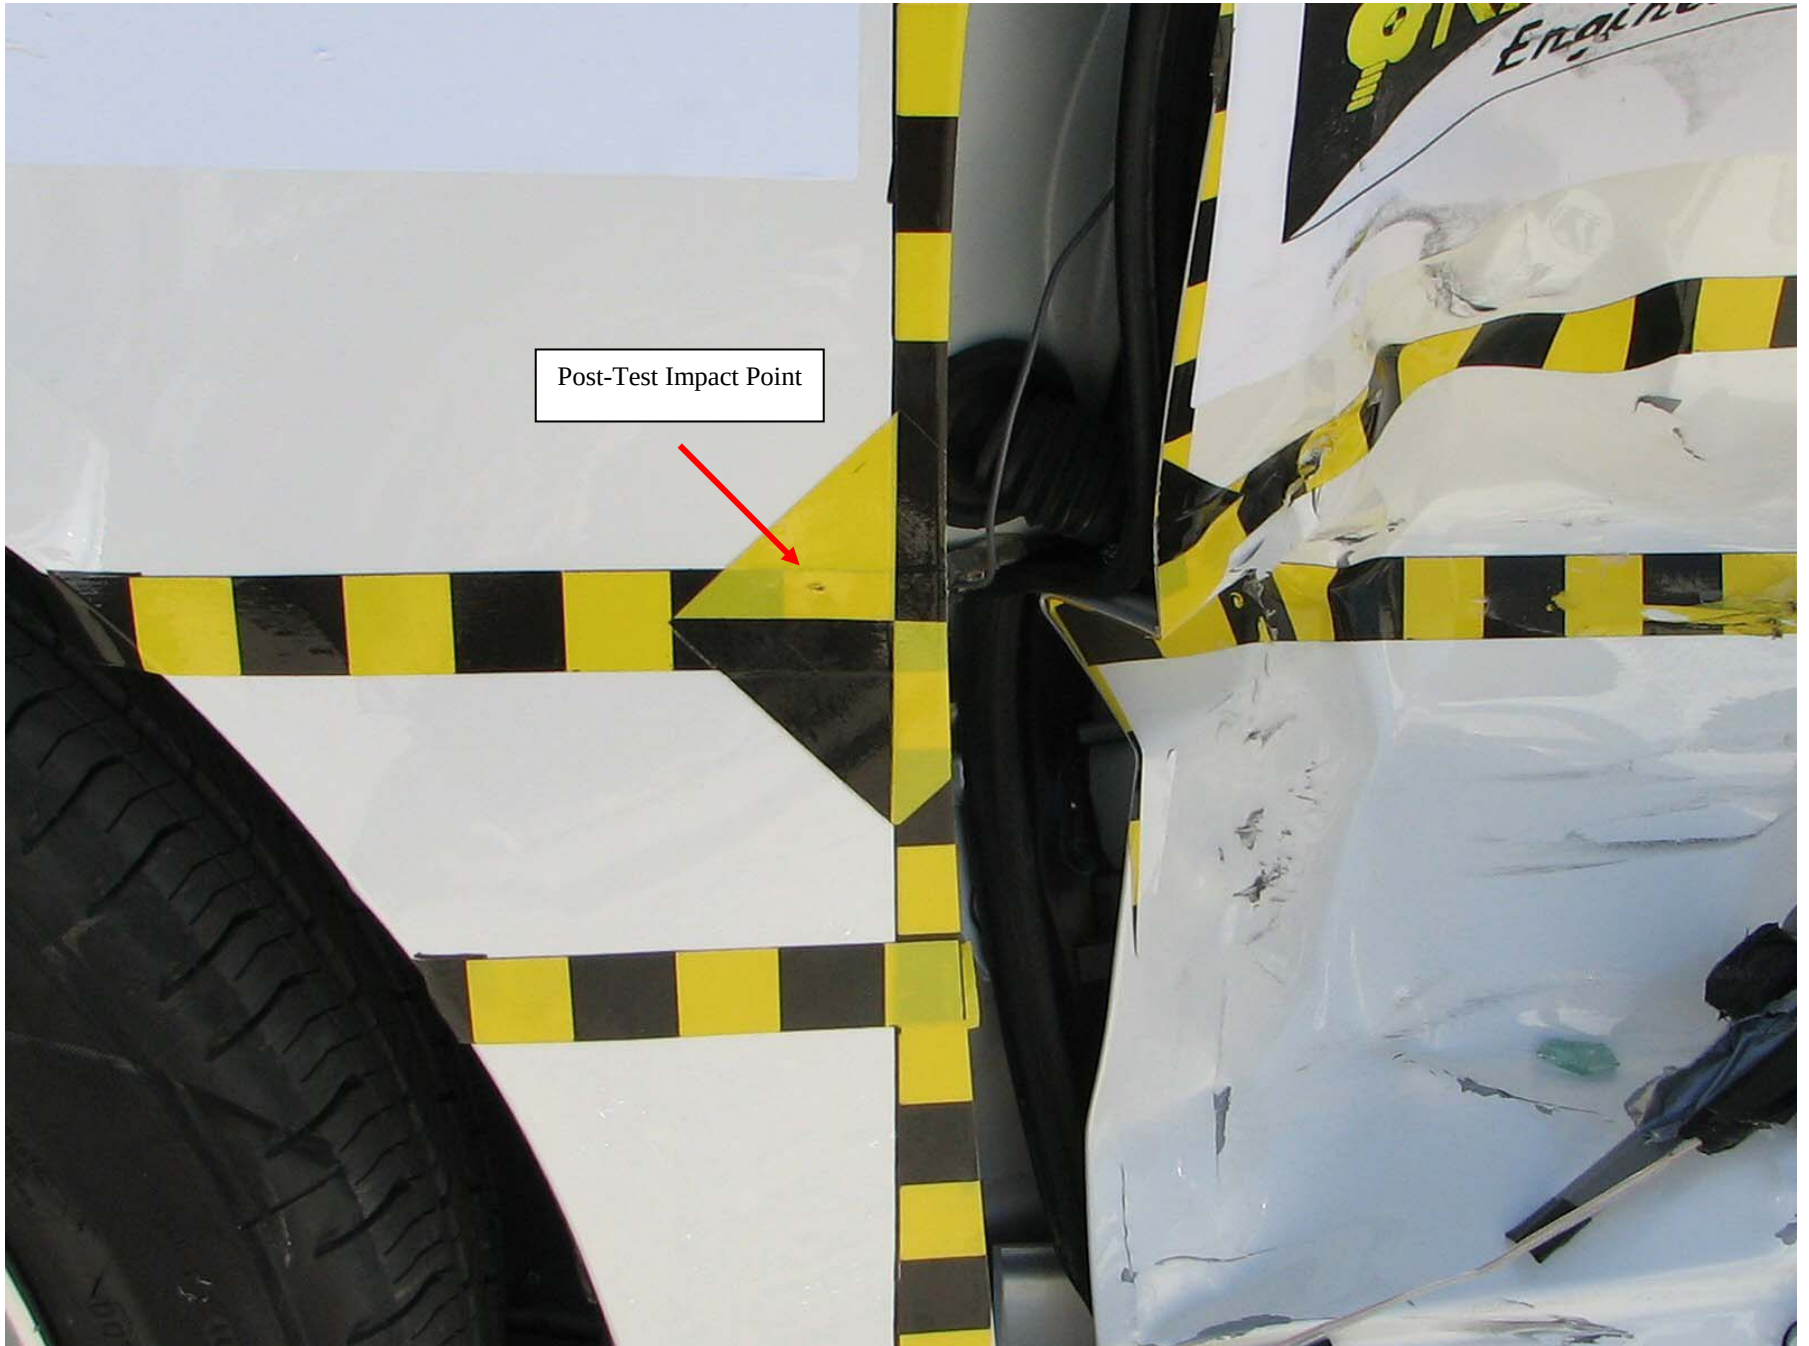
Figure A-26: Post-Test Left Impact Point

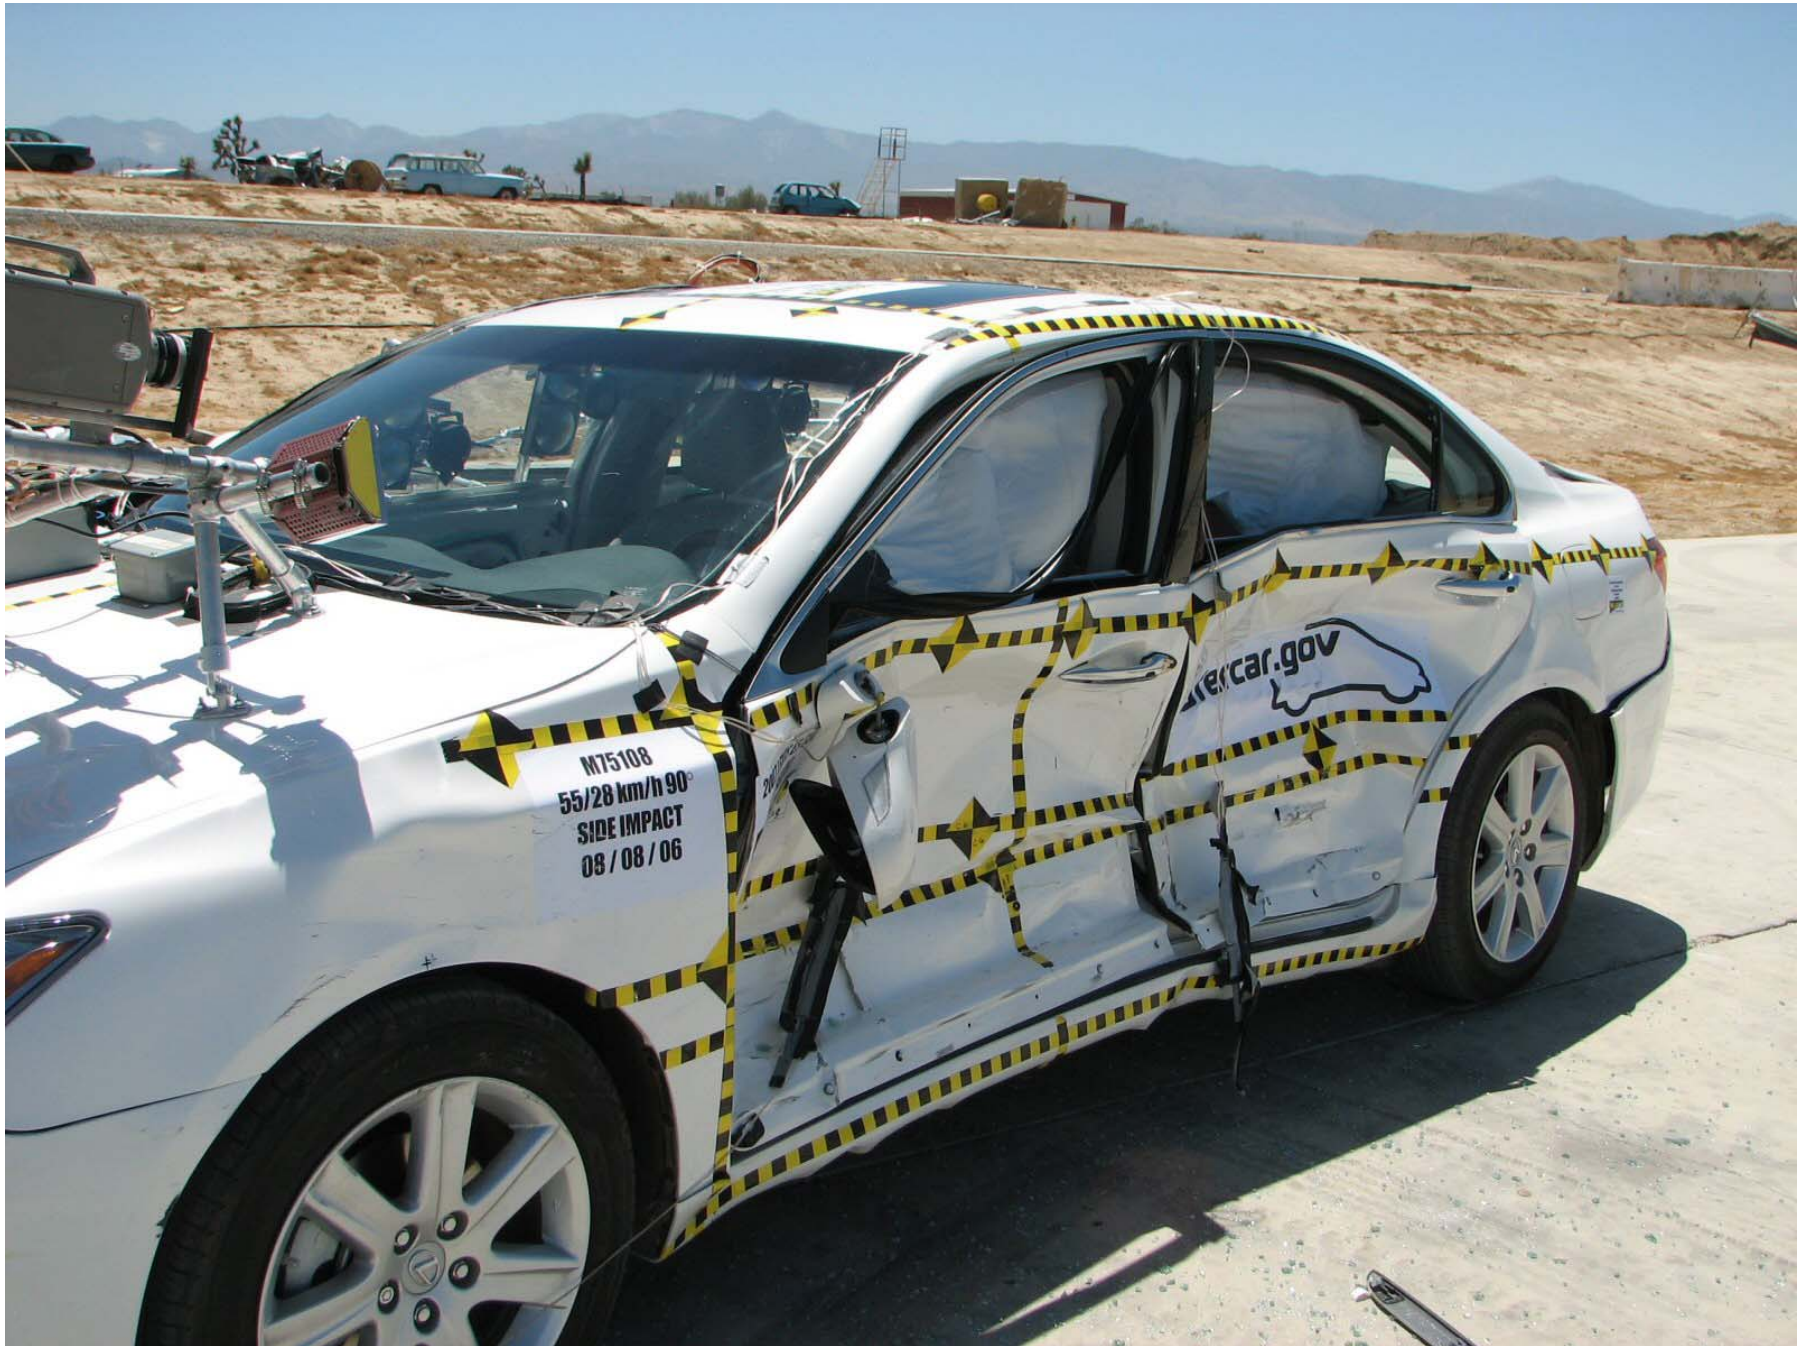
Figure A-28: Post-Test Front  $\frac{3}{4}$  View of Left Side Door

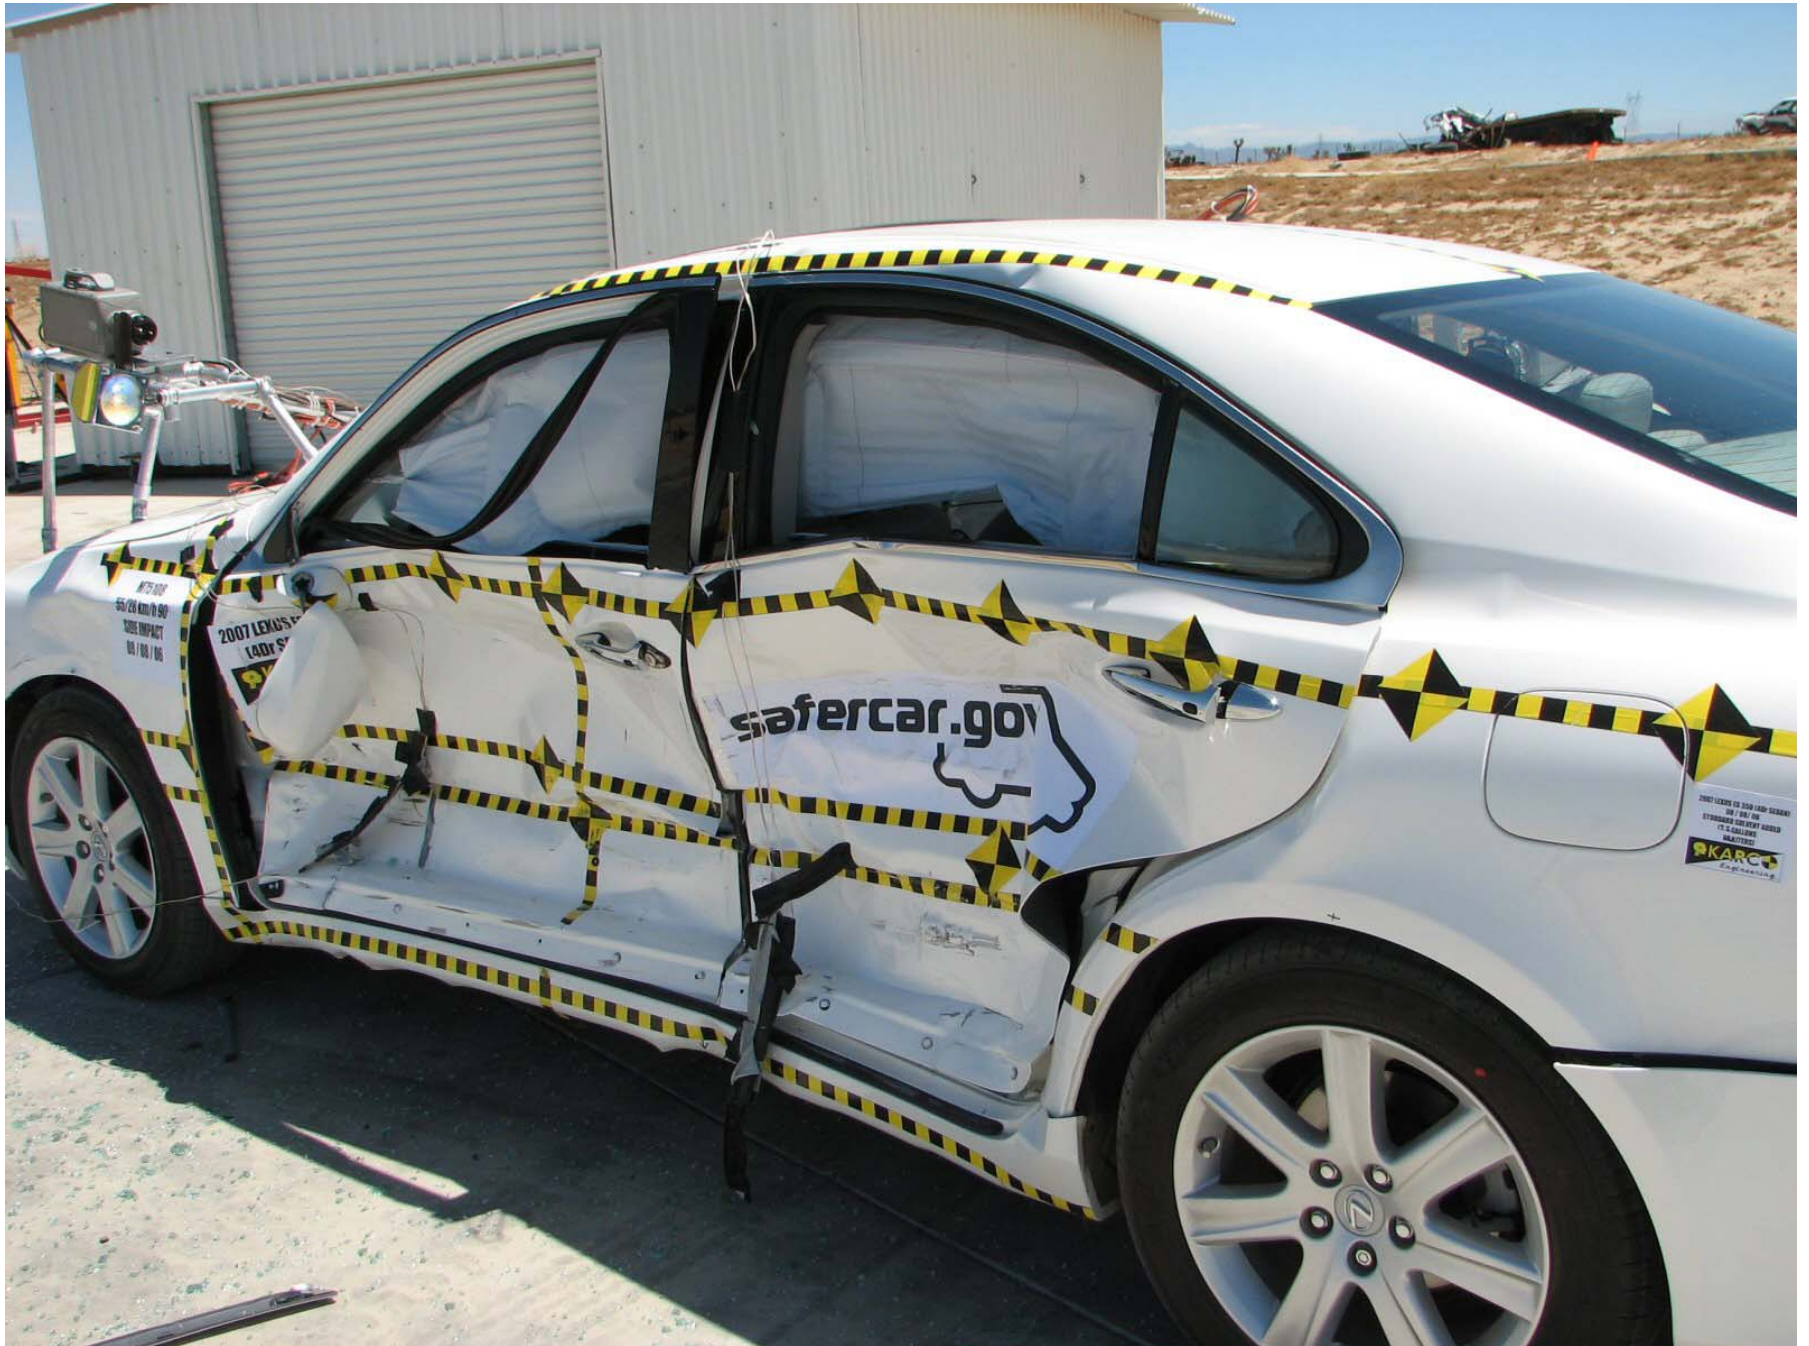
Figure A-30: Post-Test Rear  $\frac{3}{4}$  View of Left Side Door

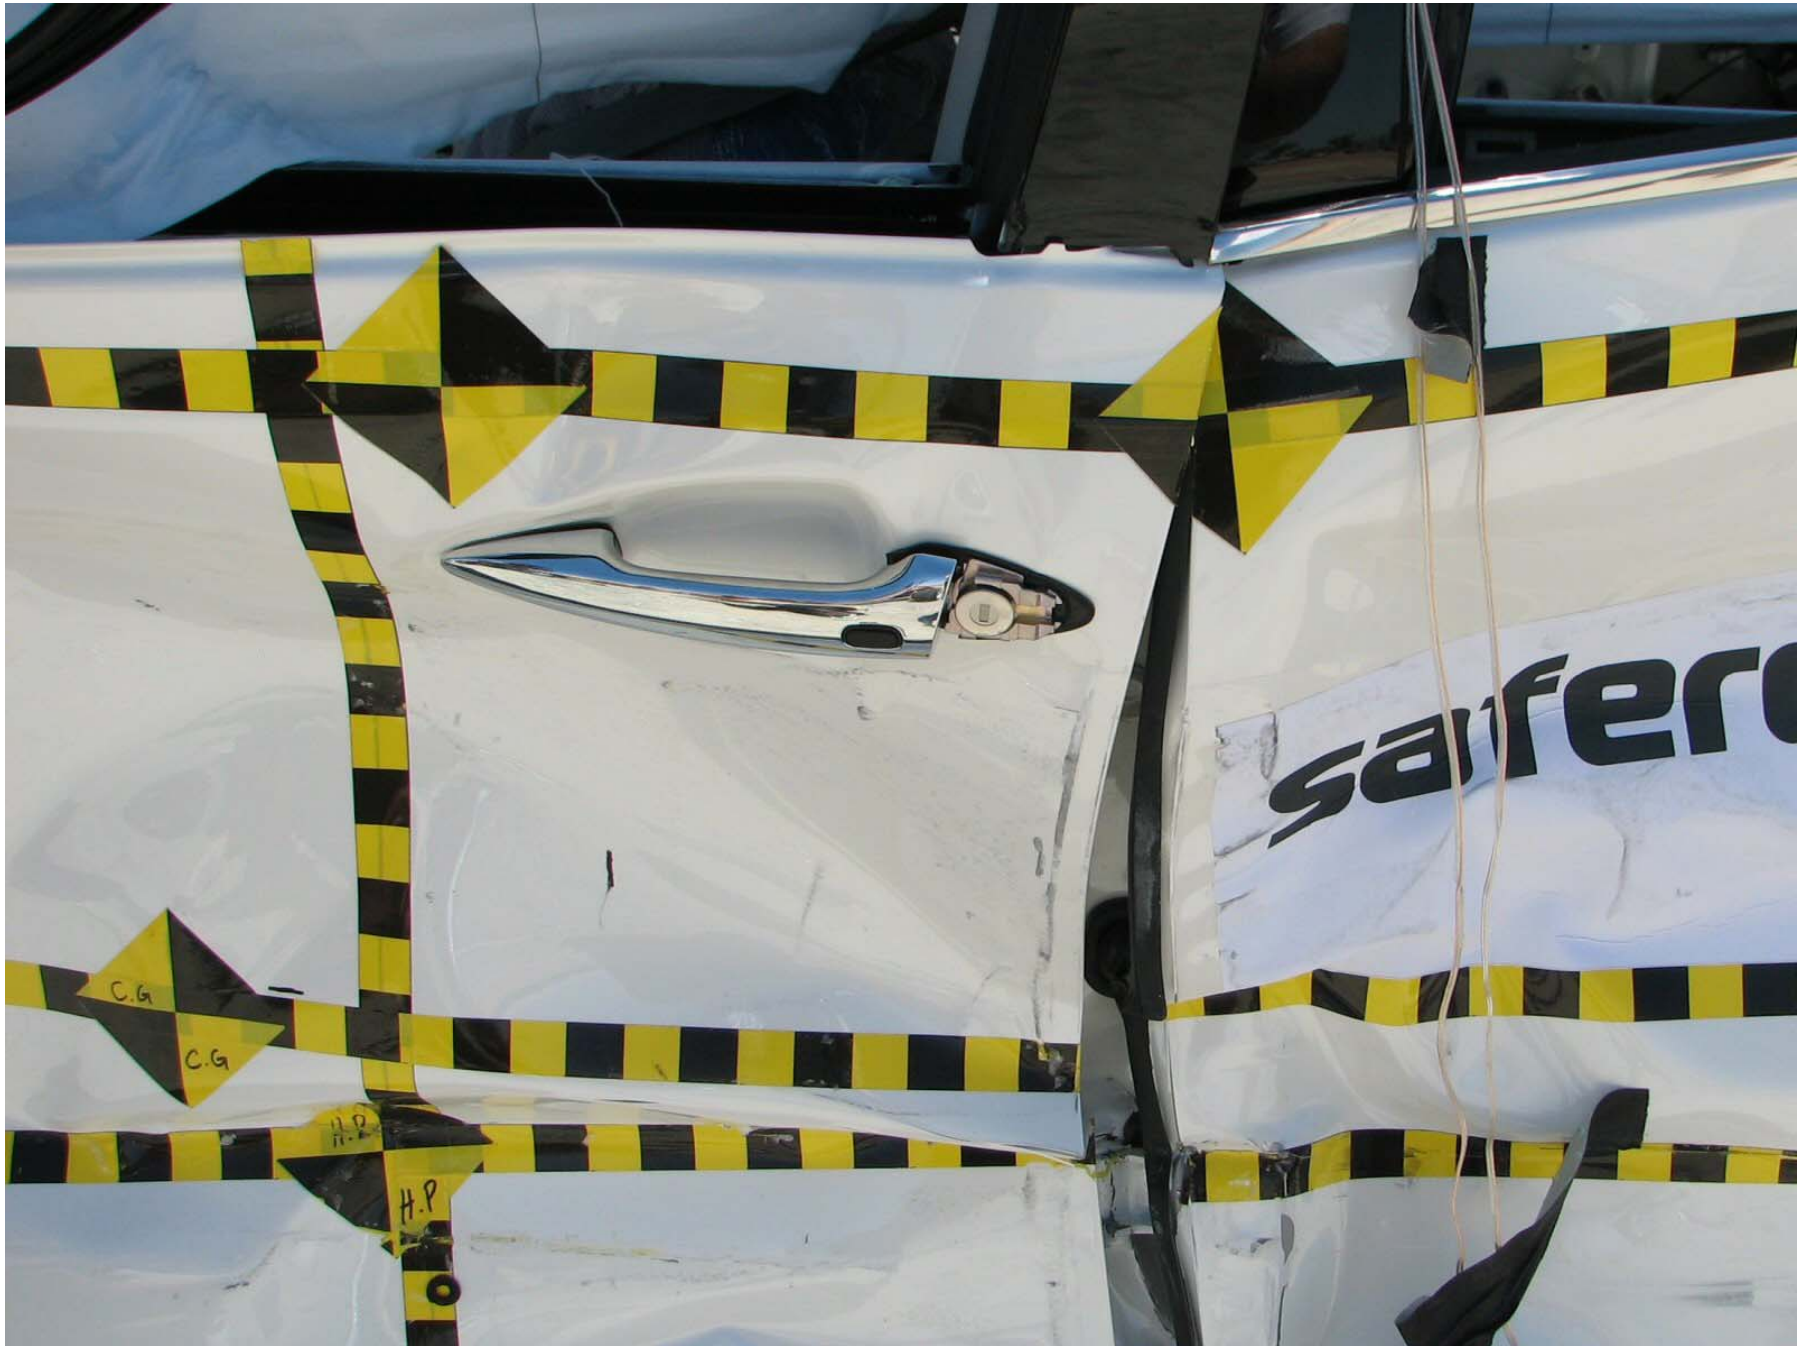
Figure A-32: Post-Test Left Front Door

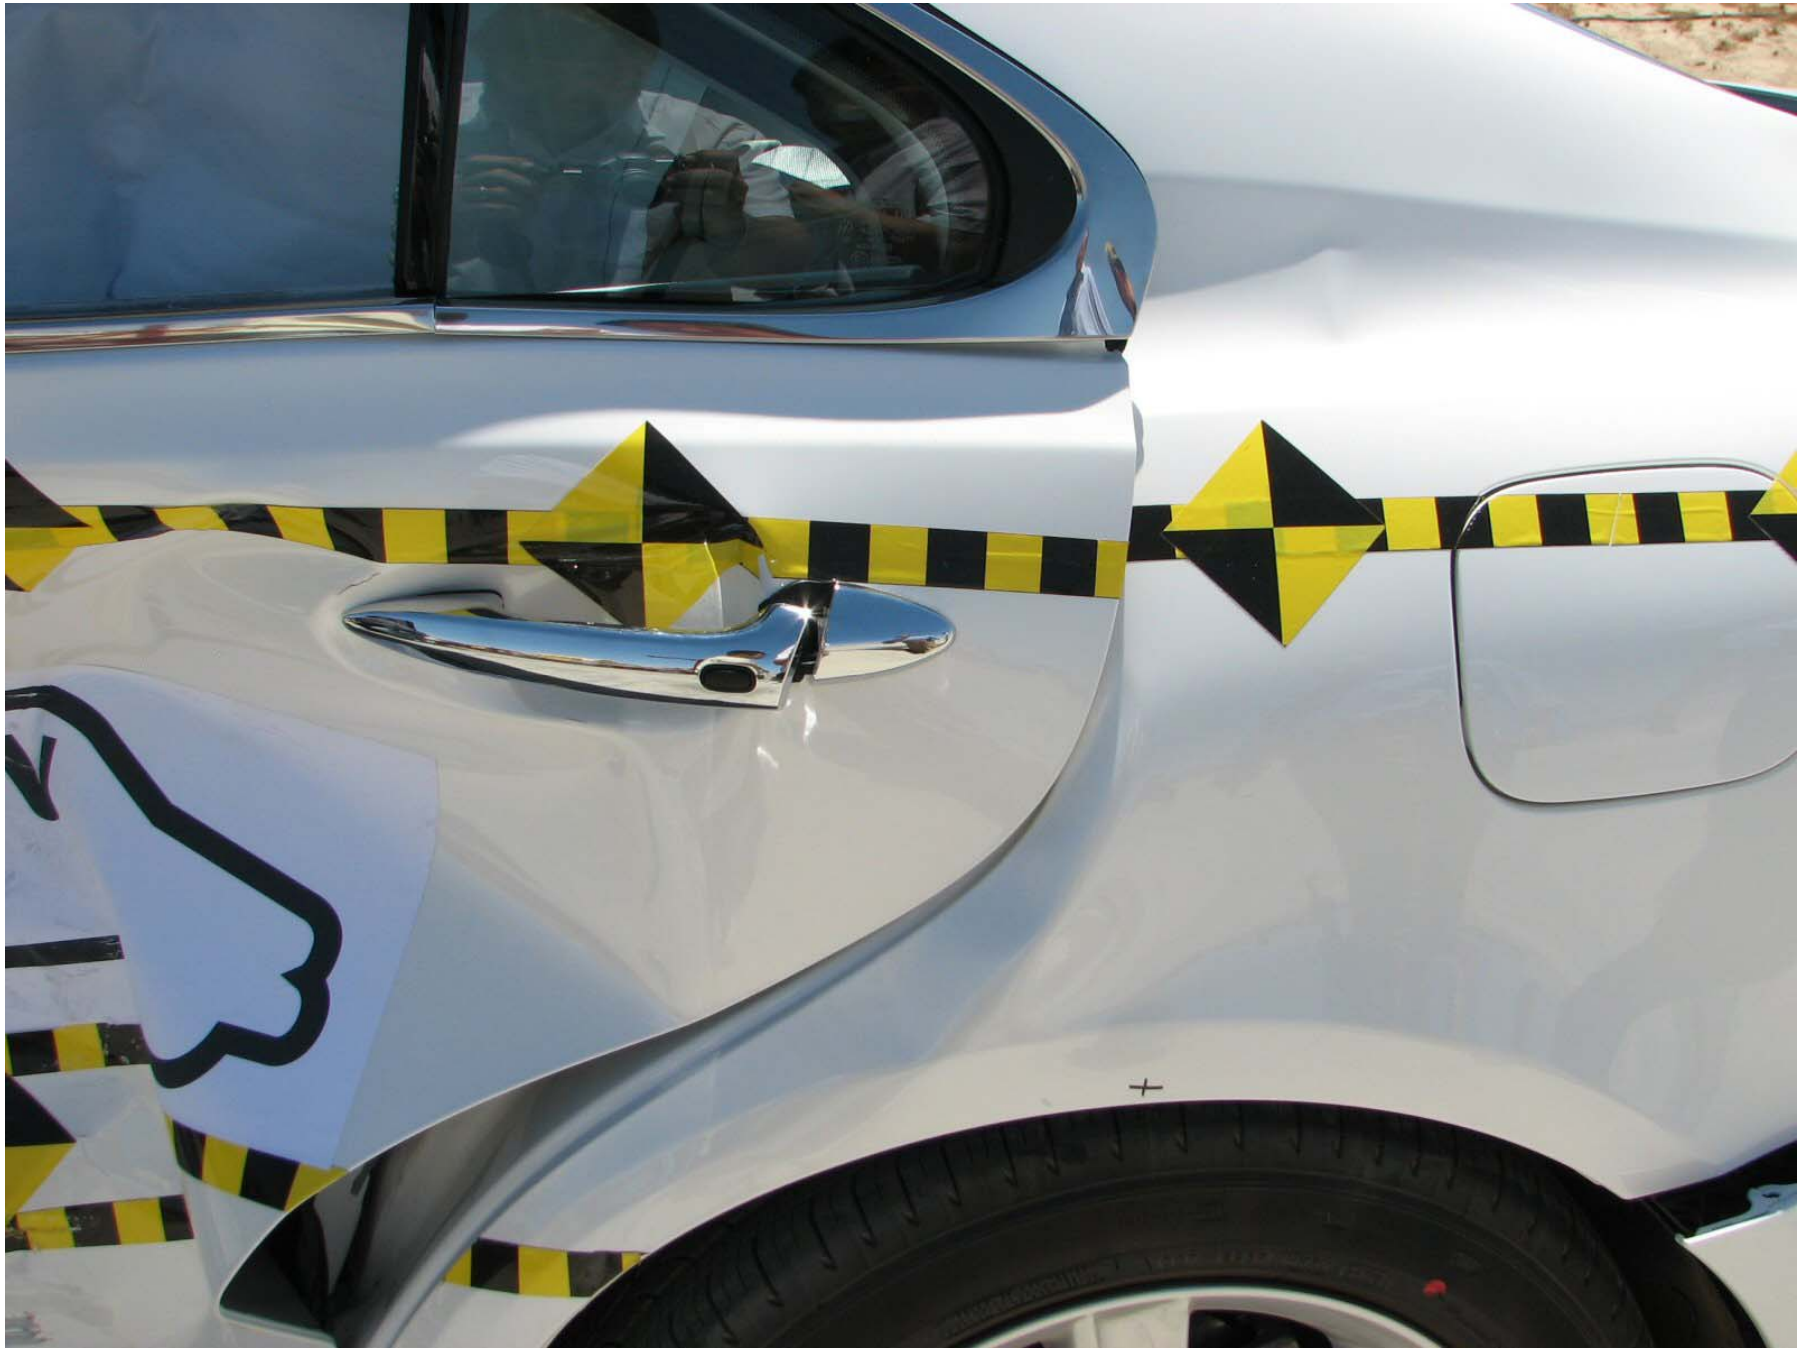
Figure A-34: Post-Test Left Rear Door

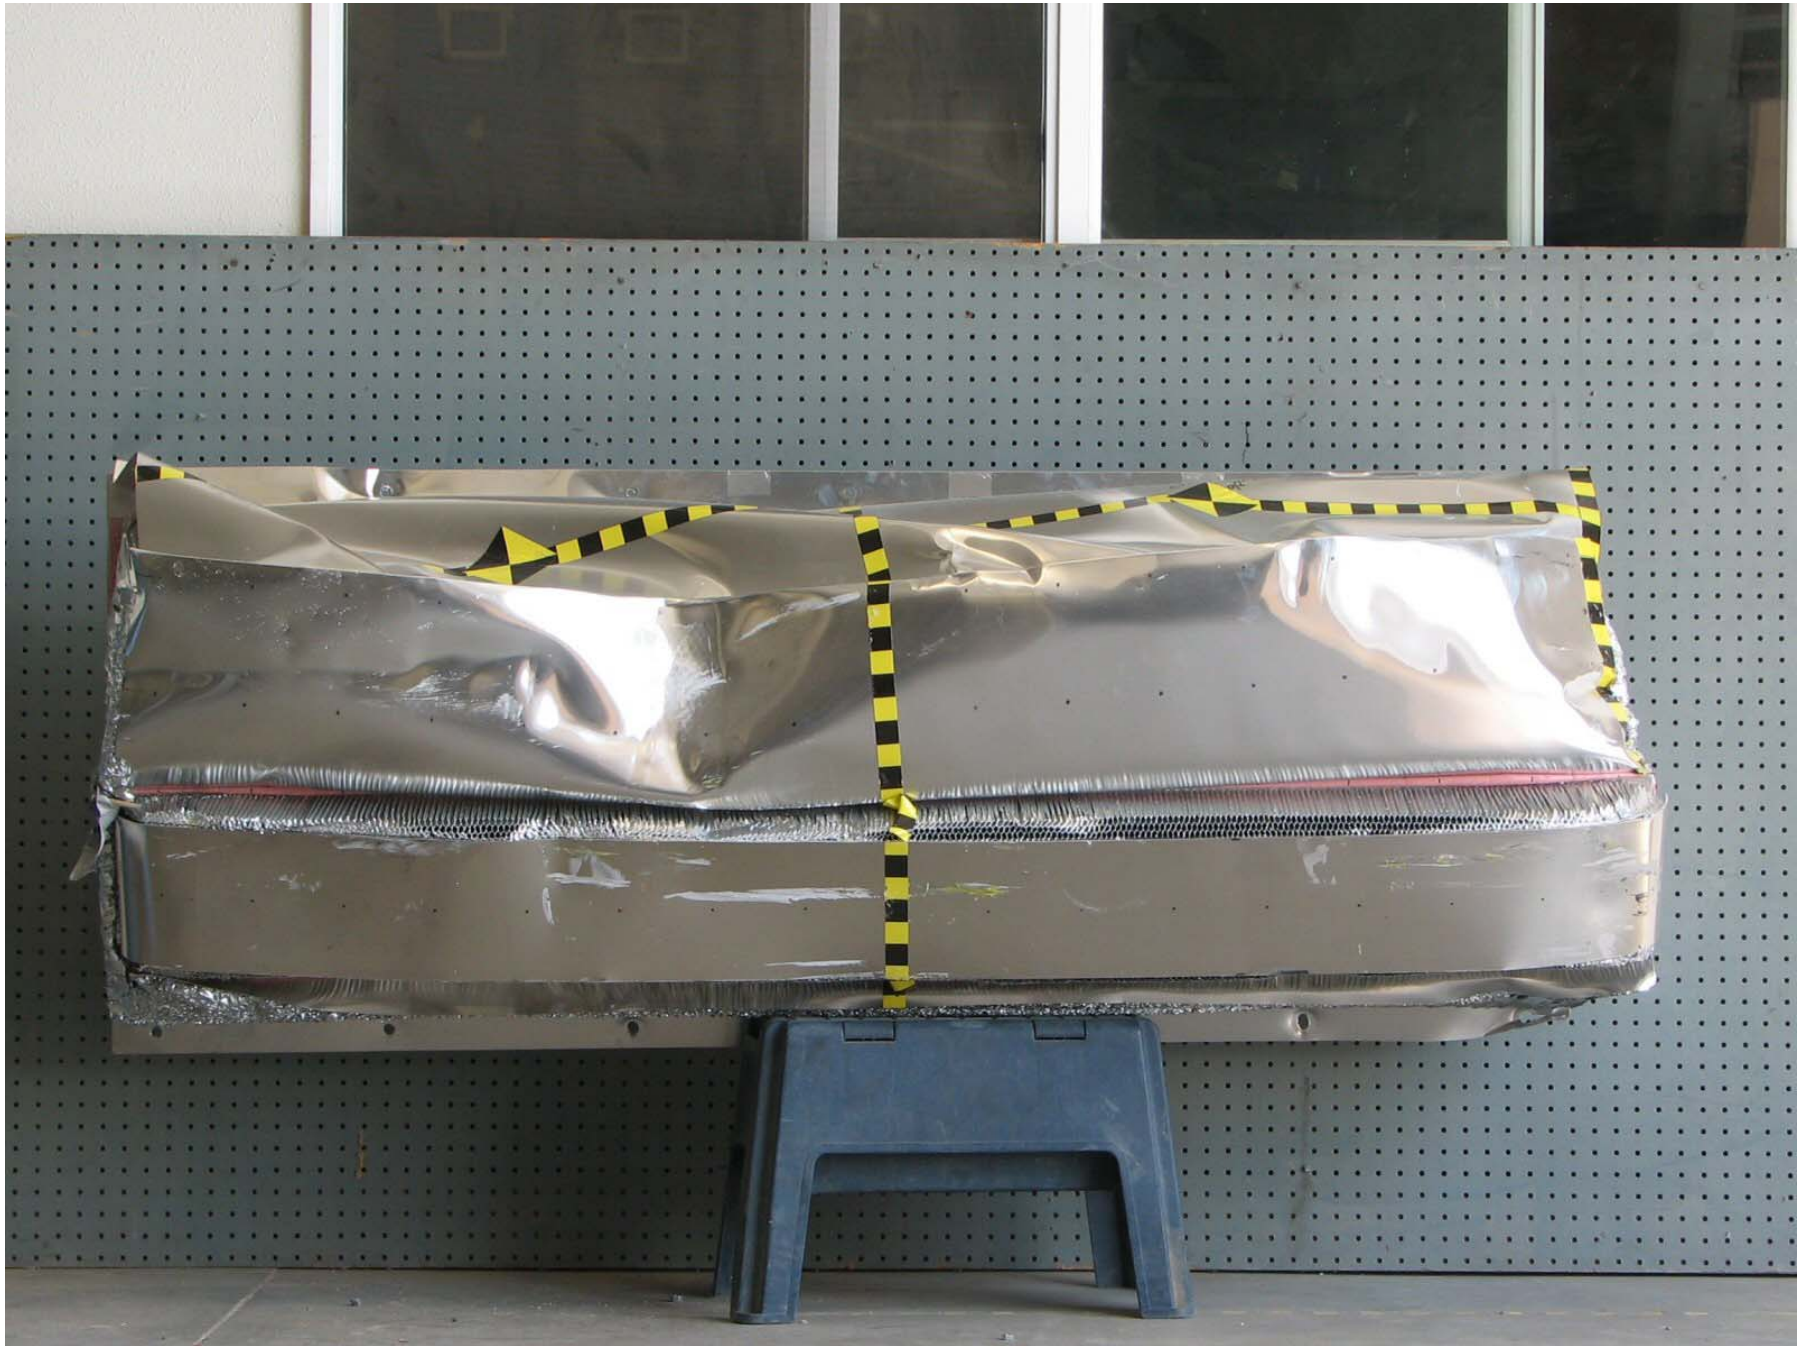
Figure A-54: Post-Test Front View of Deformable Barrier

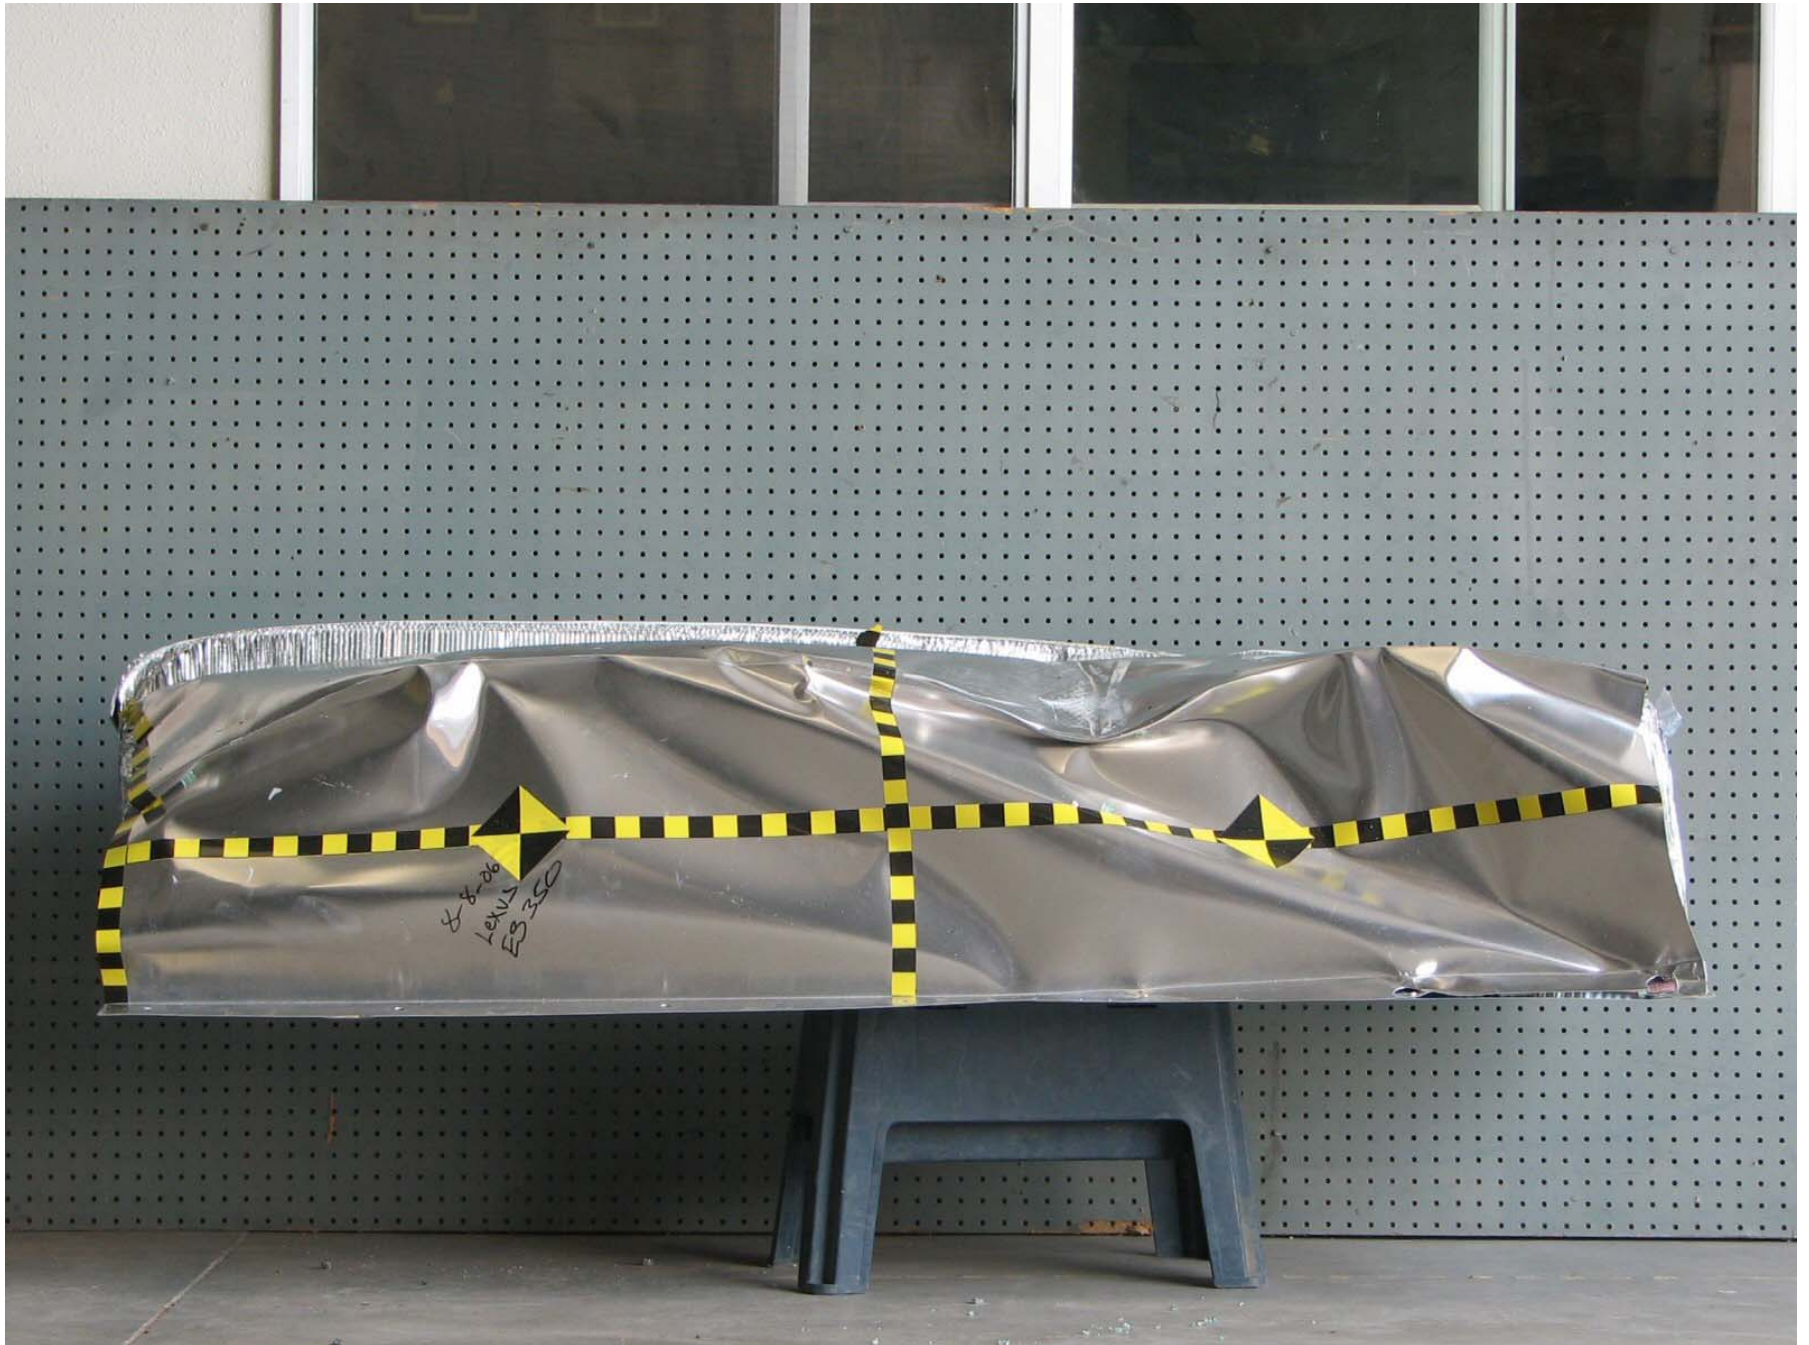
Figure A-56: Post-Test Top View of Deformable Barrier

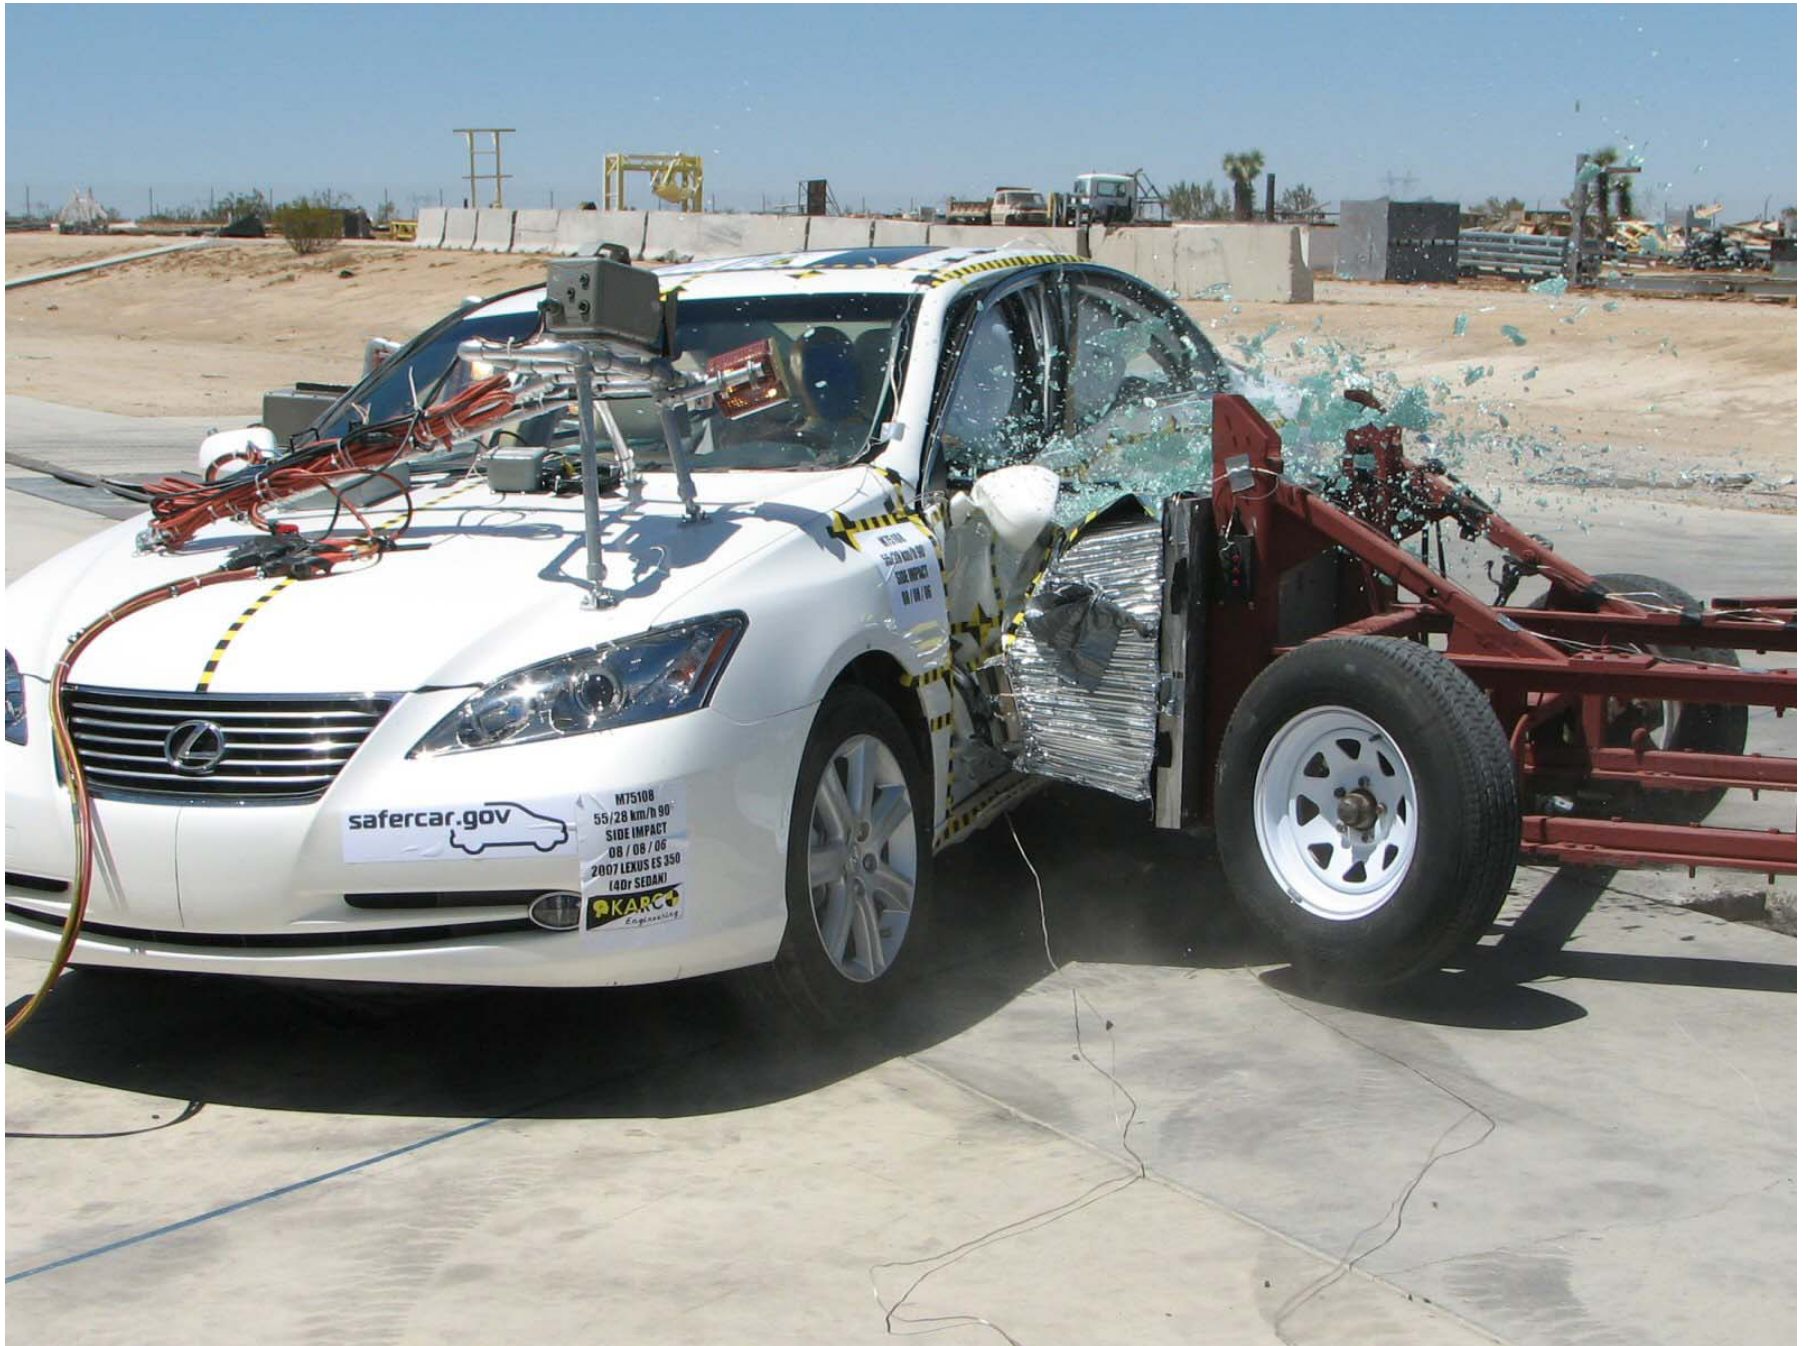
Figure A-65: Vehicle Impact
