REPORT NUMBER: CAL-07-03

**NEW CAR ASSESSMENT PROGRAM (NCAP)  
FRONTAL BARRIER IMPACT TEST**

FORD MOTOR COMPANY  
2007 FORD RANGER  
TWO-DOOR PICKUP

FINAL REPORT

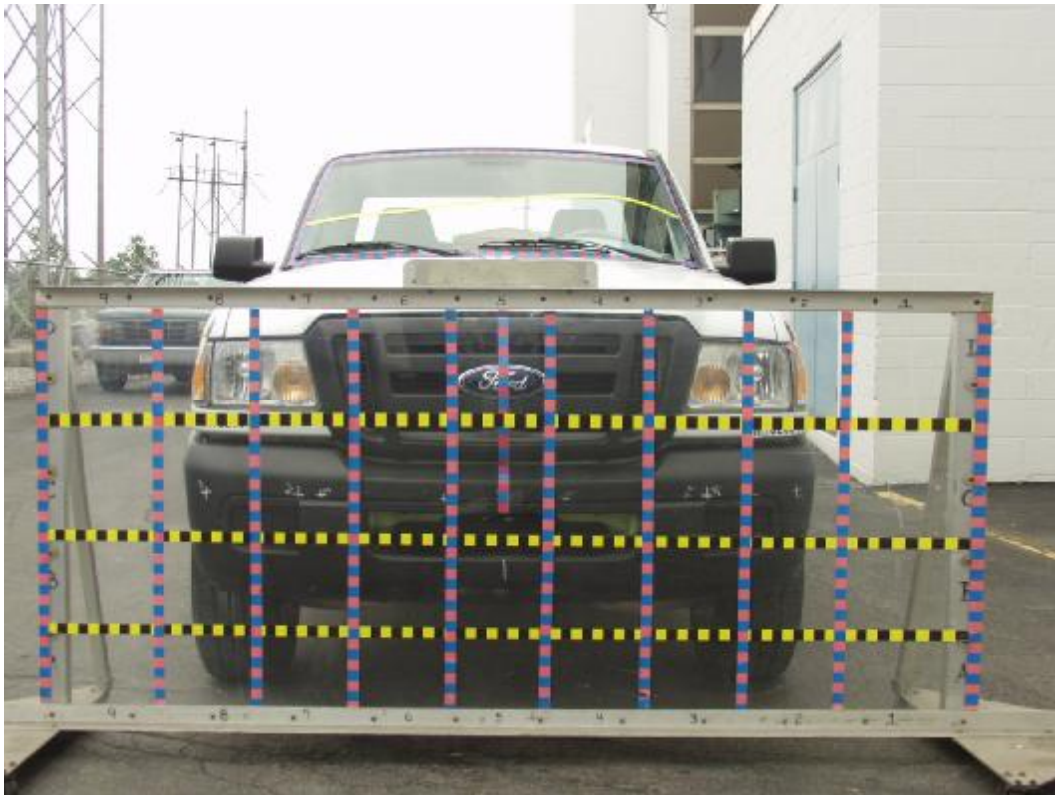
**Figure A-1: Load Cell Locations**

A load cell barrier consisting of 36 load cells was impacted by a 2007 Ford Ranger Two-Door Pickup at a velocity of 56.65 kph. The test was performed at Calspan on August 15, 2006. Pre- and post-test photographs of the vehicle and dummies can be found in Appendix A.

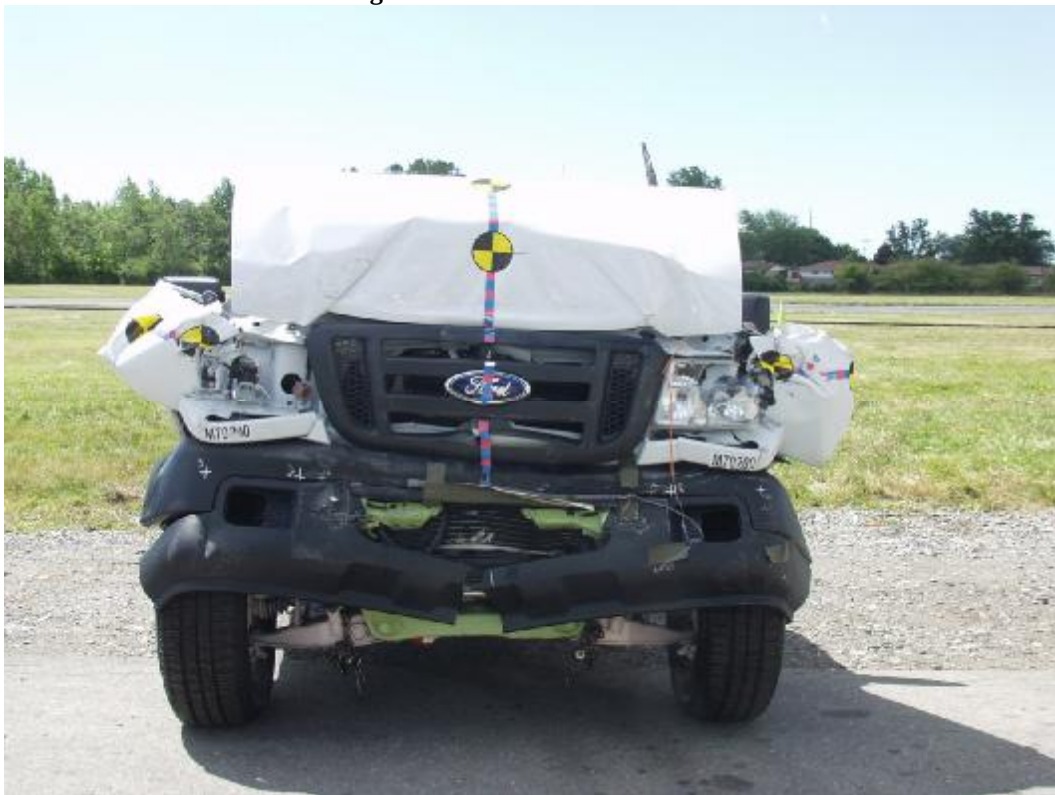
**Figure A-7: Post-Test Front View**

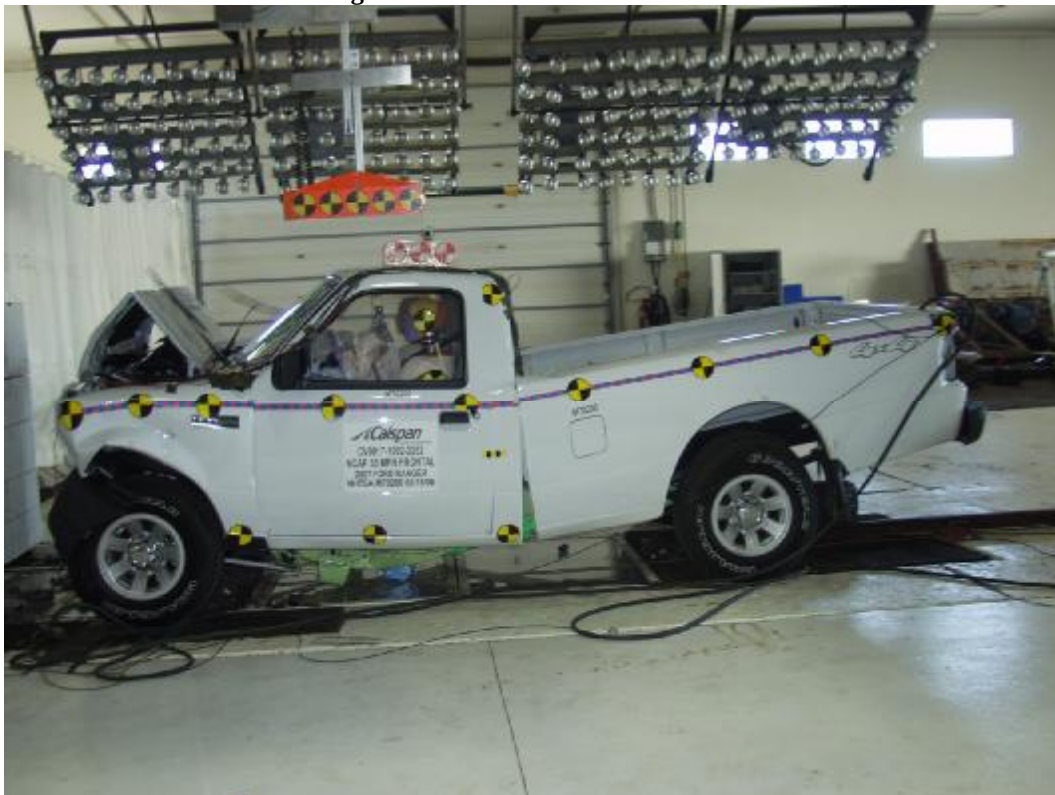
Figure A-9: Post-Test Left Side View

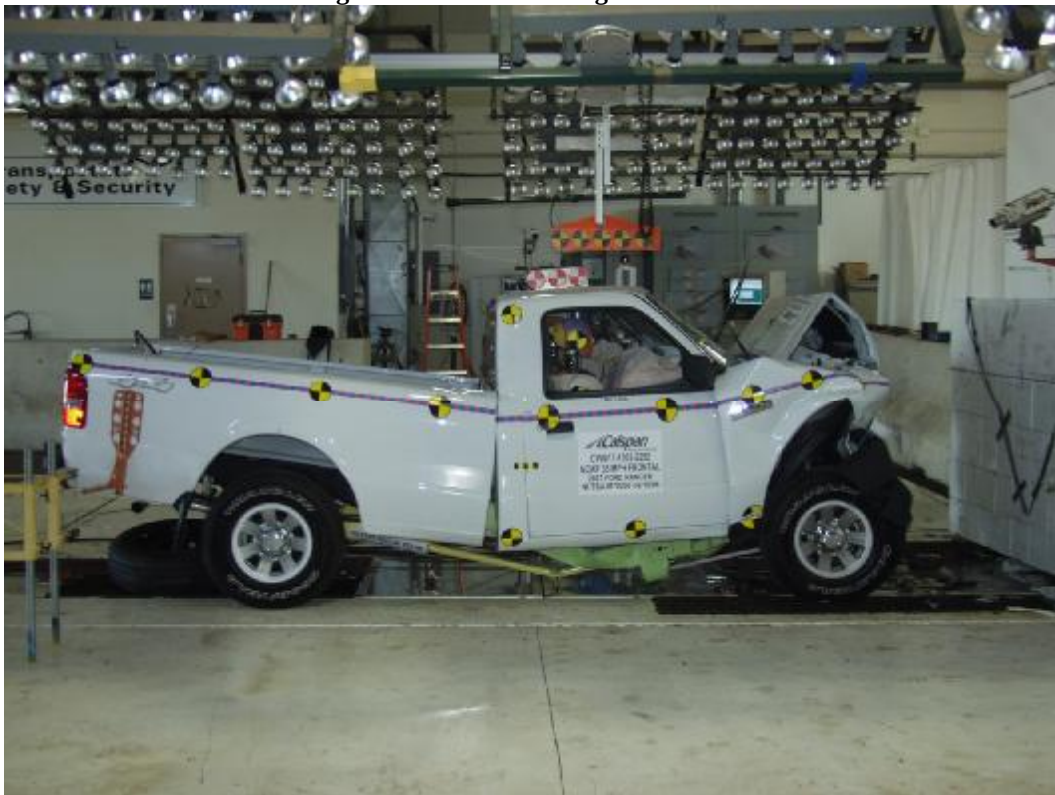
Figure A-11: Post-Test Right Side View

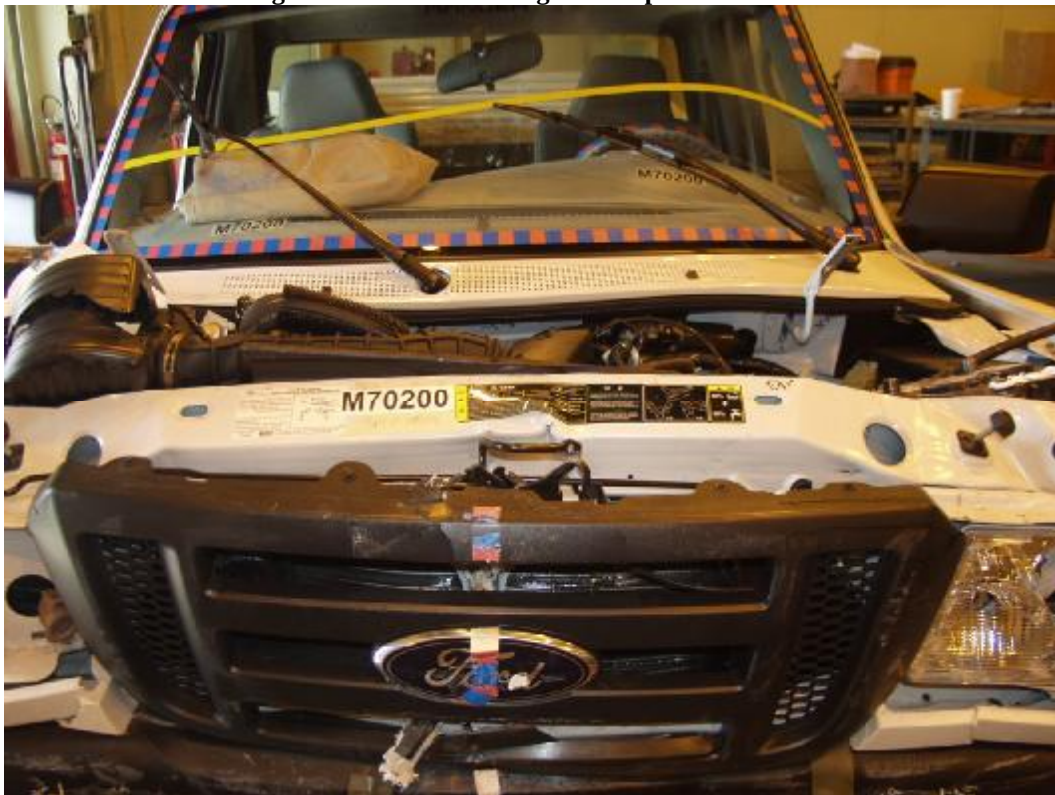
**Figure A-21: Post-Test Engine Compartment View**

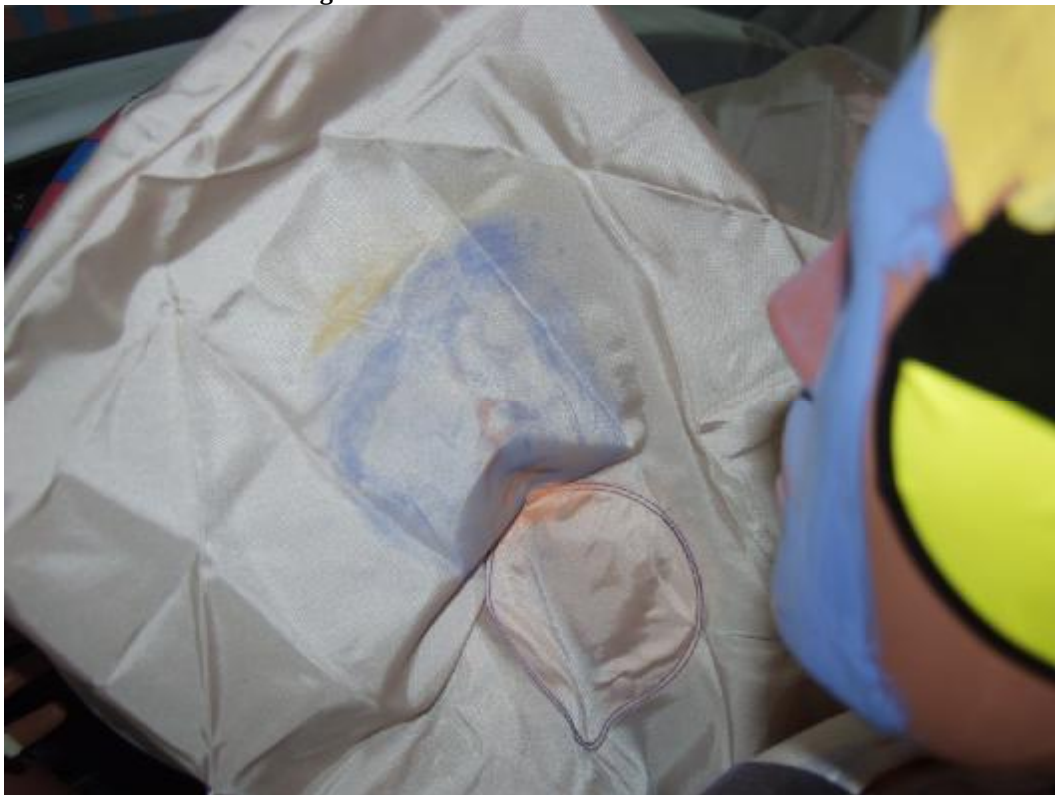
**Figure A-43: Post-Test Driver Contact to Airbag**

| | DRIVER | PASSENGER |
|---|---|---|
| Head Contact: | The face to the top of the center of the airbag, the back of the head to the center of the head restraint. | The face to the center of the airbag, the back of the head to the right of the center of the head restraint. |

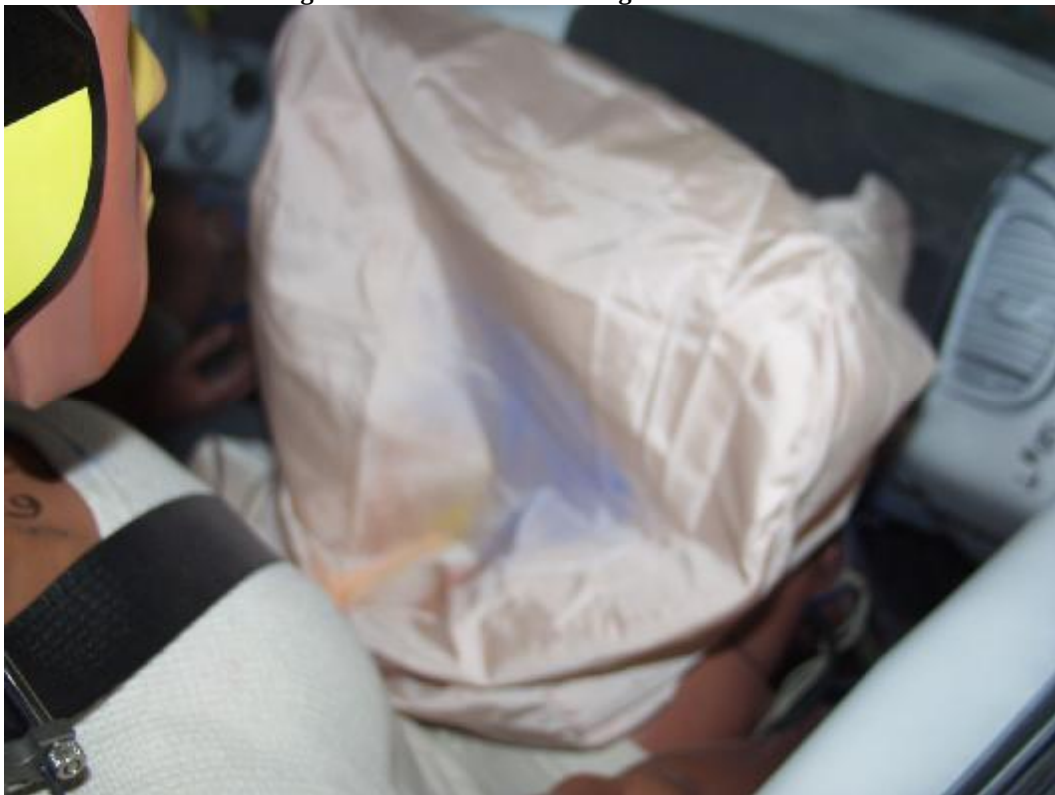
**Figure A-57: Post-Test Passenger Contact to Airbag**

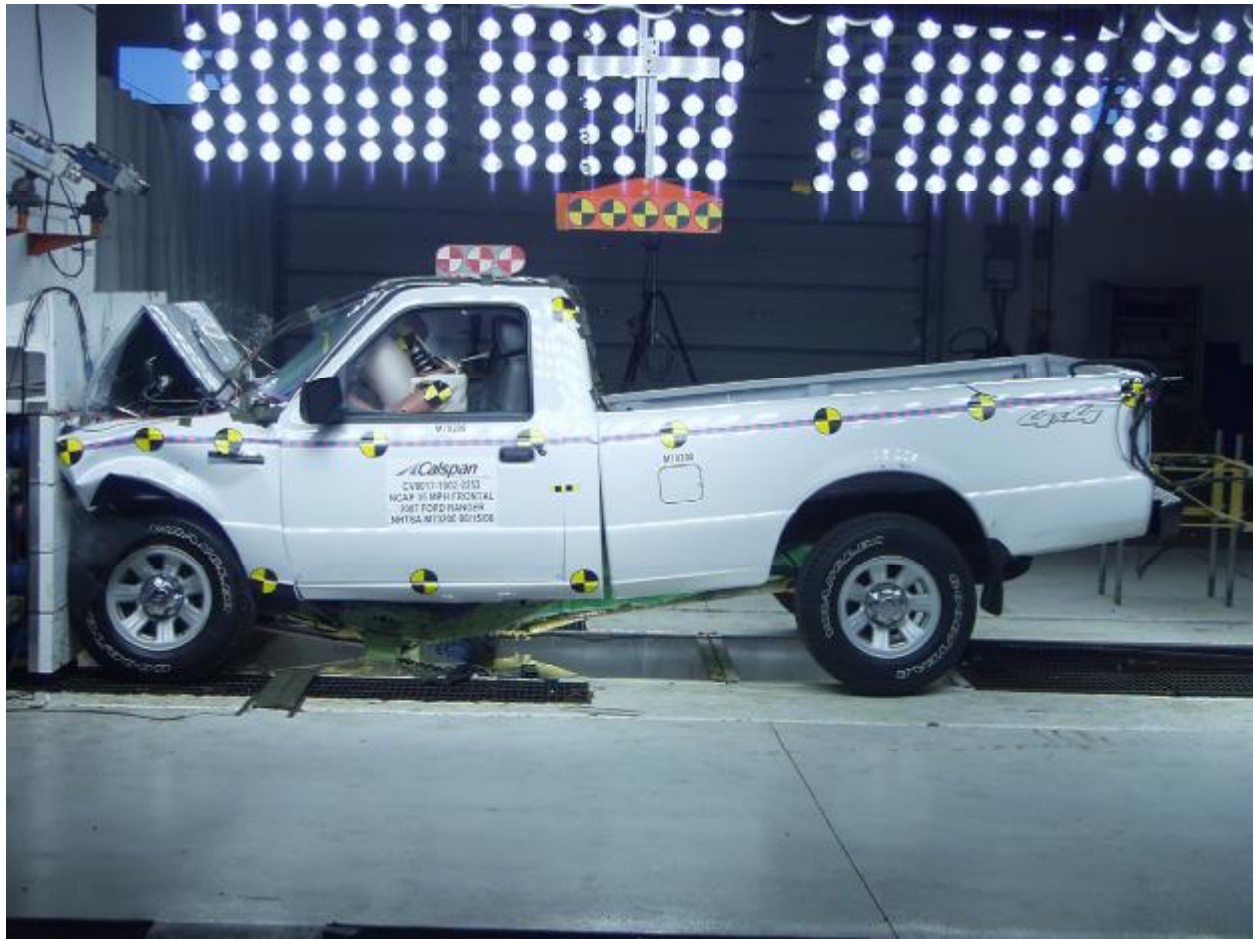
Figure A-62: Impact View
