**NEW CAR ASSESSMENT PROGRAM  
FRONTAL BARRIER IMPACT TEST**

**NISSAN MOTOR CORPORATION  
2007 NISSAN VERSA 1.8S  
5-DOOR HATCHBACK**

**NHTSA NUMBER: M75200**

**FINAL REPORT**

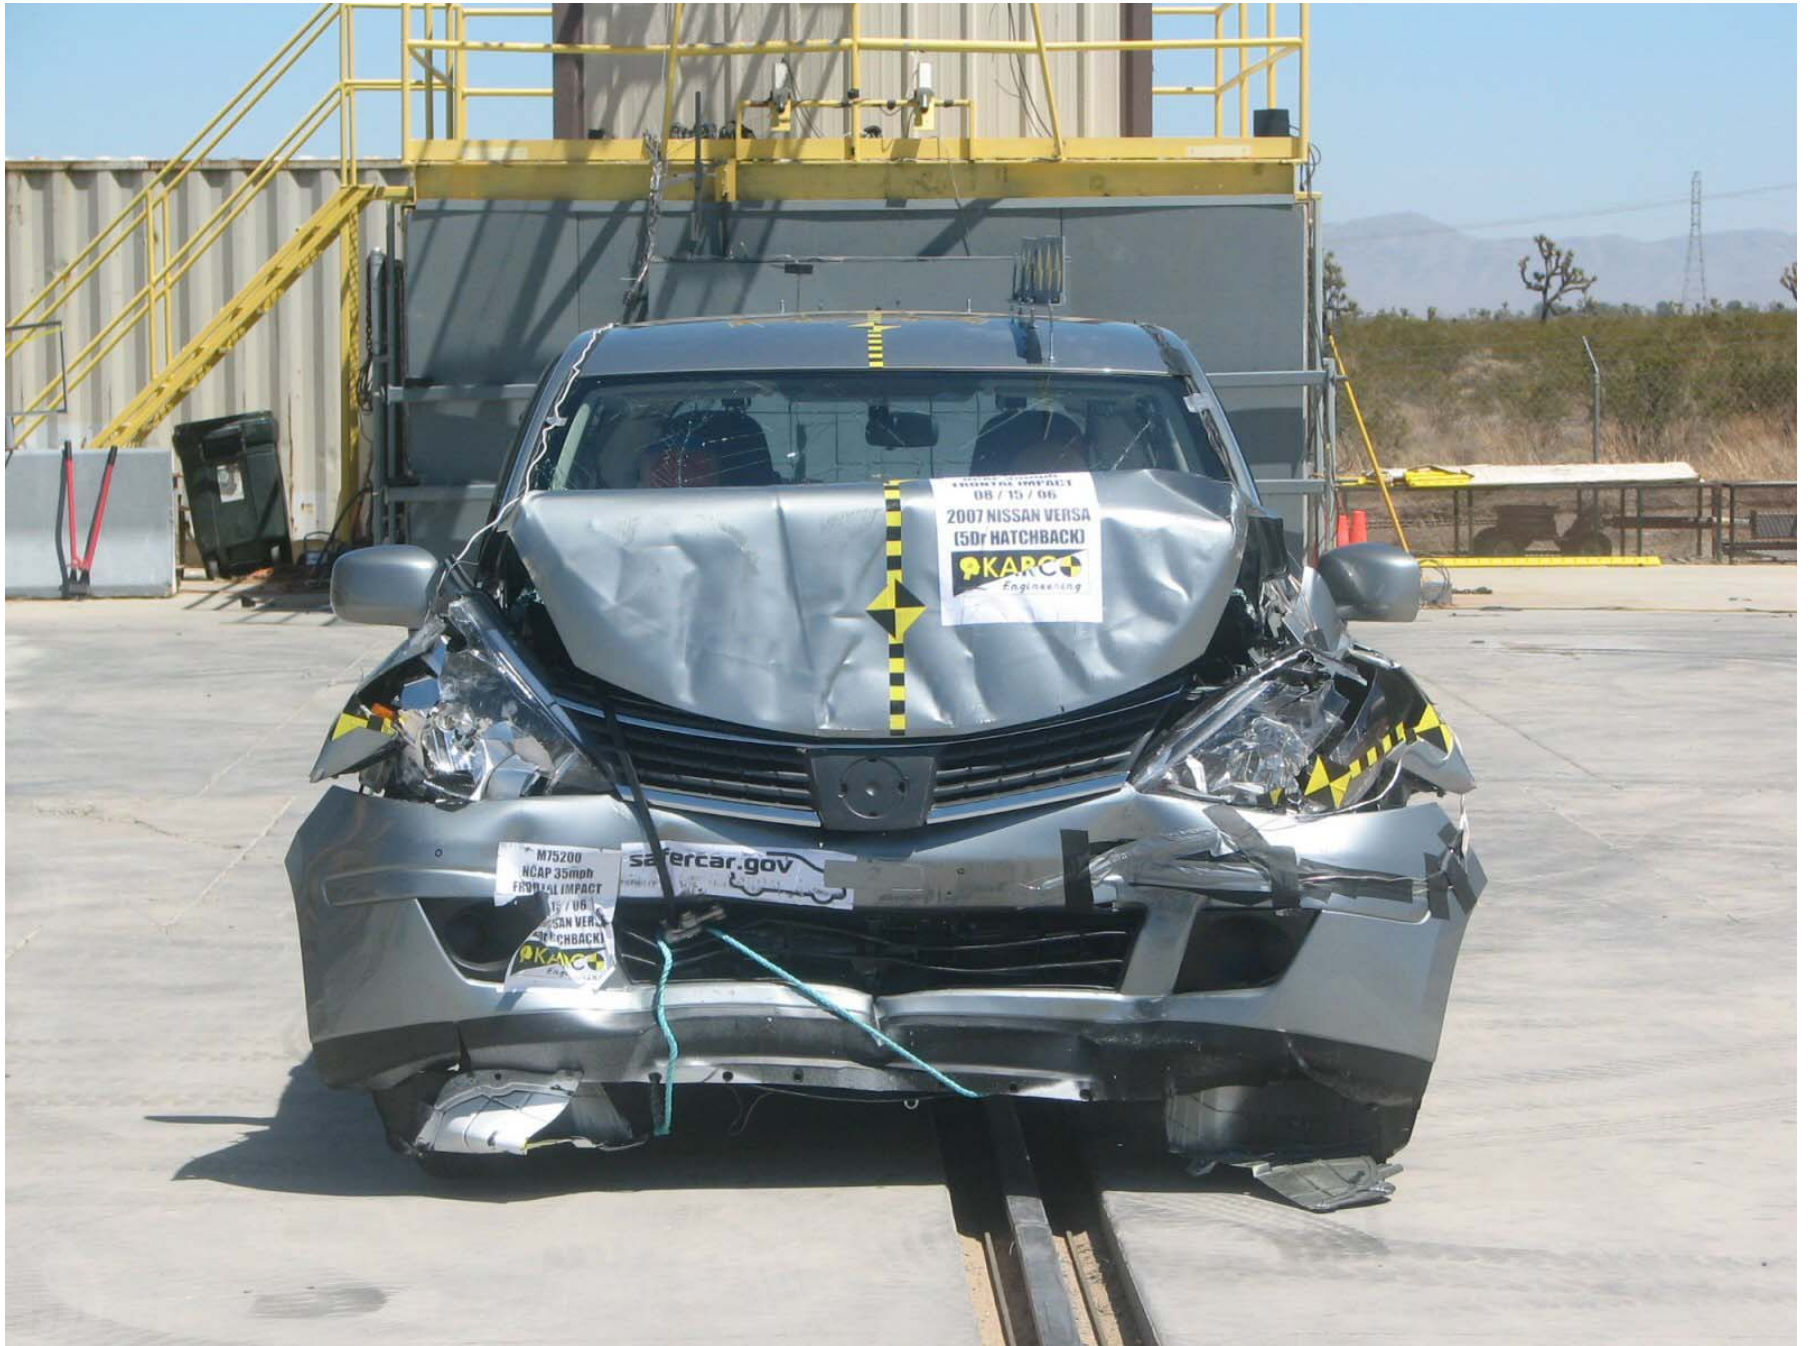
Figure A-7: Post-Test Front View

The maximum static crush of the vehicle was 581 mm to the left of the vehicle's centerline and both the driver and the passenger side doors remained closed and latched during the impact event and were operable after the impact.

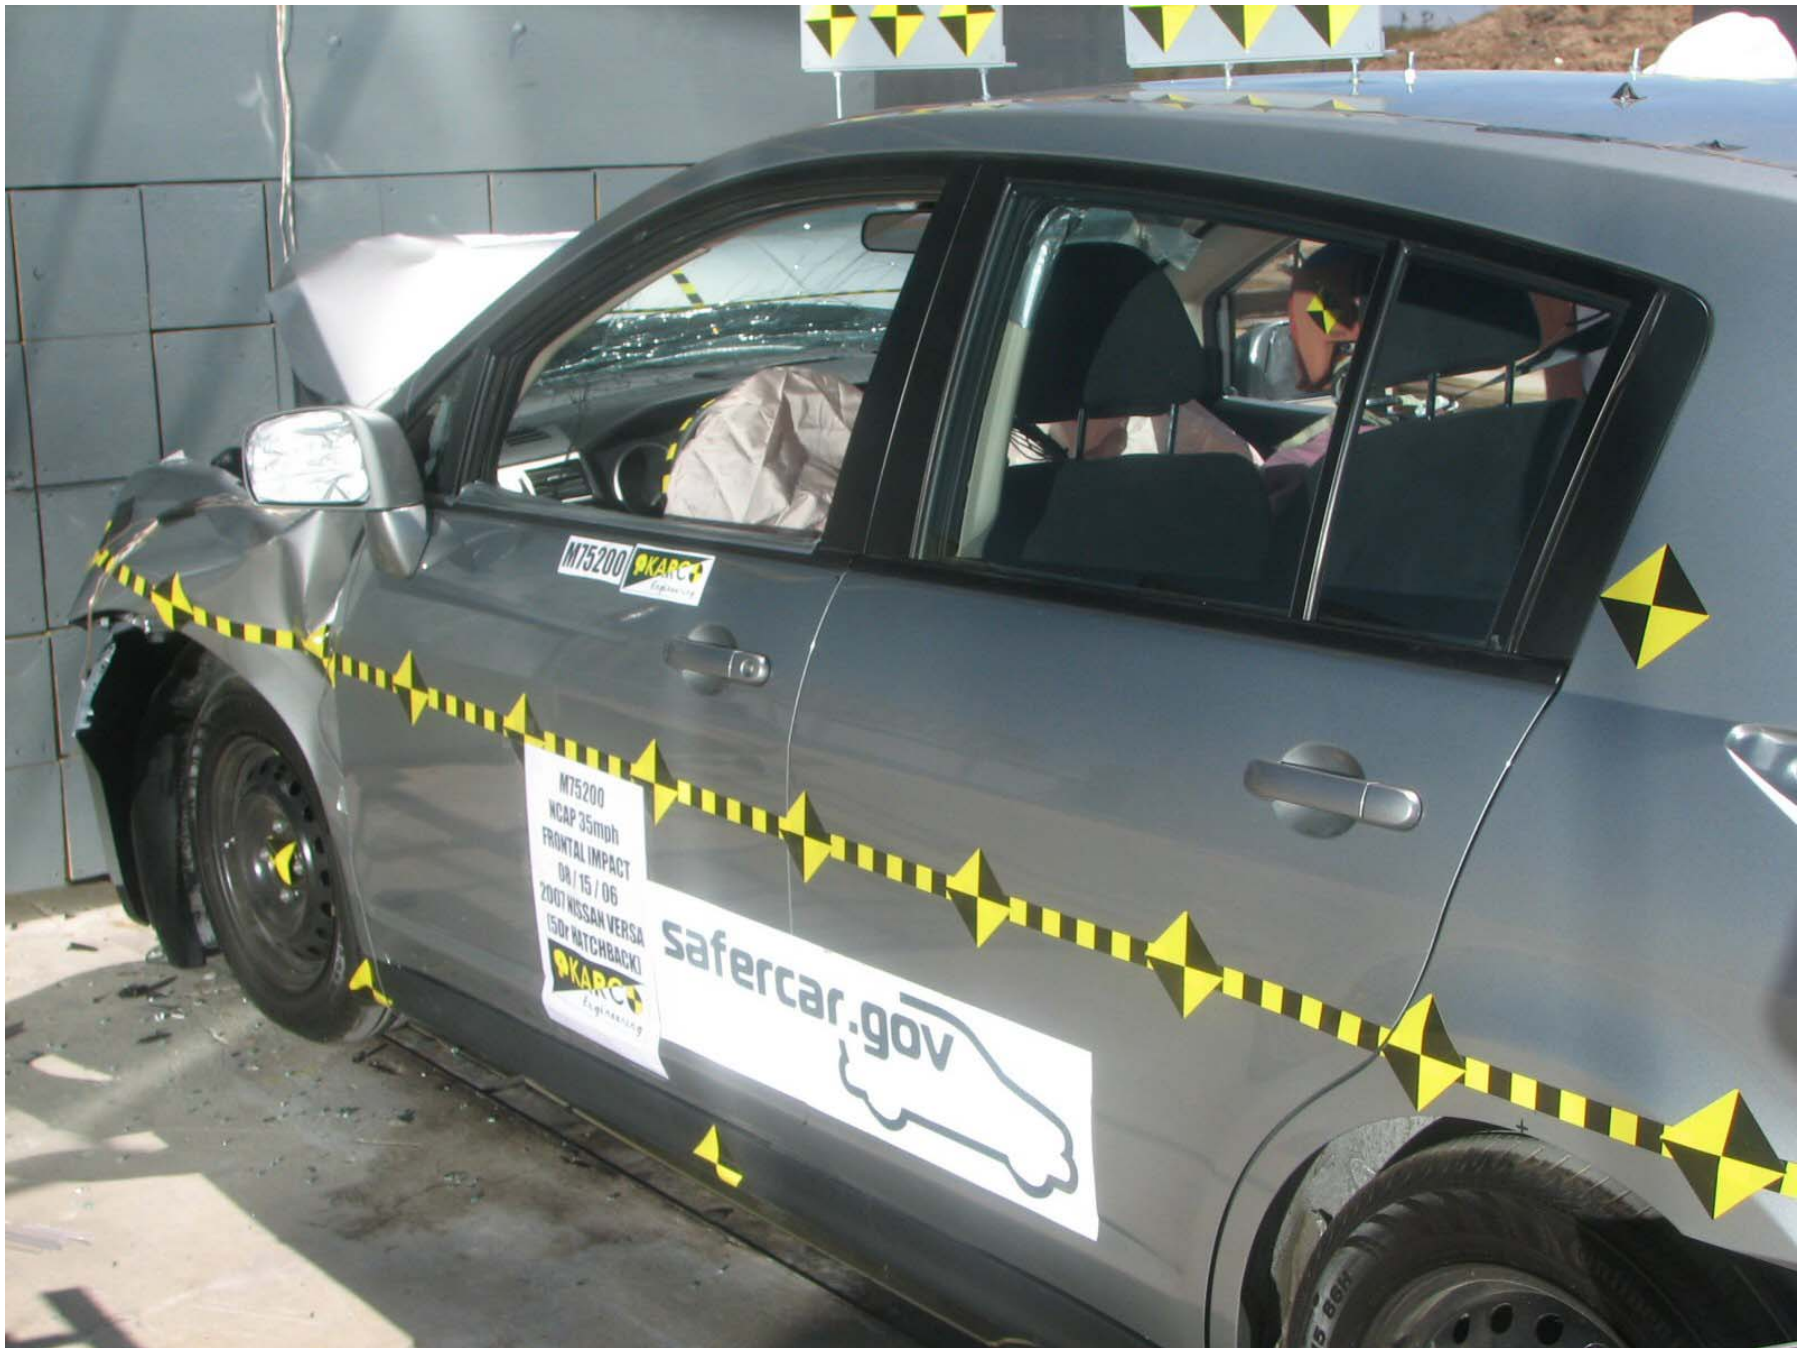
Figure A-16: Post-Test Left Side  $\frac{3}{4}$  View of Doors After Impact

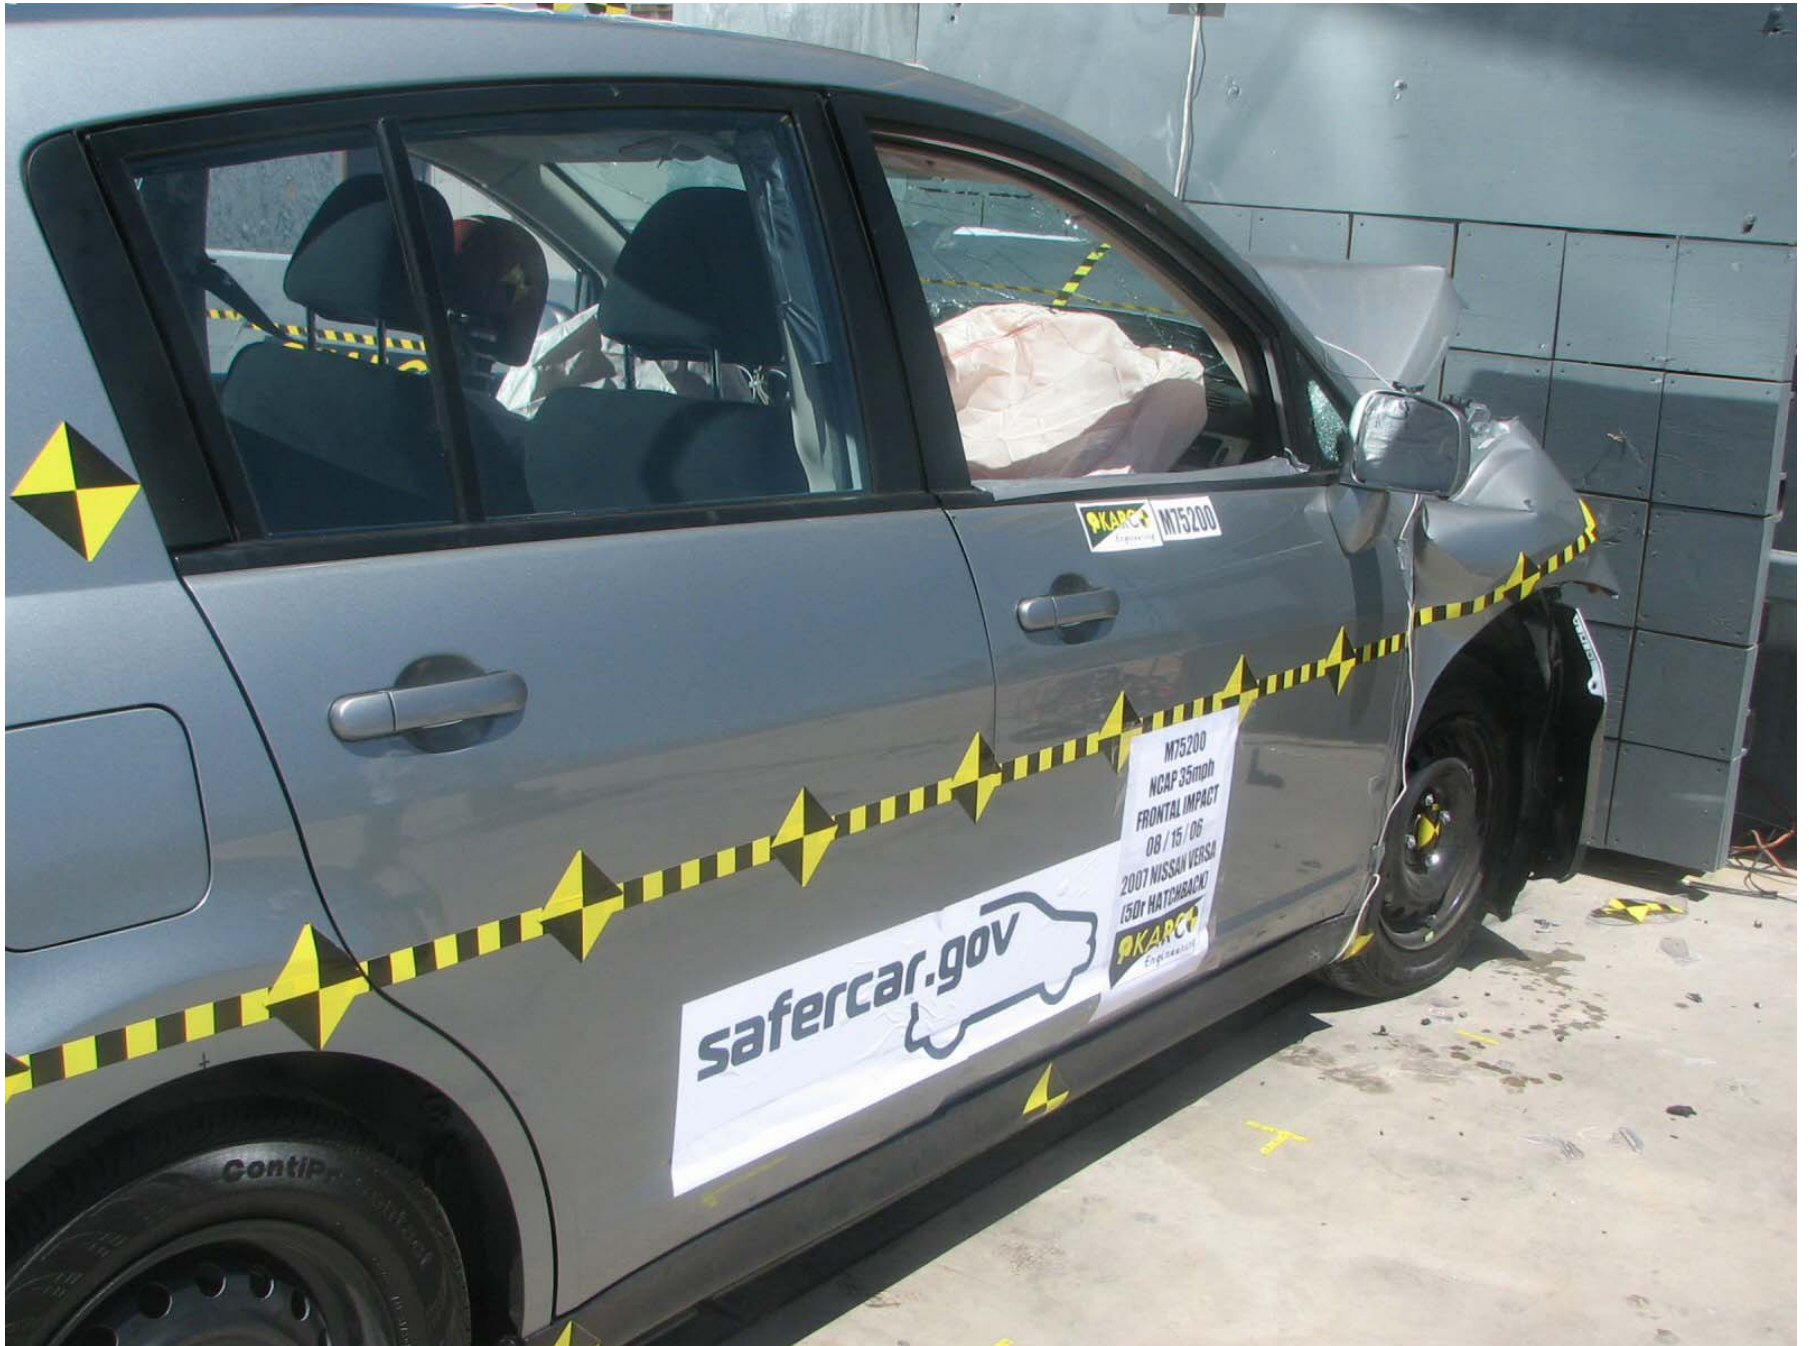
Figure A-17: Post-Test Right Side  $\frac{3}{4}$  View of Doors After Impact

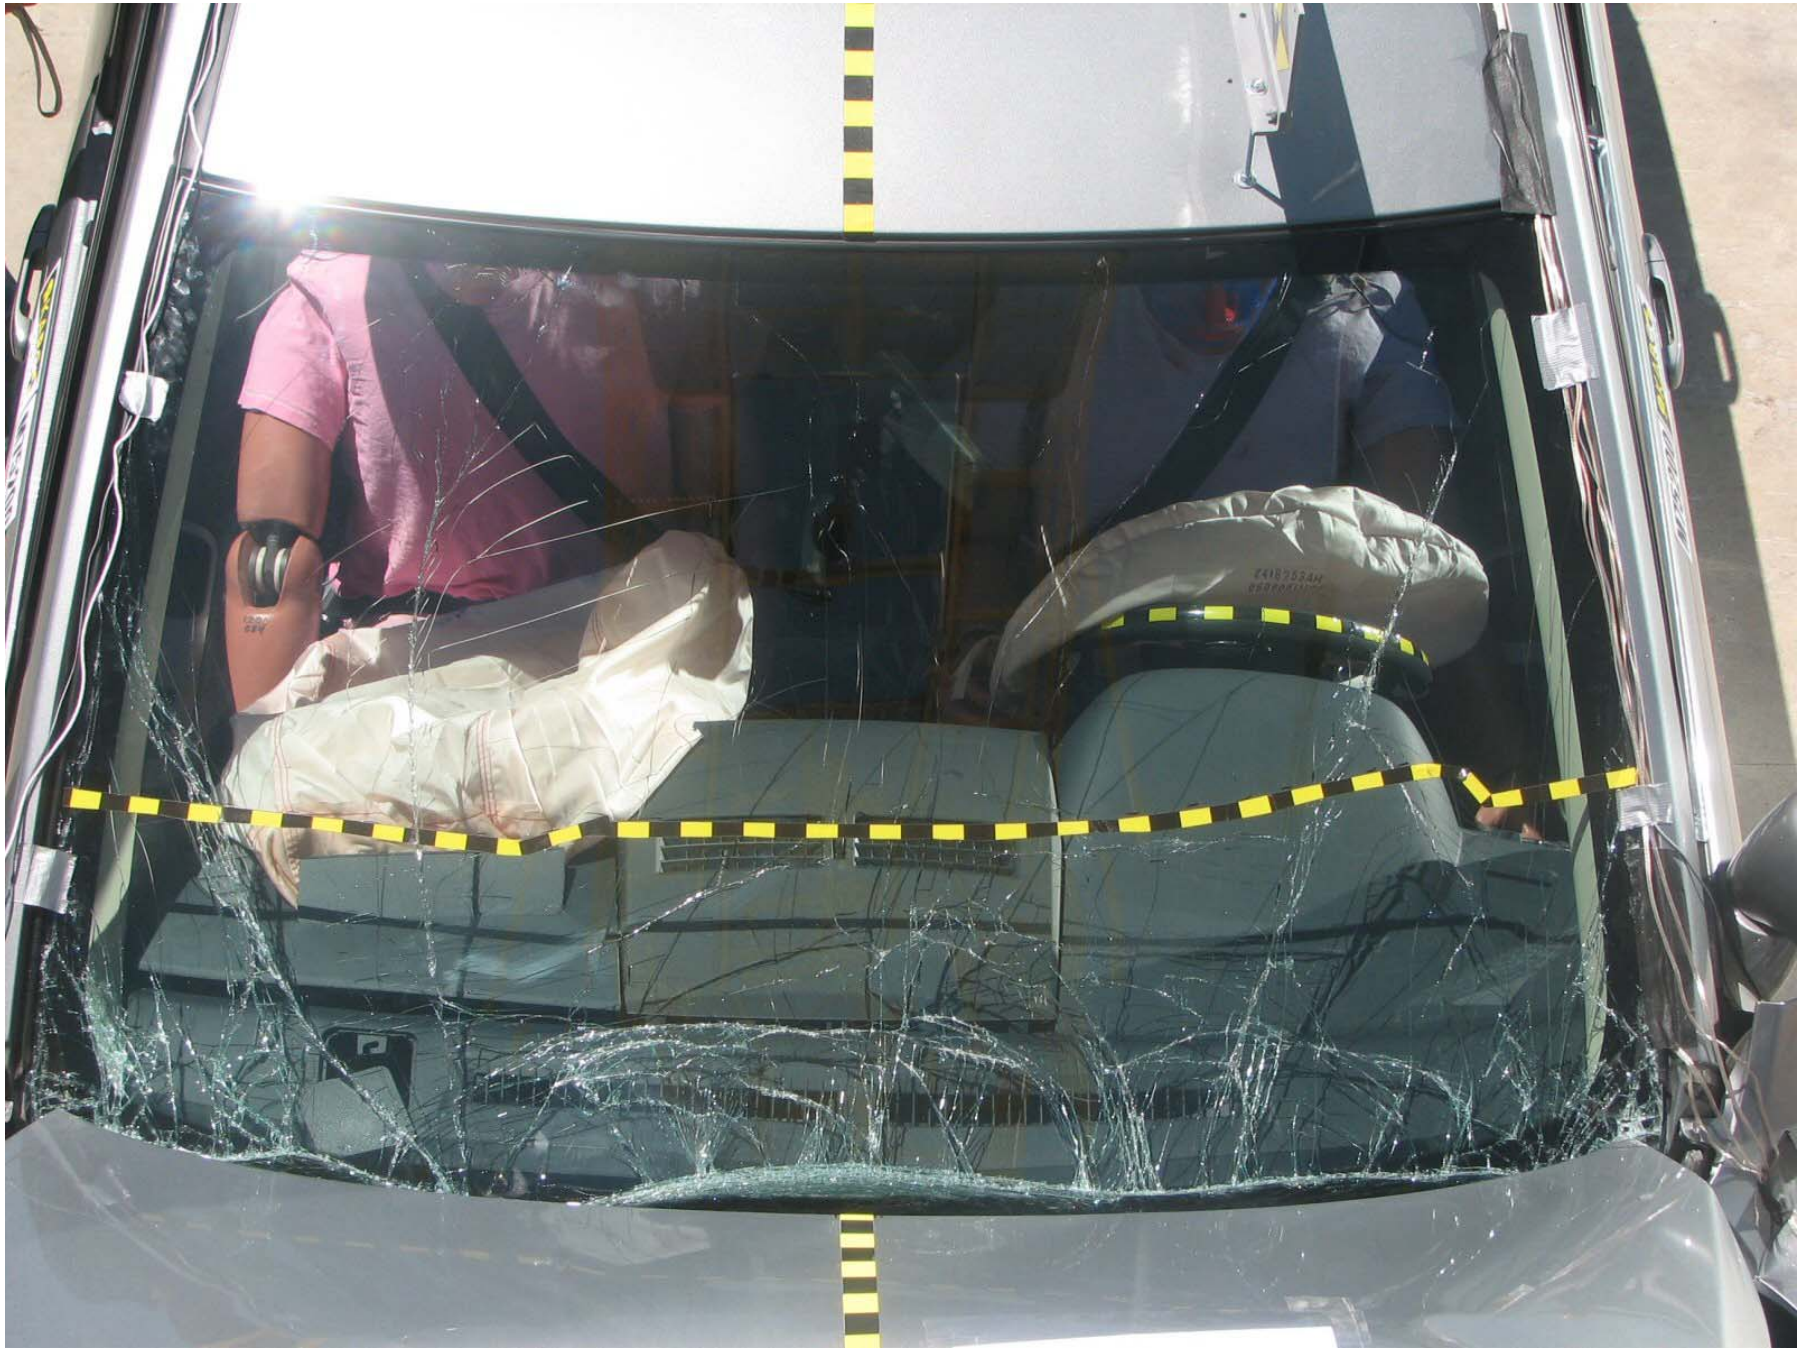
Figure A-19: Post-Test Windshield

There was 100 percent windshield retention and there was no intrusion into the protected zone of the windshield during the impact event. There was no stoddard solvent leakage after the event or during any phase of the static rollover.

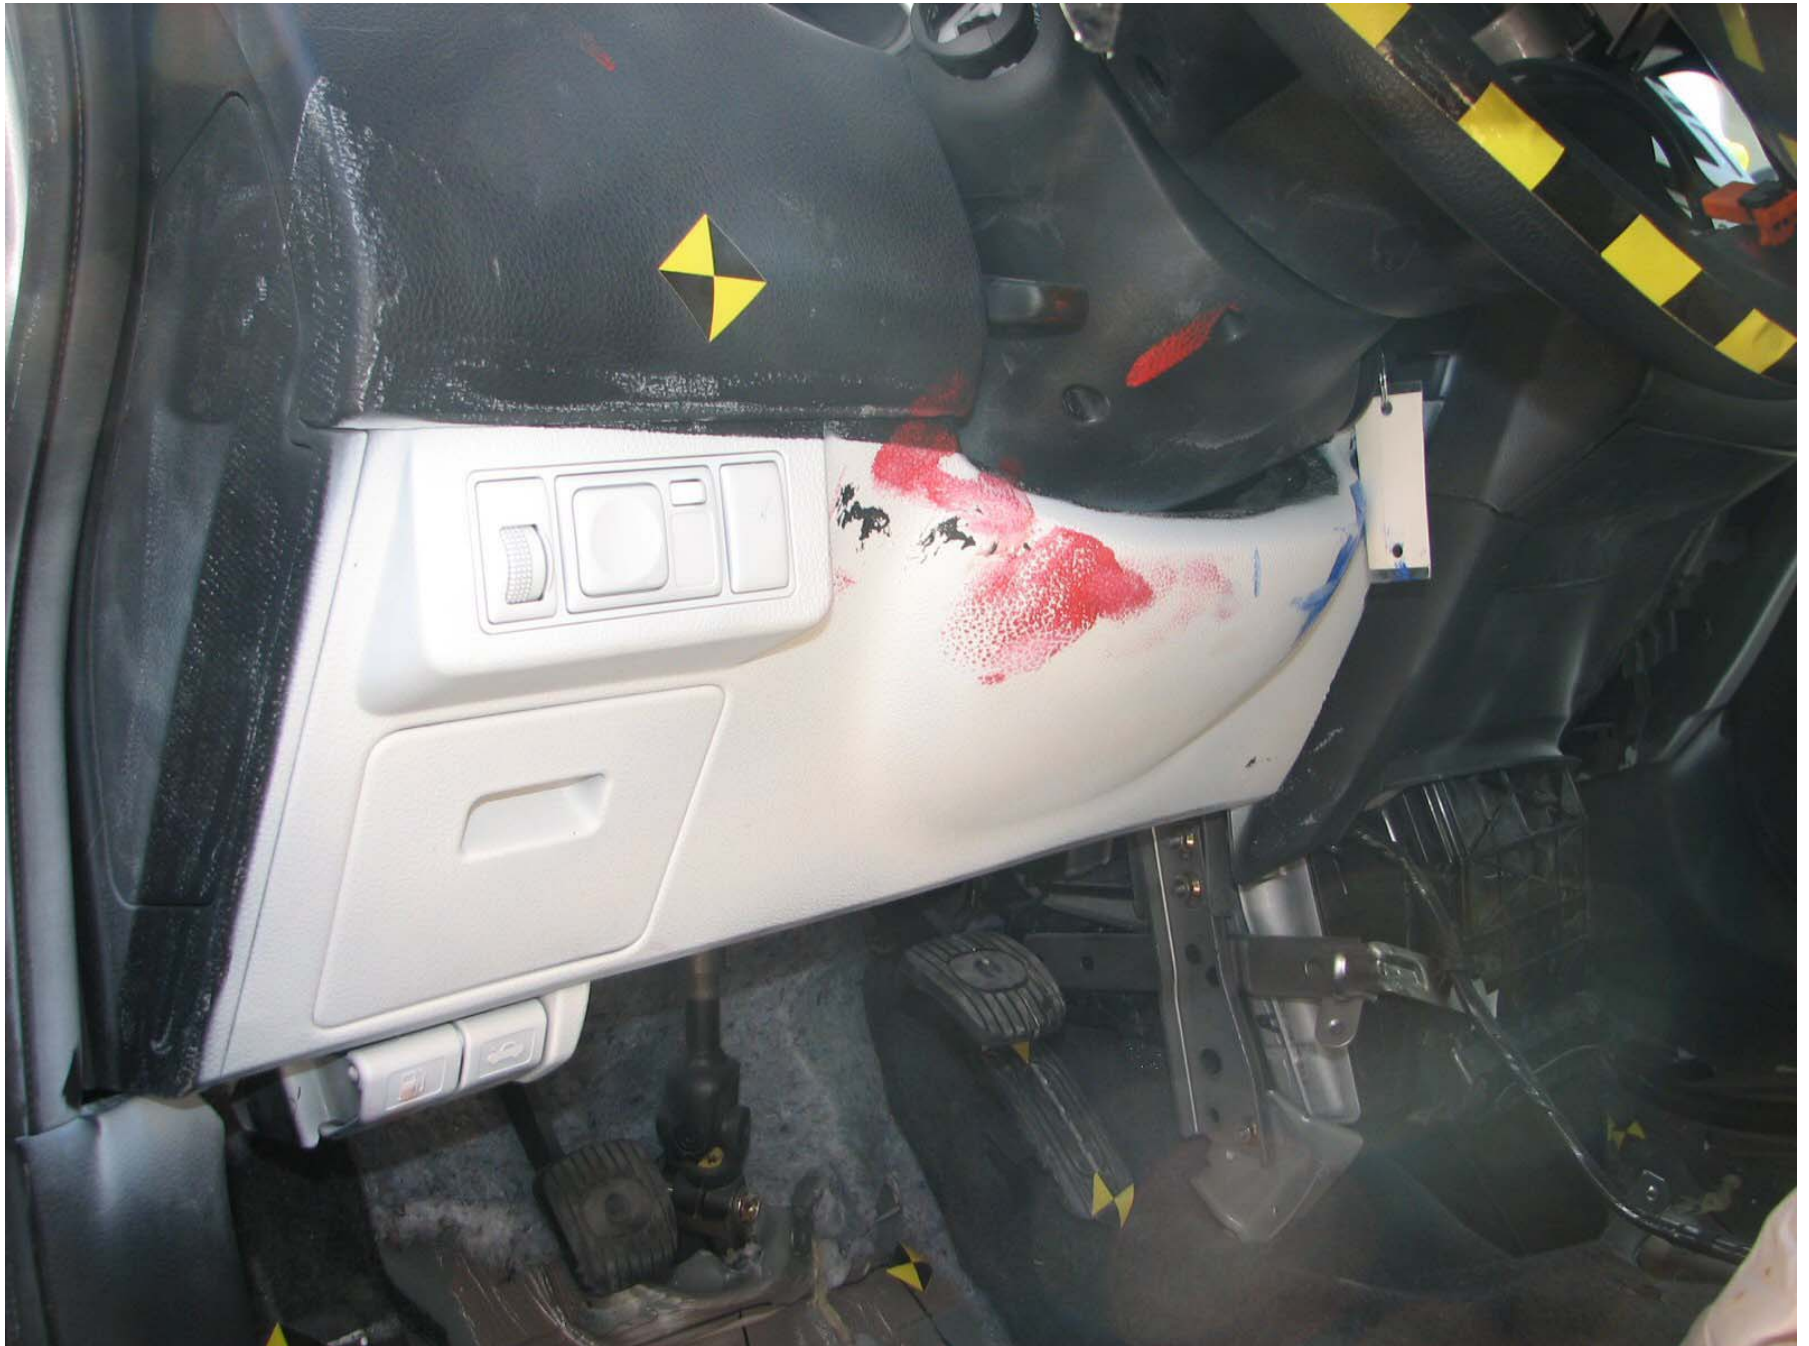
Figure A-39: Post-Test Driver Side Knee Bolster

The driver's visible contact points were as follows: The driver ATD's head and chest contacted the airbag and the abdomen had no contact. Both knees contacted the knee bolster.

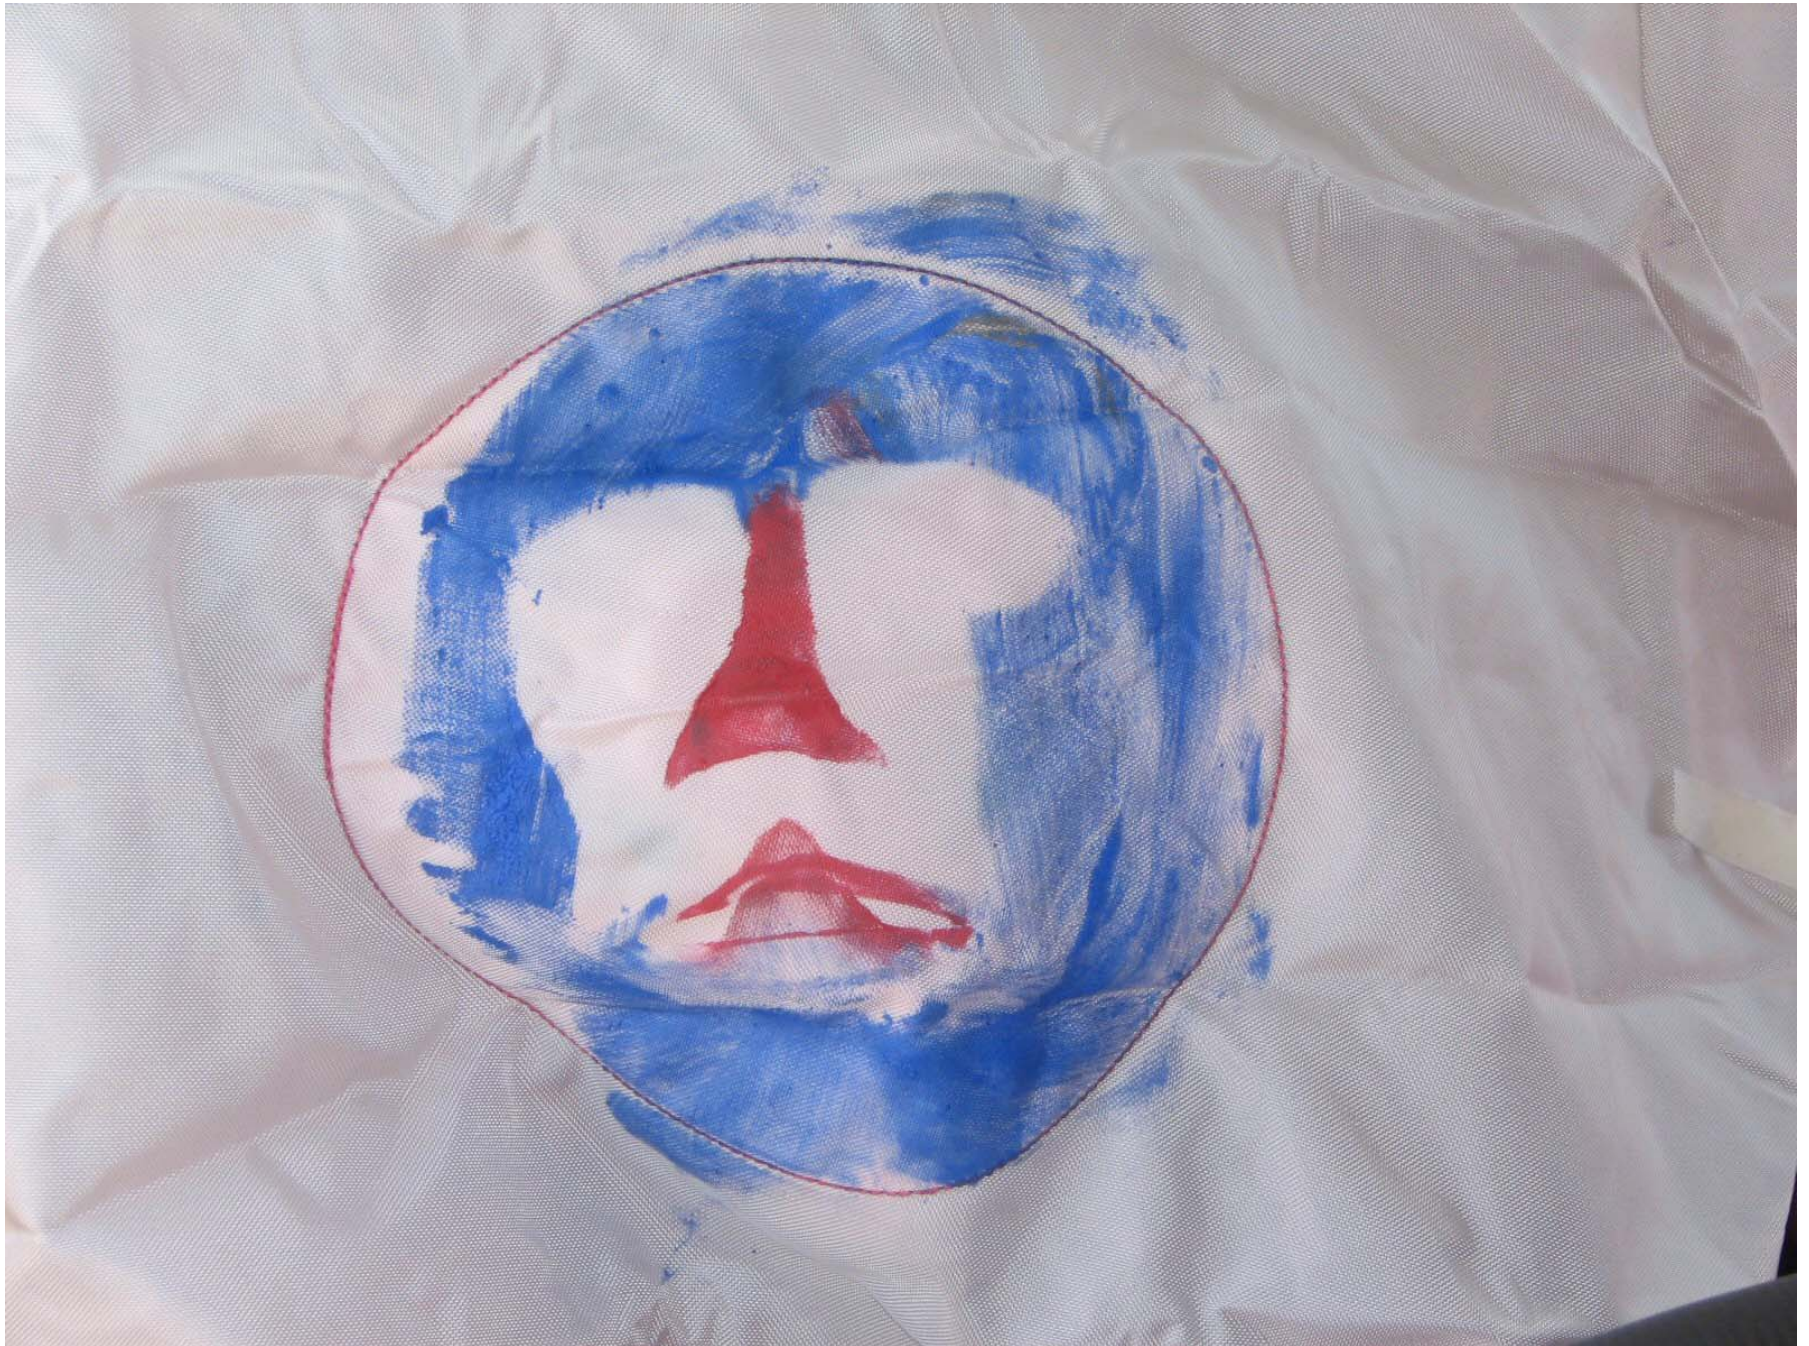
Figure A-43: Post-Test Driver Dummy Airbag Contact

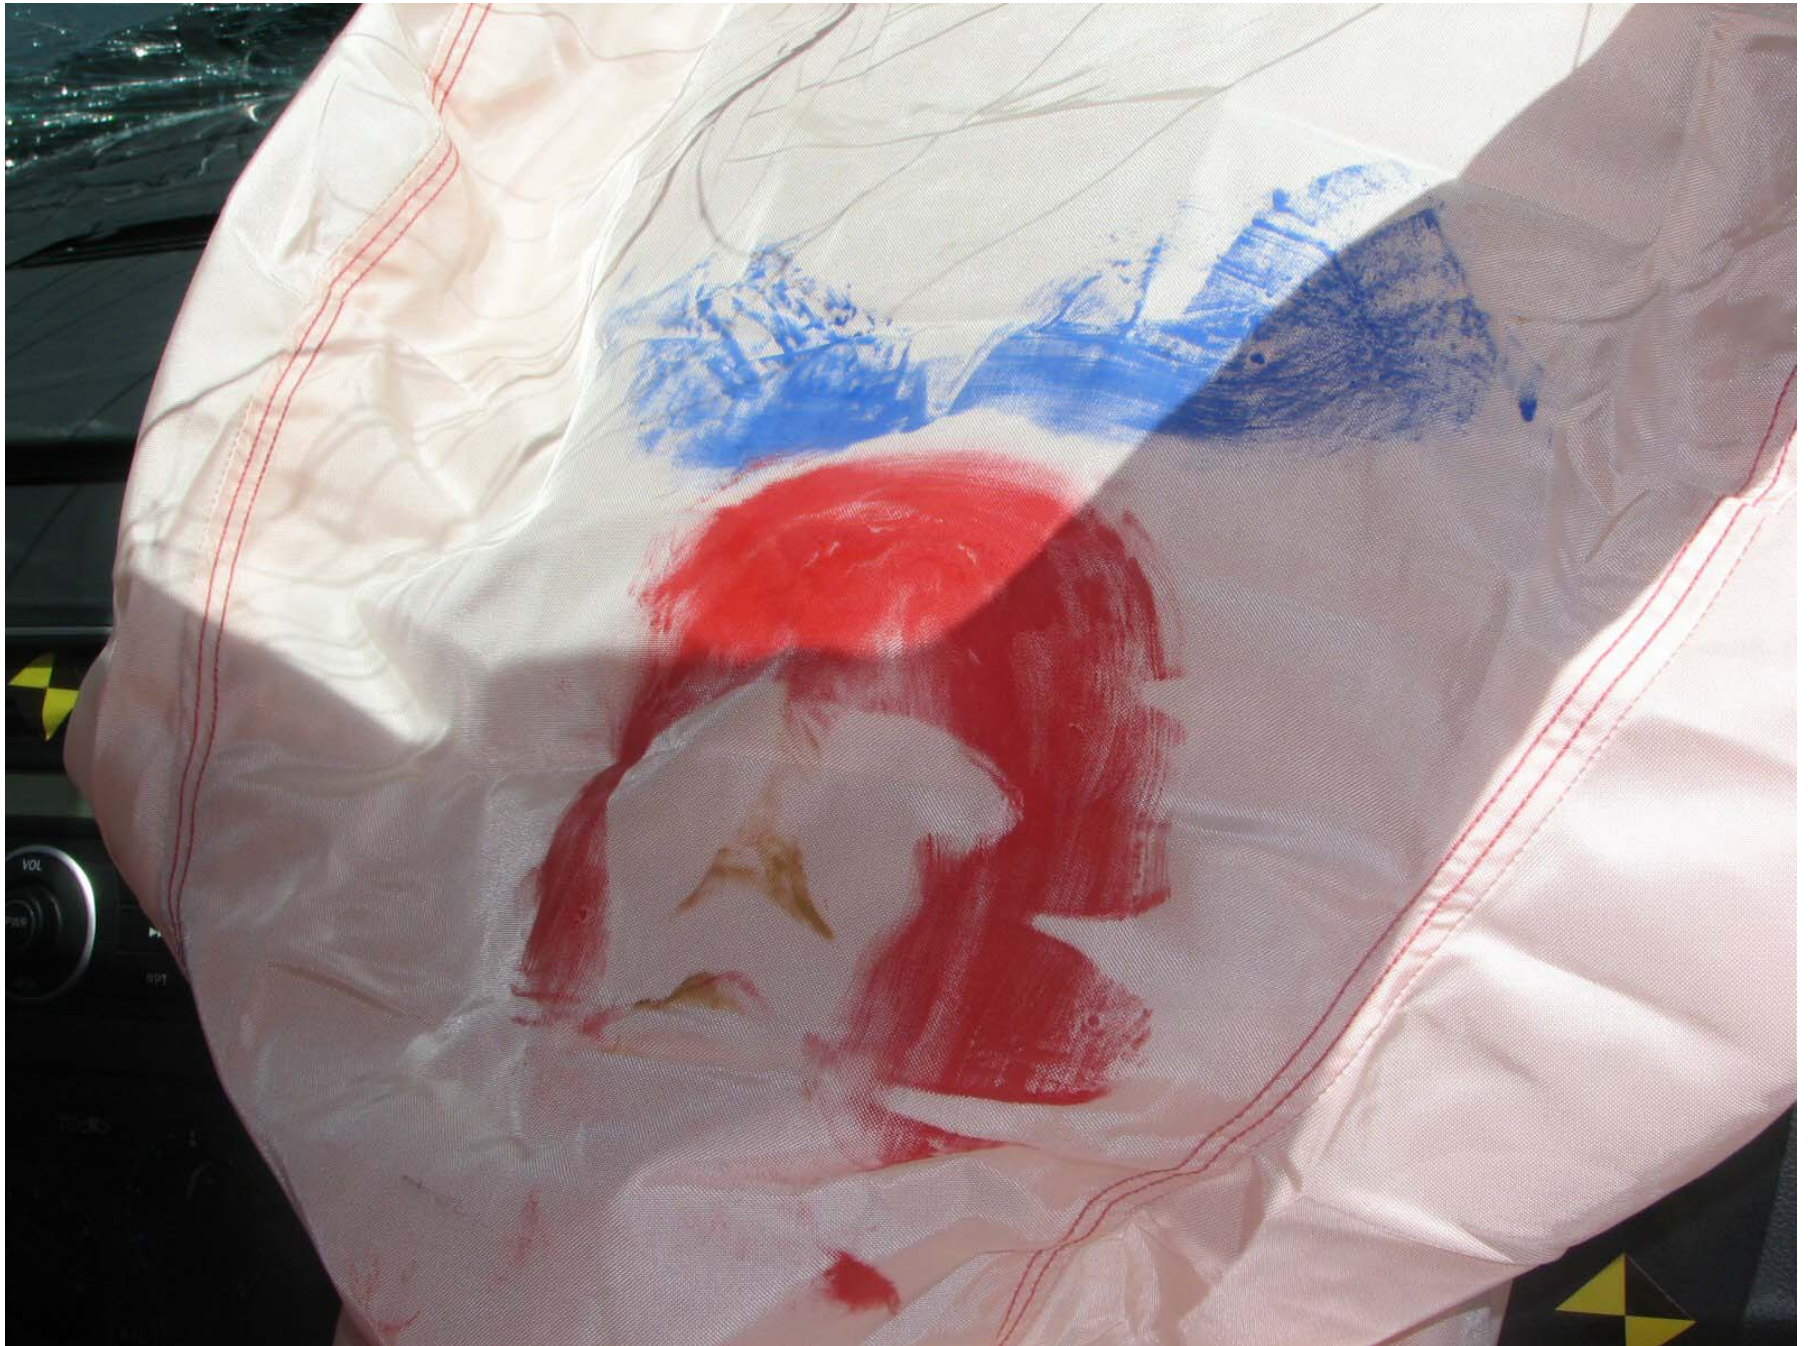
Figure A-57: Post-Test Passenger Dummy Airbag Contact

The passenger's visible contact points were as follows: The passenger ATD's head, chest and abdomen contacted the airbag. Both knees contacted the knee bolster.
