**NEW CAR ASSESSMENT PROGRAM  
FRONTAL BARRIER IMPACT TEST**

**NISSAN MOTOR CORPORATION  
2007 NISSAN VERSA 1.8S  
5-DOOR HATCHBACK**

**NHTSA NUMBER: M75200**

**FINAL REPORT**

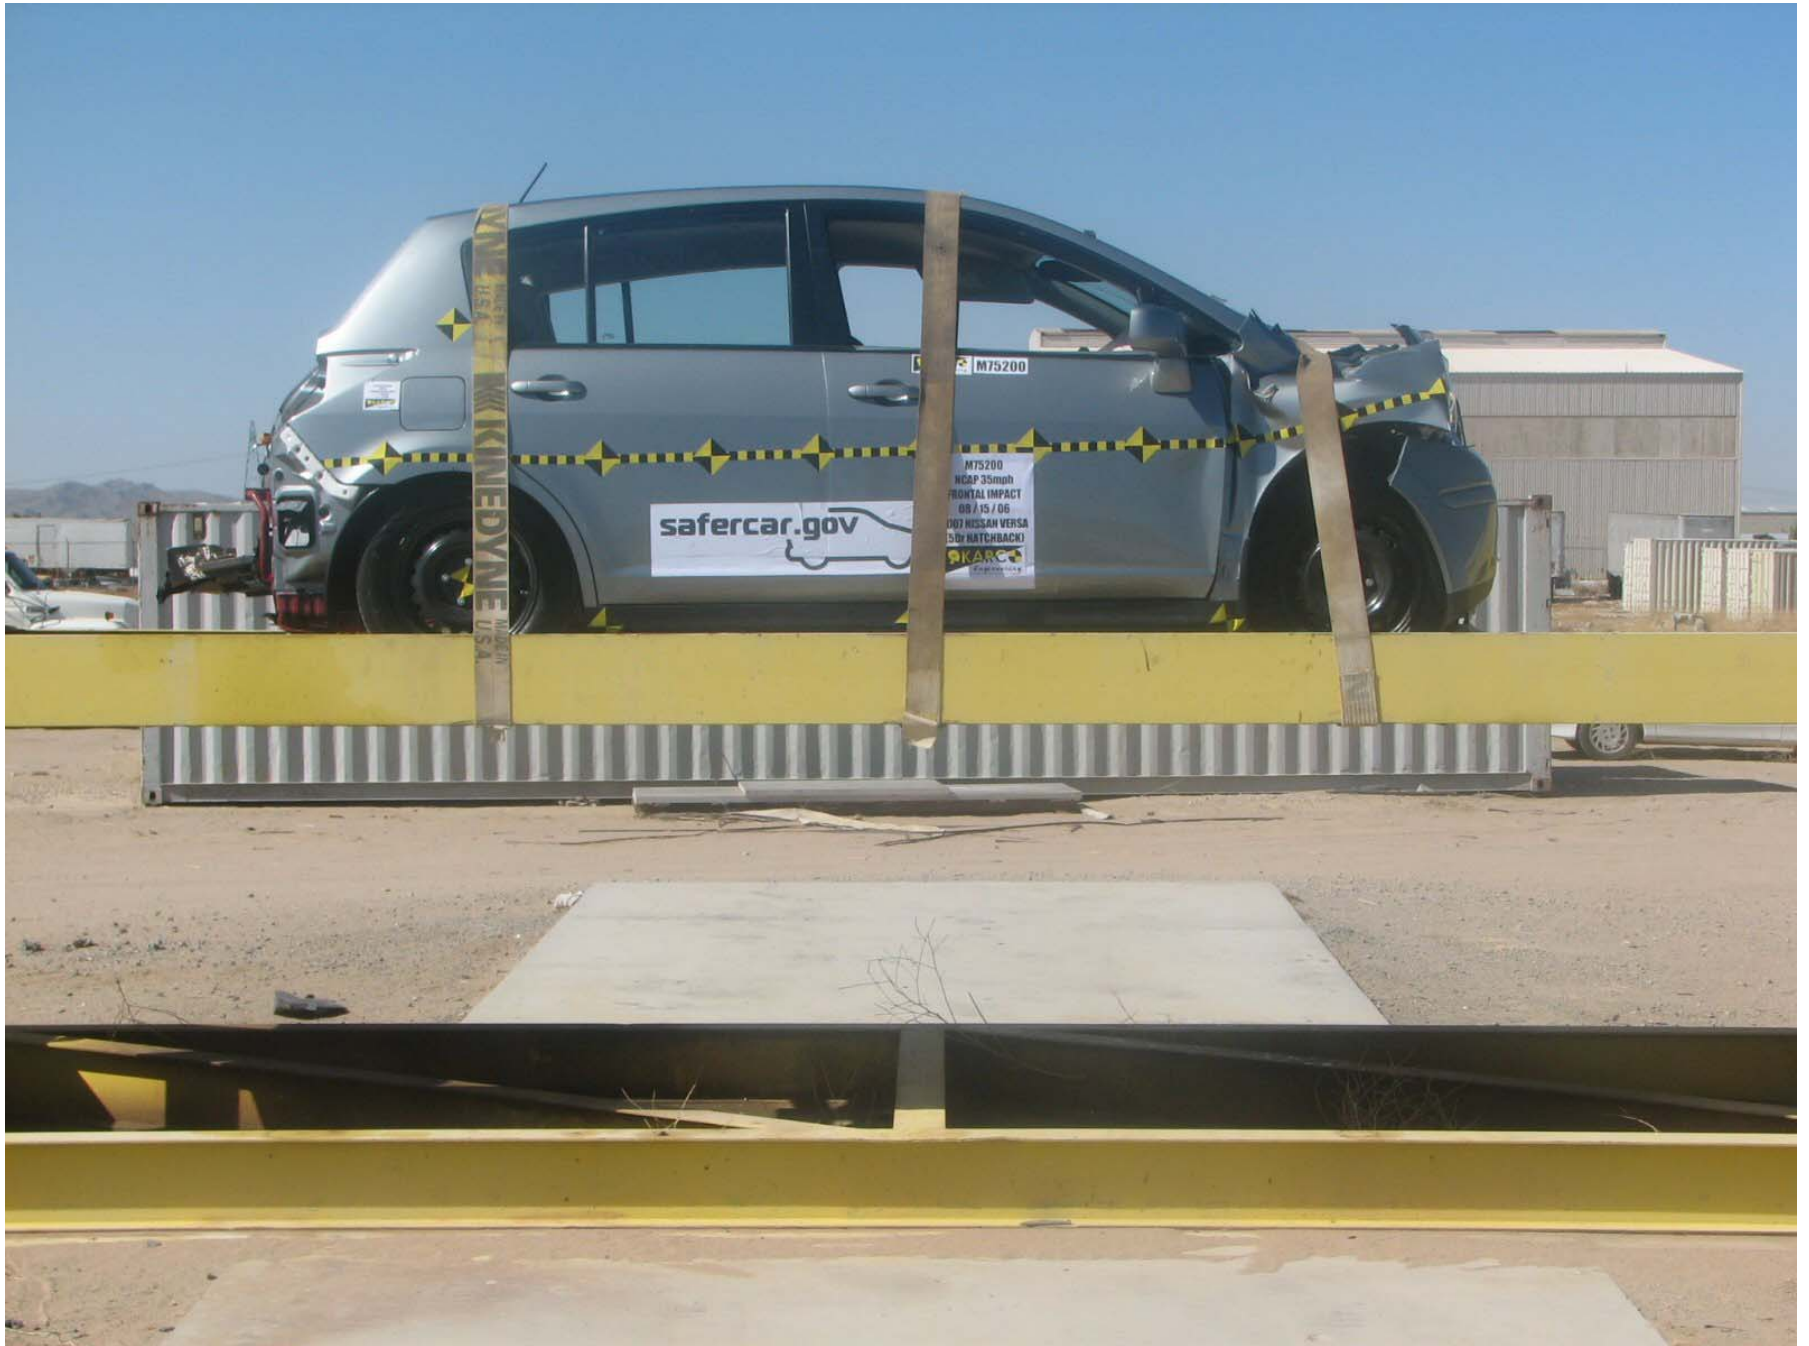
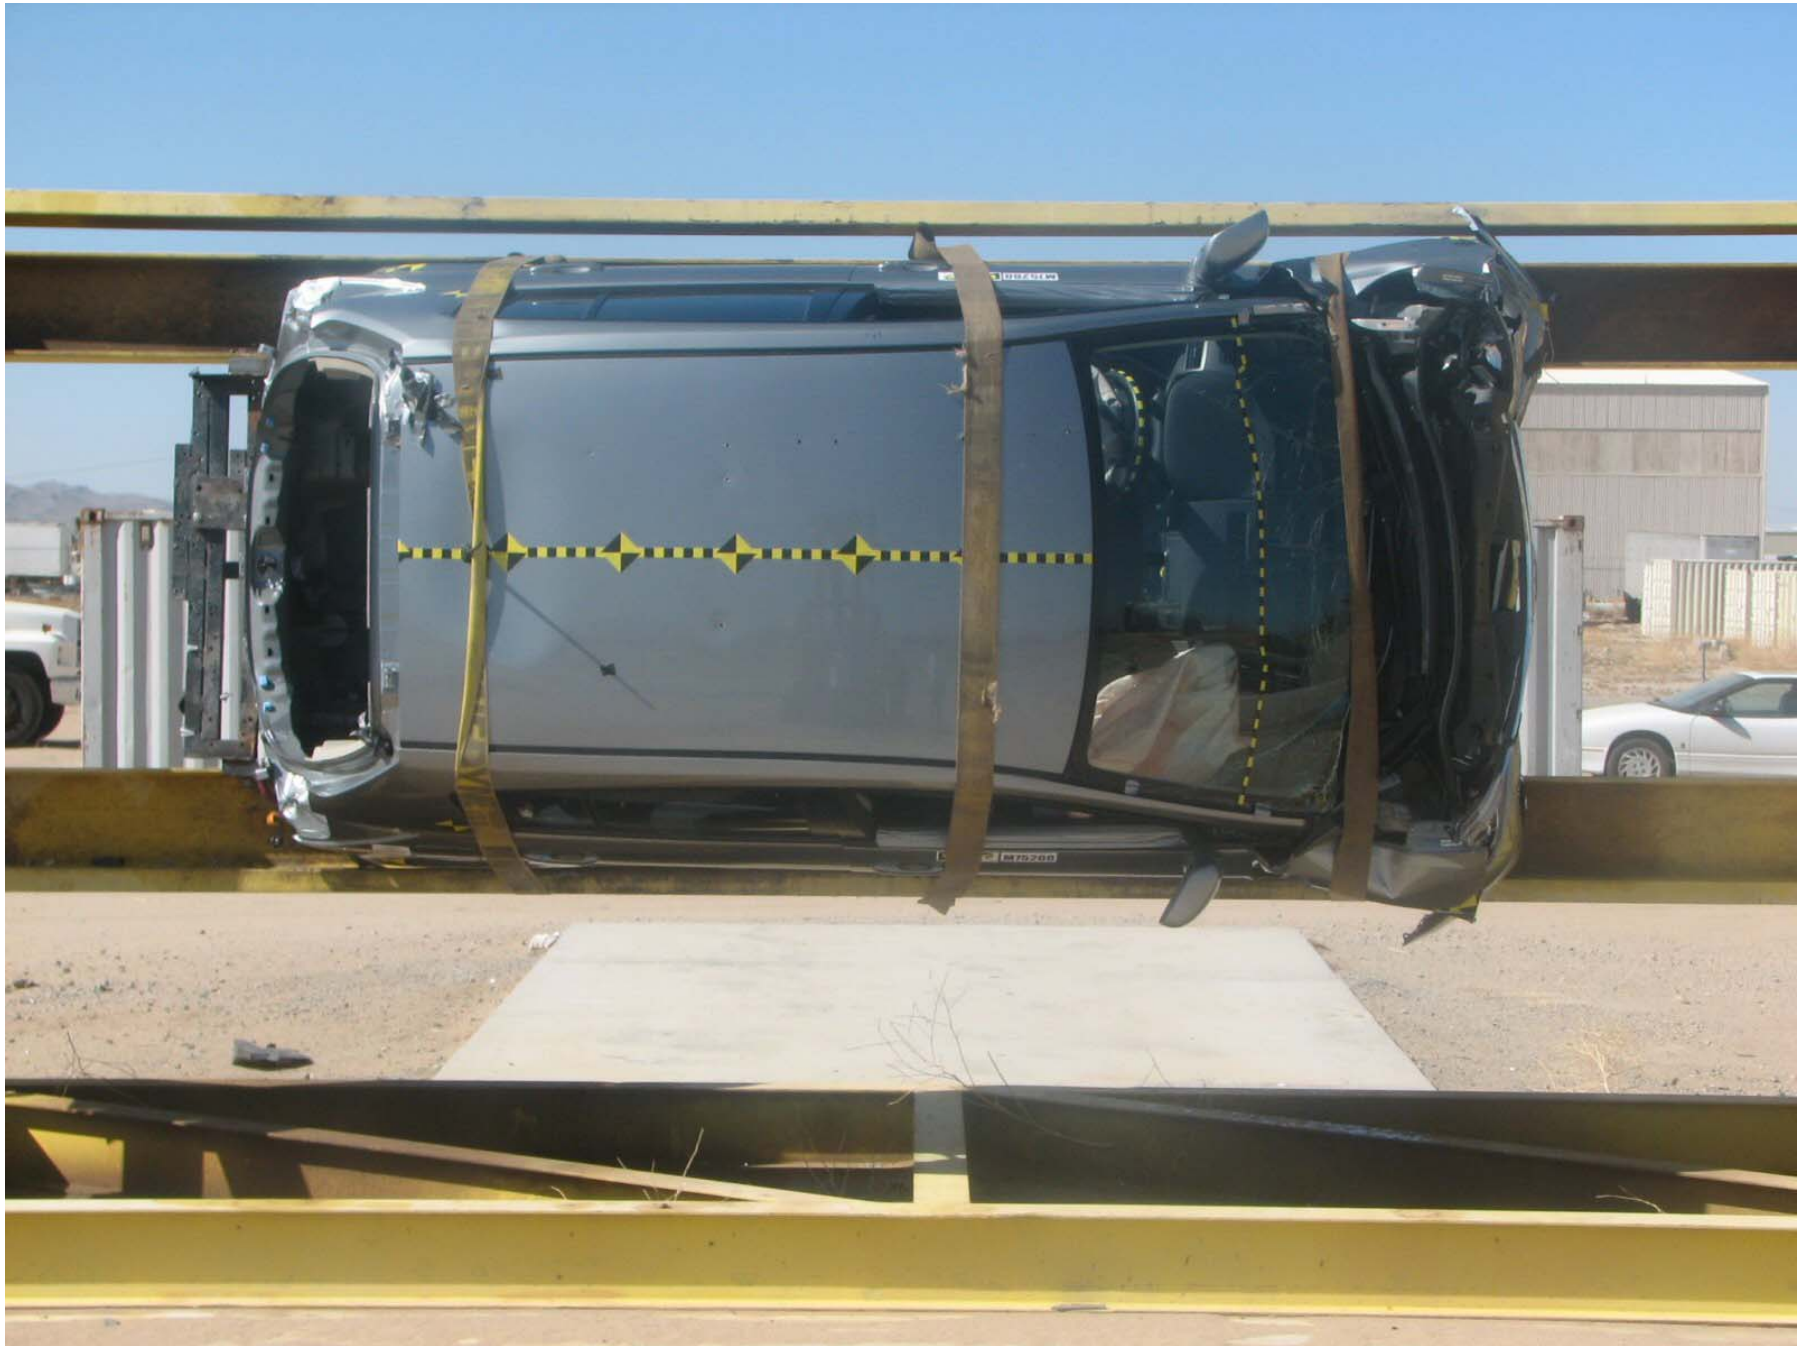
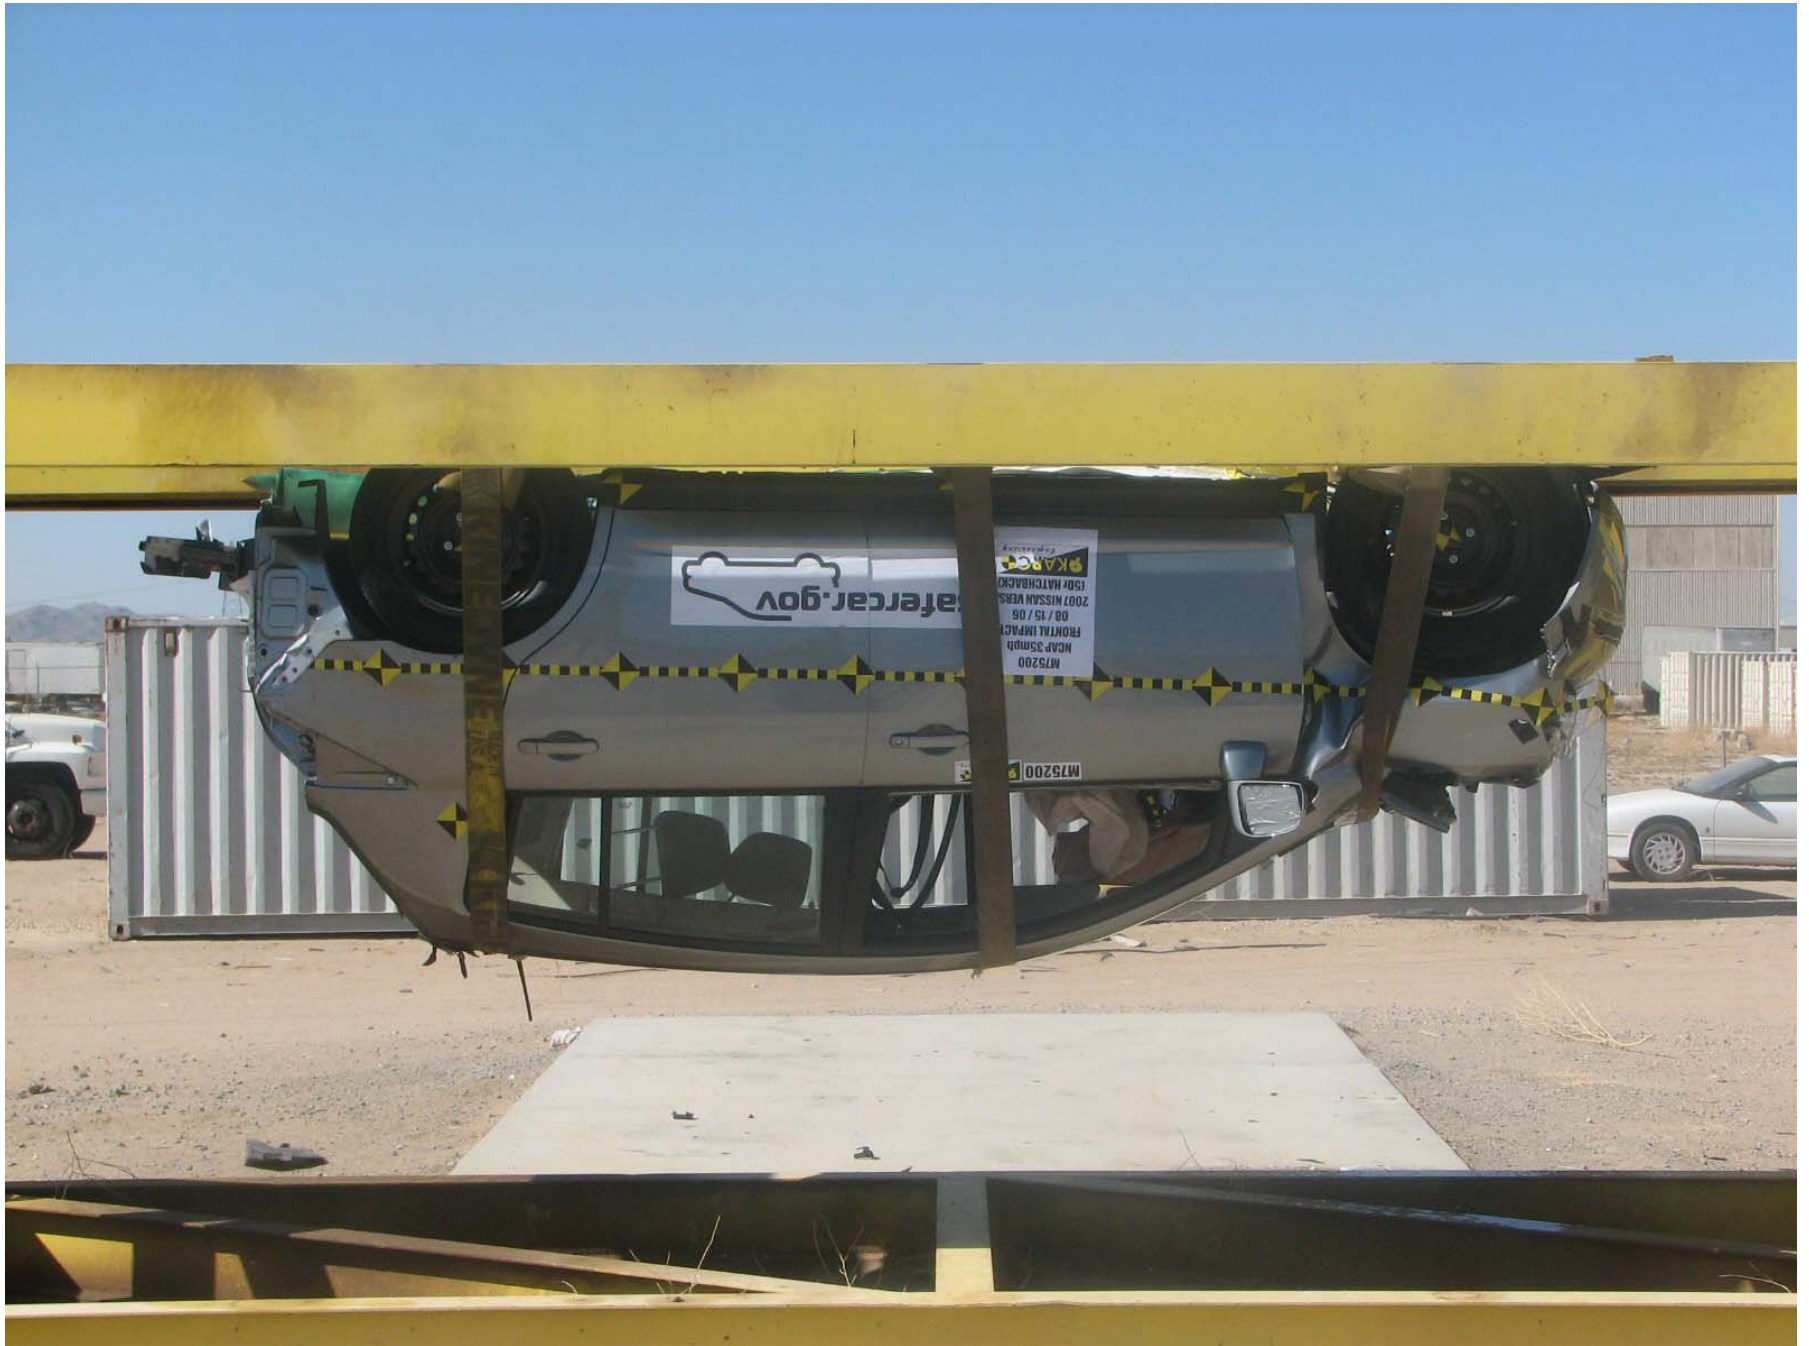
Figure A-58: Vehicle on Rollover Device (0°)

Figure A-59: Vehicle on Rollover Device (90°)

Figure A-60: Vehicle on Rollover Device (180°)

Figure A-61: Vehicle on Rollover Device (270°)

1. The specified fixture rollover rate for each 90° of rotation is 60 to 120 seconds.
2. The position hold time at each position is 300 seconds (minimum).
3. No solvent leakage occurred during rollover.

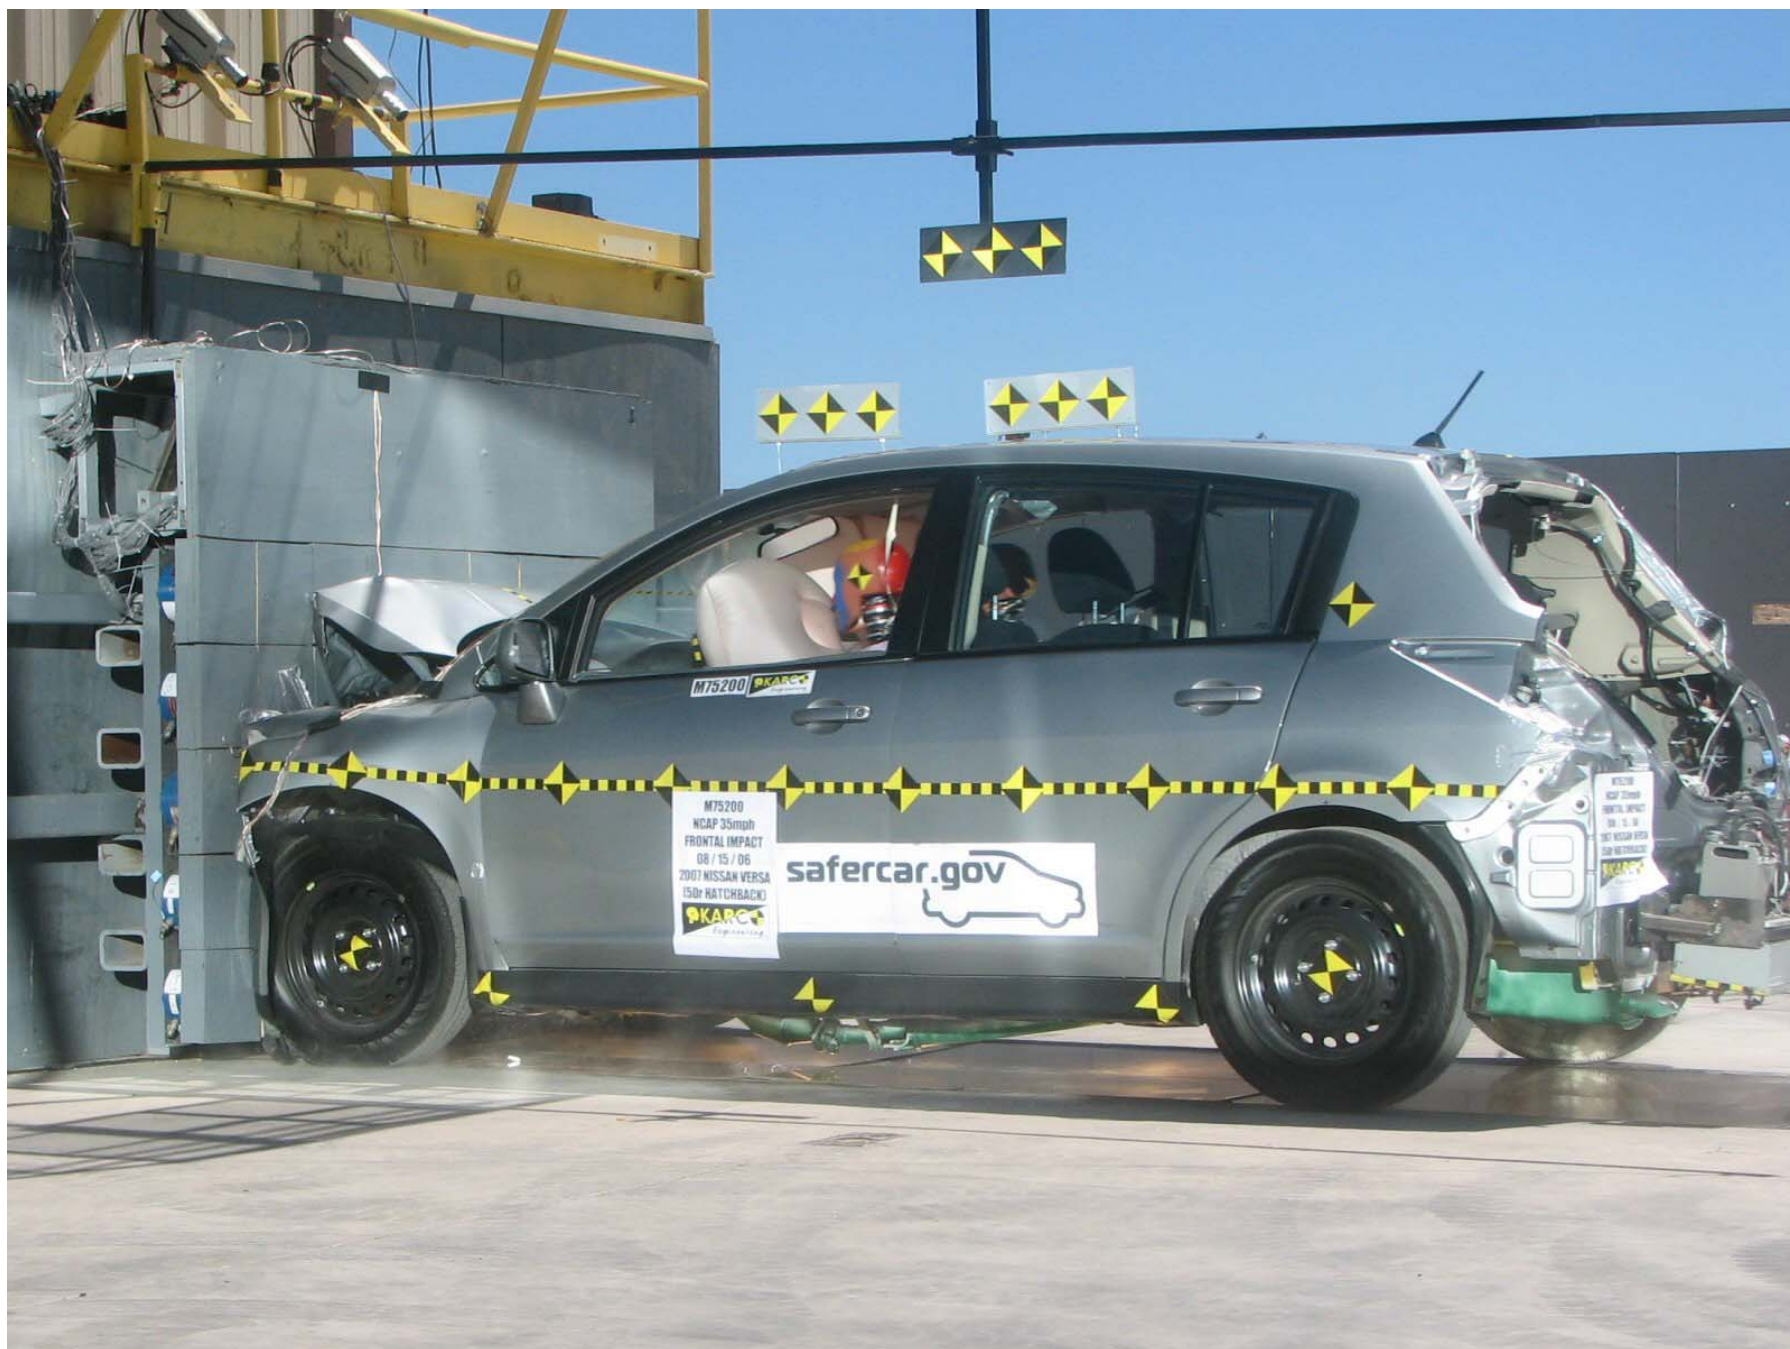
Figure A-62: Vehicle Impact
