**REPORT NUMBER TR-P27003-03-NC**

**NEW CAR ASSESSMENT PROGRAM  
SIDE IMPACT TEST**

**NISSAN MOTOR COMPANY LTD.  
2007 NISSAN VERSA 1.8S  
5-DOOR HATCHBACK**

**FINAL REPORT**

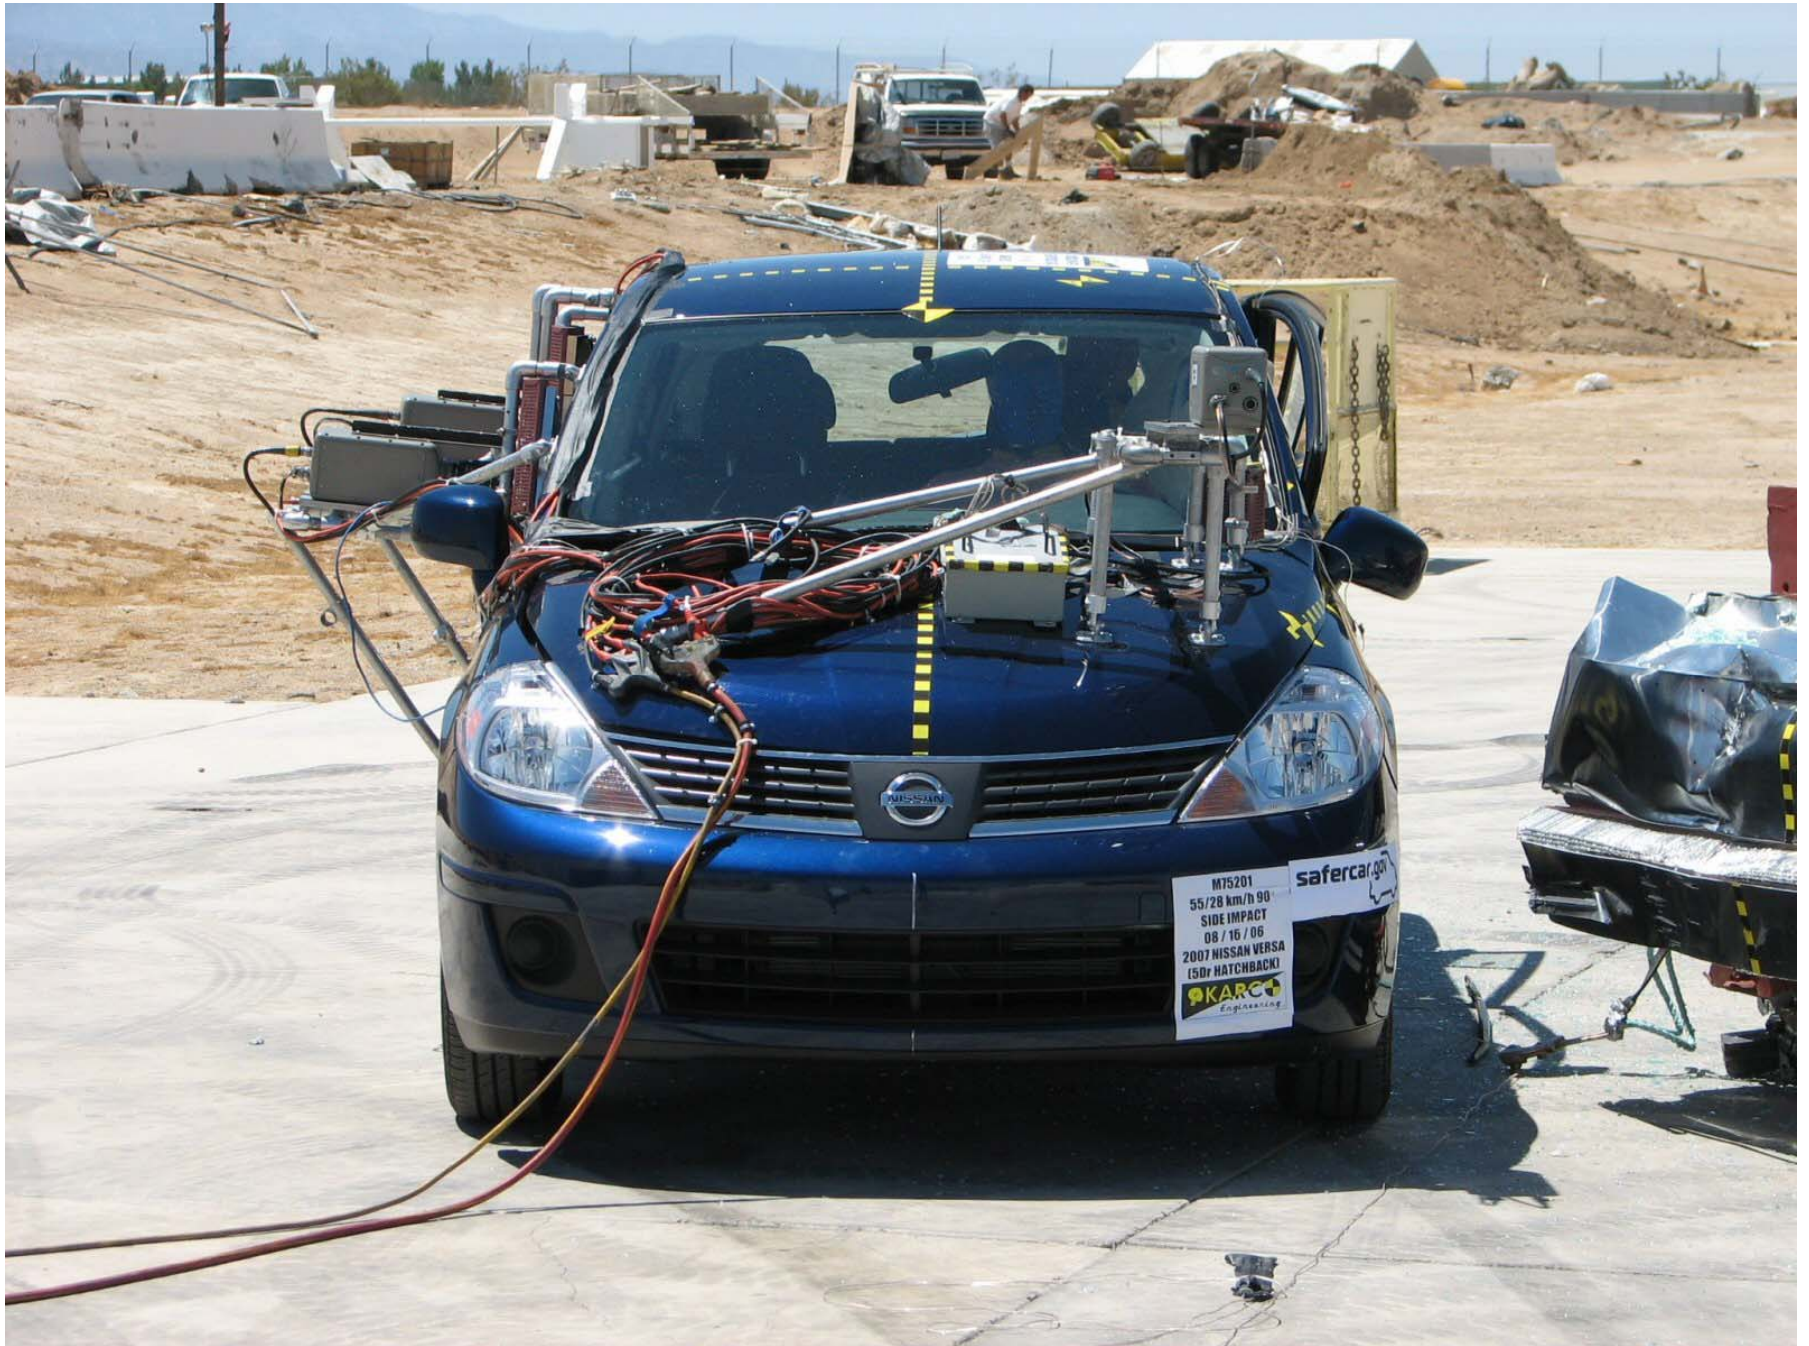
Figure A-6: Post-Test Front View

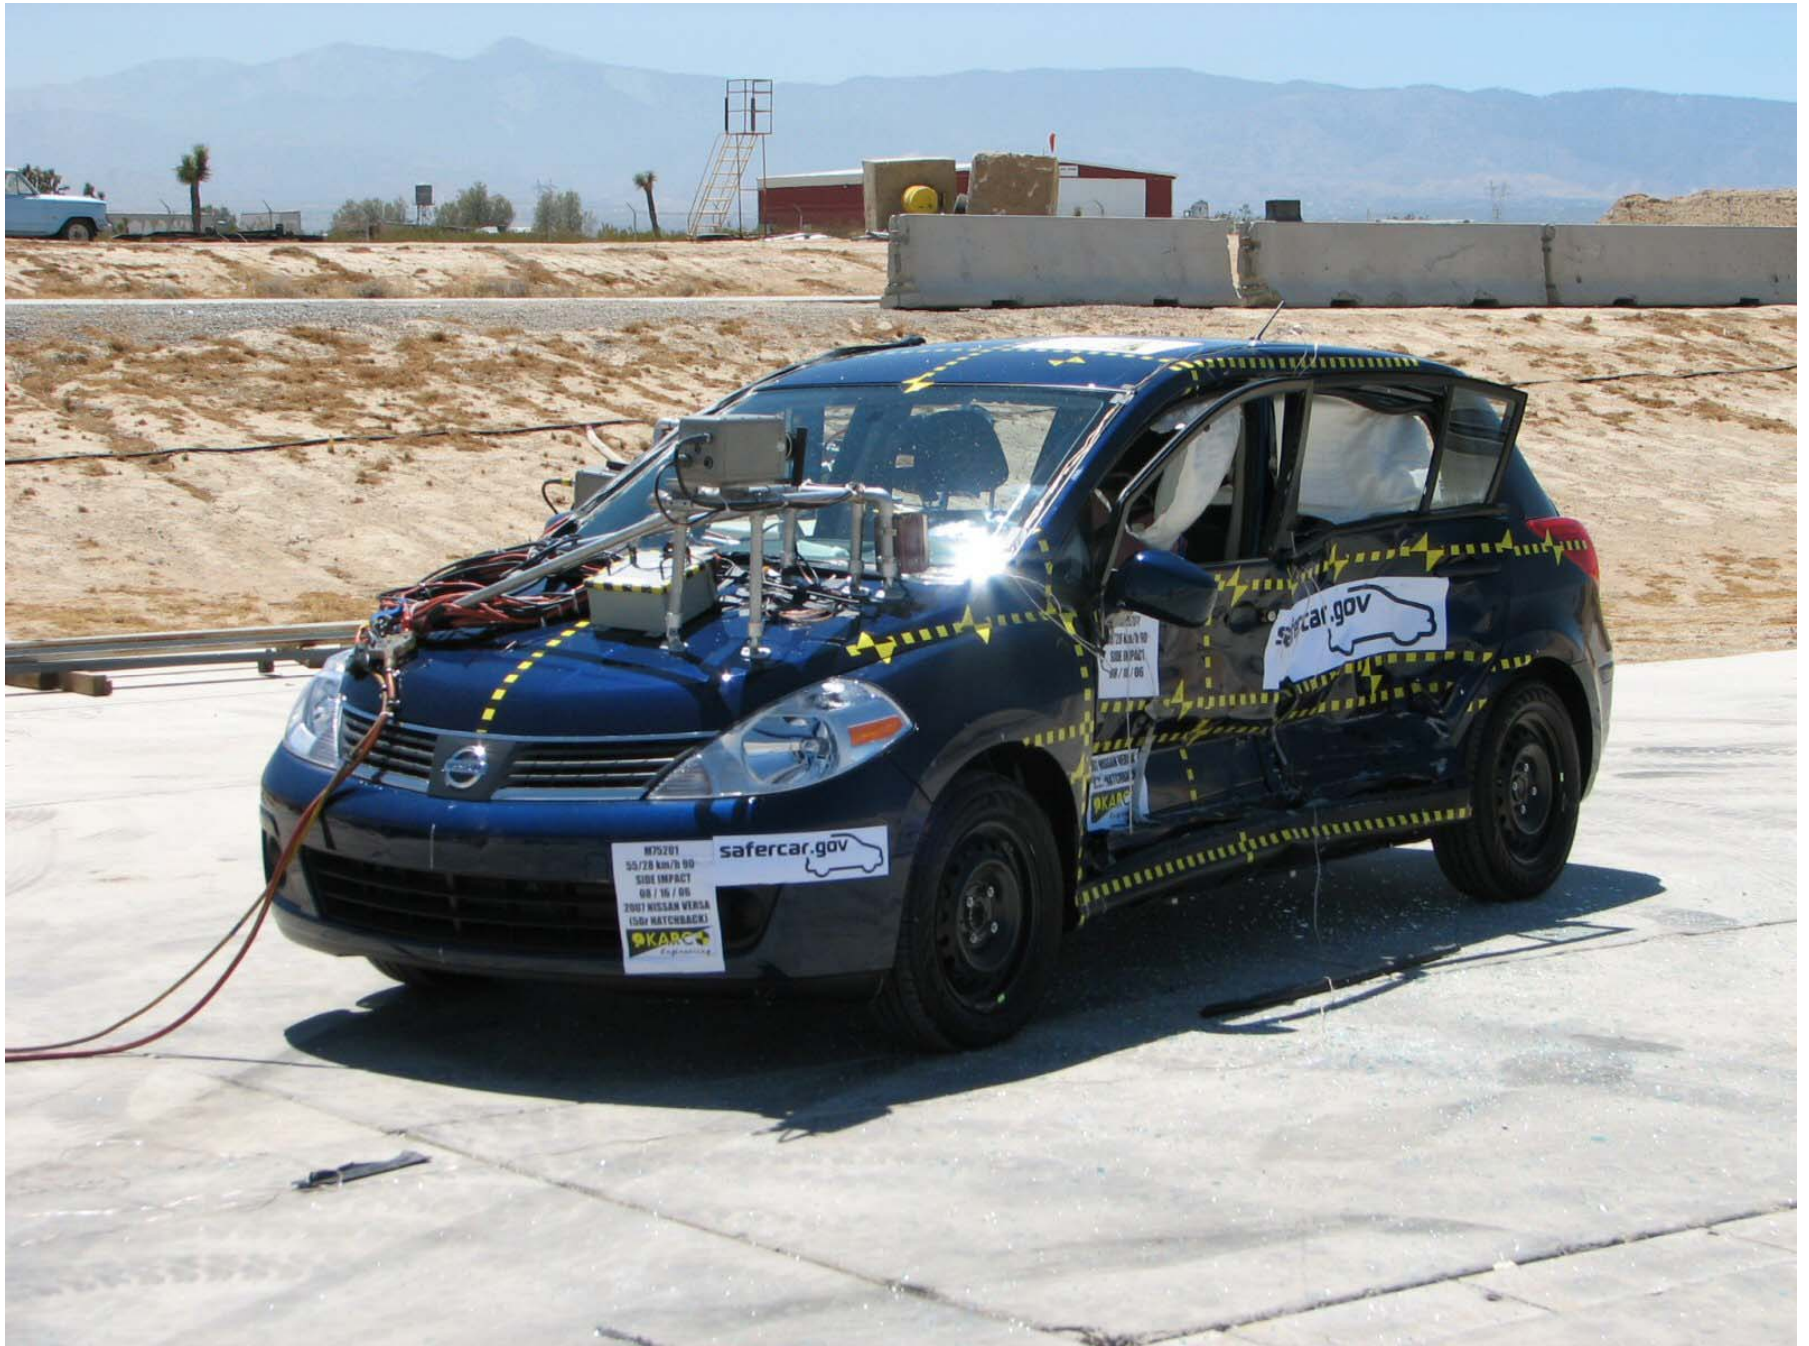
Figure A-8: Post-Test Left Front  $\frac{3}{4}$  View

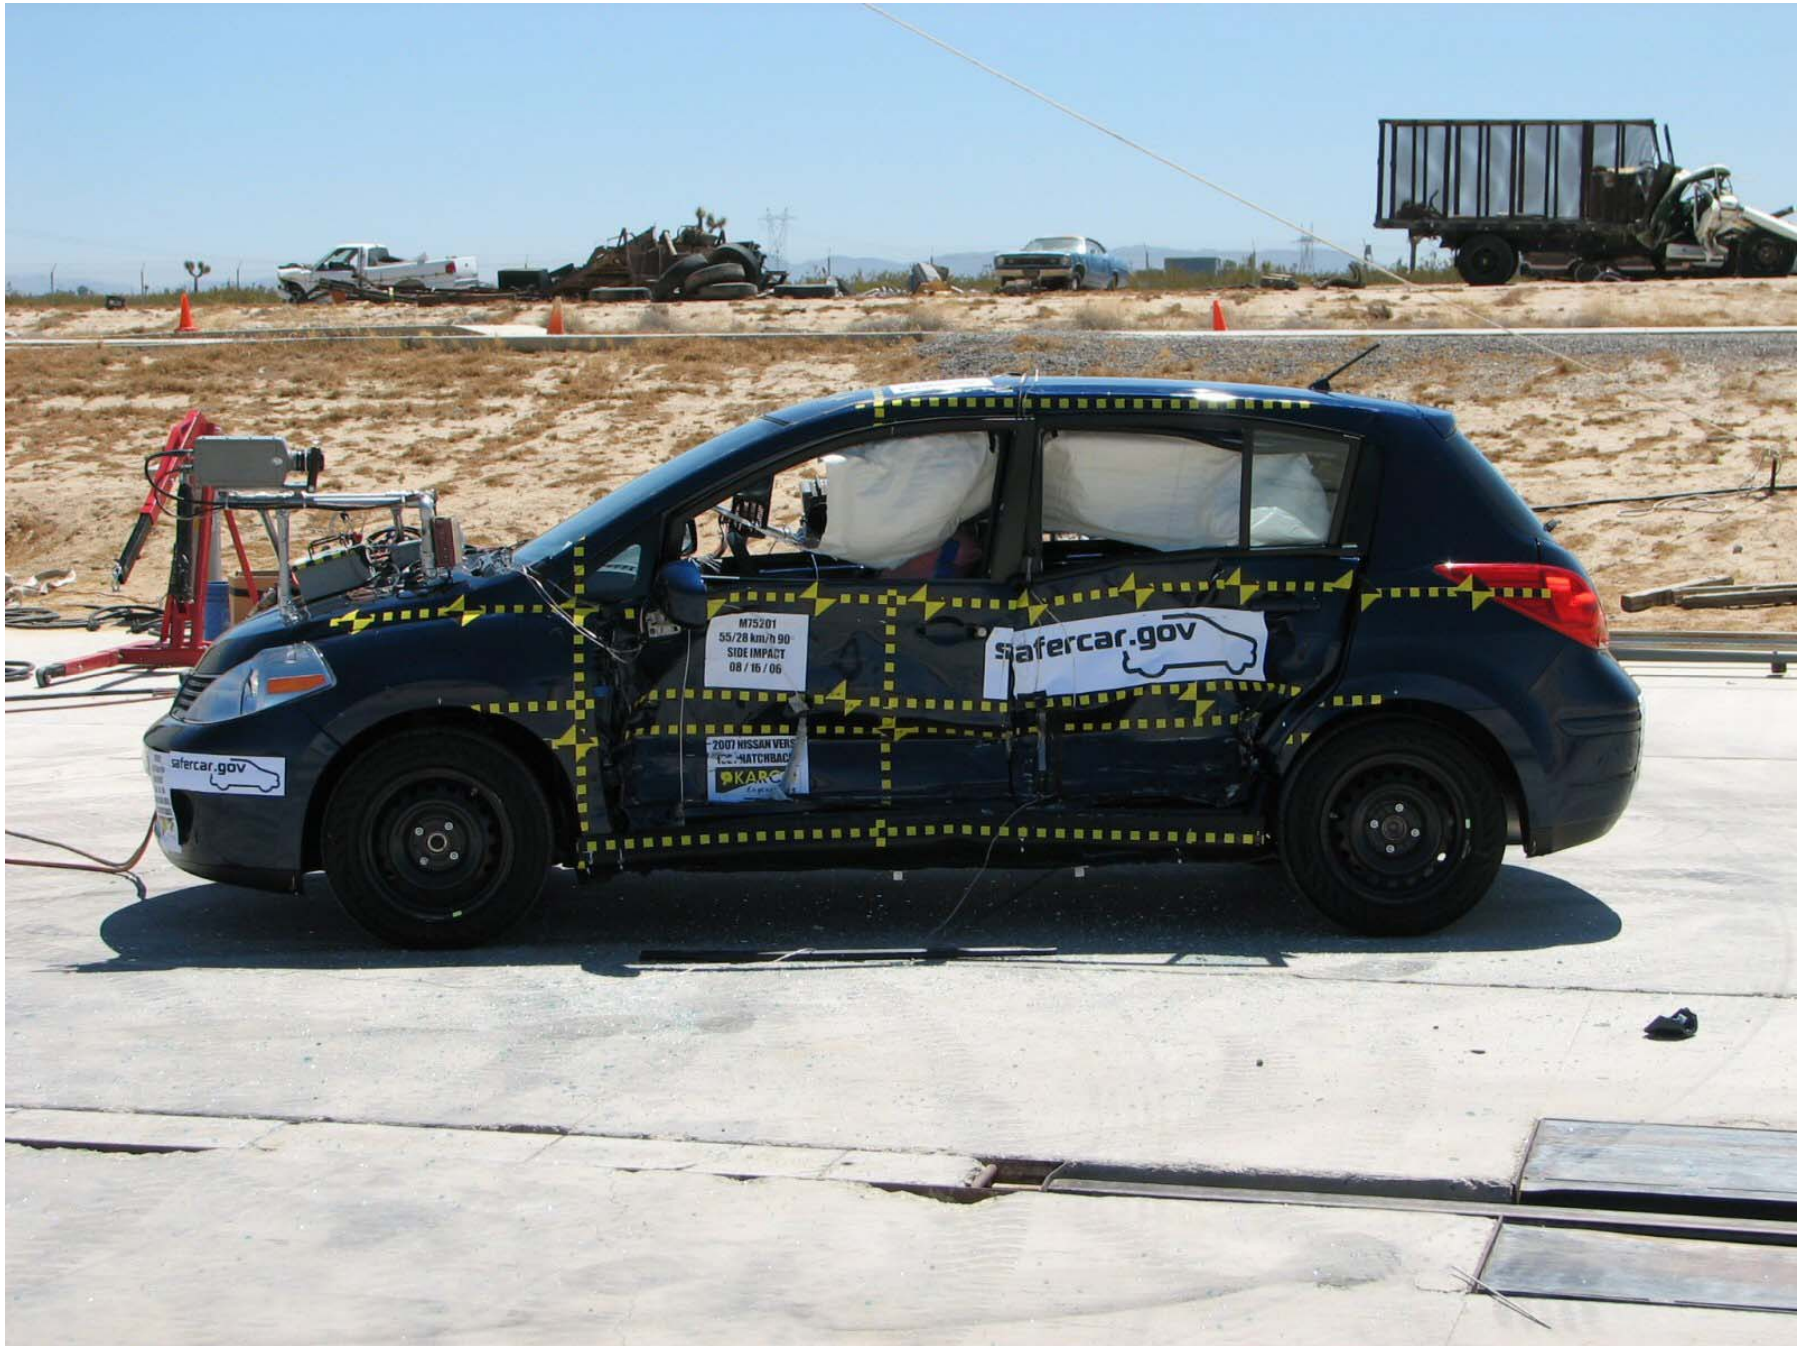
Figure A-10: Post-Test Left Side View

The driver and passenger doors remained closed during impact. The test vehicle sustained a maximum static crush of 268 mm at level 2, 900 mm rearward of the left vertical impact point. The driver SID/Hybrid III, Serial No. 274 and the passenger SID/Hybrid III, Serial No. 275 were calibrated prior to this test. The SID/Hybrid III injury criteria is summarized as follows:

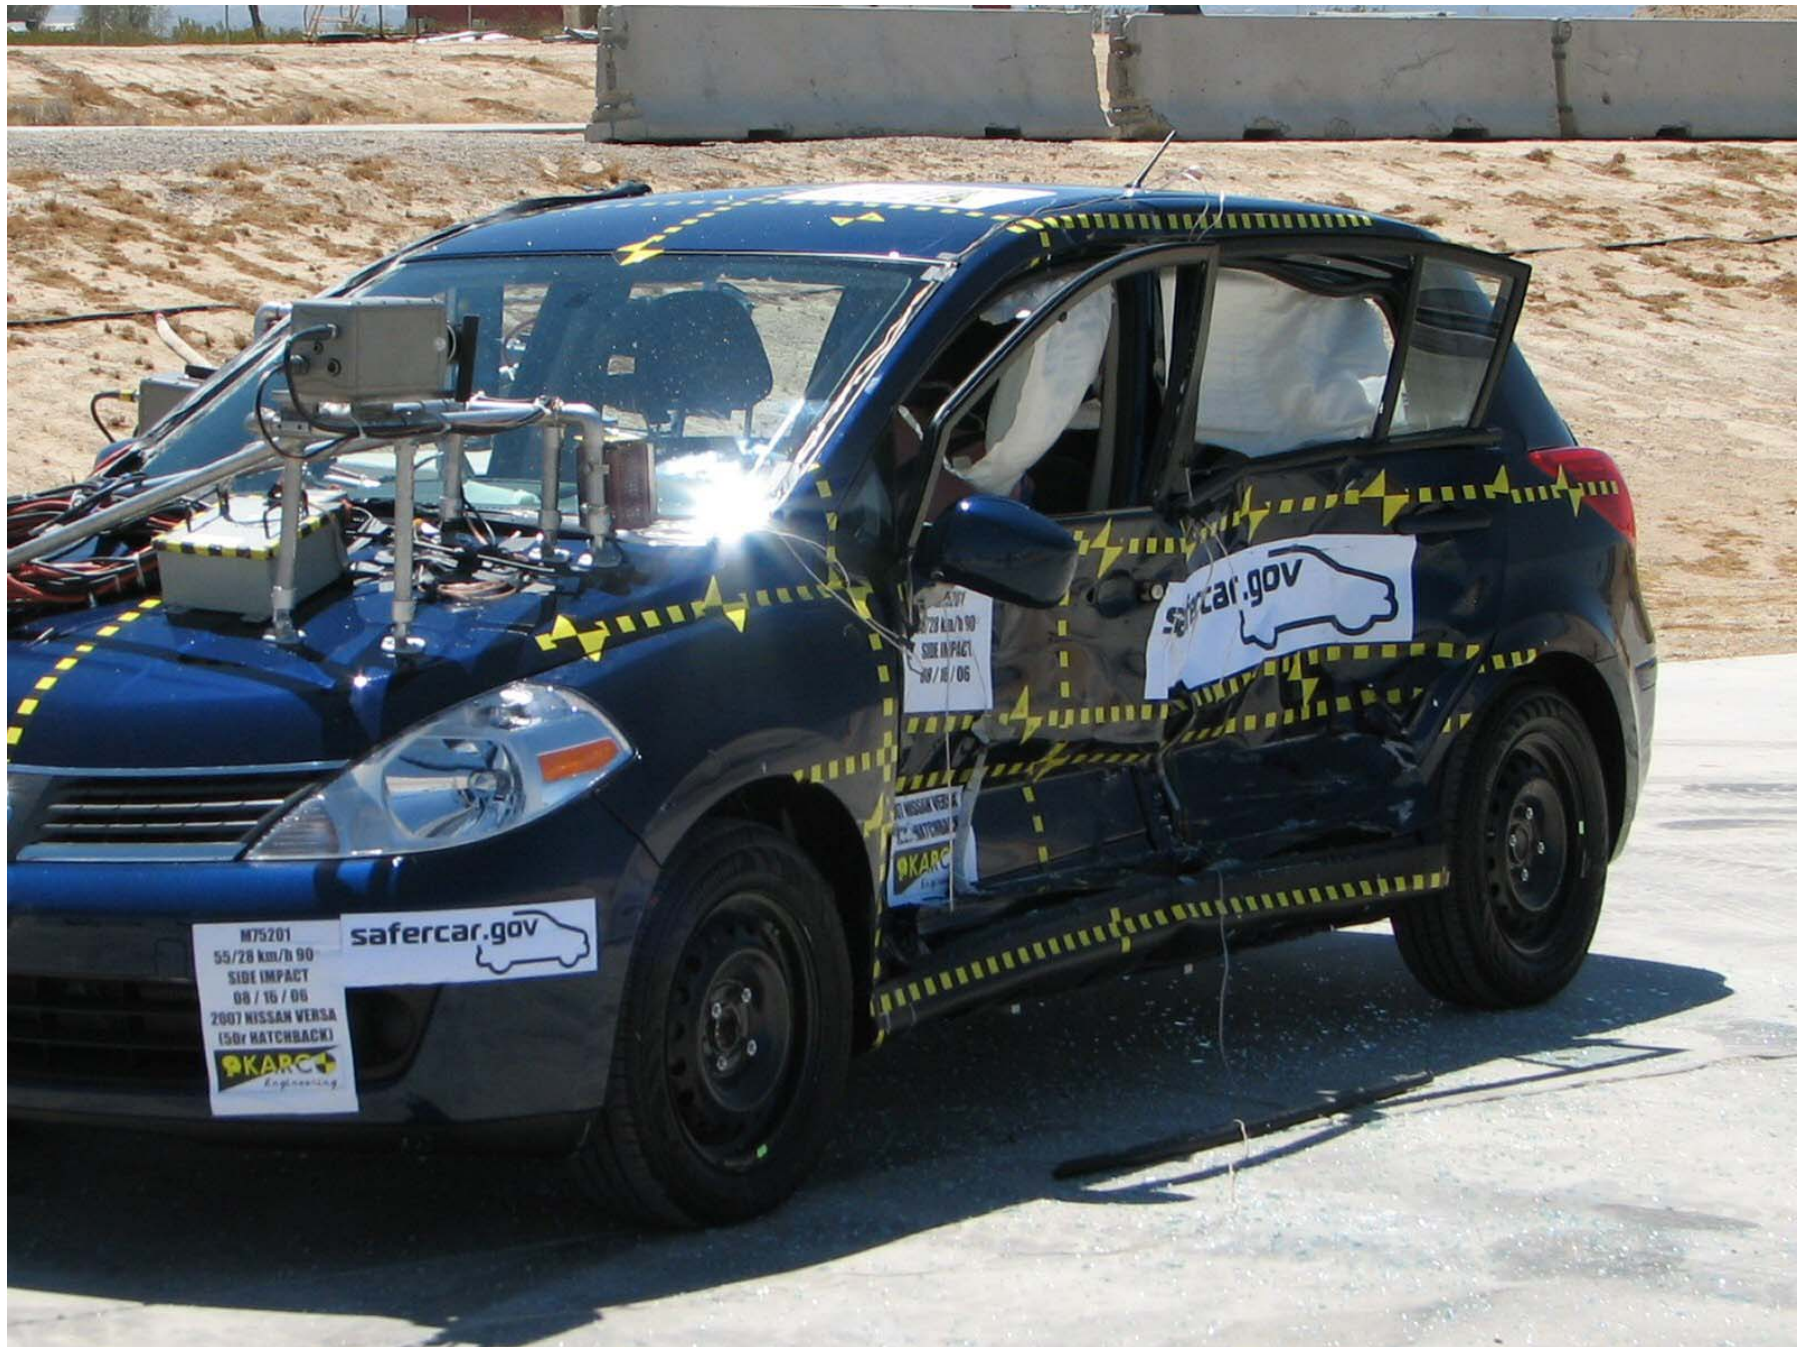
Figure A-28: Post-Test Front  $\frac{3}{4}$  View of Left Side Door

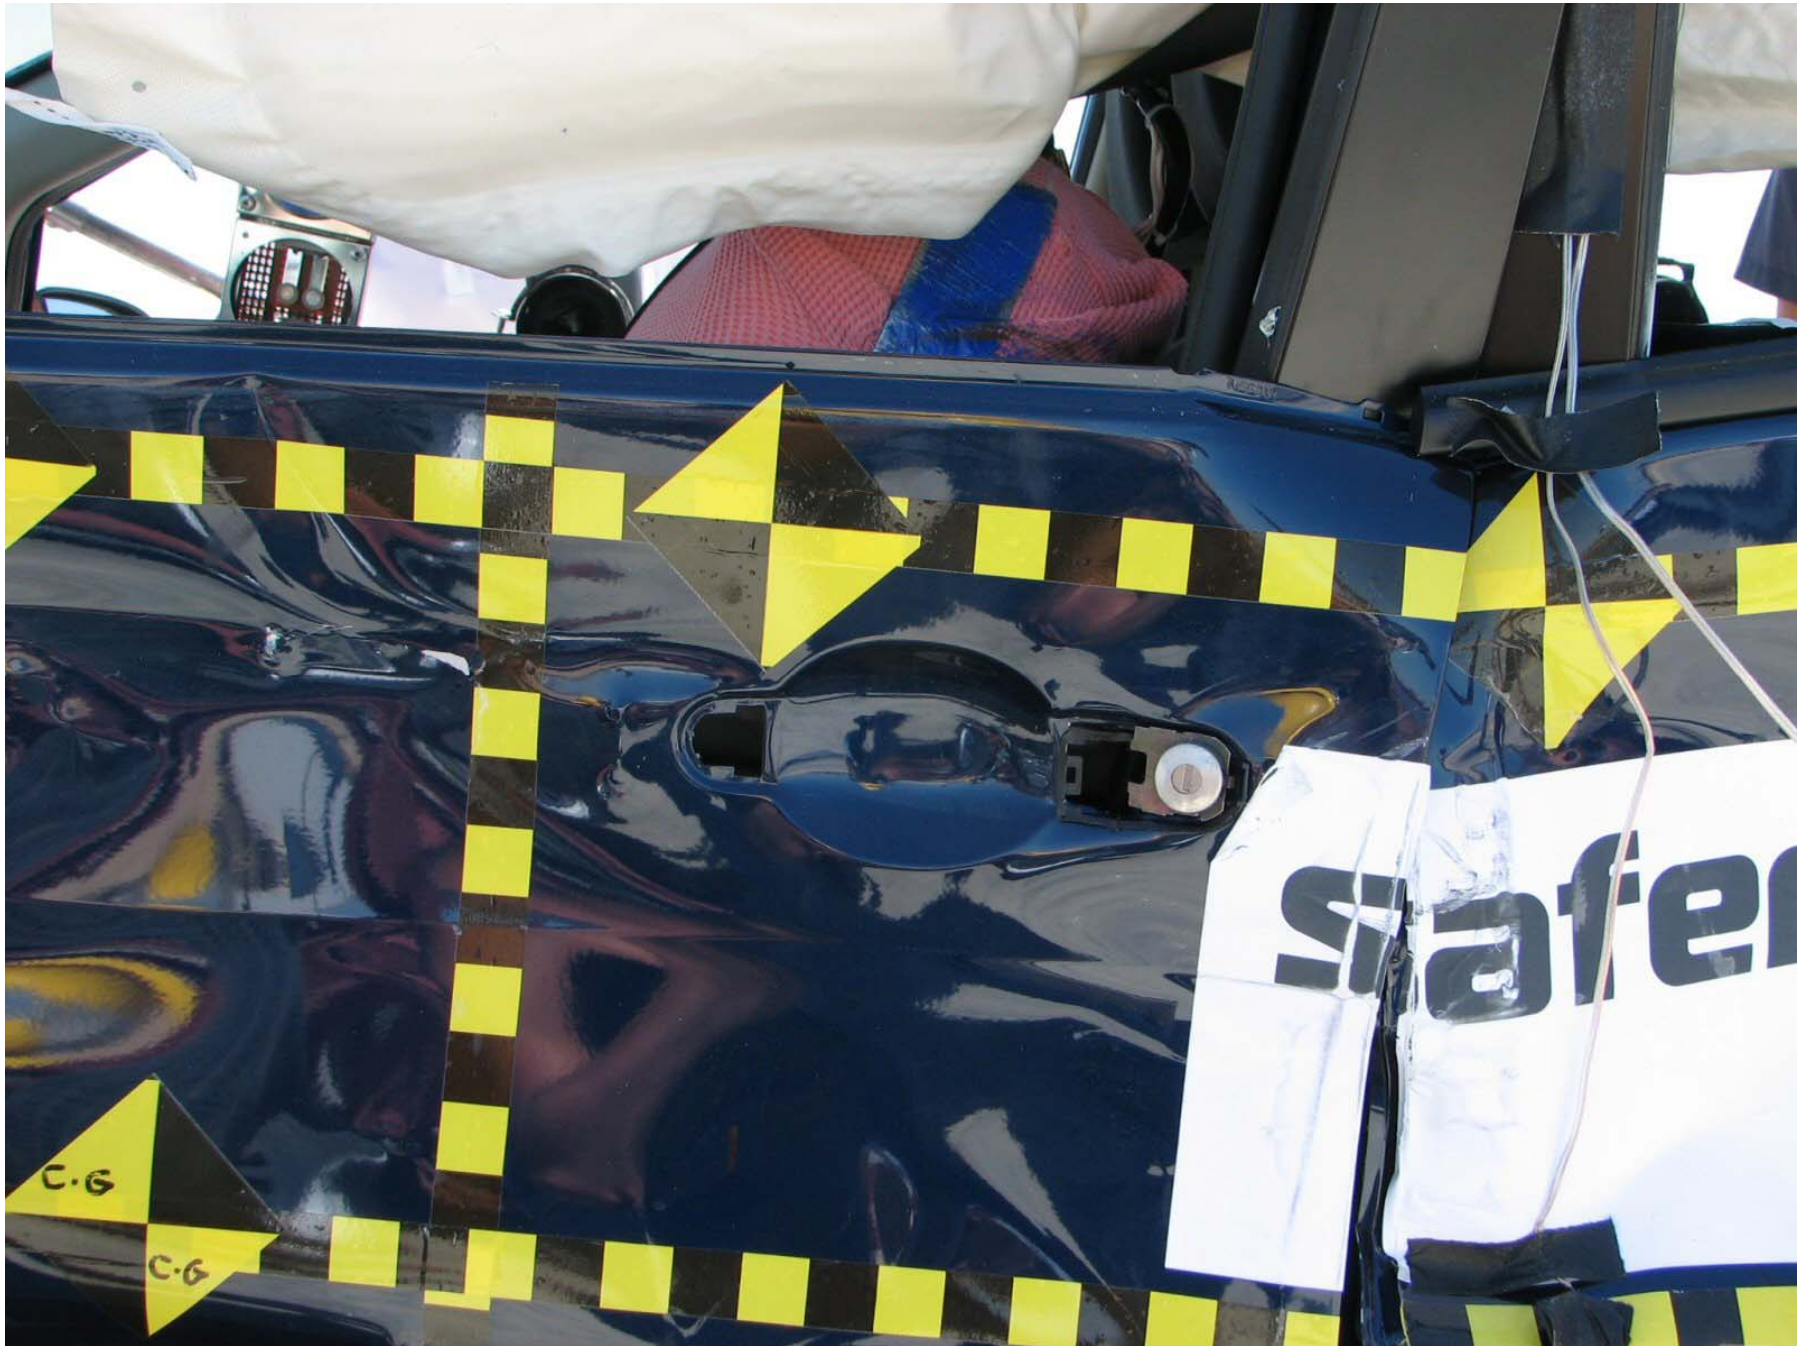
Figure A-32: Post-Test Left Front Door

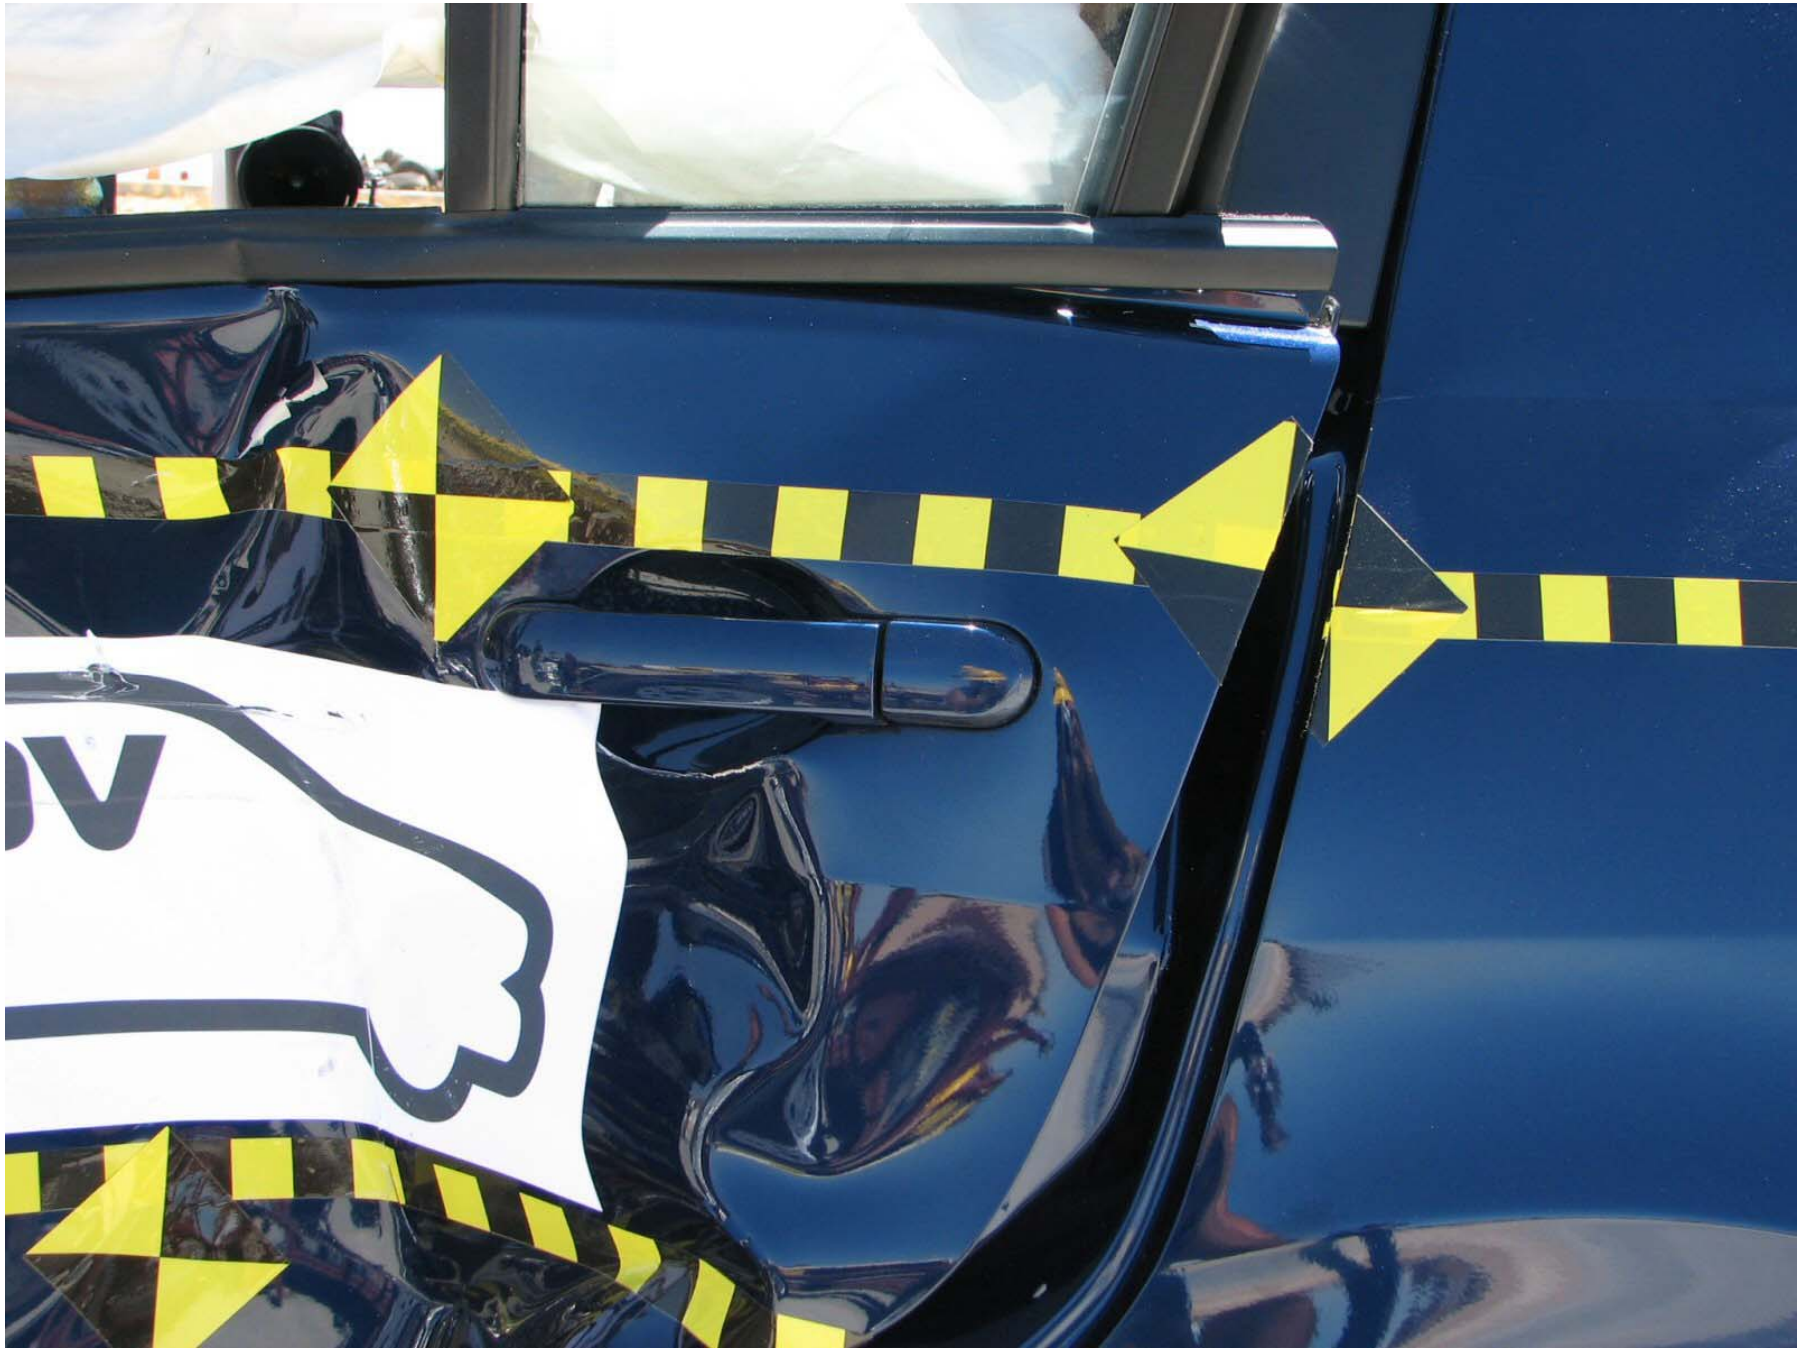
Figure A-34: Post-Test Left Rear Door

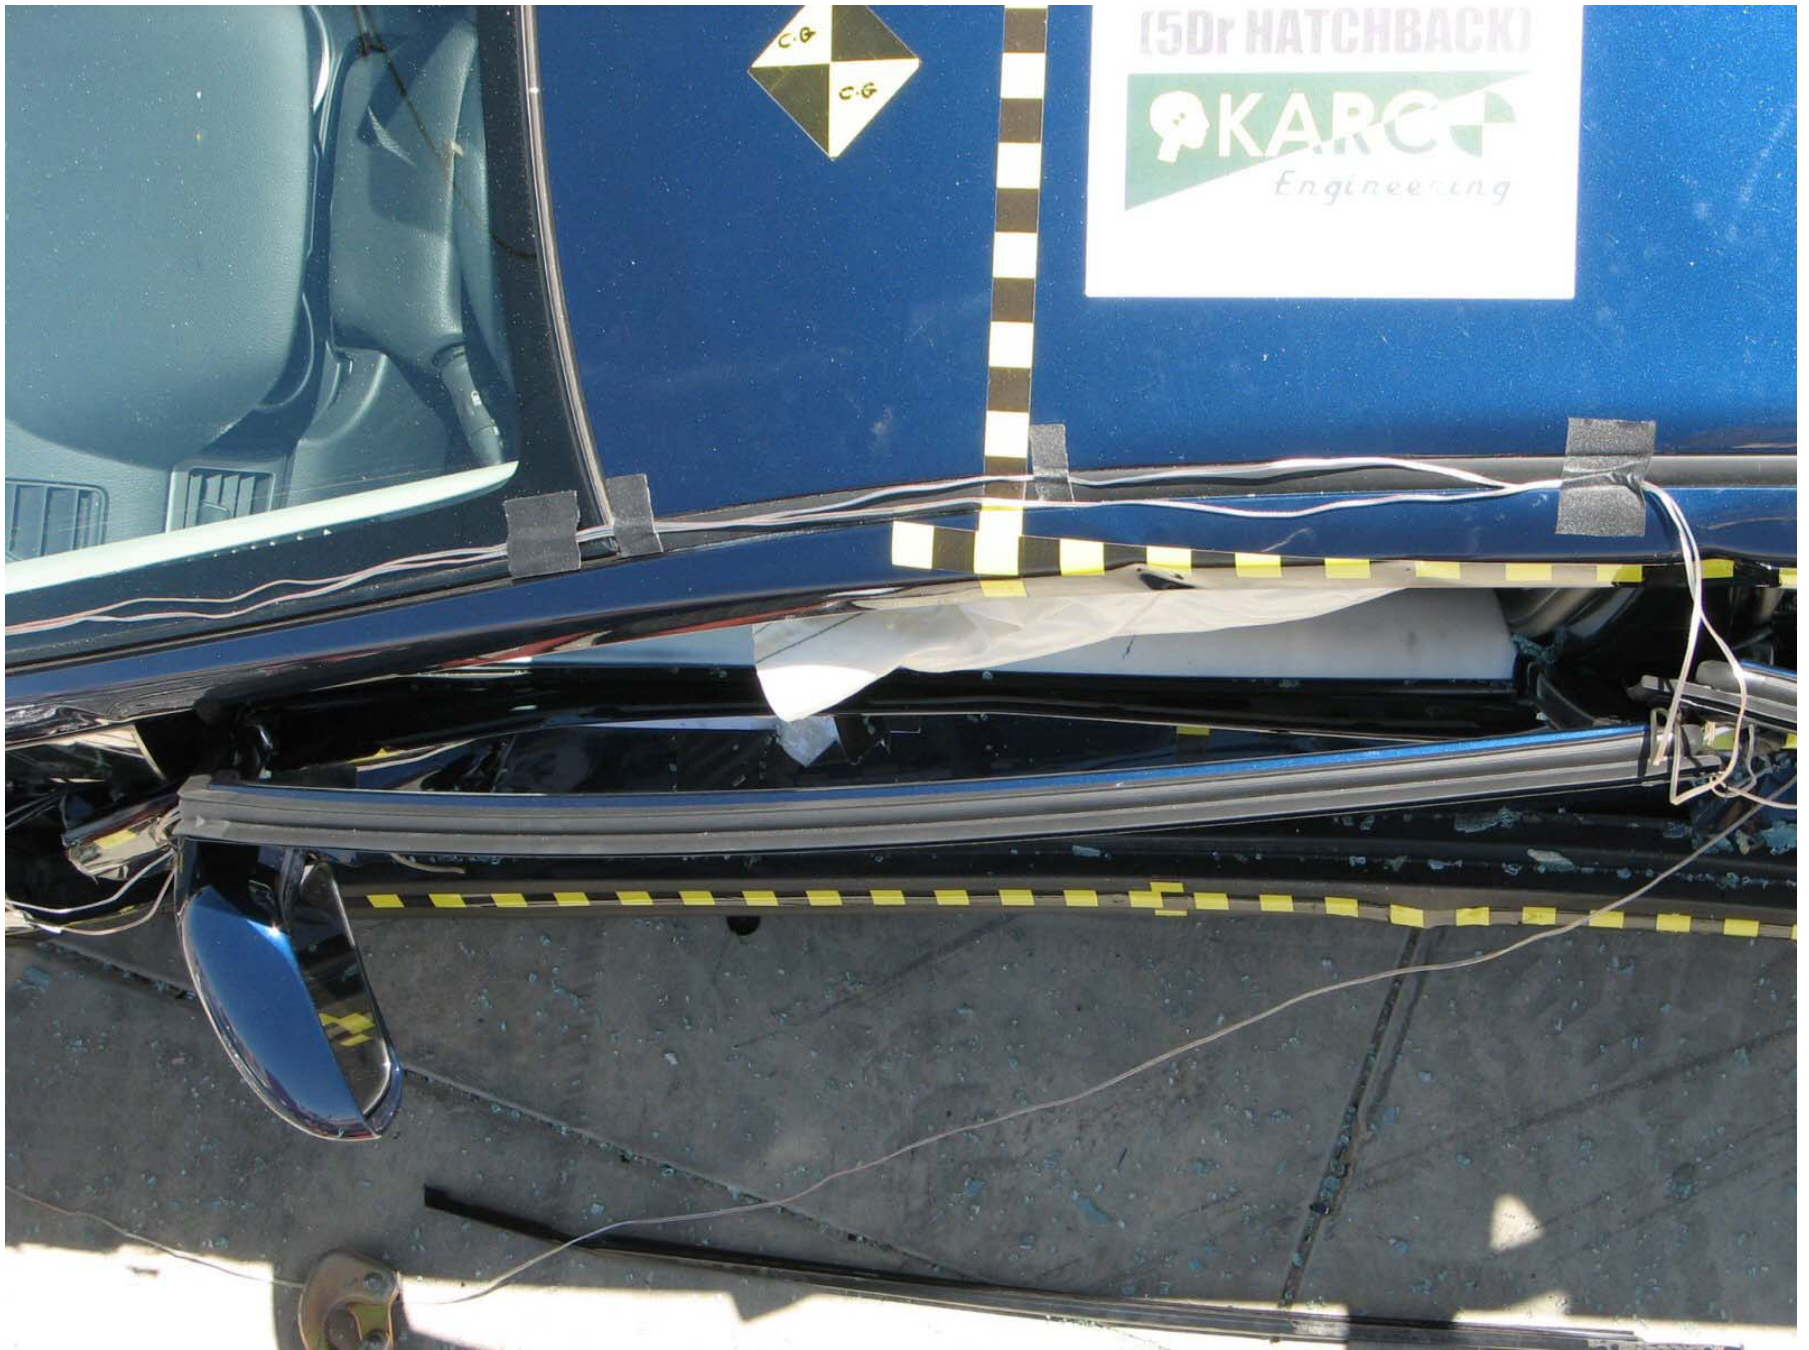
Figure A-39: Post-Test Driver Dummy Clearance From Door

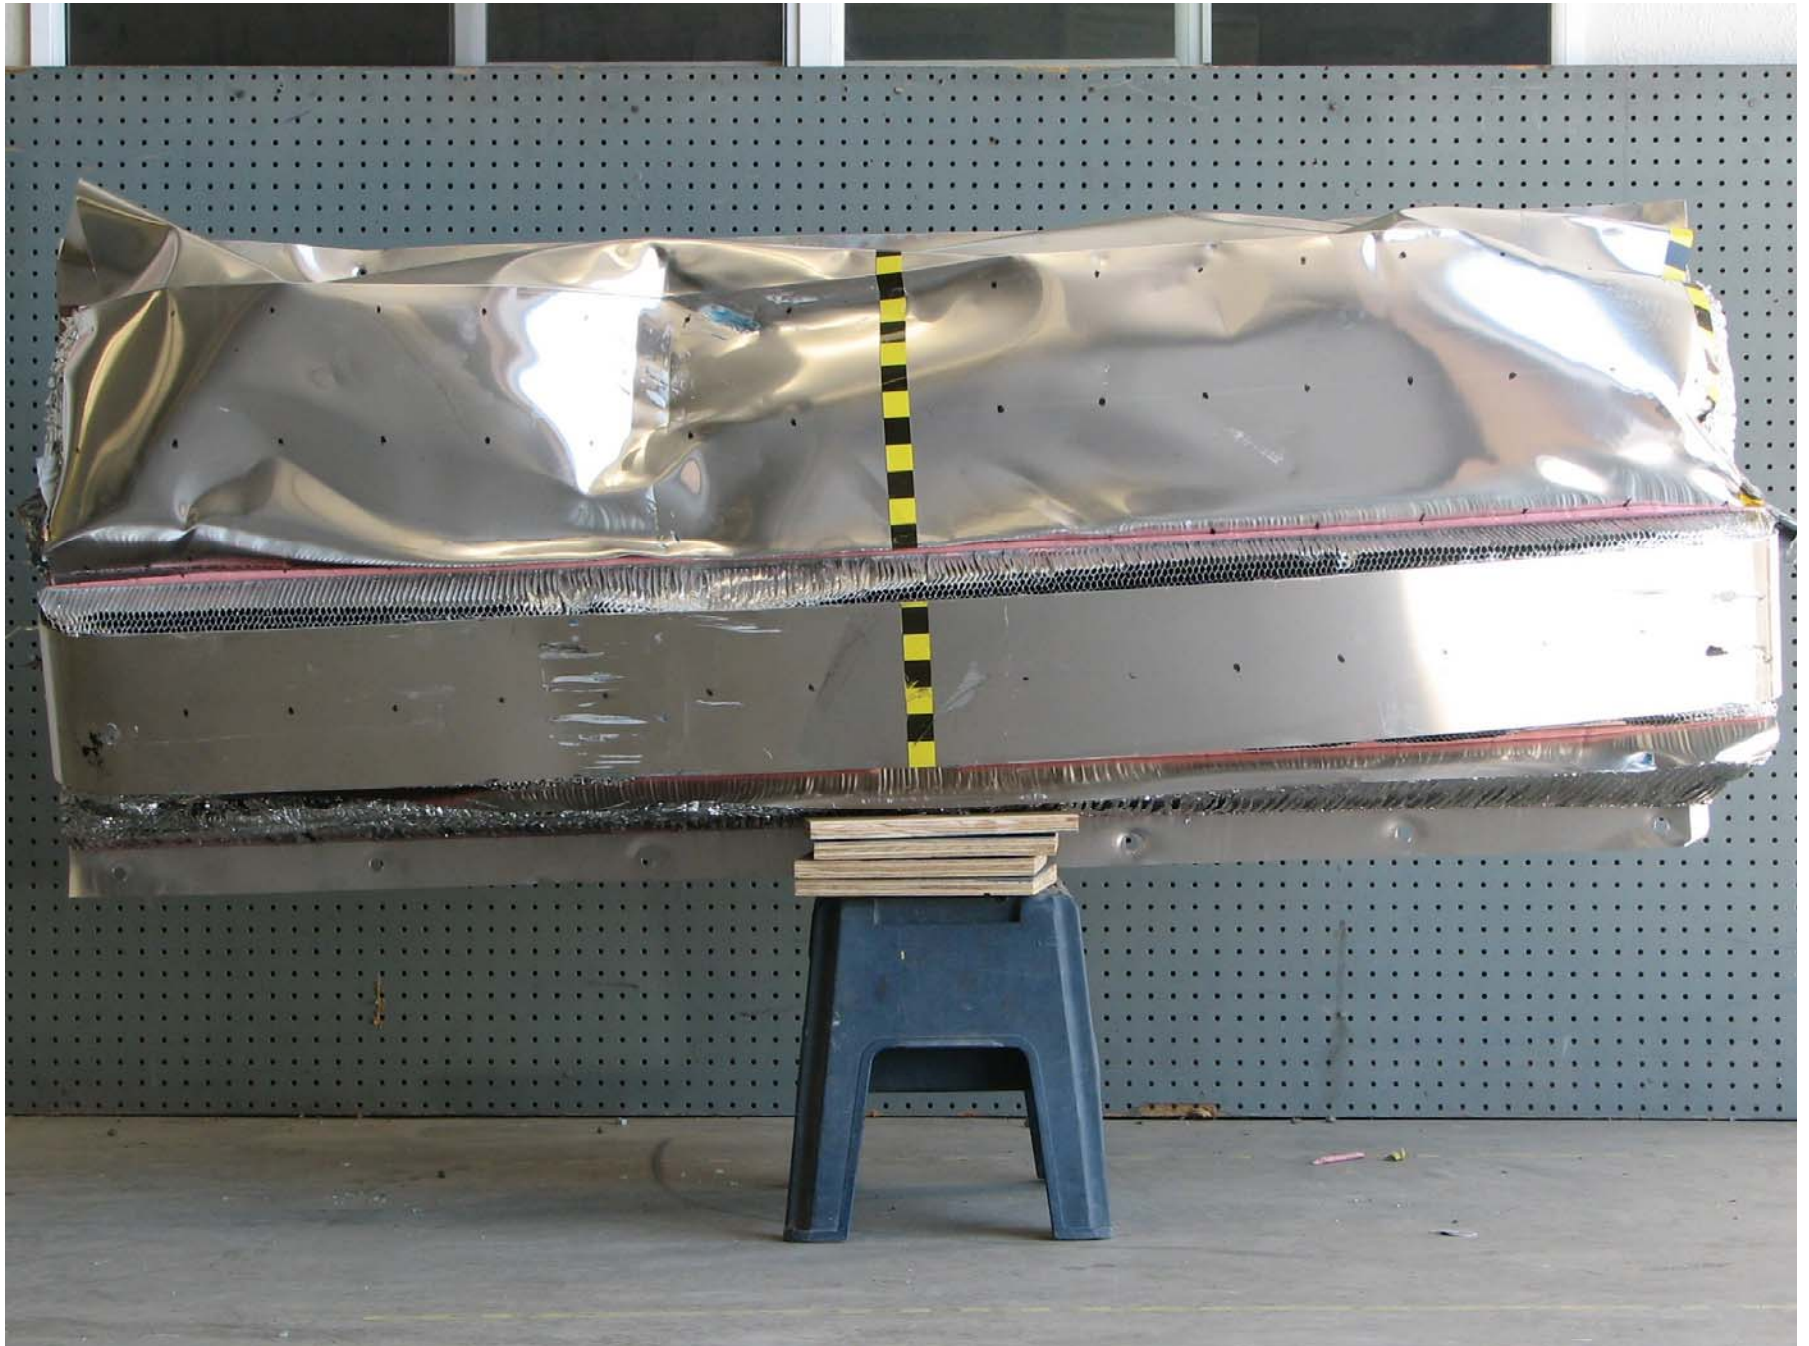
Figure A-54: Post-Test Front View of Deformable Barrier
