**REPORT NUMBER TR-P27003-03-NC**

**NEW CAR ASSESSMENT PROGRAM  
SIDE IMPACT TEST**

**NISSAN MOTOR COMPANY LTD.  
2007 NISSAN VERSA 1.8S  
5-DOOR HATCHBACK**

**FINAL REPORT**

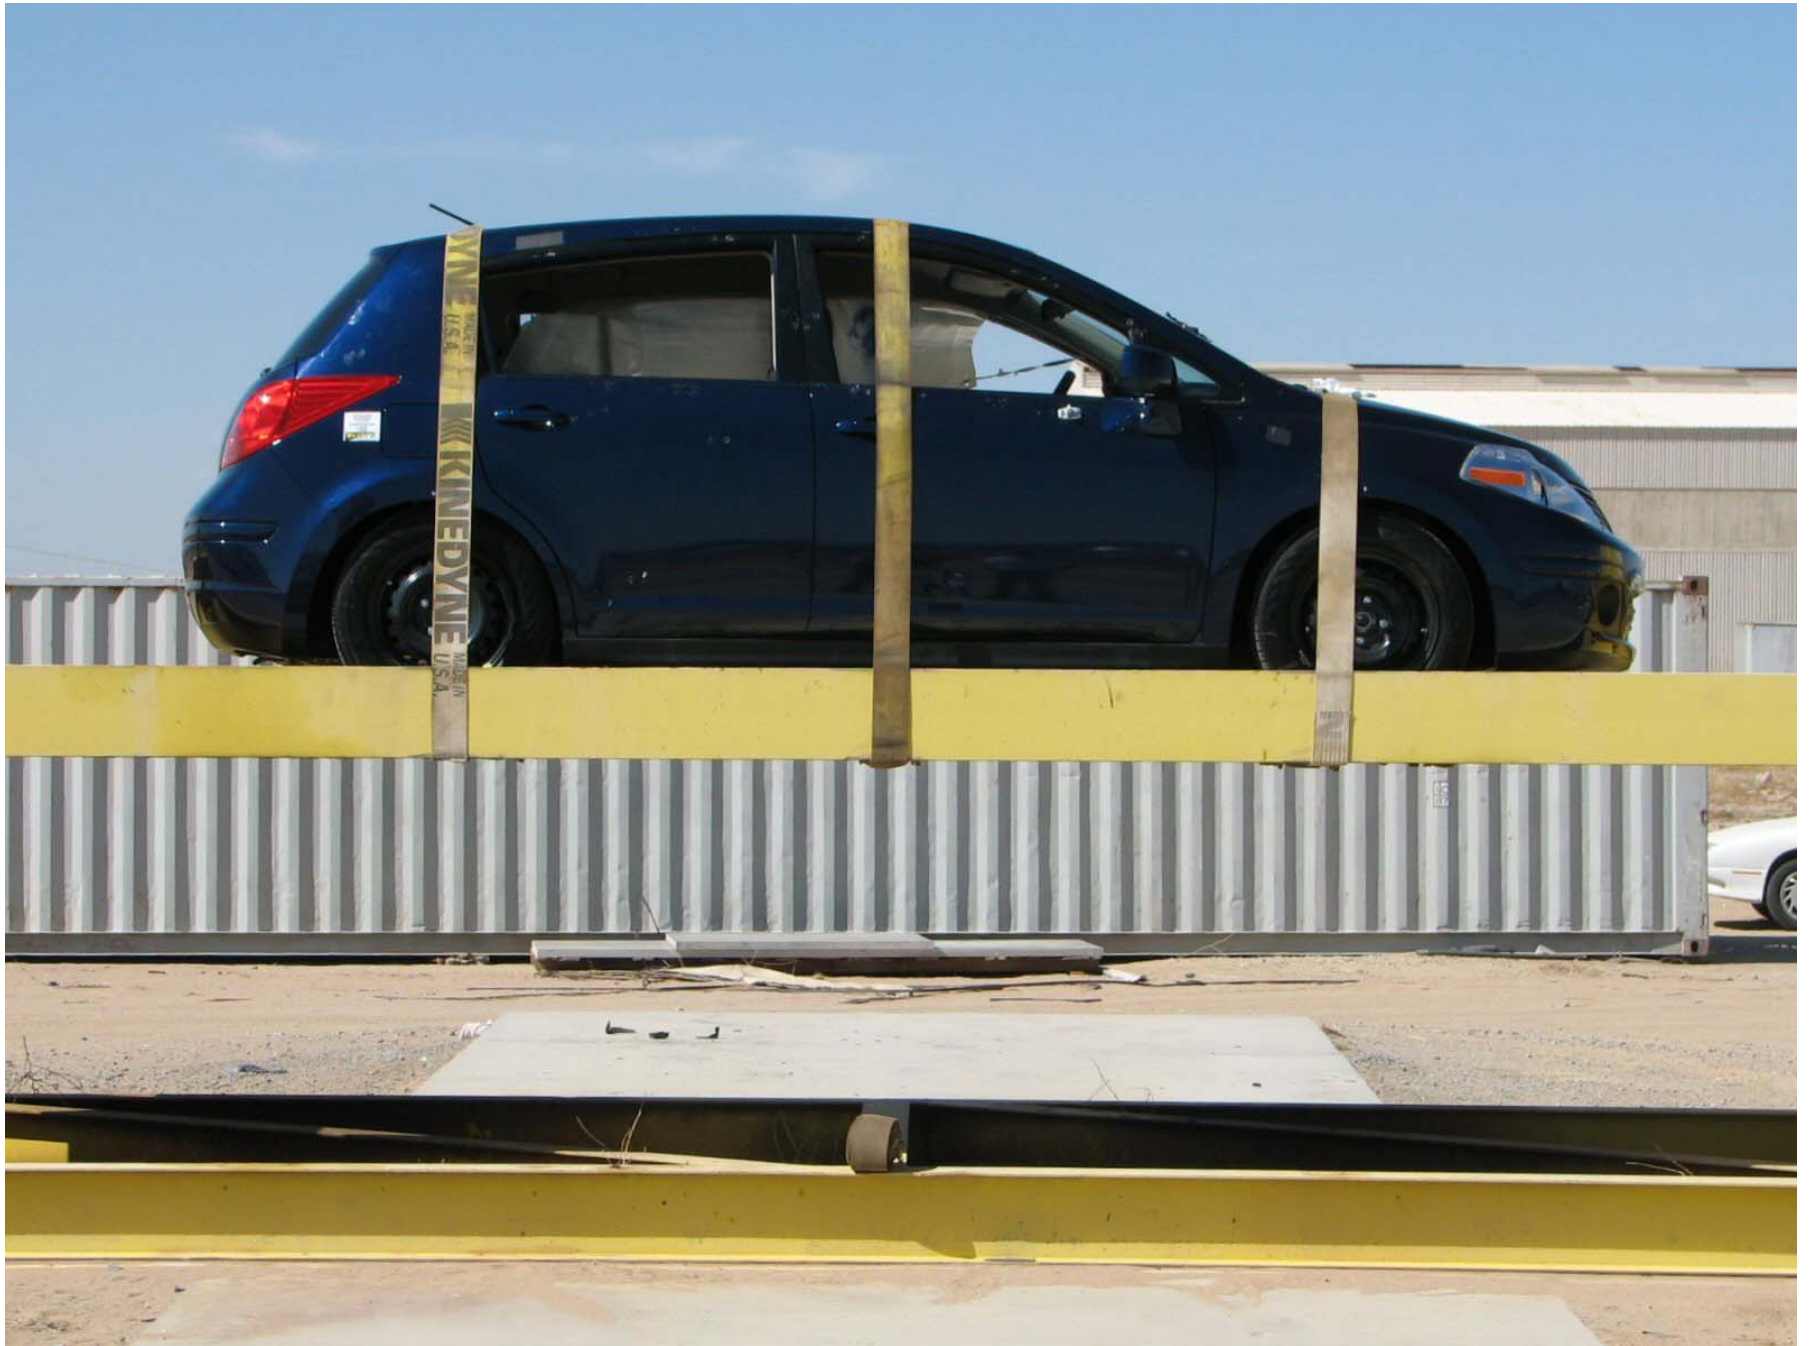
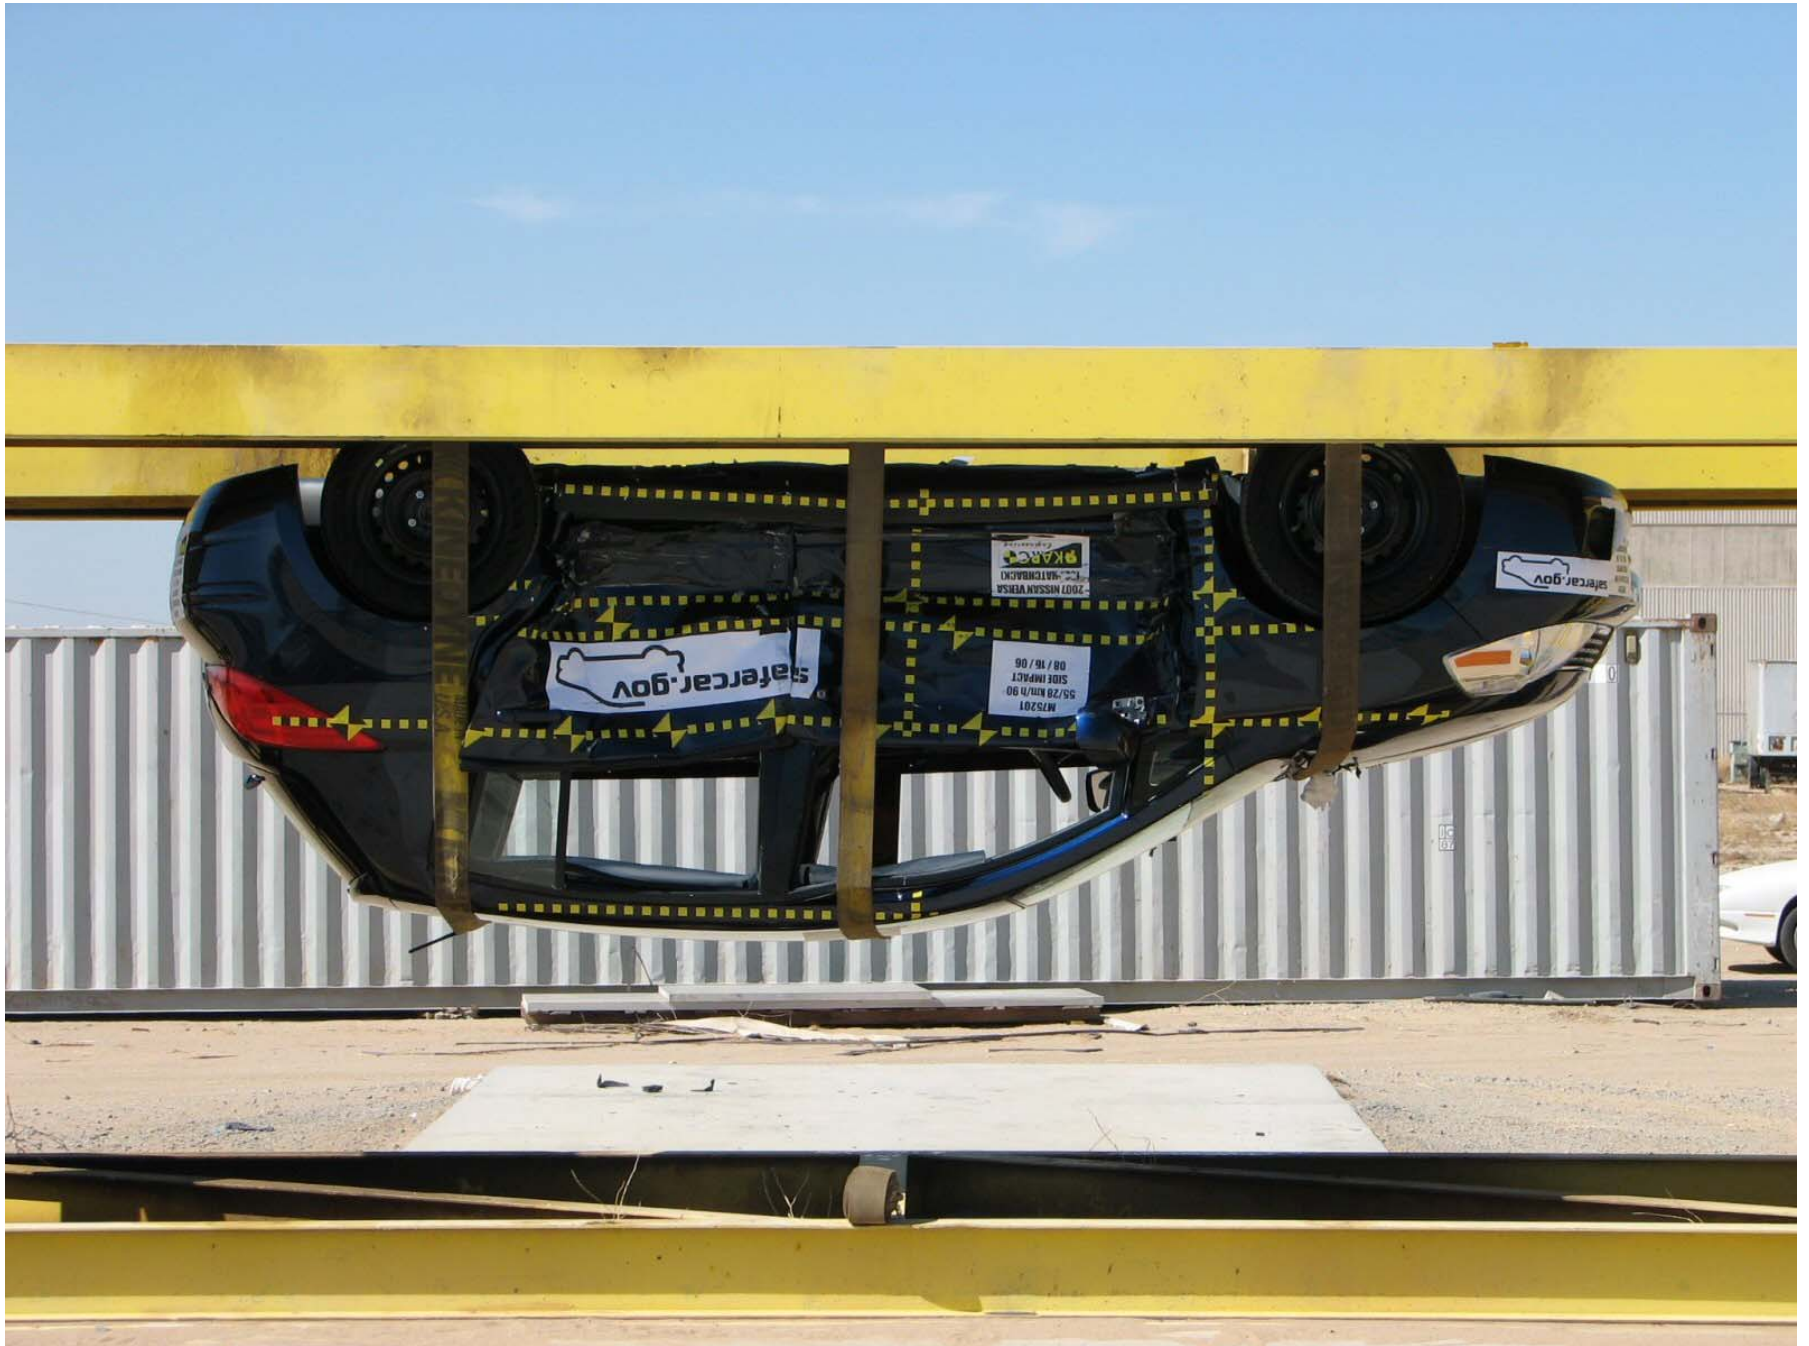
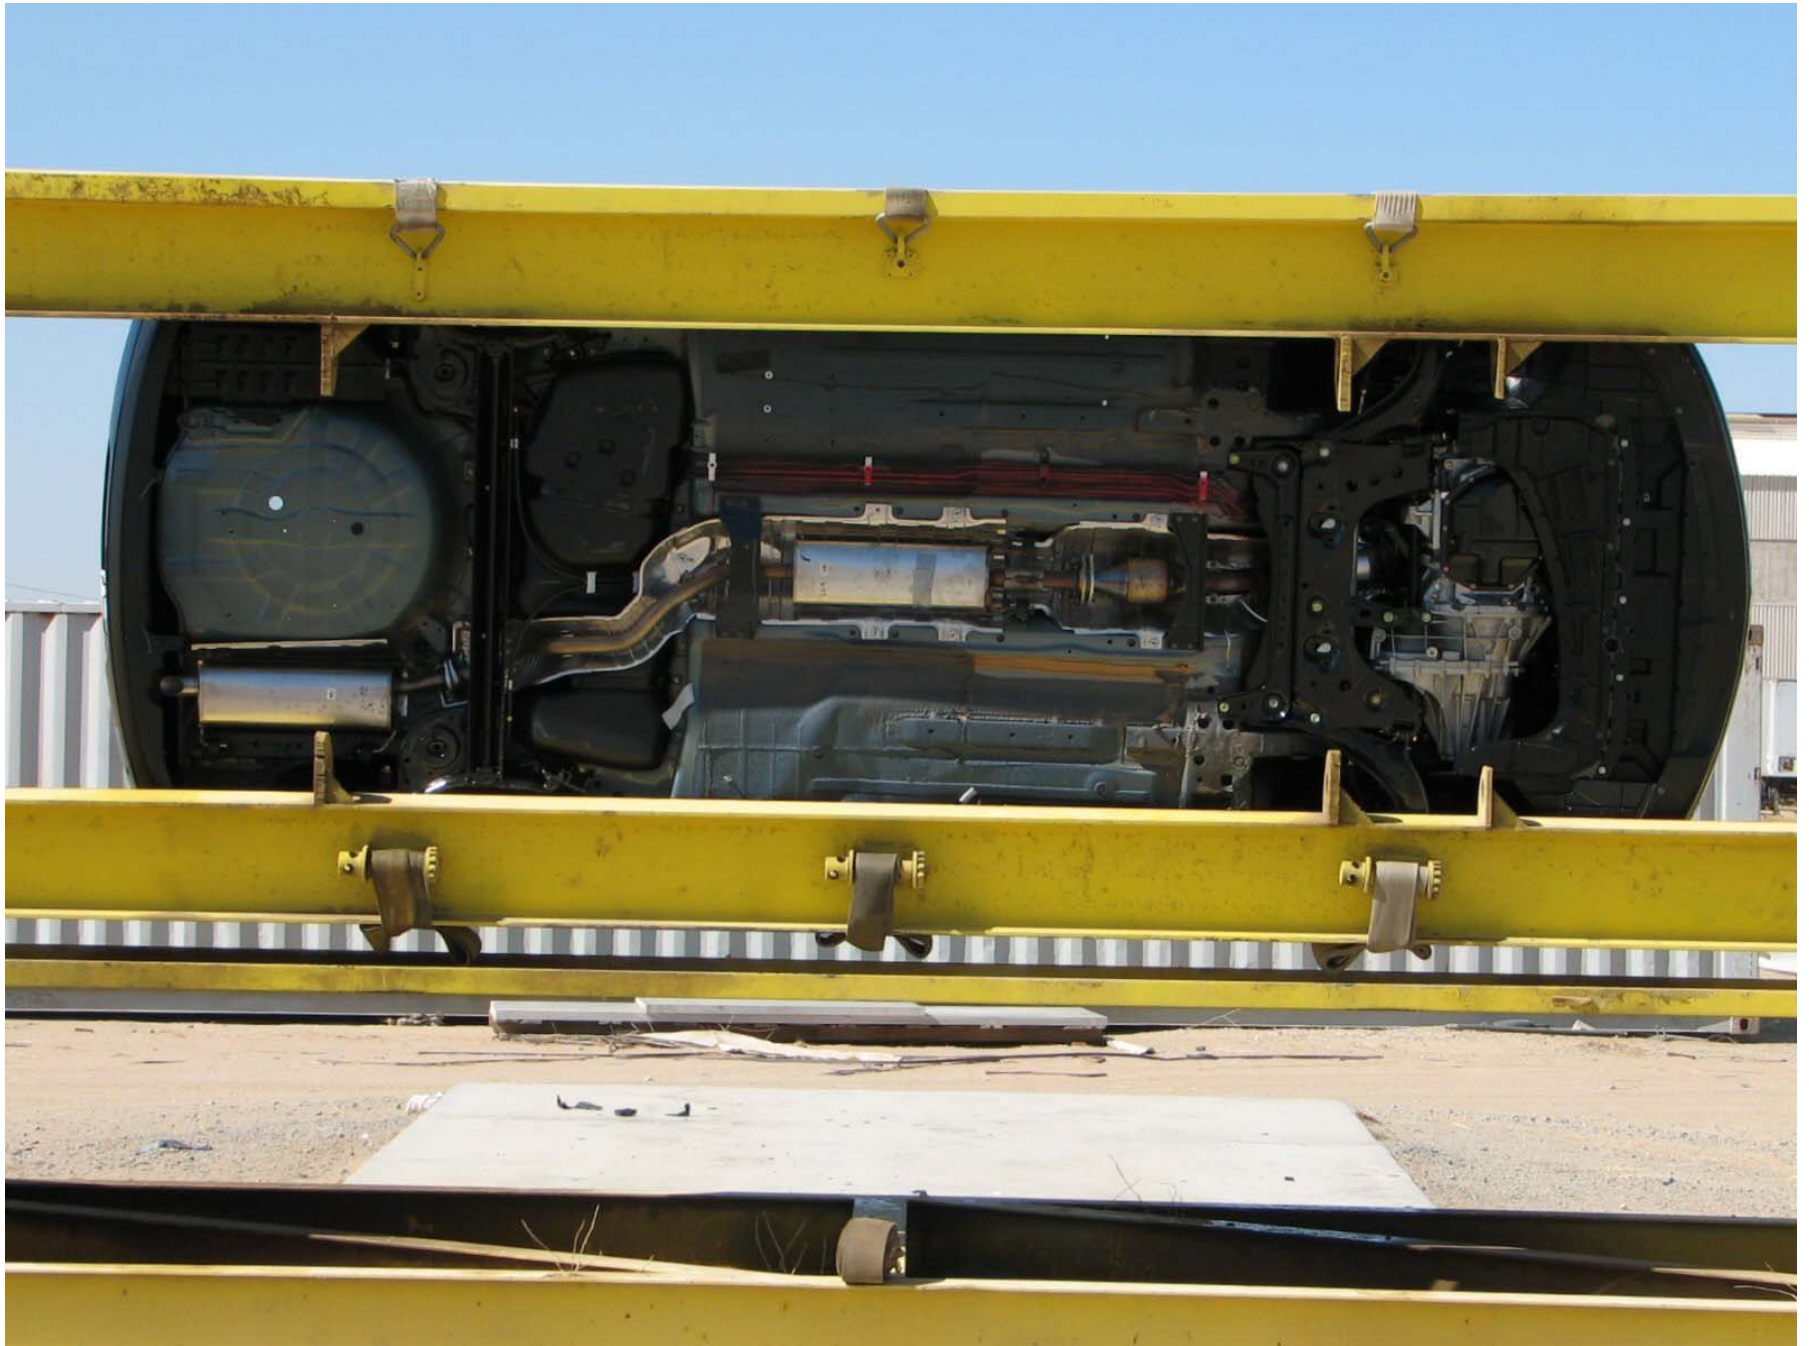
Figure A-61: Vehicle on Rollover Device (0°)

Figure A-62: Vehicle on Rollover Device (90°)

Figure A-63: Vehicle on Rollover Device (180°)

Figure A-64: Vehicle on Rollover Device (270°)

1. The specified fixture rollover rate for each 90° of rotation is 60 to 120 seconds.
2. The position hold time at each position is 300 seconds (minimum).
3. Details of Stoddard Solvent spillage locations.  
No solvent leakage occurred during static rollover testing.
